Re: RIPDES RIR101477 / WQC 16-171 Unanticipated Bypass Notification  
Fields Point Liquefaction Project  
642 Allens Avenue/121 Terminal Road  
Providence, Rhode Island

We are providing this written notification of an unanticipated bypass of sediment and erosion controls at the Fields Point Liquefaction Project (FPLP) that occurred on the morning of Monday 11/23/2020. Per the requirements of Section V.P.2 of the Rhode Island Pollutant Discharge Elimination System (RIPDES) Construction General Permit (CGP), National Grid provided a verbal notification to RIDEM (within 24-hours) of the bypass on 11/24/2020 at 9:30 am.

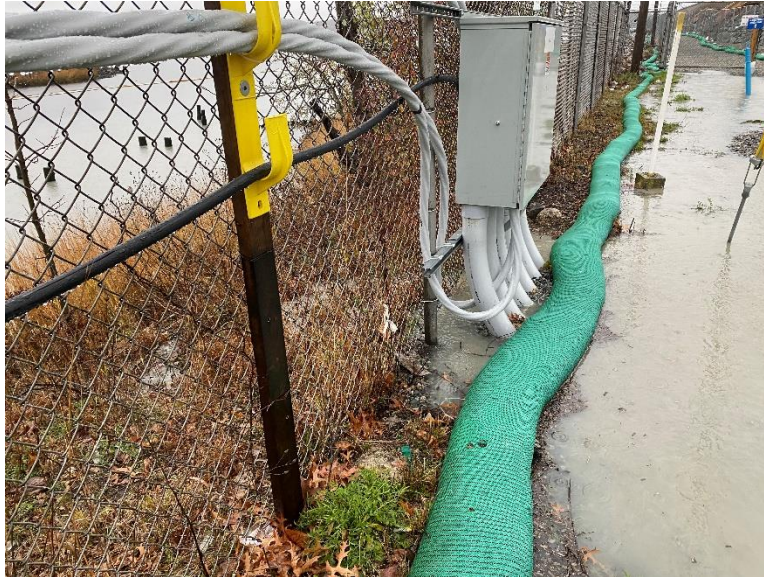
GZA first discovered the unanticipated bypass at approximately 10:30 am on 11/23/2020 during the SESC inspection. The unanticipated bypass occurred on the northern boundary of the project area. The perimeter controls along this northern boundary consist of filtrex soxx placed on both sides (north and south sides) of the access road that runs along the northern boundary of the project area. During the time of the inspection the filtrex soxx were observed to be in good condition. The bypass consisted of turbid water that was able to flow underneath the filtrex soxx due to a preferential pathway that likely developed from a temporary electrical conduit trench running across the access road (refer to the photos below). This turbid water was able to reach the cove area, resulting in a turbid plume. The plume was contained within the cove area by the existing containment boom and did not appear to impact the water beyond the boom (refer to the photo below).

*Photo 1: Unanticipated bypass of the perimeter controls on the northern boundary of the Site.*

Representatives from National Grid, GZA and Kiewit met the following morning (11/24/2020) to further investigate the cause of the bypass and discuss additional response actions. The project team determined that the bypass was most likely caused by the following factors:

- Protective steel plates were placed over the temporary electrical conduit trench running across the access road. The row of filtrexx soxx on the southern side of the access road was placed on top of the steel plates, which allowed sediment laden stormwater runoff to flow underneath the steel plates and bypass the row of filtrexx soxx on the southern side of the access road.

- A 5-foot section of filtrexx soxx along the northern side of the access road had been placed over crushed stone, which was used to stabilize the surface of the temporary electrical conduit trench. The crushed stone underneath this section of filtrexx soxx along the northern side of the access road allowed a preferential pathway underneath the filtrexx soxx.

- A significant grade change in the area immediately south of where the unanticipated bypass occurred over the past several months. This grade change resulted in steeper slopes that temporarily direct overland stormwater flow towards the area of the temporary electrical trench. The steep slopes will be mitigated during future construction phases and overland storm water flow will be directed to the sand filter that will be built as part of the project.

Upon discovery, GZA notified National Grid and Kiewit of the issue and requested that additional controls be installed. Kiewit responded by adding two (2) additional rows of filtrex soxx along the northern perimeter, which was completed by 11:00 am (refer to photo below). GZA observed that once the two additional rows of filtrex soxx were installed, the volume of stormwater runoff leaving the site was significantly reduced and the clarity of the runoff was significantly improved. At that point, the project was placed under a safety stand-down due to lightening in the area.

In response to these observations, on 11/24/2020 Kiewit added a second row of filtrexx soxx on the north side of the access road, refer to photo below. On 11/25/2020 Kiewit installed additional filtrexx soxx and filter fabric along the southern side of the access road, and specifically south of the steel plates, to prevent stormwater runoff from flowing underneath the steel plates, refer to photos below. A small trench (6-inches deep, 1-foot wide, and 15-feet long) was excavated south of the steel plates, the trench was lined with filter fabric and a 15-foot section of filtrexx soxx was placed in the trench over the filter fabric. Also, on 11/25/2020, Kiewit spread crushed stone over select areas south of the electrical conduit trench within the Project Area to stabilize soils. Lastly, Kiewit will add crushed stone to the driving paths

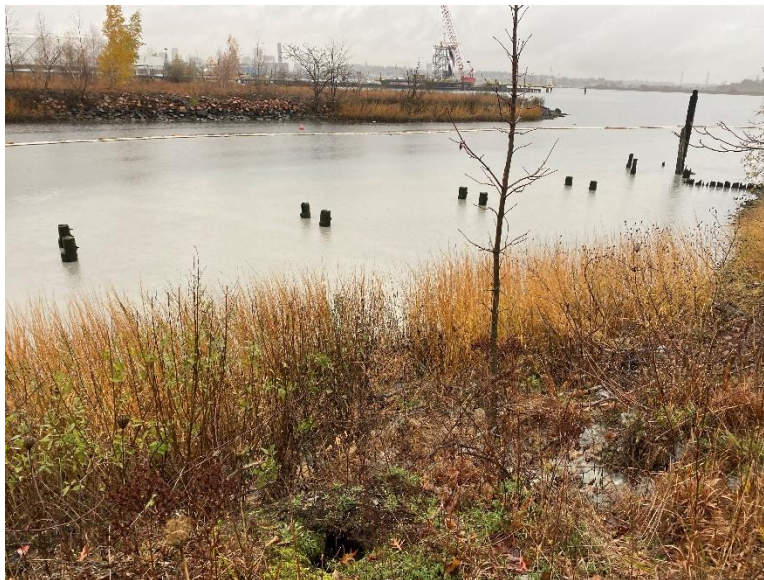
*Photo 2: Turbid plume contained within the existing boom in the cove area north of the Project Area.*

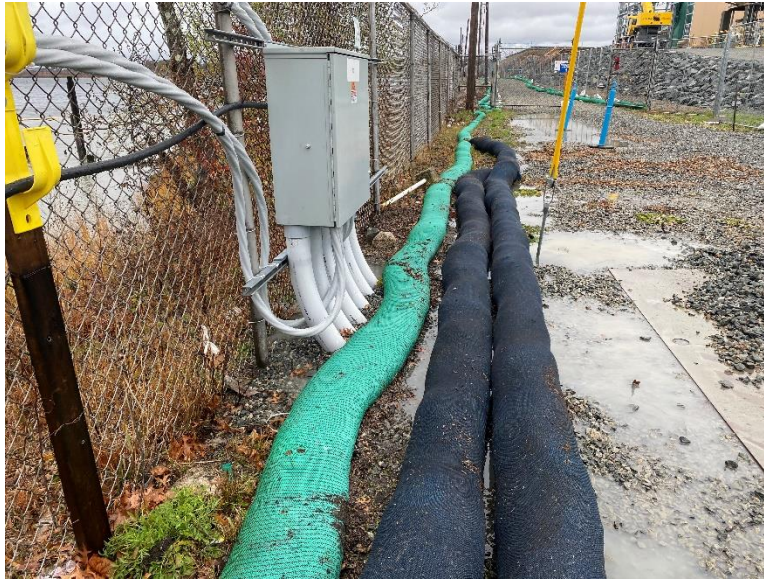
*Photo 3: Additional filtrexx soxx installed in response to the unanticipated bypass.*

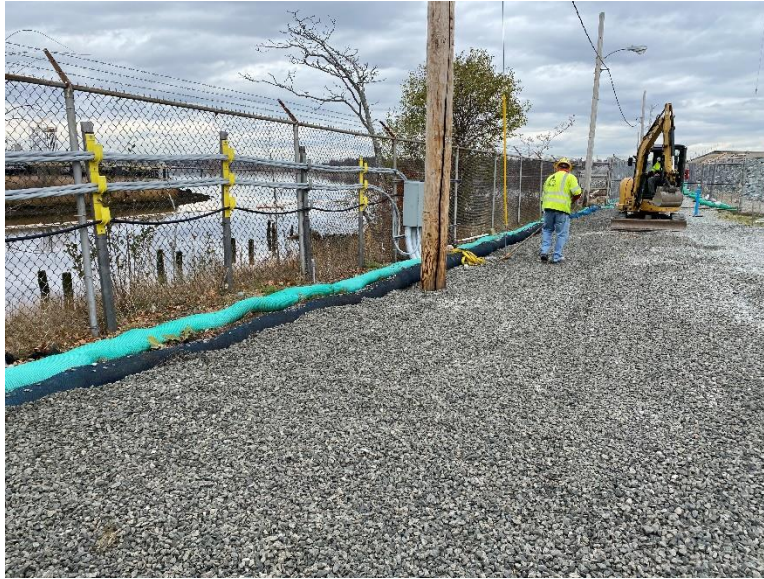
*Photo 4: Second row of filtrex soxx on the north side of the access road*

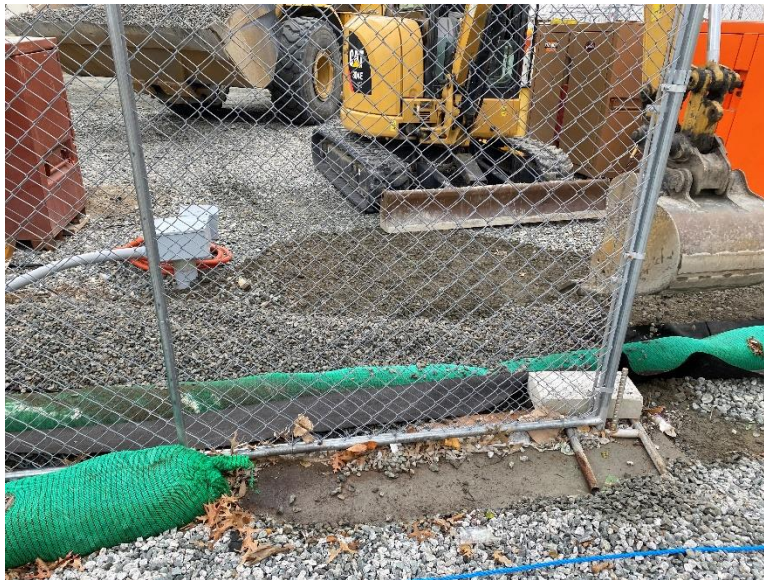
*Photo 5: Trench south of steel plates with filter fabric and filtrex soxx, crushed stone added to the area south of the electrical conduit trench.*

in the project area immediately south of where the bypass occurred to stabilize soils and reduce stormwater runoff velocity. Kiewit will also install a second layer of filtrex soxx on top of the 15-foot section placed in the trench south of the steel plates and will extend the filtrex soxx on the south side of the access road.

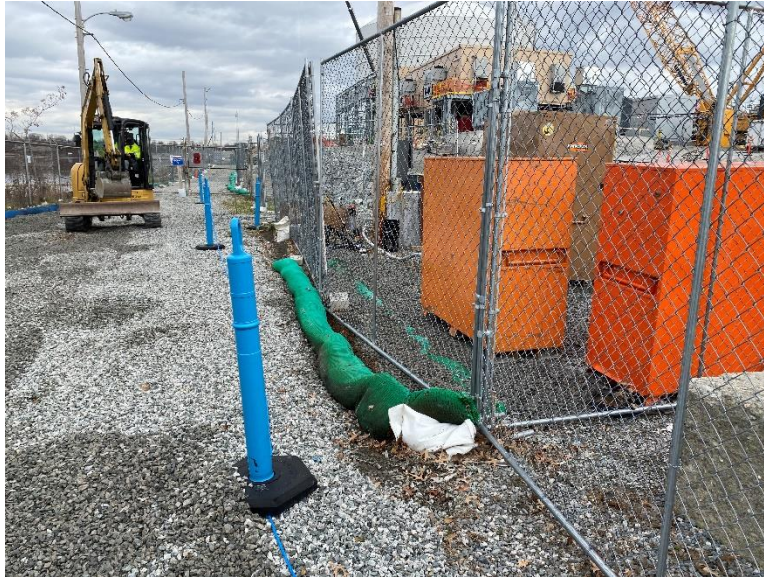
*Photo 6: Filtrexx soxx along the south side of the access road to be extended.*
