WATERMAN RESERVOIR DAM, SMITHFIELD (111)

ATTACHMENT I
FIELD RECONNAISSANCE CHECKLIST

DAM HAZARD POTENTIAL CLASSIFICATION MAP

WATERMAN RESERVOIR DAM
SMITHFIELD, RHODE ISLAND

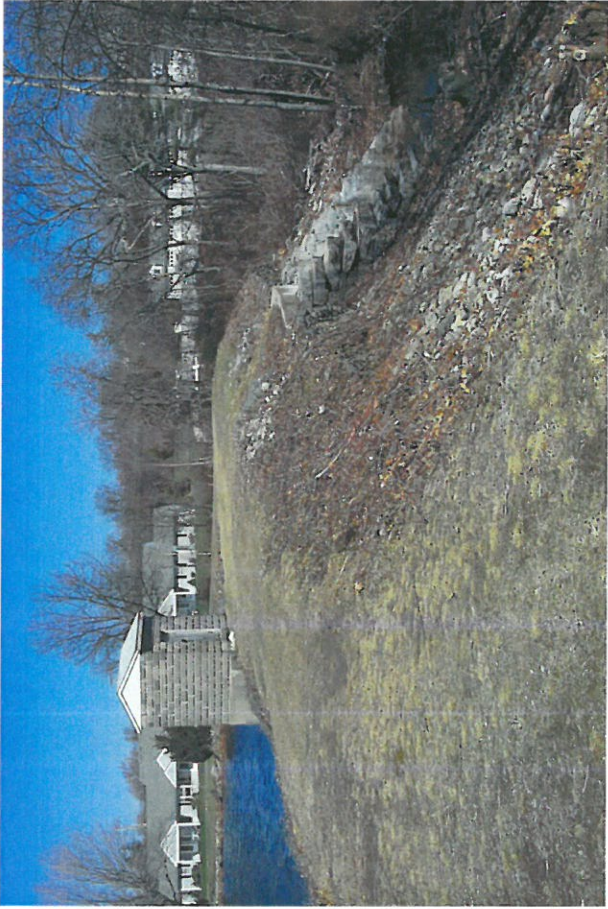
Description: Photo 1. View of gatehouse and embankment near left abutment of dam.

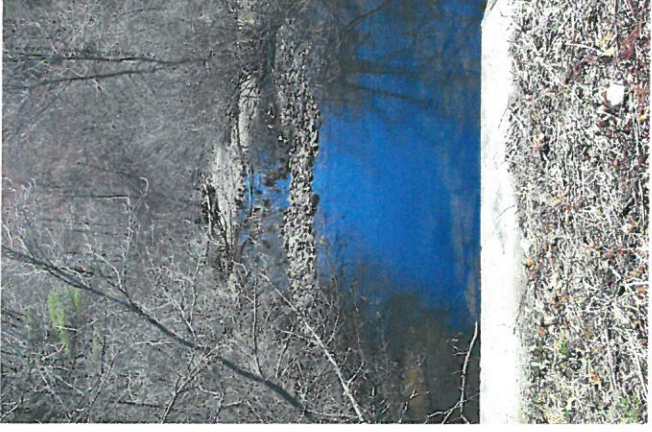
Description: Photo 2. View of downstream channel from gatehouse.

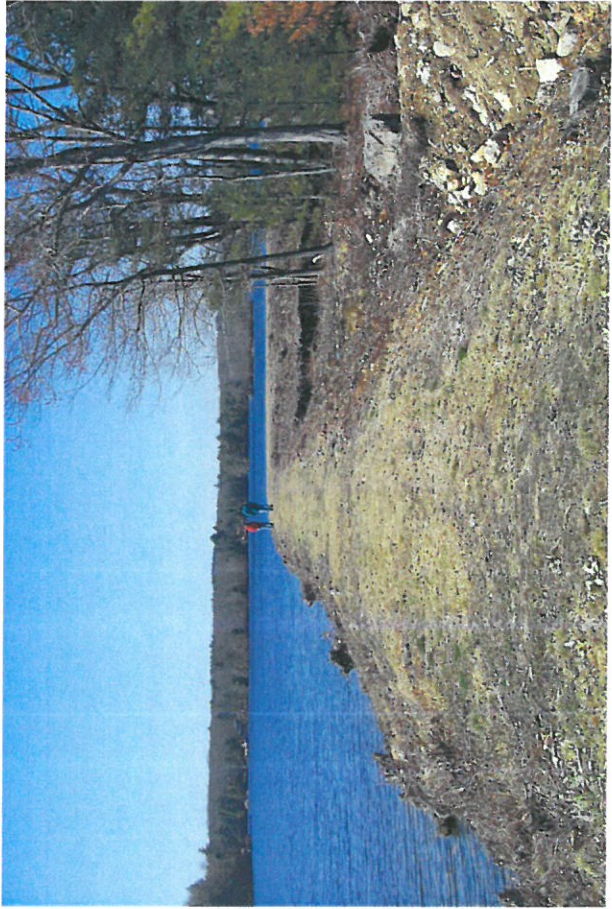
Description: Photo 3. Typical embankment section of Waterman Dam.

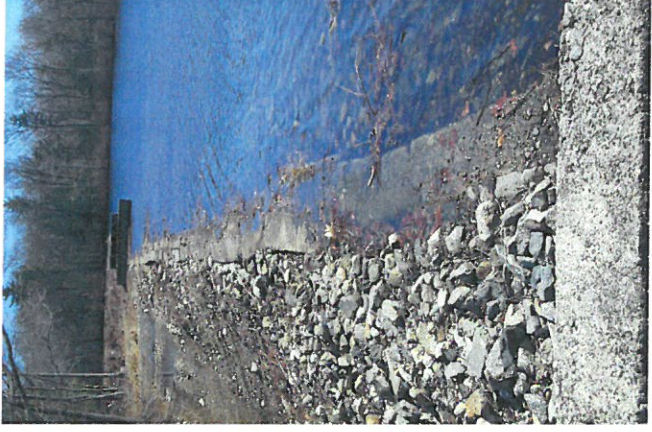
Description: Photo 4. View of spillway from left spillway abutment.

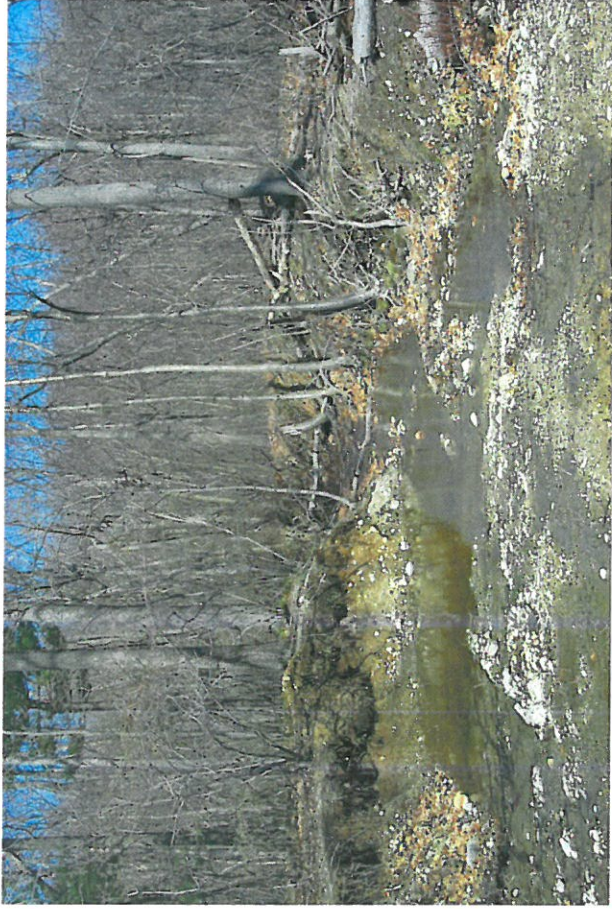
Description: Photo 5. View of spillway discharge channel.

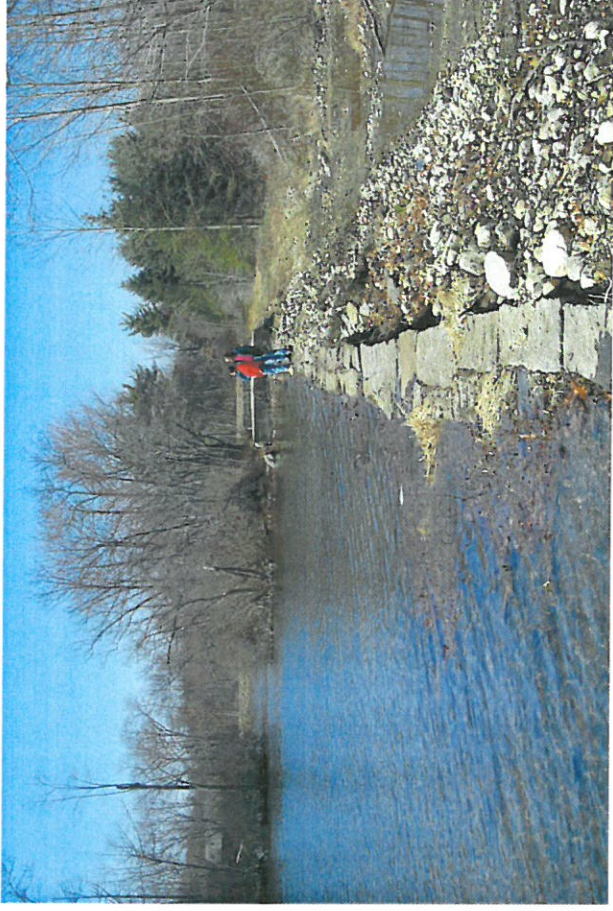
Description: Photo 6. View of spillway and embankment left of spillway.

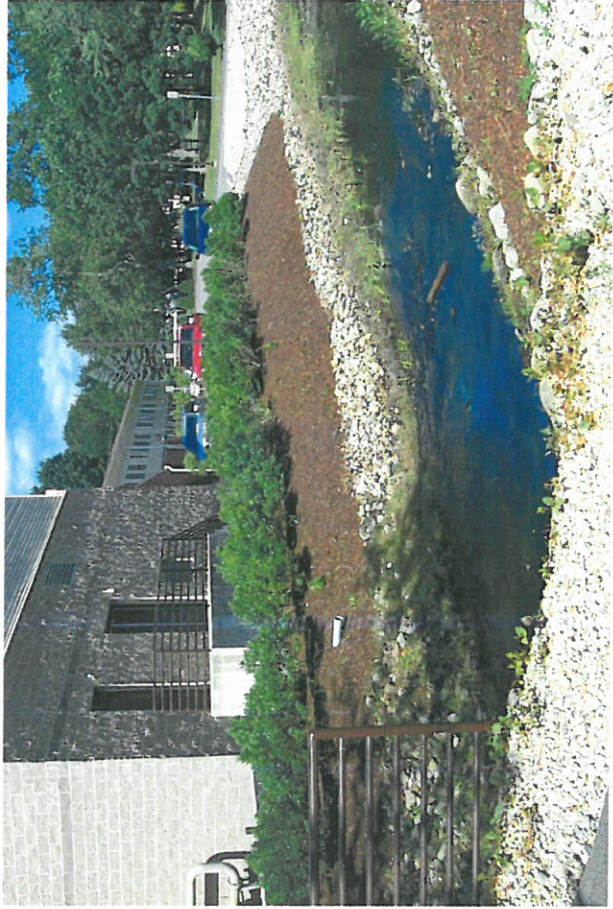
Description: Photo 7. View of downstream channel with assisted living facility in background.

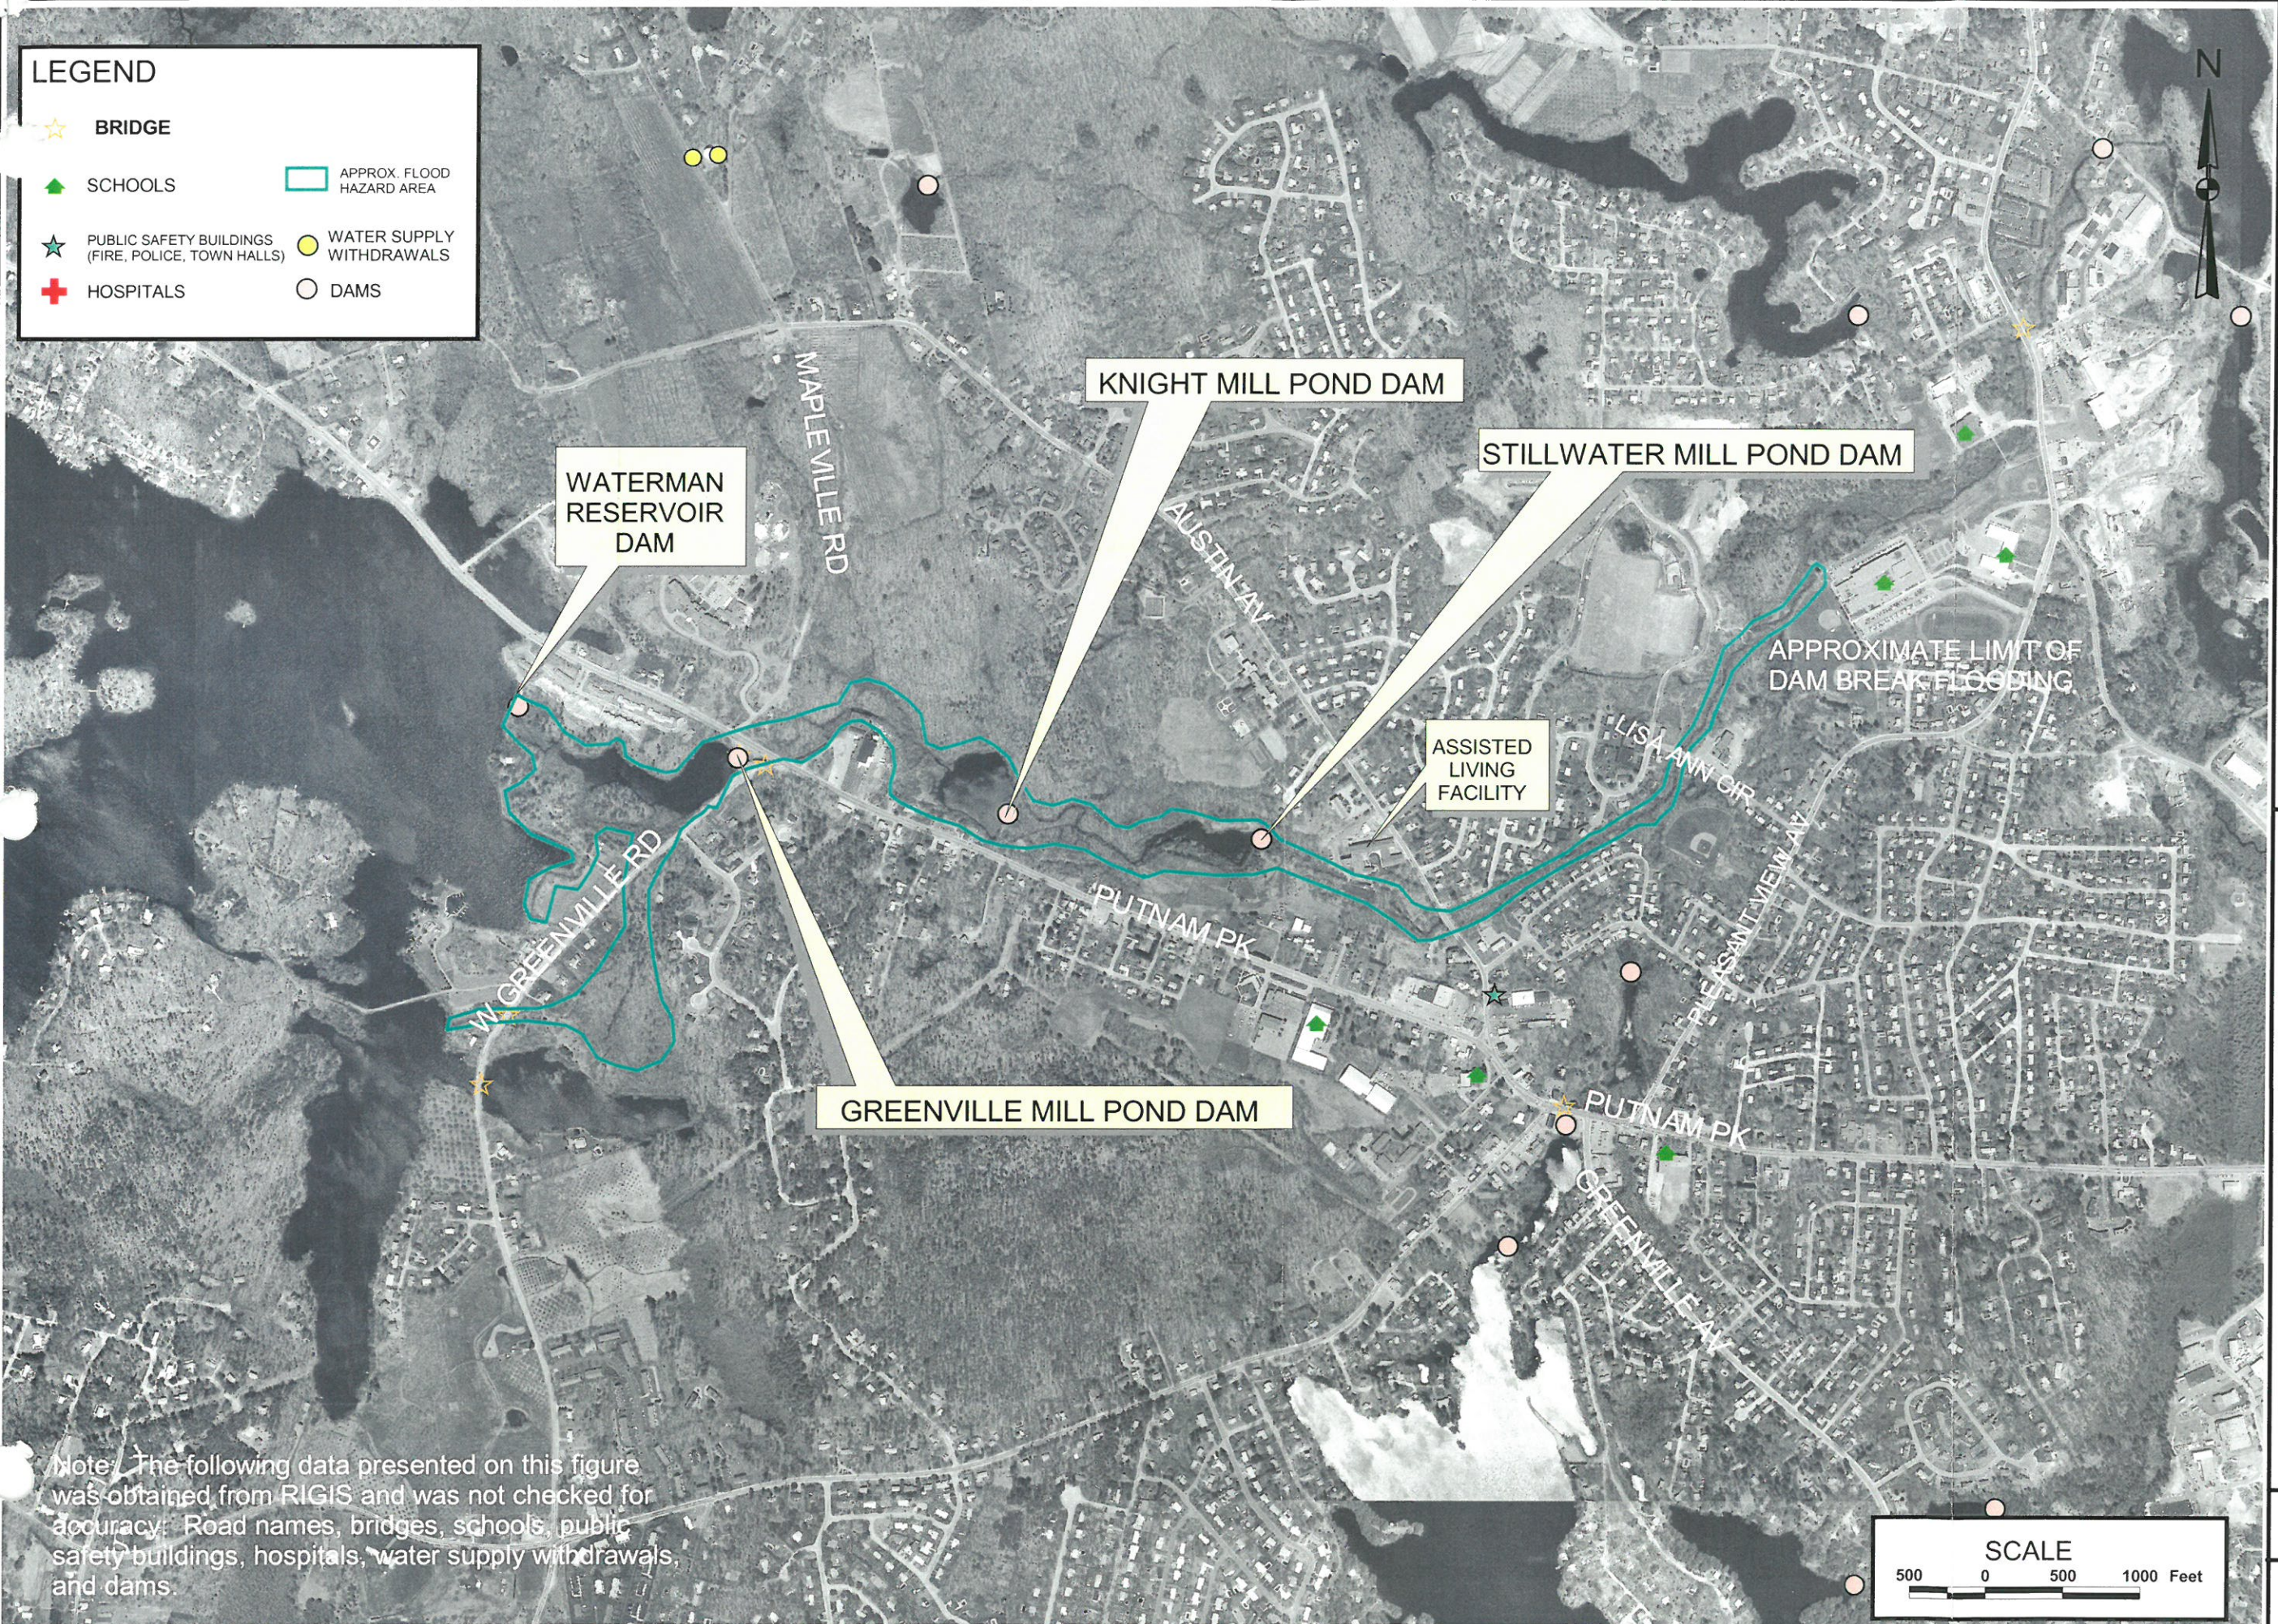
FIGURE 2

Several riverine cross sections, developed by GZA from USGS 7.5 minute quadrangle maps, were input into the SMPDBK model to preliminarily estimate approximate peak water surface elevations. The results of the analysis are provided as the approximate inundation area depicted in **Figure 2**.

Results of the analysis indicate a peak flood depth at the immediate toe of the dam of about 10 feet. As the flood wave progresses downstream, it is expected to attenuate. Thus, peak flood depths are predicted to decrease to about 6 ft about 2.5 miles downstream of the dam. It is likely that the failure of Waterman Reservoir Dam would result in the domino failure of the three small mill dams (discussed in Section 1.23) on the Stillwater River. Flooding may also occur on Putnam Pike / Route 44 and the nursing home located on the left overbank of the Stillwater River would likely experience flooding.

GZA recommends that Waterman Reservoir Dam be classified as *High Hazard* based on the aforementioned analyses, site / downstream valley reconnaissance, site-specific GIS mapping and other existing data, and professional judgment. A potential dam failure of Waterman Reservoir Dam would result in probable loss of human life, and cause major economic losses to the downstream vicinity. The major issue in the hazard classification of Waterman Reservoir Dam is the presence of the nursing home about 5 to 10 feet above the river channel about 1.0 mile downstream, a portion of which is likely to be subjected to flood flows, jeopardizing human life. The potential impact areas also include damage to small downstream dams, possible submergence and washout of Route 44 (resulting in the possibility of loss of life considering its proximity to the dam and well-traveled nature), and potential damage to the culvert beneath Austin Avenue.
