2020 Biennial Inspection Report

Flat River Reservoir Dam Coventry, Rhode Island RI Dam ID No. 167

RTG Project No. 20102.00

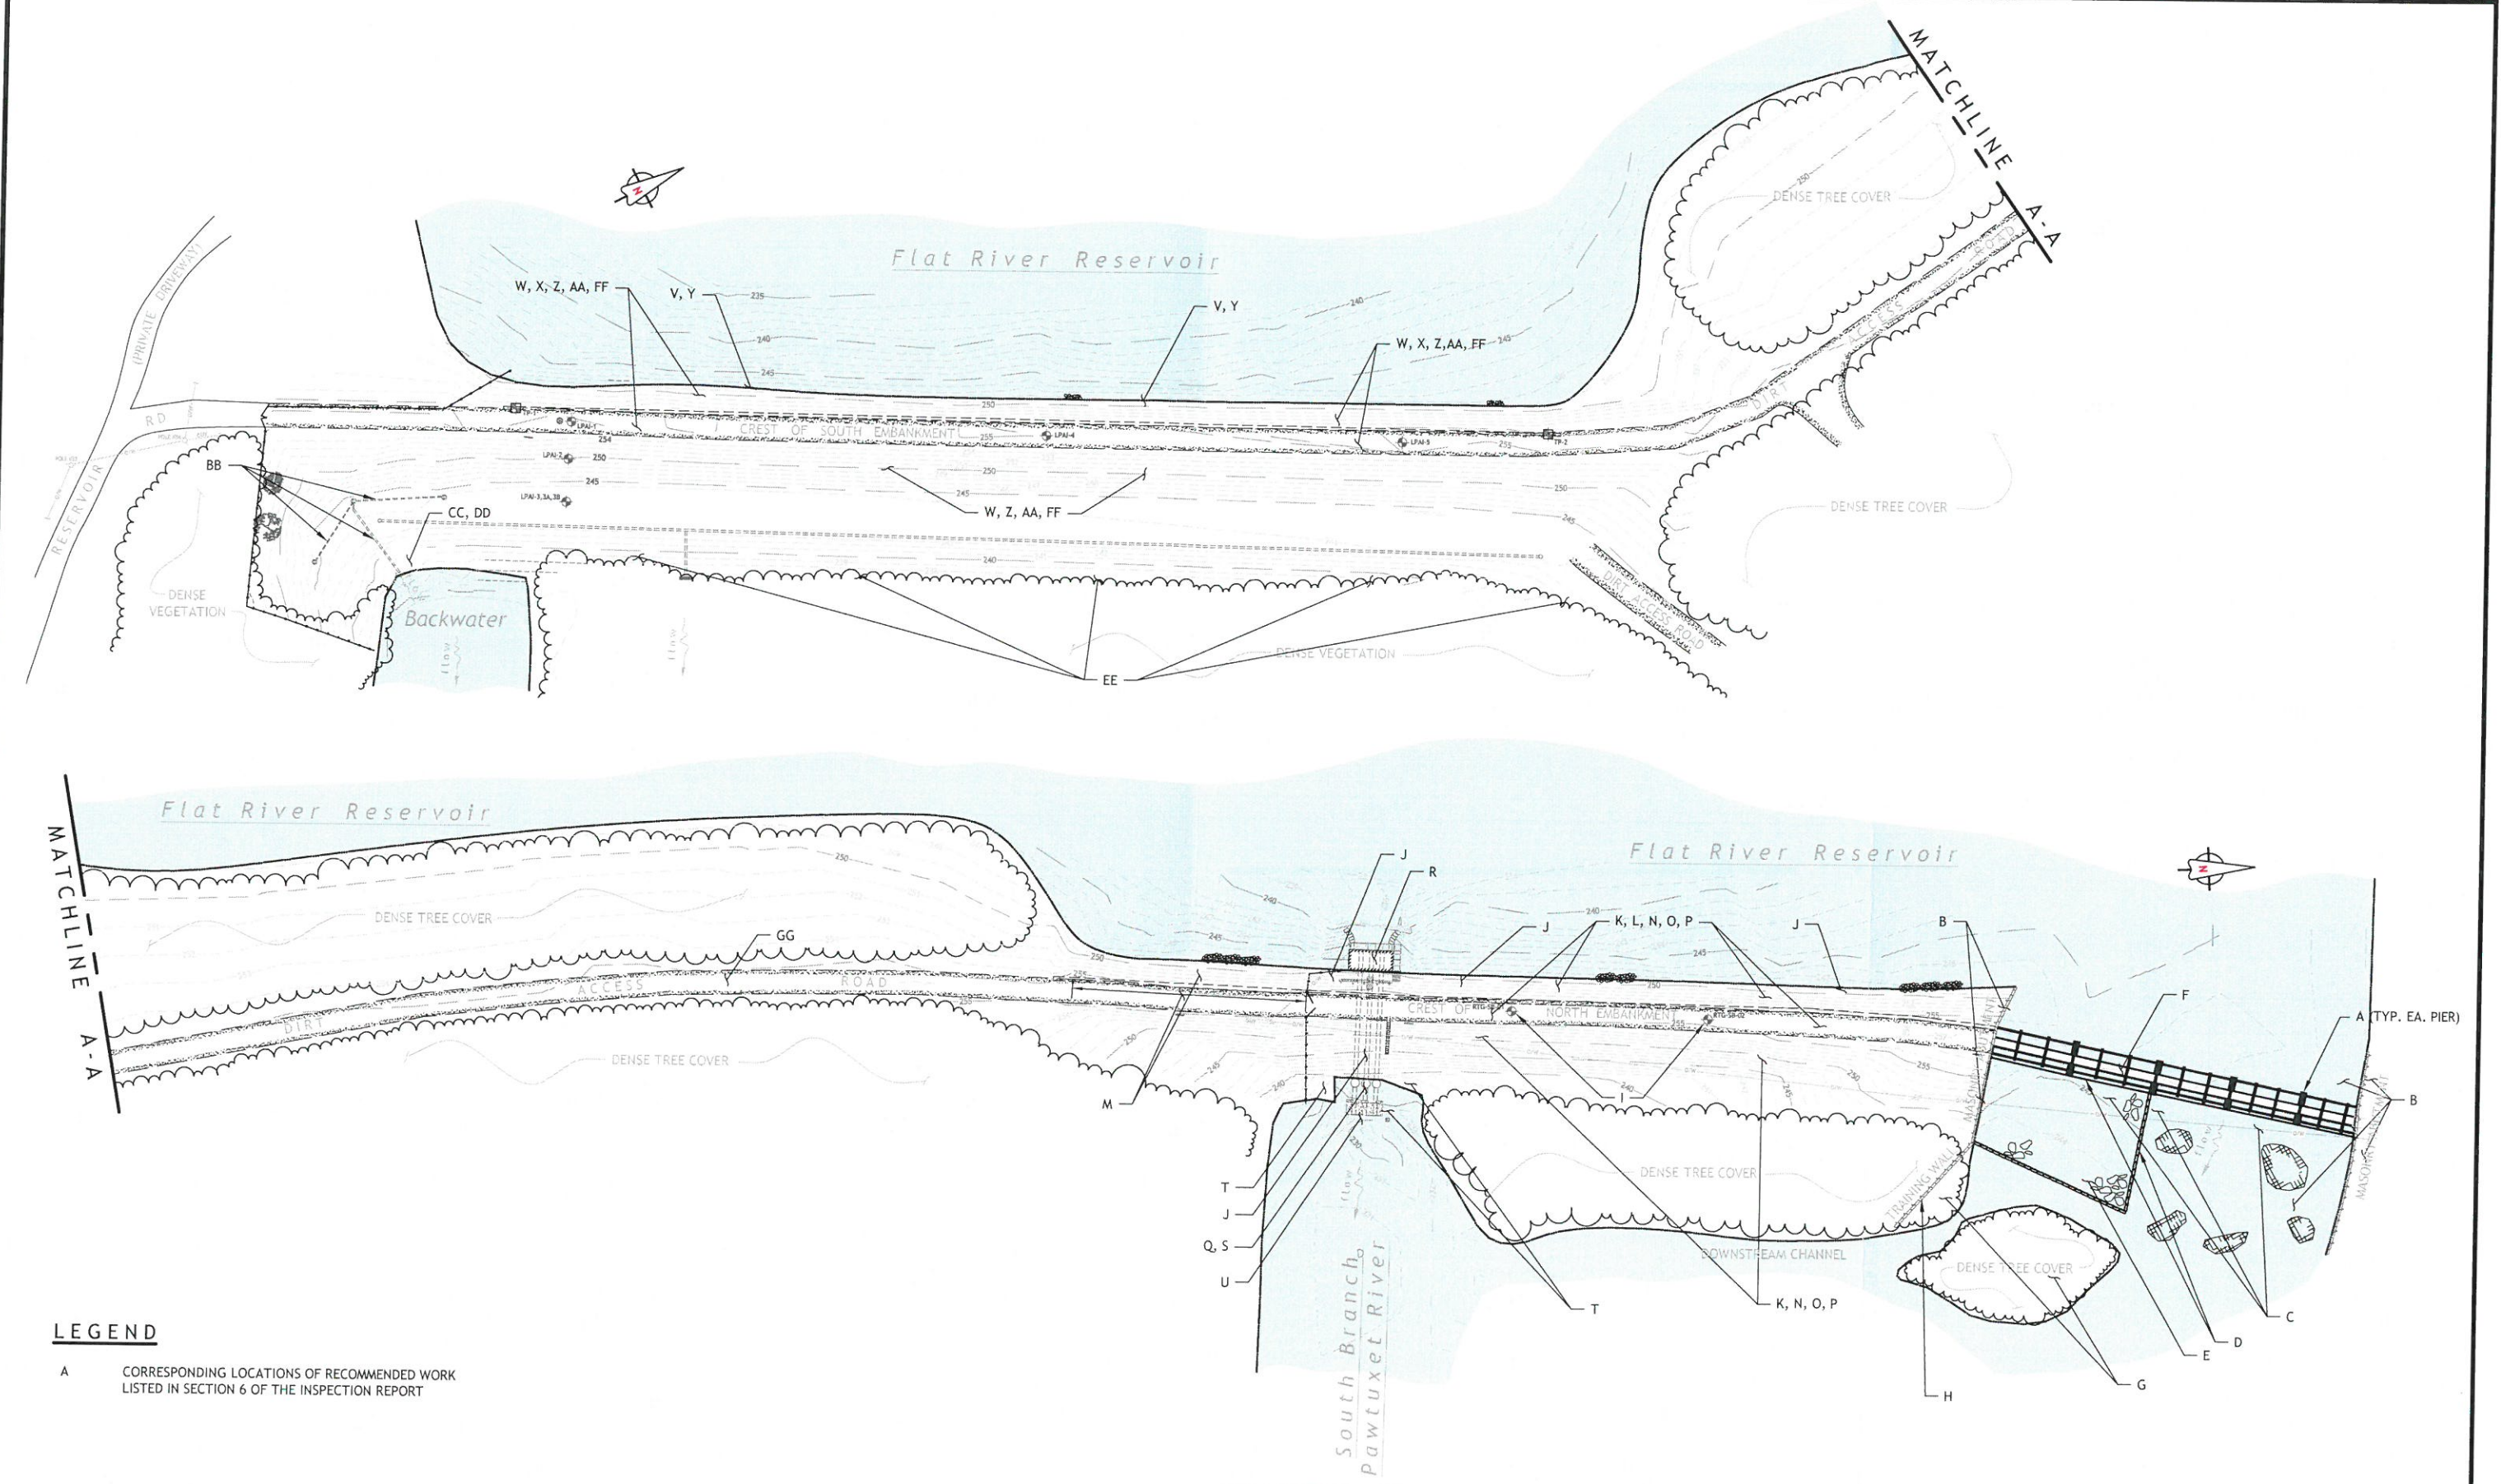
**FIGURE 6-1
 OBSERVED DEFICIENCIES AND
 RECOMMENDATIONS PLAN**

Based on the visual inspection completed, the Flat River Reservoir Dam is considered to be in fair condition. The following recommendations are presented in the same order as presented in the report and their corresponding locations are shown on Figure 6-1. The recommendations are ranked for action as follows:

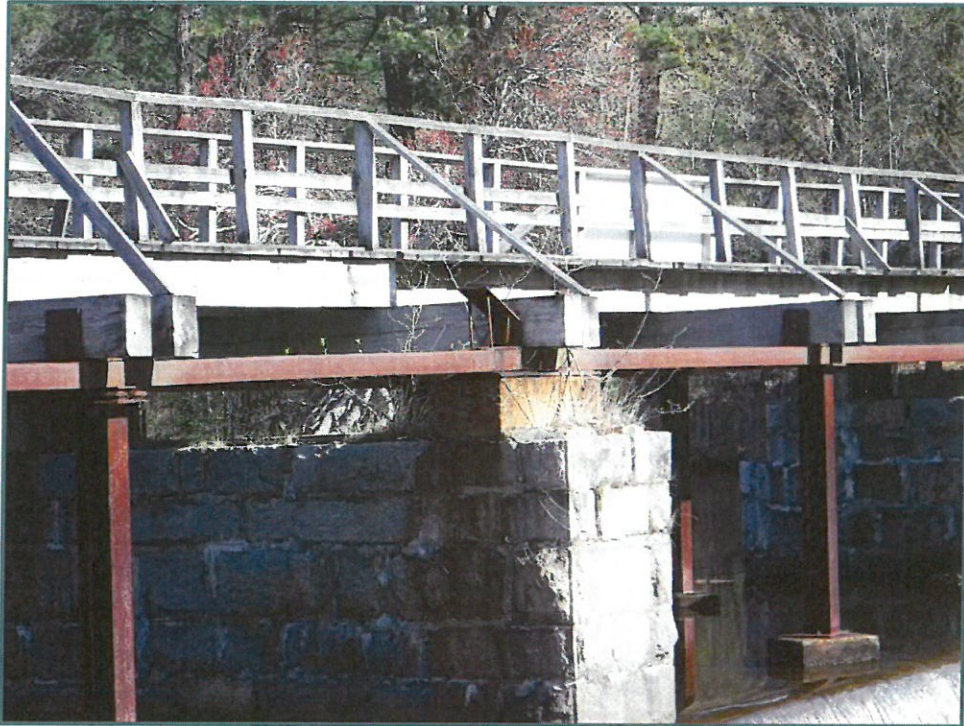
Photo No. 3:

The footbridge piers were observed to be mostly in fair condition. However, open joints were observed in some of the piers and vegetation was observed to be growing from them in some areas. Vegetation was also observed growing along the top of the piers (Photo No. 3). It is recommended that this vegetation be removed to prevent it from loosening the stonework and that the open joints in the piers be cleaned and repointed with grout.

Vegetation growing along the top of the spillway piers and open joints within the spillway piers with vegetation, looking northwest, photo taken on May 11, 2020.

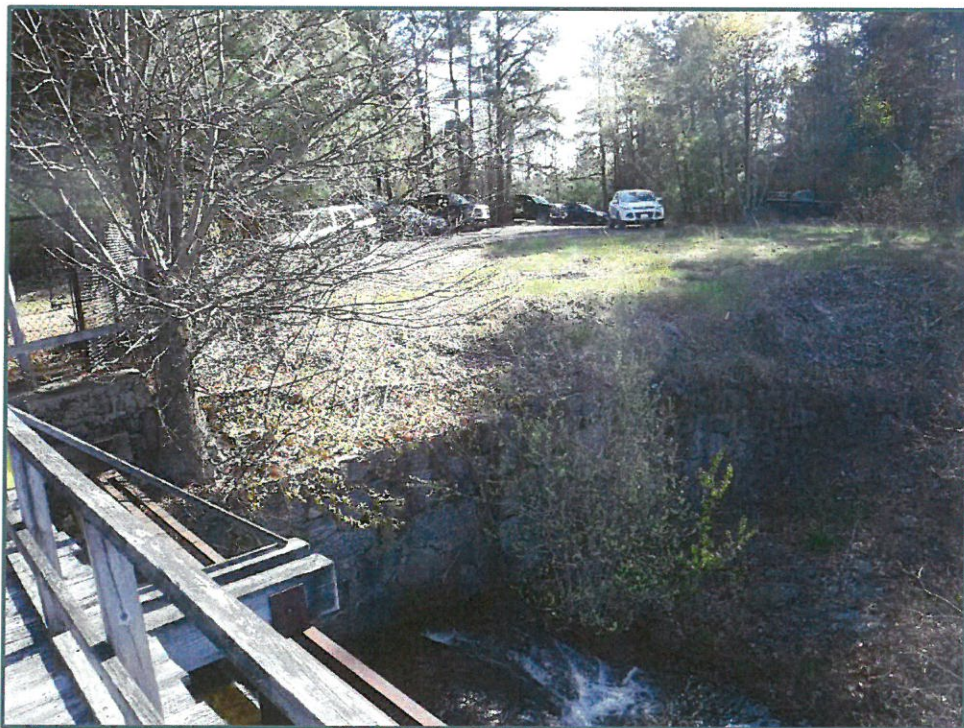
Photo No. 4:

Overgrown vegetation was observed in front of and behind the north and south masonry abutments (Photo Nos. 4 and 5) as well as adjacent to the spillway in the upstream and downstream areas (Photo Nos. 6 and 7). The vegetation behind the abutment walls could dislodge their masonry stones or cause the abutments to collapse should the larger trees become uprooted. The vegetation in the spillway could obstruct flow during a significant storm event. It is recommended that this vegetation be removed and any resulting voids or soil disturbance filled by placing, grading, and compacting granular material followed by loam and seed.

Overgrown vegetation in front of and behind the north abutment wall, looking northeast, photo taken on May 11, 2020.

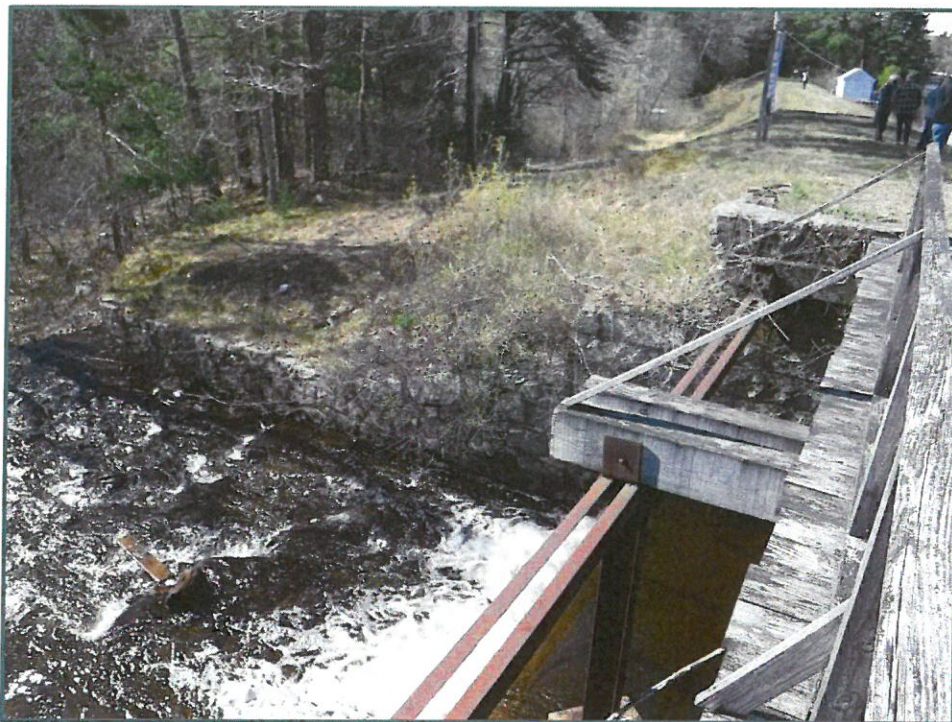
Photo No. 5:
Overgrown vegetation behind the south abutment wall,
looking south, photo taken on May 11, 2020.

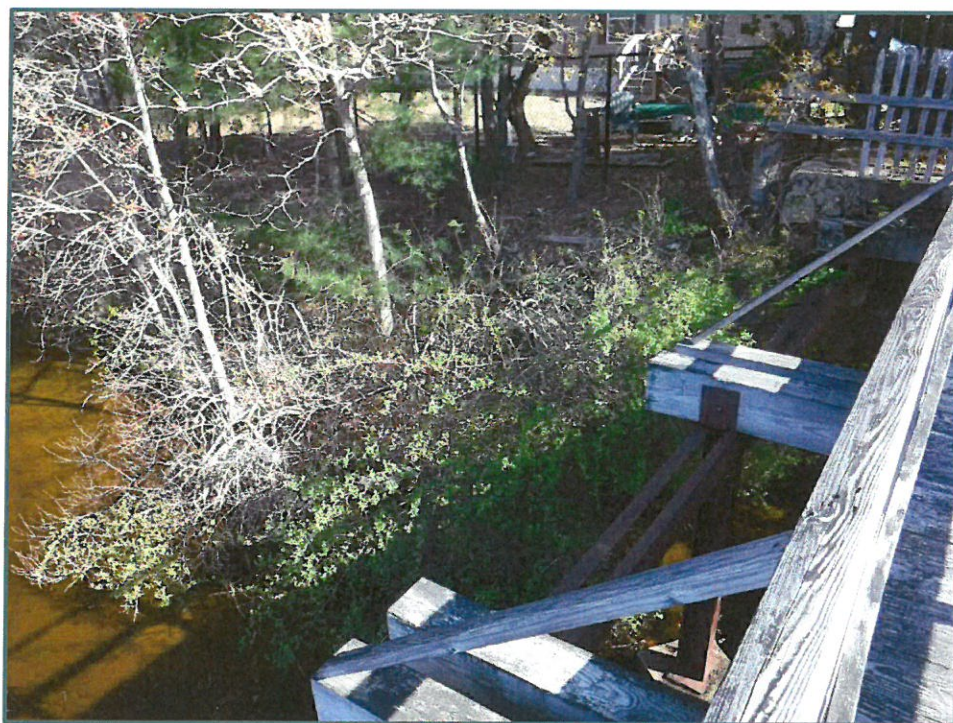
Photo No. 6:
Overgrown vegetation along the left side of the upstream spillway area,
looking north, photo taken on May 11, 2020.

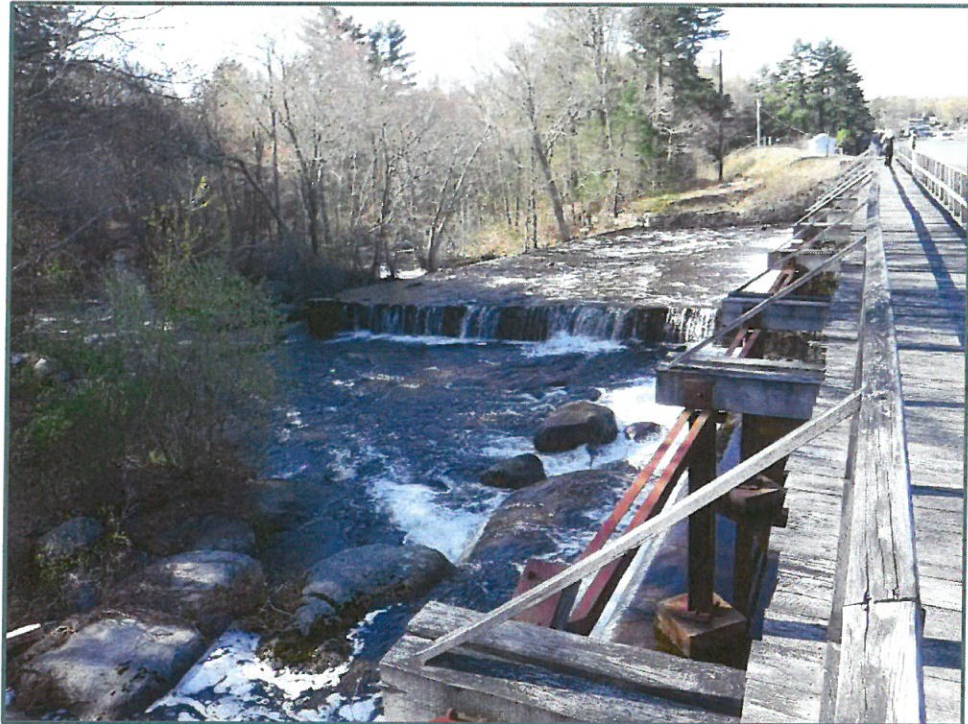
Photo No. 7:
Overgrown vegetation along the left side of the downstream spillway area, looking south, photo taken on May 11, 2020.

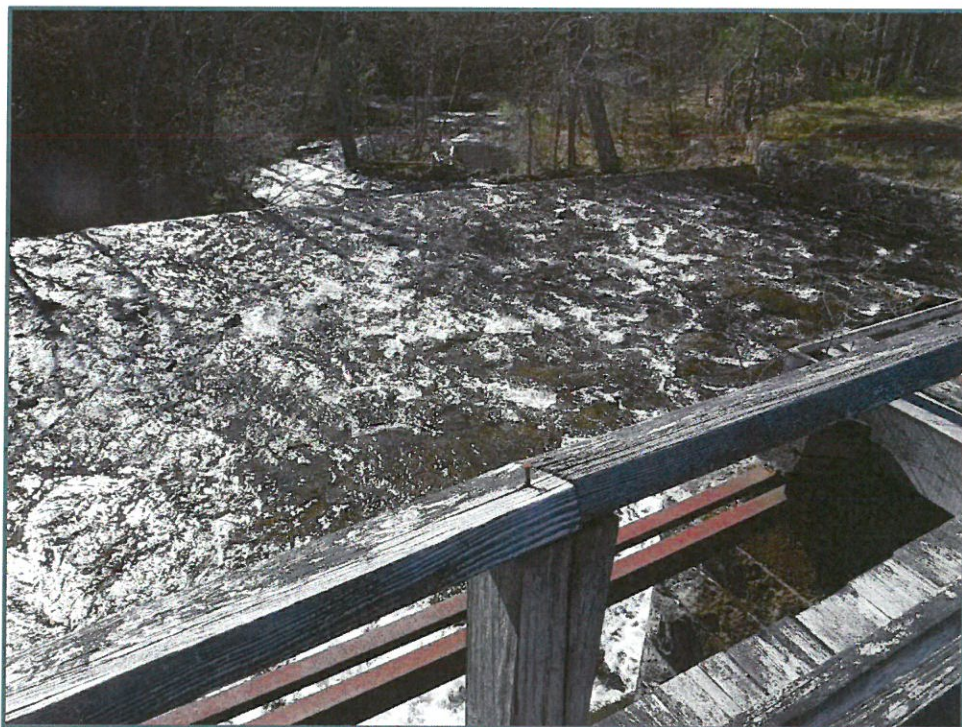
Several timber boards/braces were observed to be splintered and/or loose along the footbridge and footbridge handrails with fasteners becoming dislodged (Photo No. 8). It is

Photo No. 8:
Loose timber handrail and fastener along the timber footbridge, looking southeast, photo taken on May 11, 2020.

recommended that all splintered and loose boards/braces and loose fasteners be repaired/replaced as required.

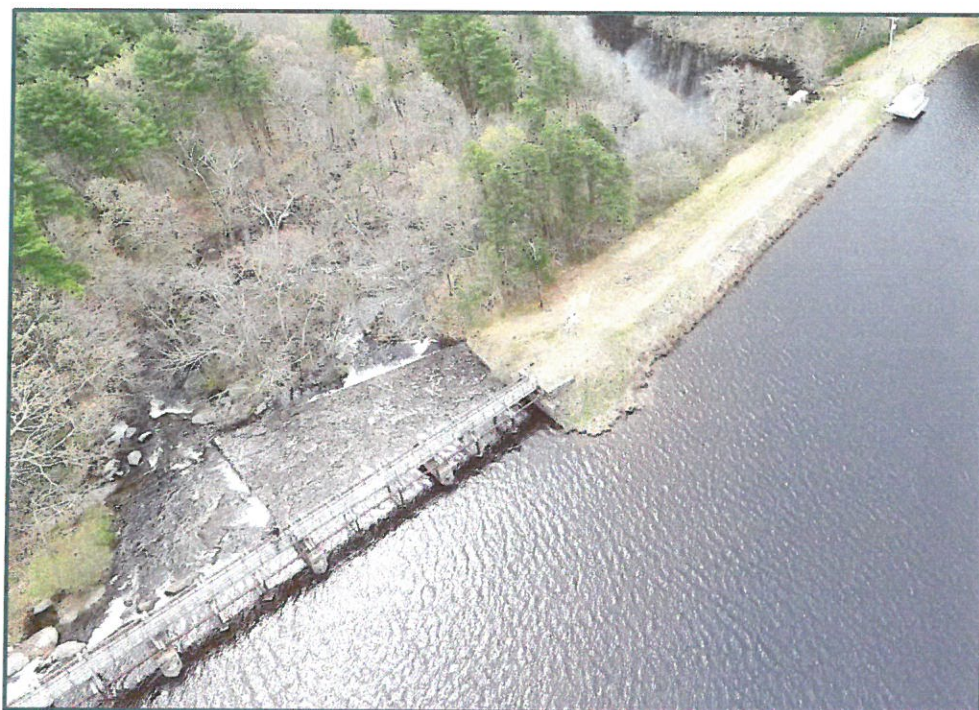
Heavy vegetation including mature trees and undergrowth was observed within the downstream channel which could obstruct flow during a significant storm event (Photo No. 9). Vegetation is also present behind and in front of the masonry training wall and has dislodged stones in some locations (Photo No. 10). It is recommended that this vegetation be removed from the downstream channel and near the masonry training wall. It is also recommended that voids in the wall be filled with appropriately sized stones, and the entire wall re-chinked with smaller stones.

Photo No. 9:
Downstream channel, looking southeast,
photo taken on May 11, 2020.

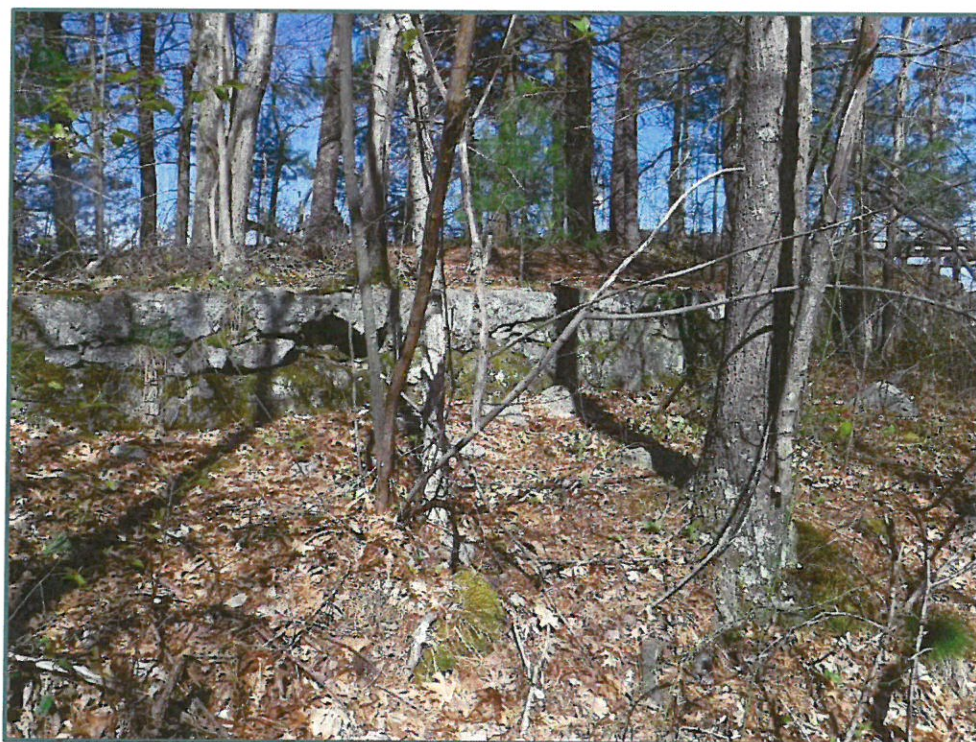
Photo No. 10:
Voids within and heavy vegetation at the downstream masonry training wall,
looking southwest, photo taken on May 11, 2020.

- H. Replace missing stones and re-chink the masonry training wall (3).

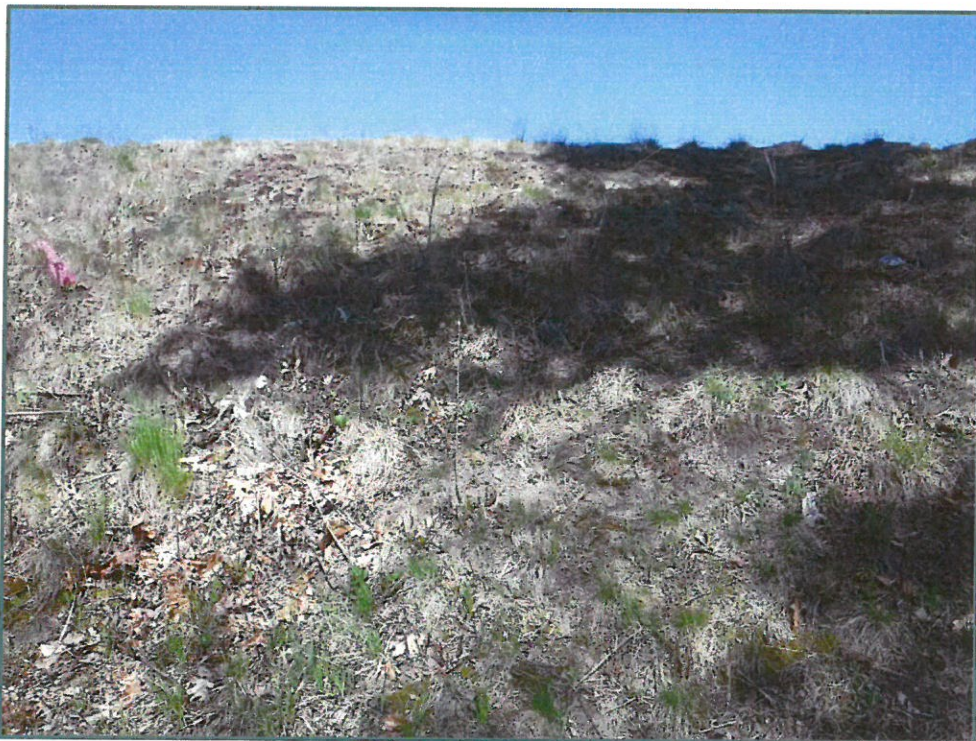
The grass cover on the upstream slope, crest, and downstream slope was observed to be sparse with frequent bare areas throughout containing little to no loam (Photo Nos. 12 and 13). In addition, overgrown woody vegetation exists along the toe of the upstream slope

Photo No. 12:
Typical sparse grass cover along the downstream slope of the north embankment,
looking west, photo taken on May 11, 2020.

It is recommended that the overgrown woody vegetation be cut, removed, and maintained. It is also recommended that all rodent holes be backfilled with granular material and compacted by "rodding" with a metal probe followed by loaming and seeding. With respect to the lack of grass cover, it is recommended that bare areas be loamed and seeded (i.e., similar to the "Test Section") in order to establish a healthy stand of grass to help minimize the potential for erosion from rainwater runoff and/or wave action.

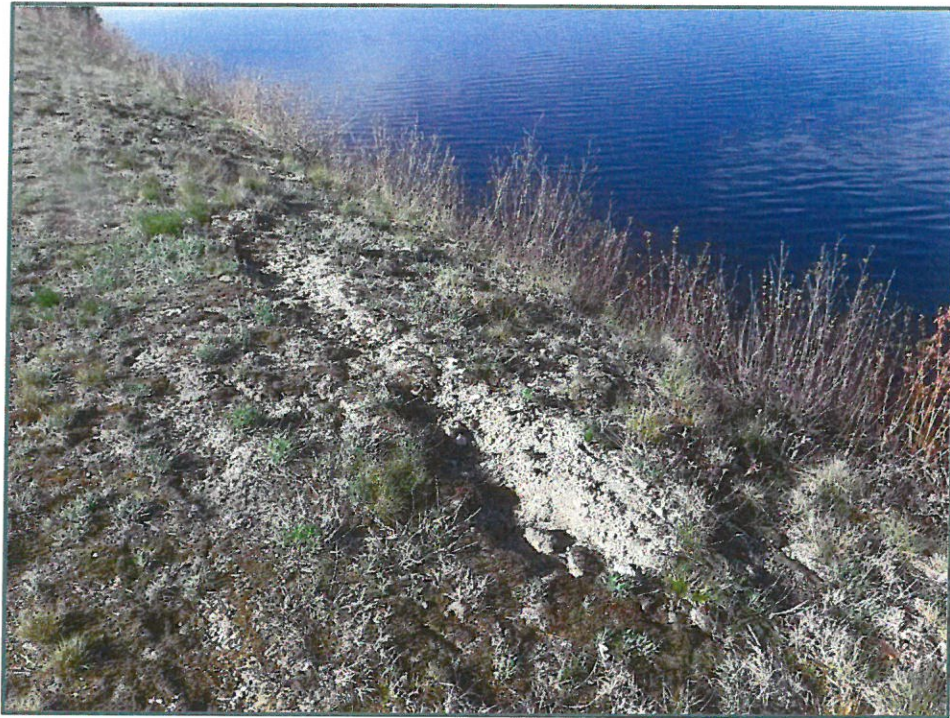
Photo No. 13:

(Photo No. 13), adjacent to the gatehouse on the upstream slope (Photo No. 14), and at the downstream slope in some areas (Photo No. 15). Some rodent holes were also observed in the dense vegetation on the downstream slope.

Typical sparse grass cover along the crest/upstream slope and overgrown woody vegetation along the base of the upstream slope of the north embankment, looking southwest, photo taken on May 11, 2020.

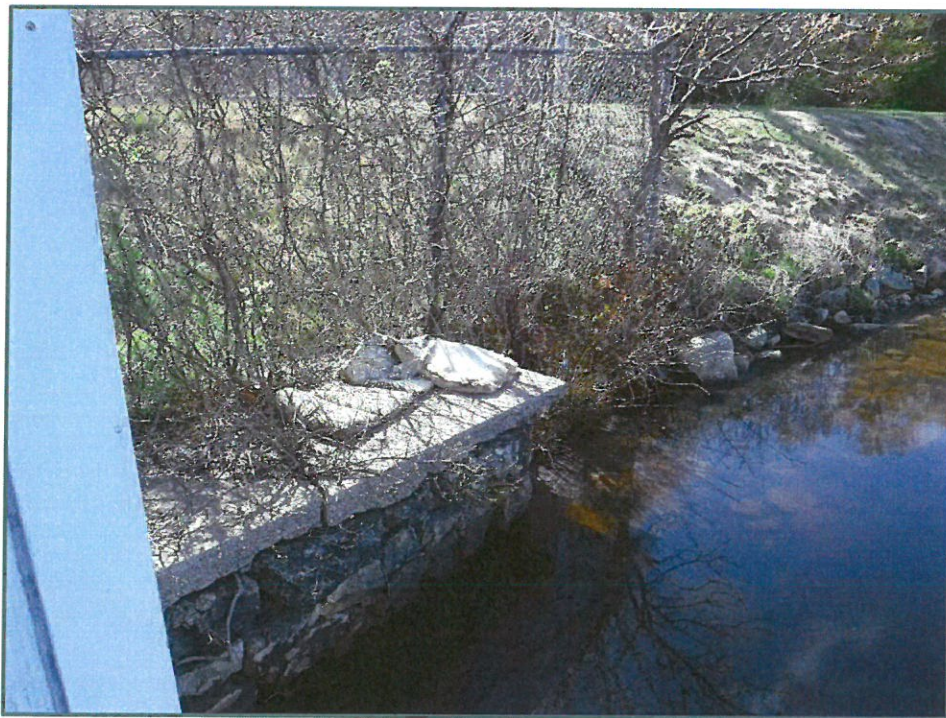
Photo No. 14:

Overgrown woody vegetation along the upstream slope of the north embankment near the gate house, looking southeast, photo taken on May 11, 2020.

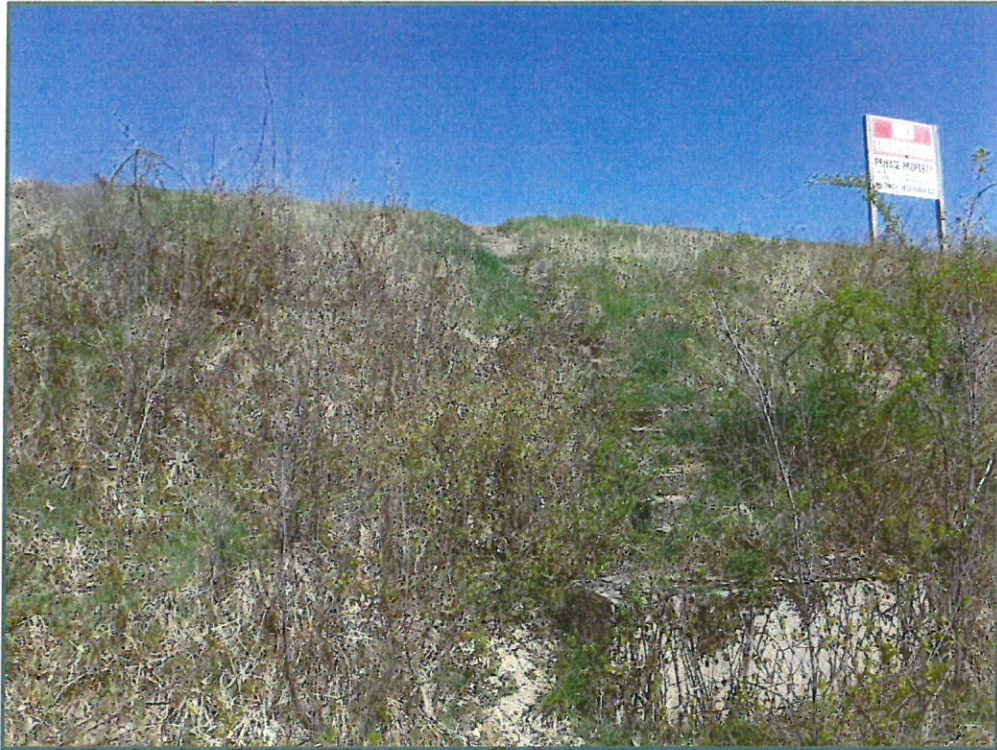
Photo No. 15:
Overgrown woody vegetation along the downstream slope of the north embankment, looking west, photo taken on May 11, 2020.

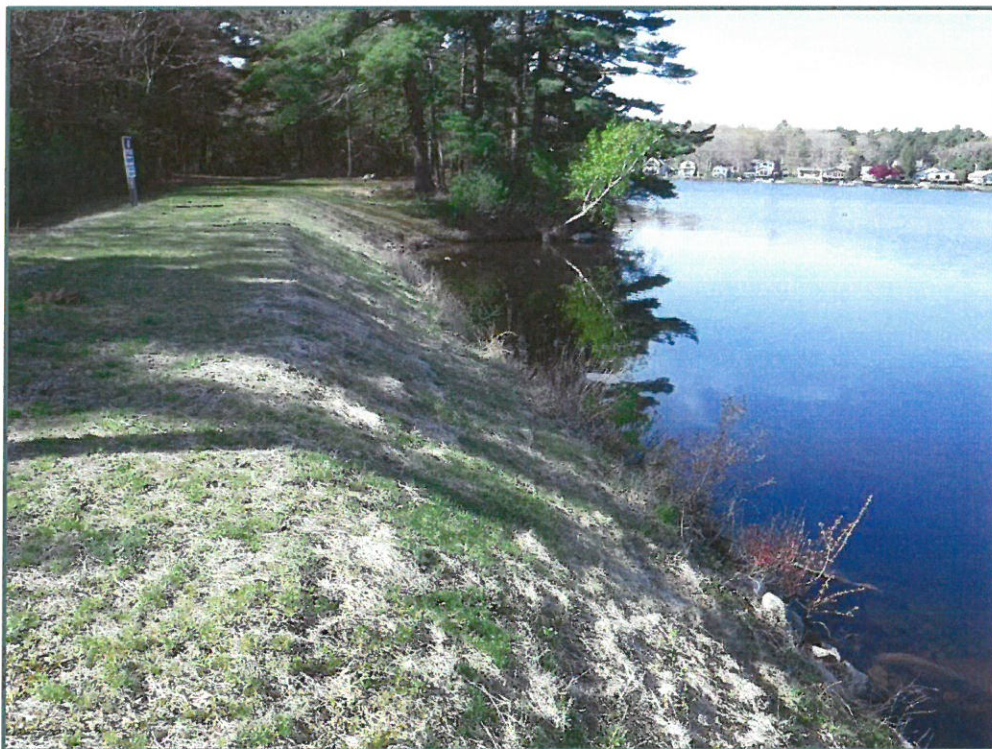
Based on our observations of the "Test Section" (Figure 1-2), there appears to be established grass cover in this area, but some bare spots still exist (Photo No. 16). It is recommended that this area be aerated and over-seeded this upcoming Fall in order to help further promote the establishment of grass cover. However, it should be noted that this repair and other loaming and seeding repairs along the upstream slope, are considered to be an interim repair until such time that the recommendations contained in the *Stability and Seepage Analyses Report* (RTG, December 23, 2009) can be implemented.

Photo No. 16:
“Test Section” at the crest and upstream slope of the north embankment, looking southwest, photo taken on May 11, 2020.

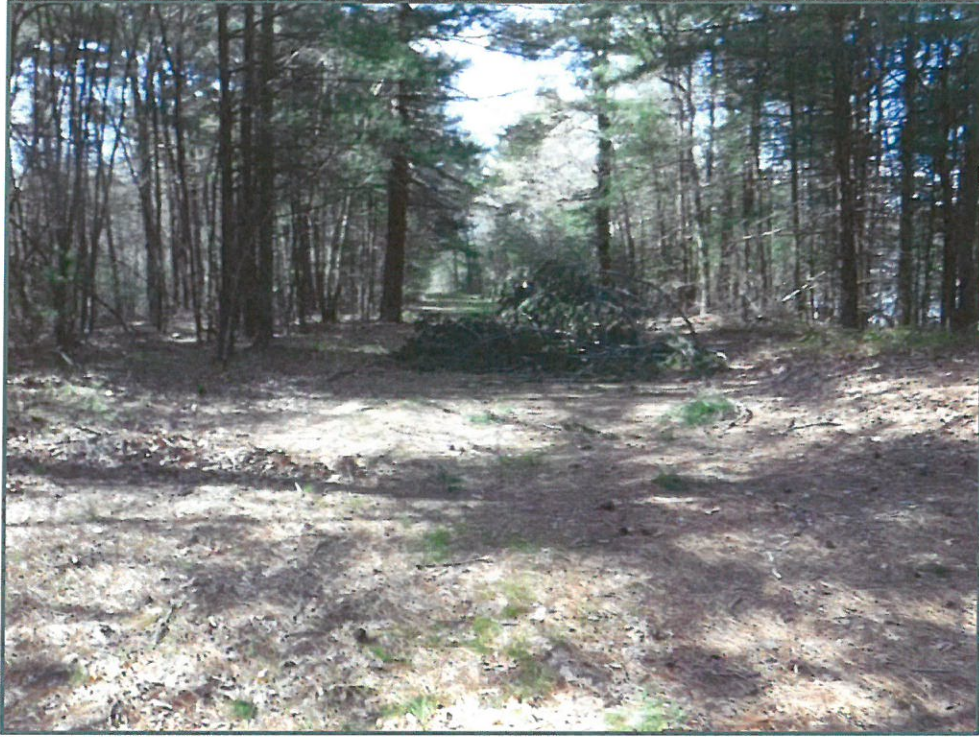
Photo No. 17:

There is an access road which connects the north and south embankments and allows for vehicular traffic between the two areas (Figure 1-2). A portion of this access way was observed to be blocked by fallen tree branches during the inspection (Photo No. 17) and it is recommended that these tree branches be removed in order to maintain access.

Fallen tree branches obstructing the access way between the north and south embankments, looking south, photo taken on May 11, 2020.

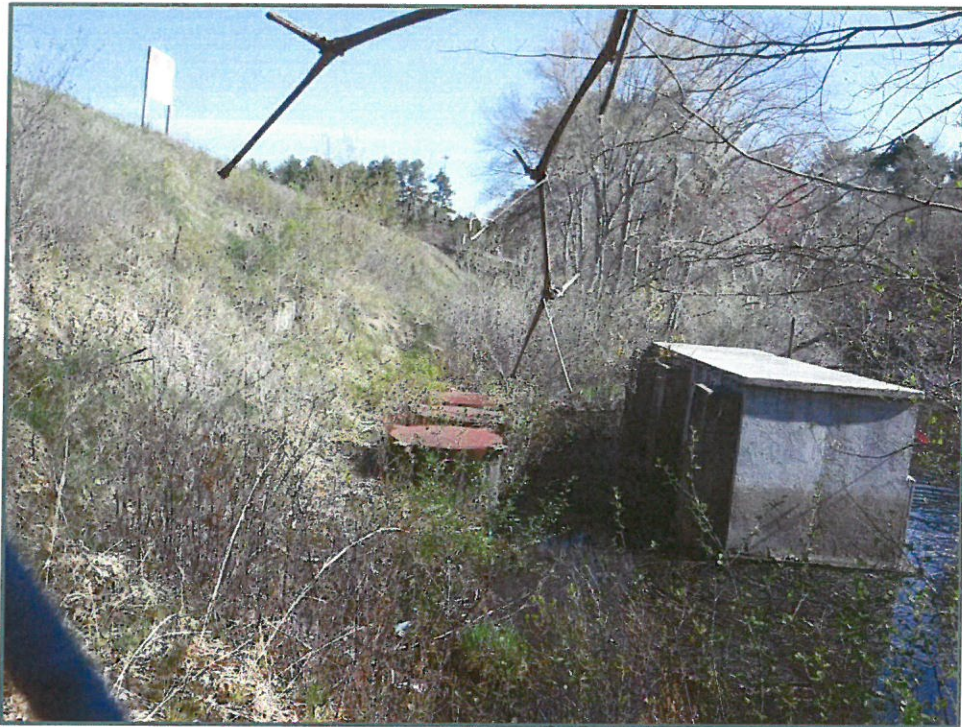
As mentioned, the downstream outlet structure is located on the downstream side of the north embankment at its southern end (Figure 1-2, Photo No. 19). Dense woody vegetation was observed growing around this structure. It is recommended that this vegetation be removed and any resulting voids or soil disturbance filled by placing, grading, and compacting granular material followed by loam and seed.

Photo No. 19:
Thick woody vegetation near the downstream outlet structure, looking north,
photo taken on May 11, 2020.

- T. Remove overgrown vegetation located around the downstream outlet structure and fill any resulting voids or soil disturbance by placing, grading, and compacting granular material followed by loam and seed (3); and
- U. Repair the downstream outlet structure below the waterline (1).

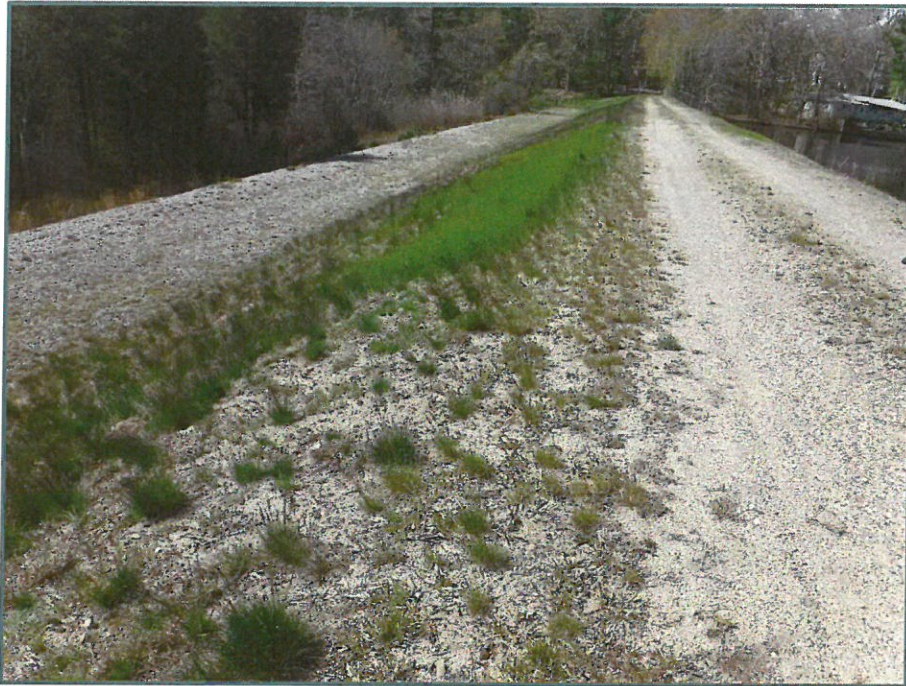
Photo No. 21:

The grass cover on the upstream slope, crest, and downstream slope was observed to be patchy with frequent bare areas throughout containing little to no loam and grass (Photo No. 21). Also, woody vegetation exists at the toe of the upstream slope (Photo No. 22). Rodent/turtle holes were observed in some locations along the upstream and downstream slopes.

Sparse vegetative cover and bare areas on the crest and downstream slope of the South Embankment, looing south, photo taken on May 11, 2020.

It is recommended that the overgrown woody vegetation be cut, removed and maintained. It is also recommended that all rodent holes be backfilled with granular material and compacted by "rodding" with a metal probe followed by loaming and seeding. In addition, it is recommended that the crest and upstream slope along the south embankment be loamed and seeded similar to the "Test Section" in order to reduce the likelihood of future erosion.

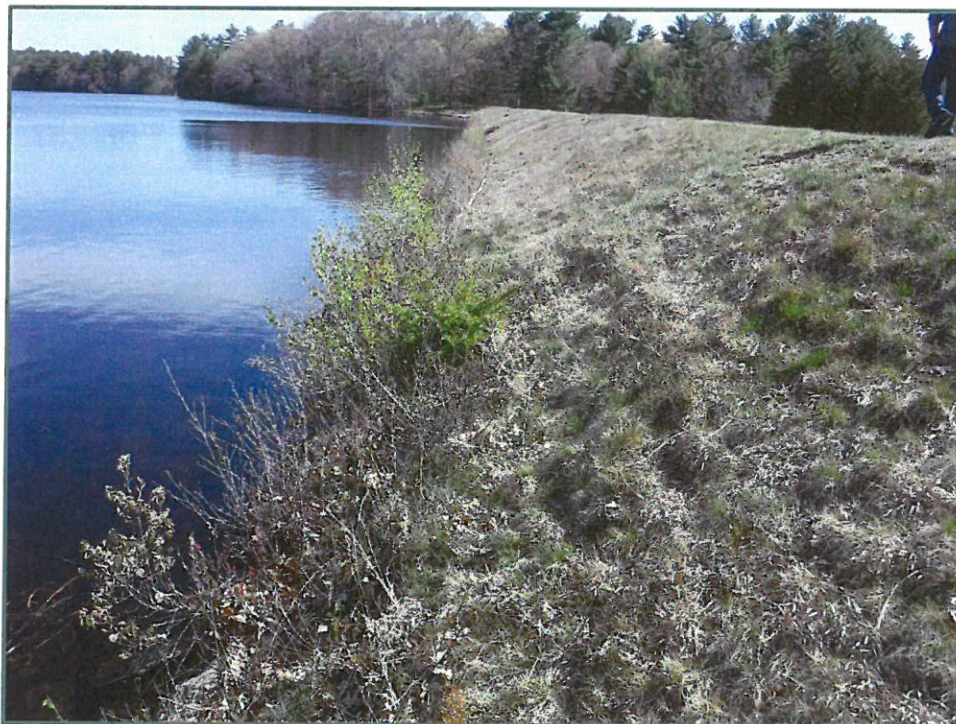
Photo No. 22:

Woody vegetation along the toe of the upstream slope of the South Embankment, looing northeast, photo taken on May 11, 2020.

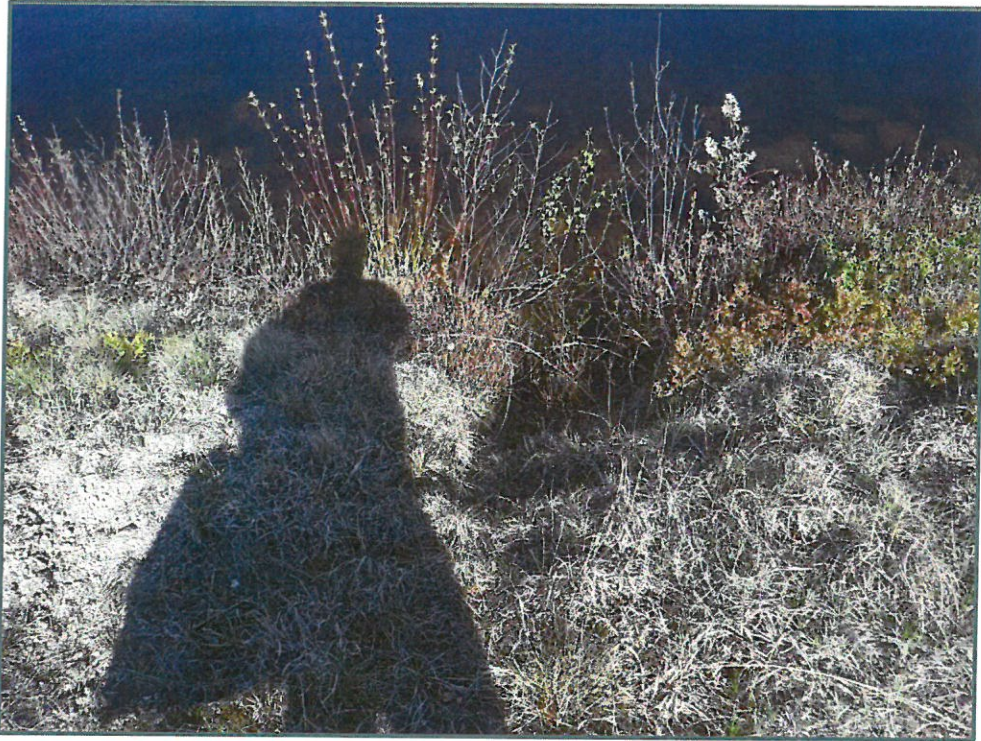
Photo No. 23:

During the visual inspection, two (2) areas of scour/erosion were observed along the upstream slope located approximately 275 and 360 feet north of the south entrance gate of

the Dam (Photo Nos. 23 and 24). Riprap appears to have been placed at the scour area located 360 feet north of the gate. Erosion was also noted along the toe of the upstream slope in some areas, but was difficult to see due to the dense woody vegetation present along the toe.

Scoured/eroded area along the upstream slope of the south embankment about 275 feet north of the south gate, looking northwest, photo taken on May 11, 2020.

As part of the above work, it is recommended that all existing scour/erosion areas be excavated to native material, the exposed surface be scarified, and the excavation be filled with compacted granular material (e.g., silty sand). Please note that the above are considered to be interim repairs until such time that the recommendations contained in the *Stability and Seepage Analyses Report* (RTG, December 23, 2009) can be implemented.

- Y. Repair the upstream scour/erosion areas as described previously (2);
- Z. Eradicate the ant colonies that have appeared on the crest and upstream slope of the south embankment (2);

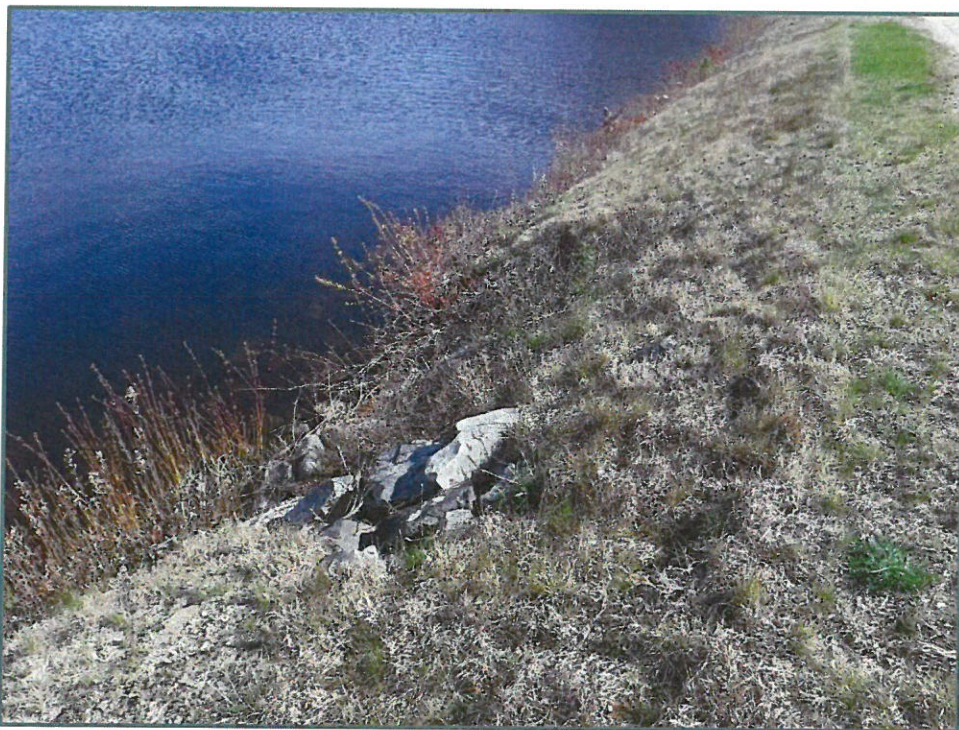
Photo No. 24:

Scoured/eroded area along the upstream slope of the south embankment about 360 feet north of the south gate, looking north, photo taken on May 11, 2020.

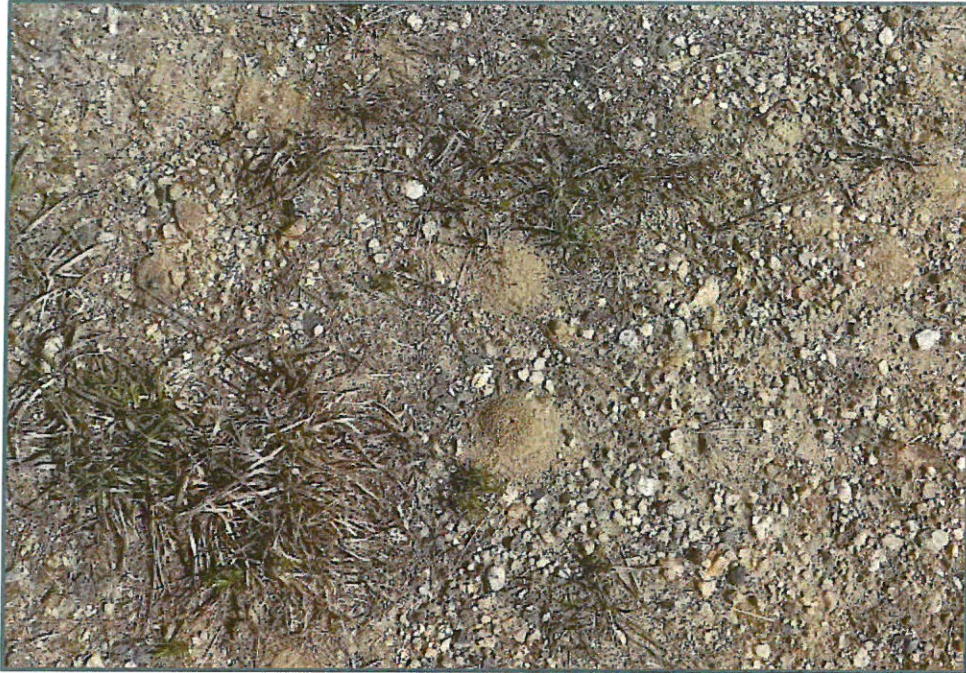
Ant infestation was observed throughout the south embankment along the crest and upstream slope (Photo No. 25). It is recommended that SOSCIA and the Town monitor the south embankment for ant colonies and initiate the eradication program in this location to help eliminate the ant colonies that were observed. In addition, it is recommended that the areas of current ant infestation be excavated and re-compacted with imported granular fill as part of the recommended loaming and seeding work in accordance with the previously submitted plans (RTG, May 15, 2013).

Photo No. 25:
Ant colony along the crest of the south embankment, looking down,
photo taken on May 11, 2020.

- AA. Excavate the previous areas of ant infestation, and re-compact with imported granular fill (complete prior to implementing recommendation “FF” below) (2);

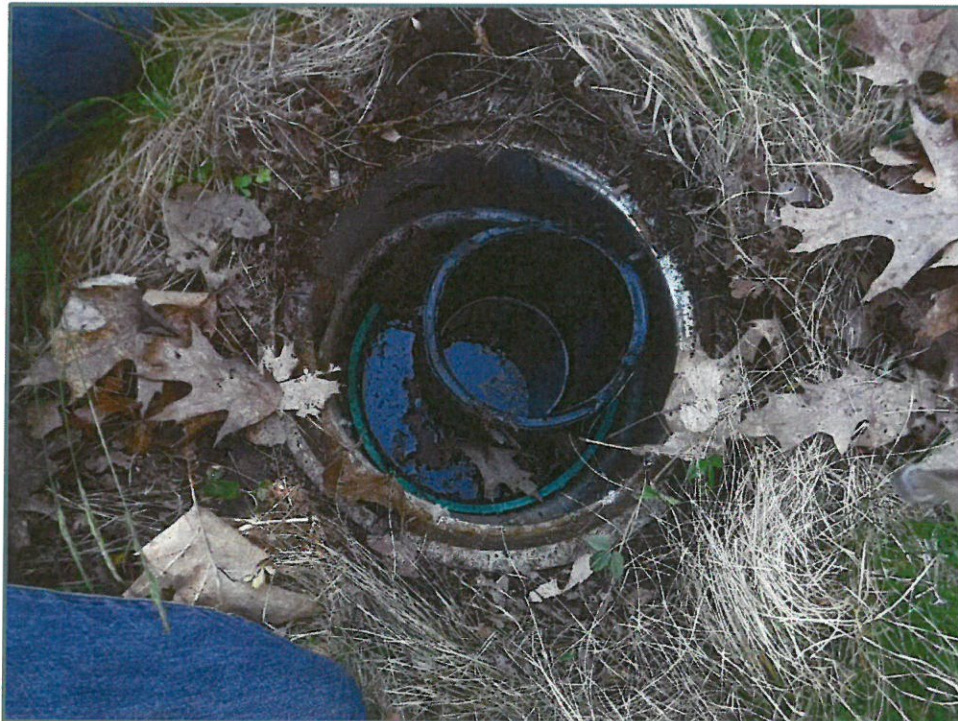
Three (3) handhole cleanouts were installed within the secondary toe-drain (Figure 1-2). The handholes were opened during the inspection and standing water was observed at varying depths below the surface in each of them (Photo No. 26). It is recommended that the secondary toe-drain be cleaned out with a water jet drain cleaner.

Photo No. 26:
Standing water within the secondary toe-drain cleanout, looking down,
photo taken on May 11, 2020.

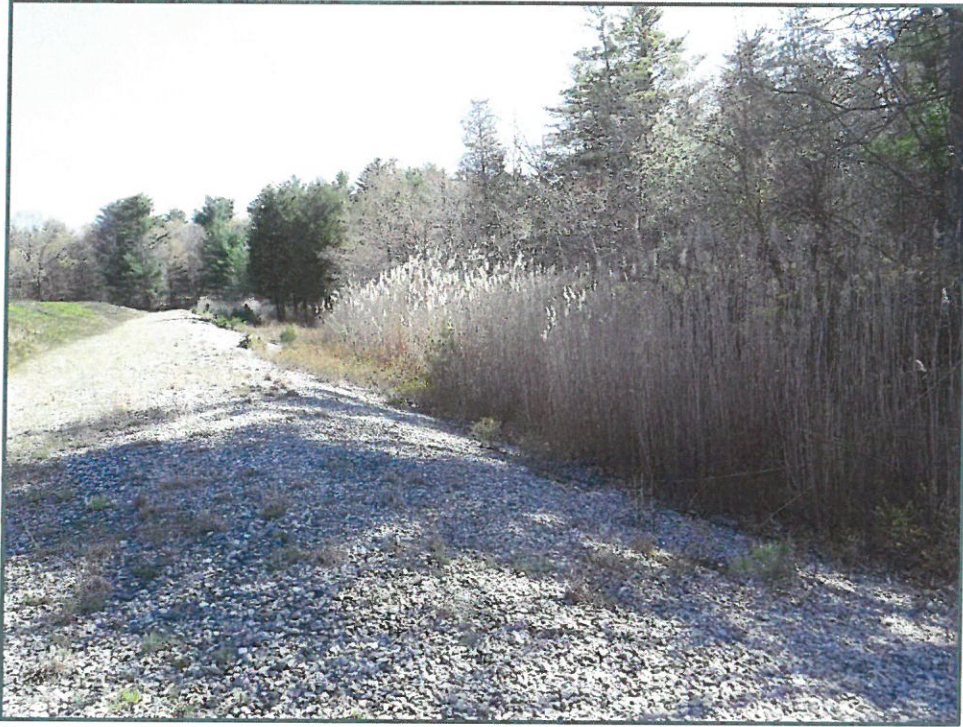
Photo No. 27:

Dense vegetation including mature trees and reeds exists on the downstream slope of the counterweight berm along the entire length of the south embankment (Photo No. 27). It is recommended that this vegetation be removed from the downstream slope of the counterweight berm and within 10 feet downstream of the toe of the counterweight berm. Any resulting voids or soil disturbance should be filled by placing, grading, and compacting granular fill followed by loam and seed.

Heavy vegetation along the downstream side of the counterweight berm, looking northeast, photo taken on May 11, 2020.
