WOOD RIVER JUNCTION DAM VISUAL INSPECTION / EVALUATION REPORT

Dam Name:	<i>Wood River Junction Dam</i>
State Dam ID #:	<i>273</i>
Owner:	<i>Unknown</i>
Town:	<i>Richmond</i>
Consultant:	<i>Fairbanks Engineering Corporation</i>
Date of Inspection:	<i>October 5, 2014</i>

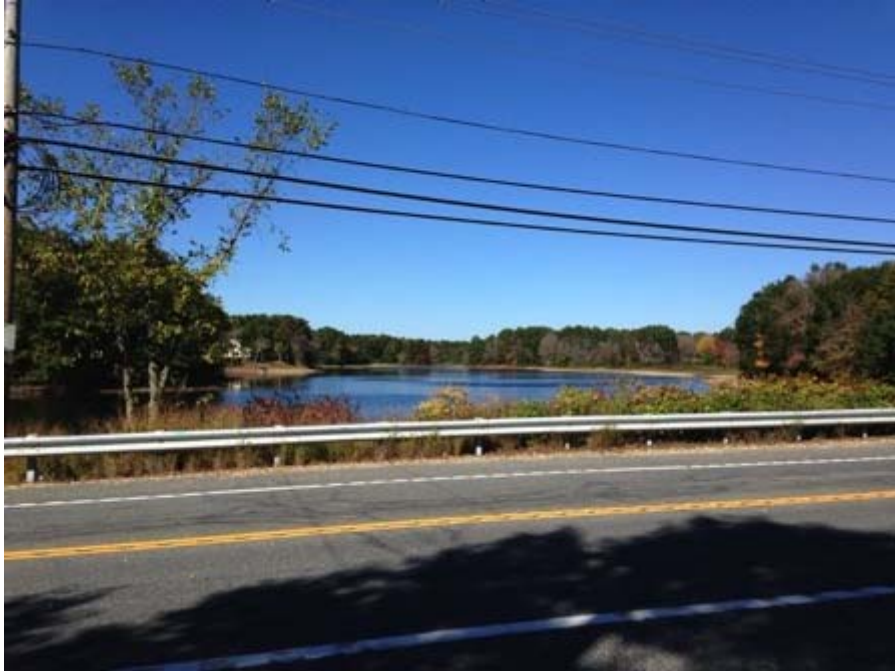
Photo 1: Overview of impoundment area

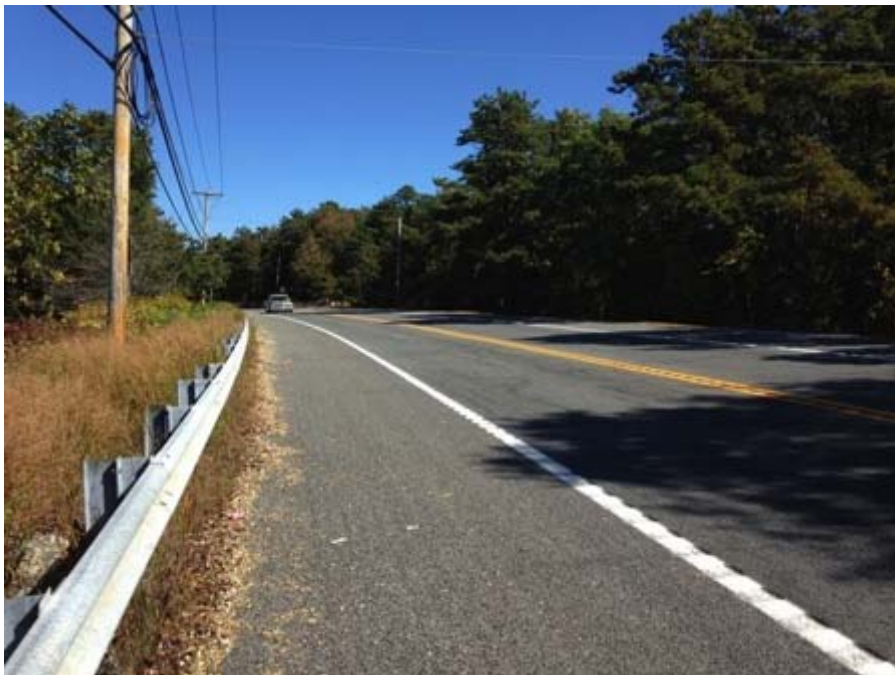
Photo 2: Overview of dam crest from right abutment looking left

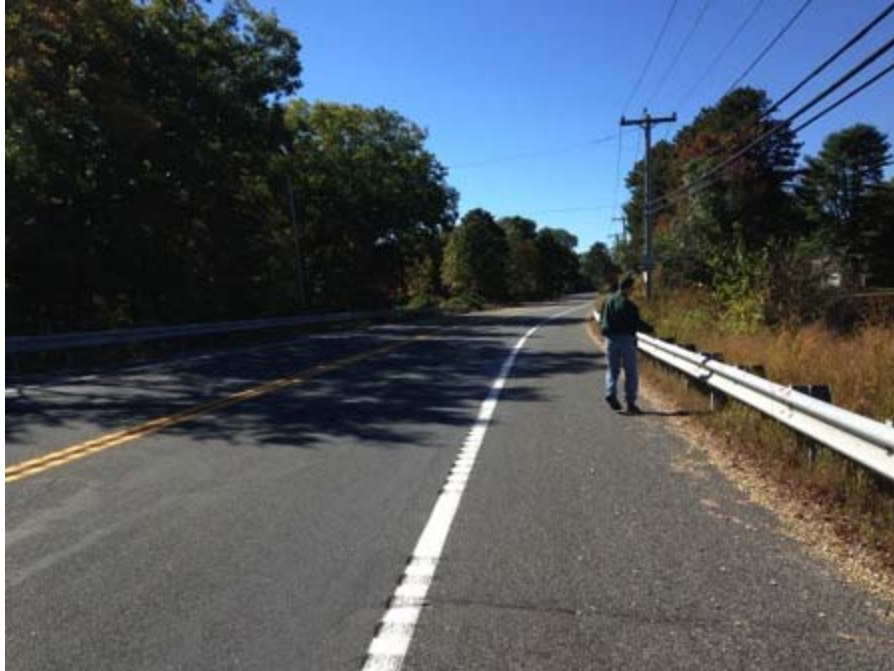
Photo 3: Overview of dam crest from left abutment looking right

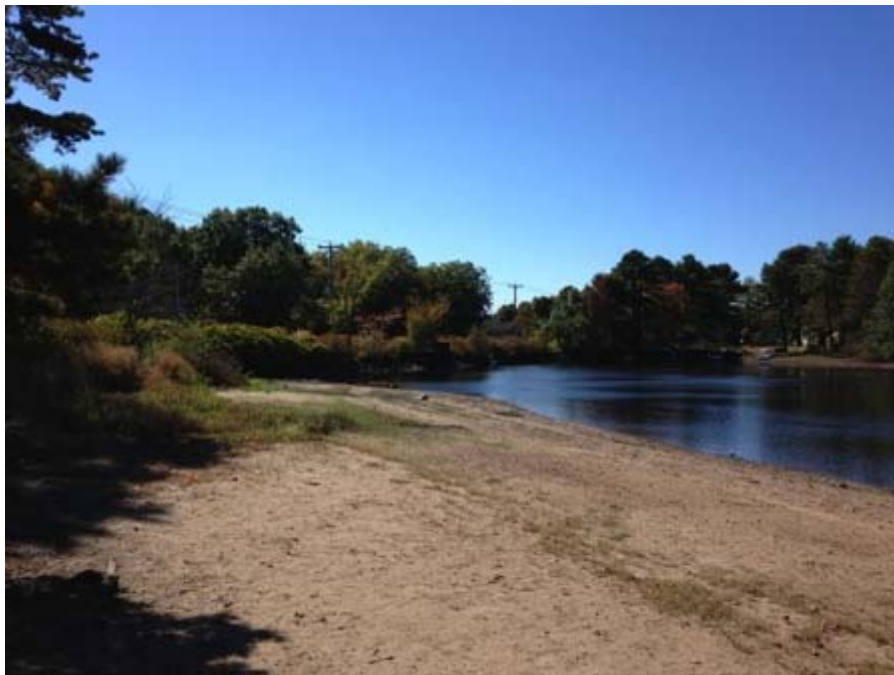
Photo 4: Overview of upstream slope looking downstream

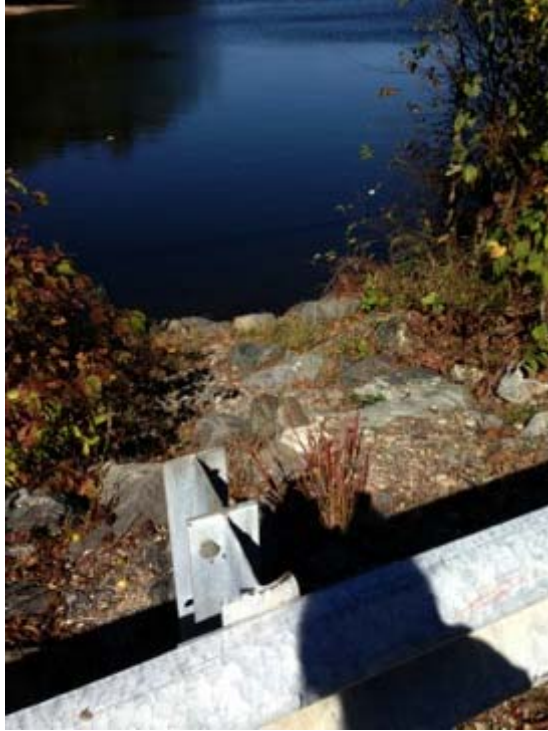
- The riprap along the upstream slope is typically overgrown with brush and several trees. The riprap generally appears to be stable and suitably sized.

- Some displacement of riprap was noted in areas, apparently the result of public use of the area to access the pond.
- Several significant trees (larger than 6-inches in diameter) were noted along the length of the upstream slope.

Photo 5: Overview of rip rap on upstream slope

6. Reset displaced riprap and extend the limits of riprap to provide protection along the entire length of the dam.
7. Remove trees, brush and unwanted vegetation less than 6-inches in diameter from the dam slopes and within 10-feet of the downstream slope. Removal of trees larger in size is not recommended due to the potential negative impacts to the embankment. Removal of the large trees will require complete re-construction of the embankments due to the need to excavate and remove the root systems which is necessary to avoid piping concerns in the future. If there is a concern about stability of the larger trees the canopies may be trimmed to reduce the area and corresponding wind forces.

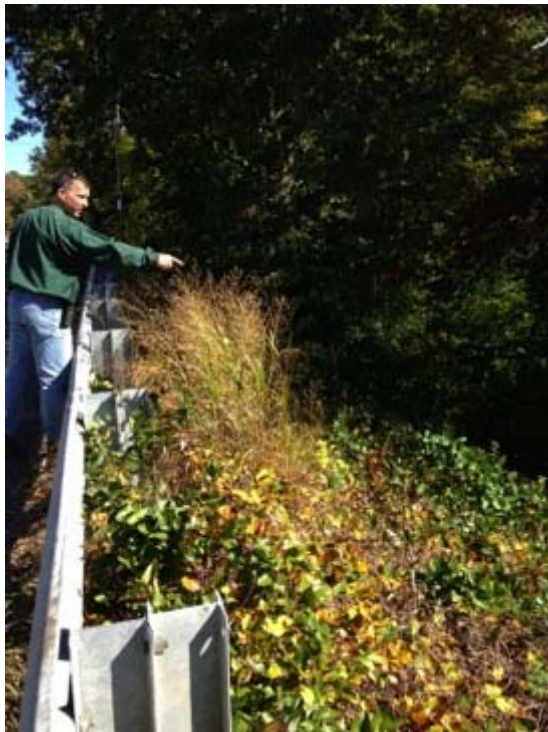
- The slope/riprap is covered with leaves and small woody vegetation. Slope conditions partially limited inspection, particularly left of spillway.
- Approximately 210-feet right of the left abutment, some of the riprap appears to be displaced, possibly by public use of the area.

Photo 6: Overview of vegetation along upstream slope

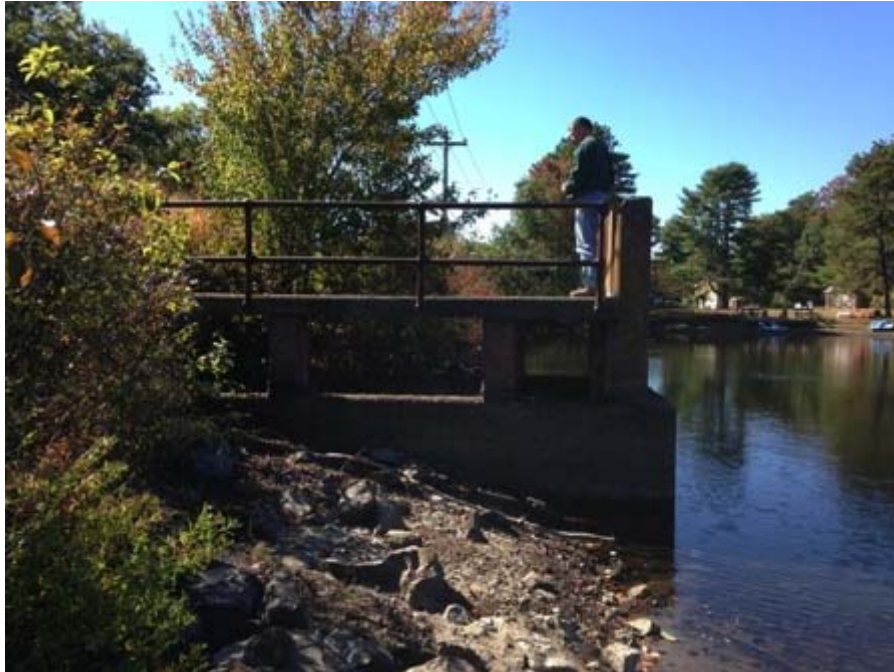
Photo 7: Overview of spillway weir

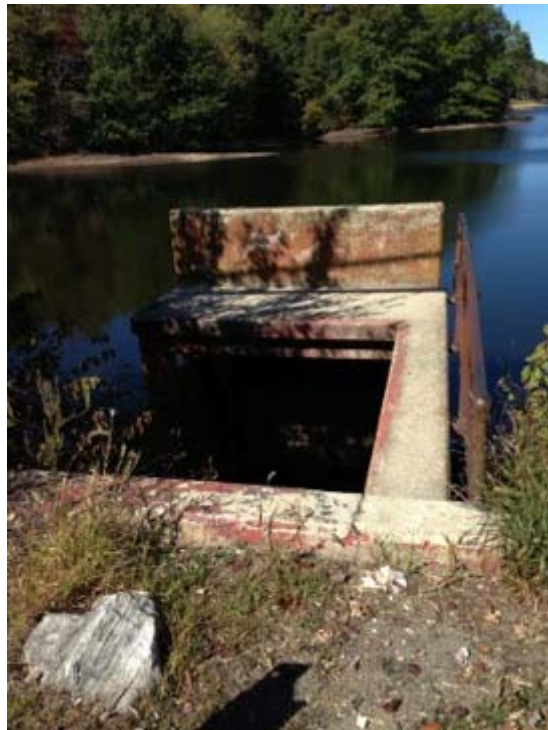
Photo 8: Overview of spillway weir

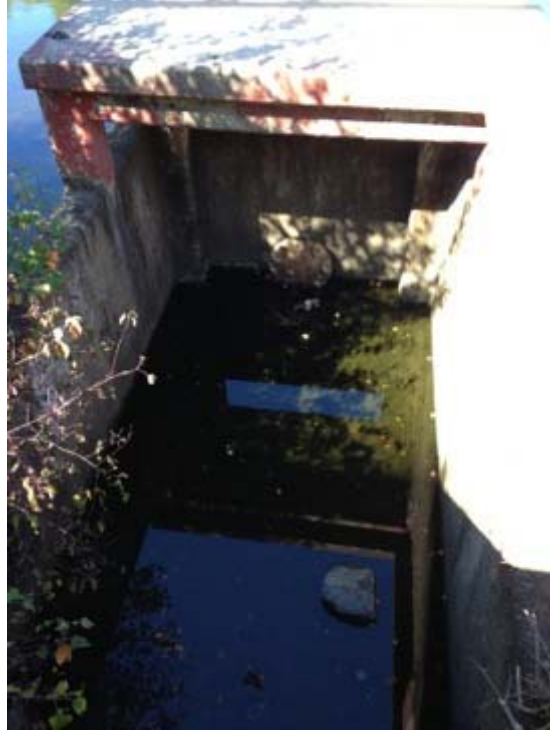
The outlet end of a pipe was noted in the upstream wall of the control structure. However, no controls to regulate flow through this outlet were noted.

Photo 9: Overview of controls in spillway

5. Complete an underwater inspection to assess the presence and condition of an operable low level outlet. Evaluate means to restore operability to the outlet.

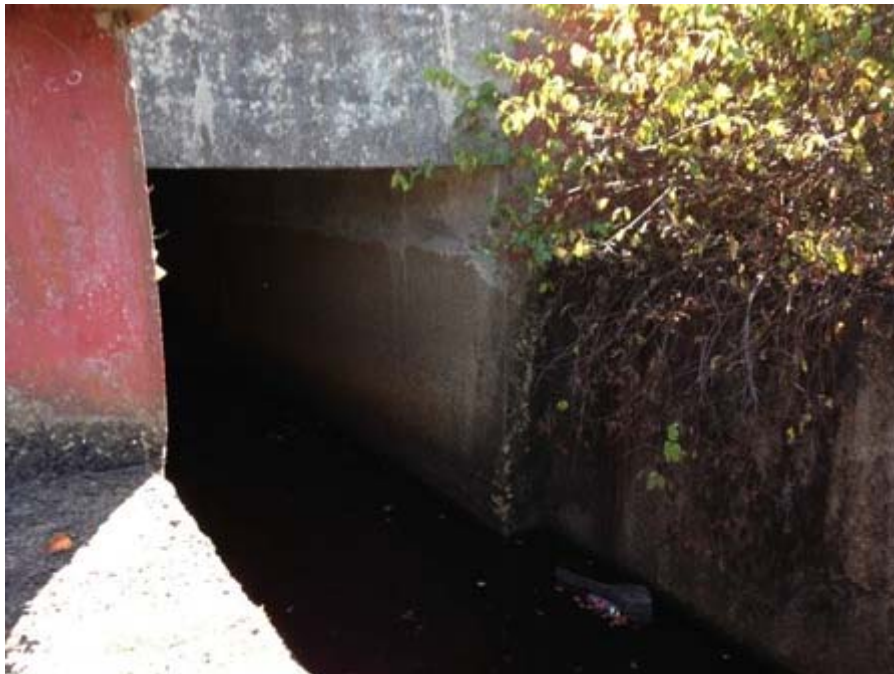
Photo 10: Spillway concrete culvert

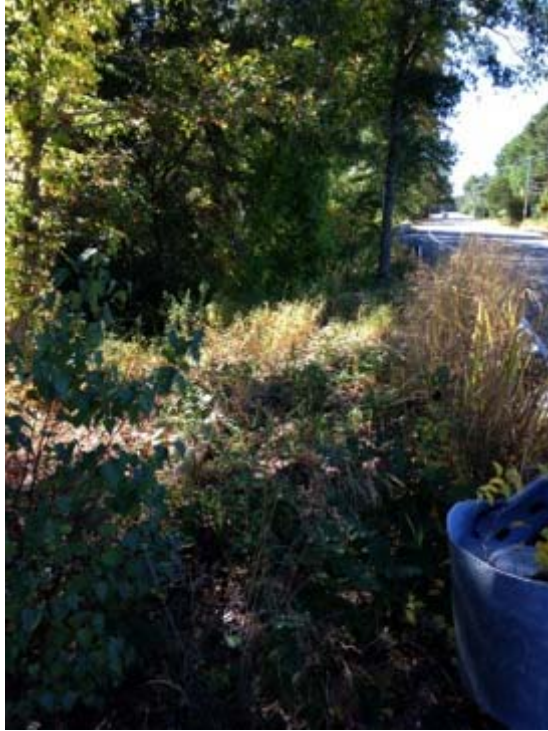
Photo 11: Overview of downstream slope from left abutment looking right

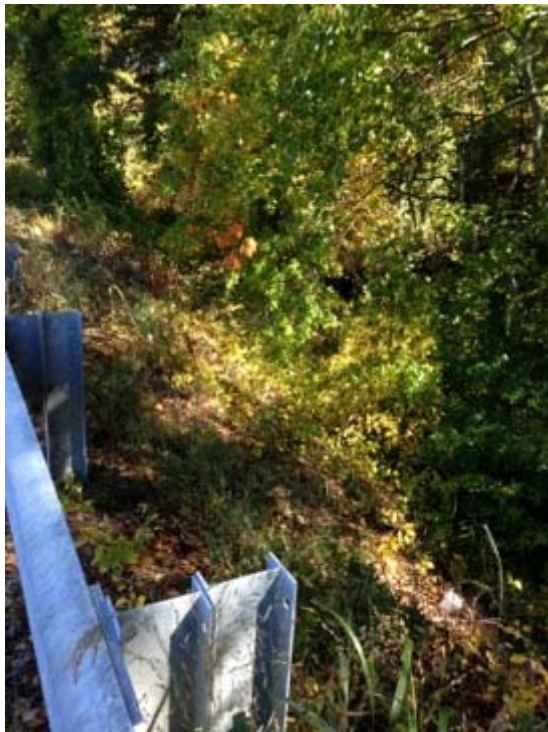
- From the right side of the spillway to right abutment, the downstream slope is steep with an average approximate slope of 1.25H+/-:1V estimated during the inspection. The slope is typically vegetated with unmaintained grass and brush. The top 6-feet of the slope appears to be regularly cut as part of roadway maintenance procedures. Sloughing was typical within the bottom foot of the slope.

Photo 12: Overview of downstream slope

8. Regrade the downstream slope to a stable cross section. Loam and seed the embankment to provide a surface that can be easily maintained and inspected.

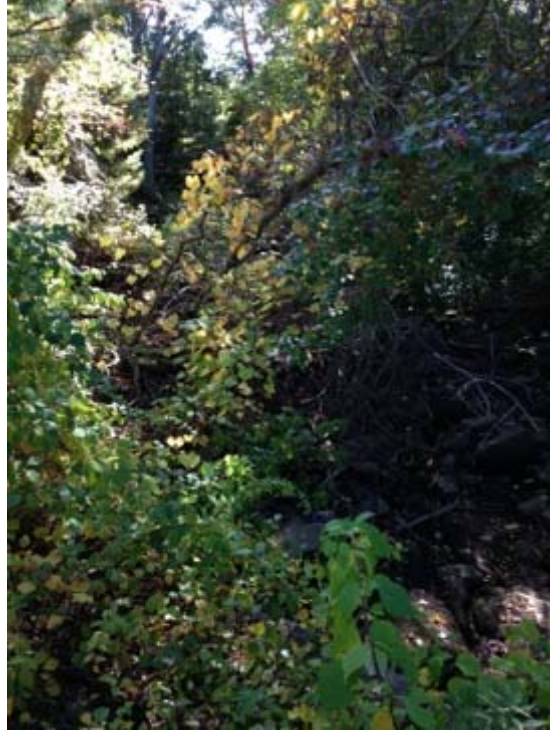
Photo 13: Overview of downstream area

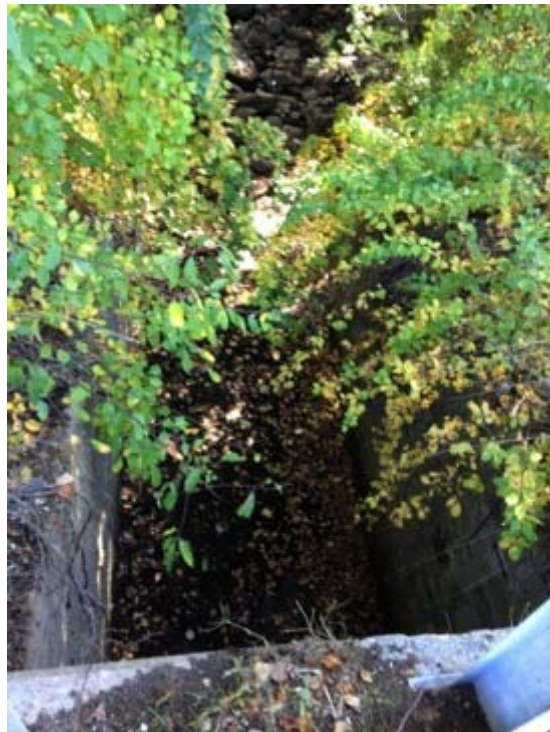
Photo 14: Overview of downstream spillway canal

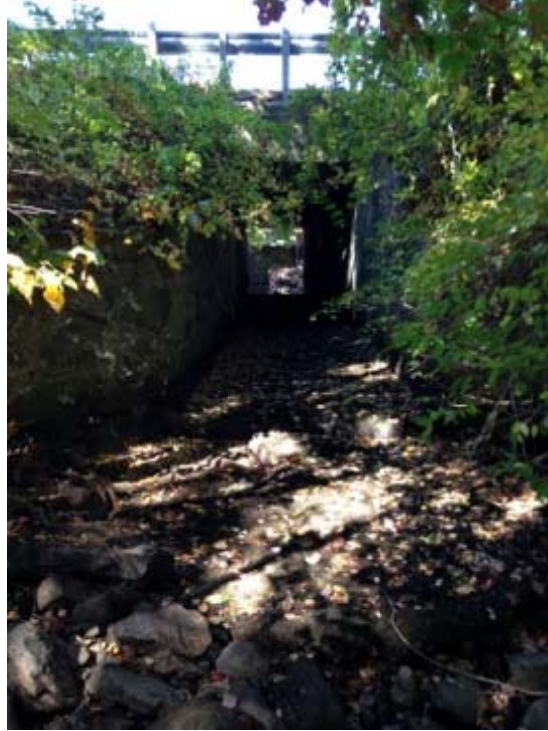
Photo 15: Primary spillway culvert

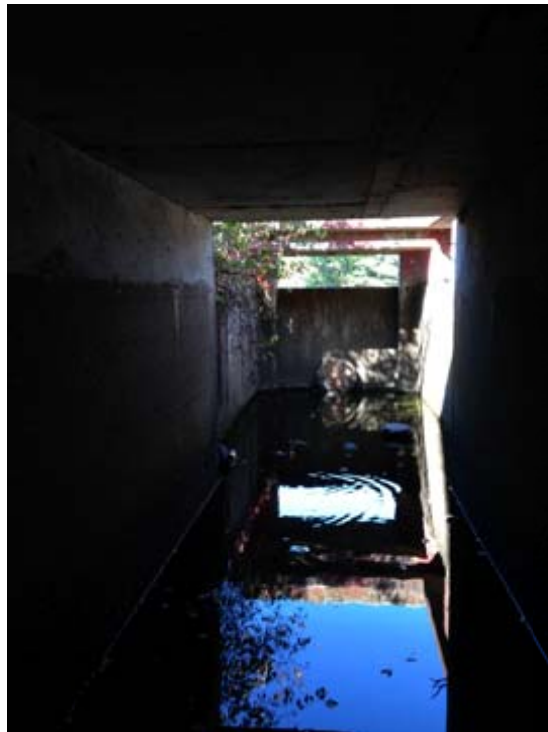
Photo 16: Primary spillway culvert

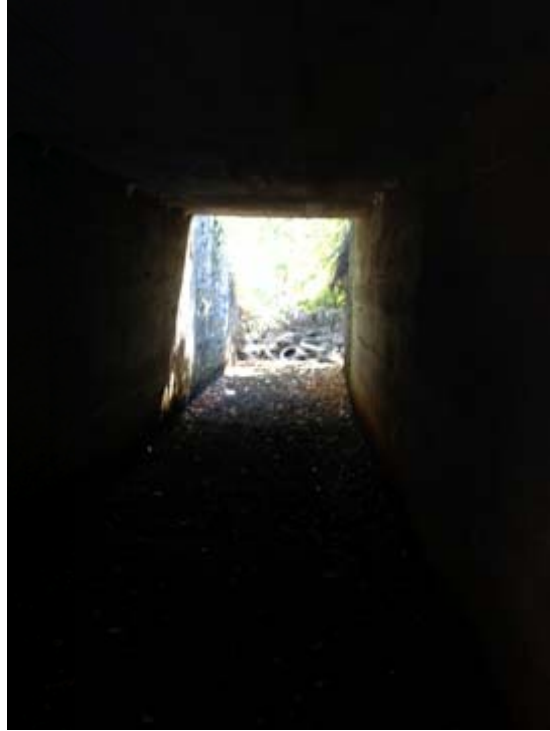
Photo 17: Primary spillway culvert

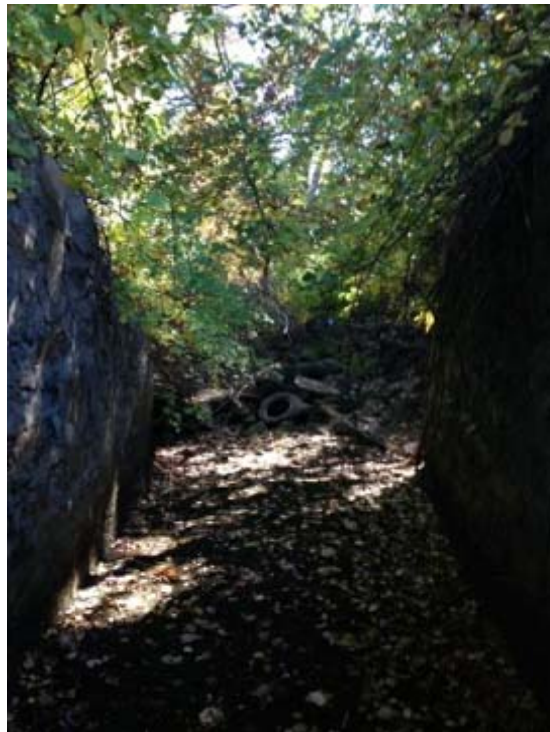
- The downstream left wing wall is generally in fair condition. However, a significant percent of mortar is missing from this section of wall.
- The channel downstream of the dam is generally poorly defined with accumulated debris and trash resulting in the stream overflow the banks of the channel.

As noted above the downstream channel is clogged with debris, resulting in erosion and overflow of the banks of the channel with flow occurring outside the natural channel limits.

Photo 18: Primary spillway downstream channel

9. Clear the downstream channel of accumulated debris.
10. Repoint the stone masonry walls along the downstream channel. Remove all trees from the vicinity of the walls.

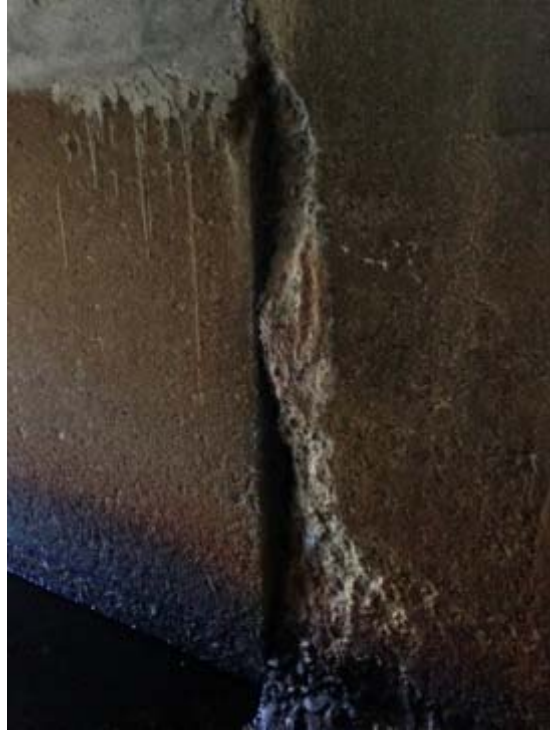
- Spillway discharges flow through the dam via a concrete box culvert which is in good condition. There is deterioration of the first construction joint (as located from the downstream end) in the left wall of the culvert.

Photo 19: Cracking at first joint in concrete culvert at primary spillway

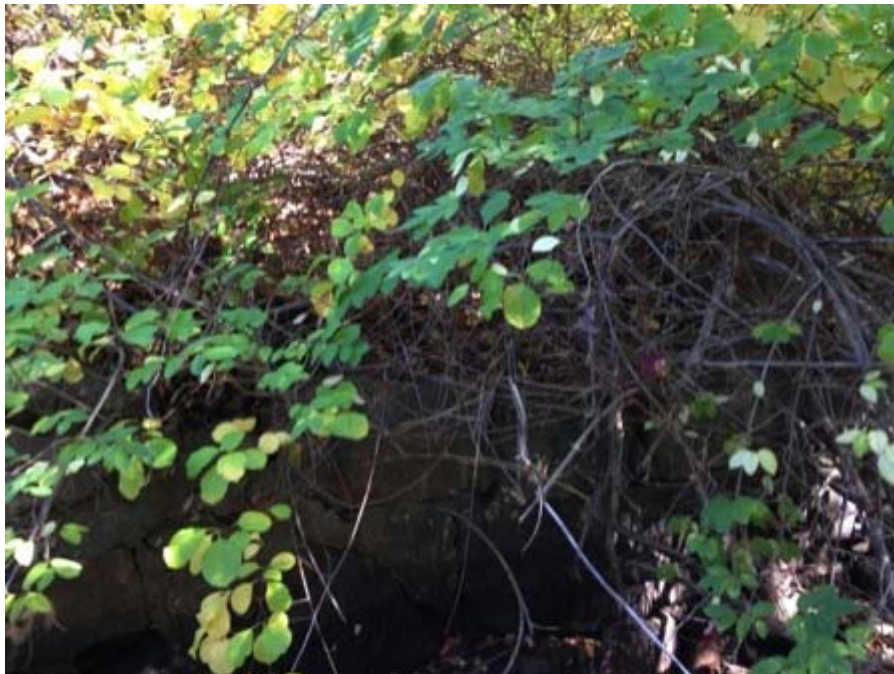
- The stone masonry training walls are generally in fair condition with mortar typically in place.
 - Several 4-inch diameter trees are present along the top of the downstream left training wall.

- The downstream right and left wing walls are missing several capstones. The wing walls also has more missing mortar than the training walls.
 - An 8-inch diameter tree is growing from the downstream toe of the wall near the approximate midpoint of the length of the wall.

Photo 20: Downstream training walls
