Dam Visual Inspection/Evaluation Report

Cherry Valley Pond Dam

Glocester, Rhode Island

Dam Name: *Cherry Valley Pond Dam*
State Dam ID#: *021*
Town: *Glocester*
Hazard Classification: ***Significant***
Owner: *Unknown*

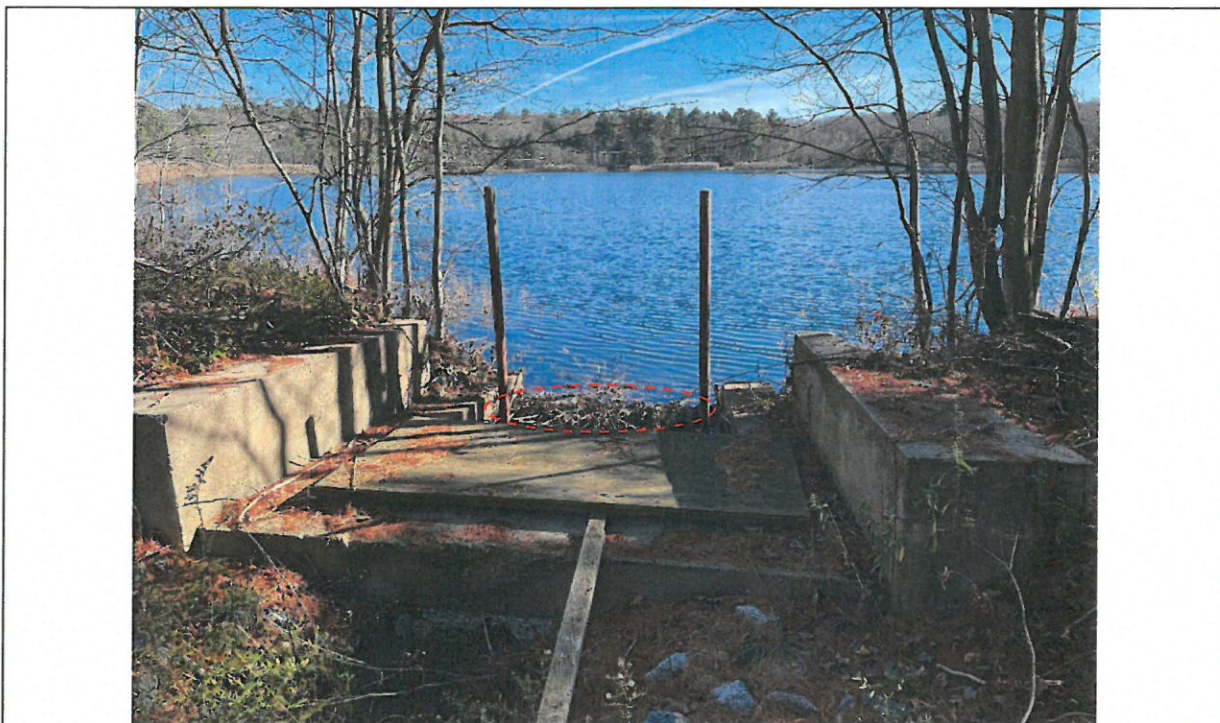
Approximately an inch over spillway. The impoundment elevation is raised slightly due to debris accumulated on the weir.

Irregularities Noted: Some debris is accumulating on the weir, in the culvert, and in the spillway discharge channel. Vegetation in the discharge channel would reduce spillway discharge capacity.

Photo 1: View of the impoundment from the primary spillway. Note the sticks/debris accumulating on the weir (circled in red).

1. Clear vegetation and have owner's engineer inspect areas.
2. Remove debris impacting the capacity at the spillway drop chamber and culvert.
3. Remove vegetation at the spillway discharge channel to 15 feet beyond the toe of slope.

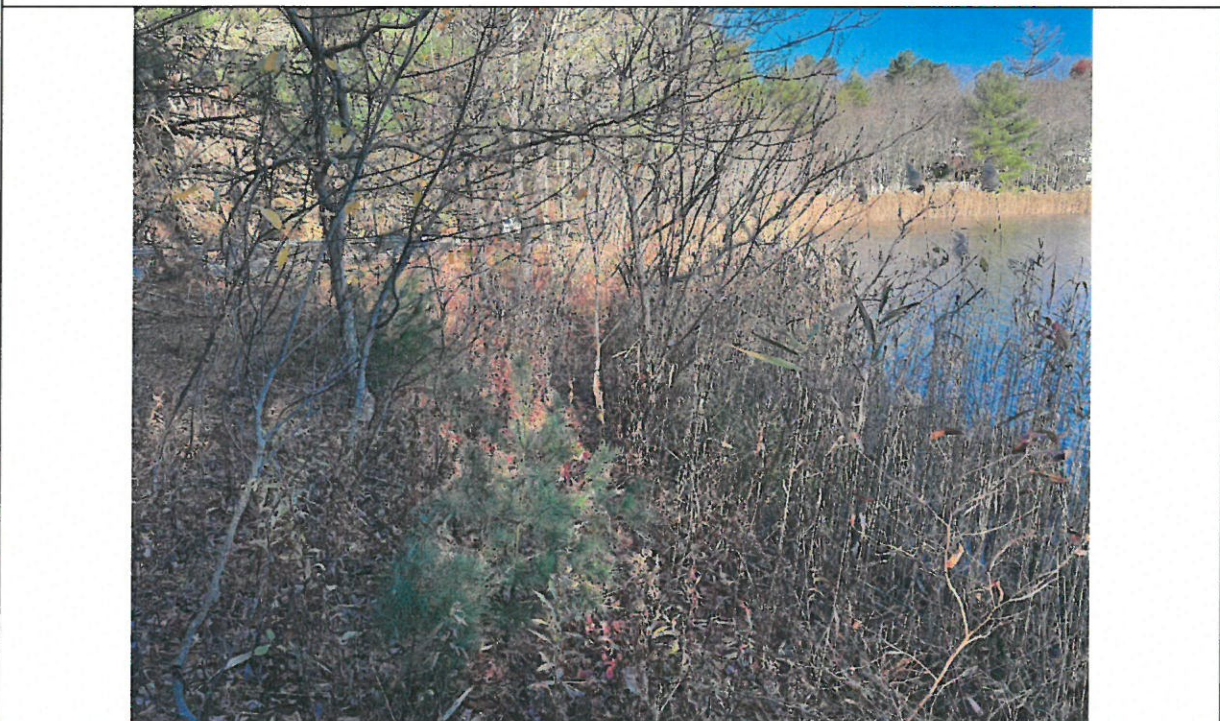
Irregularities Noted: The upstream embankment has irregular alignment, minor scarping at the waterline, vegetation, leaf/pine litter, and large trees on the embankment.

Photo 2: Upstream embankment as viewed from the left abutment looking right. Note the leaf litter and developing vegetation.

1. Remove the trees from the upstream embankment and downstream toe of slope in accordance with Rule 10(A) (1) of the Rules and Regulations for Dam Safety.
2. Remove the vegetation and leaf litter along the upstream and downstream embankments and within the discharge channel to 15 feet beyond toe of slope. Inspect these areas for any deficiencies and refer to a professional engineer for appropriate corrective measures.
3. Install erosion protection/armoring along the upstream embankment to prevent future scarping at the waterline.
4. Have owners remove all debris accumulating on the spillway weir, within the drop inlet, and in the culvert. Have owner regularly schedule debris clearing to prevent blockages.
5. Have owner's engineer assess the condition of the undermined section of culvert/wingwall and make recommendations.

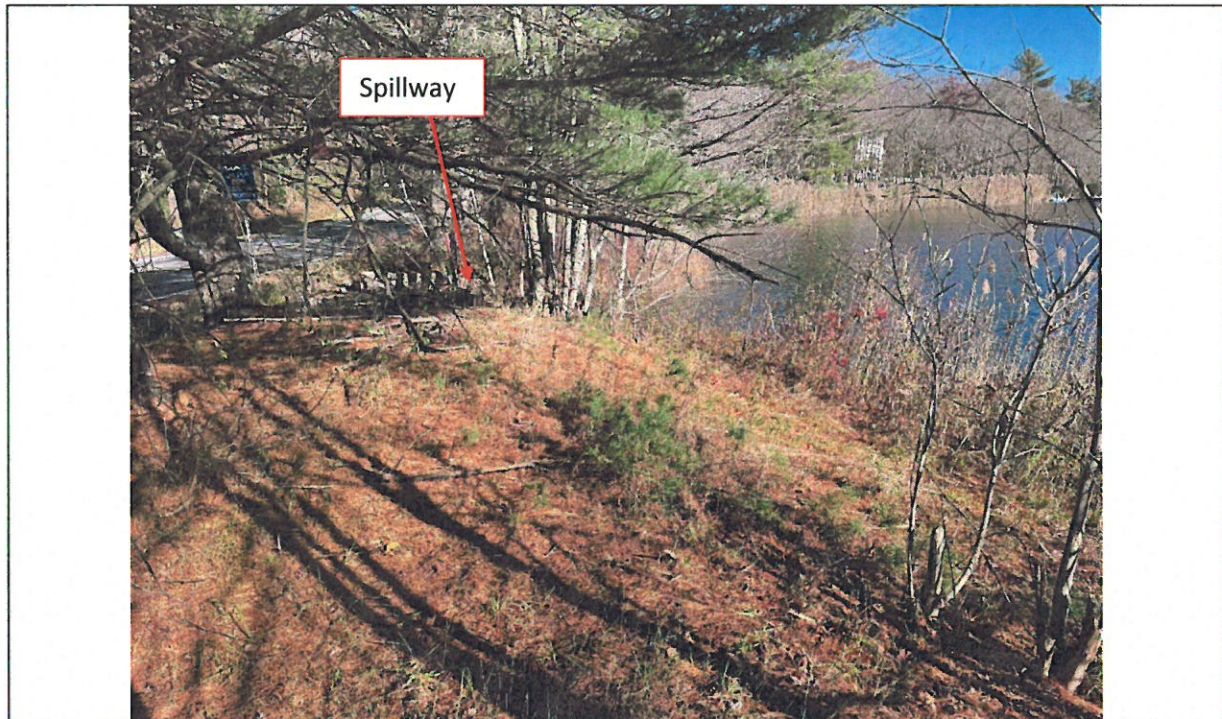
Photo 3: Upstream embankment and crest as viewed from left of the primary spillway looking right.

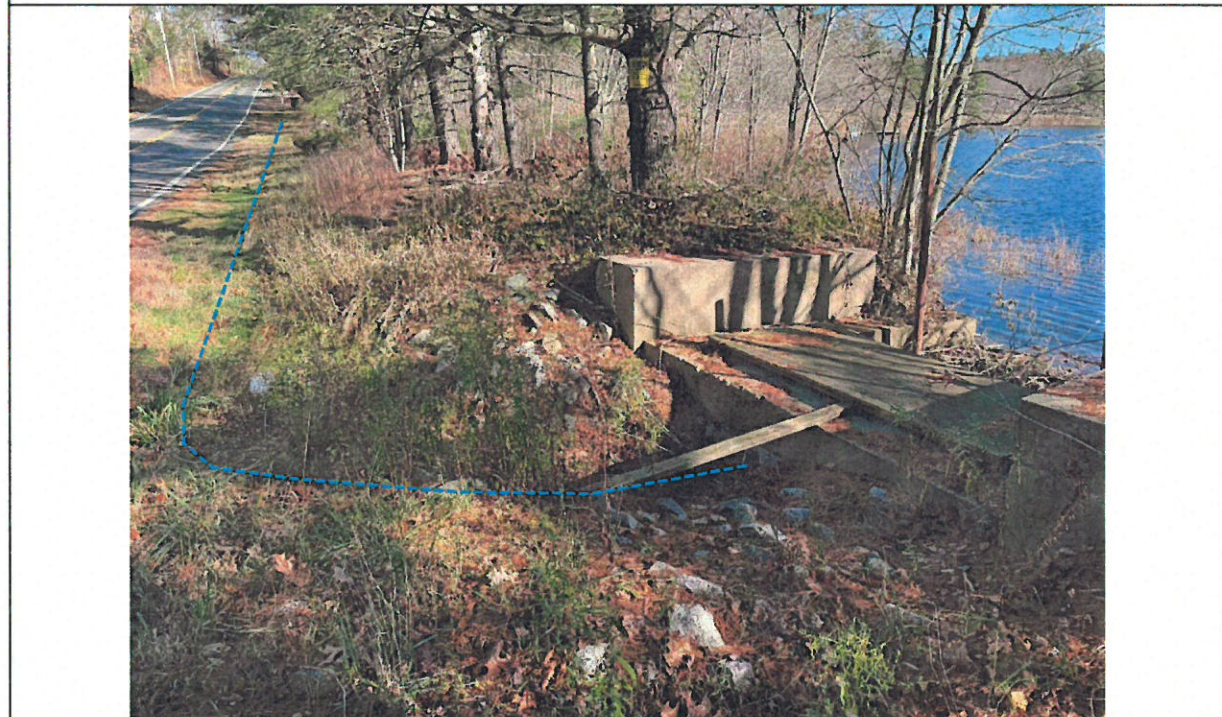
Irregularities Noted: The upstream shoulder of the road is an irregular swale that flows into the primary spillway drop inlet. Minor rutting is present near the swale.

Photo 4: View of the dam crest and embankment from the primary spillway looking right. Note the drainage swale slopes into the back of the primary spillway (blue).

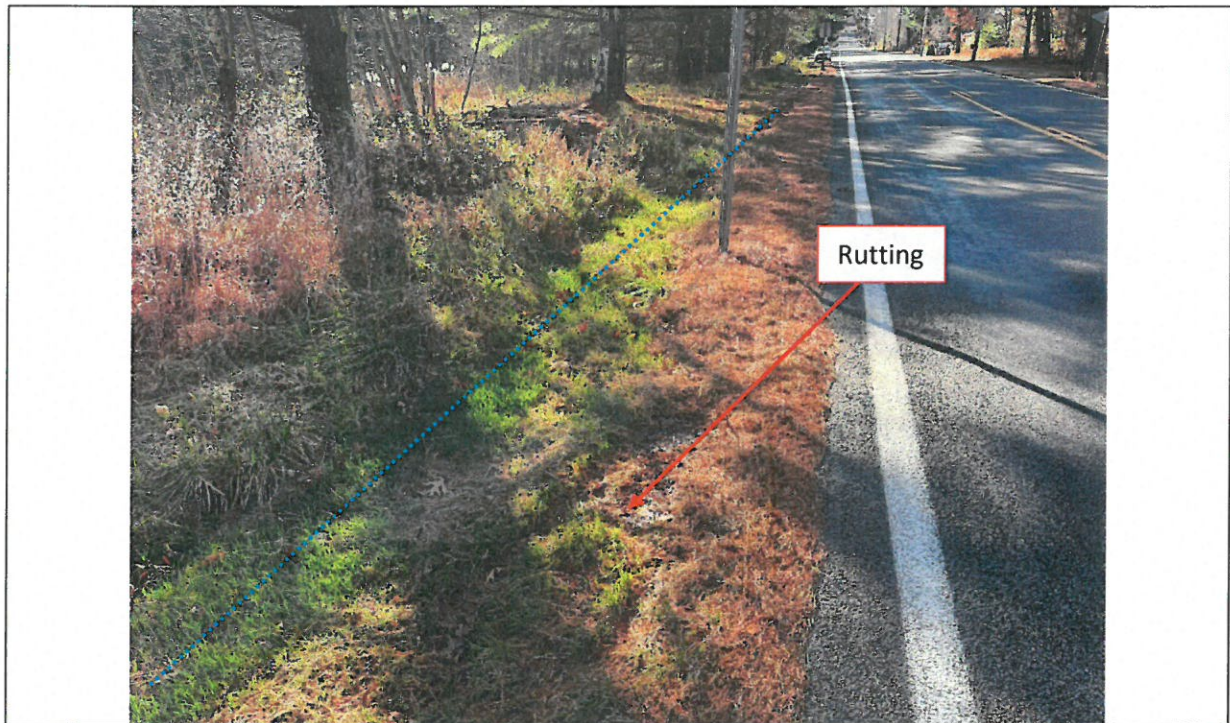
Photo 5: View of the right drainage swale looking left (blue). Some tire rutting is also noted near the roadway.

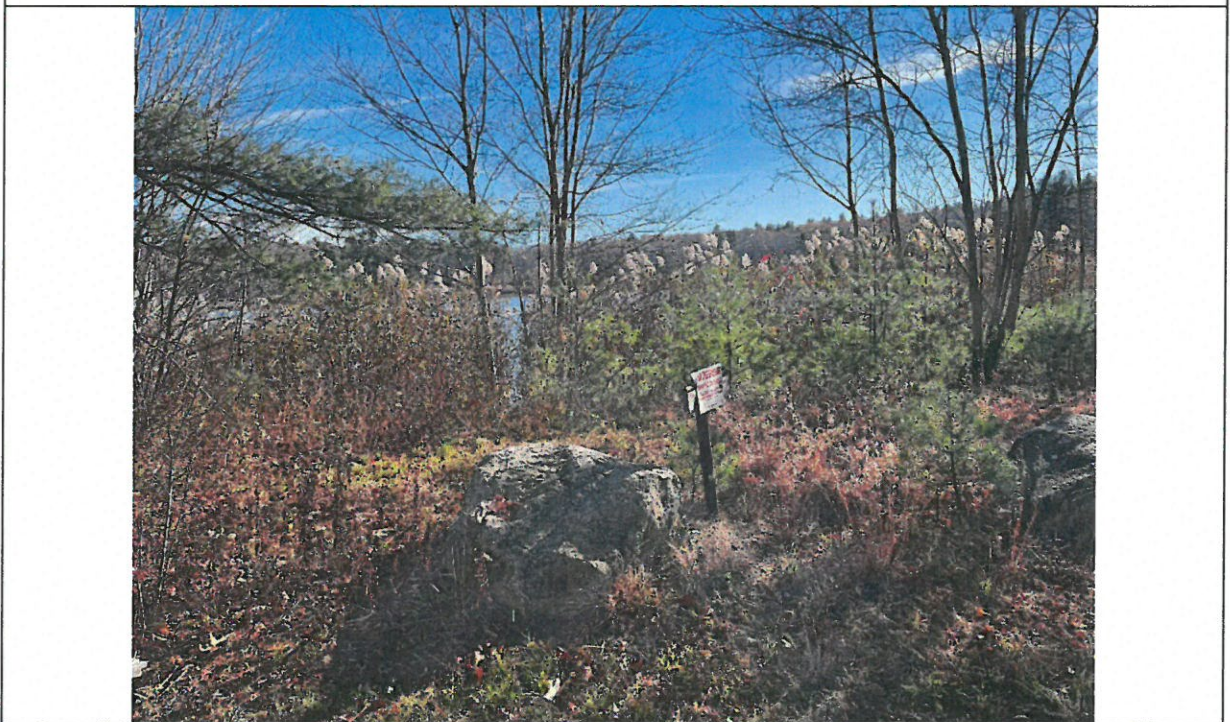
Photo 6: View of the dam upstream embankment and boulder line as viewed near the right abutment looking upstream.

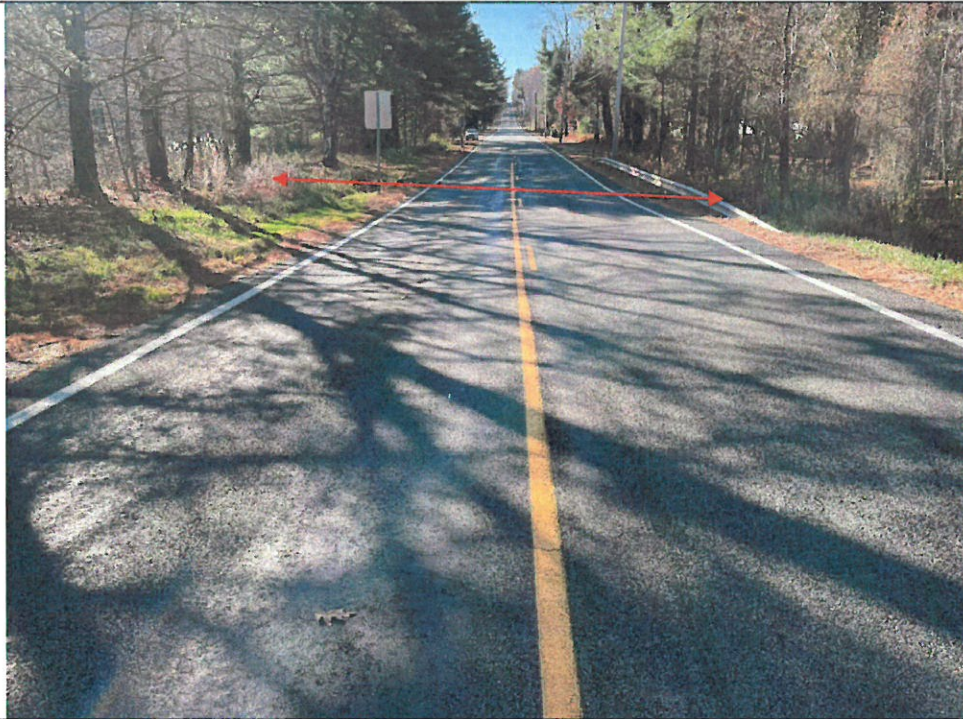
Photo 7: View of the crest and embankment from the right abutment looking left. Note the location of the primary spillway culvert (red).

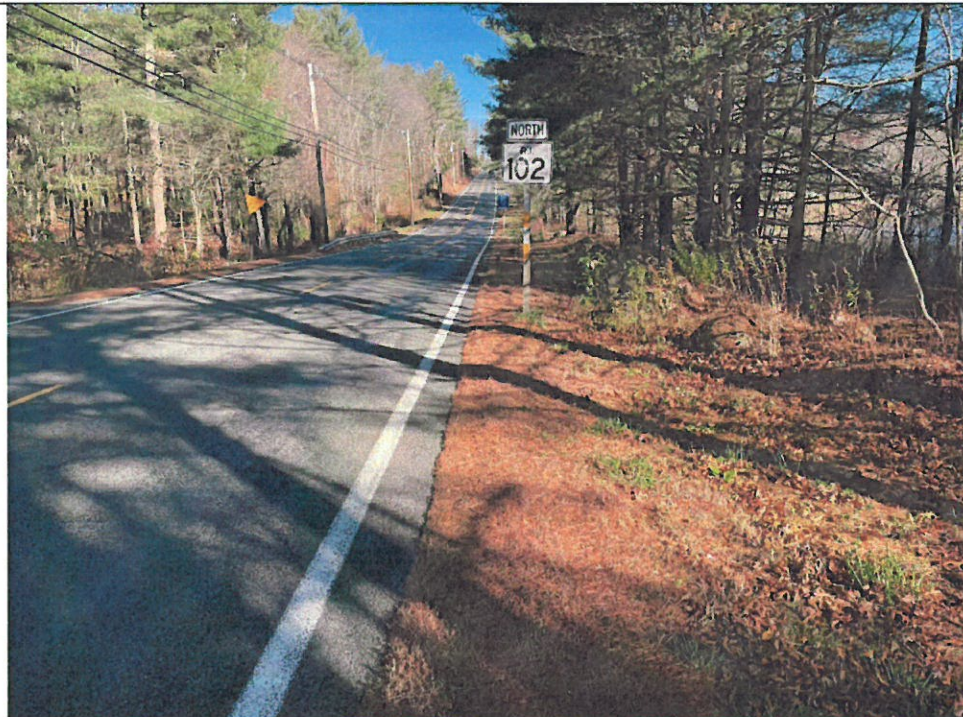
Photo 8: View of the crest and embankment from the left abutment looking right.

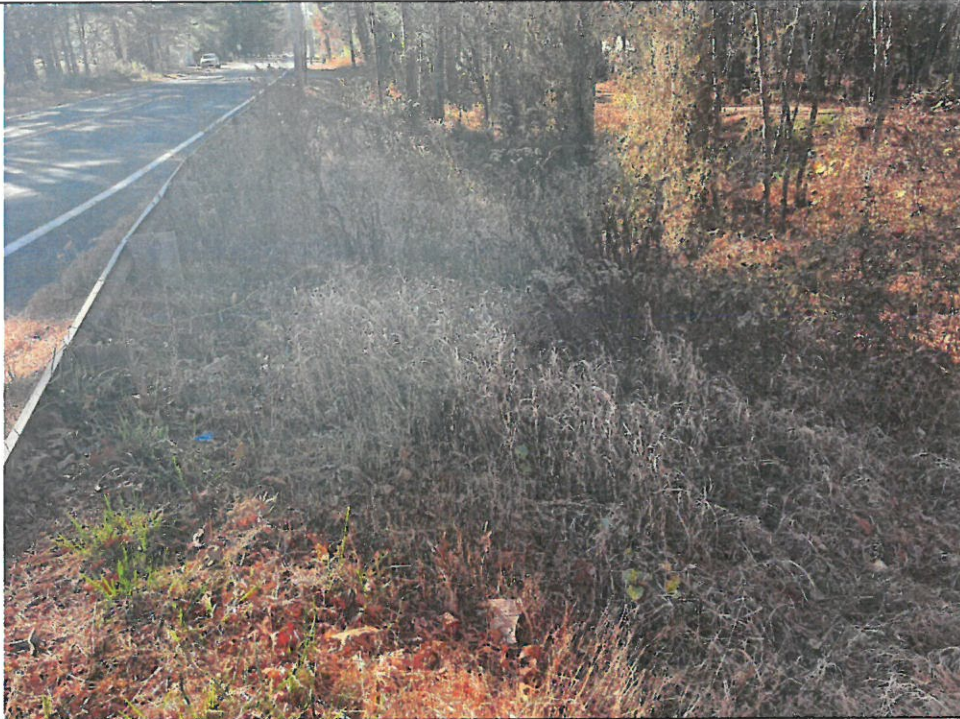
- The downstream embankment consists of a steep, irregular earthen embankment supporting Chompmist Hill Road (Photo 9).
 - The slope is overgrown with vegetation, tall grasses, briars, and leaf litter preventing access for a complete inspection.
- Several medium trees are growing within 15 feet of the downstream embankment's toe of slope.
- No animal burrows, seeps, sinkholes, depressions, or slumps were observed.

Irregularities Noted: The downstream embankment has a steep, irregular surface overgrown with vegetation and leaf litter preventing access for a visual inspection of the area. Medium trees are growing within 15 feet of the toe of slope.

Photo 9: View of the downstream embankment from the right abutment looking downstream and left. Note the dense vegetation.

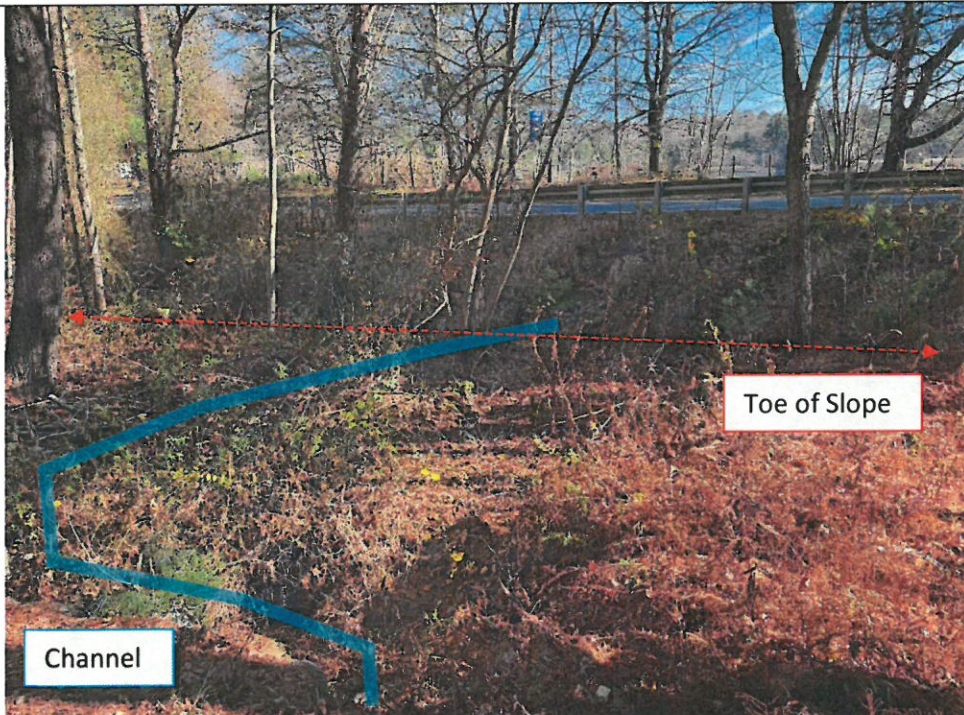
Photo 10: View of the spillway discharge channel (blue) from atop the downstream private road looking upstream. The downstream toe of slope is shown in red.

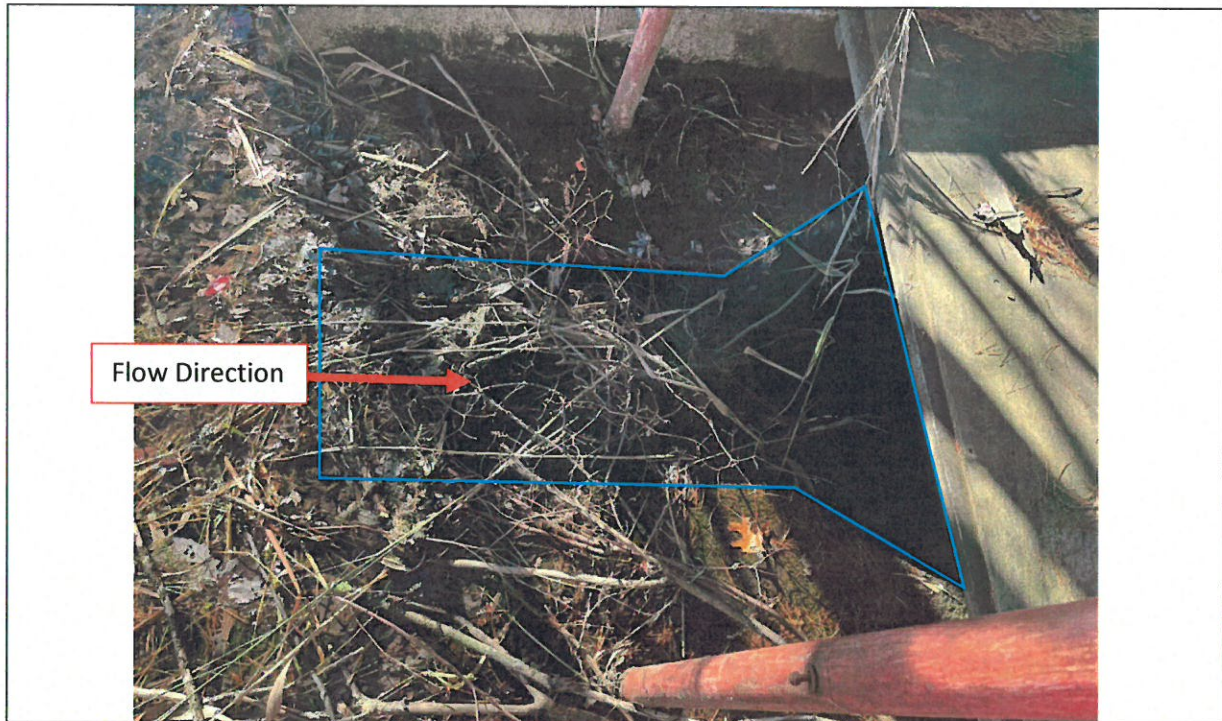
Photo 11: View of primary spillway drop inlet from its right training wall looking left. Note the accumulating debris within the drop inlet cross section (blue) and in the chamber below.

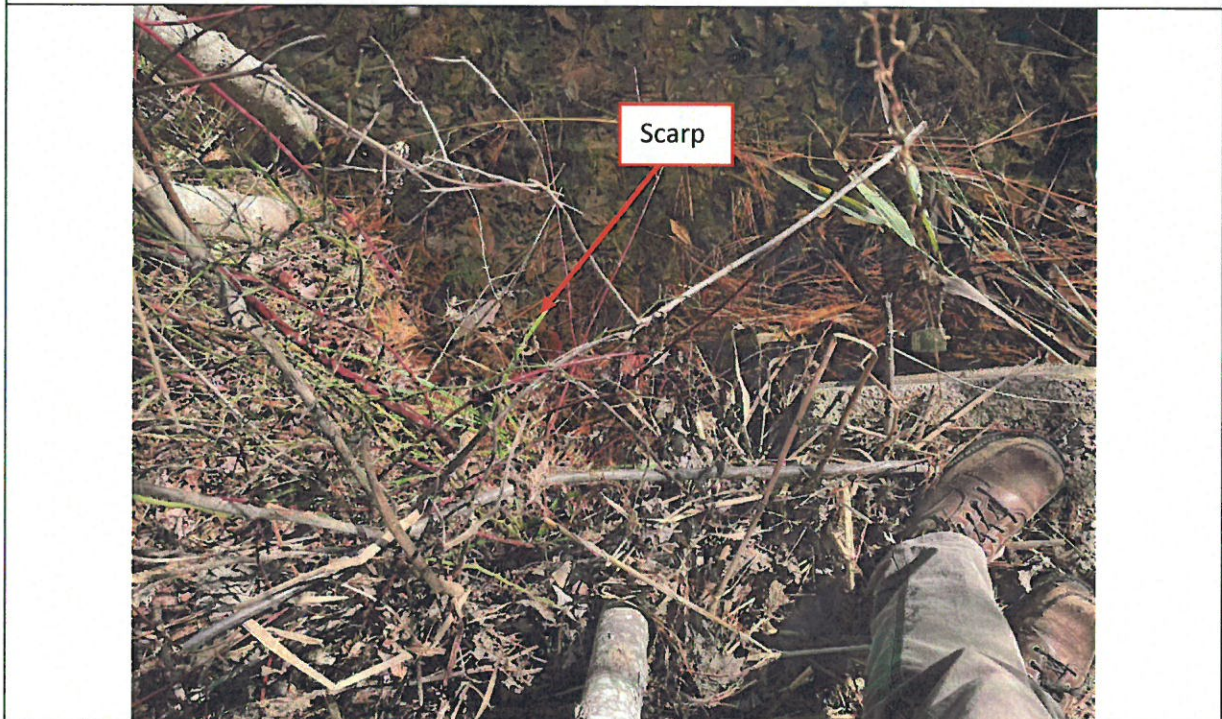
Photo 12: Minor scarping behind the right training wall.

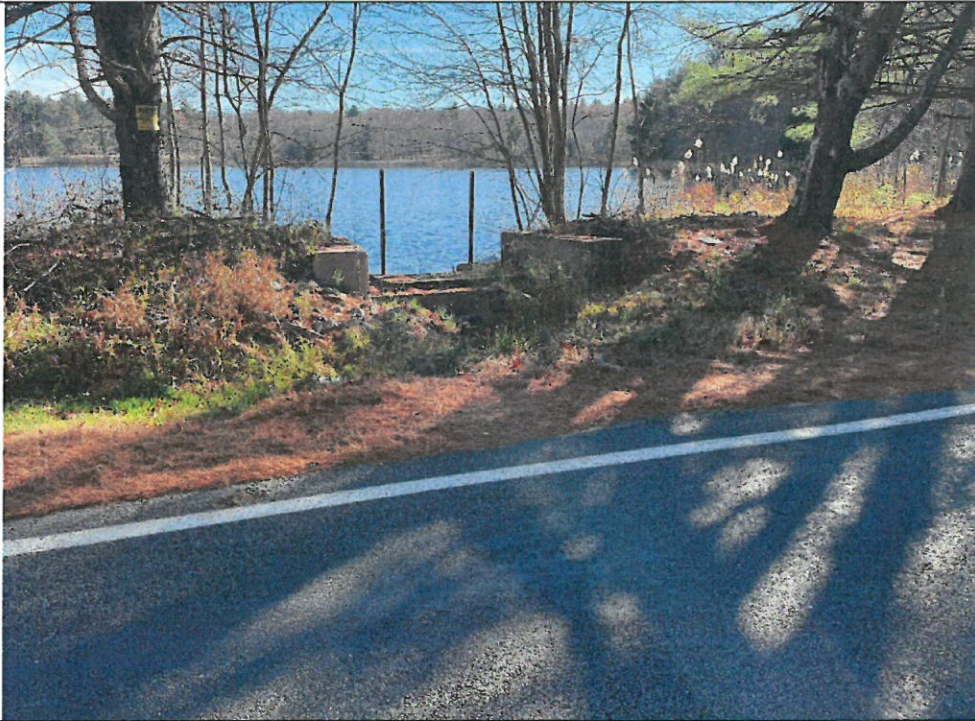
Photo 13: View of the primary spillway from the roadway looking upstream and left.

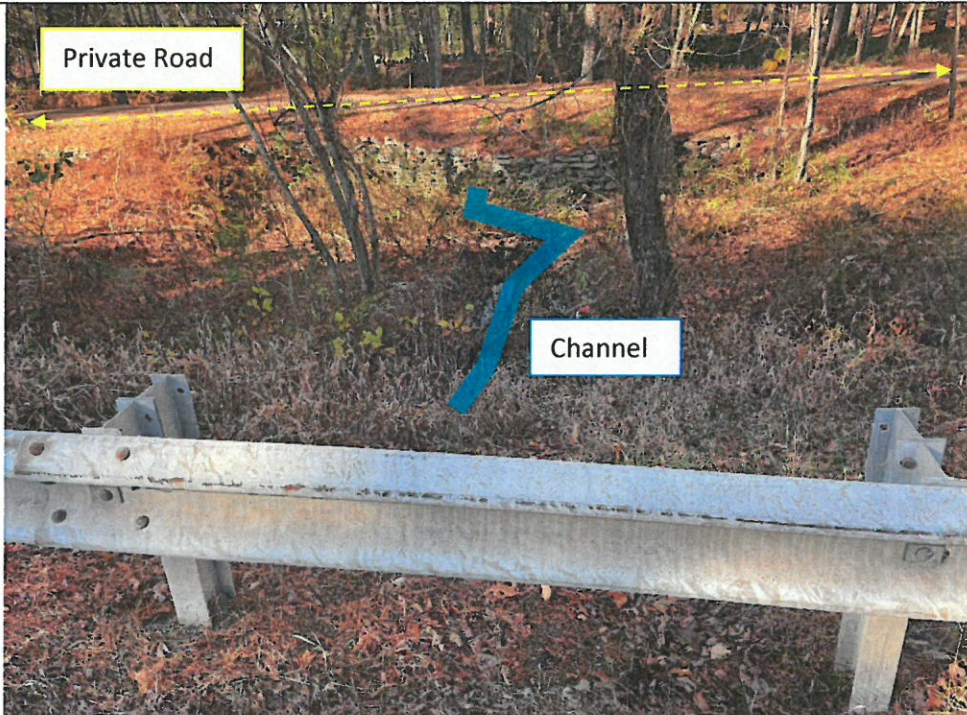
- Where the culvert meets the right downstream wingwall, the bottom section of the culvert has scoured/broken away (Photos 15-16).
- The downstream headwall and wingwalls have good alignment.
 - The right wingwall is undermined at least one foot but shows no signs of movement at this time.
- The discharge channel is overgrown with trees, briars, and vegetation which will impact capacity.
 - No energy dissipaters were noted in the downstream channel.
 - Roughly 50 feet downstream of the primary spillway discharge headwall the channel leads to a stone masonry culvert which exits under a private road (Photo 14).
 - Debris in the channel may block this channel in the event of a significant flood event.

Photo 14: View of the primary spillway's discharge channel from the roadway looking downstream. Note the private road and stone masonry wall/culvert supporting it.

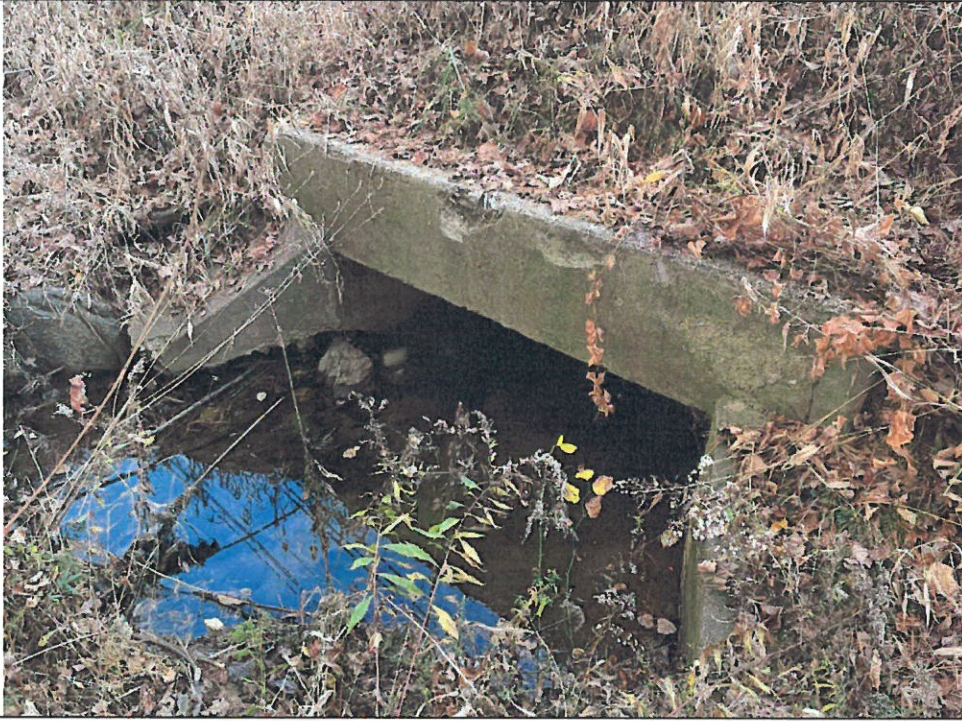
Photo 15: View of the primary spillway discharge outlet and wingwalls. Note the encroaching vegetation that would reduce spillway discharge capacity.

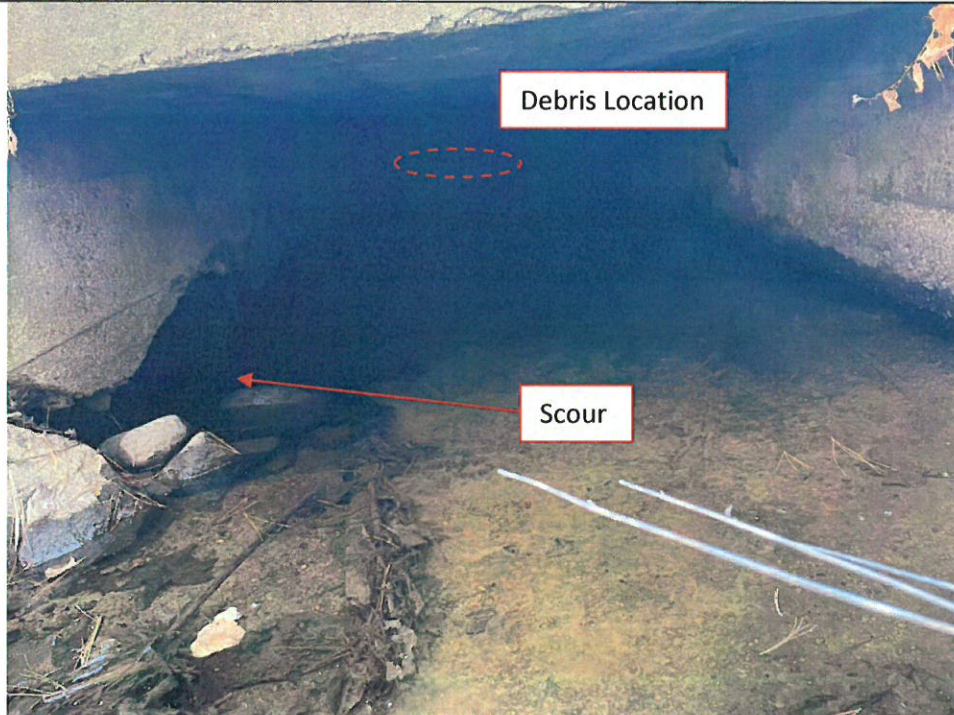
Photo 16: View from the inside of the primary spillway's discharge culvert looking upstream. Note the right wingwall/culvert is deeply scoured, and the debris in the drop inlet.
