**-- SMITH & SAYLES RESERVOIR DAM --
VISUAL
INSPECTION / EVALUATION REPORT**

Dam Name: *Smith & Sayles Reservoir Dam*

Date of Inspection: *May 20, 2022*

Dam Name (No): Smith & Sayles Reservoir Dam (023)
Location: Glocester
Hazard Classification: Significant

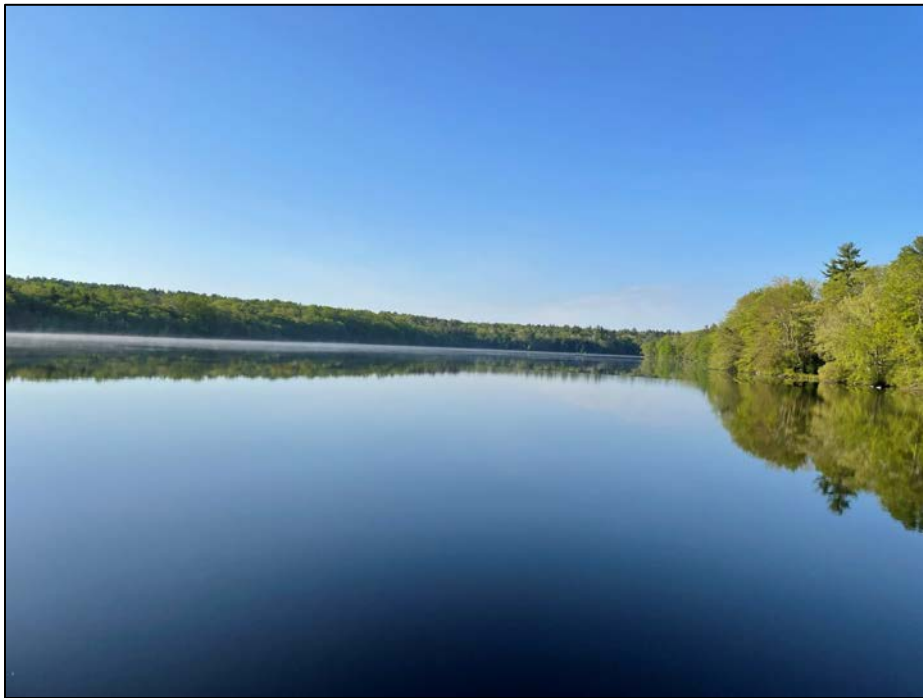
Photo No. 1.: Overview of the impoundment from the low level outlet (LLO) intake structure looking upstream.

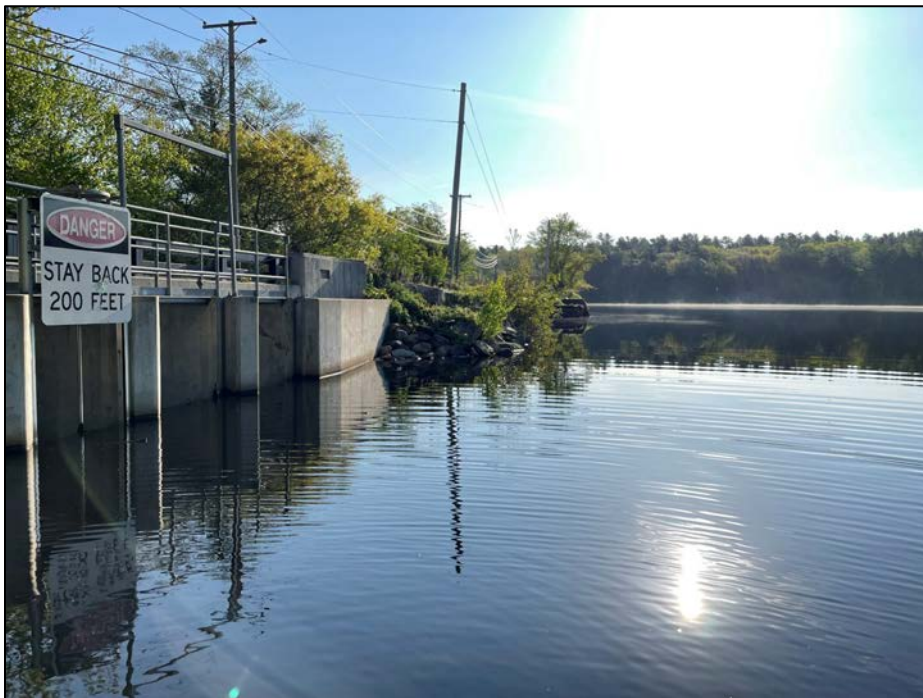
- Both the wall and the slope appeared irregular, but no apparent signs of movement or instability were noted.
- Maintained weed and brush vegetation is present throughout; the denseness of which limited a full viewing of the slope. Underwater areas were also not accessible.

Photo No. 2.: Upstream slope from the left abutment looking right.

- Given these two limitations, it is recommended that the next inspection be completed in late winter / early spring prior to leaf out and while the impoundment is at the winter drawdown elevation.

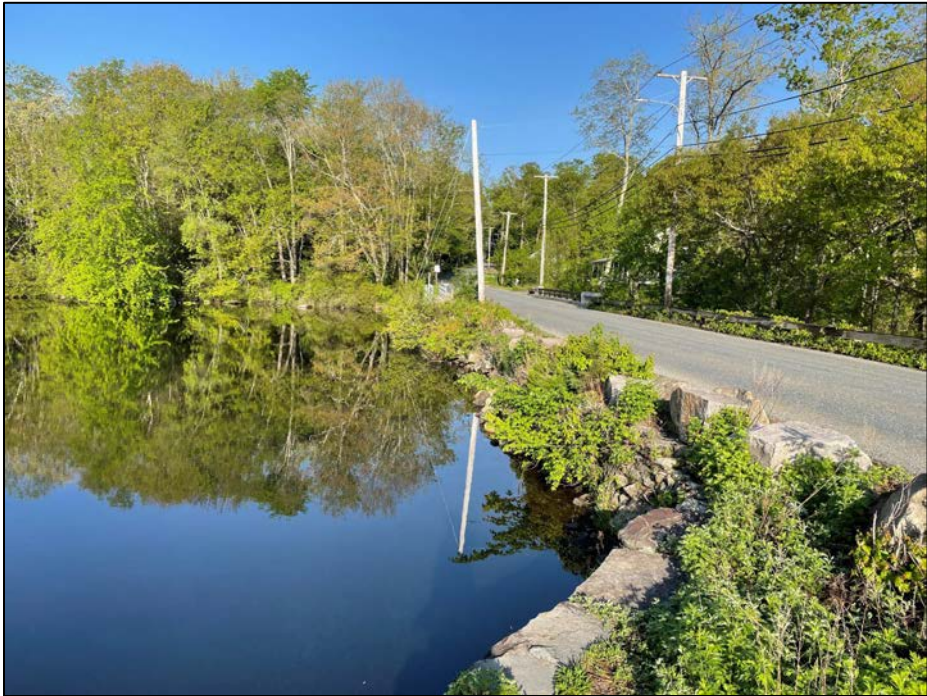
Photo No. 3.: Upstream slope from the LLO intake structure looking left.

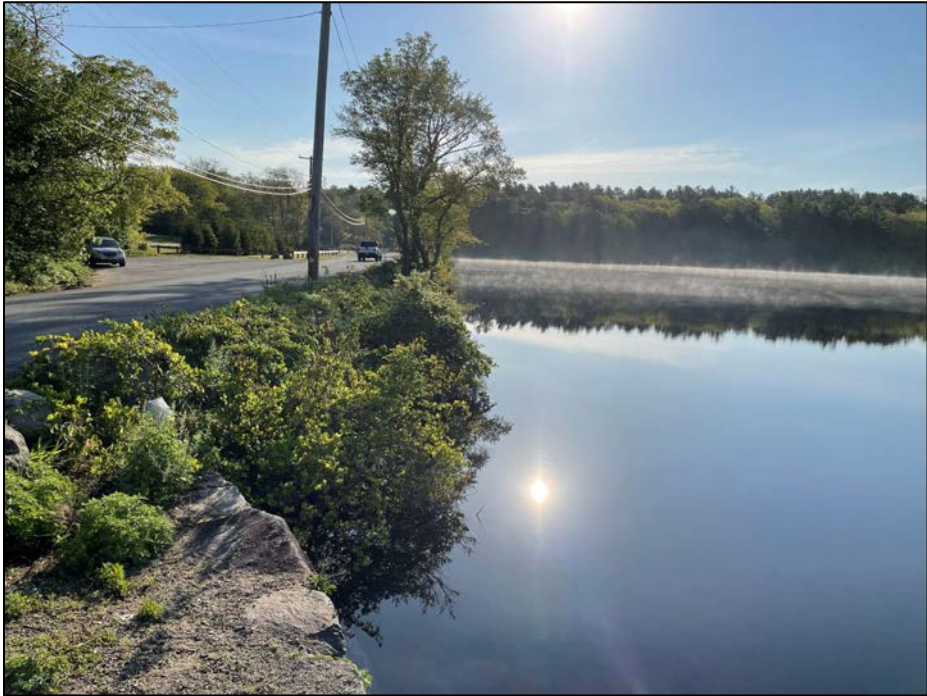
Photo No. 4.: Upstream slope from the LLO intake structure looking right.

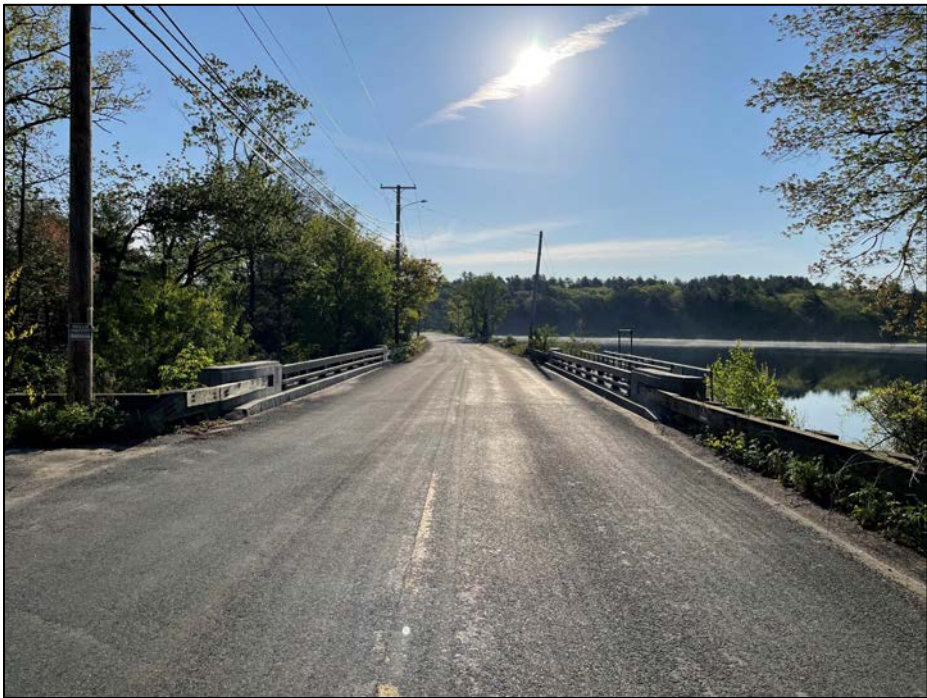
- The crest consists of a paved roadway (Chestnut Hill Road) and is in good condition with no depressions, holes, rutting, or puddling observed.
- The right side of the crest appeared to be lower than the left side which appears to be an as-built condition. The grade across the crest appears slightly sloped from upstream to downstream.

Photo No. 5.: Crest from the left abutment looking right.

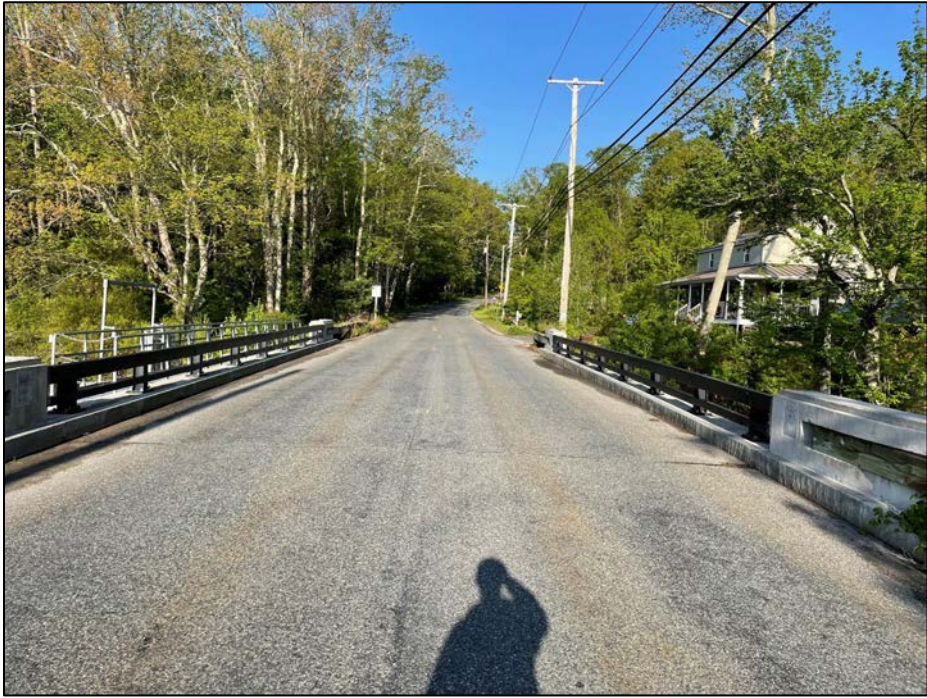
Photo No. 6.: Crest from right of the bridge over the spillway channel looking left.

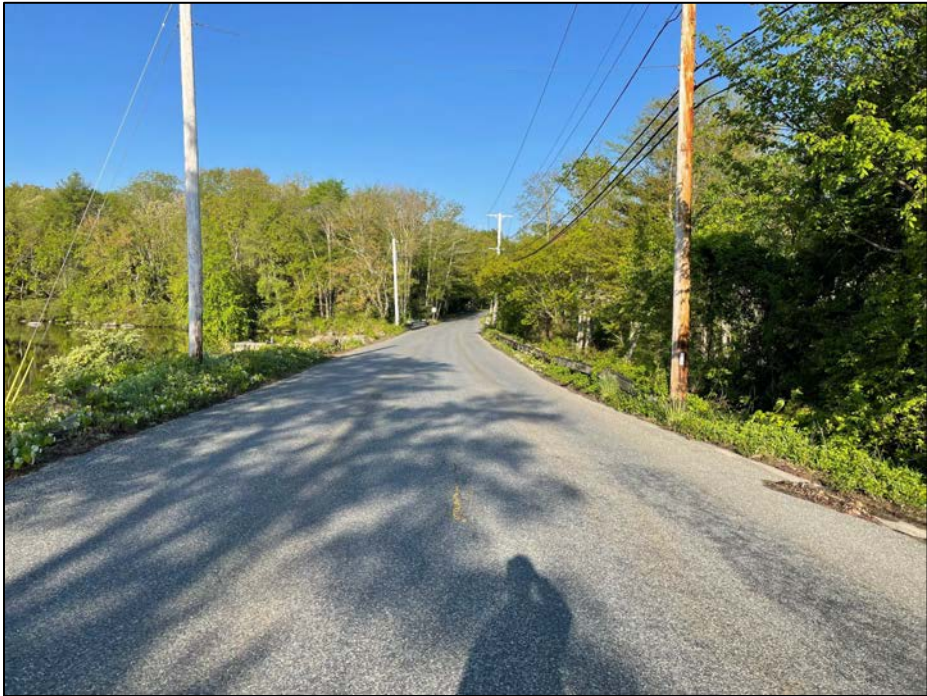
Photo No. 7.: Crest from the right abutment looking left.

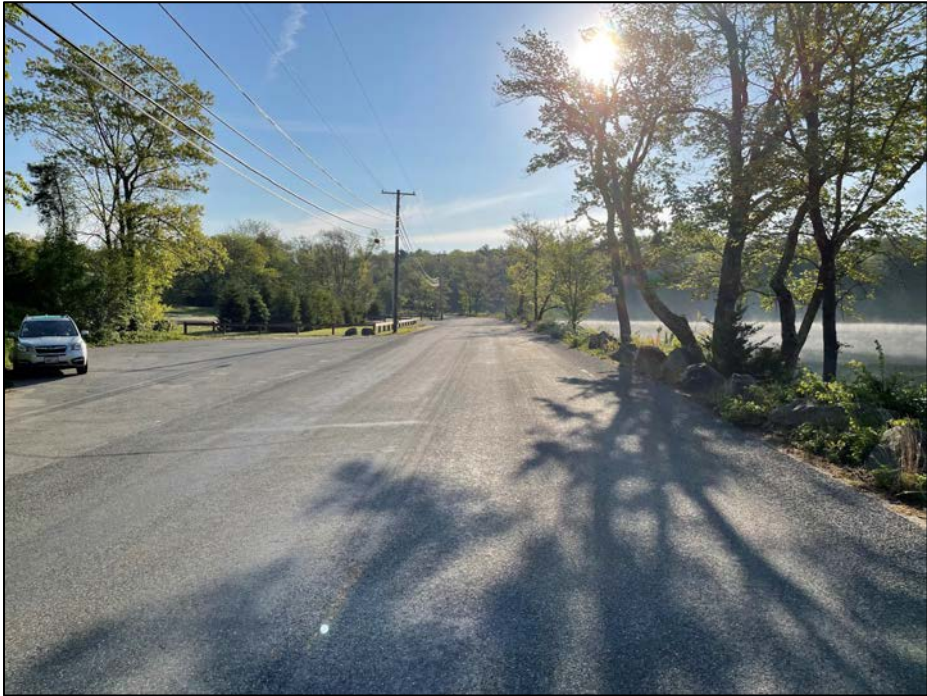
Photo No. 8.: Crest of the right abutment looking right.

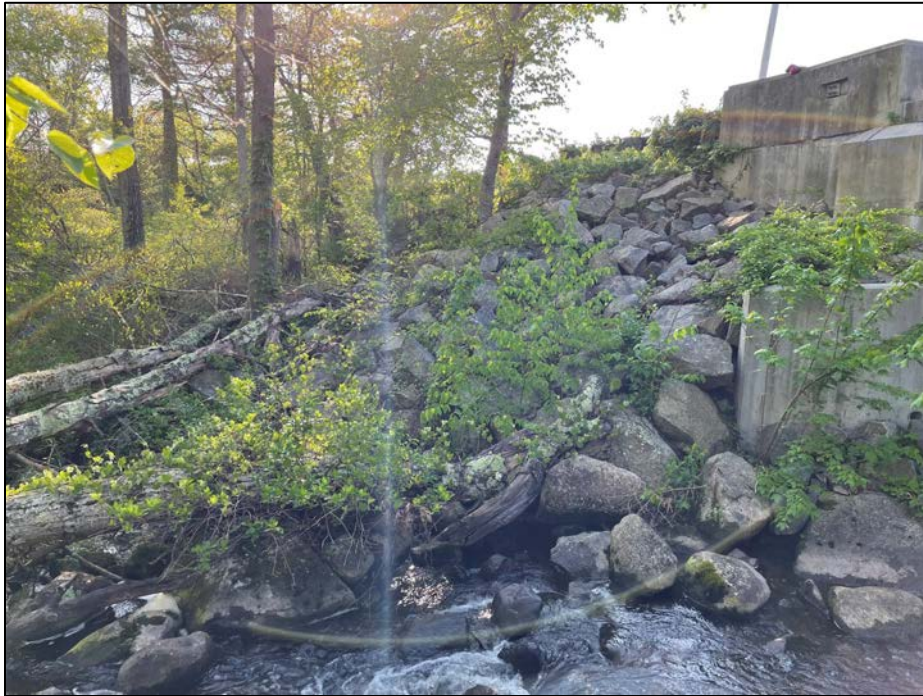
- The following was noted along the portion of the slope from the spillway to within 10 feet of the LLO:
 - The slope is overgrown with large diameter tree and dense brush vegetation.

Photo No. 9.: Downstream slope from the spillway channel looking right. Note growth of woody vegetation within riprap and along the slope further right.

1. Clear the upstream and downstream embankment of all trees, vegetation, and deadfall to a distance of 15 feet beyond the downstream earthen toe/bottom of walls. Remove stumps and root systems from the dam embankment and along the downstream toe of the embankment. Fill resulting voids with compacted engineered fill. **Impacts to the embankment should be evaluated by an engineer prior to grubbing roots from the dam. Given the location of the stumps along the downstream wall, and the conditions prevalent at the time of the work, instability, seepage or piping conditions could develop if not undertaken in a controlled manner.**

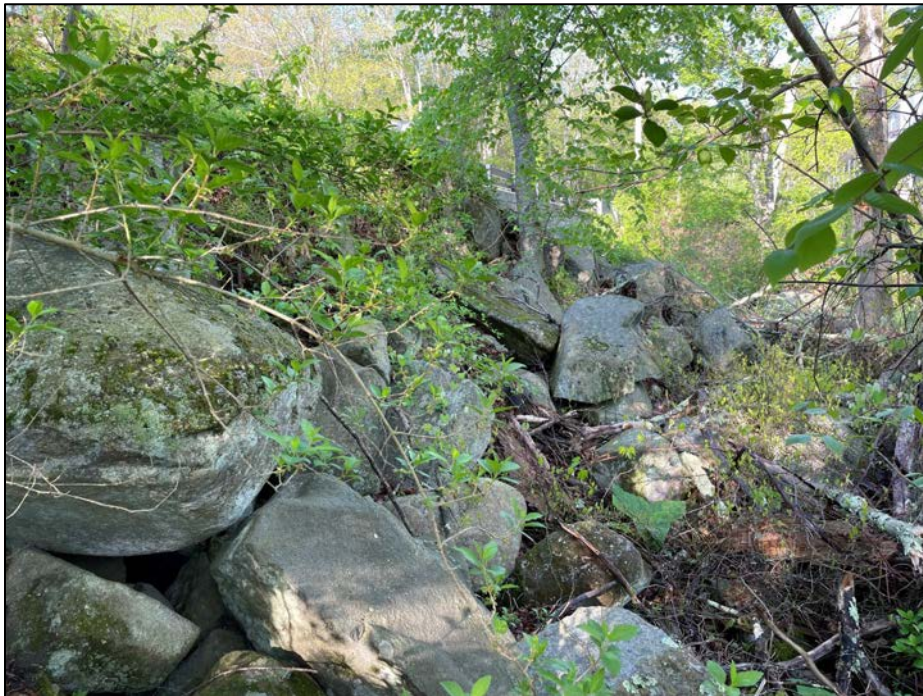
- Accessible portions of the slope were observed to consist of very large diameter boulders that were stacked/dumped irregularly that result in a steep slope approaching greater than 1H:1V.

Photo No. 10.: View of the large and irregularly stacked boulders of the downstream slope looking left.

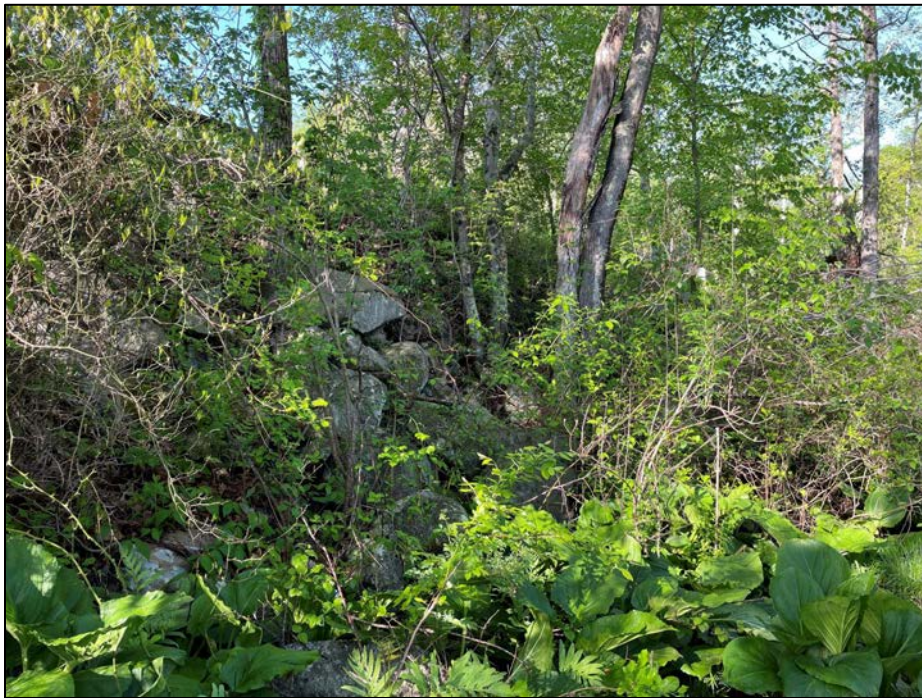
Photo No. 11.: View of the large and irregularly stacked boulders of the downstream slope looking left.

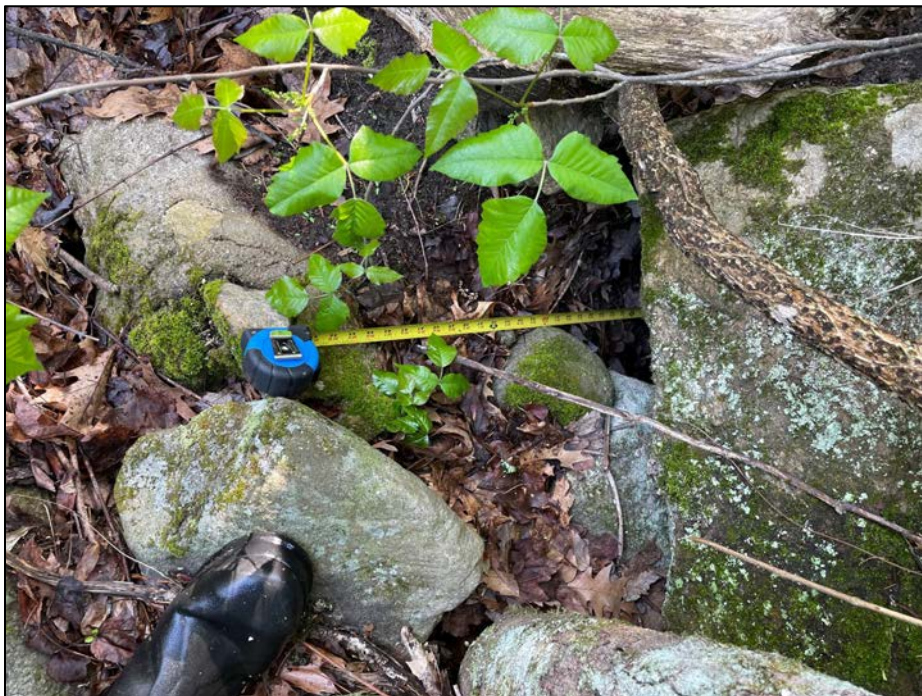
Photo No. 12.: View of one of the many voids within the large boulders that extend as far as 4 feet in the upstream direction.

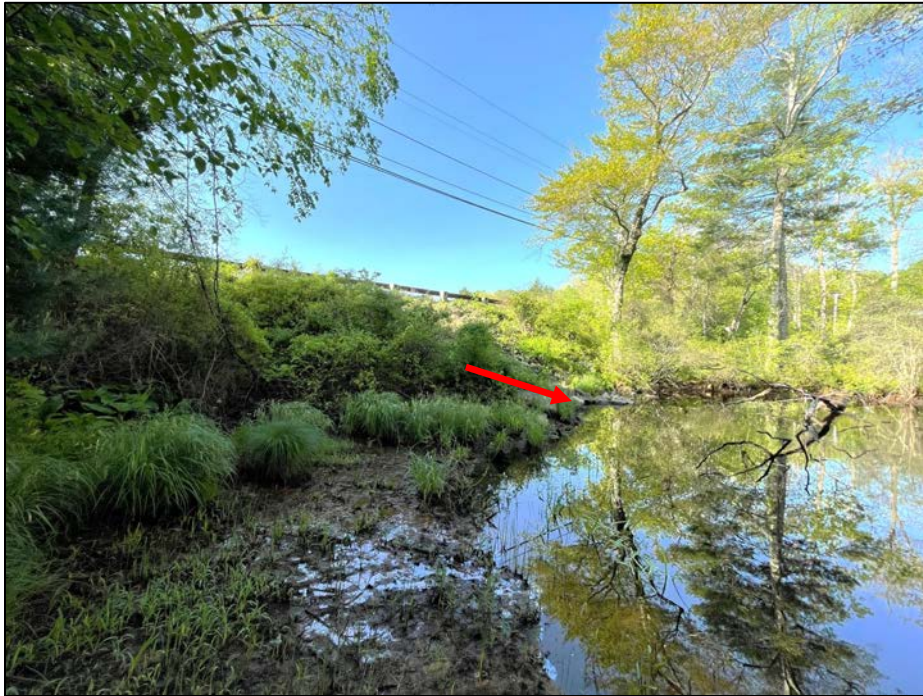
Photo No. 13.: View of the downstream slope from the right edge of the tailwater pool looking left and upstream. Note location of the LLO pipe (red arrow). Note the tall tree growth along the left (photo right) half of the slope and smaller height weed and brush growth along the right half (photo left)

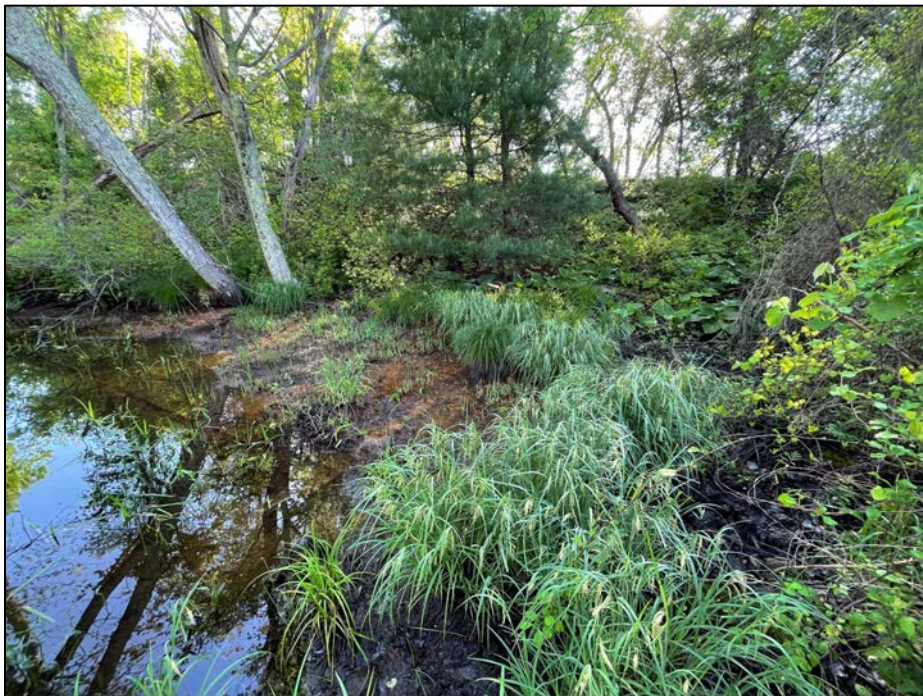
- The slope within 10 feet of the right abutment and the right abutment itself is overgrown with trees and brush. The toe and downstream area is saturated (but firm) with iron oxide stained water flowing slowly to the tailwater pool. It appears that most of this condition is the result of groundwater flow from the right abutment and there was no apparent evidence that suggested it was the result of seepage through the dam. However, the area should be reassessed during a time of year that permits viewing less obstructed by vegetation.

Photo No. 14.: View of the saturated downstream area with iron oxide staining and low flow along the toe of the right abutment slope.

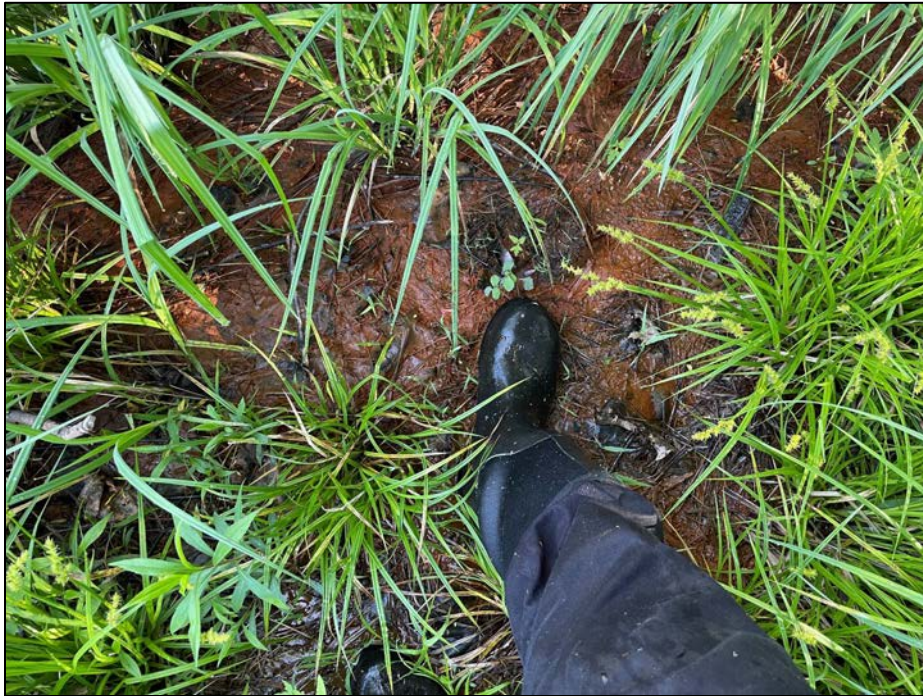
Photo No. 15.: Photo showing the ground surface within the saturated area shown in Photo #14. Note that the ground is firm and the boot is generally not sinking in below the surface when traversed.

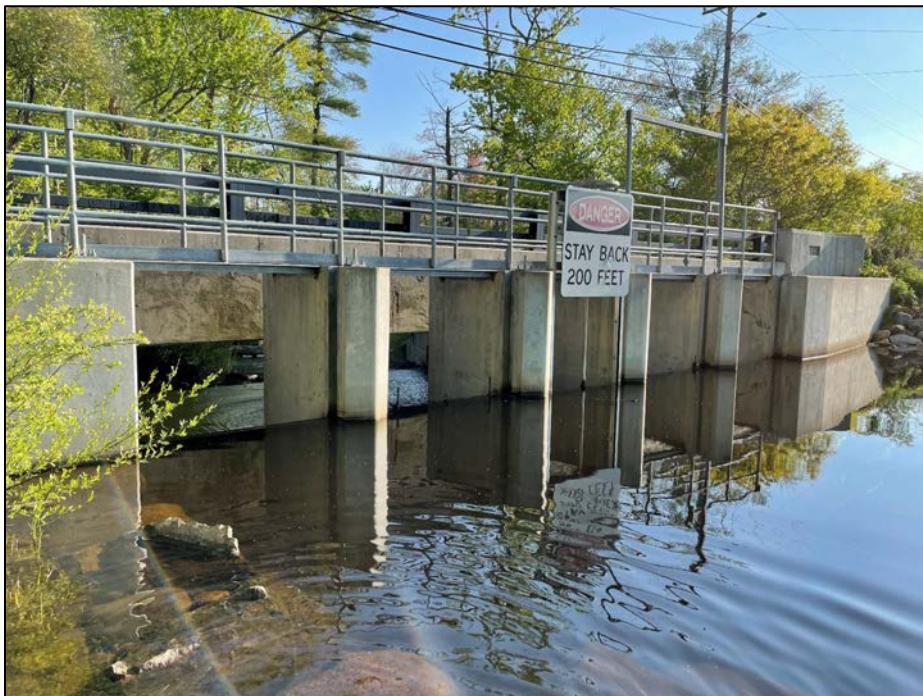
Photo No. 16.: Approach and upstream side of the controls of the spillway system.

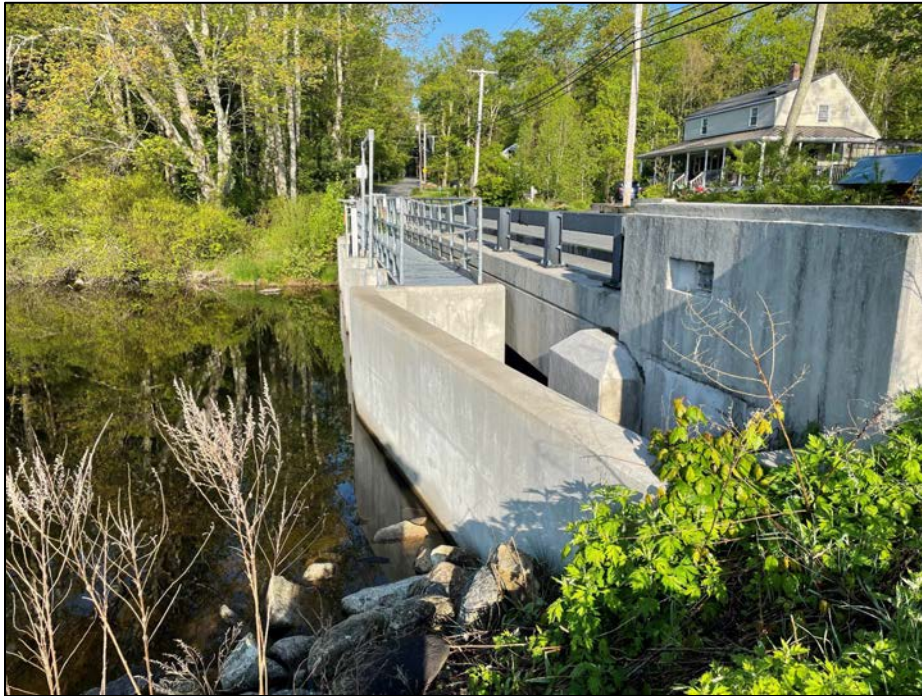
Photo No. 17.: Spillway approach and controls section from the right end looking left.

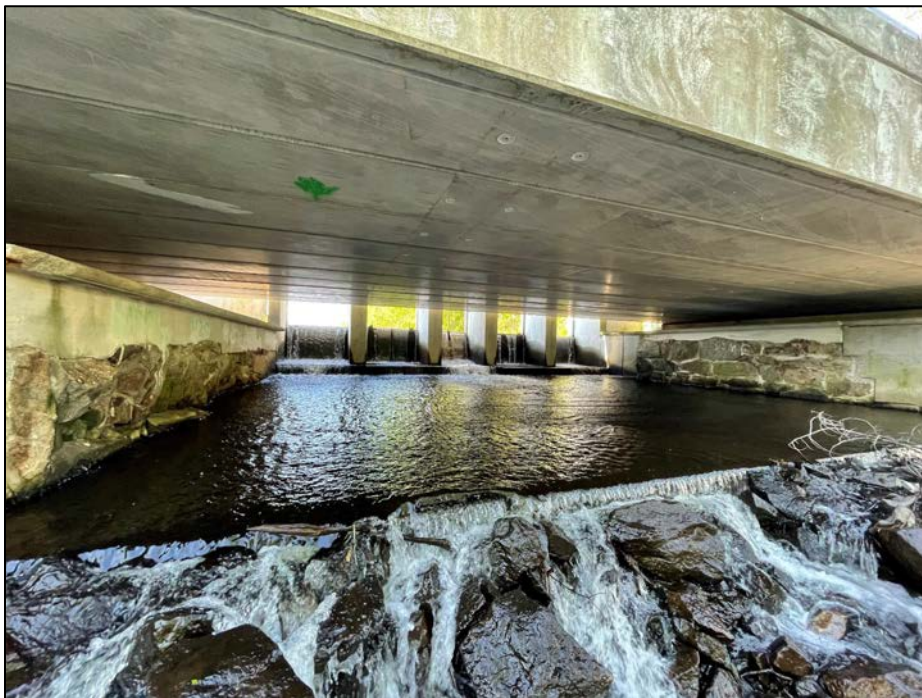
of the concrete discharge slab appear to have been displaced resulting in a vertical drop between the slab and top of remaining riprap of up to 1 foot. This condition as is does not appear to be a risk to lead to slab undermining; however, should be monitored to assess that additional riprap displacement does not occur to the point where slab undermining would be a concern.

Photo No. 18.: Discharge area of the spillway looking upstream.

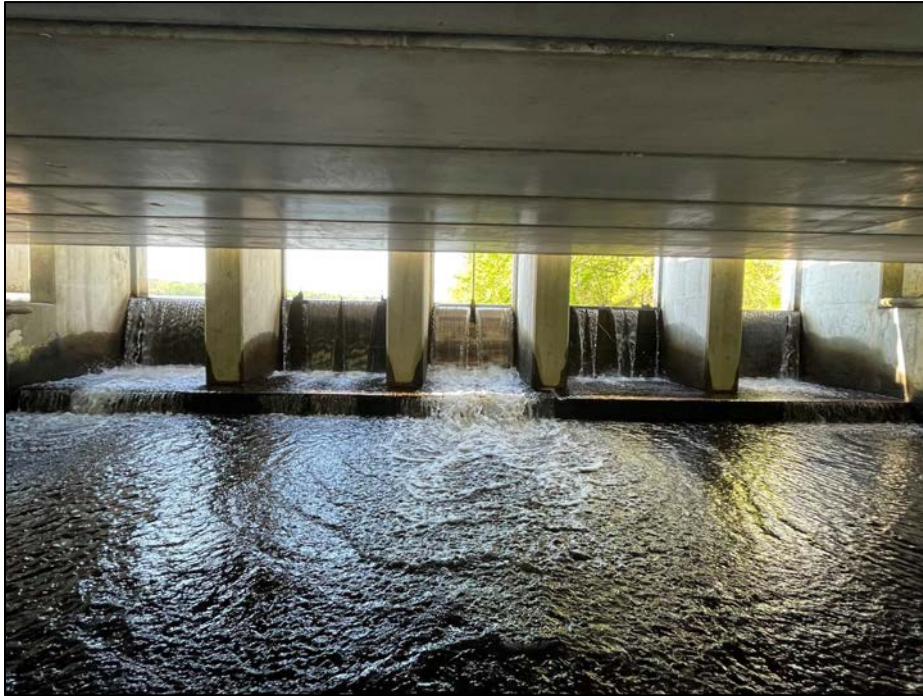
Photo No. 19.: View of the five control bays of the spillway; all bays are stop log controlled except for the upward operating slide gate within the center bay.

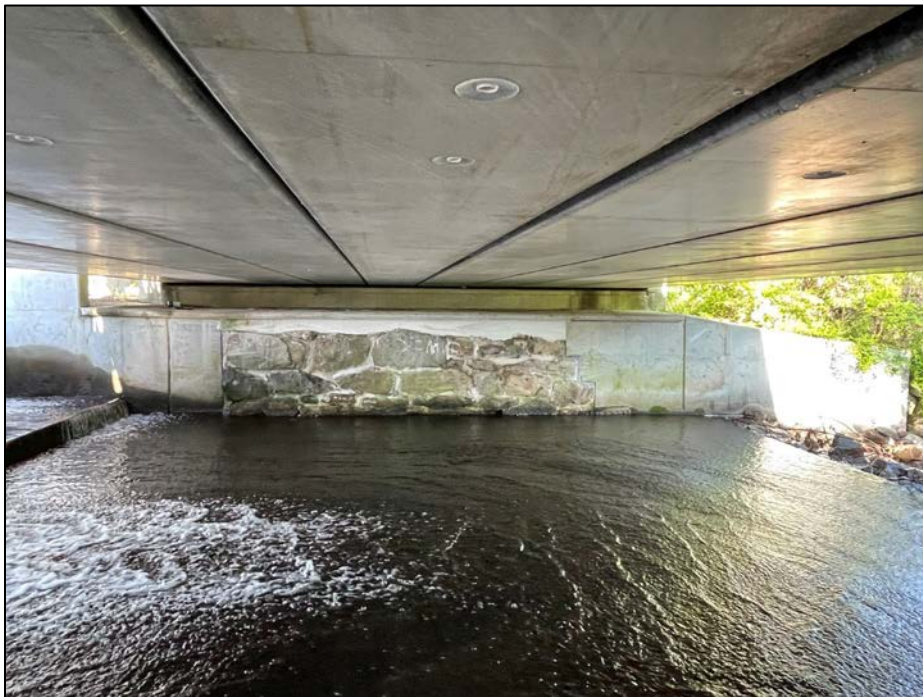
Photo No. 20.: Left training wall of the spillway discharge channel.

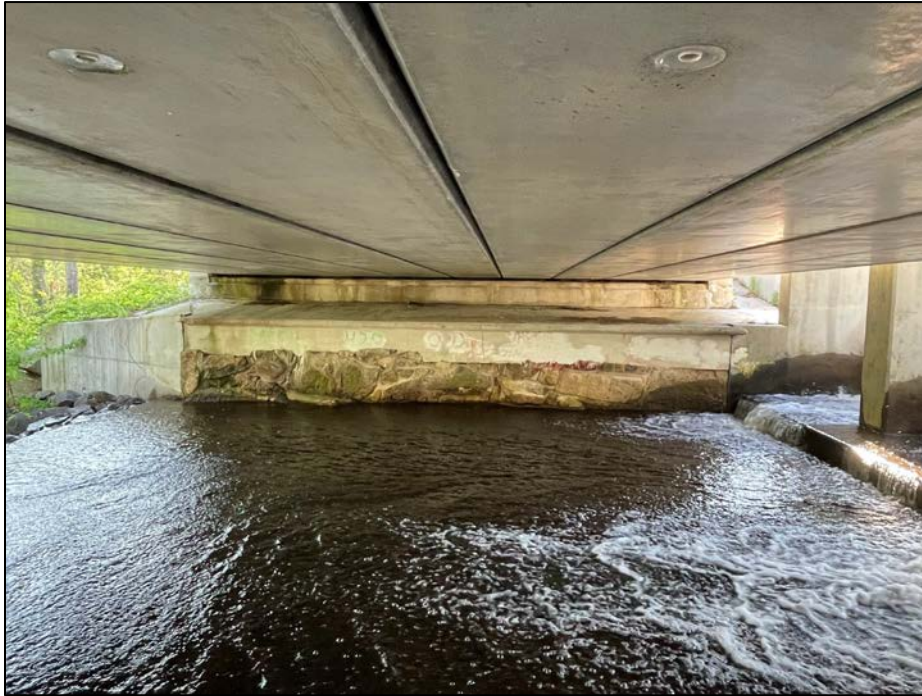
Photo No. 21.: Right training wall of the spillway discharge channel.

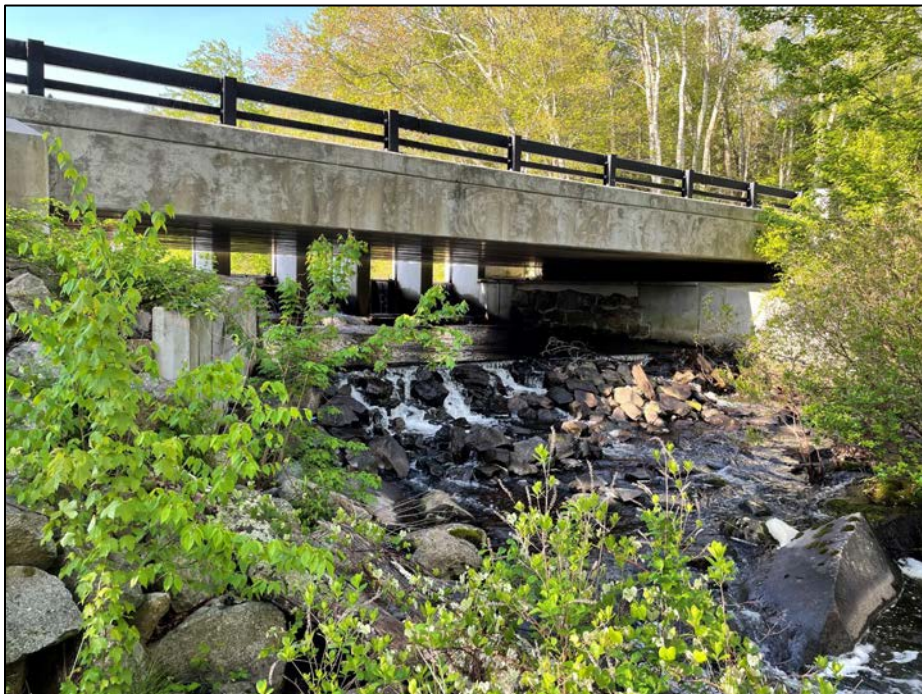
Photo No. 22.: View of the discharge channel of the spillway.

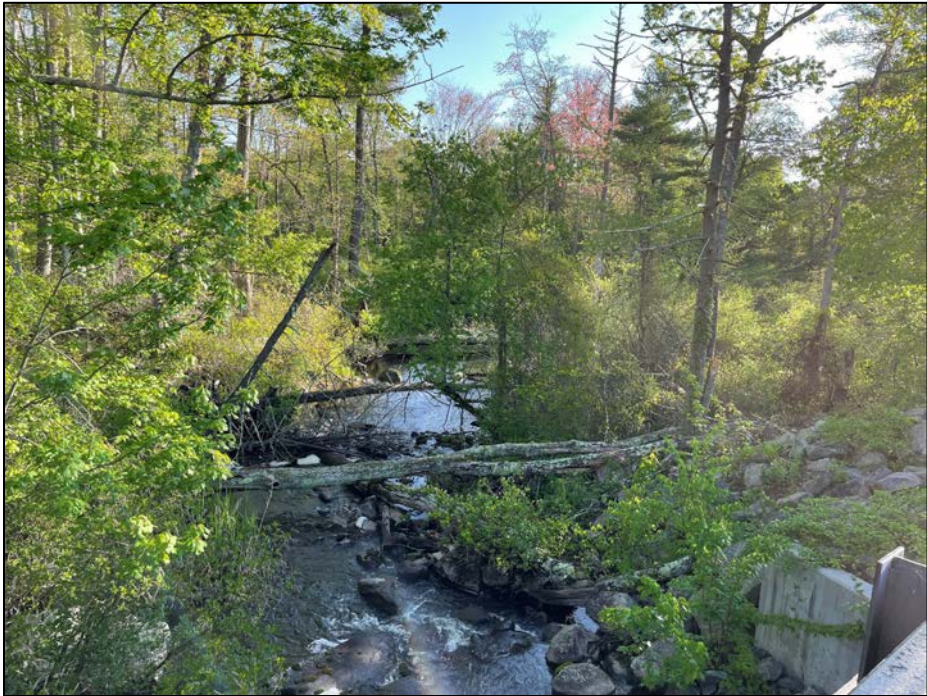
Photo No. 23.: Downstream channel of the spillway.

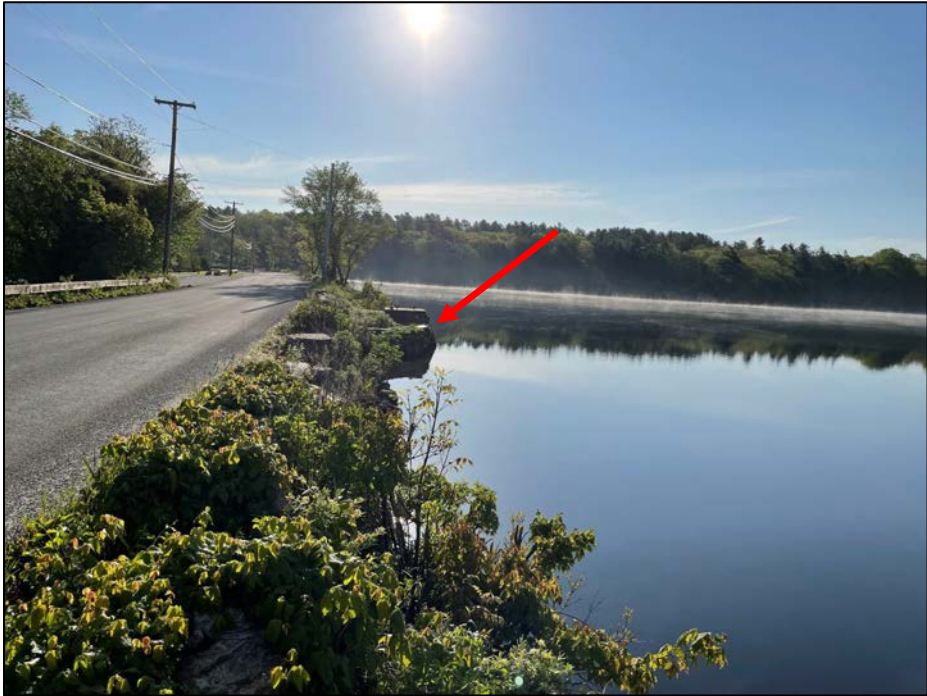
Photo No. 24.: View of the LLO intake structure (red arrow).

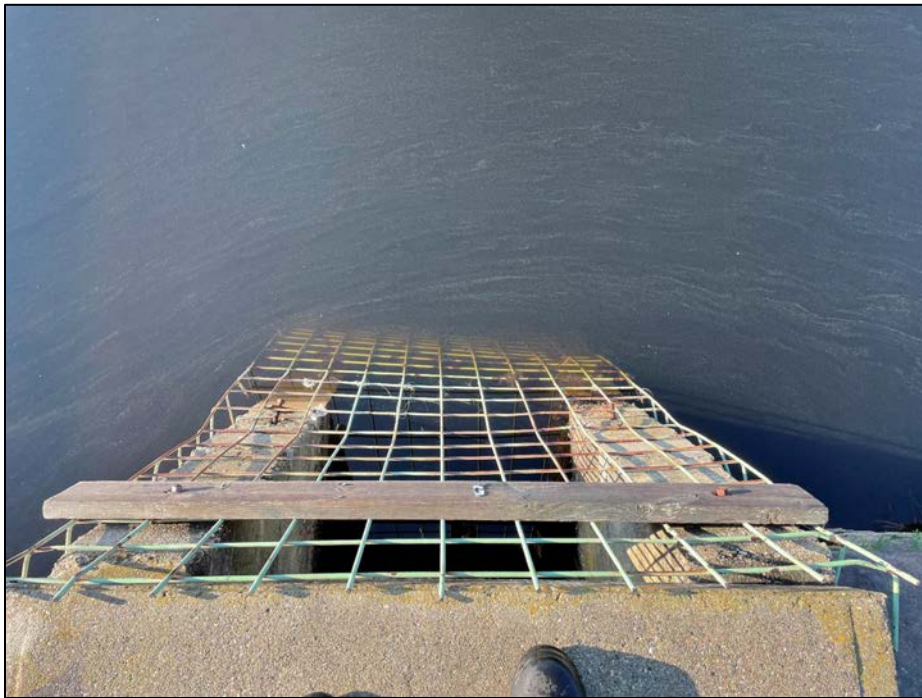
- The trash rack is in good condition.
- The concrete at the inlet structure is in fair condition with aged but structurally sound concrete.
- The Owner reported that the gate is operated annually to perform a winter drawdown of the impoundment with the last operation reportedly occurring in April 2022; as such, the outlet was not operated during this inspection. Based on a review of the outlet conditions (i.e. clear pipe conduit, cleared approach and discharge areas) the outlet appears operable.

Photo No. 25.: Trash rack at the upstream end of the intake structure.

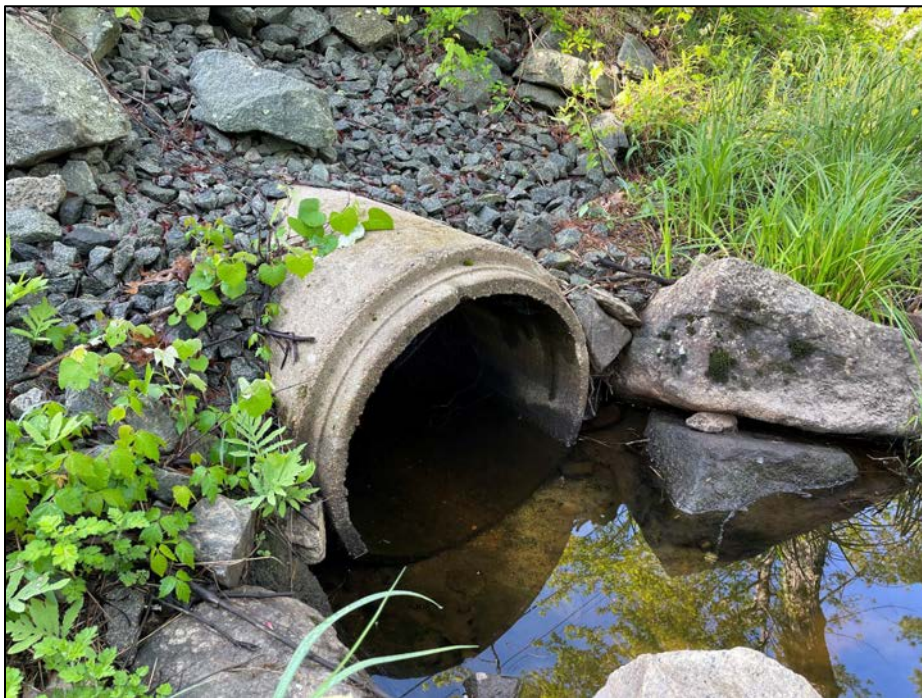
Photo No. 26.: Outlet end of the LLO outlet pipe.

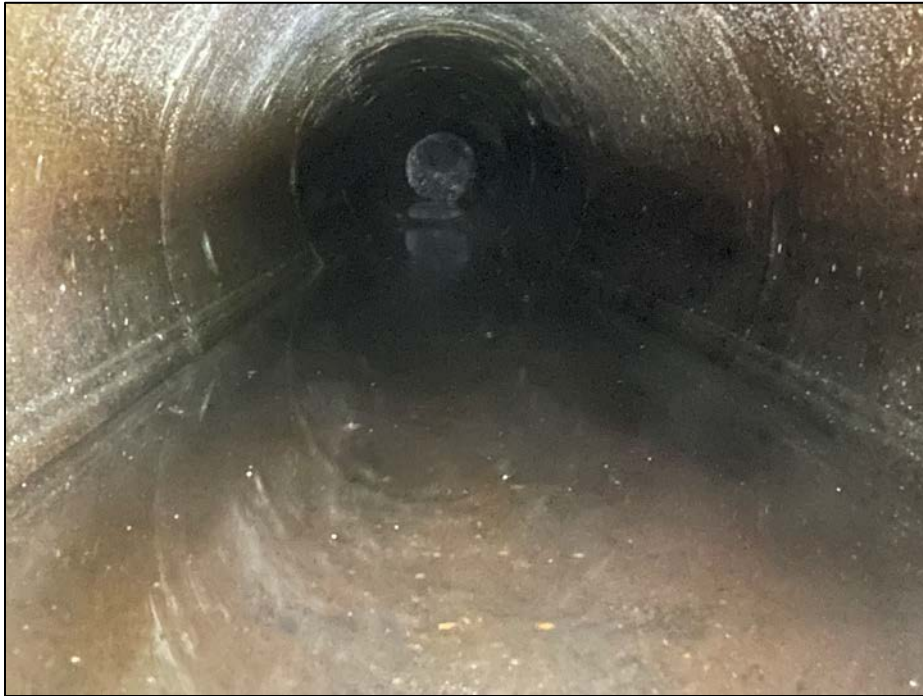
Photo No. 27.: View within the outlet pipe from the outlet end of the pipe looking upstream.

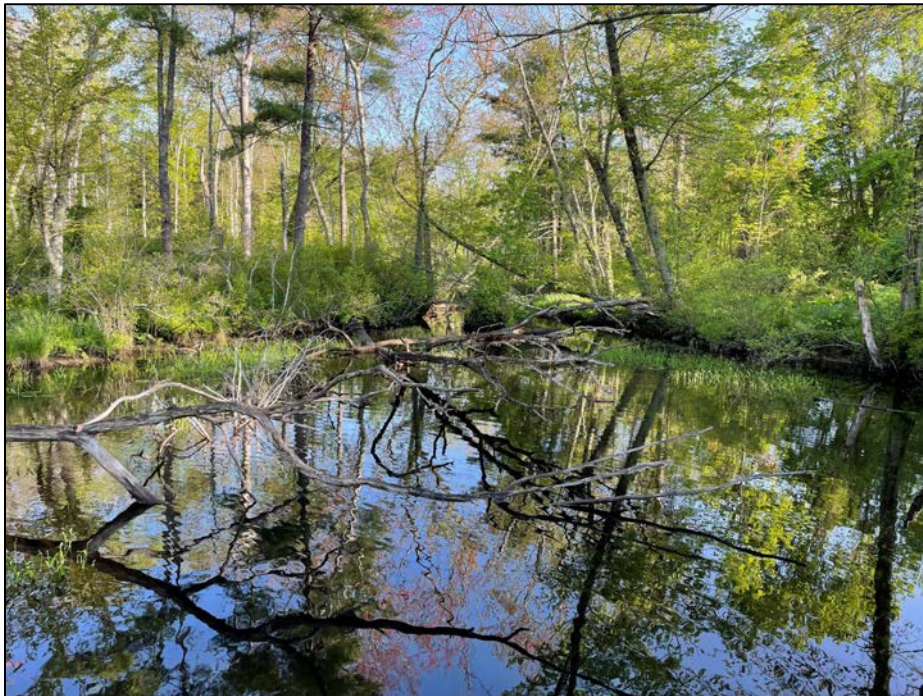
Photo No. 28.: View of the discharge area and tailwater pool downstream of the LLO pipe from the outlet end of the pipe looking downstream.
