**162 MOSWANSICUT POND**

## MOSWANSICUT POND DAM, SCITUATE (162)

GZA reviewed available DEM files associated with Moswansicut Pond Dam (Figure 1), including records of a U.S. Army Corps (COE) Phase I Report dated October, 1980. The dam has historically been classified by DEM as having a **Low Hazard** potential.

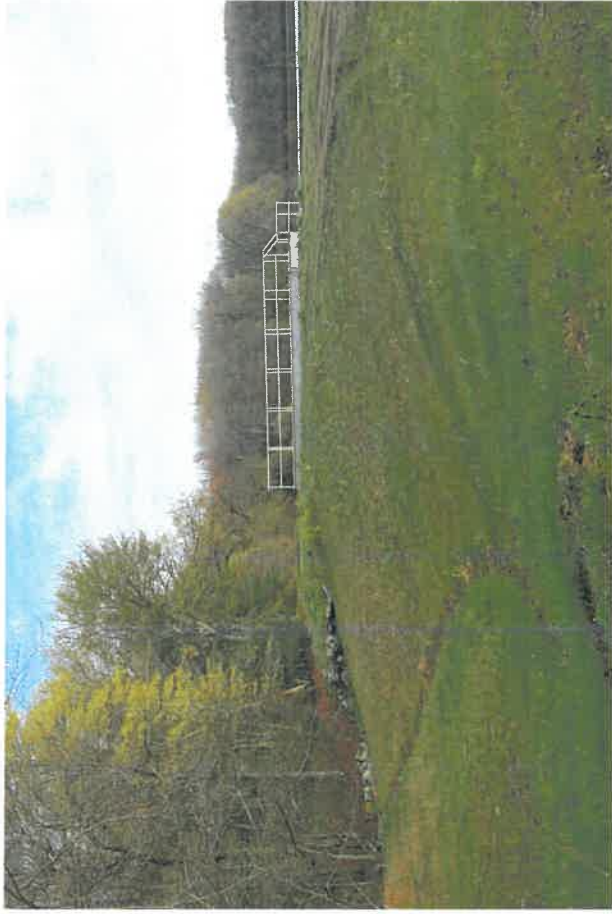
**Description:** Photo 1. View of dam from near left abutment.

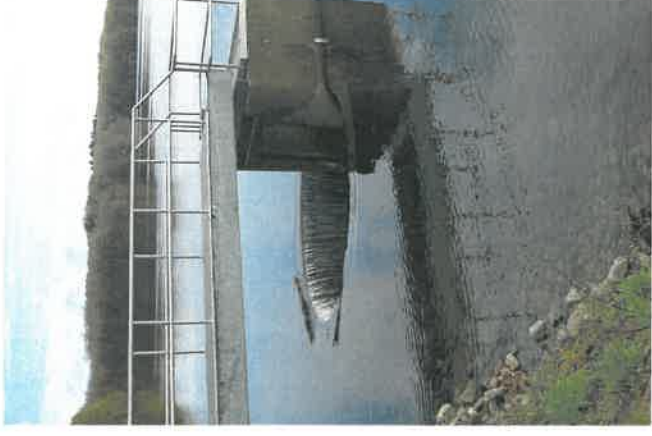
**Description:** Photo 2. View of morning glory spillway inlet.

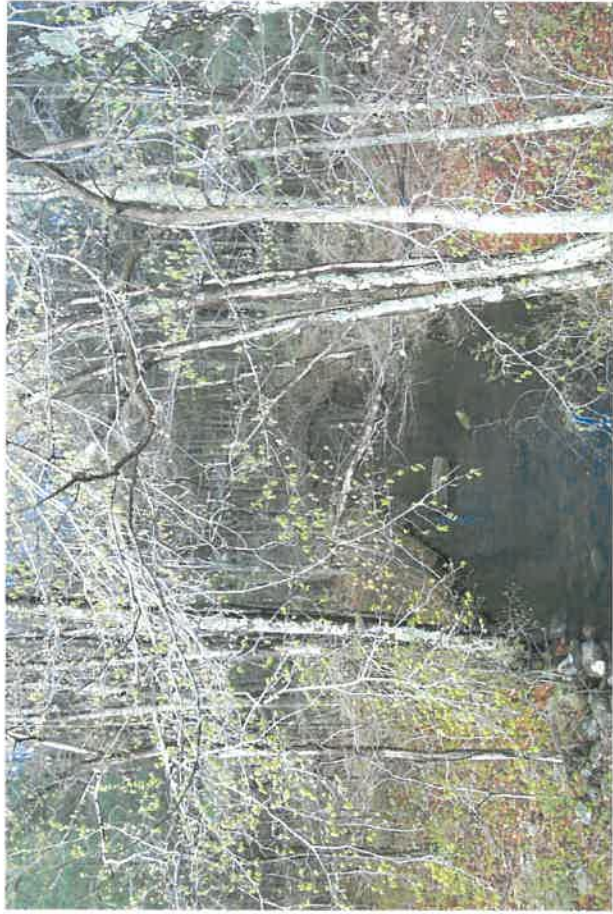
**Description:** Photo 3. View of receiving stream just downstream of dam.

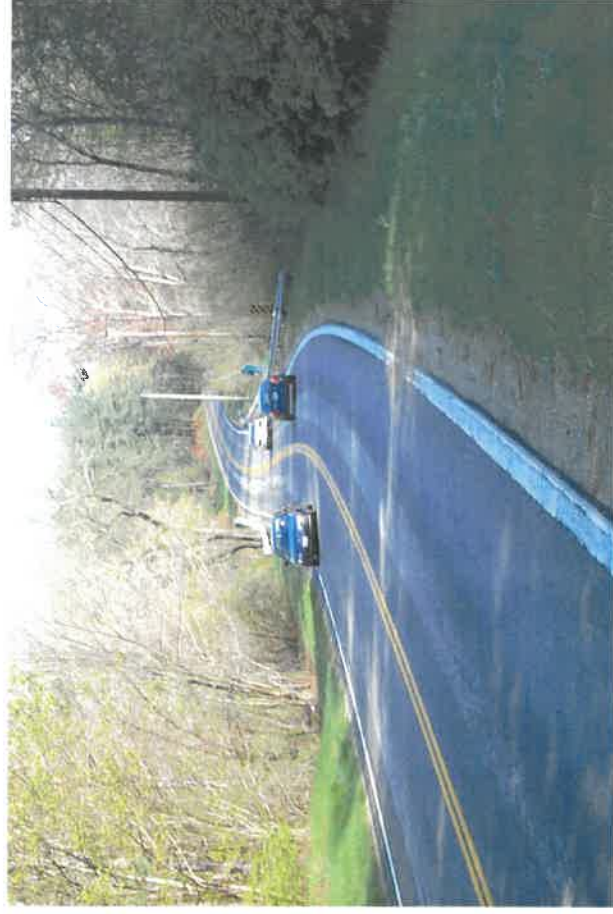
There is a concrete arch culvert about 5 ft wide by 3 ft high beneath Route 116 (West Greenville Road), about 600 feet downstream of the dam. Route 6 (Hartford Pike) crosses the brook in a wetland area via an assumed submerged culvert, about 2,000 ft downstream of the dam.

**Description:** Photo 4. Rt 116 Bridge / culvert crossing, 600' downstream of dam.

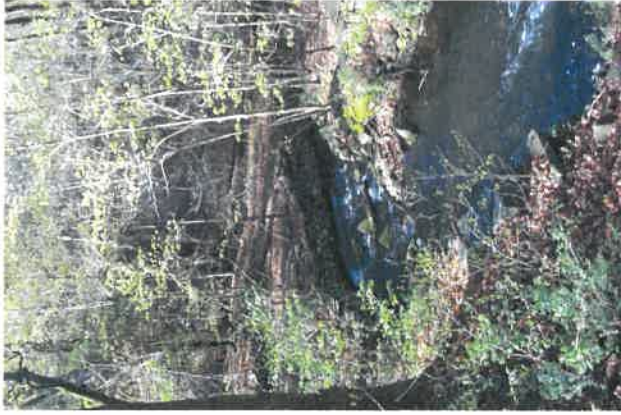
purposes. Immediately downstream of Route 116, there are remnants of stone mill buildings and the brook is channelized by stone masonry training walls, about 8 to 10 feet in height. However, the floodplain is currently uninhabited and undeveloped.

**Description:** Photo 5. View of Moswansicut Brook downstream of Rt 116.

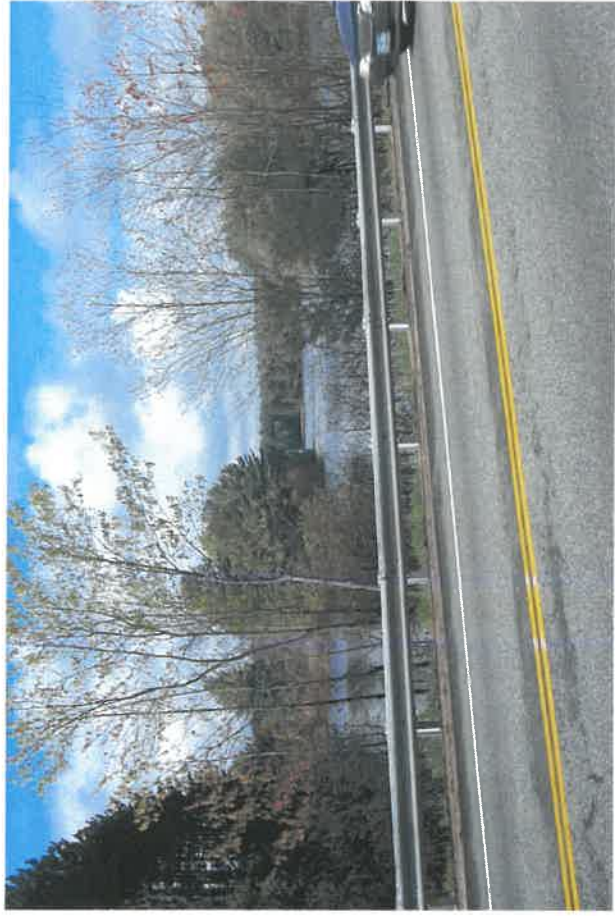
**Description:** Photo 6. View of Rt 6, looking downstream, at assumed location of culvert.

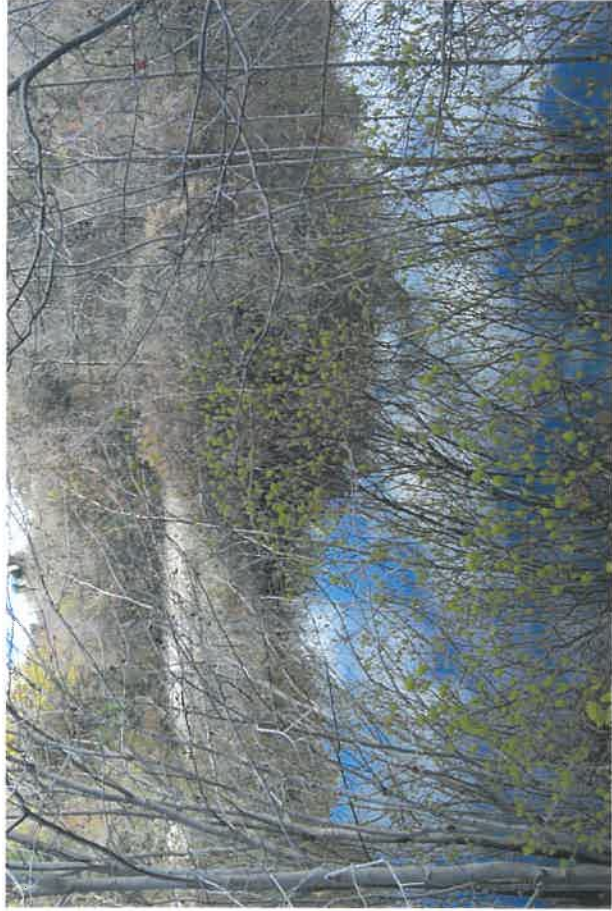
**Description:** Photo 7. Wetland area upstream of Rt 6 at Moswansicut Brook.

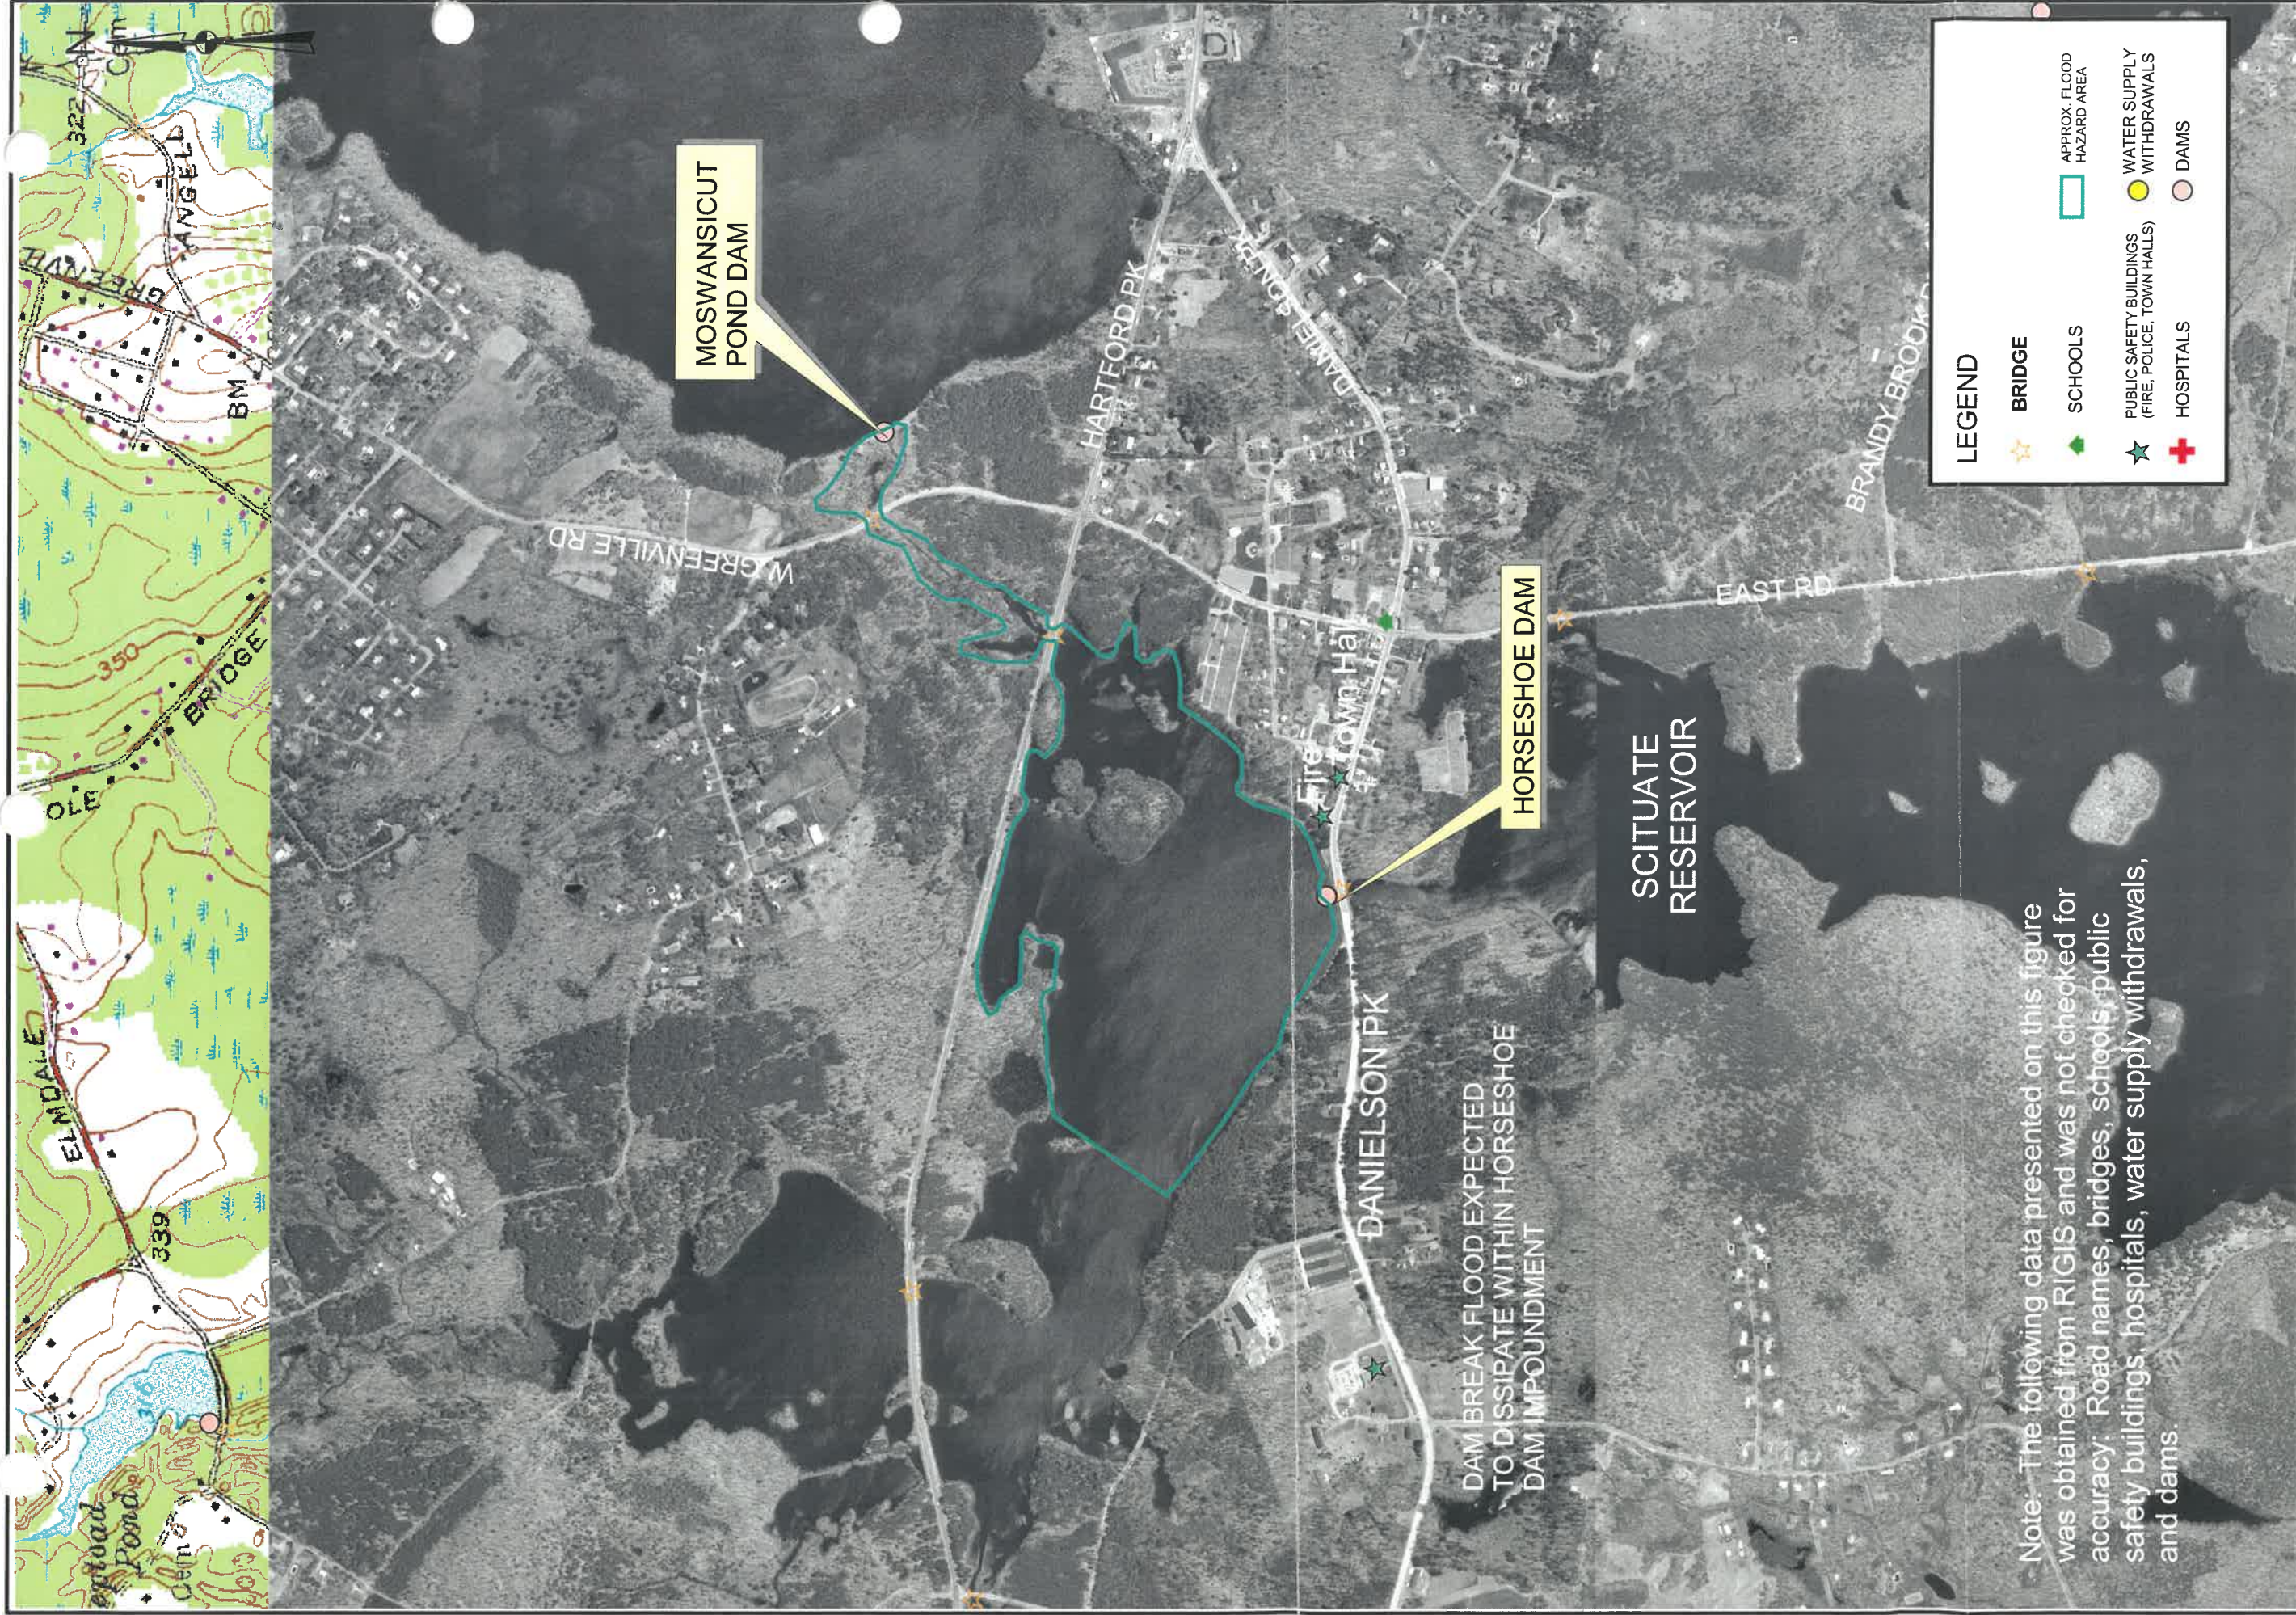
FIGURE 2	GZA NO. 17085	<p><b>DAM HAZARD POTENTIAL CLASSIFICATION MAP</b></p> <p><b>RIGIS</b></p> <p>SOURCE</p>	<p>DATE OF MAP: APRIL 1997</p>
MOSWANSICUT POND DAM SCITUATE, RHODE ISLAND		<p>SCALE</p> <p>0 500 1000 Feet</p>

Several riverine cross sections, developed by GZA from USGS 7.5 minute quadrangle maps, were input into the SMPDBK model to preliminarily estimate approximate peak water surface elevations. The results of the analysis are provided as the approximate inundation area depicted in **Figure 2**.

Results of the analysis indicate a peak flood depth at the immediate toe of the dam of about 9 feet. As the flood wave progresses downstream, it is expected to attenuate. Thus, peak flood depths are predicted to decrease to about 3 feet near the upstream extent Scituate Reservoir. The extent of flooding due to the hypothetical dam break includes flooding of the unpopulated wooded area adjacent to the Moswansicut Brook, and potential shallow flooding at Routes 116 and 6.

GZA recommends that Moswansicut Pond Dam be classified as *Significant Hazard* based on the aforementioned analyses, site / downstream valley reconnaissance, site-specific GIS mapping and other existing data, and professional judgment. While a potential dam failure of Moswansicut Pond Dam would likely result in no probable loss of human life, some disruption to Routes 116 and Route 6 may be expected as a result of potential shallow flooding of roadway crossings from the dam break. The Pond also serves as a water supply for the Providence area, and its loss may have effects on water supply availability.
