164 BARDEN RESERVOIR

BARDEN RESERVOIR DAM, SCITUATE (164)

DAM HAZARD POTENTIAL
CLASSIFICATION MAP

BARDEN RESERVOIR DAM
SCITUATE, RHODE ISLAND

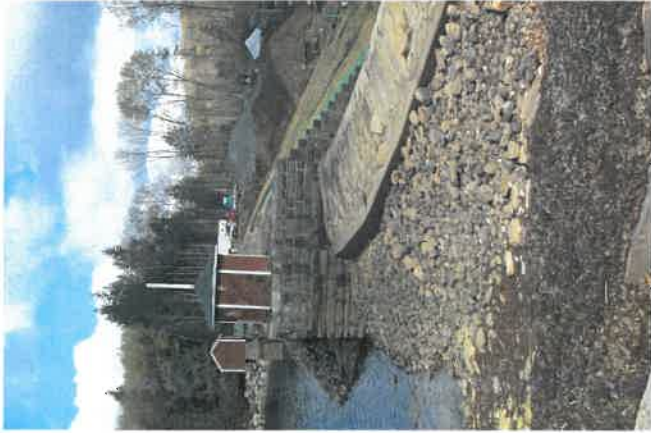
Description: Photo 1. View of dam from right abutment.

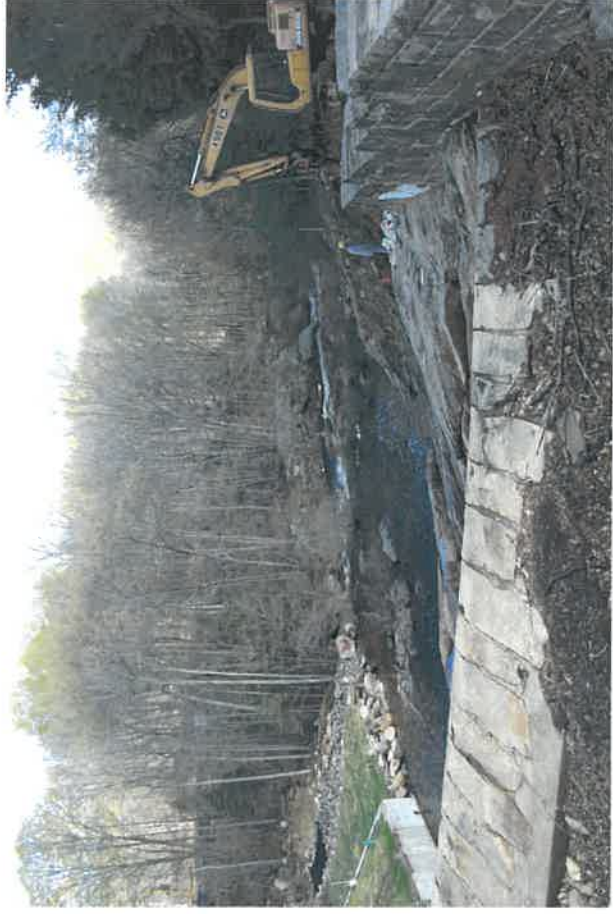
Description: Photo 2. View of spillway crest and downstream channel.

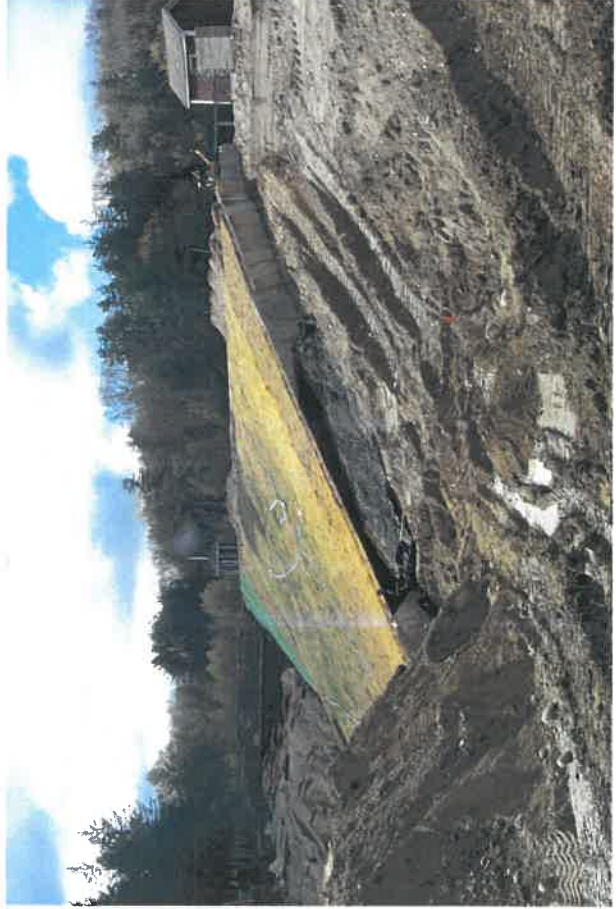
Description: Photo 3. Overview of embankment under repair.

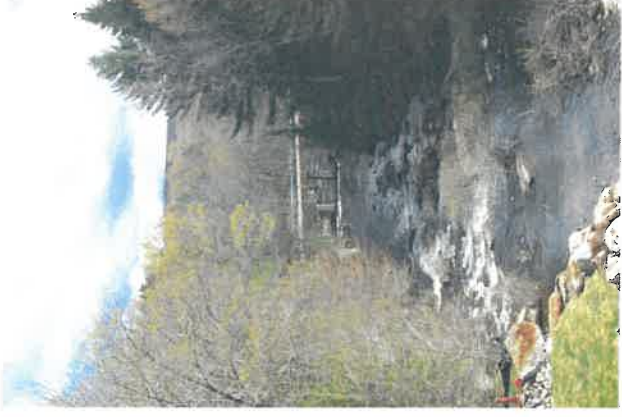
Description: Photo 4. View of downstream channel from top of dam.

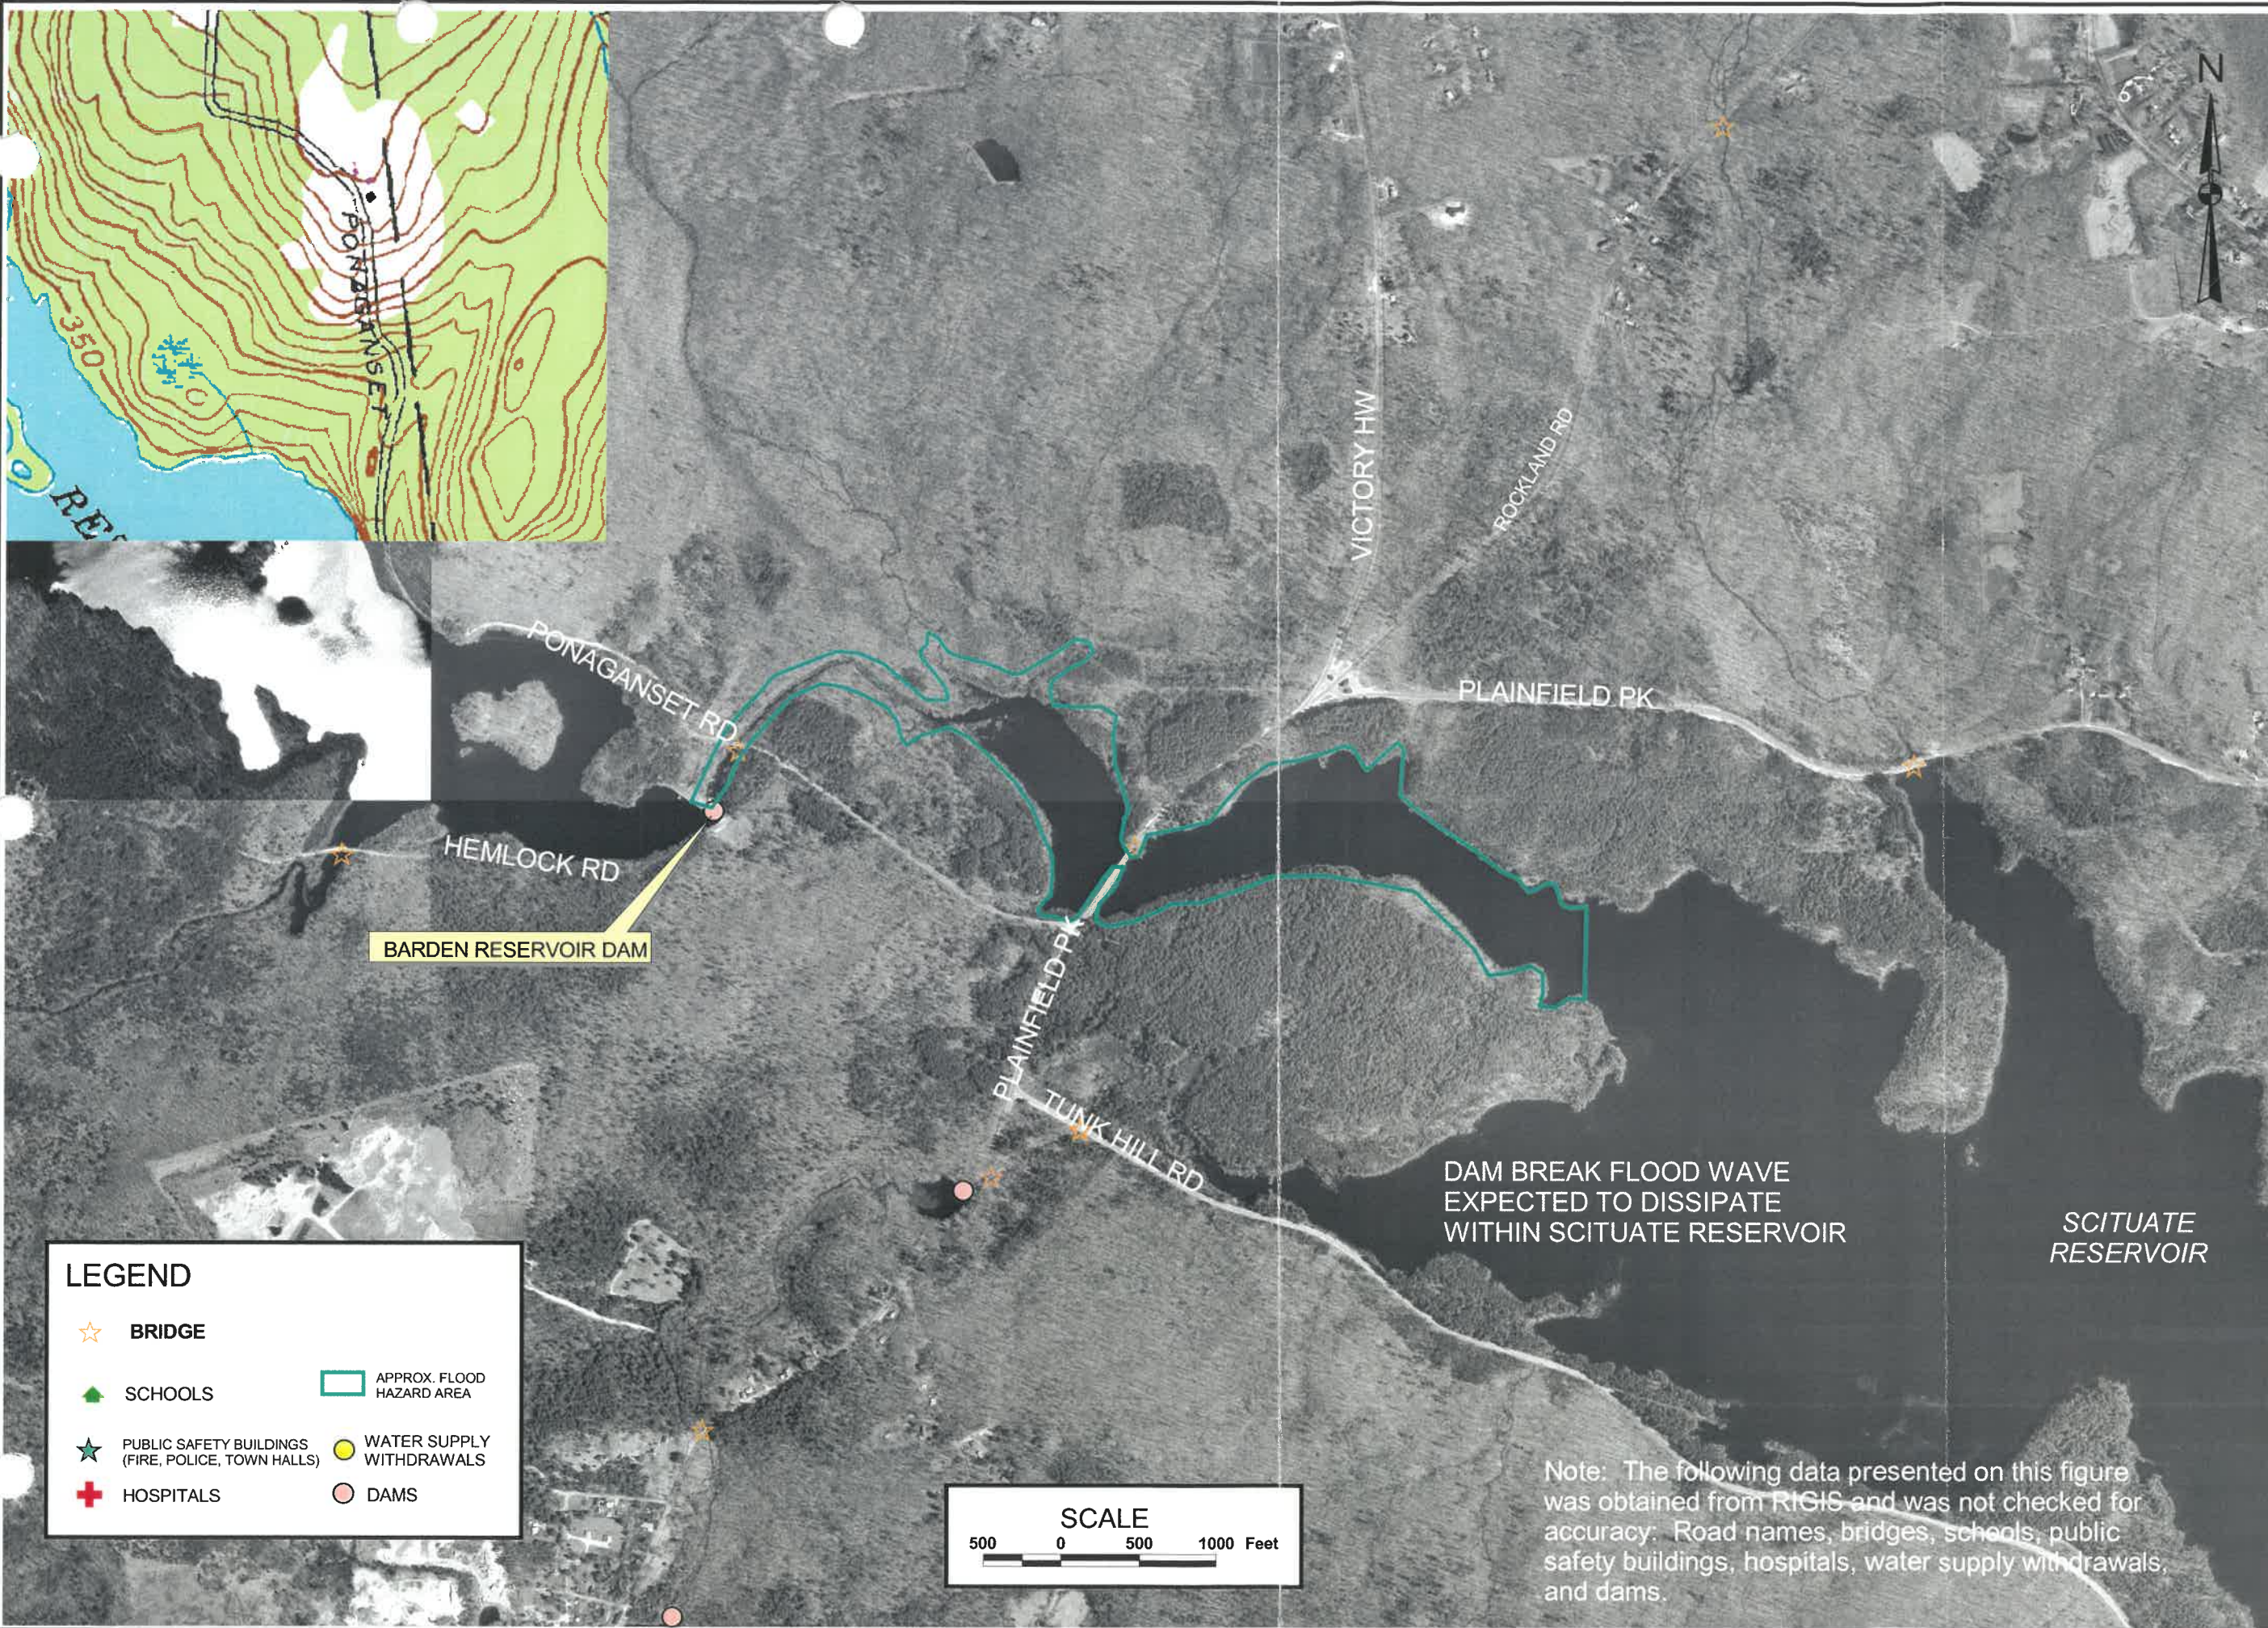
FIGURE 2

Several riverine cross sections, developed by GZA from USGS 7.5 minute quadrangle maps, were input into the SMPDBK model to preliminarily estimate approximate peak water surface elevations. The results of the analysis are provided as the approximate inundation area depicted in **Figure 2**.

Results of the analysis indicate a peak flood depth about 0.2 miles downstream of the dam of about 17 feet. As the flood wave progresses downstream, it is expected to attenuate. Thus, peak flood depths are predicted to decrease to about 2 feet at the Scituate Reservoir. The extent of flooding due to the hypothetical dam break includes flooding of the unpopulated wooded area adjacent to the Ponaganset River.

DAM BREAK FLOOD WAVE
EXPECTED TO DISSIPATE
WITHIN SCITUATE RESERVOIR
