345
JORDAN POND DAM

JORDAN POND DAM (345), SCITUATE

Jordan Pond Dam (Figure 1) is classified by DEM as having a **Significant Hazard** potential. The following report summarizes GZA's evaluation of the dam's potential impact area due to failure of the dam.

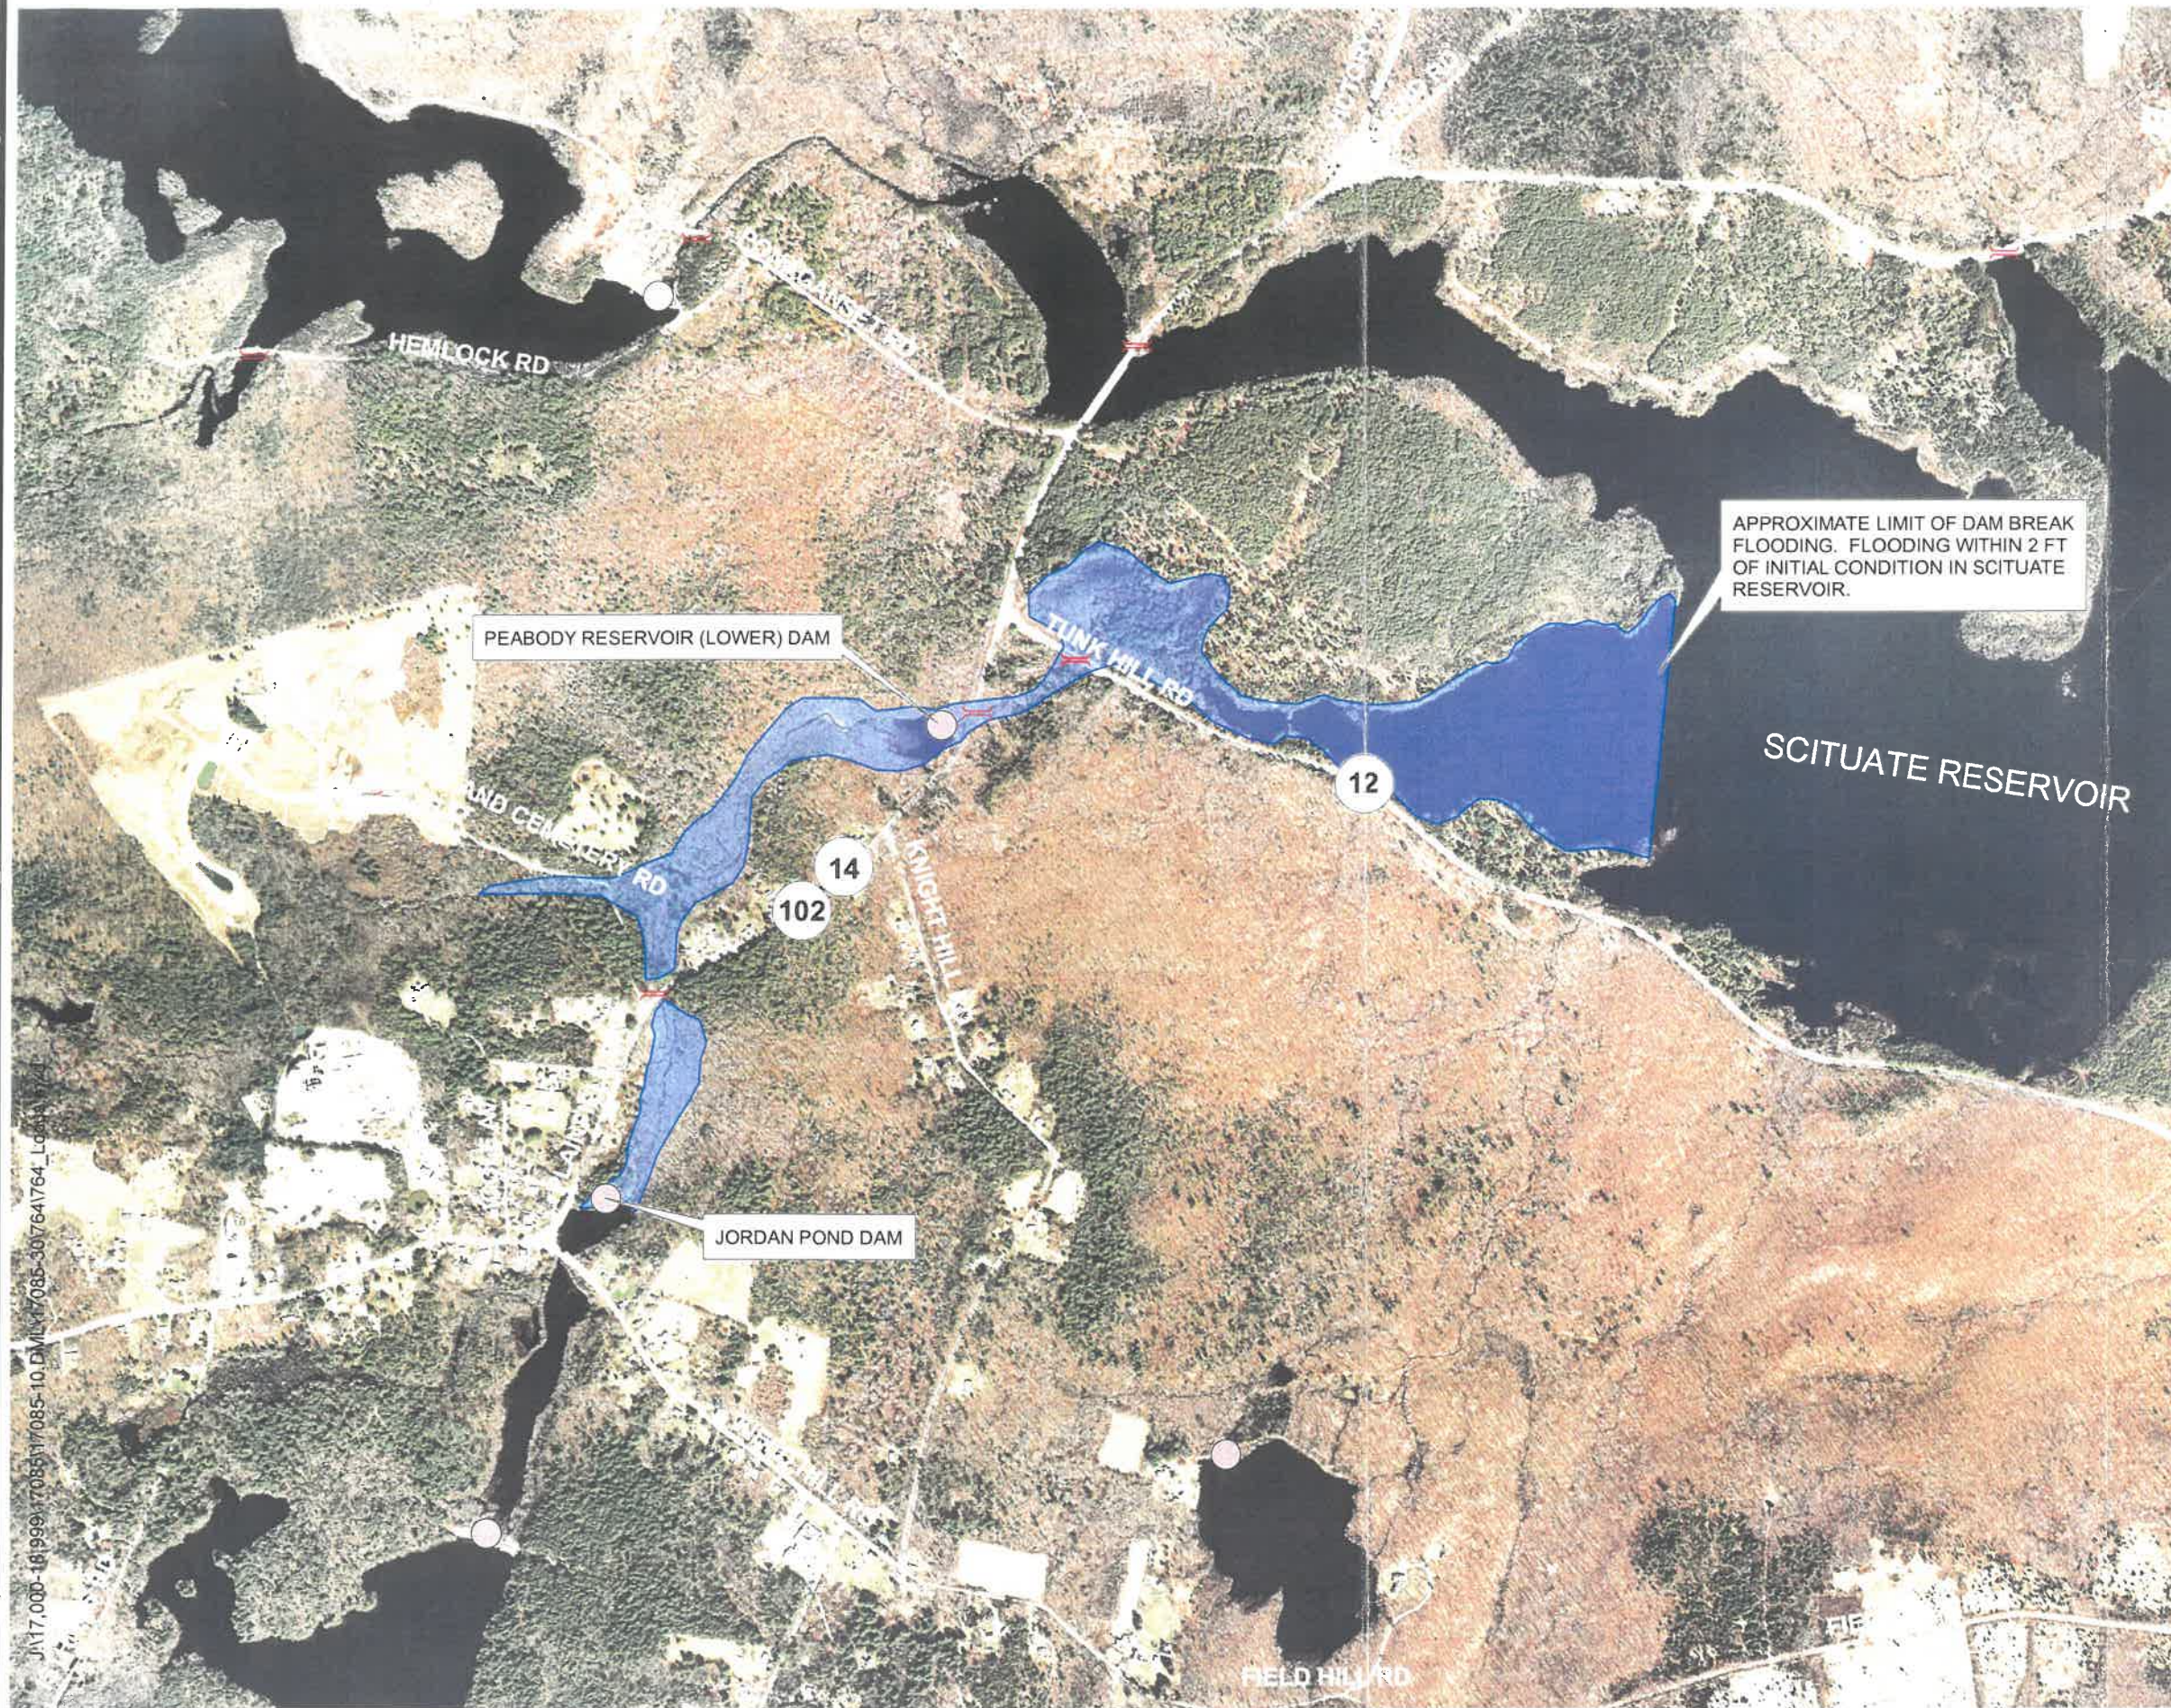
Figure No.:
2

Several riverine cross sections, developed by GZA from USGS 7.5 minute quadrangle maps, were input into the SMPDBK models to preliminarily estimate approximate peak water surface elevations. The results of the analysis are provided as the approximate inundation area depicted in **Figure 2**.

Results of the analysis indicate a peak flood depth downstream of the dam on Westconnaug Brook of about 10 feet. A peak flood depth of about 2 feet is anticipated in the Scituate Reservoir just downstream of the Westconnaug Brook confluence.

The hypothetical failure of the dam would likely flood the low-lying valley along the Westconnaug Brook for about 1.1 miles to its confluence with the Scituate Reservoir. Failure of the dam would likely result in the overtopping and possible destruction of Route 14/102 (second crossing), Rockland Cemetery Road, and Route 12. Failure of the dam would likely result in the "domino" failure of the Peabody Reservoir (Lower) Dam. No residences or other structures are located within the anticipated dam break inundation area.

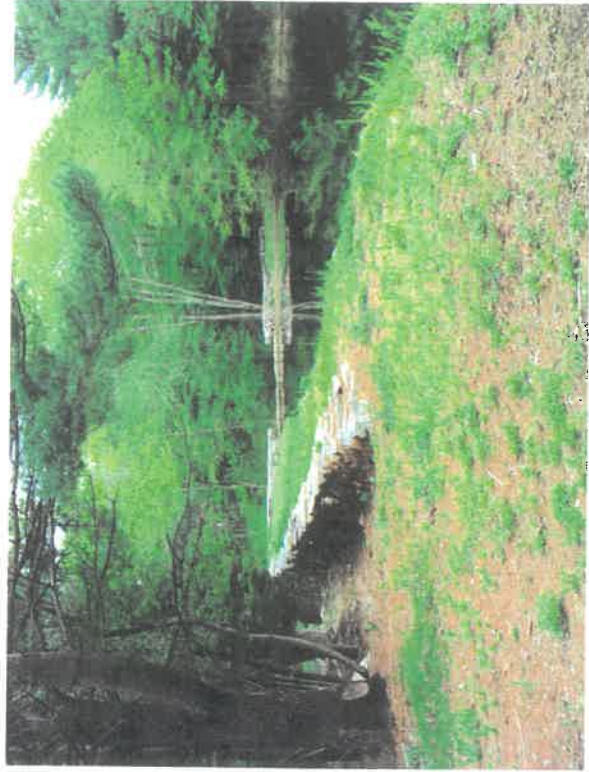
Photo 1. Overview of dam from left abutment.

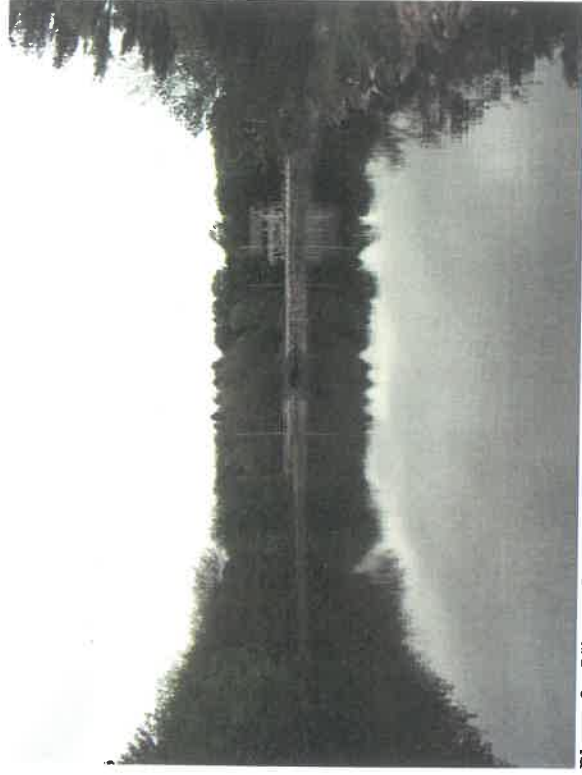
Photo 2. View of Jordan Pond from top of dam.

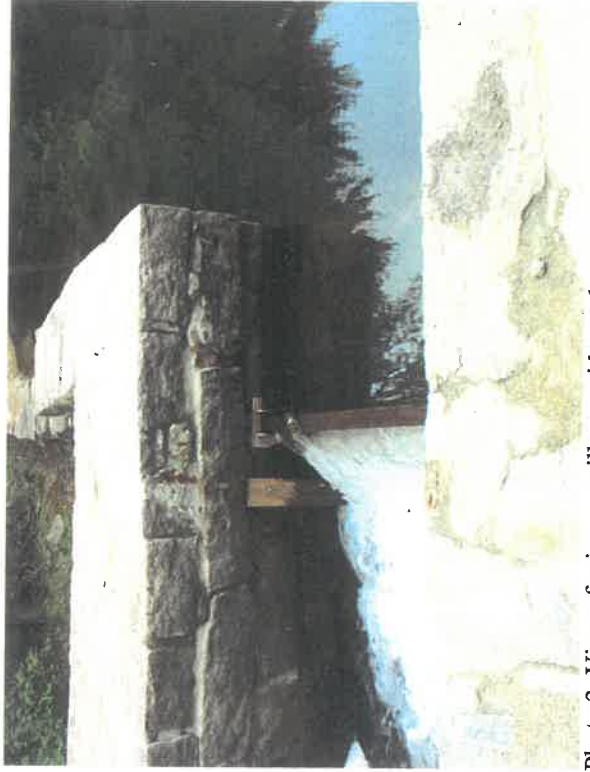
Photo 3. View of primary spillway with stoplogs.

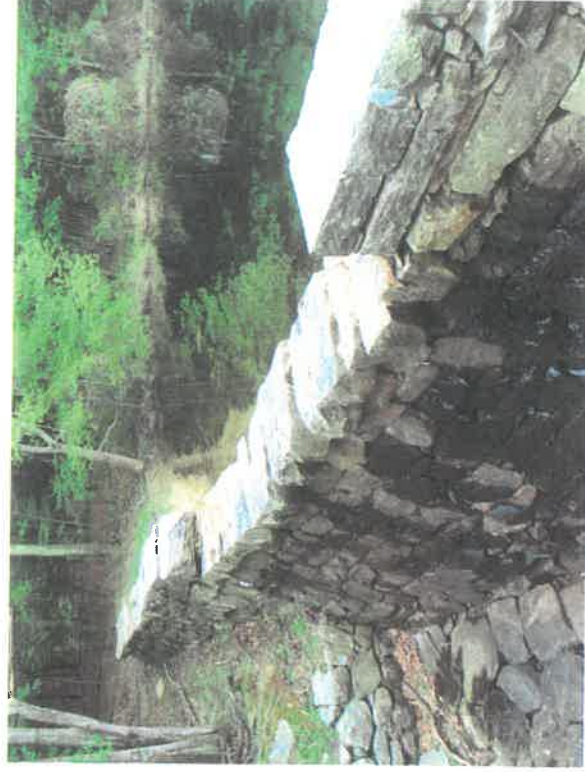
Photo 4. View of emergency spillway on right side of dam.

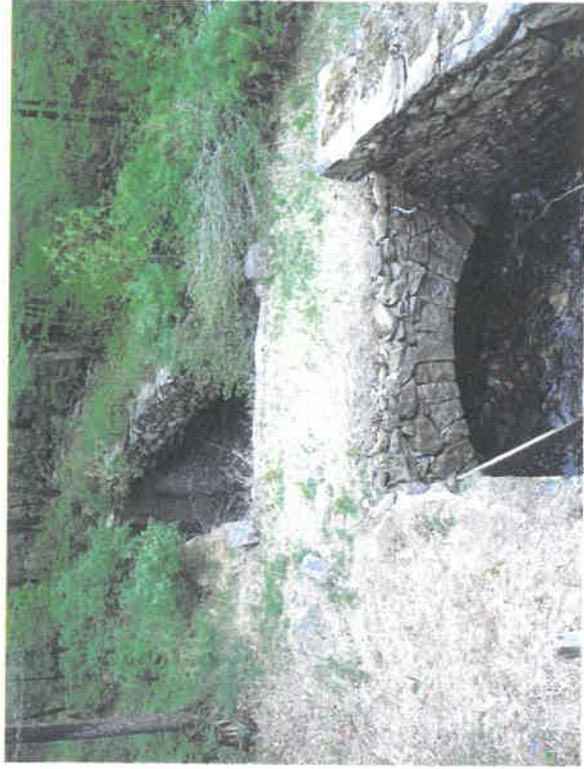
Photo 5. View from top of dam of primary spillway discharge Channel with stone arch bridge.

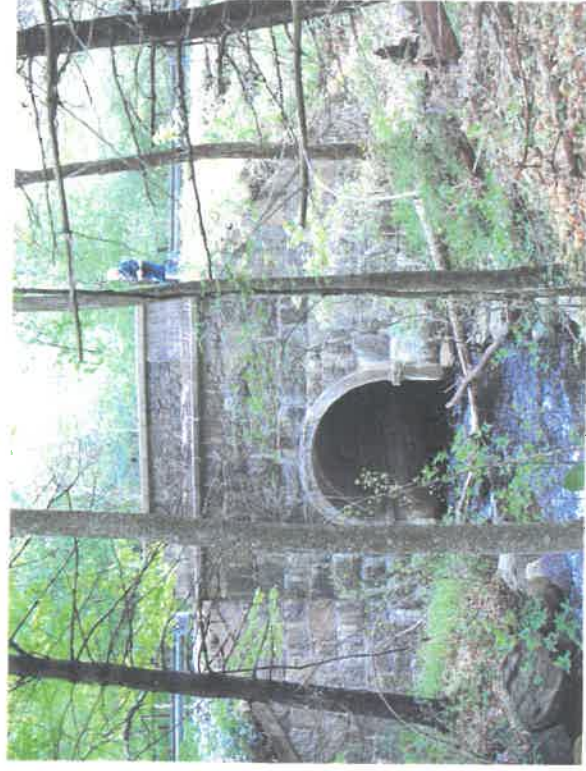
Photo 6. View of stream channel looking upstream from first bridge at Route 14 / 107.

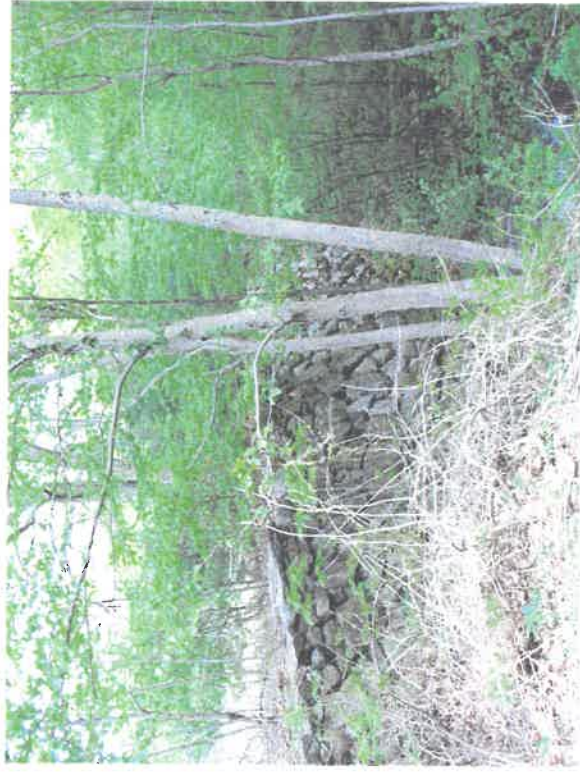
About 0.75 miles downstream of Jordan Pond Dam, Westconnaug Brook is impounded by the Peabody Reservoir (Lower) Dam (344), which is a stone masonry gravity dam with a maximum height of approximately 10 feet. Failure of the Jordan Pond Dam would likely overtop and potentially lead to the failure of the Peabody Reservoir (Lower) Dam.

Photo 7. View from right abutment of downstream dam (DEM #344) along Route 14 / 107.

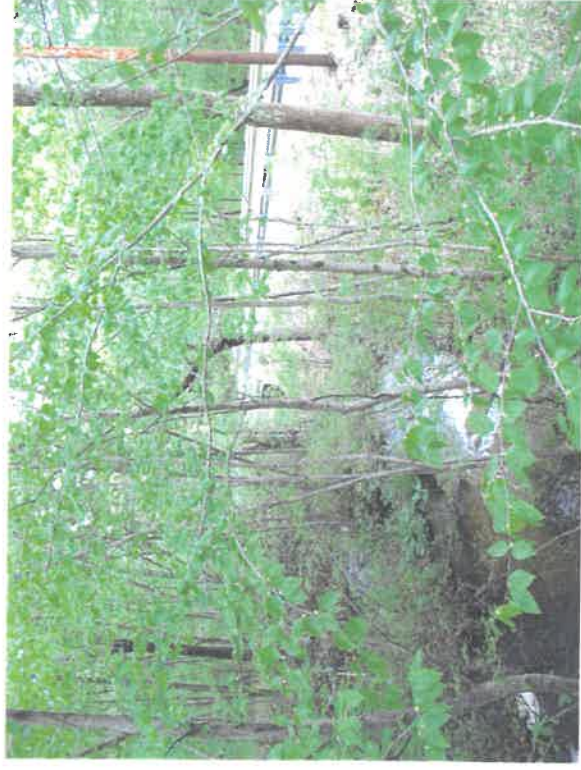
Photo 8. View of Route 14 / 107 crossing downstream of Dam 344.
