HORSESHOE DAM, SMITHFIELD (360)

Horseshoe Dam (Figure 1) has been classified by DEM as having a **Significant Hazard** potential. The following report summarizes GZA's evaluation of the dam's potential impact area due to failure of the dam.

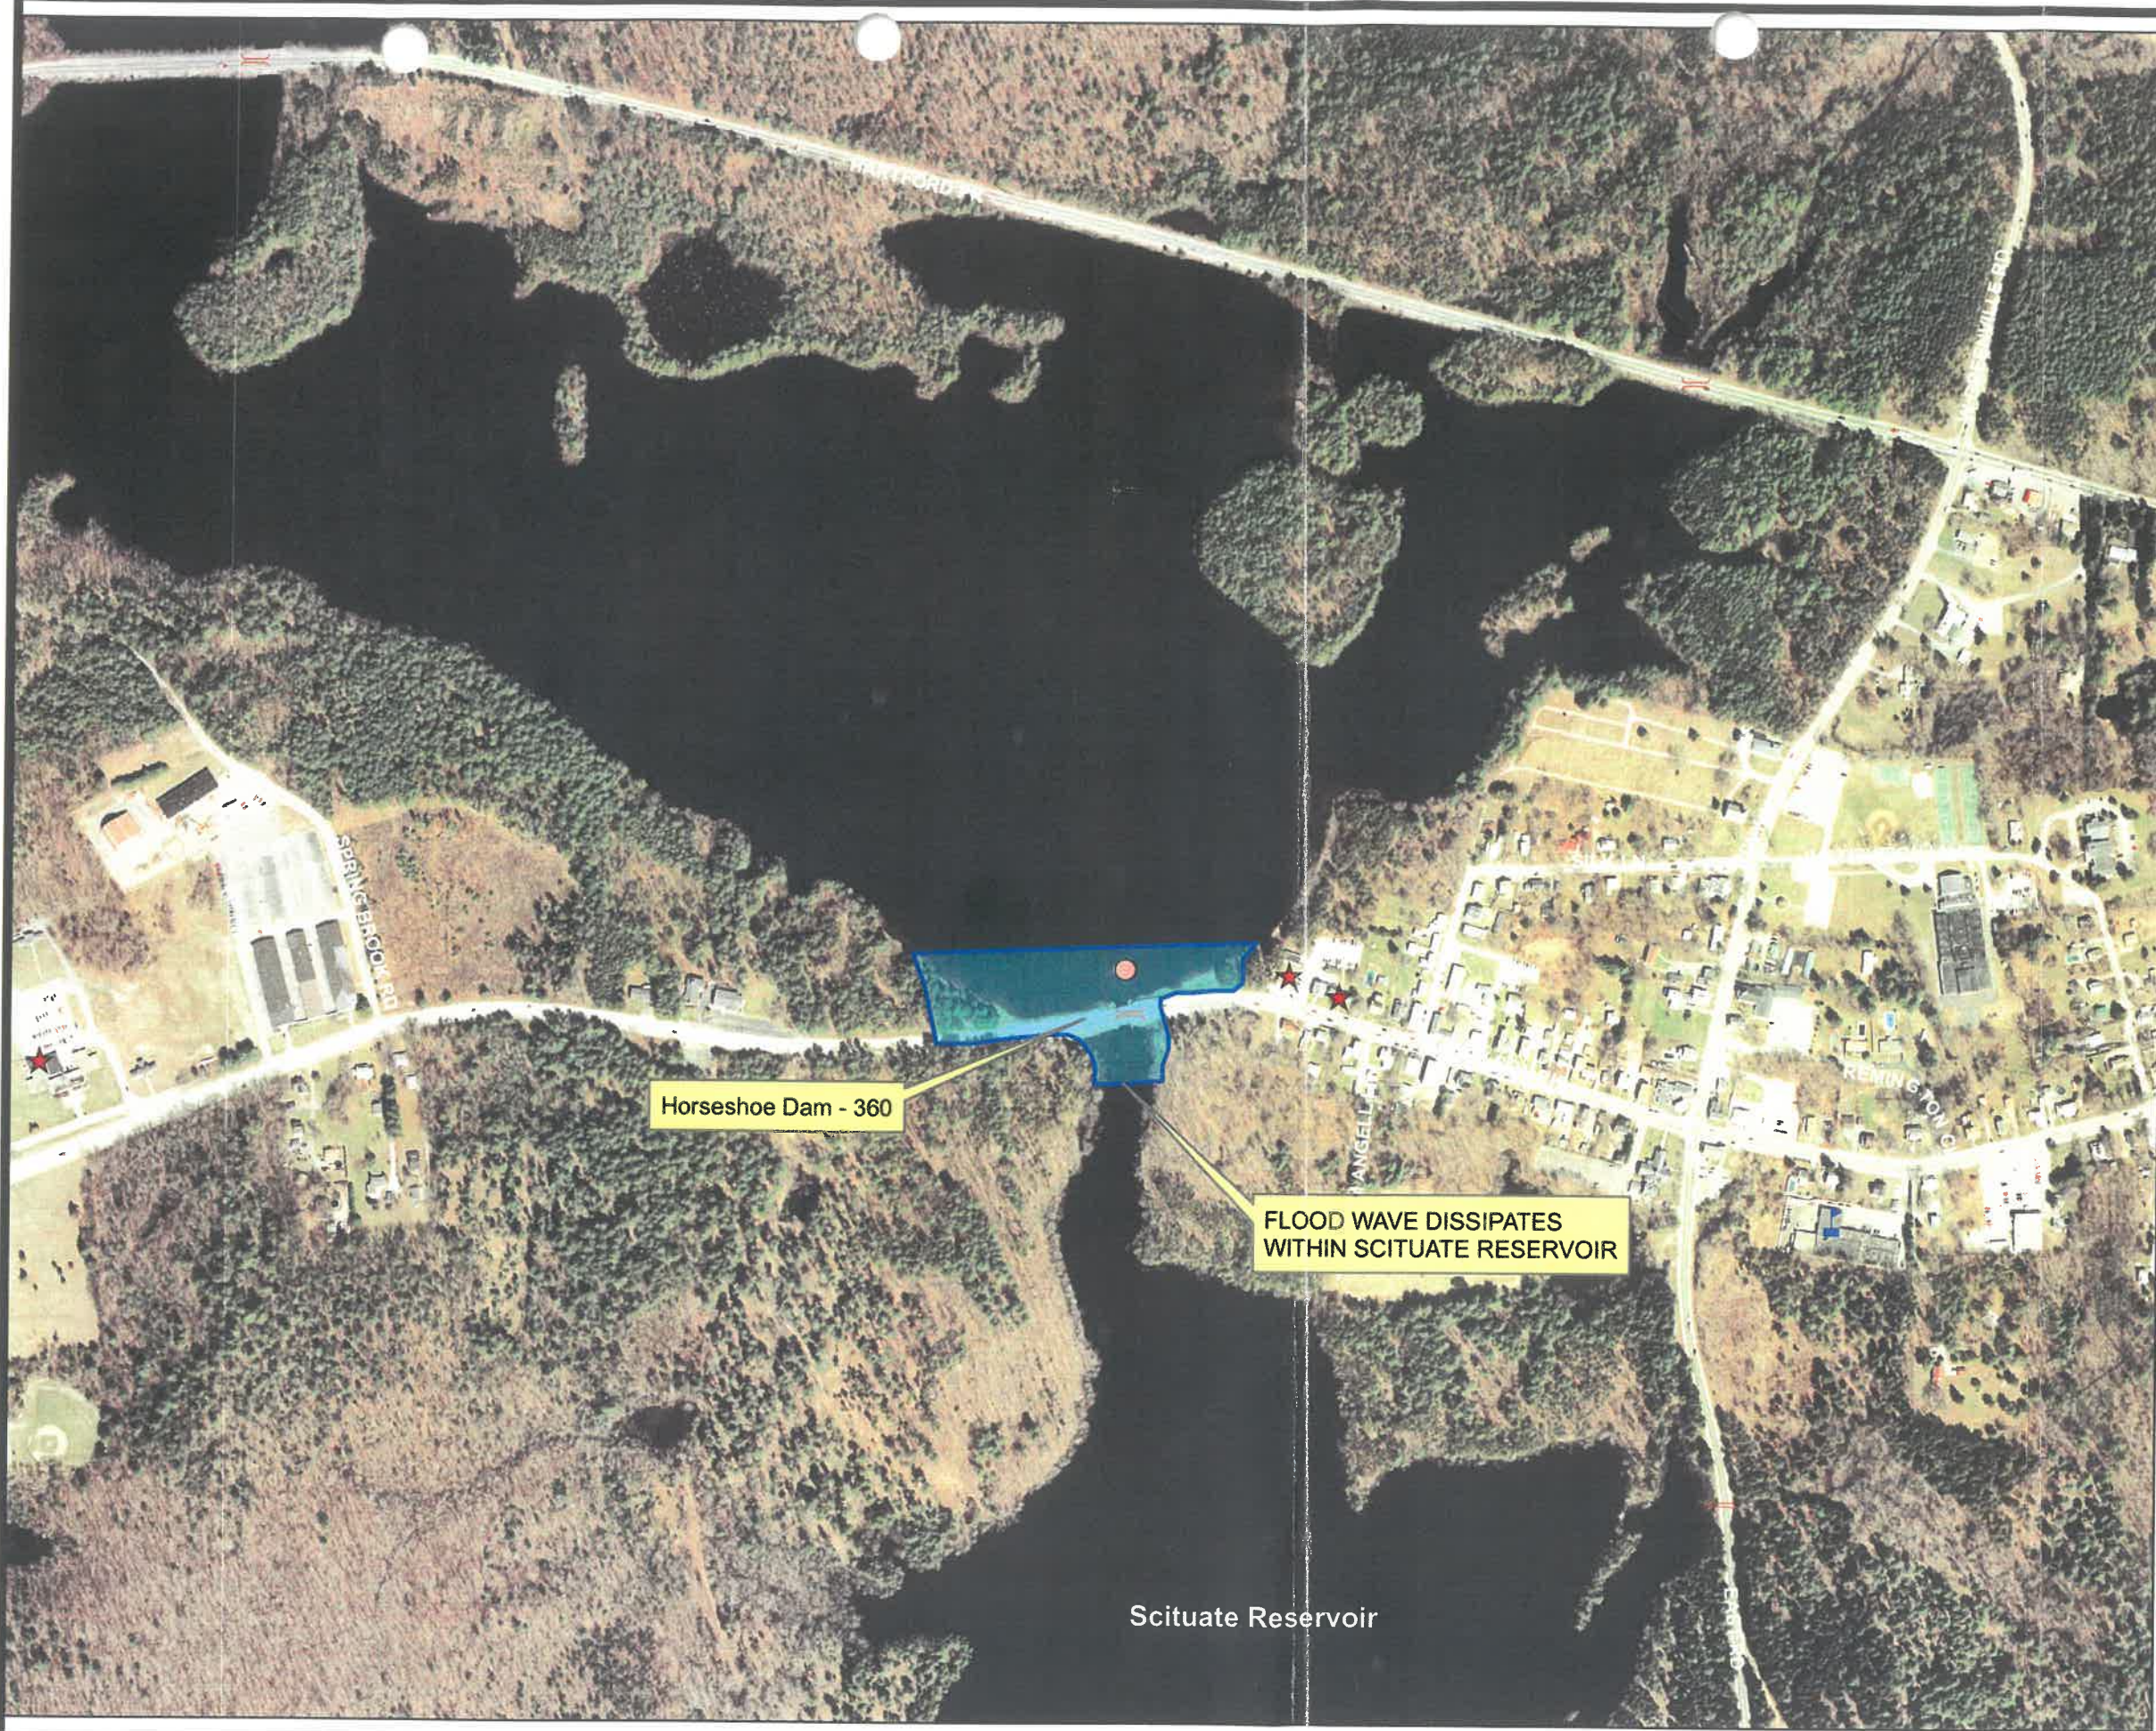
Figure No.:
2

Two riverine cross sections, developed by GZA from USGS 7.5 minute quadrangle maps, were input into the SMPDBK model to preliminarily estimate approximate peak water surface elevations. The results of the analysis are provided as the approximate inundation area depicted in **Figure 2**.

GZA estimated that the water surface elevation within Scituate Reservoir may rise by about a half of foot if Horseshoe Dam were to fail. The hypothetical dam breach flow is not expected to result in any damage or loss of life in downstream areas. The dam failure would, by default, result in loss of the regulating reservoir used for municipal water supply, and also the destruction of Danielson Pike (Route 6) which traverses top of the dam.

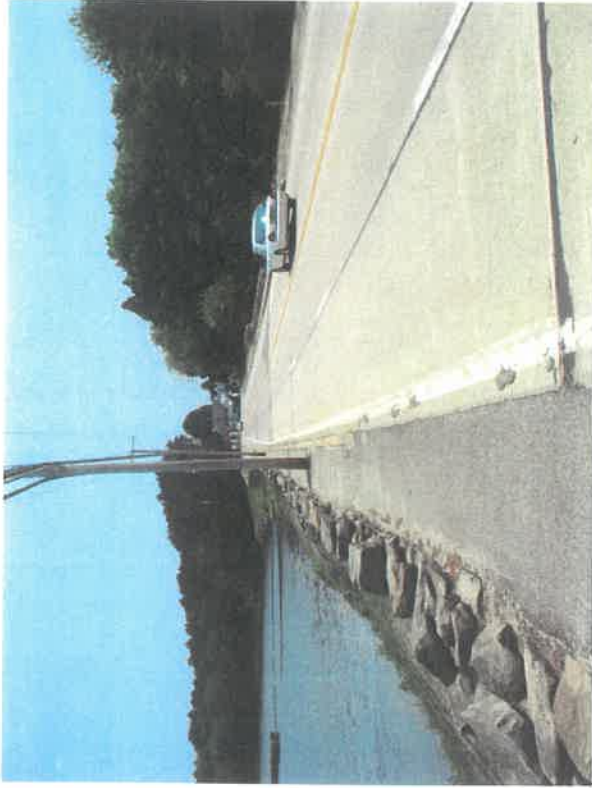
Photo 1. Looking at Horseshoe Dam road embankment (Danielson Pike) from right abutment

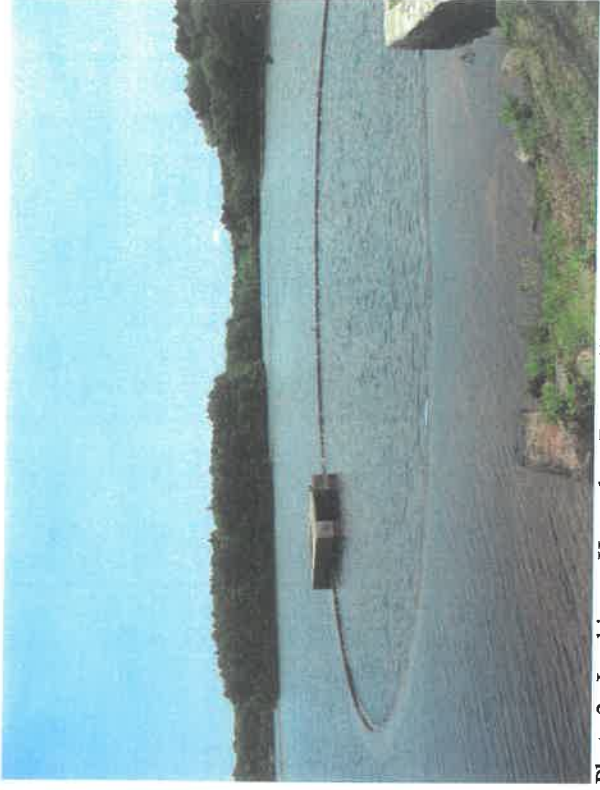
Photo 2. Looking at Horseshoe Dam spillway from top of dam.
Note high tailwater elevation from Scituate Reservoir.

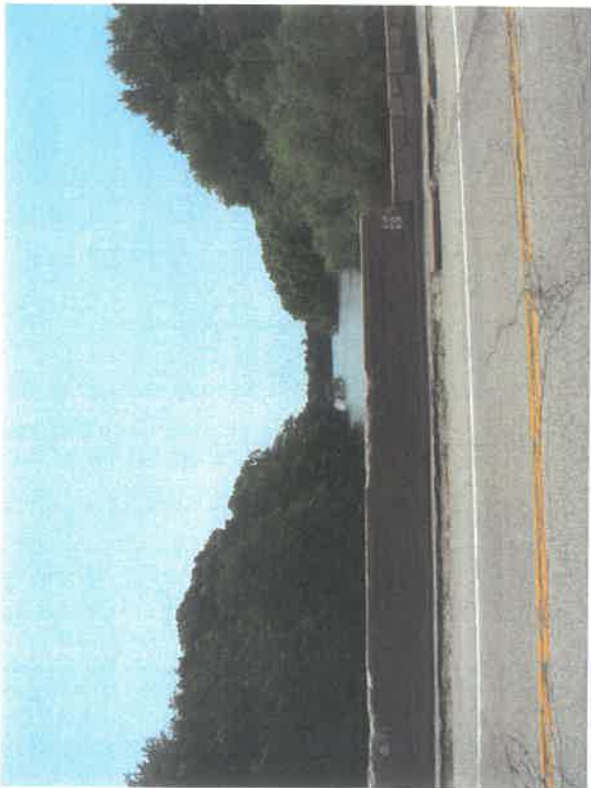
Photo 3. Looking downstream toward Scituate Reservoir from top of dam.
