PINE SWAMP RESERVOIR NO. 1 DAM, SCITUATE (361)

1.00 SUMMARY OF SITE AND POTENTIAL DOWNSTREAM IMPACT AREA

2.00 DAM HAZARD POTENTIAL ASSESSMENT

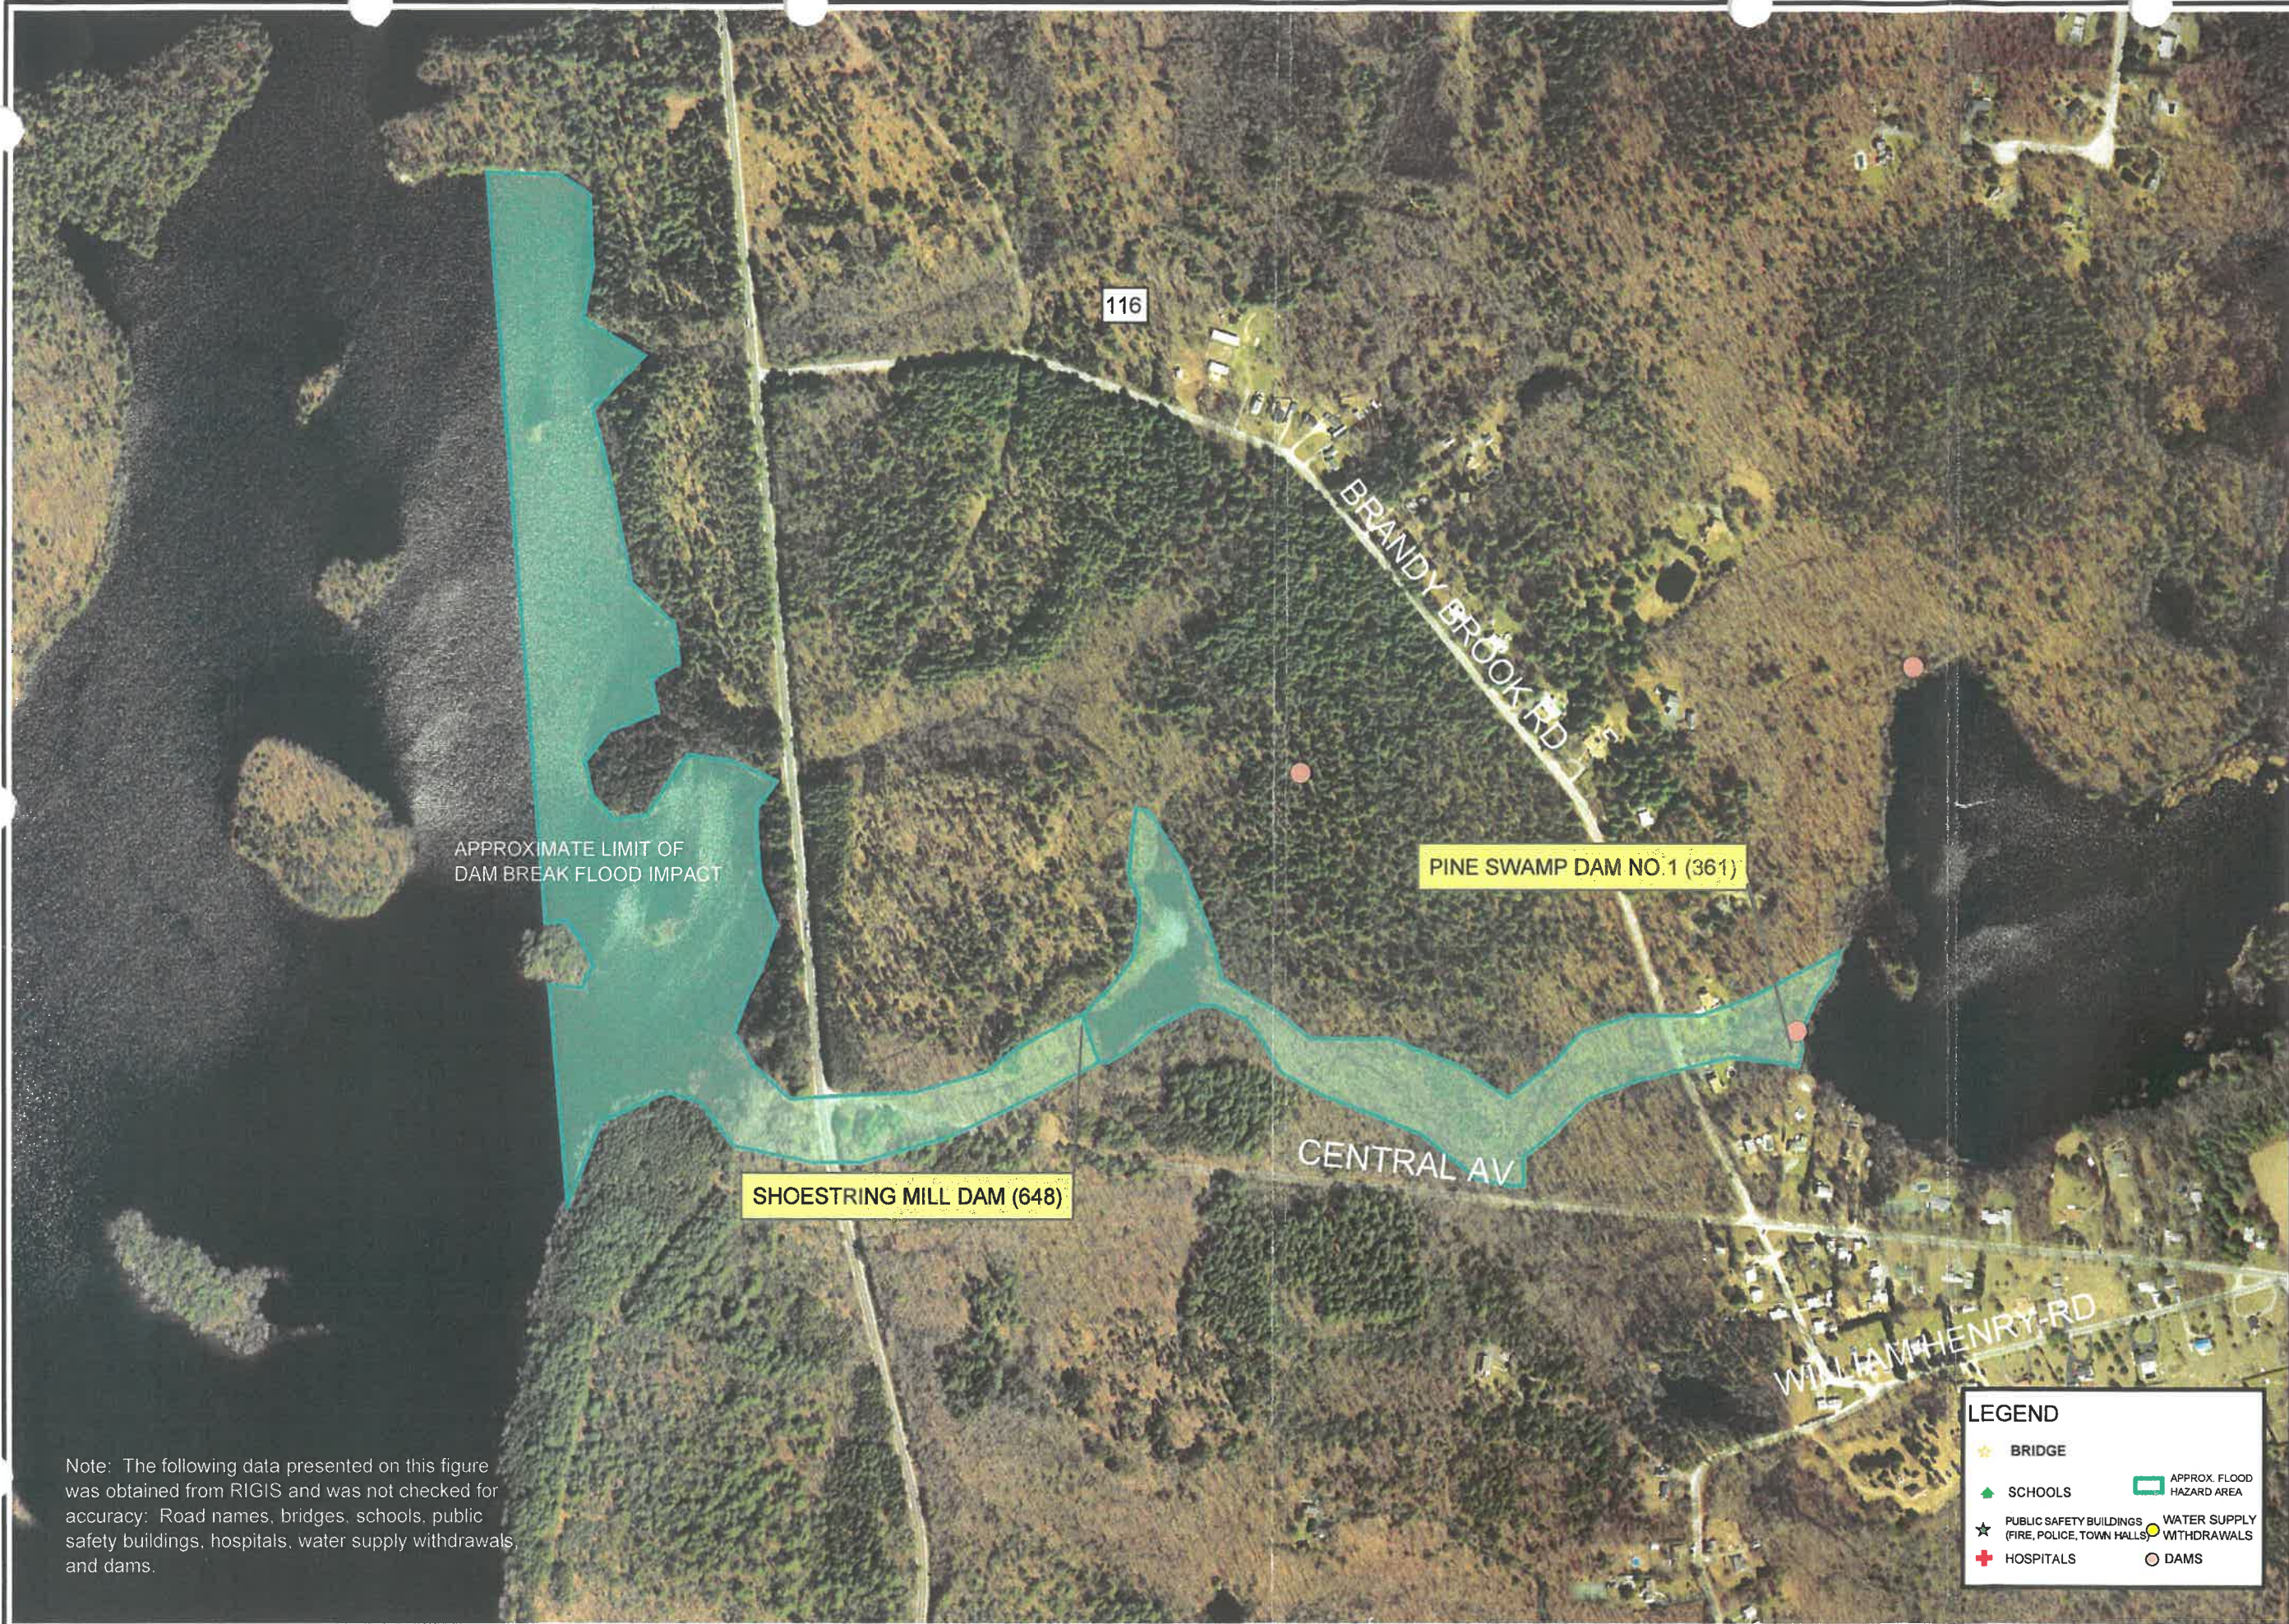
DAM HAZARD POTENTIAL CLASSIFICATION MAP		SOURCE	DATE OF MAP: APRIL 1997
PINE SWAMP RESERVOIR NO. 1 DAM SCITUATE, RHODE ISLAND		 SCALE 0 250 500 1,000 Feet 	
GZA NO. 17085.10		FIGURE 2

Several riverine cross sections, developed by GZA from USGS 7.5 minute quadrangle maps, were input into the SMPDBK model to preliminarily estimate approximate peak water surface elevations. The results of the analysis are provided as the approximate inundation area depicted in **Figure 2**.

Results of the analysis indicate a peak flood depth at the immediate toe of the dam of about 6 feet. As the flood wave progresses downstream, it is expected to attenuate. Peak flood depths just upstream of Scituate Reservoir, approximately 0.75 miles downstream of Pine Swamp Reservoir No. 1 Dam, are predicted to decrease to approximately 3.75 feet. Peak flood depths are expected to further decrease to less than 0.5 feet within Scituate Reservoir Dam. The extent of flooding due to the hypothetical dam break likely does not include residences along Brandy Brook Road, but could overtop roadway crossings and Shoestring Mill Dam. GZA has recommended Shoestring Mill Dam be classified as a **Significant Hazard** structure.

GZA recommends that Pine Swamp Reservoir No. 1 Dam be classified as **Significant Hazard** based on the aforementioned analyses, site / downstream valley reconnaissance, site-specific GIS mapping and other existing data, and professional judgment. A potential dam failure of Pine Swamp Reservoir No. 1 Dam would likely result in no probable loss of human life, but may result in major economic losses, including the overtopping and potential washout of Brandy Brook Road, East Road (Route 116), and Central Avenue. Shoestring Mill Dam may also be overtopped and breached.

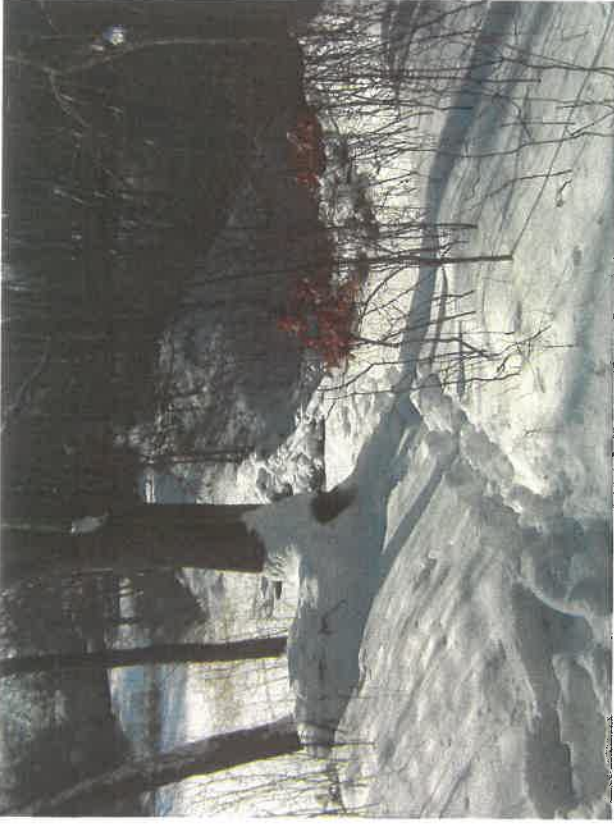
3. Unclear from snow and ice accumulation; Erosion near and around spillway indicate previous overtopping and loss of dam material. It appears likely that the dam would (continue to) erode / fail if water surface elevations rise. Impoundment is present, but appears shallow (emergent vegetation)

Description: Photo 1. View of spillway and breach-like section near dam's left abutment

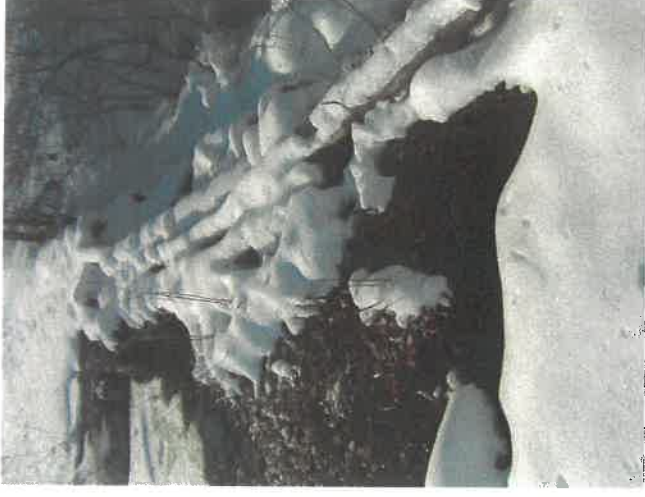
Description: Photo 2. Close-up of spillway.

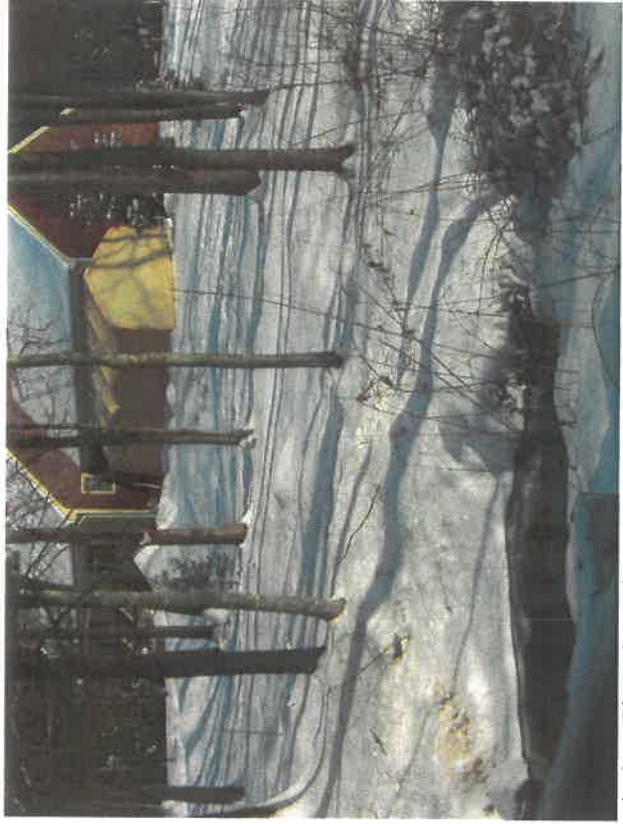
Pine Swamp Reservoir No. 1 Dam is located on the Brandy Brook in the Town of Scituate. The immediate downstream area is primarily wooded and there is one residence located near the right bank of the brook about 400 ft downstream, about 5 to 10 feet above the channel.

Description: Photo 3. Residential development above the right bank of Brandy Brook, about 400 ft downstream.

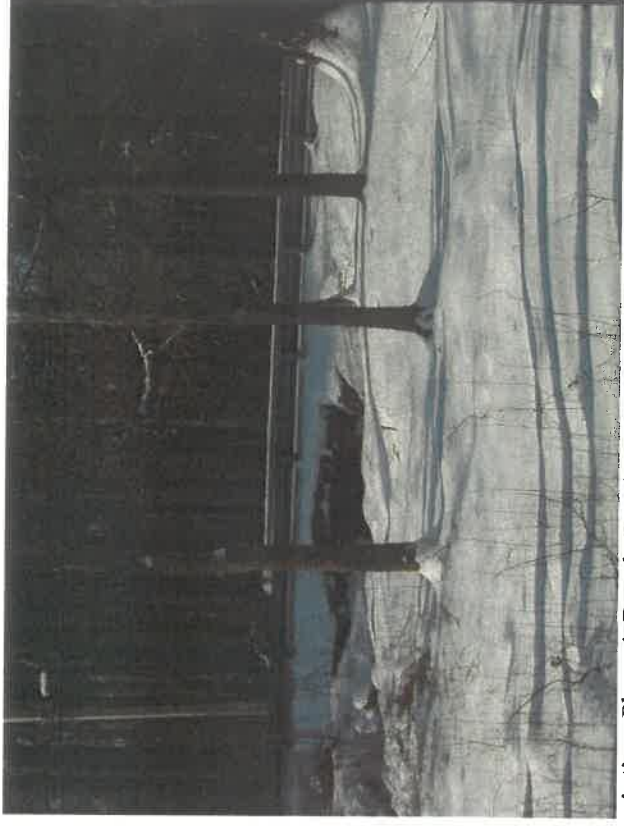
A culvert beneath Brandy Brook Road is located about 400 ft downstream. Central Avenue and East Road (Route 116) cross the brook downstream of Shoestring Mill Dam, about 3,200 ft and 3,400 ft downstream of Pine Swamp Reservoir Dam No. 1.

Description: Photo 4. Brandy Brook Road culvert, about 400 ft downstream of the dam.
