May 17, 2023

**RE: Hazard Classification Change Request  
RI04441 Shoestring Mill Pond Dike (648)  
Scituate, Rhode Island  
(Pare Project No. 14256.42)**

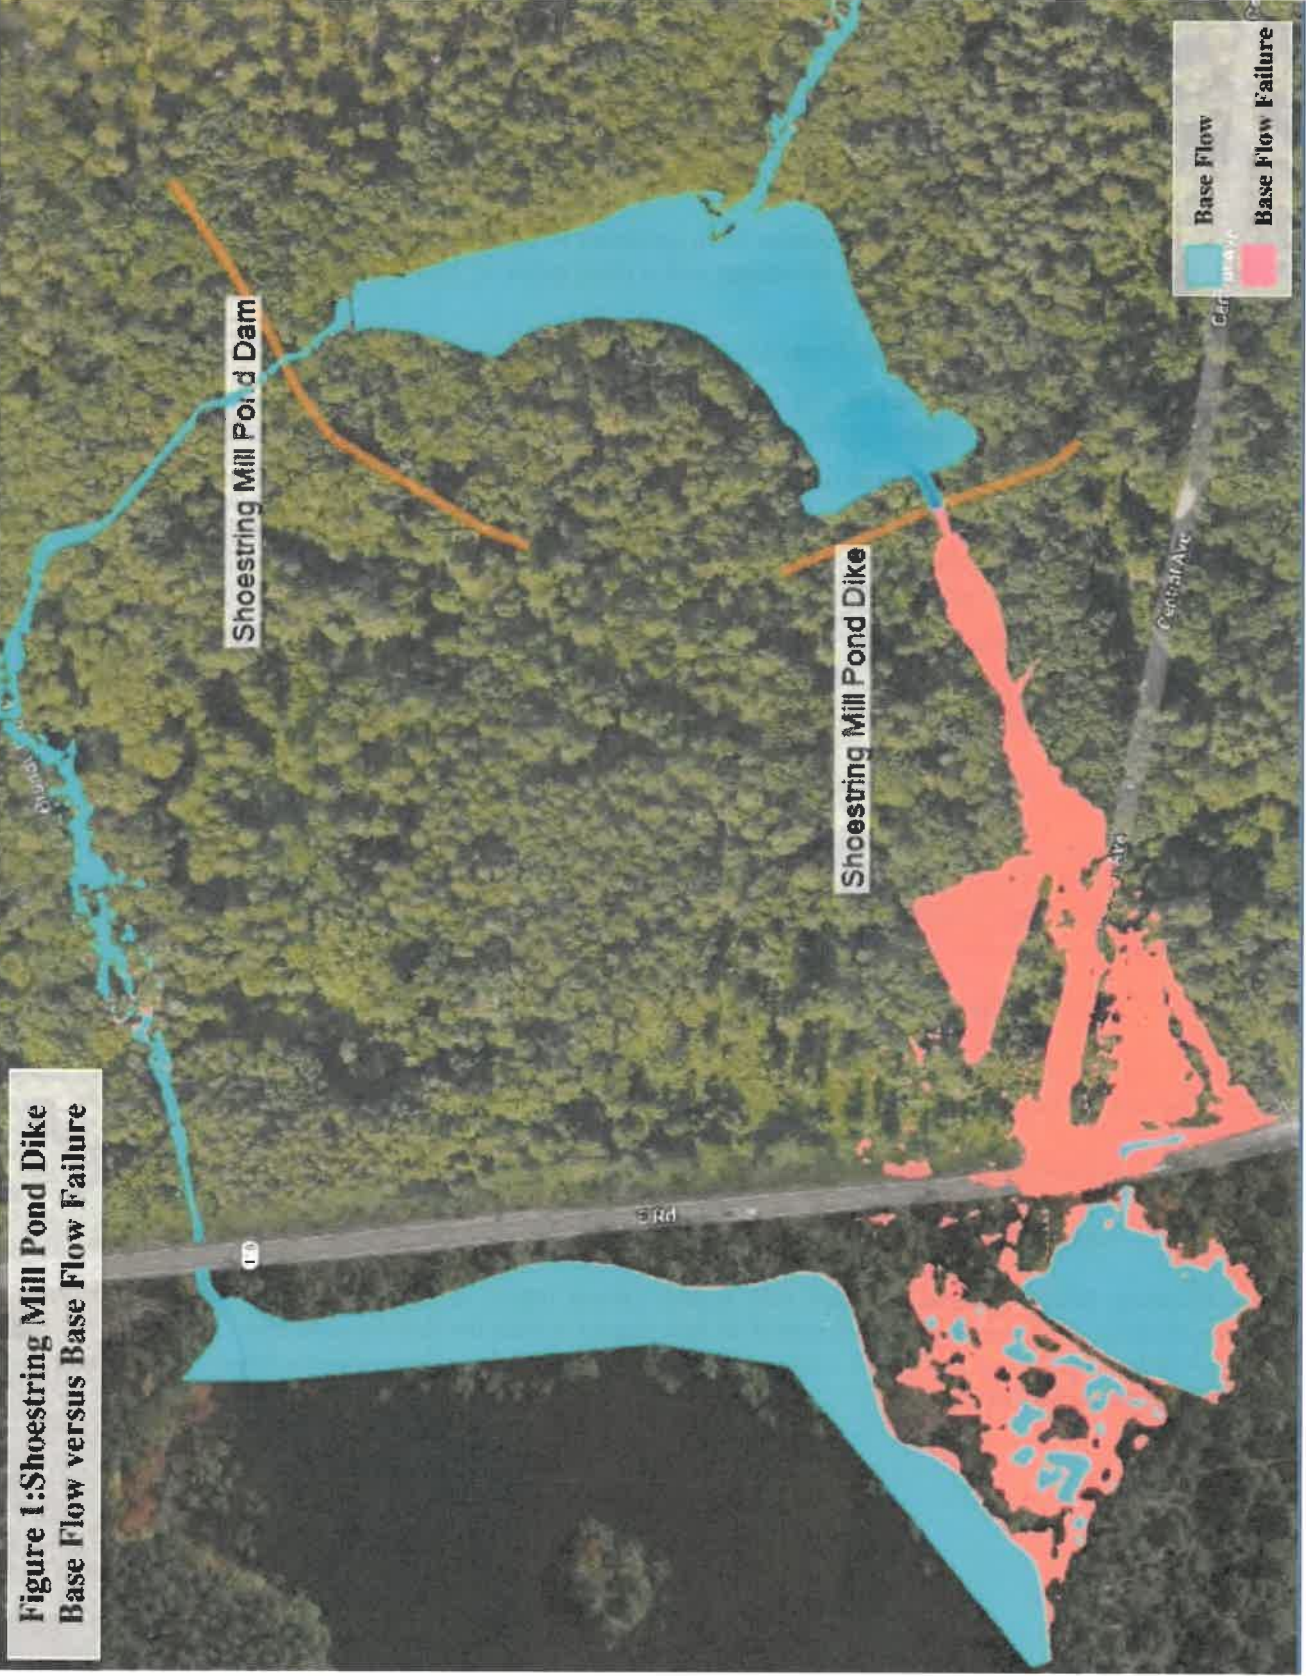
**Figure 1: Shoestring Mill Pond Dike  
Base Flow versus Base Flow Failure**

The dam failure analysis revealed that a dike failure during a sunny day event (normal baseflow conditions) is expected to have minimal to low impact within the downstream area. The image on the following page below shows the comparison of the failure (pink) and non-failure (blue) inundation areas during the sunny day event.

- a. **Central Avenue:** Dike failure during normal baseflow conditions results in a 4.9-foot rise in river levels upstream of the roadway from El. 306.7 to EL. 311.6. This rise results in shallow overtopping of the roadway up to 12 inches in depth. The velocity of the overtopping flow is generally low to moderate within the footprint of the roadway and along the downstream slope of the roadway (2-6 ft/sec).
  - o Overtopping conditions of these depths and velocities fall within the “Low Danger Zone” on ACER TM 11 Figure 4.0; these conditions are unlikely to result in damage to the roadway,
  - o The roadway may become impassable during the isolated peak of overtopping, limited to a 20-minute duration; emergency vehicles could likely still pass the roadway at these flood depths.

- b. **E Road (Route 116):** Dike failure during normal baseflow conditions results in a 6.0-foot rise in river levels from El. 288.7 to El. 294.7. This results in shallow overtopping of the roadway up to 3 inches in depth. The velocity of the overtopping flow is generally low within the footprint of the roadway and along the downstream slope of the roadway (0.5-2.3 ft/sec).
  - o Overtopping conditions of these depths and velocities fall within the “Low Danger Zone” on ACER TM 11 Figure 4.0; these conditions are unlikely to result in damage to the roadway,
  - o The roadway may become impassable during the isolated peak of overtopping, limited to a 20-minute duration; emergency vehicles could likely still pass the roadway at these flood depths.

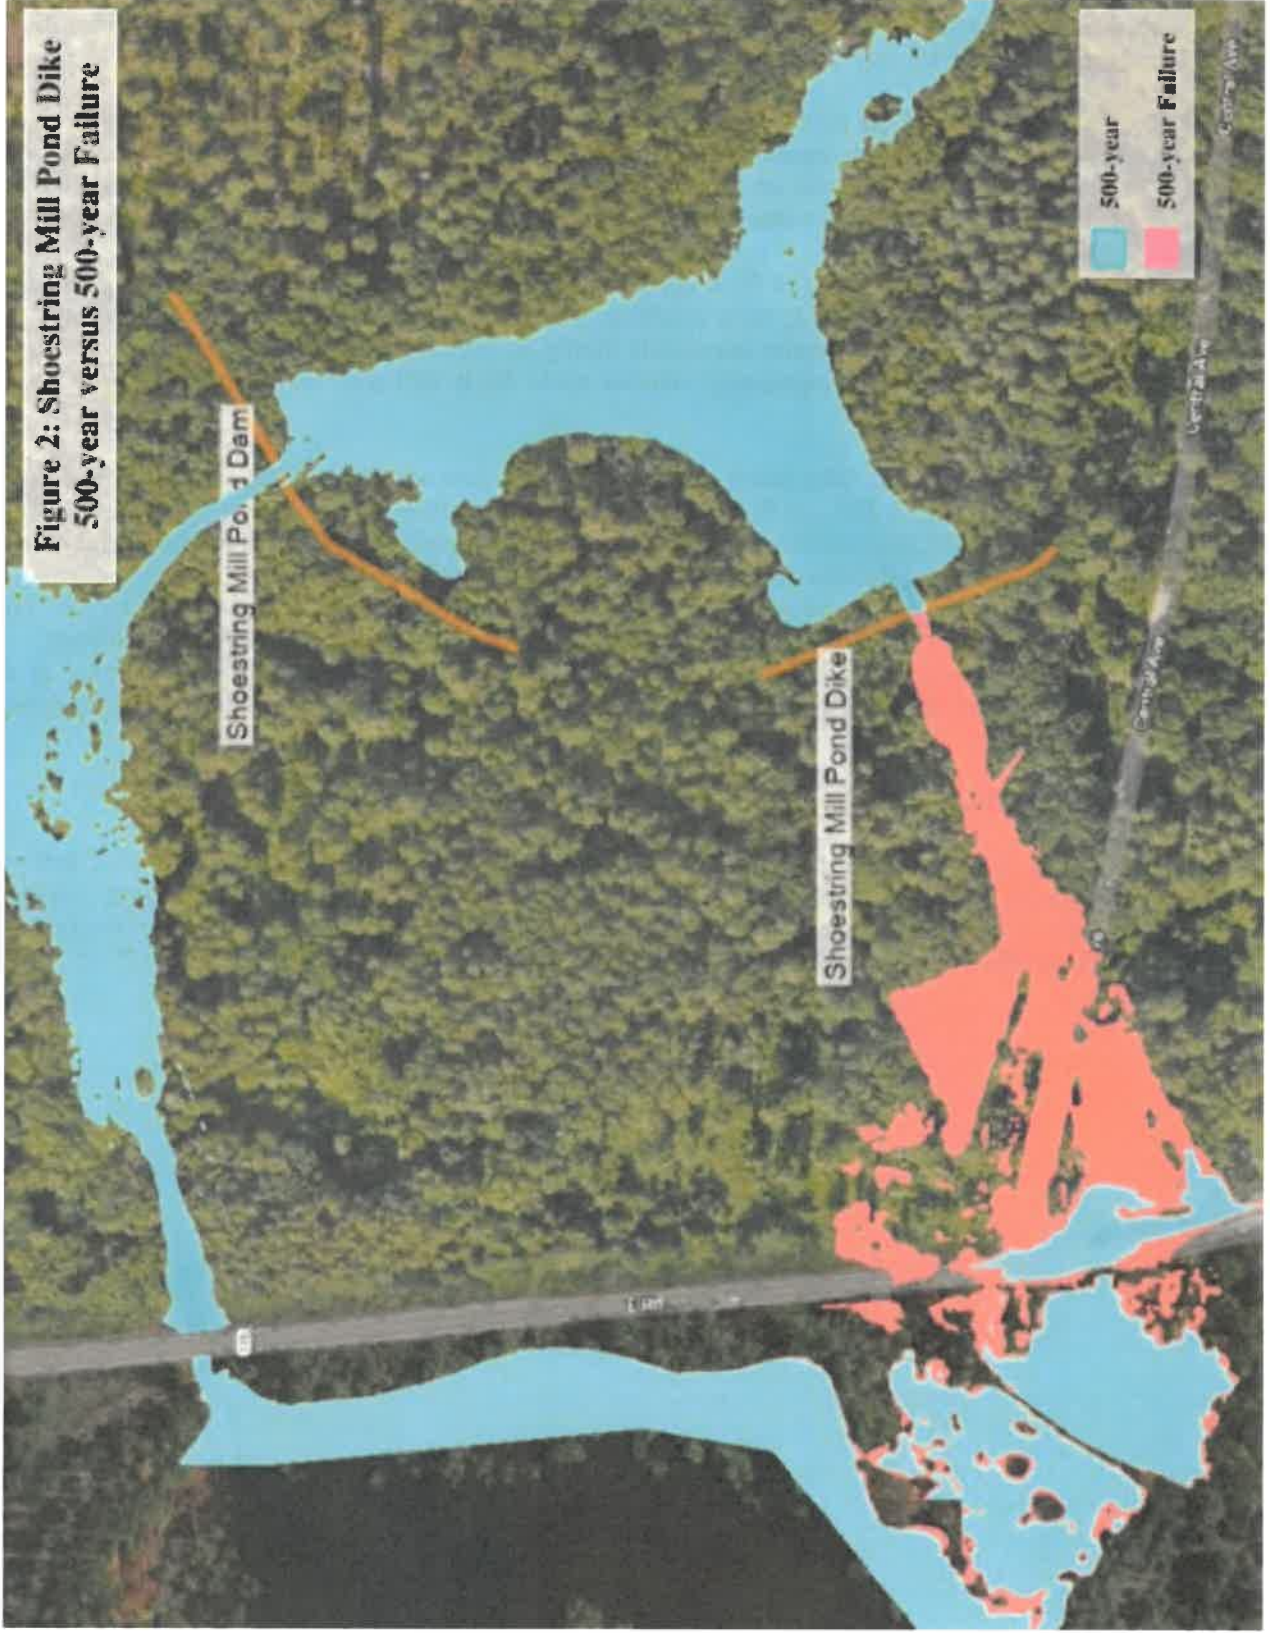
The dam failure analysis revealed that a dike failure during a 500-year event is expected to have low to moderate impacts within the downstream area. The notable impact areas include the Central Avenue crossing and E Road (Route 116). The image on the following page shows the comparison of the failure (pink) and non-failure (blue) inundation areas during the 500-year event.

- a. **Central Avenue:** Dike failure during the 500-year event results in a 5.2-foot rise in river levels upstream of the roadway from El. 306.7 to EL. 311.9. The rise in river levels results in roadway overtopping up to 16 inches in depth. The velocity of the overtopping flow is generally low within the footprint of the roadway and along the downstream slope of the roadway (2-7 ft/sec).

- o Overtopping conditions of these depths and velocities fall within the “Low Danger Zone” on ACER TM 11 Figure 4.0; these conditions are unlikely to result in damage to the roadway,

- o The roadway may become impassable during the peak of overtopping; emergency vehicles could likely still pass the roadway at these flood depths. The duration of the peak of overtopping is relatively long at 6 hours due primarily to the timing of the base event and the fact that with a failure of the dike, all flow from the base event is redirected from its normal flow path through the former Shoestring Dam site through the dike, which normally sees no flow.

- b. **E Road (Route 116):** Dike failure during the 500-year event results in a 12-inch rise in river levels from El. 294.7 to El. 295.7. This rise results in the depth of roadway overtopping increasing from 1 inch under the base event to 13 inches with dike failure. The velocity of the overtopping flow is generally low within the footprint of the roadway and along the downstream slope of the roadway (0.5-3 ft/sec).

- o The roadway may become impassable during the isolated peak of overtopping; emergency vehicles could likely still pass the roadway at these flood depths. The duration of the peak of overtopping is relatively long at 8 hours due to the base event as described within Note A of the Central Avenue discussion included above.

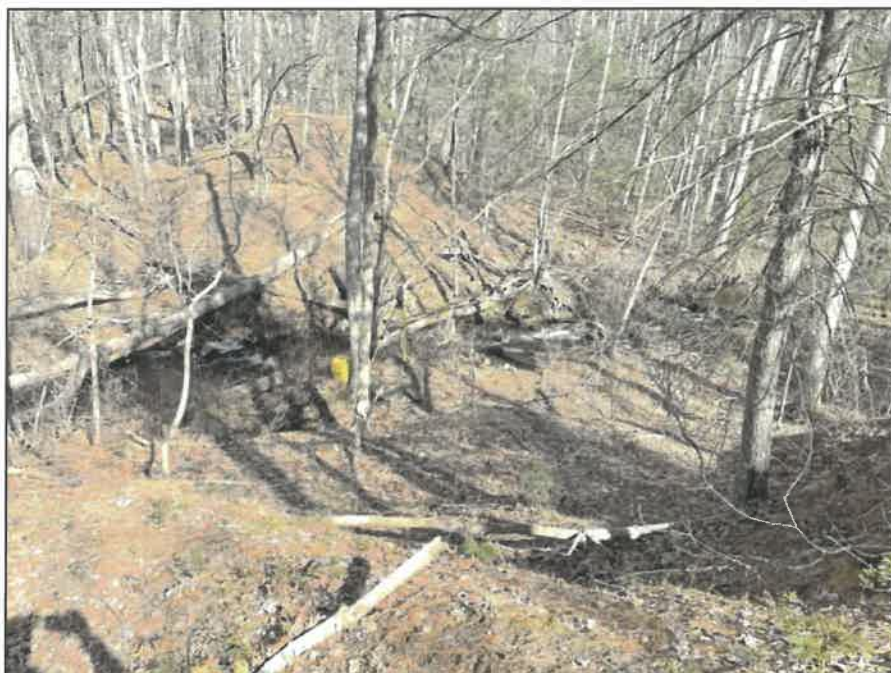
Photo No. 1.: View of the former Shoestring Mill Pond Dam site looking right. Note that the dam has been fully breached for some time.

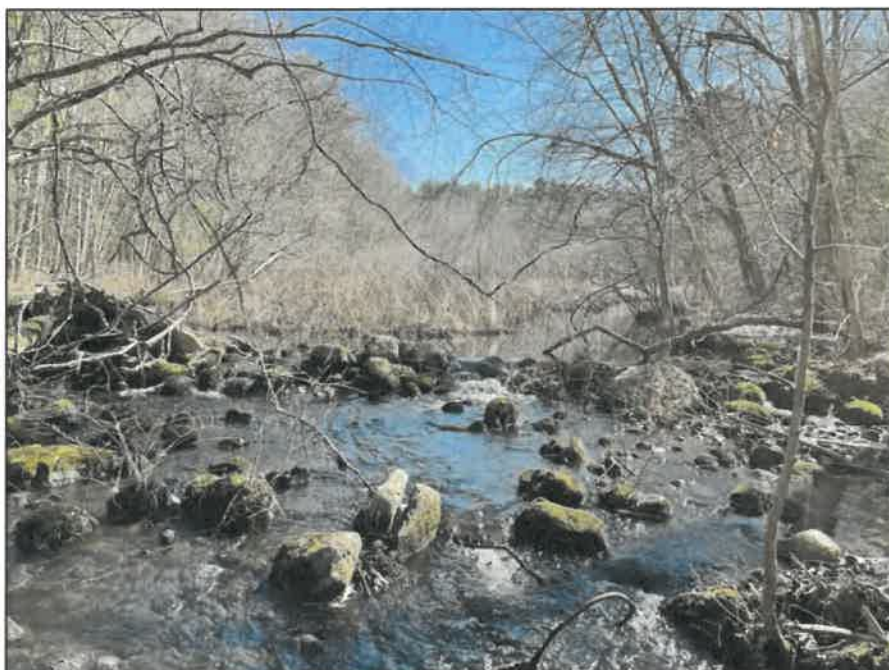
Photo No. 2.: View of the natural stone weir located 100 feet upstream of the former dam embankment.

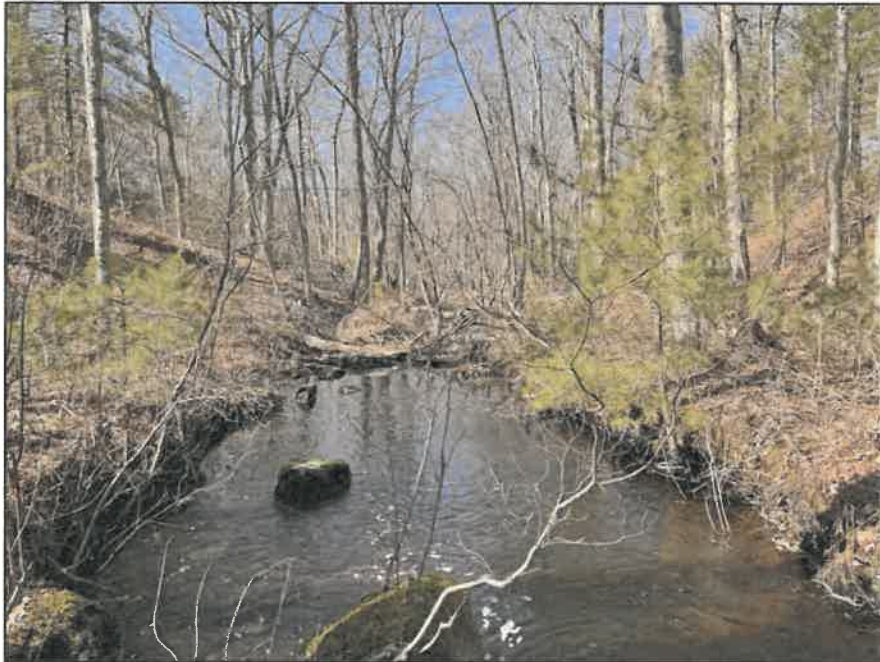
Photo No. 3.: View of the channel through the former dam from 50 feet upstream of former dam centerline looking downstream.

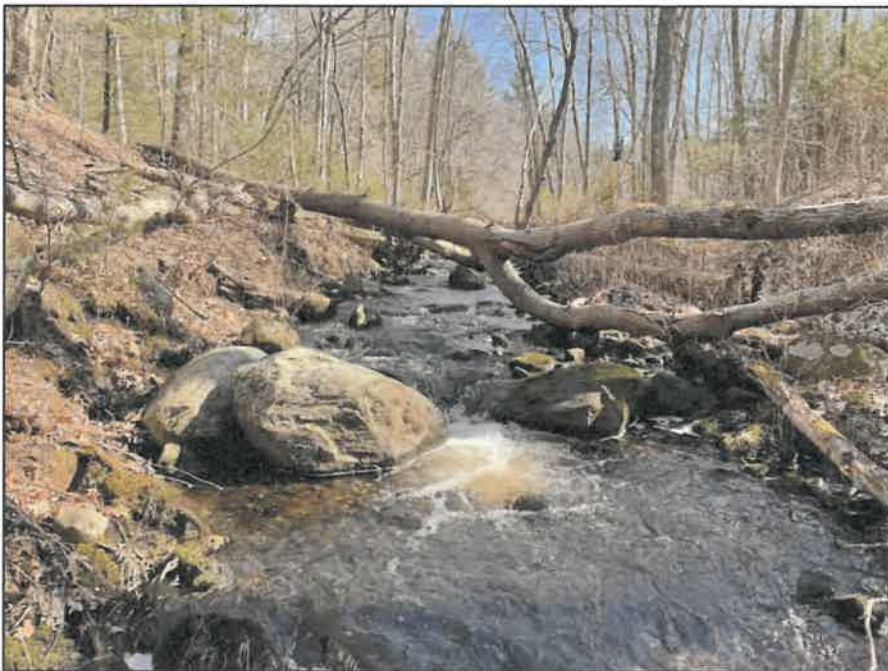
Photo No. 4.: Channel through the former dam from 20 feet downstream of former dam centerline looking upstream.

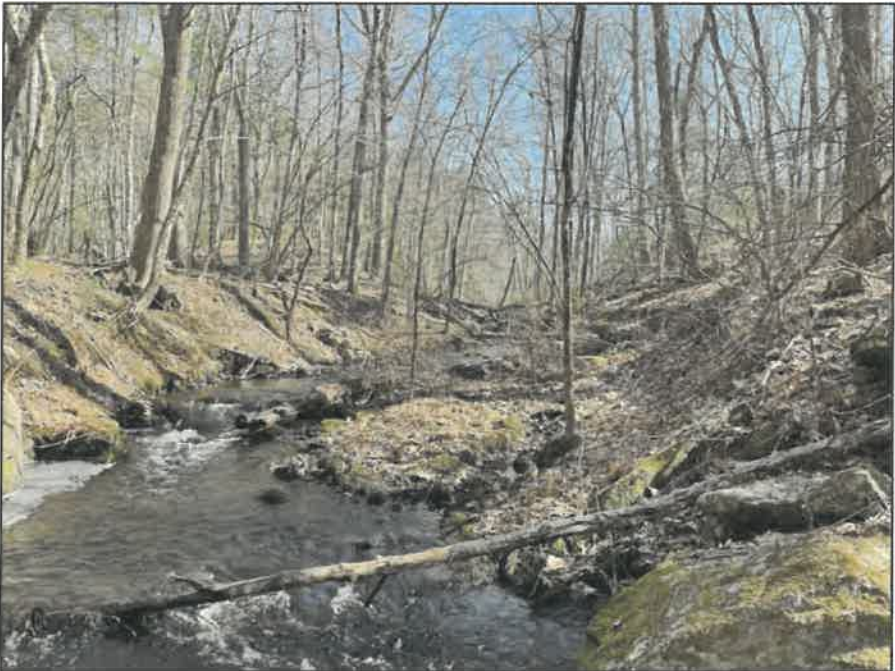
Photo No. 5.: Channel through the former dam from 200 feet downstream of the former dam centerline looking upstream.

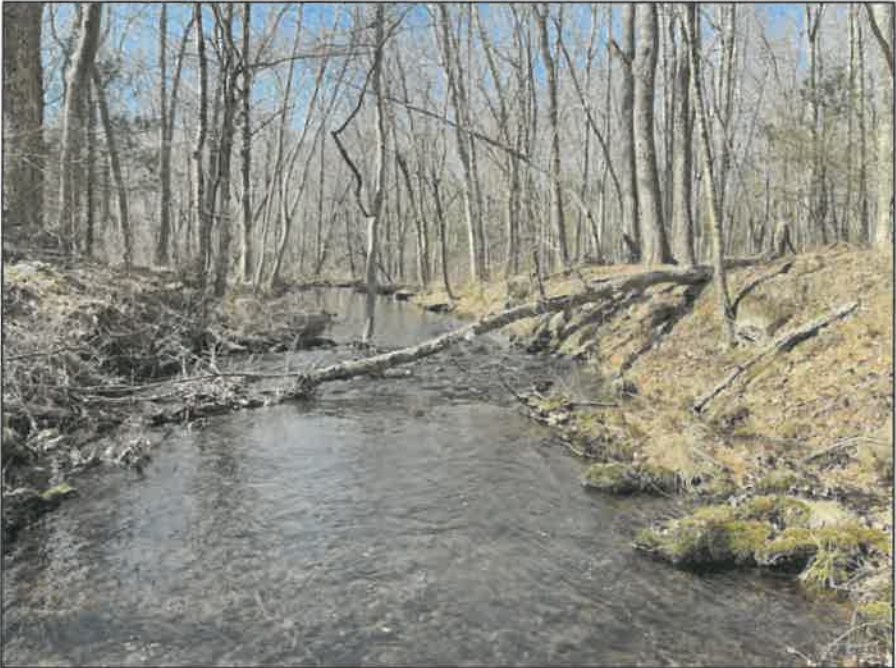
Photo No. 6.: Downstream channel from 200 feet downstream of the former dam centerline looking downstream.

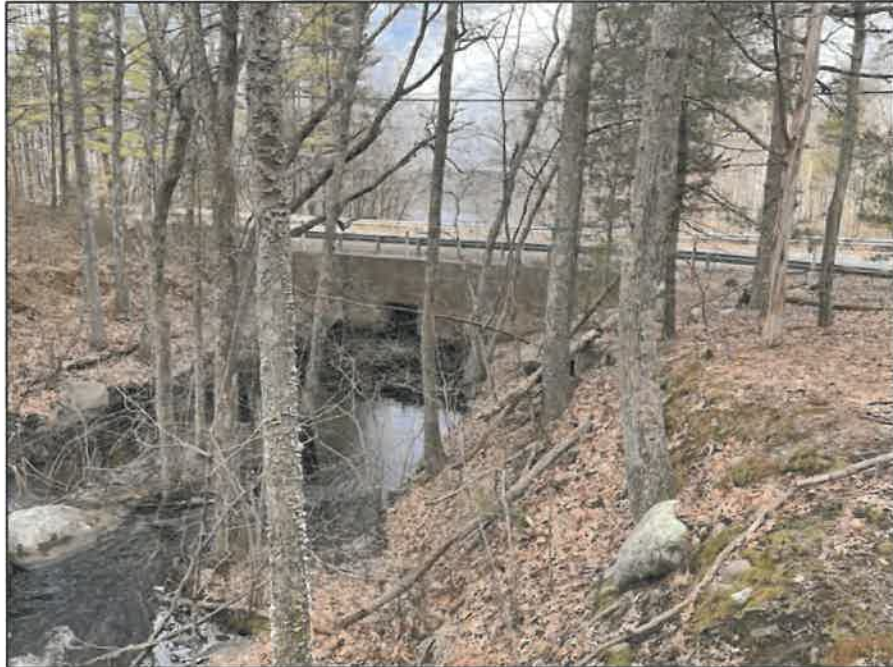
Photo No. 7.: View of the Route 116 culvert crossing downstream of the former Shoestring Mill Pond Dam site.

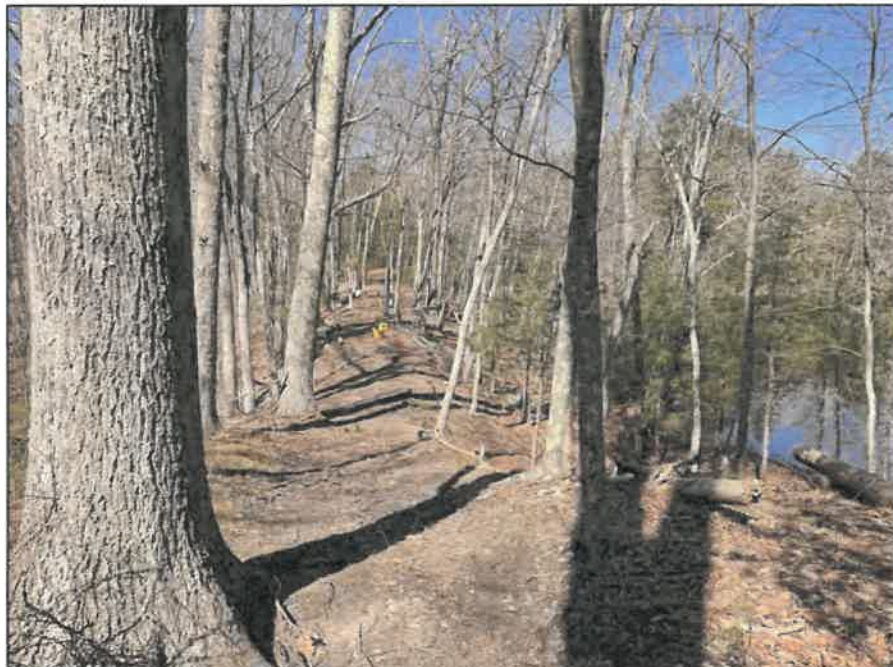
Photo No. 8.: Shoestring Mill Dike embankment from the left abutment looking right.

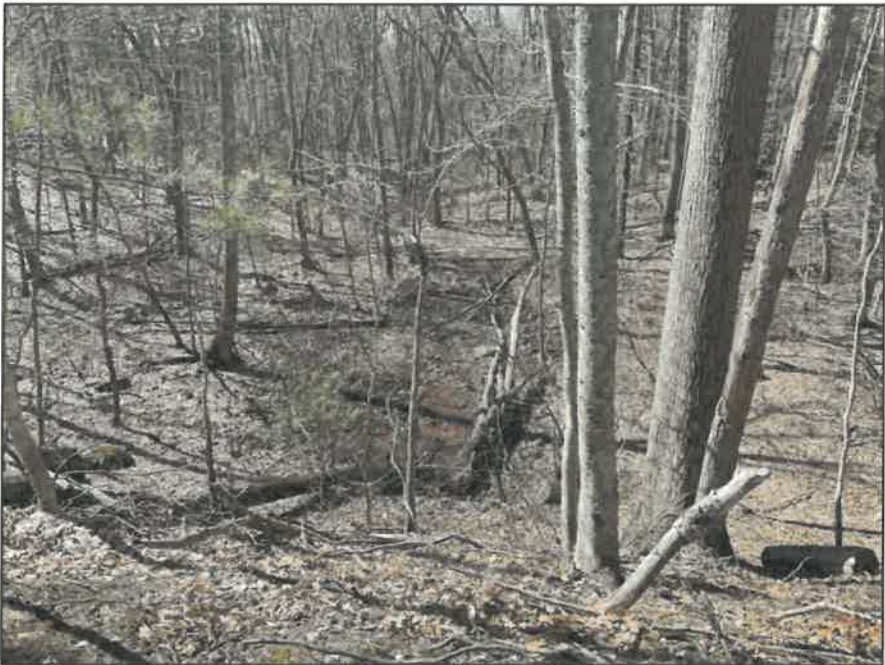
Photo No. 9.: Area downstream of the dike embankment from the crest of the dike at mid-length looking downstream.

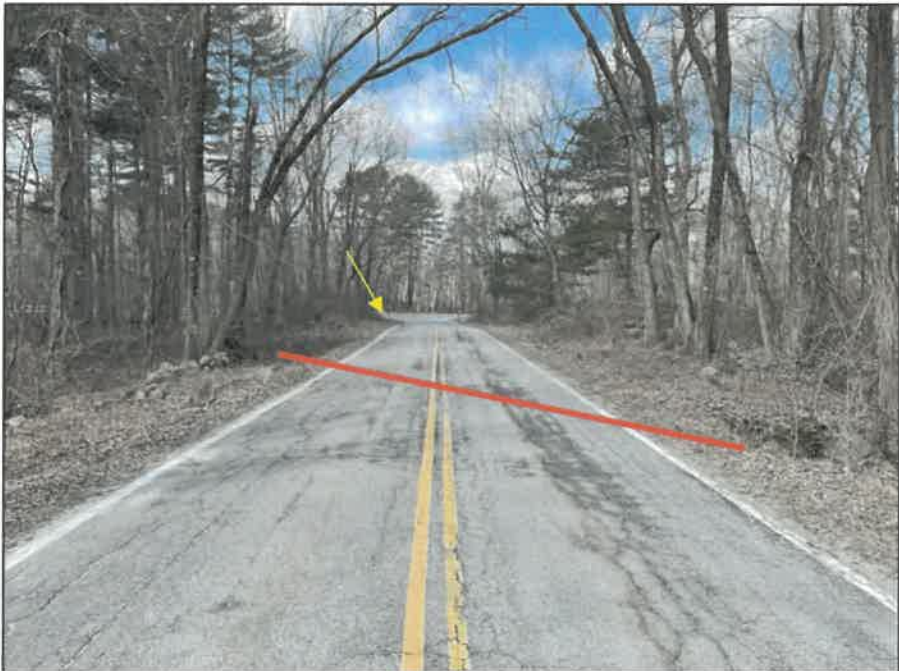
Photo No. 10.: View of Central Avenue located downstream of the dike embankment. Note the alignment of the culvert crossing along Central Avenue (red line) in the foreground and the location of the Route 116 culvert crossing (yellow arrow) in the background

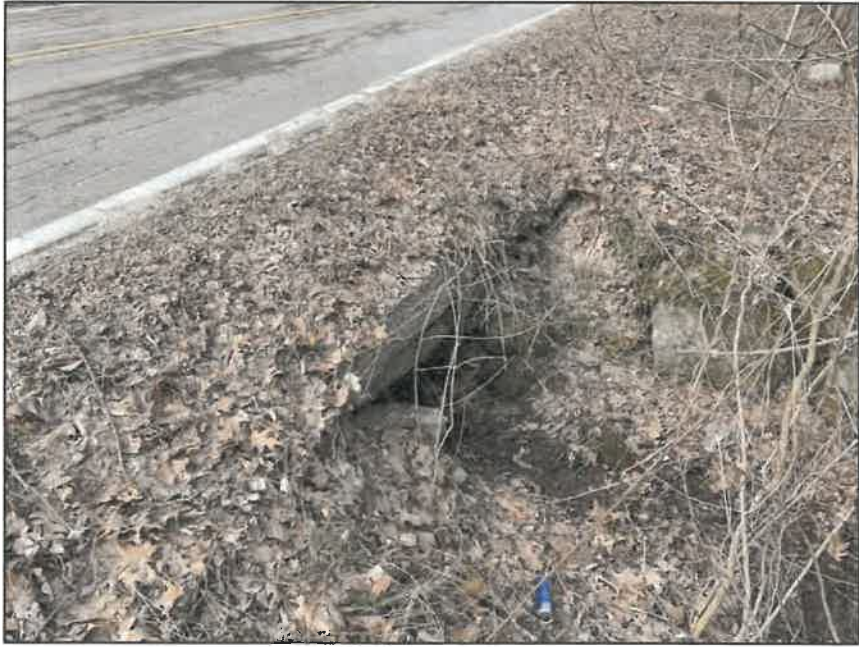
Photo No. 11.: Upstream end of the Central Avenue culvert crossing.

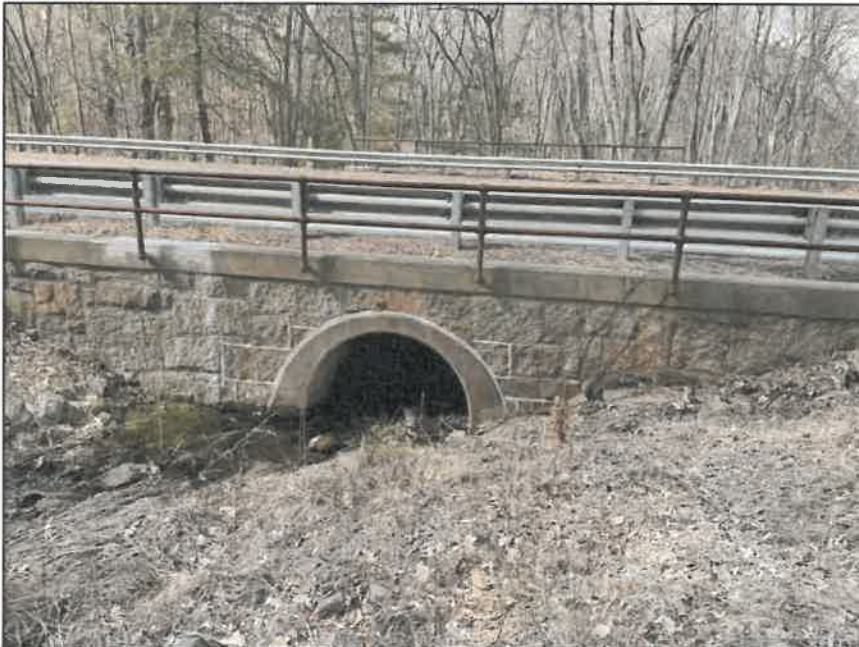
Photo No. 12.: Upstream end of the Route 116 culvert crossing located downstream of the dike.
