Inspection Report

79'-0" x 4'-1½" ϕ Boiler House Chimney Gould Island - Narragansett Bay Jamestown, Rhode Island

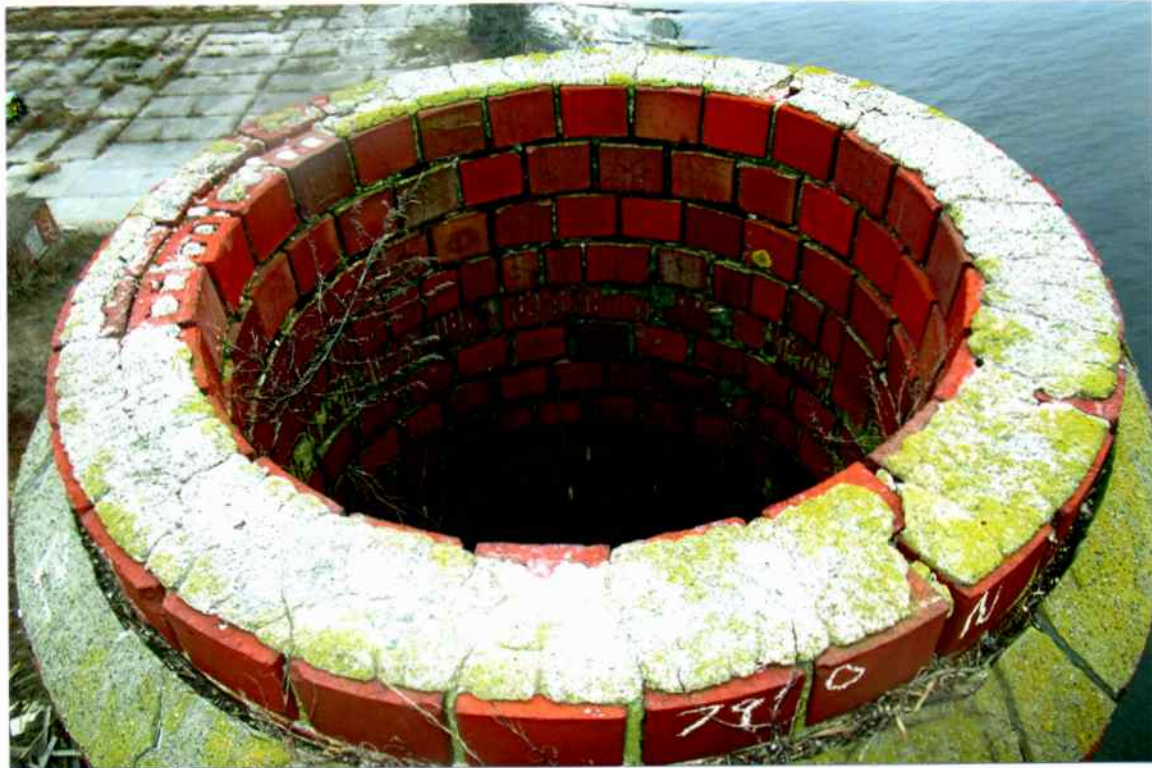
Photo 1. Poor condition of the remaining cement cap atop the chimney. Note the deteriorated and dislodged areas of the thin layer of material.

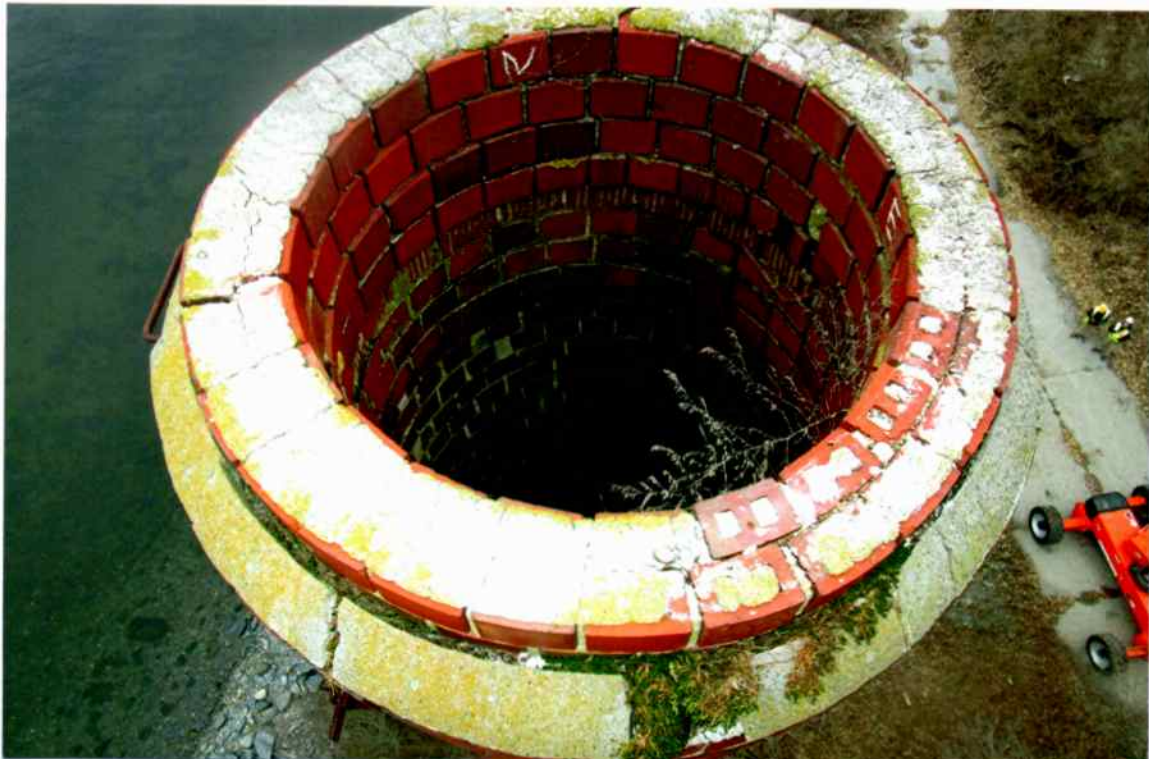
Photo 2. Poor condition of the remaining cement cap atop the chimney.

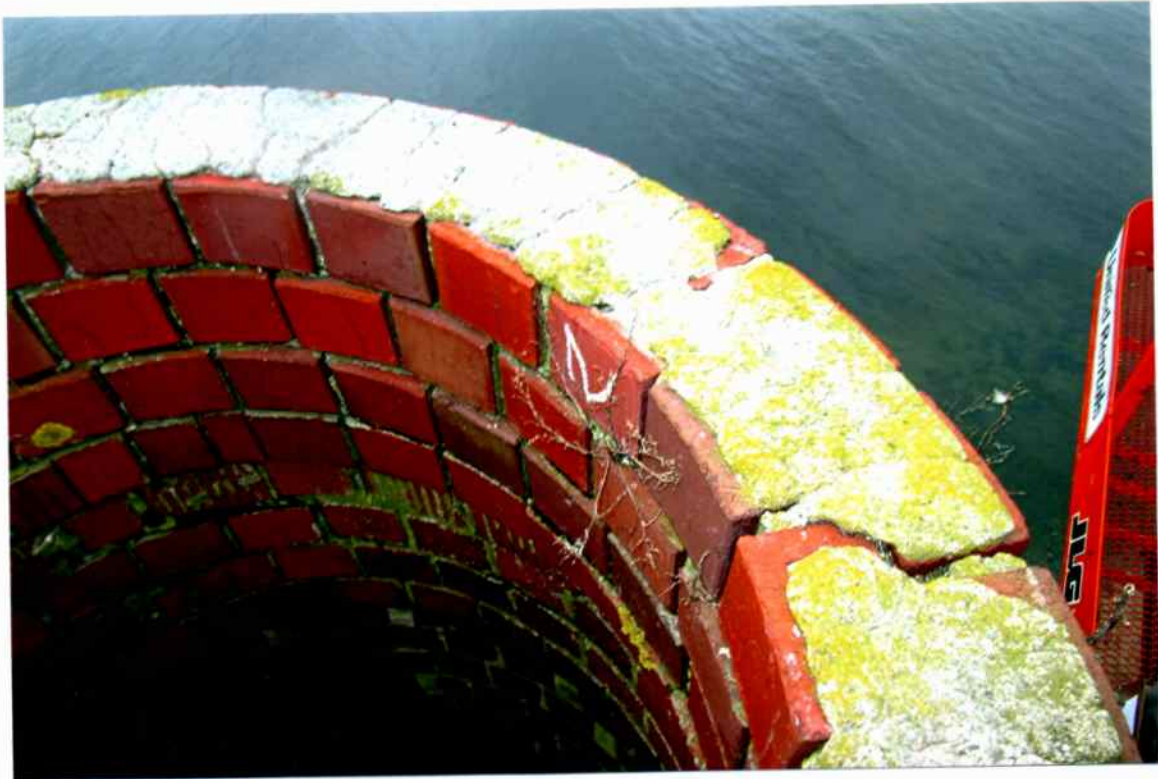
Photo 3. Poor condition of the remaining cement cap atop the chimney (north side).

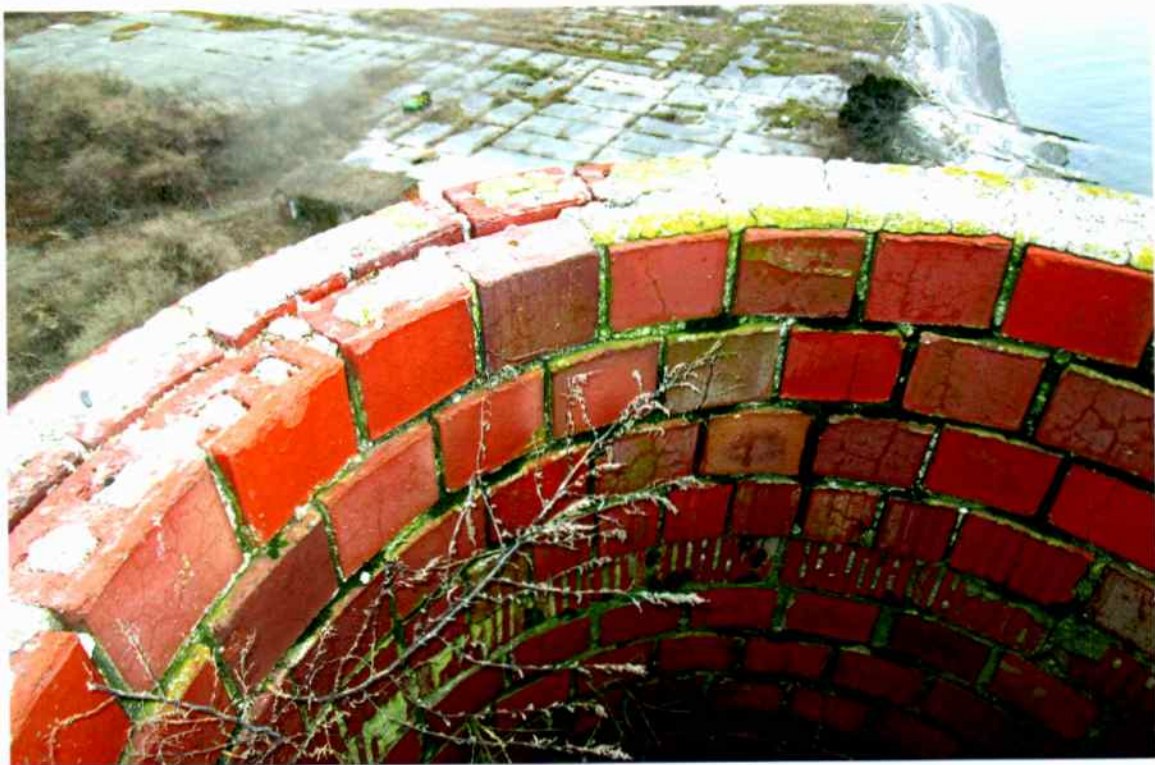
Photo 4. Very poor condition of the remaining cement cap atop the chimney (south side).
Note the region where the cement has completely dislodged.

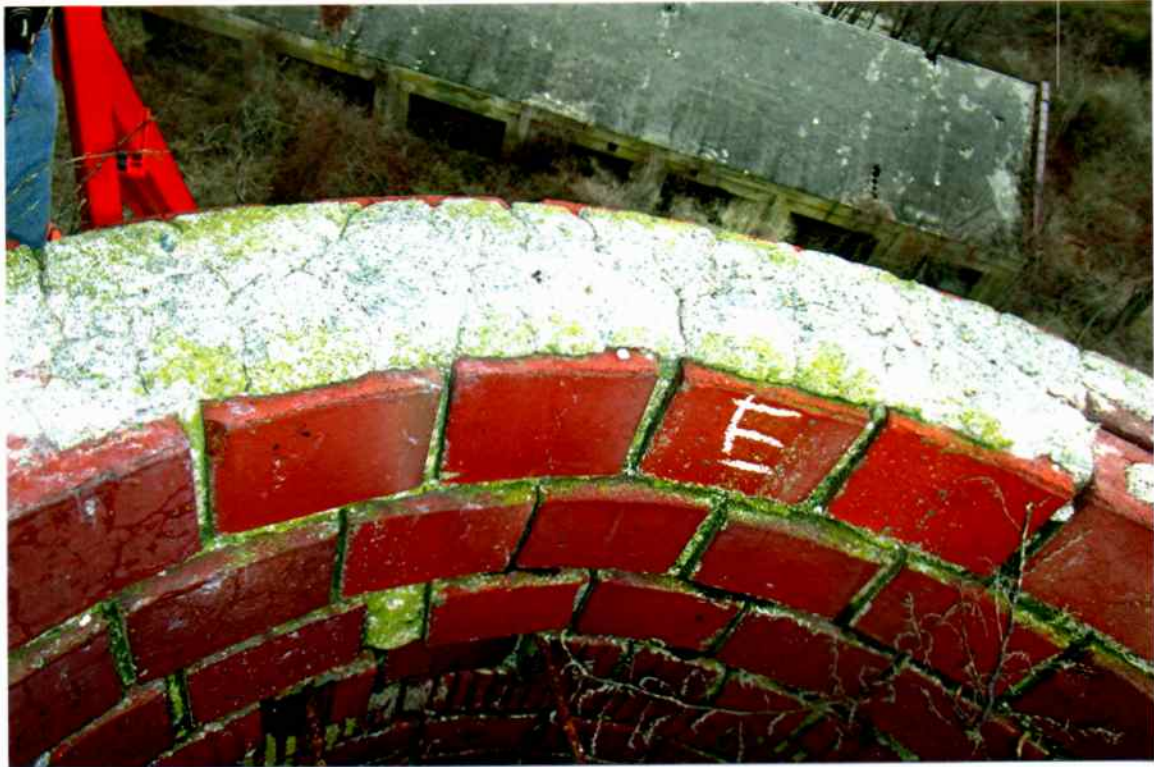
Photo 5. Poor condition of the remaining cement cap atop the chimney (east side).

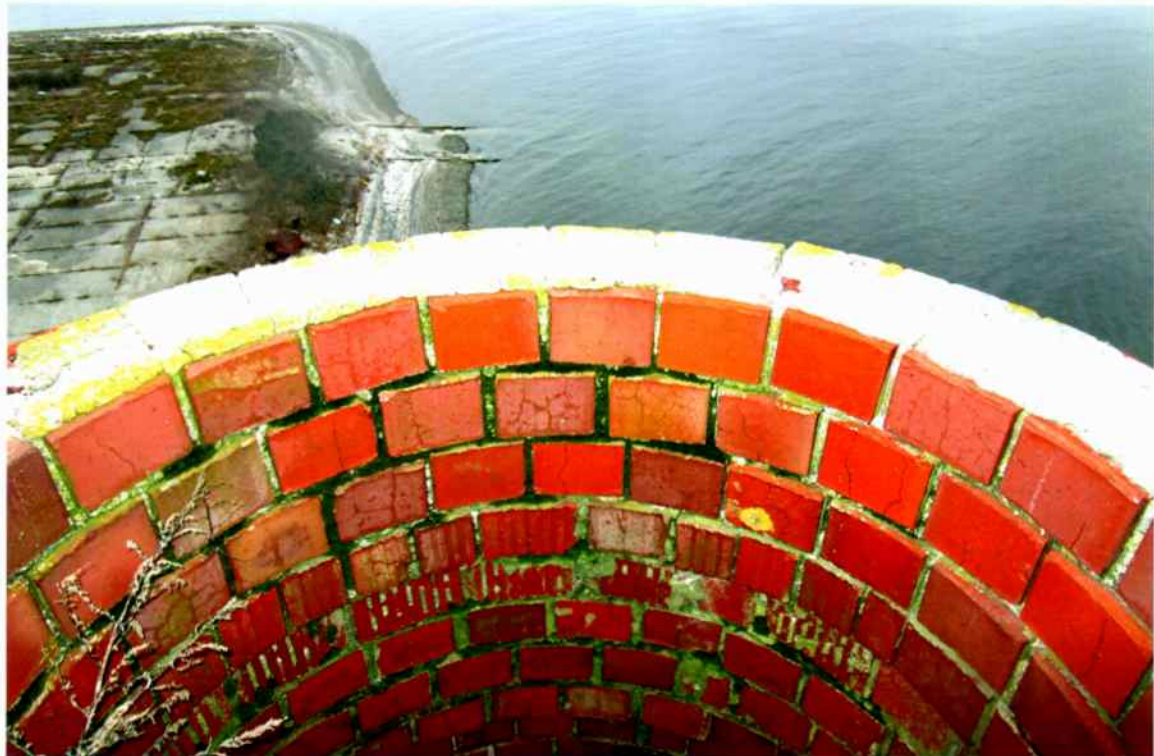
Photo 6. Poor condition of the remaining cement cap atop the chimney (west side).

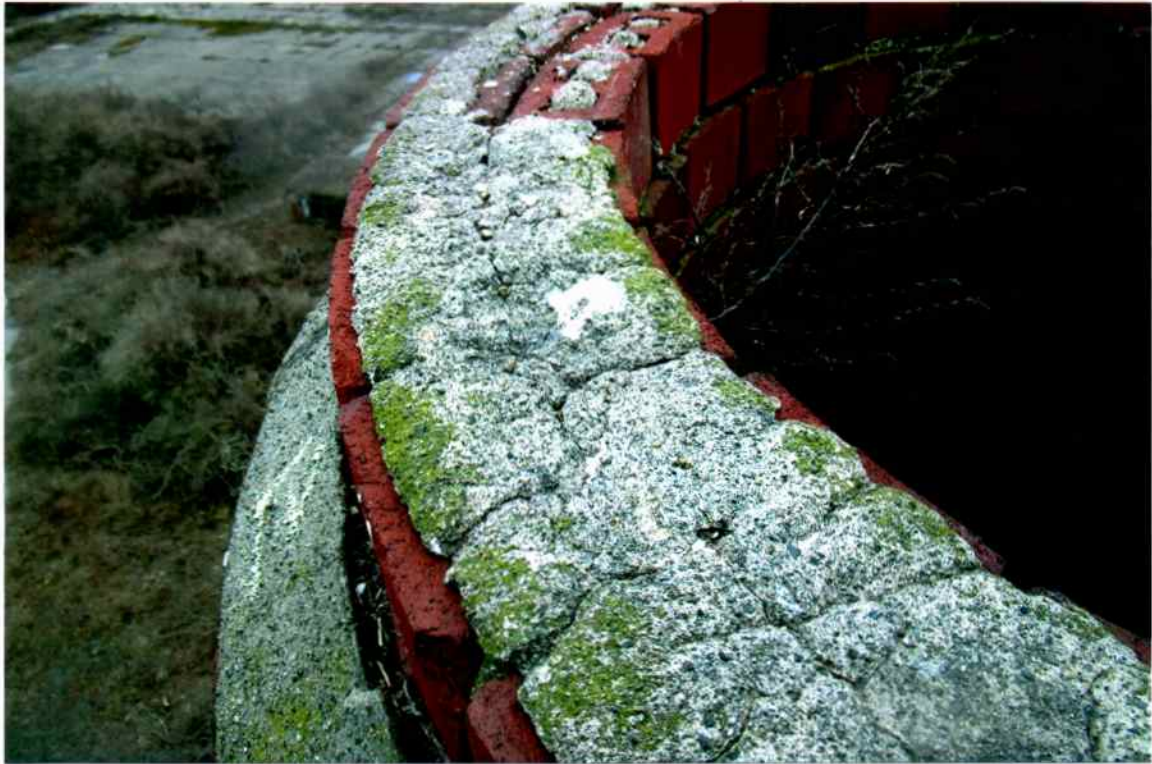
Photo 7. Close-up of the remaining deteriorated cement cap atop the chimney.

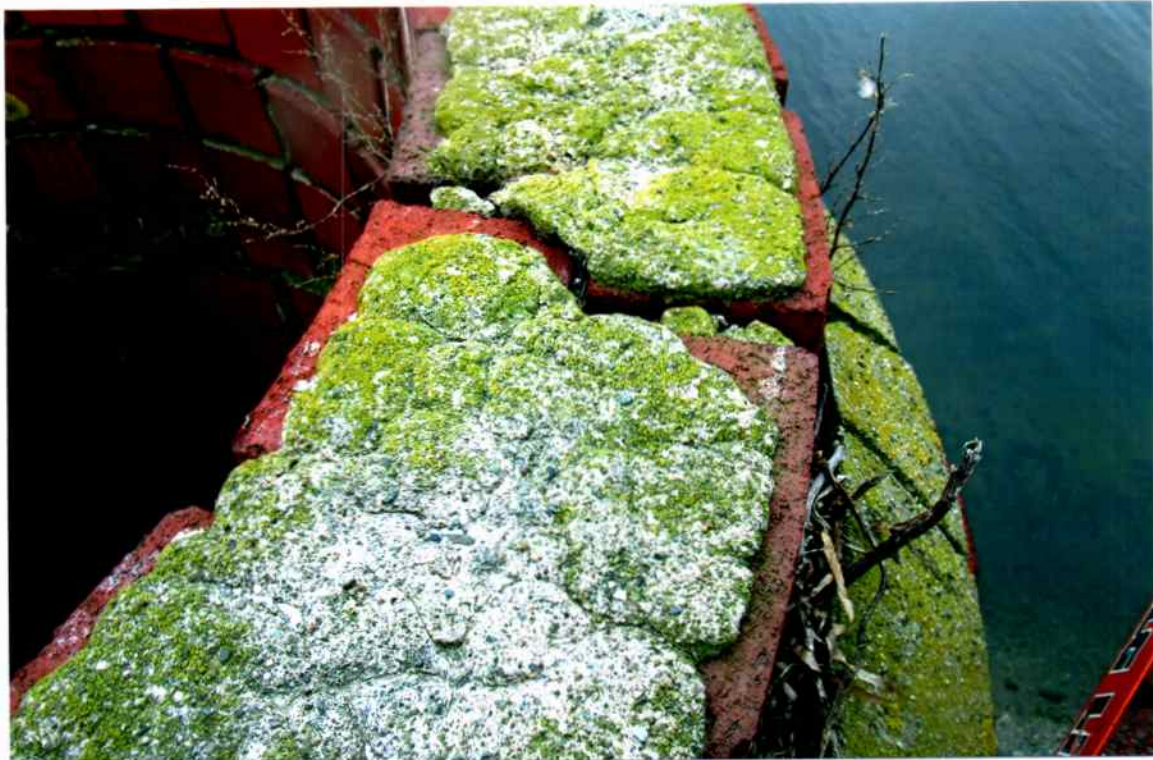
Photo 8. Close-up of the remaining deteriorated cement cap atop the chimney.

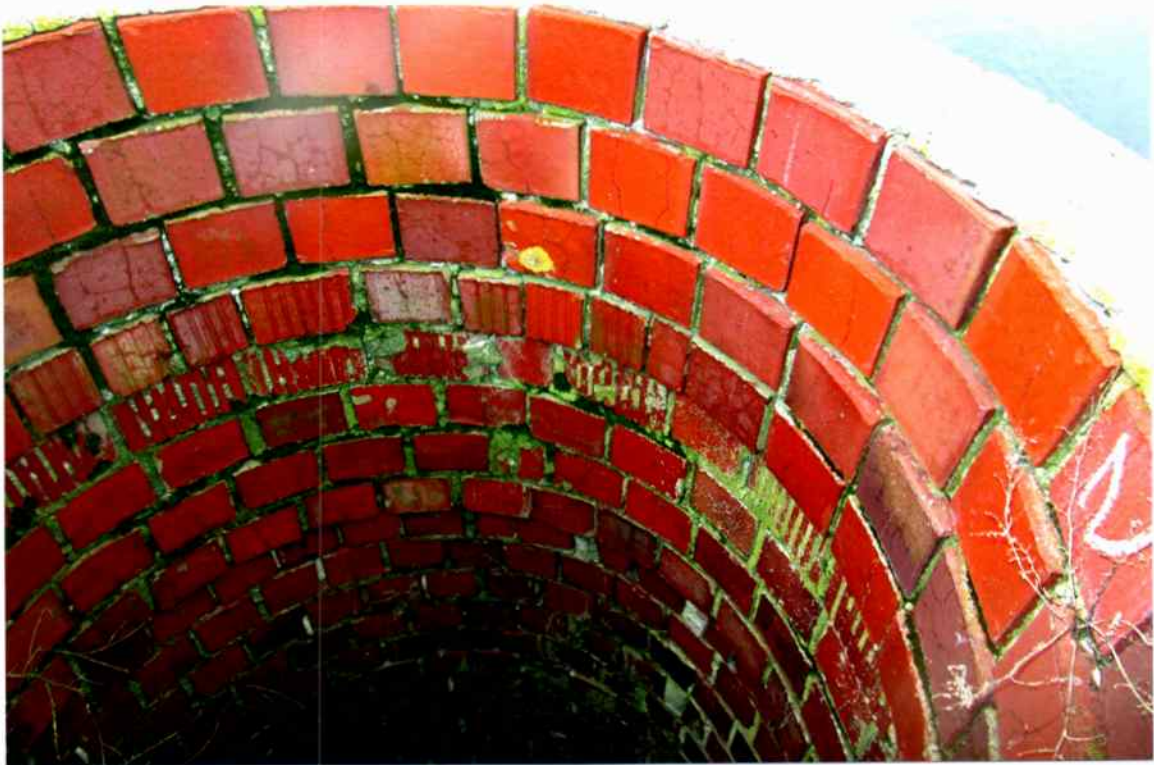
Photo 9. Fair interior condition of the upper elevations (northwest side). No concerns were seen with brick faces but mortar joints were recessed up to $\frac{3}{4}$ " near the top.

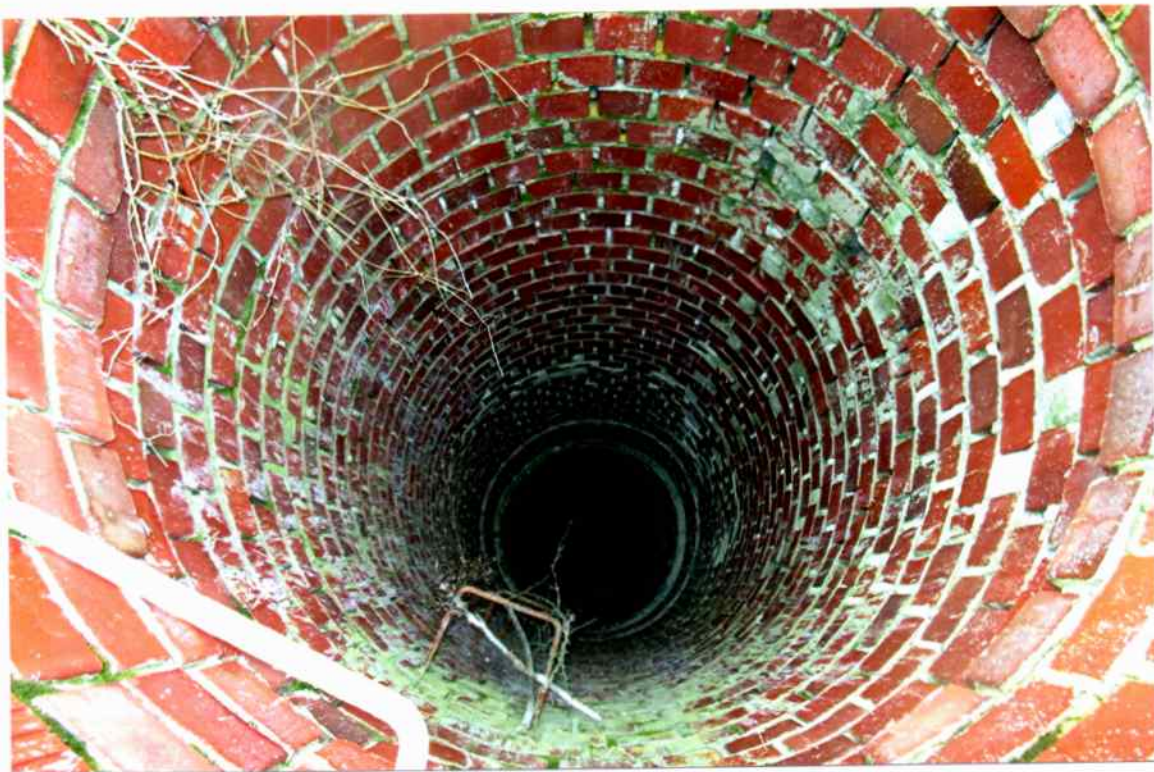
Photo 10. Fair interior condition of the upper elevations looking down from the top. No concerns were seen with brick faces. Local areas of mortar joints were recessed $\frac{3}{4}$ " to 1".

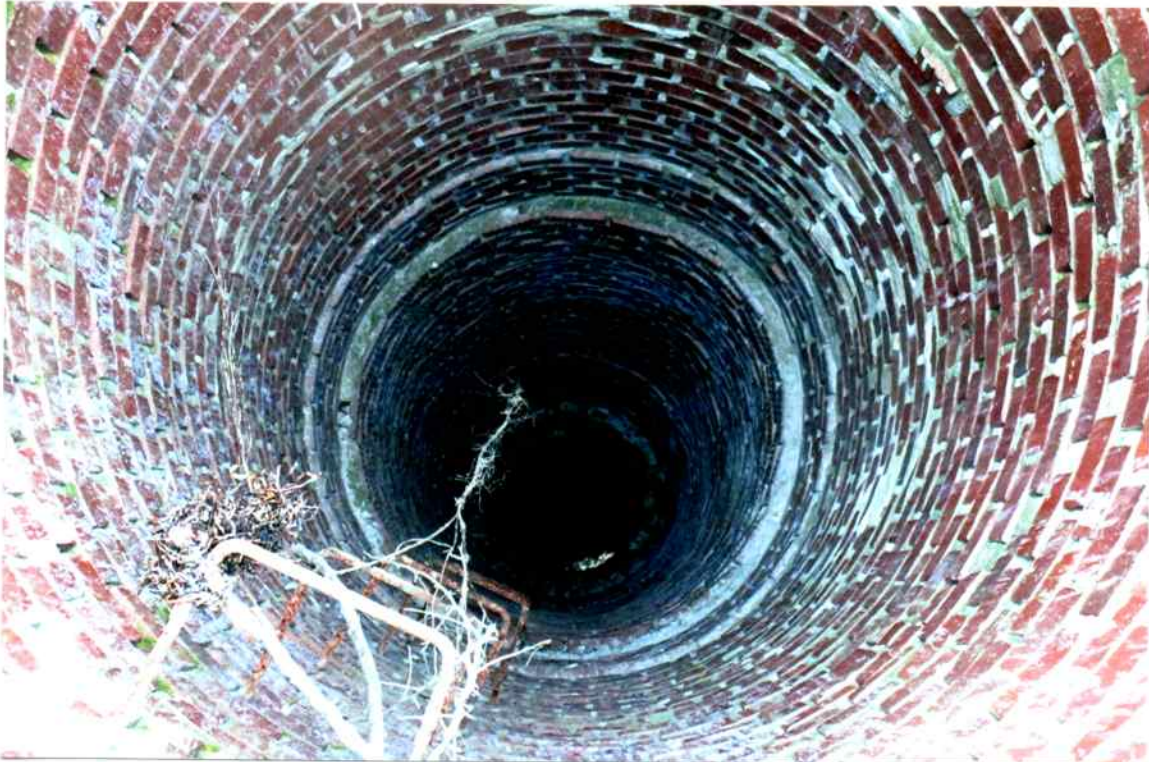
Photo 11. Fair interior condition between the 60' and 50' levels. Mortar joints were only slightly recessed in this region.

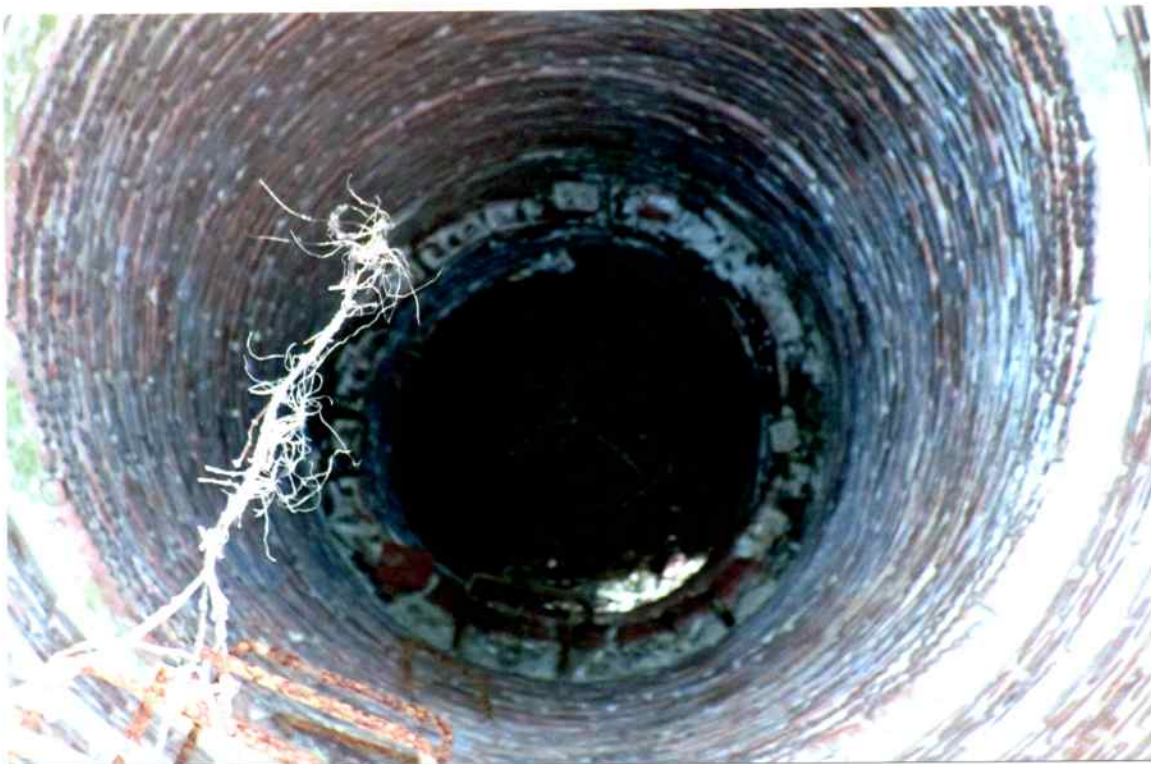
Photo 12. Poor condition along the top of the inner liner wall near the 29' level. Numerous loose and unstable bricks were seen along the top of the inner liner wall.

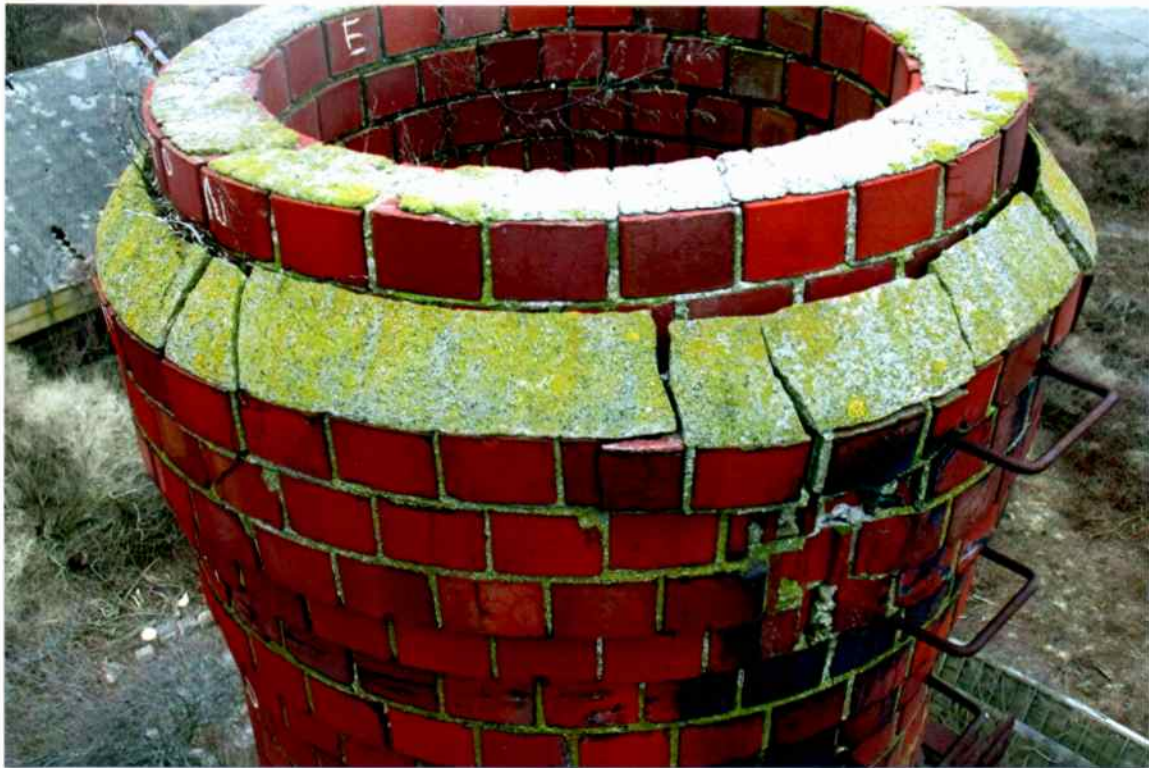
Photo 13. Poor exterior condition of the upper elevations (northwest side). Note the cracked water table (cement wash). Several bricks were in danger of dislodging.

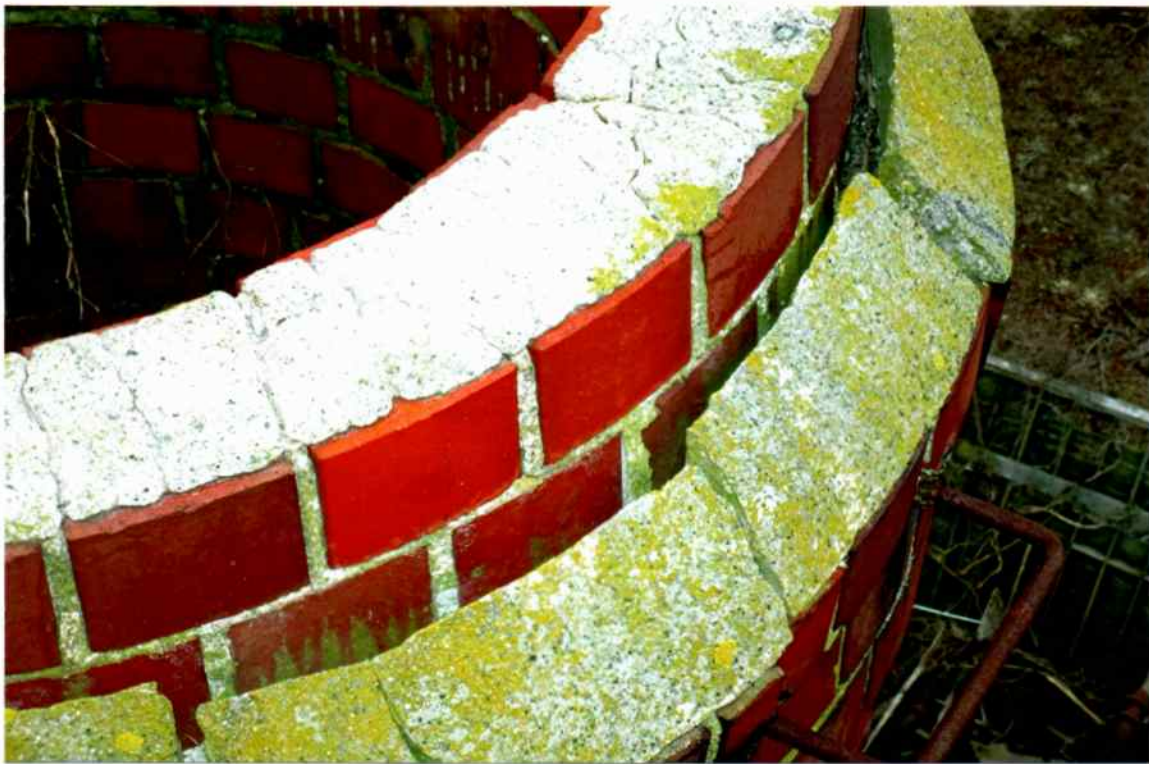
Photo 14. Close-up of loose and unstable sections of the water table (west side). Sections on this side were in danger of dislodging.

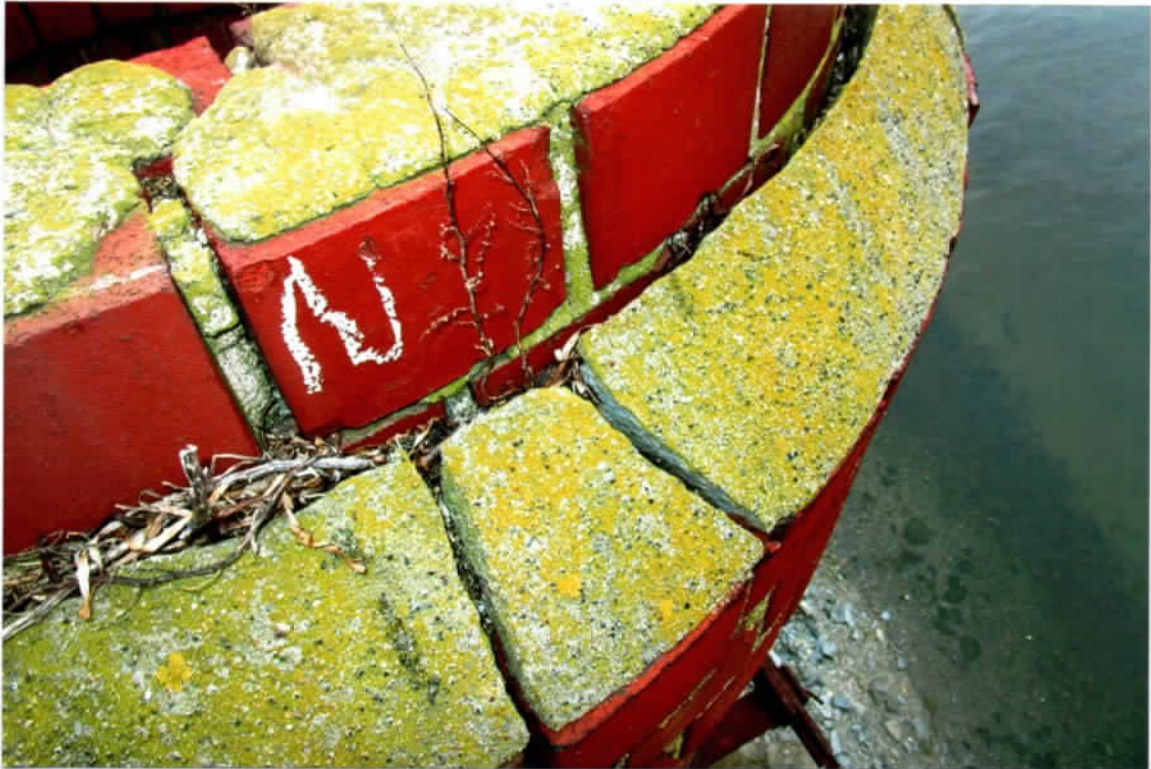
Photo 15. Close-up of cracked and loose sections of the water table (north side).

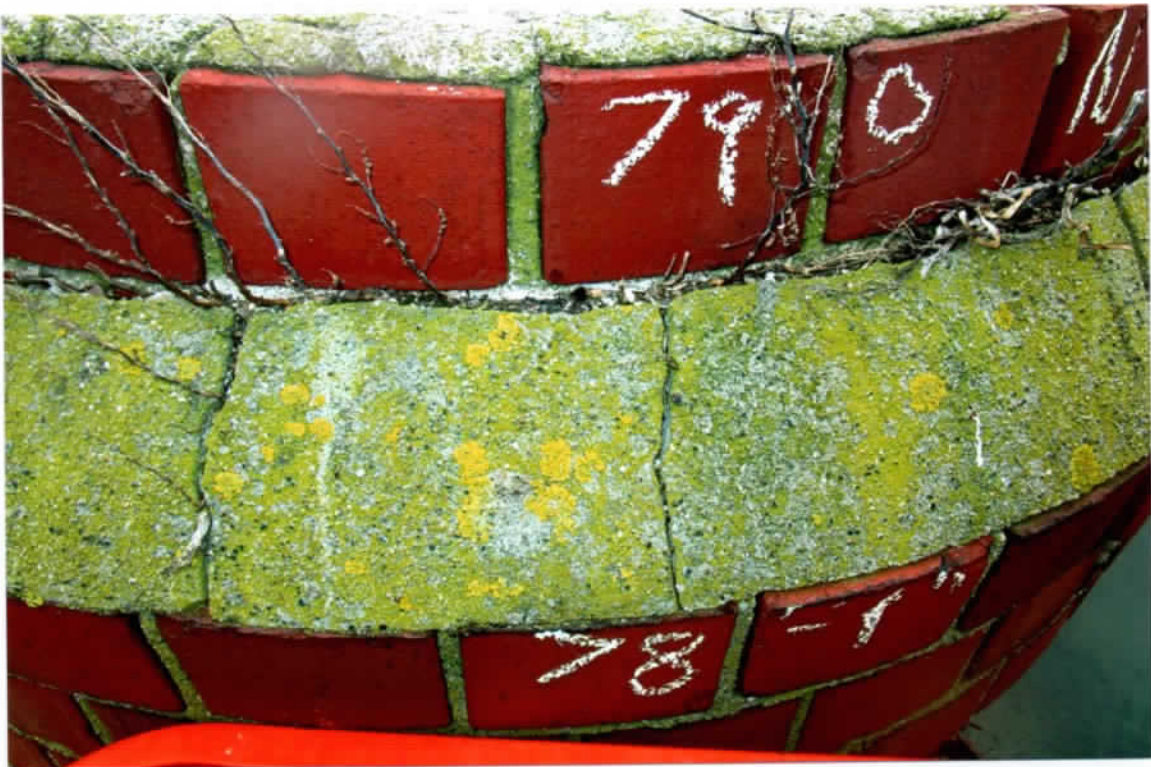
Photo 16. Close-up of cracked and loose sections of the water table (northeast side).

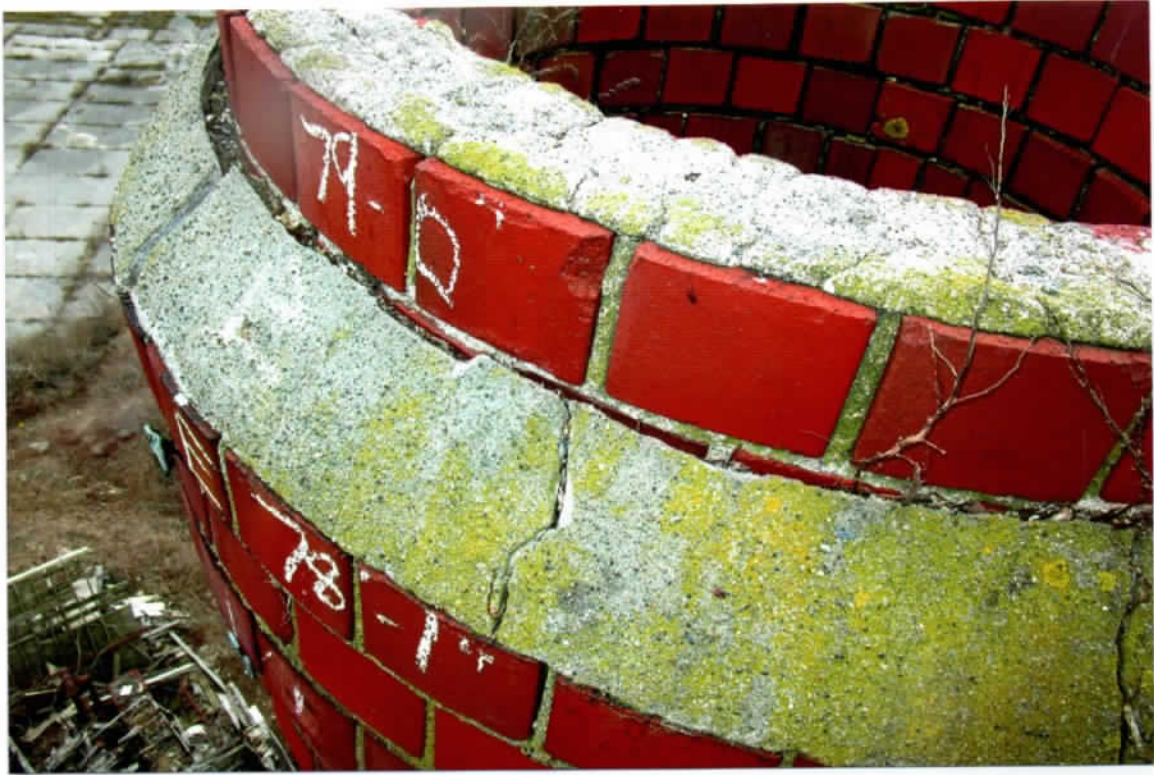
Photo 17. Close-up of cracked sections of the water table (east side).

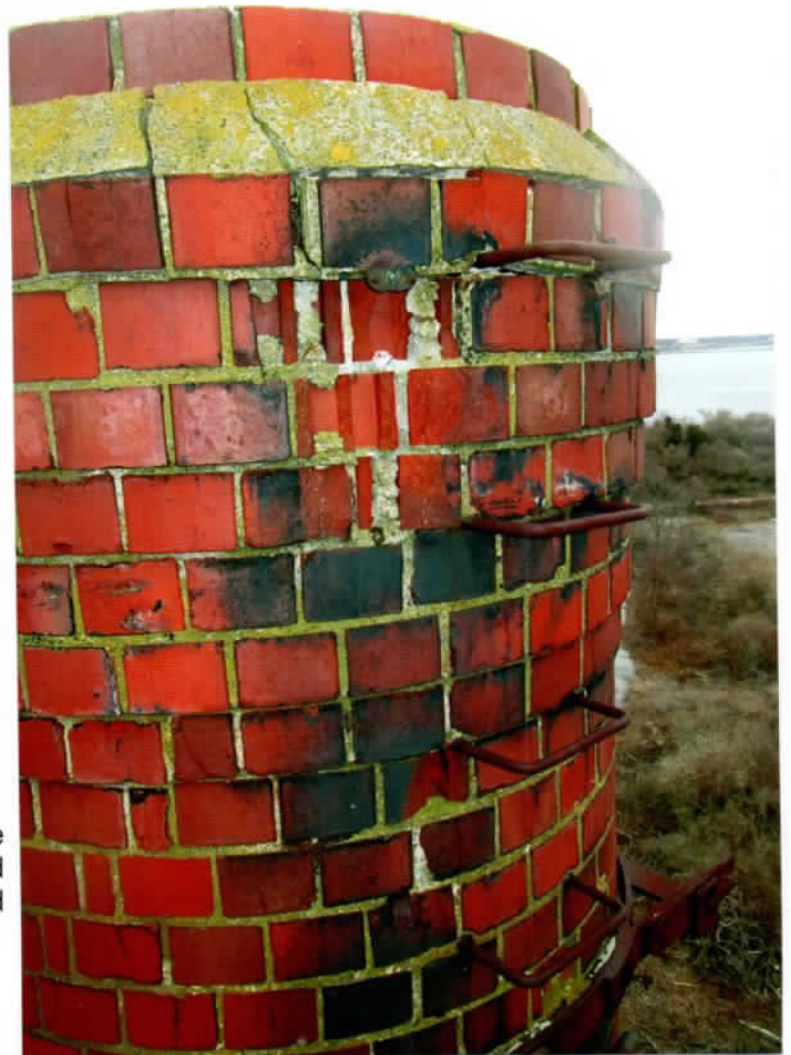
Photo 18.
Poor exterior condition of the upper 5' of the northwest side. Approximately 10 spalled bricks were seen below the loose and unstable course under the water table.

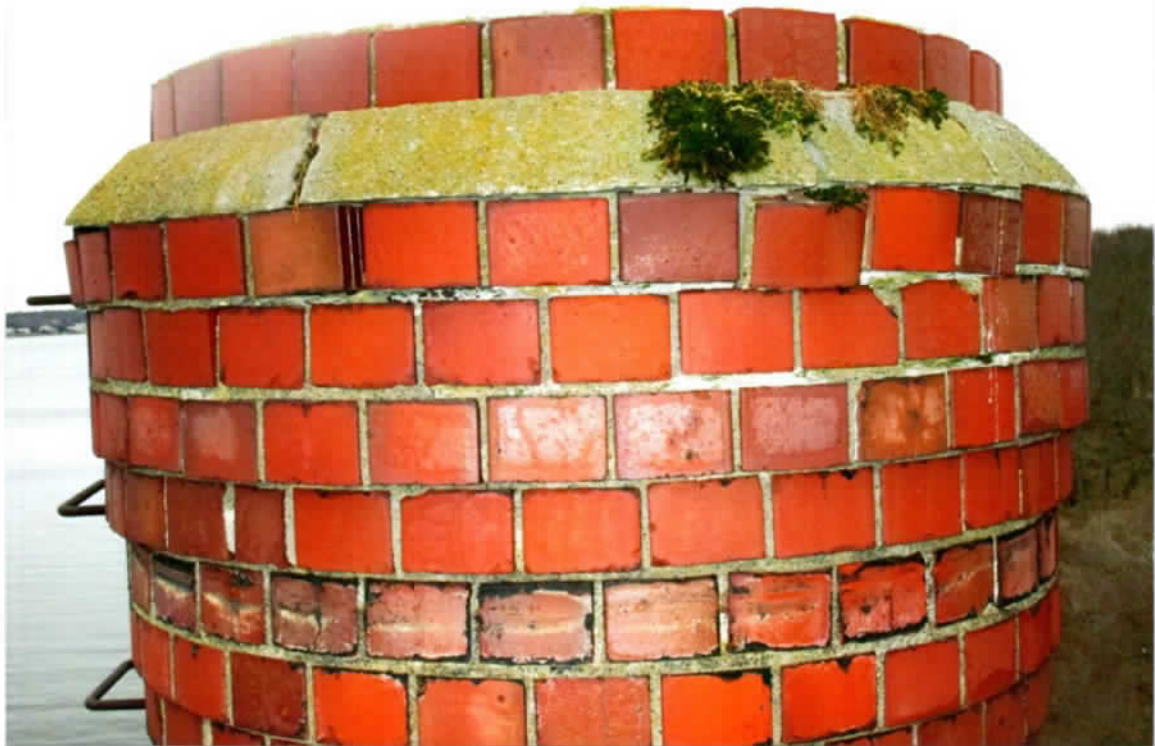
Photo 19. Poor condition of the upper 4' of the south side. Several loose and unstable bricks were seen below the water table.

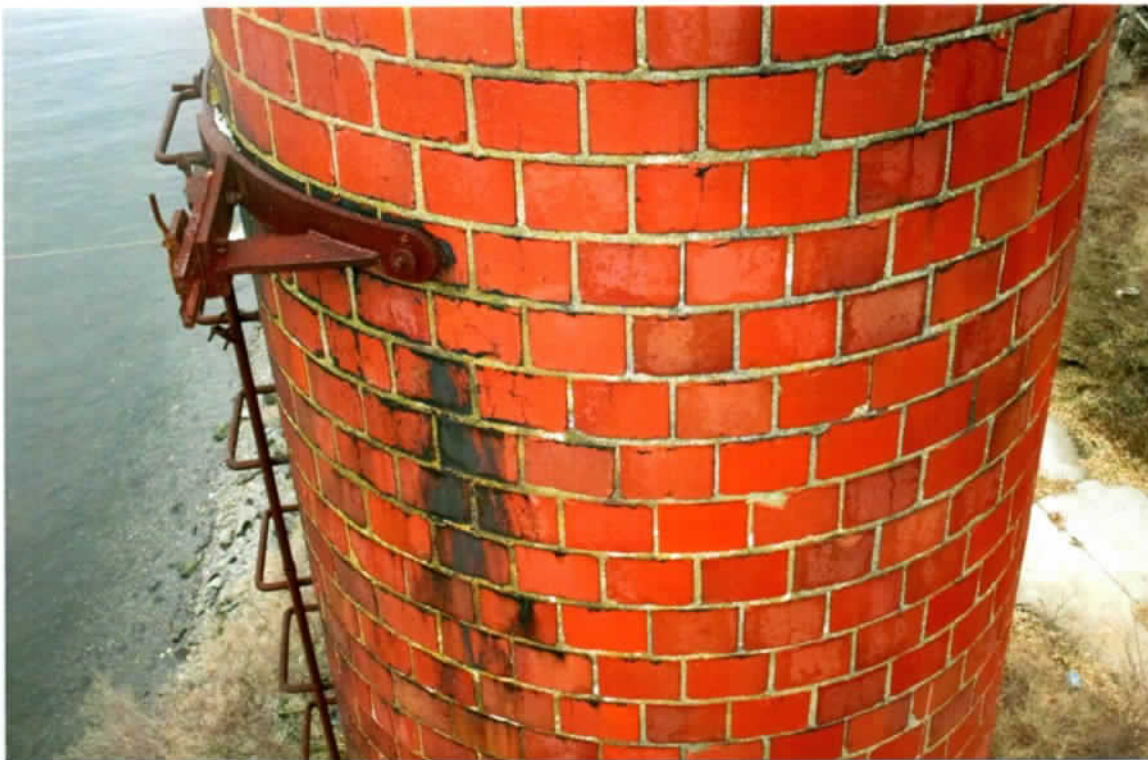
Photo 20. Fair exterior condition of the west side between the 75' and 70' levels. Mortar joints were only slightly recessed in this region.

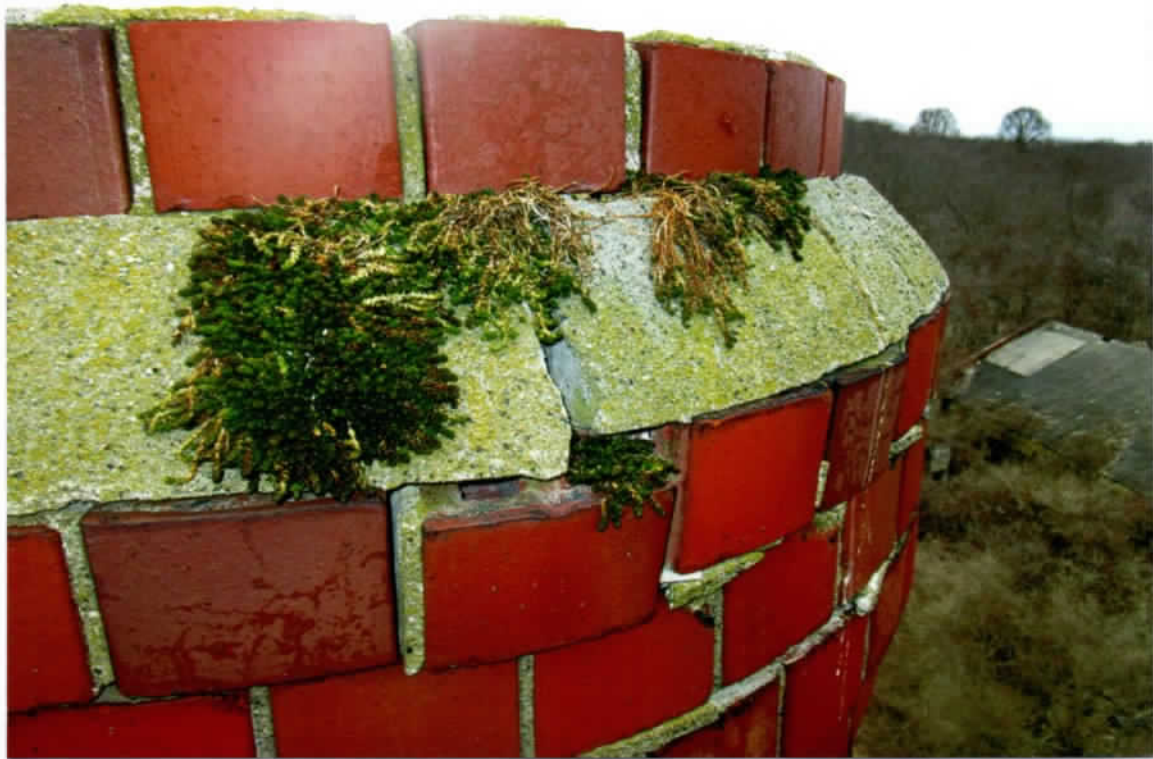
Photo 21. Close-up of unstable bricks and sections of the water table (southeast side). The one brick and small section of cement water table were removed during the inspection.

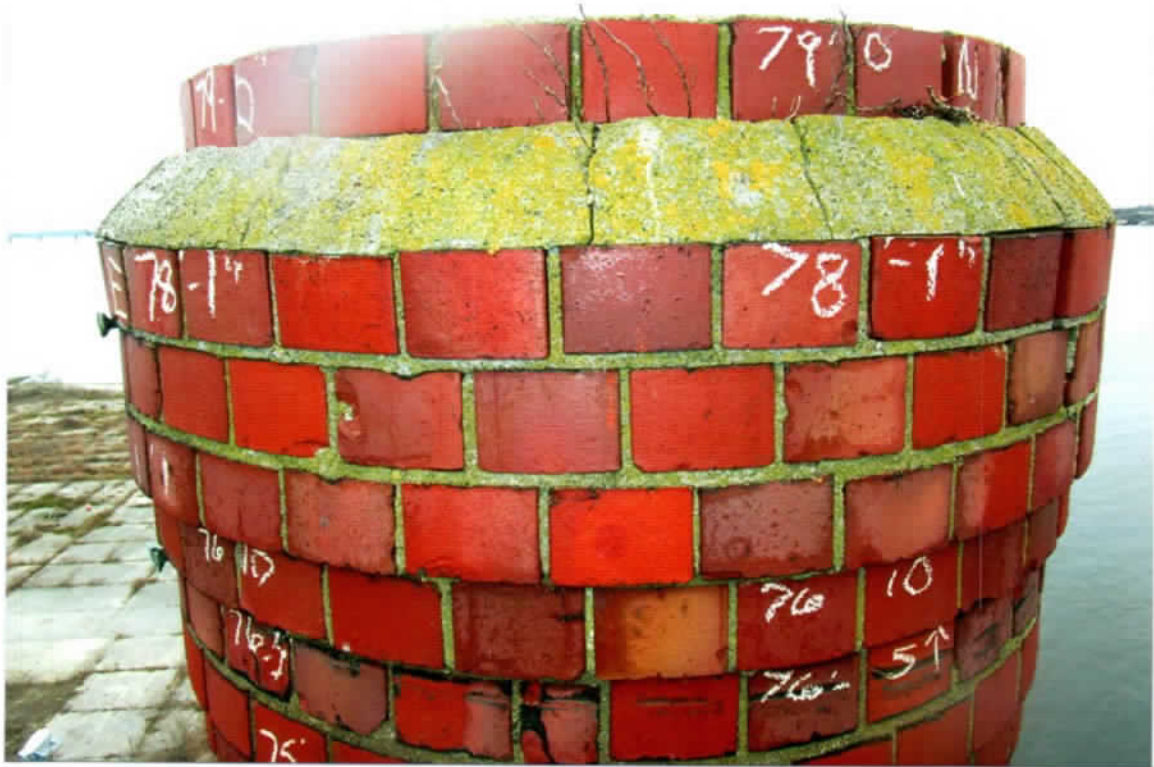
Photo 23. Fair condition of the uppermost 4' of the northeast side.
Note only the cracked sections of cement along the water table.

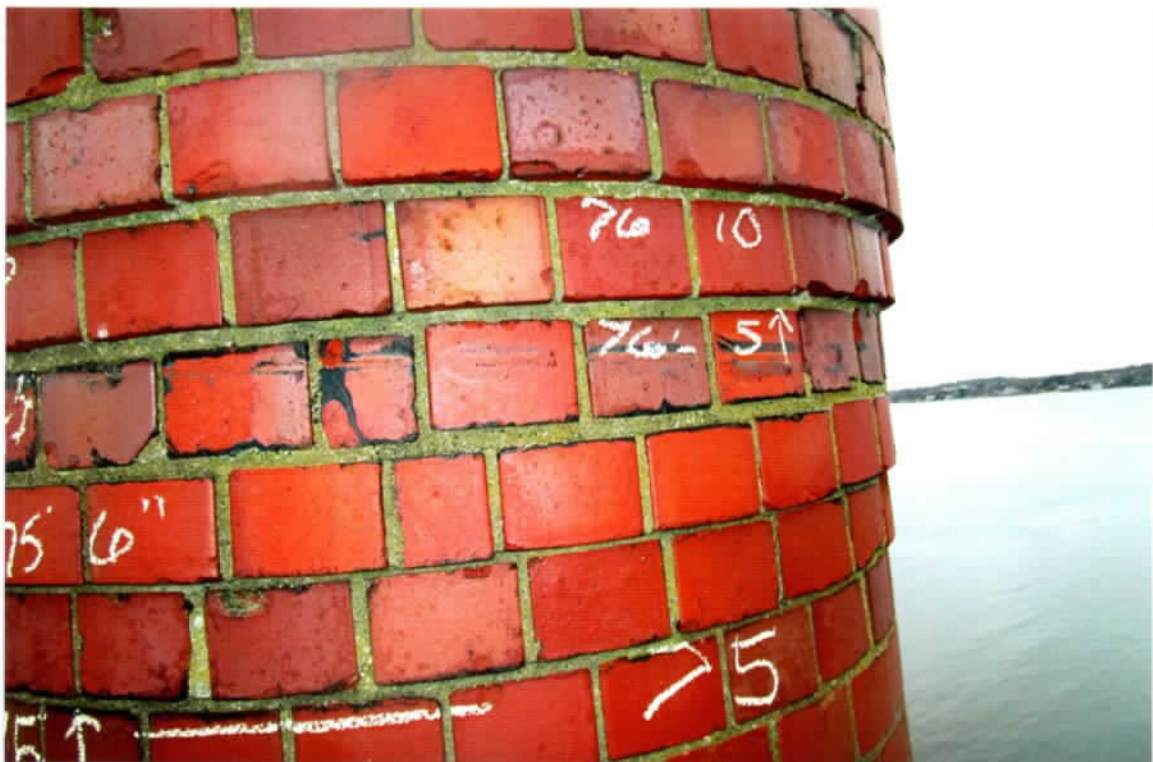
Photo 24. Fair condition of the northeast side between the 77' and 75' levels.
No obvious or immediate concerns were seen in this region.

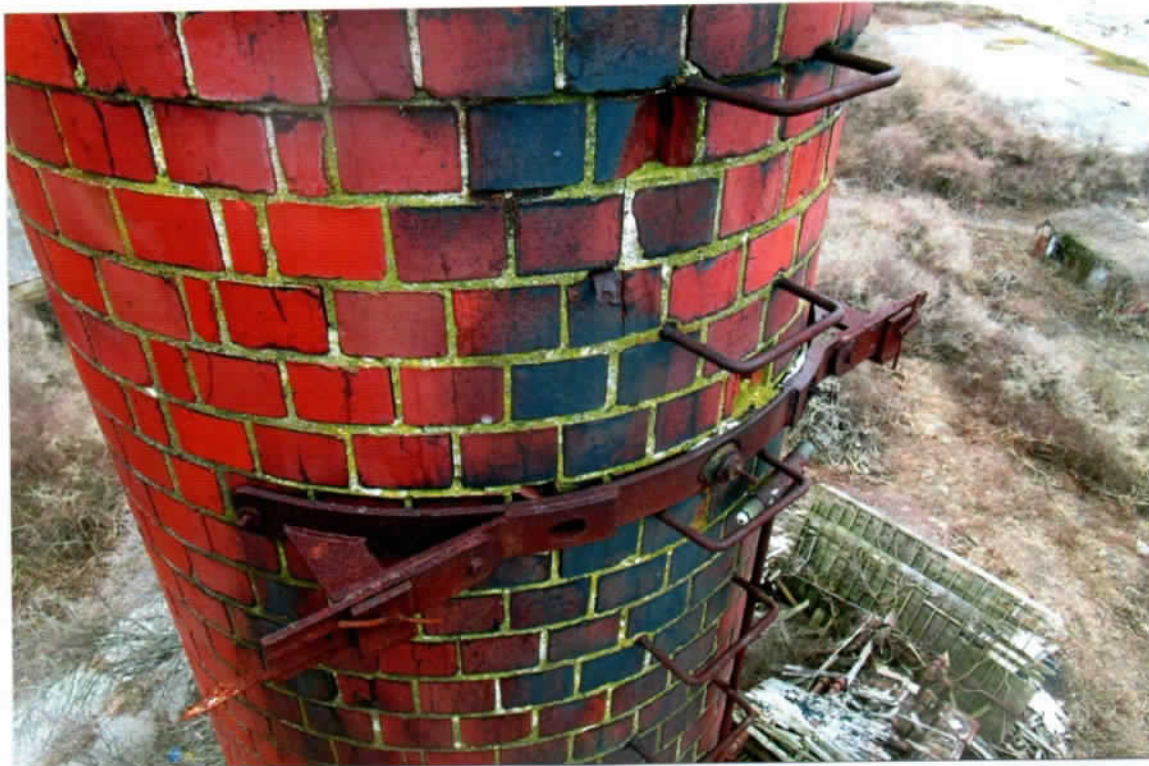
Photo 25. Fair exterior condition of the west side between the 75' and 70' levels. Note the spalled bricks in the courses below the uppermost step iron.

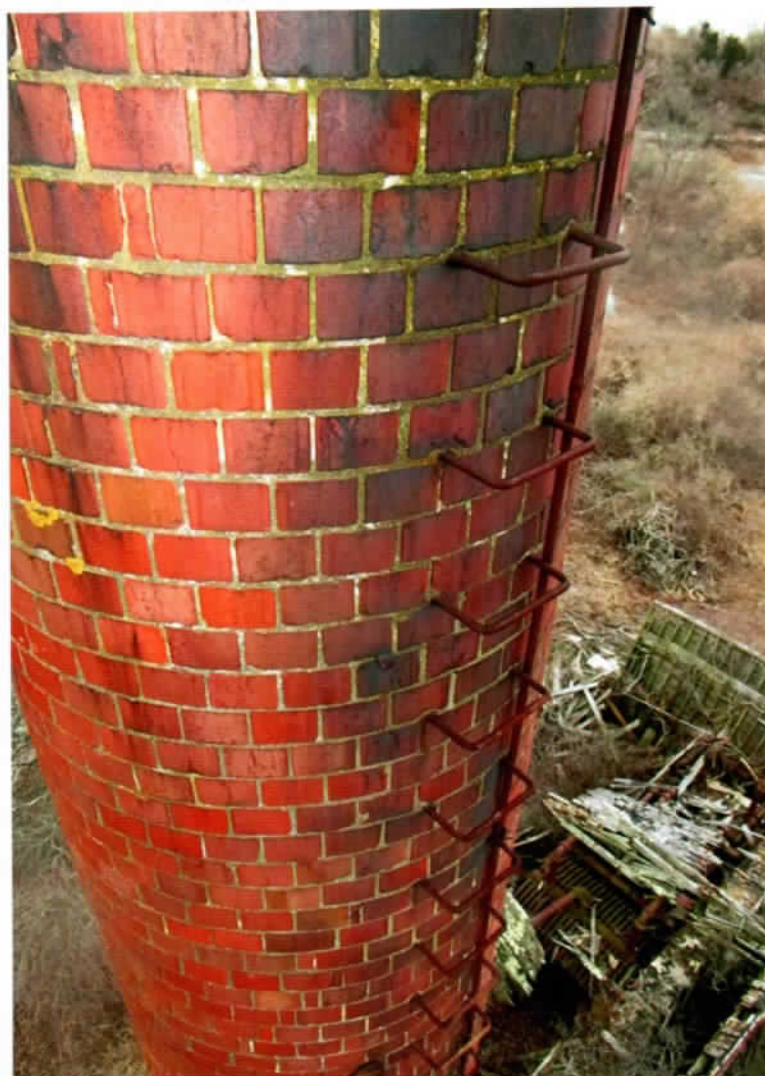
Photo 26.
Fair exterior condition of the northwest side between the 70' and 50' levels. Mortar joints were slightly recessed. No obvious structural concerns (cracks, bulges) were identified in this region.
