Inspection Report

79'-0" x 4'-1½" ϕ Boiler House Chimney Gould Island - Narragansett Bay Jamestown, Rhode Island

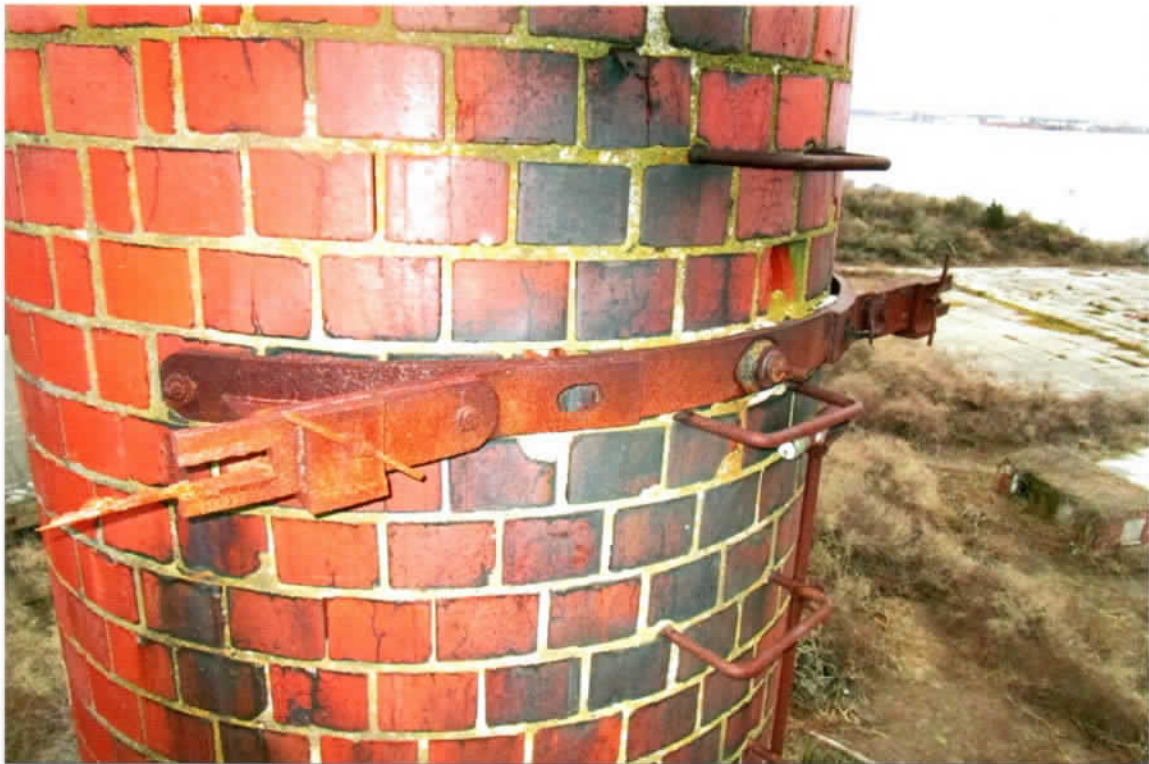
Photo 27. Fair condition of the anchored steel bracket at the 71'-6" level (northwest side). The bracket was deteriorated but secure to the wall.

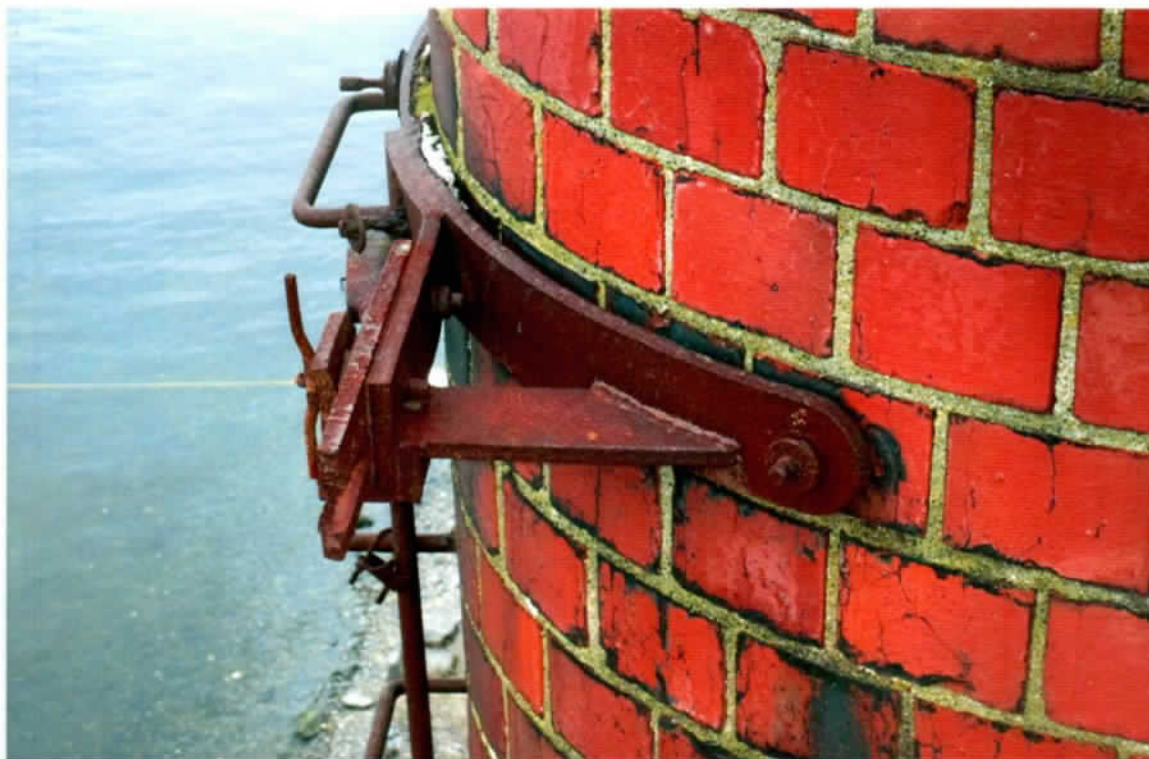
Photo 28. Fair condition of the anchored steel bracket at the 71'-6" level (southwest side). The bracket was deteriorated but secure to the wall.

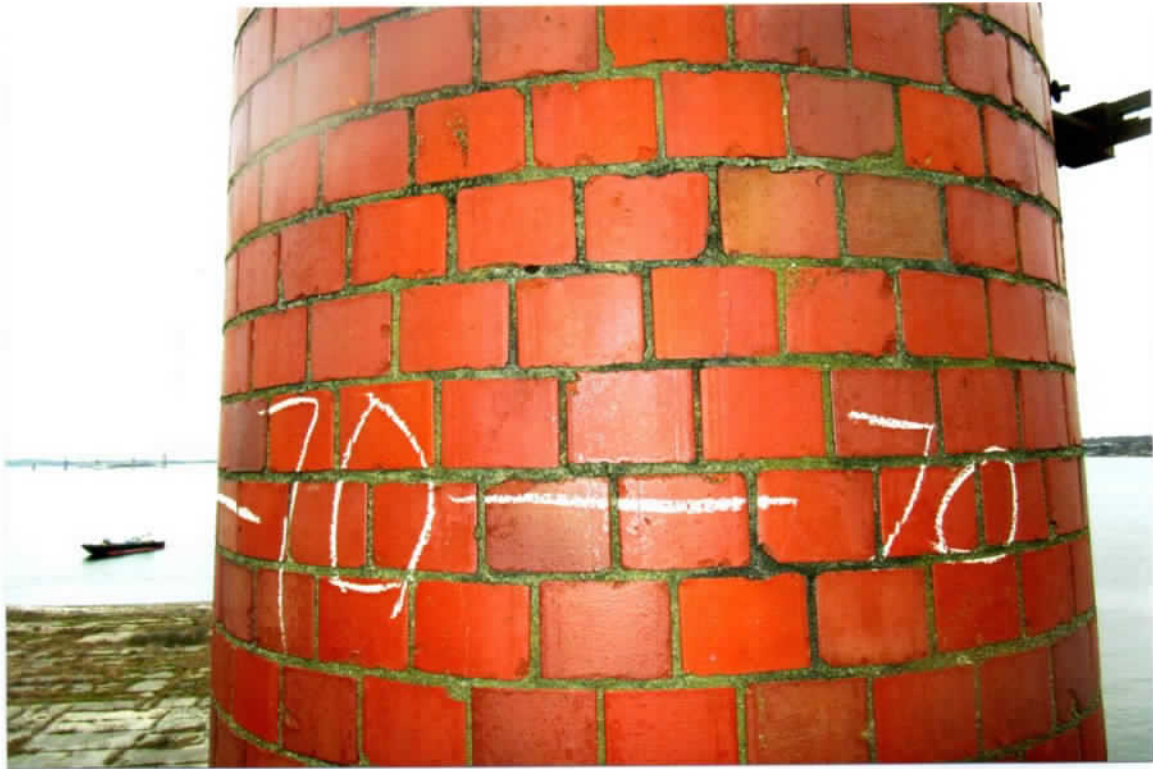
Photo 29. Fair exterior condition of the northeast side local to the 70' levels. Mortar joints were only slightly recessed in this region.

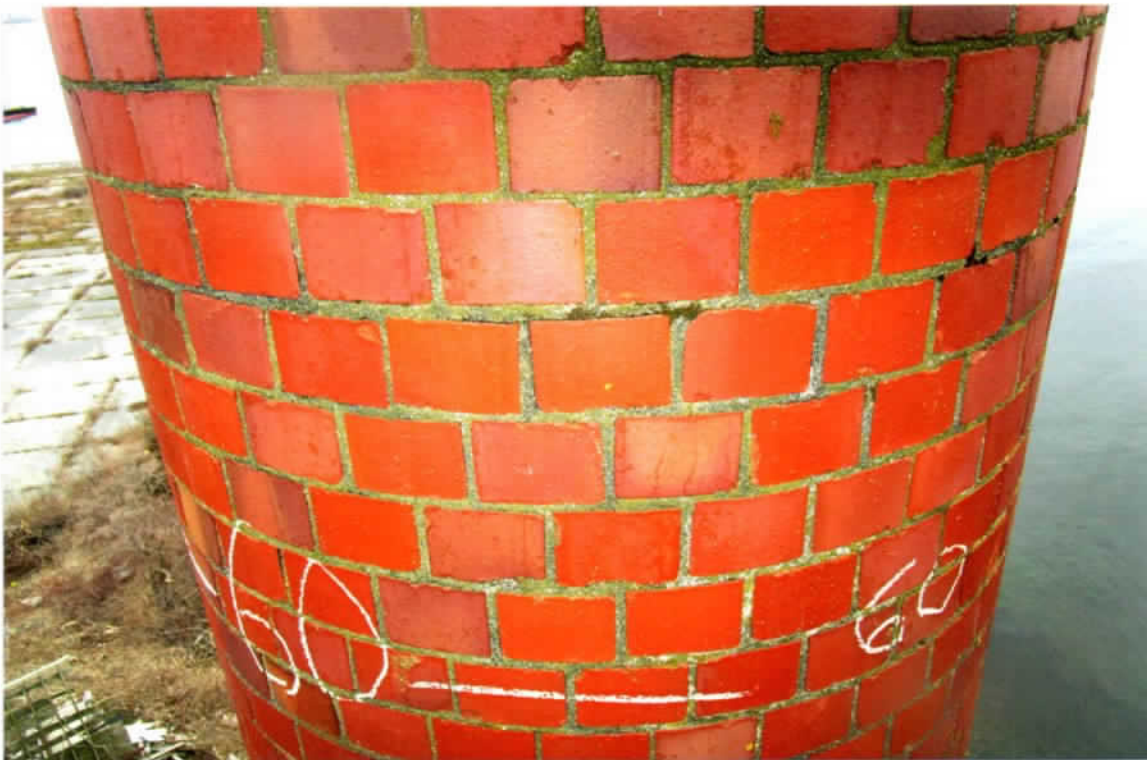
Photo 30. Fair exterior condition of the northeast side local to the 60' levels. Mortar joints were only slightly recessed in this region.

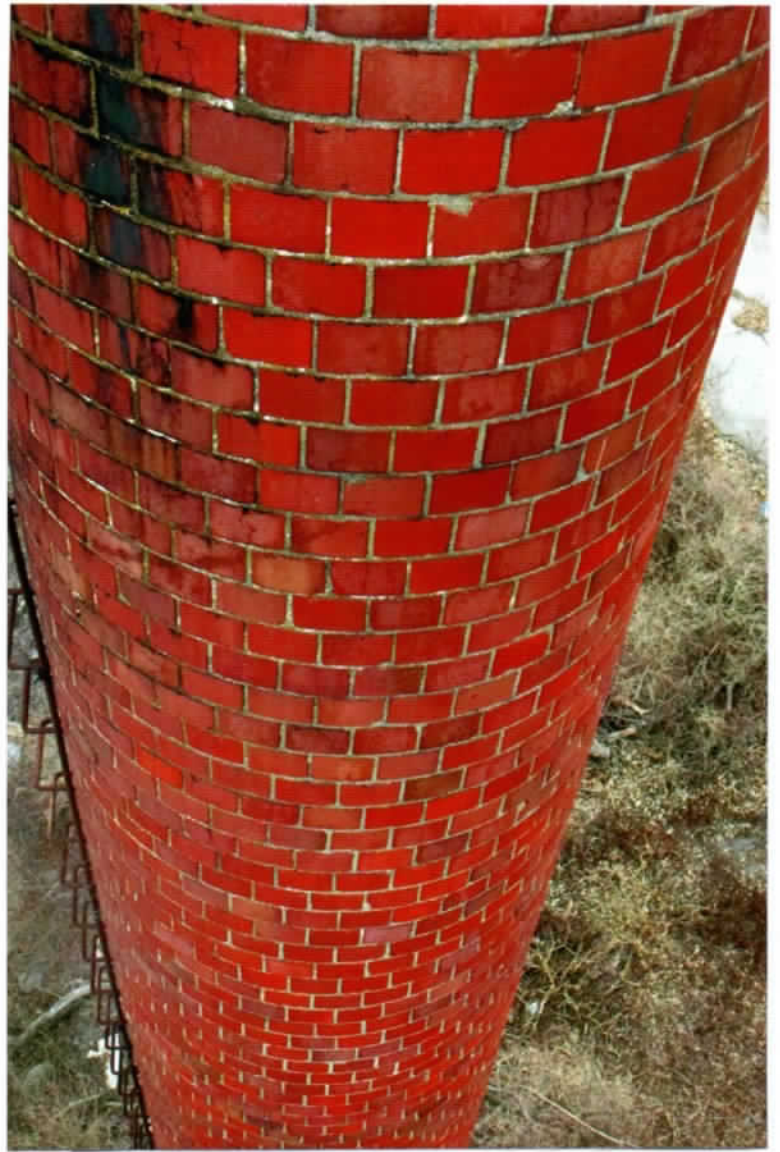
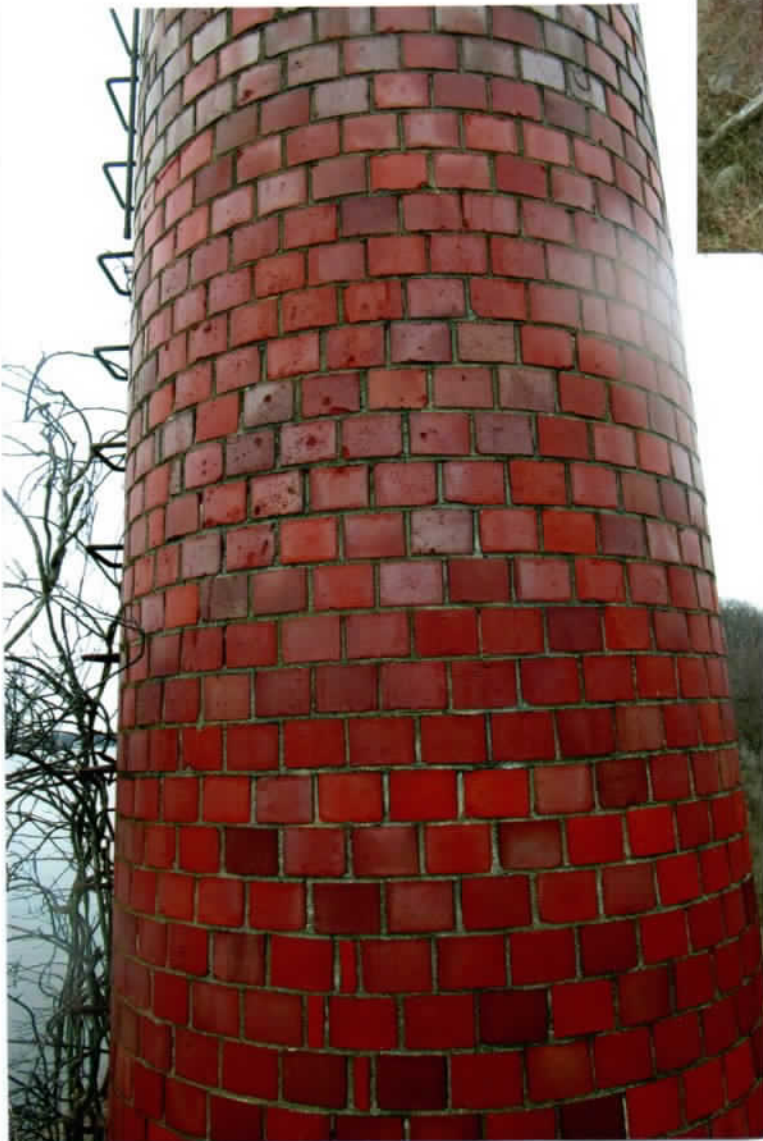
Fair exterior condition of the south side between the 70' and 50' levels. Mortar joints were slightly recessed. No obvious structural concerns (cracks, bulges) were identified in this region.

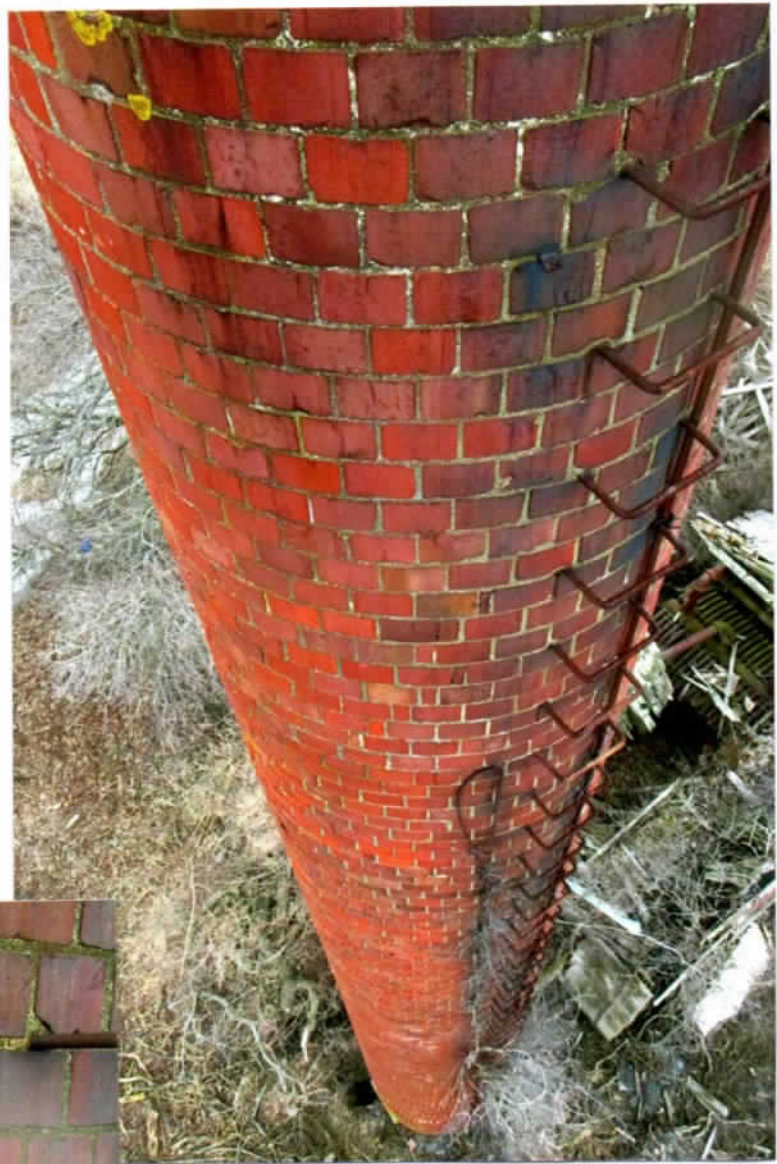
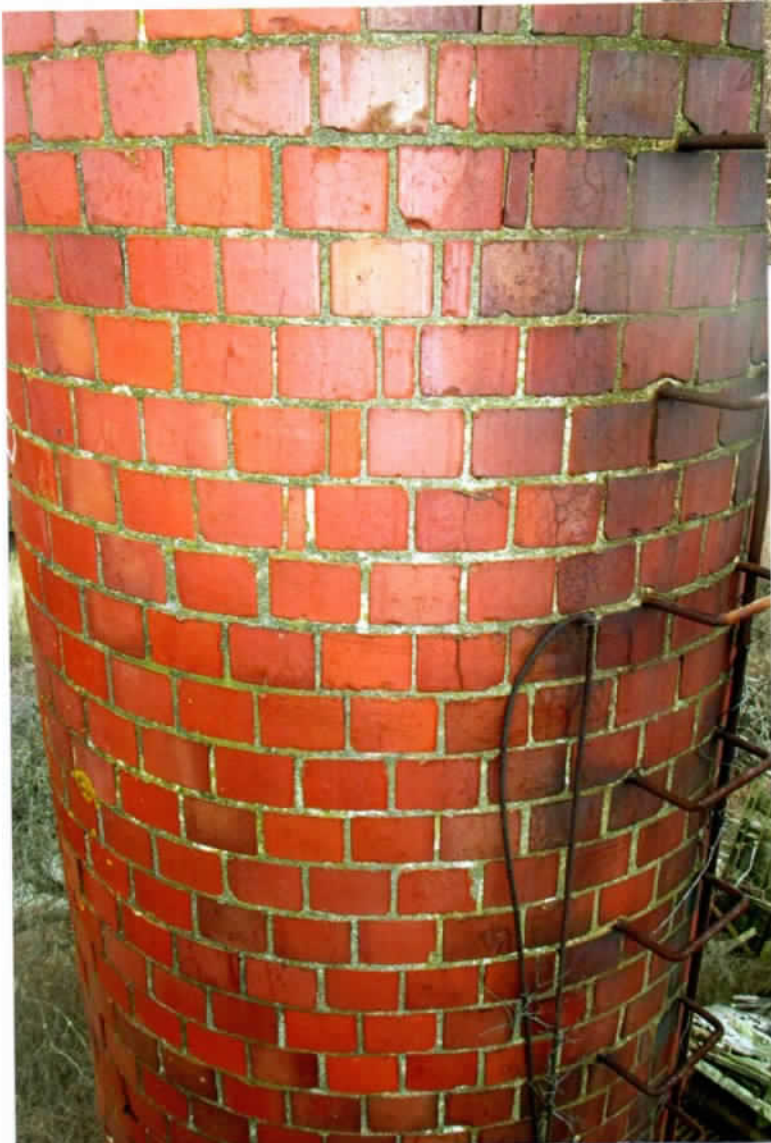
Fair exterior condition of the southwest side below the 70' level. Note the broken and hanging lightning protection cable adjacent to the lower step irons. All step irons (ladder rungs) were secure.

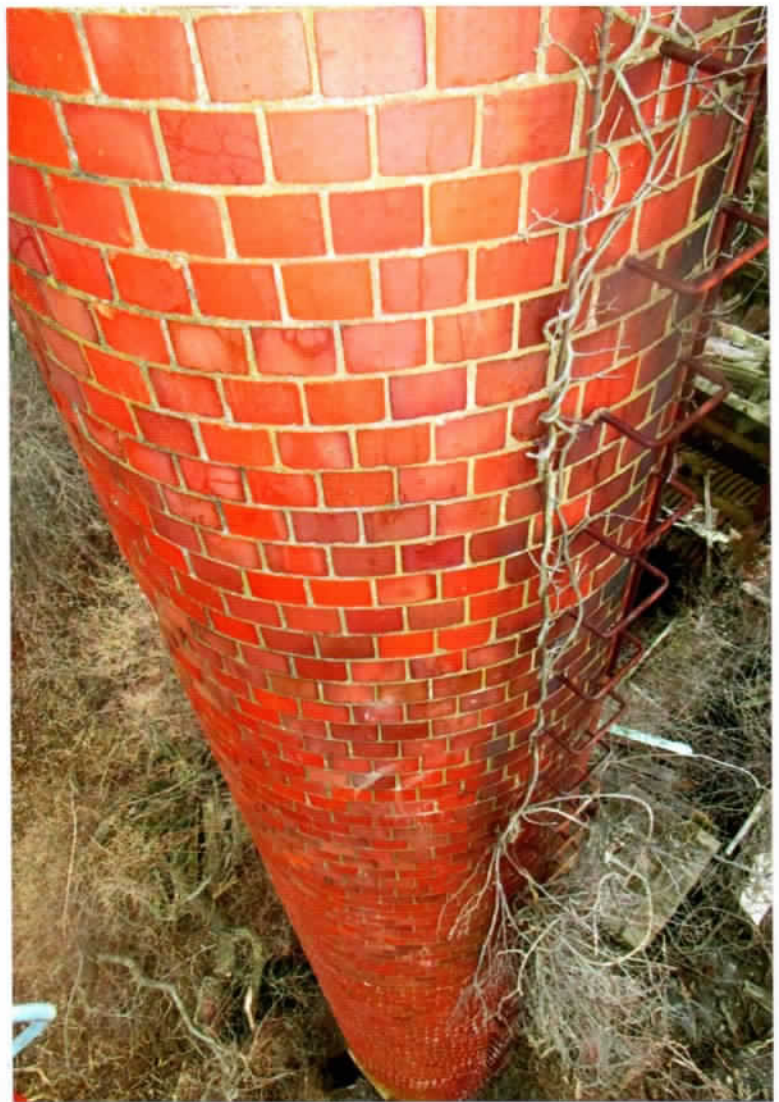
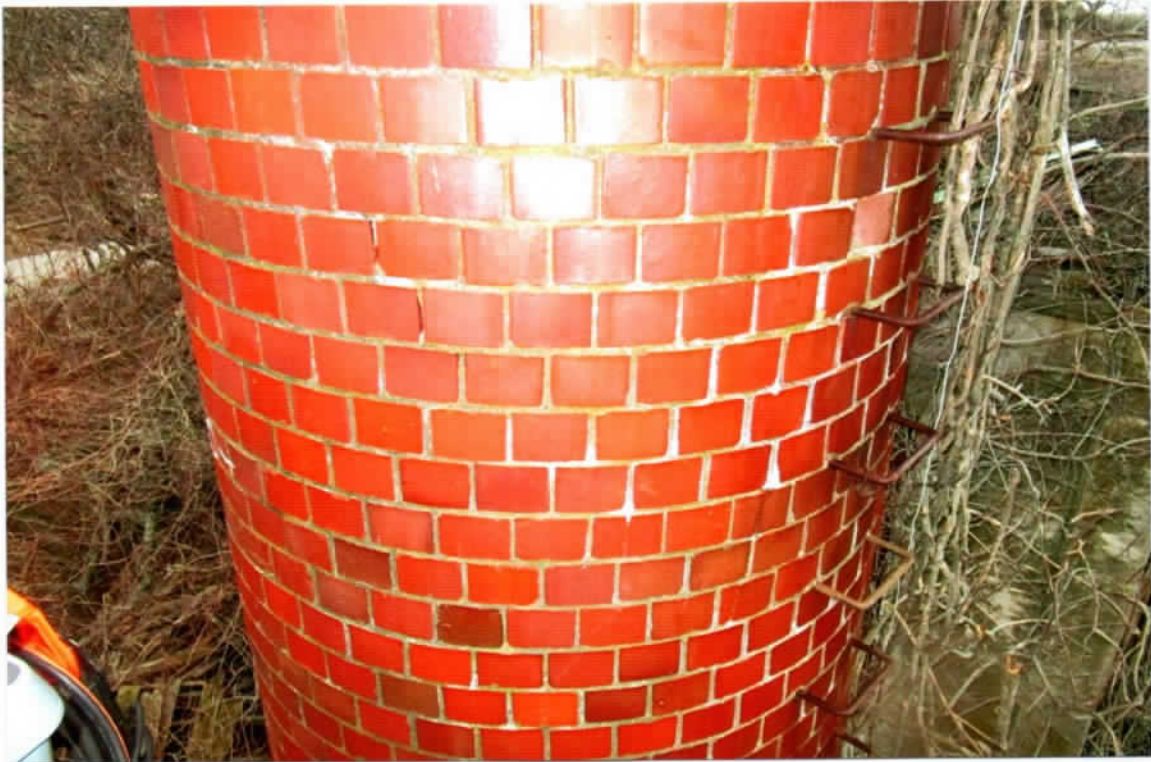
Photo 36. Fair exterior condition of the southwest side near the 20' level. A few random deteriorate and open mortar joints were seen in this region.

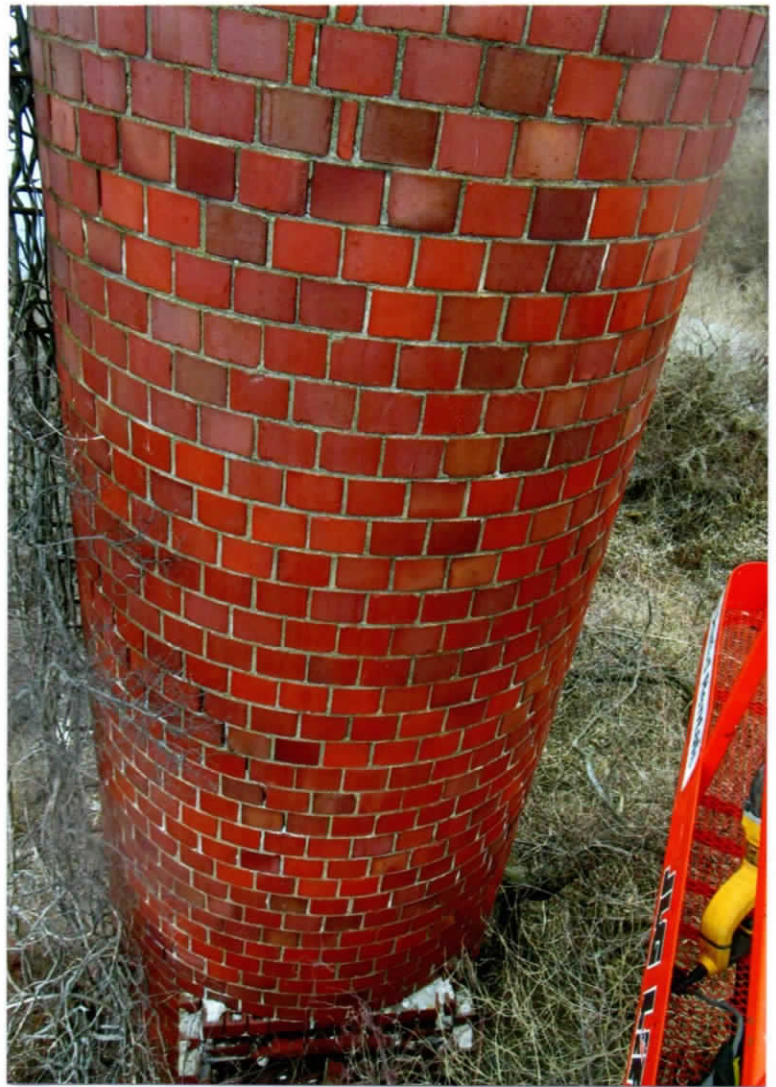
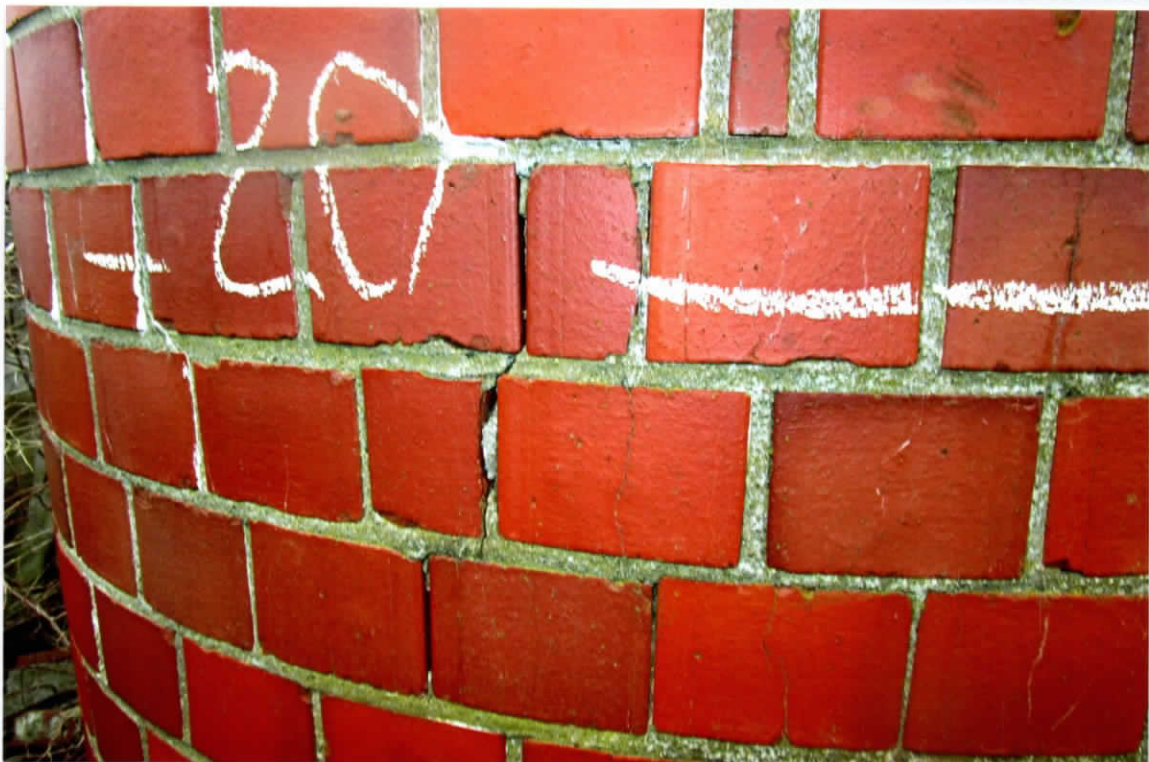
Photo 38. Fair condition of the east side near the 20' level. Note the open joints along the three courses. No cracked bricks were identified.

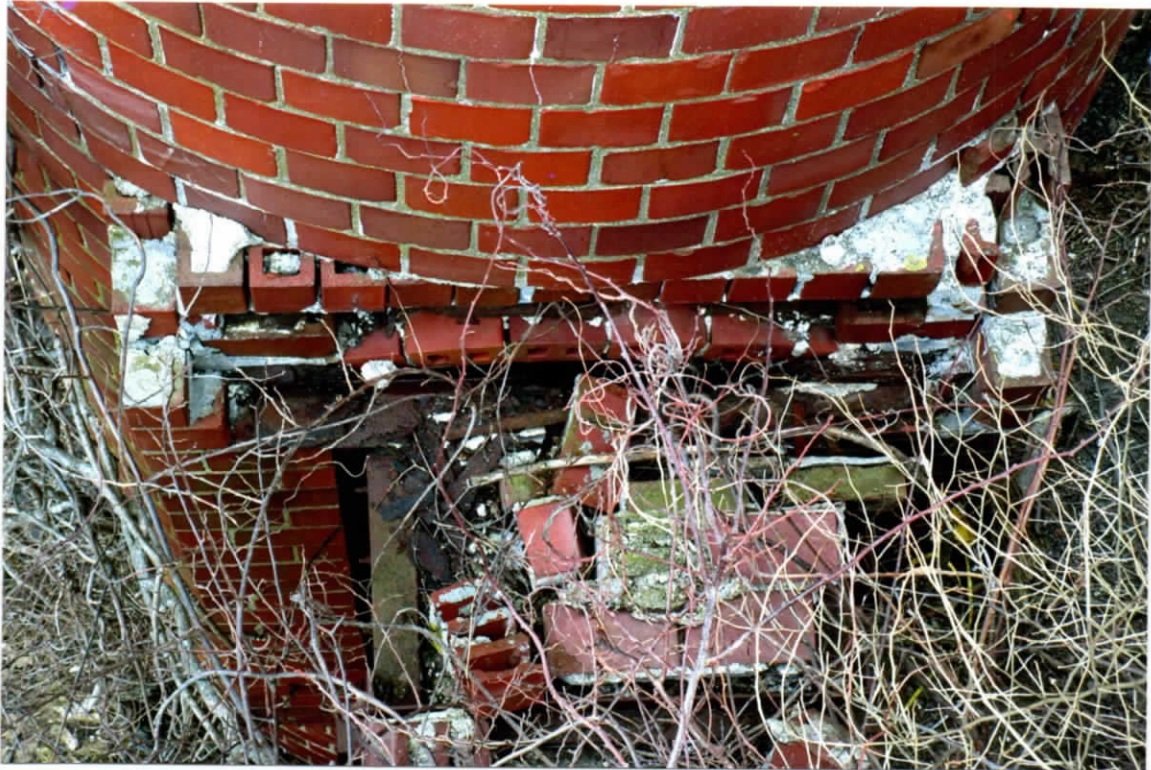
Photo 39. Very poor condition of the extended wall and lintels above the boiler duct opening. Numerous dislodged bricks were identified, and the condition of the lintel beams was poor.

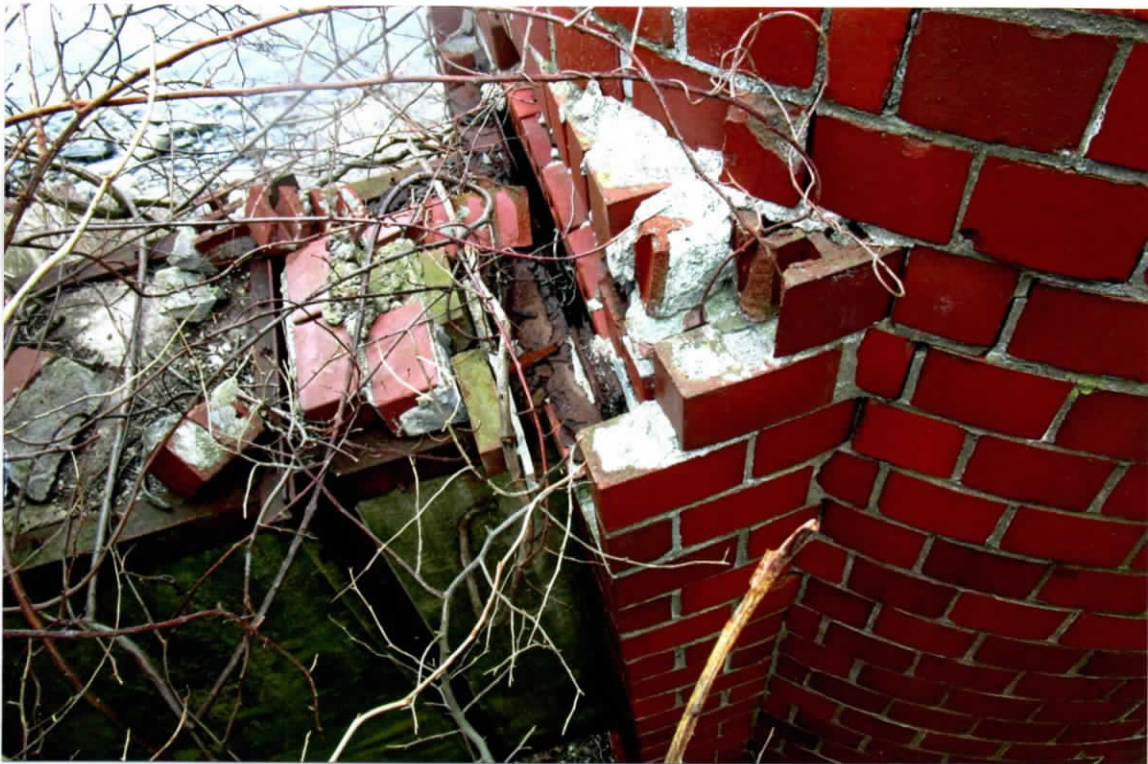
Photo 40. Very poor condition of the extended wall and lintels above the boiler duct opening. Numerous dislodged bricks were identified, and the condition of the lintel beams was poor.

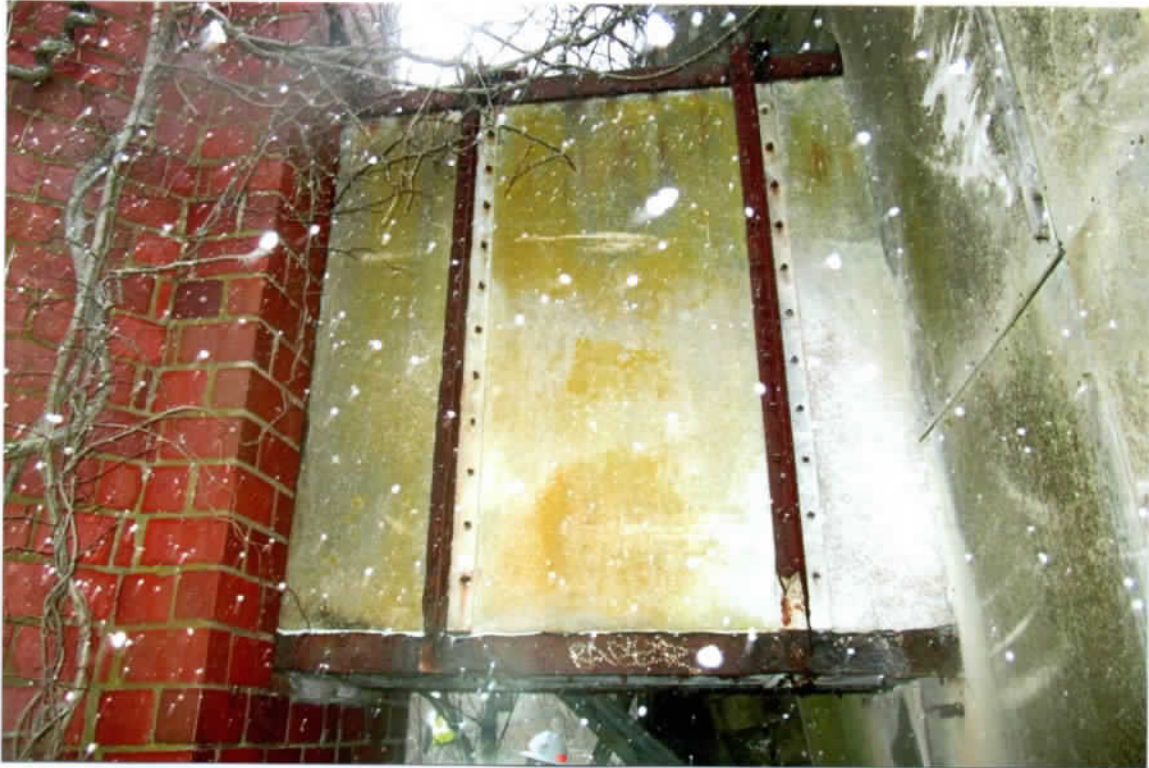
Photo 41. Poor condition of the boiler duct extending from the boiler house to the chimney. The steel angle frames were severely eroded. The duct was not in danger of collapsing.

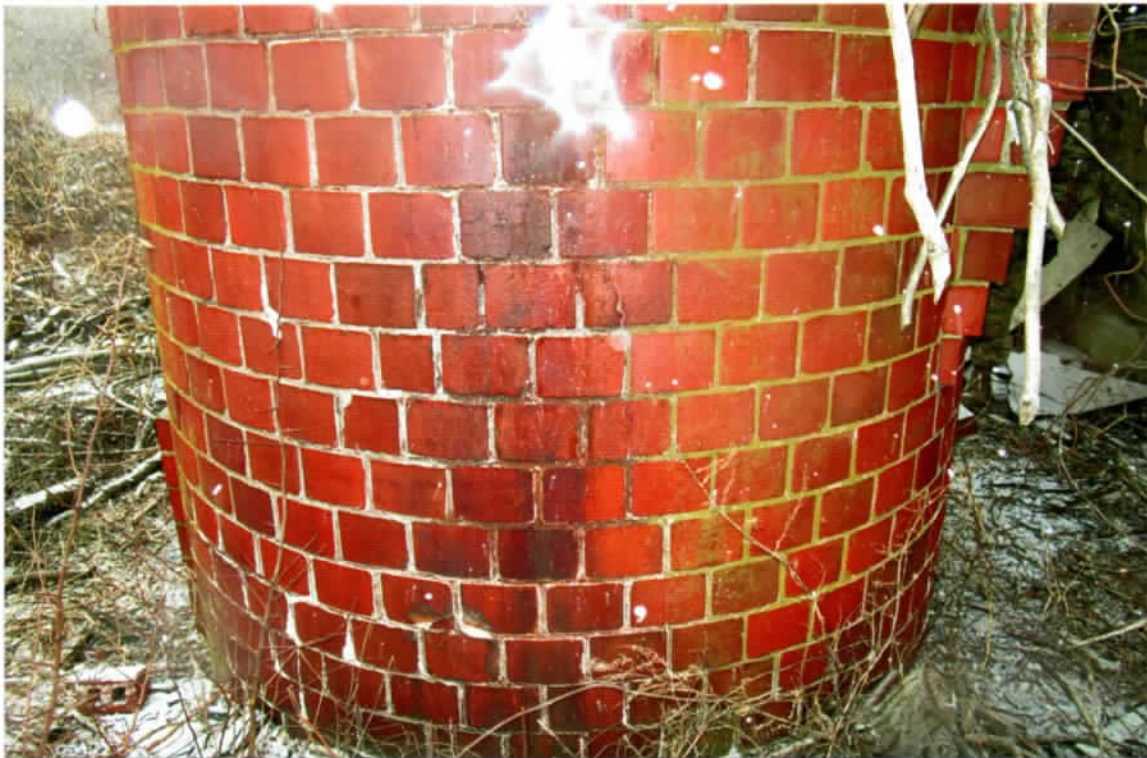
Photo 42. Fair exterior condition of the south side in the 5' above grade. A few random deteriorate and open mortar joints were seen in this region below the entering duct.

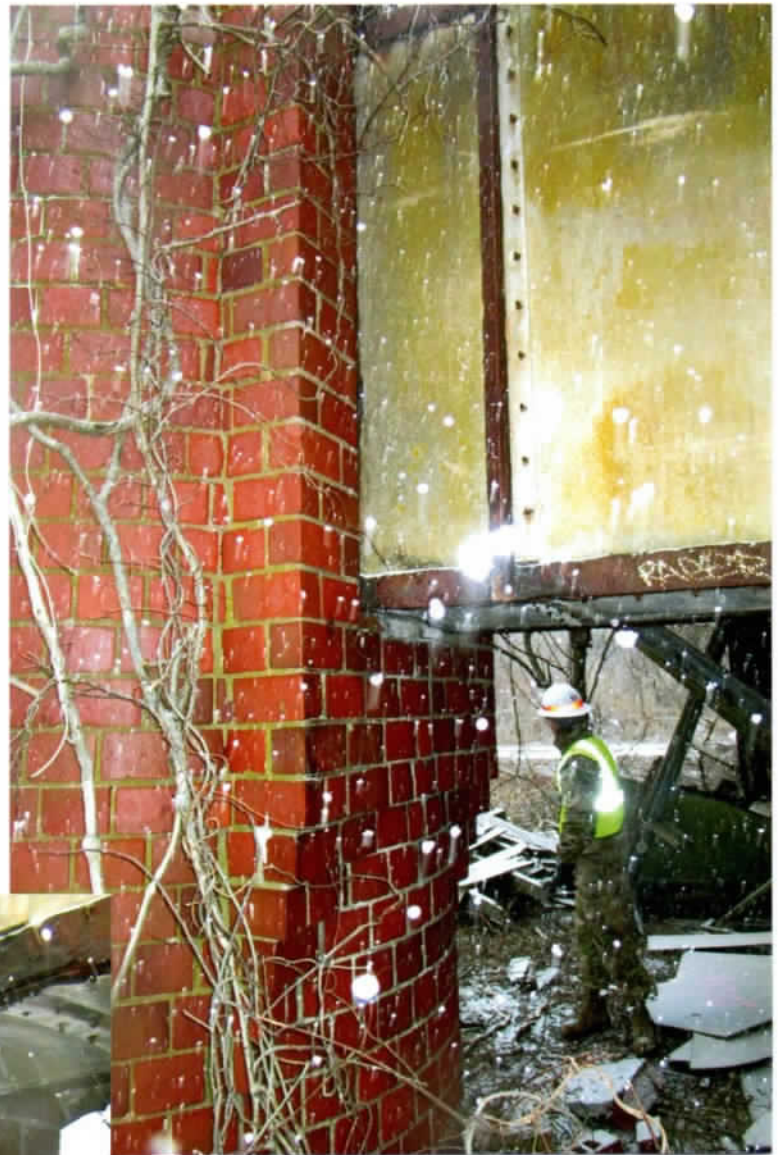
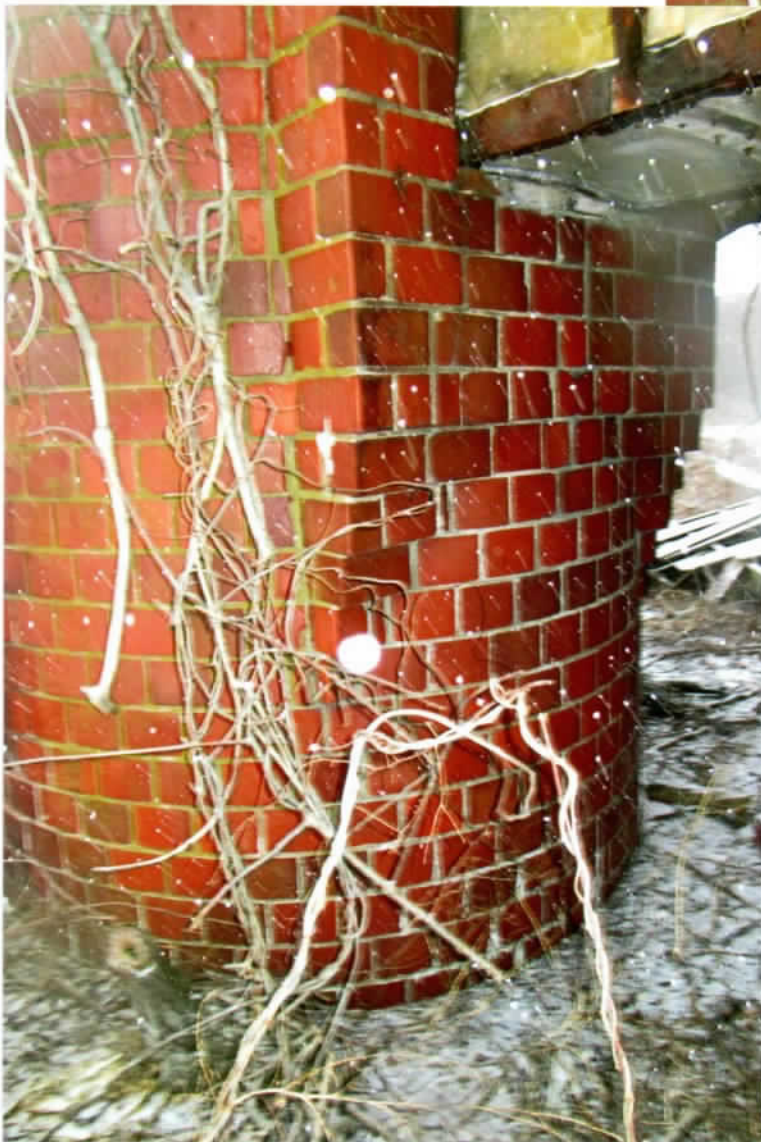
Fair exterior condition of the extended wall (southwest side) local to the duct opening. No immediate concerns were seen throughout the masonry wall in this region.

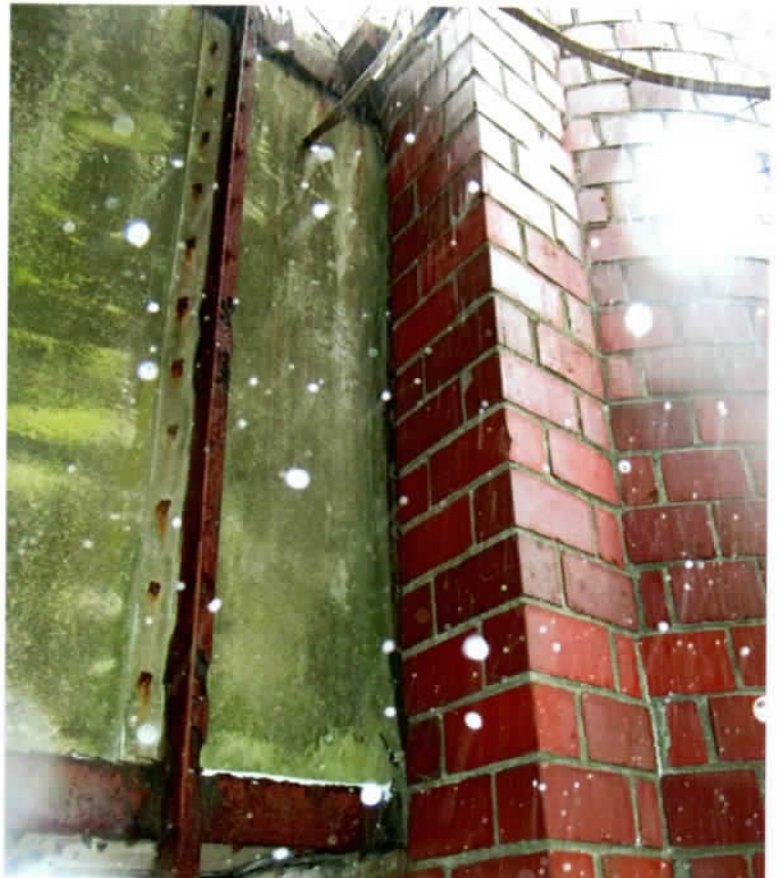
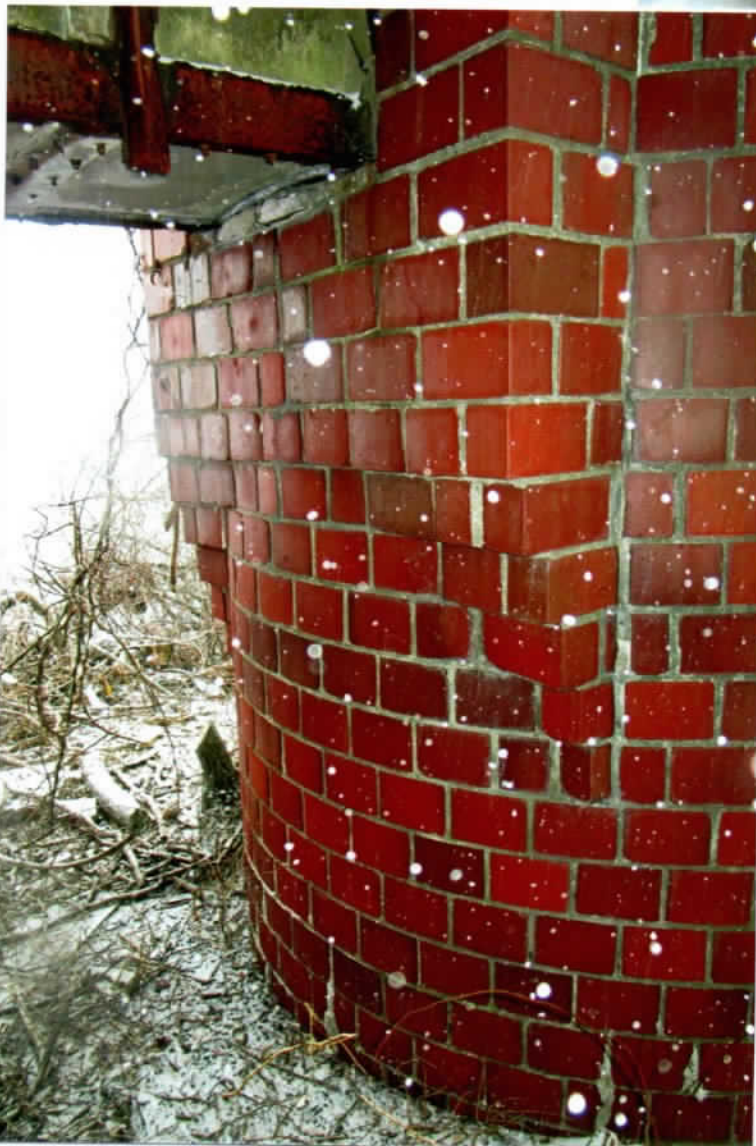
Fair exterior condition of the extended wall (southeast side) local to the duct opening. No immediate concerns were seen throughout the masonry wall in this region.

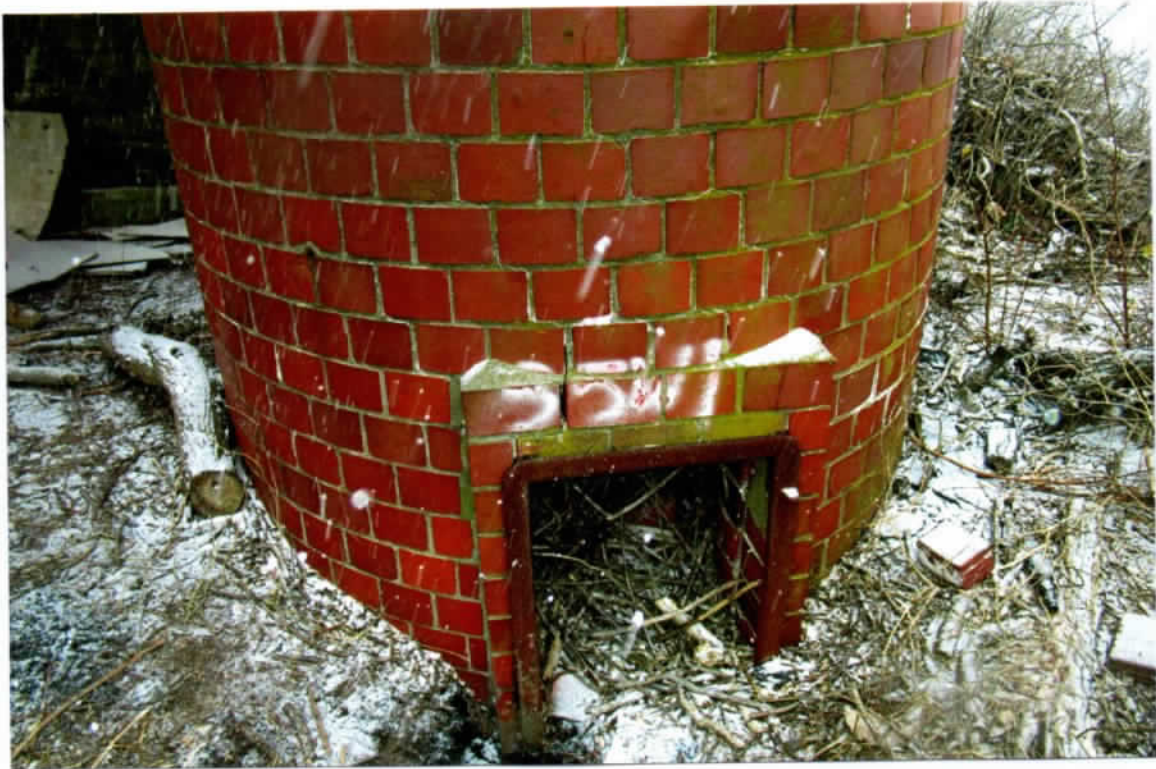
Photo 47. Fair exterior condition of the lower north side local to the cleanout opening. A few open mortar joints were identified. Note the missing cleanout door.

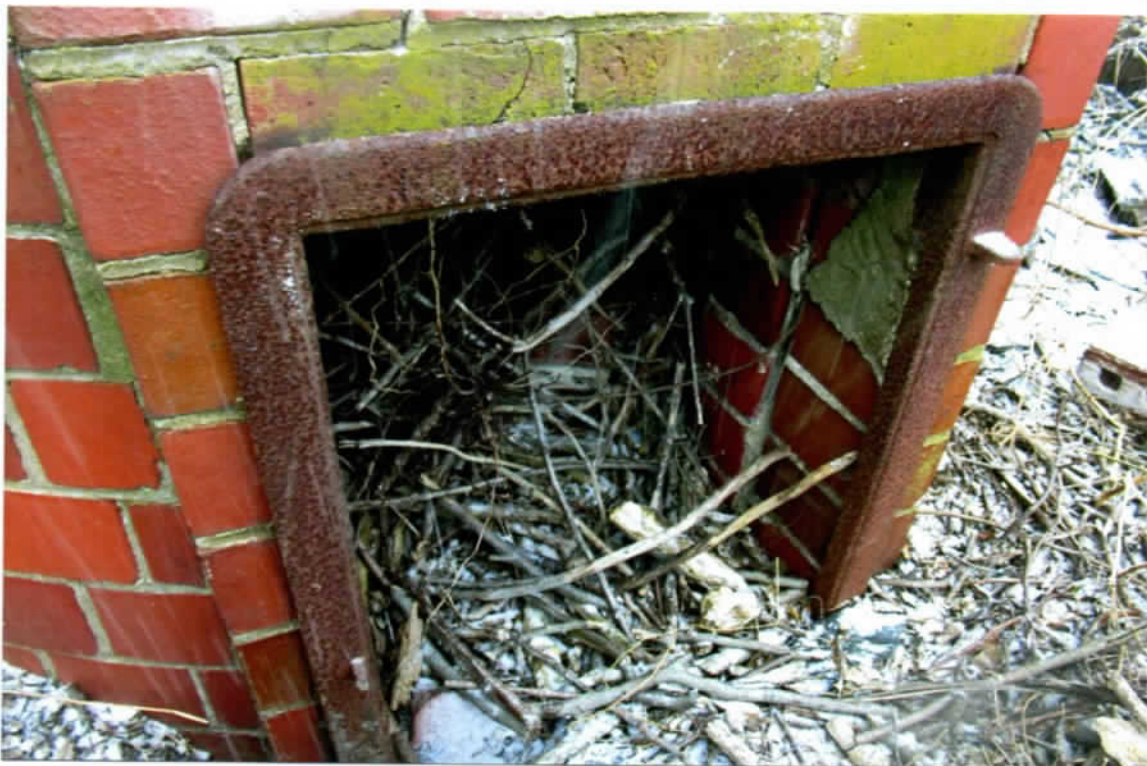
Photo 48. Deteriorated and pitted frame of the original cleanout opening. Note the accumulated brush and debris on the interior.

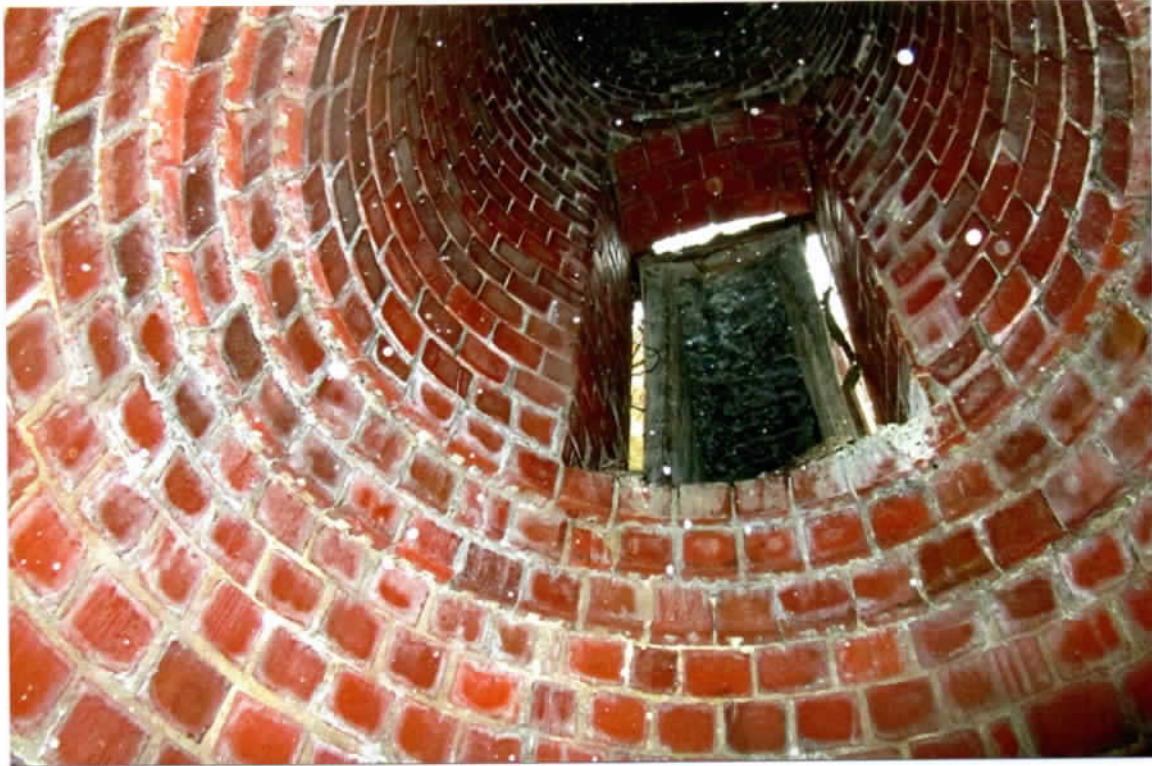
Photo 49. Overall good interior condition of the inner liner wall local to the duct opening. No obvious concerns were seen with the lower structural wall or corbelled support of the liner.

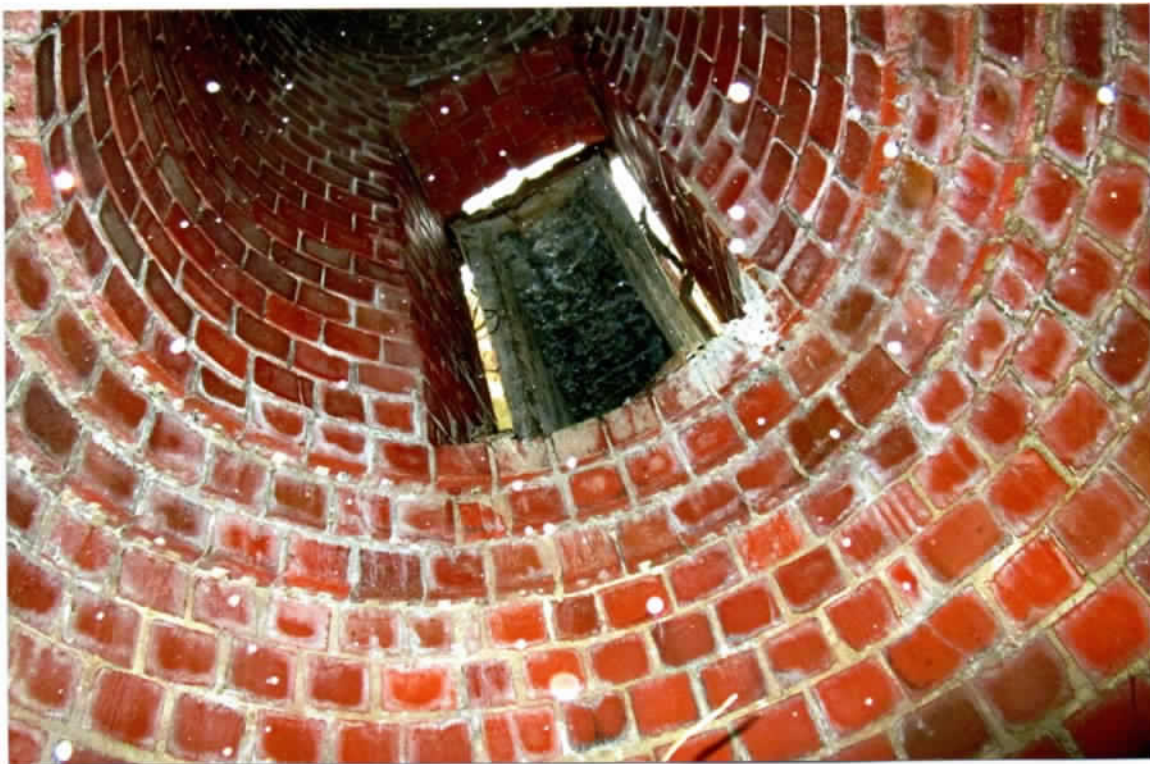
Photo 50. Overall good interior condition of the inner liner wall below to the duct opening. No obvious concerns were seen with the lower structural wall or corbelled support of the liner.
