Lincoln Lace and Braid Remediation Project

Providence Parks Department

EA Engineering, Science, & Technology, Inc.

March 2010

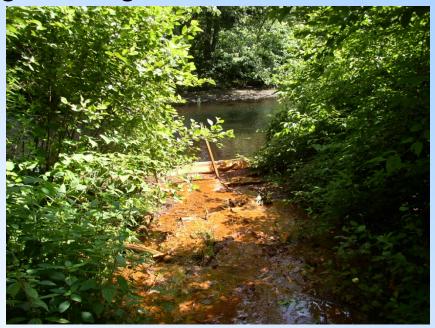
- Additional Areas Addressed
 - Demolition Debris and Bulk Waste
 - Mostly removed during building demo in 1997
 - Iron Staining in Raceway
 - Iron staining remains today but is not hazardous

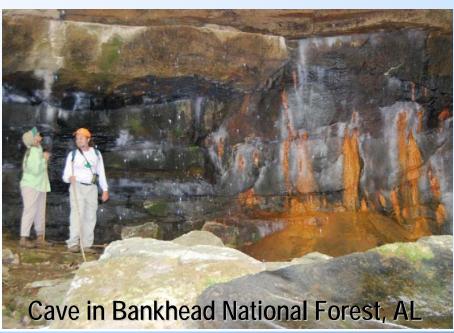
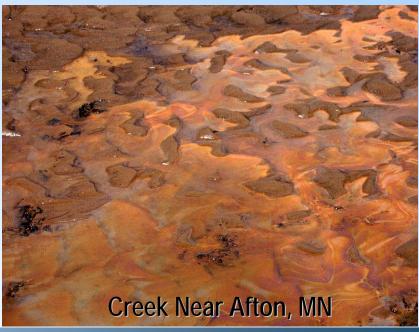
Iron Flocculent

- Found naturally when oxygen, water, and iron are present
- Ferric iron precipitate is primarily an aesthetic problem

- Iron Staining is caused by iron bacteria
 - Bacteria that "feed" on iron
 - The bacteria oxidize ferrous iron into ferric iron
 - Ferric iron is insoluble and precipitates out of water as a rust colored particle
 - Can happen when iron rich groundwater comes into contact with the atmosphere
 - Iron most likely originates from iron found within adjacent soils

- Install Check Dams
 - Aerate surface water to remove iron prior to entering Woonasquatucket River
 - Allows oxygen to mix with water

Check dams will "catch" iron flocculent before entering river

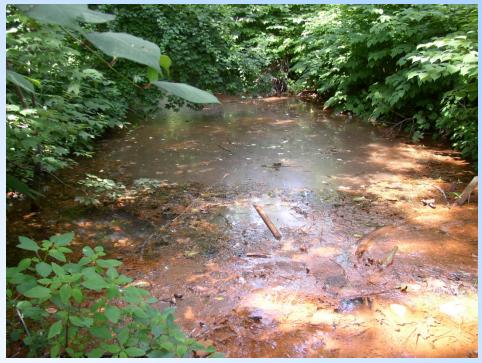
- Supplemental Sluiceway Investigation
 - Collected 2 iron flocculent samples
 - Analyzed for arsenic and lead
 - Neither metal was detected above laboratory detection limits

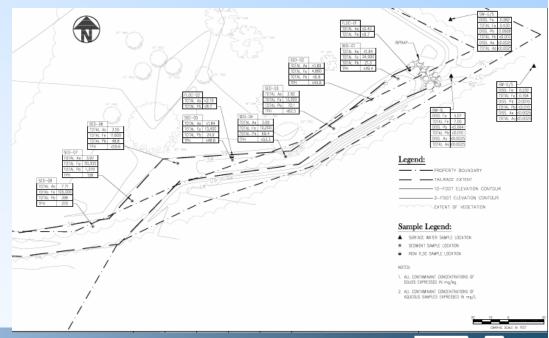
- Supplemental Sluiceway Investigation
 - Collected 8 sediment samples

Analyzed for arsenic, lead, and petroleum

hydrocarbons

Impacts found in two upstream samples

- Exceedances of standards
 - Lead
 - Arsenic

- Sluiceway Remediation
 - Install Engineered Barrier
 - Geogrid Provides stability to sluiceway
 - Geotextile Isolates impacted sediment beneath cap
 - 6" Stone layer Prevents direct exposure to contaminated sediment
