**RI Department of Environmental Management
Environmental Land Usage Restriction (ELUR)
Annual Compliance Self-Evaluation Form**
(Please type or print)

Site Name: Queen Ann Square
RIDEM File No.: 2012-010
RIDEM Project Manager: Joseph T. Martella
ELUR Recording Date: _____
Owner Telephone Number: 401-845-5802

a. Site Address: Queen Anne Square, bordered by Thames St, Mill St & Church St, Newport RI 02840

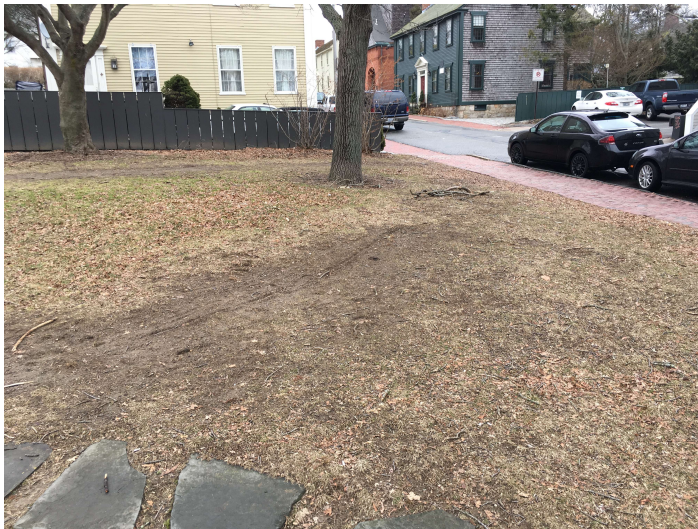
Pedestrian shortcut to Mill St prior to the 2018 installation of the decorative fence.

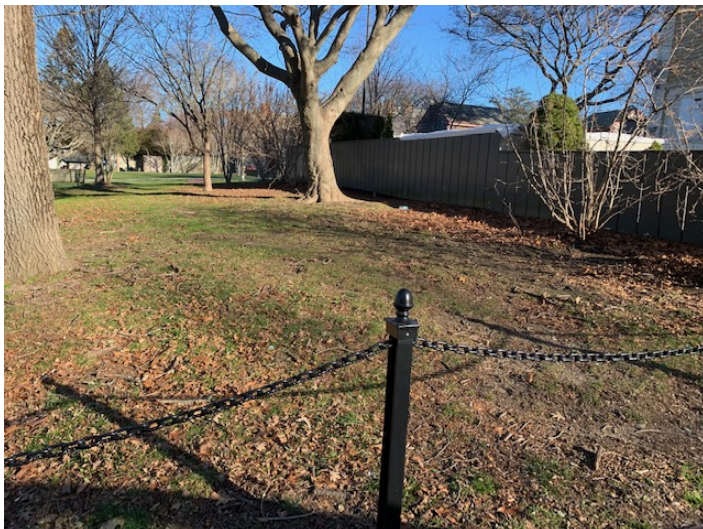
The lawn adjacent to Mill Street continues to improve thanks to the fence installed in 2018 to redirect pedestrian foot traffic form behind the "Chimney" sitting room. Maintaining grass along Mill St continues to challenging because of the limited sunlight requiring regular reseeding with shade tolerant grass. The heavily used entrance opposite Starbucks at the intersection of Church and Thames Street is showing some minor erosion beside the brick walkway that will require topdressing and seeding in 2021

Lawn protected from pedestrian traffic by Boston Garden Post & Chain fence.

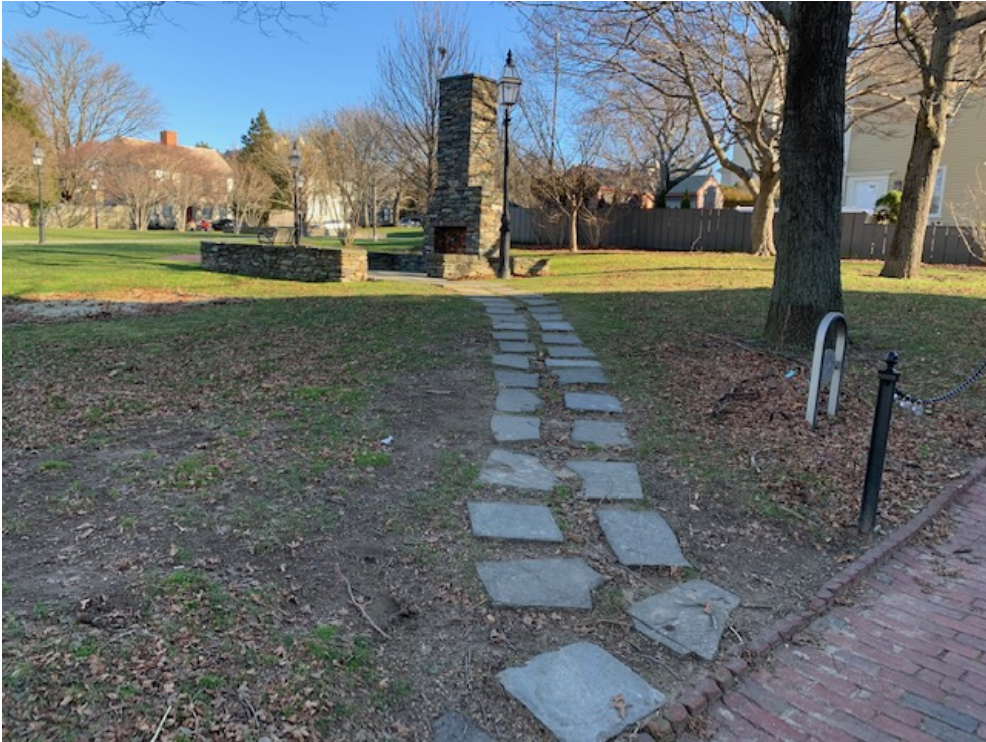
The stepping stones have relieved some wear but the QAS Trustees are considering the future installation of a brick pathway as a more permanent and safer solution

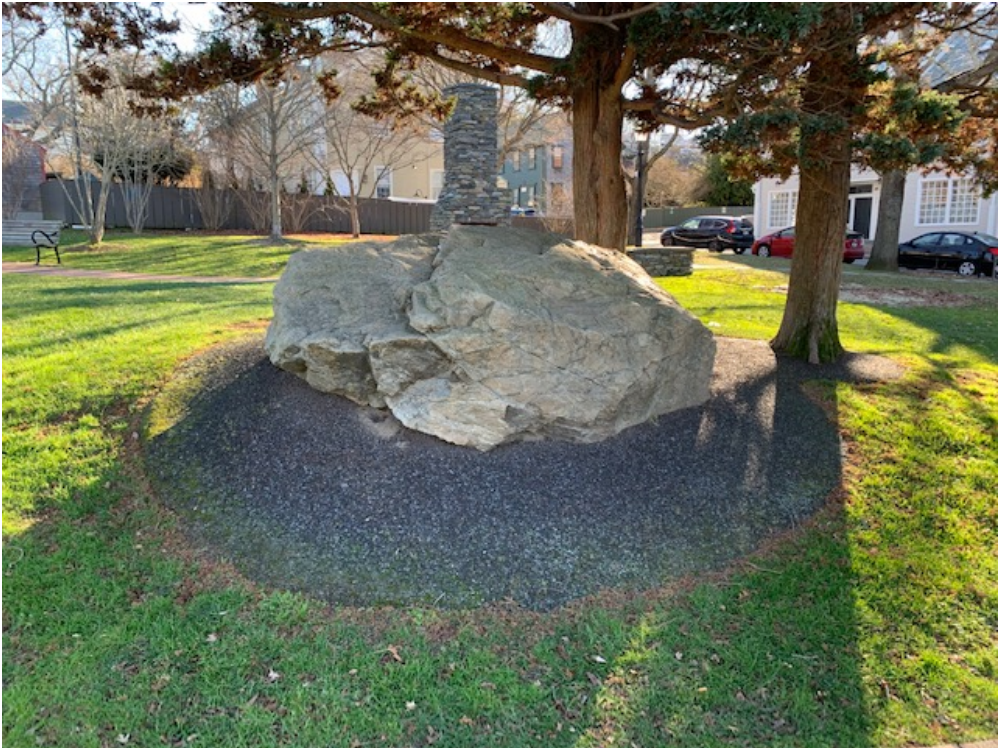
Wear area around central boulder that continues to be effectively managed by the poured in place rubber surfacing.

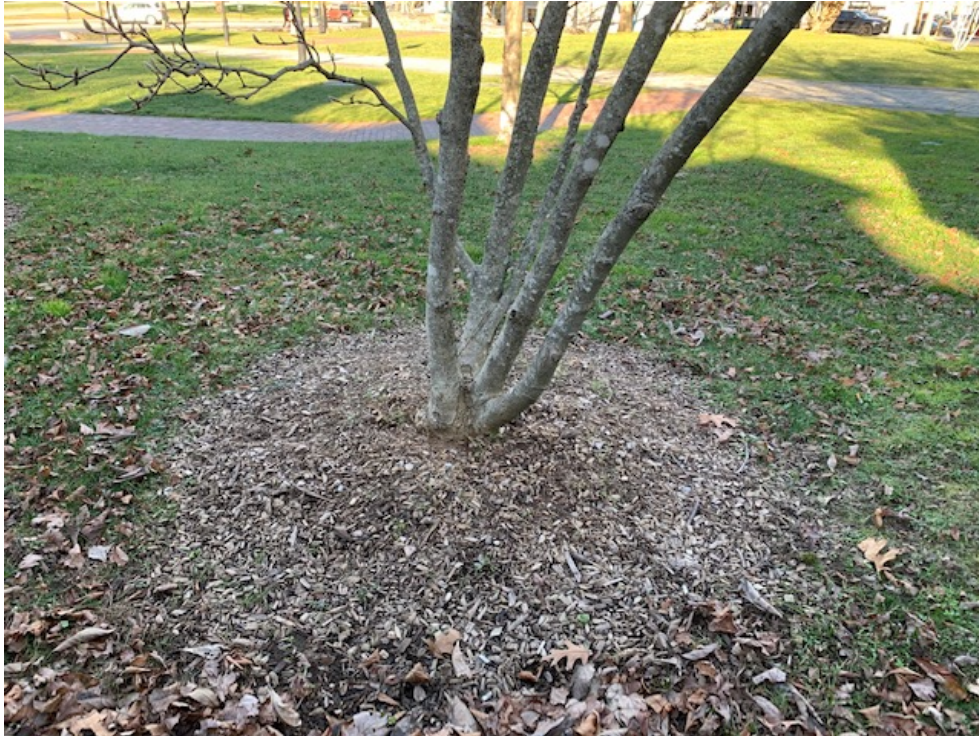
Mulch cover has been maintained around young trees

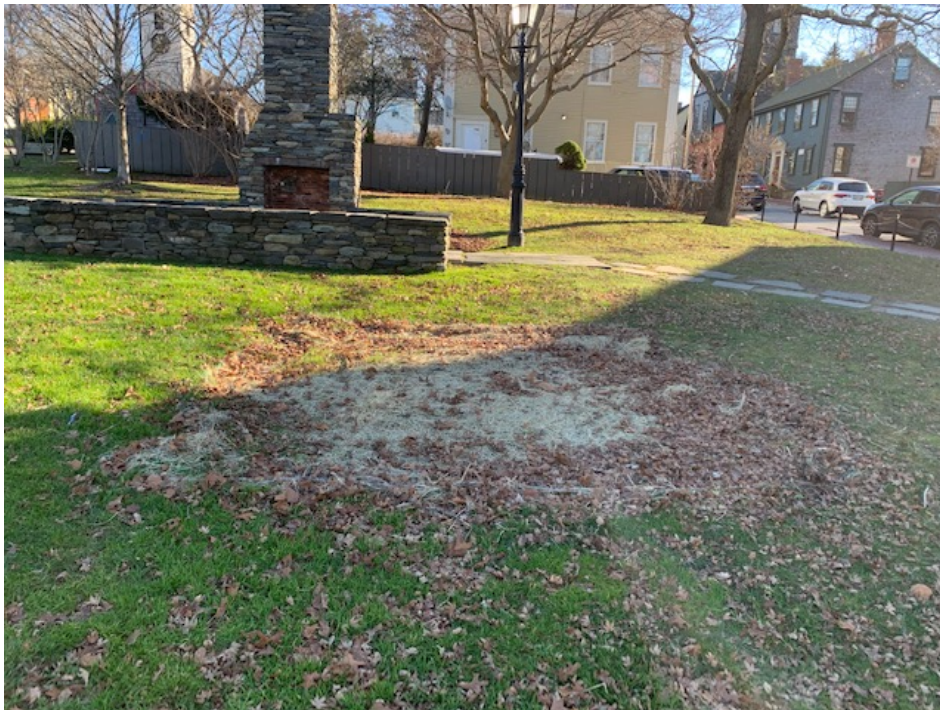
Site of removed dead oak converted to grass with application of loam, seed and hay germination fabric (stump was cut flush not ground out)

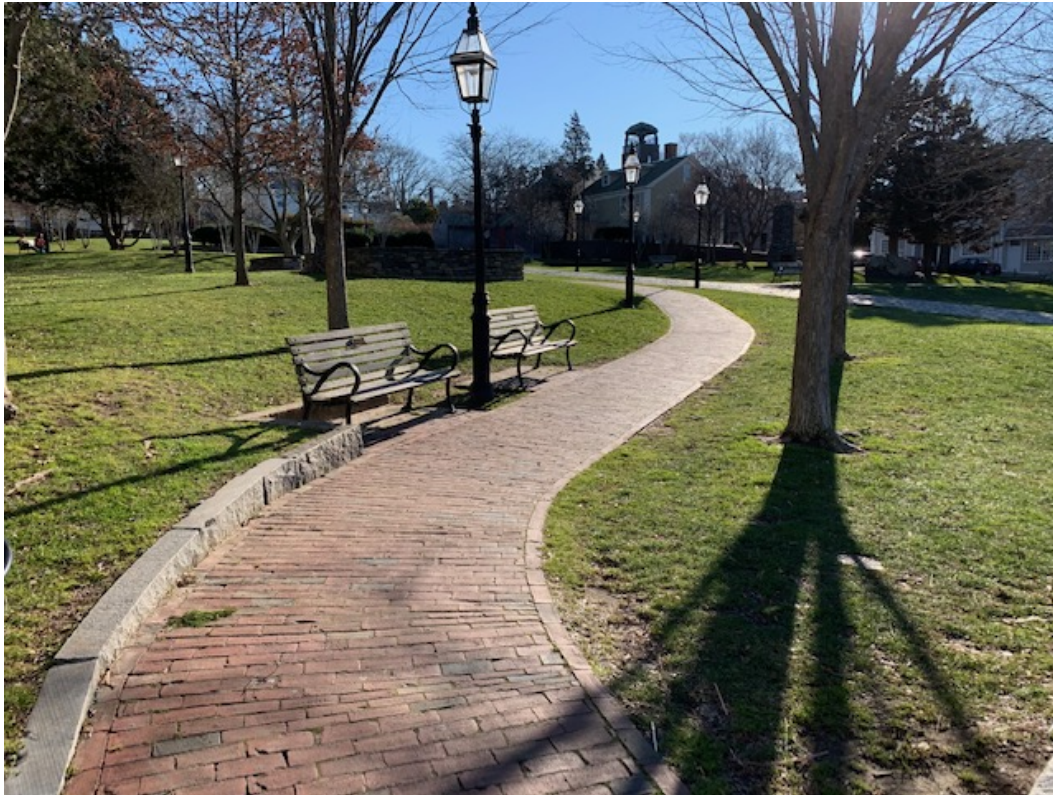
Heavily used entrance opposite Starbucks would benefit from topdressing & seeding in 2021

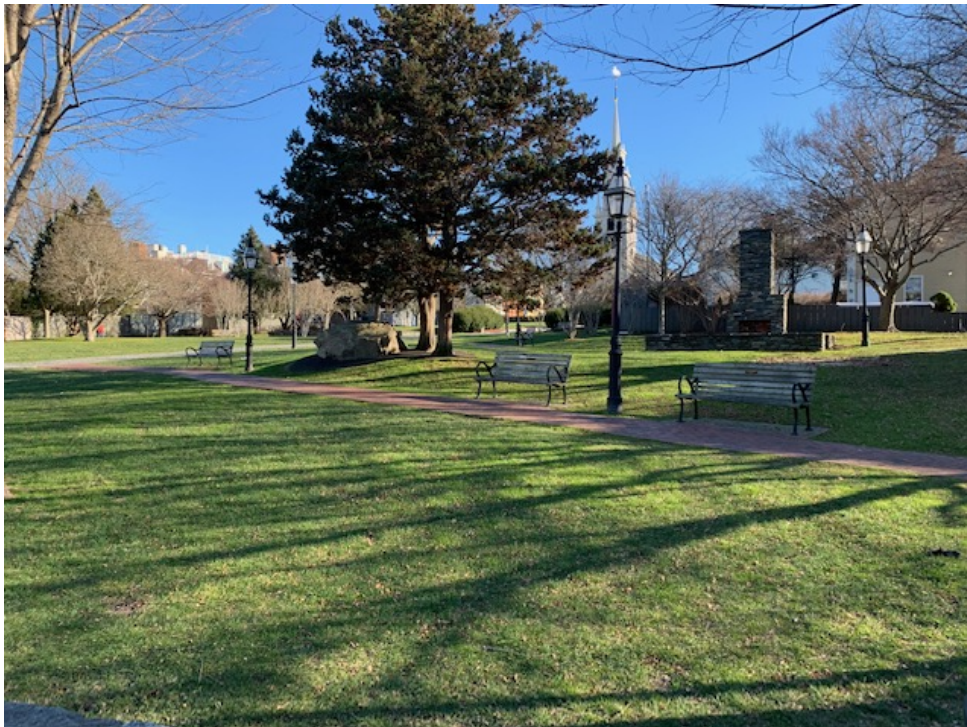
Overall the vegetative cover is in excellent condition
View NE from Mill and Thames St
