October 1, 2010 (Revised January 10, 2011) File No. 05.0043654.00-C

Re: Short-Term Response Action Plan (Revised)
Former Tidewater Facility
Pawtucket, Rhode Island
RIDEM Case No. 95-022

FORMER TIDEWATER MANUFACTURED GAS PLANT PAWTUCKET, RHODE ISLAND

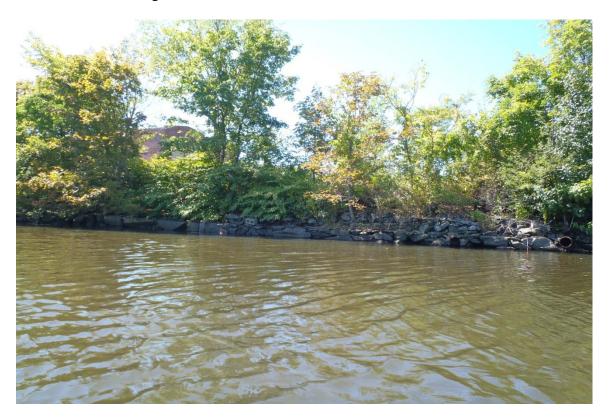
A multi-colored sheen has been periodically observed since approximately May 2010 on the water surface of the Seekonk River adjacent to the FGPA, approximately 150 feet north of the existing temporary cap area (installed in December 2009 to mitigate a sheen area migrating from a portion of the riverbank, as described in a *Short Term Response Summary Report* dated February 1, 2010), as shown on Figure 2. National Grid responded by placing oil snares along the area of this newer sheen area; however a specific source of the sheen was not initially identified. During a waterfront survey conducted on August 30, 2010, an approximately 150-foot long above ground steel pipe, varying in diameter from 4 to 6 inches, was observed running parallel to the Seekonk River, approximately 150 feet north of the existing temporary cap area and approximately 700 feet of the Site's western border along Taft Street, as shown on Figure 2. The northern end of the pipe was observed to be capped above grade and the southern end terminates below grade. Upon further inspection, certain sections of this piping were noted to be in disrepair and solidified coaltar like materials were observed on the ground surface and river embankment beneath the piping. As described above, the presence of this piping and coal tar residuals may be contributing to the intermittent sheens observed in adjacent portions of the Seekonk River.

Photo 1: Shoreline area along FGPA where intermittent sheen is observed.

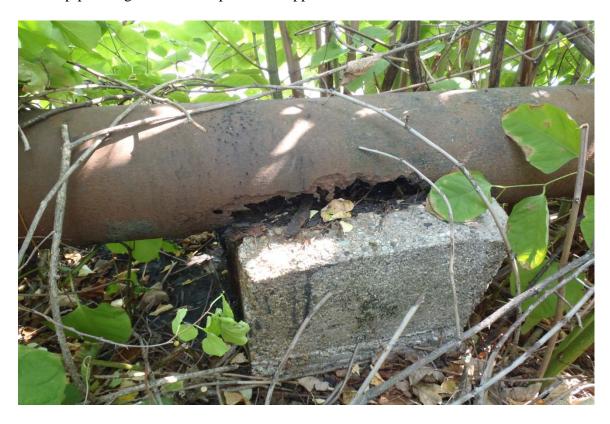
Photo 2: Broken pipe along riverbank. Pipe leak of apparent coal tar-like material.

The approximately 150-feet of above ground sections of pipe will be removed and disposed off-Site at a licensed disposal facility; the underground section of pipe on the southern end will be capped above grade with a blind flange. An approximately 5 square foot area of coal tar-impacted surface material observed in the vicinity of the damaged pipe will be removed and disposed off-Site at a licensed disposal facility. A non-woven geotextile will be placed over the removal area and the area will be backfilled to match surrounding grade with engineered material designed to stabilize the slope. In addition, residual, hardened coal tar-like material located on the river embankment will be manually removed and containerized with the removed surface soil described above and transported off-Site to a licensed receiving facility for thermal treatment or disposal.

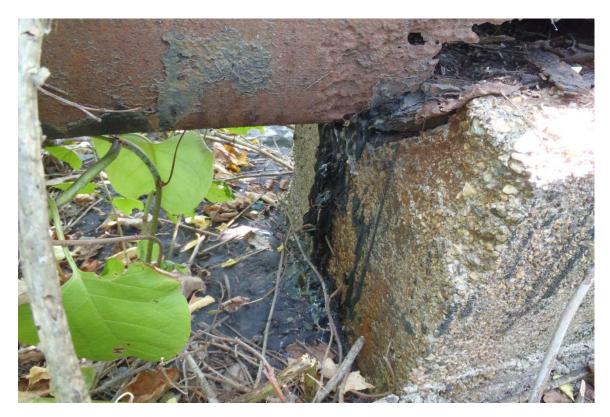
Photo 3: Close-up of damaged pipe and associated pipe leak.
