Transmittal

QUANTITY	DESCRIPTION
1	Copy of Annual (2005) ELUR Inspection Report

RE: Annual Inspection of Property at 434 Allens Avenue
Providence, Rhode Island

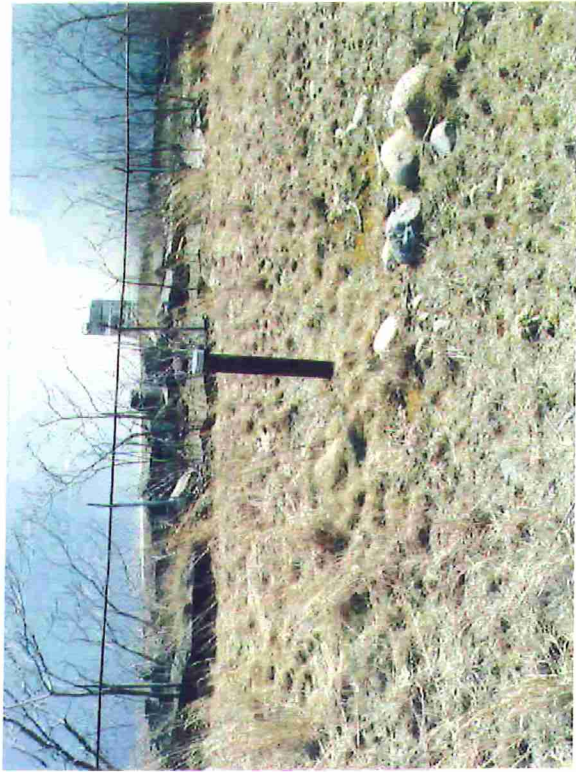
View Looking South at Monitoring Well

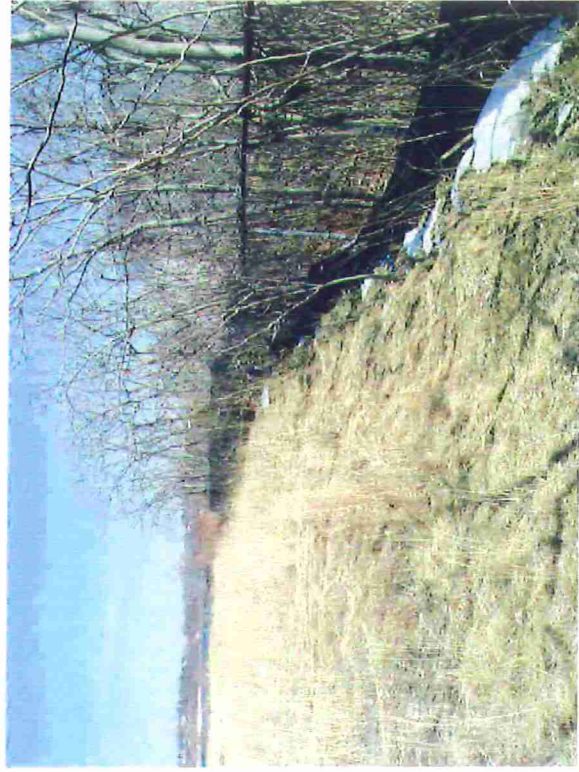
The inspection of the Property followed several transects across the Property as well as the entire perimeter of the Property. The fence surrounding the Property is generally in good condition except for two locations where trespassers have made small cuts in the chain-link fence to gain access to the Property. In addition, fence repairs made in 2004 to restrict access through a gate in the northeast corner of the parcel were damaged by vandals such that trespassers may again be able to fit through a narrow opening in the gate. Consequently, a fence contractor has been retained to make repairs to the fence and gate where needed.

View Looking East Along Fence line

Consequently, a qualified fence contractor has been retained to repair all damaged sections of the fence, thereby eliminating unauthorized access to the property. No further recommendations are offered at this time.

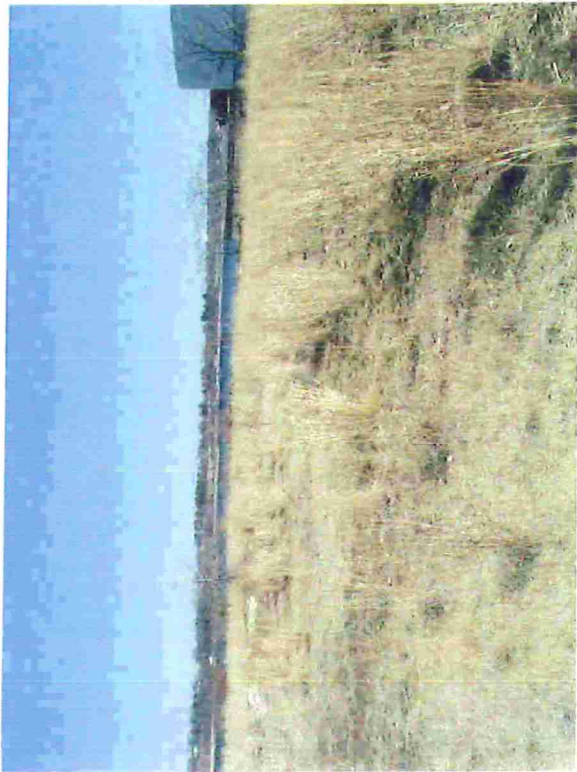
In general, unpaved portions of the Property consist of sandy well-drained soil that is well graded and in most areas, has established vegetation. The site fence and hay bales surrounding the Property are still present and functional. Areas along the Providence River appear to be stable due to protection offered from the large boulders and rip-rap along the River bank. Although a few small isolated areas at various locations on the Property show no signs of soil disturbance or erosion, they are nearly devoid of vegetation. These areas appear to be comprised of clean, sandy, coarse-grained soil and pebbles that may not contain a sufficient thickness of organic loam to sustain a healthy vegetative growth. However, due to the large grain size associated with cover material in these bare spots, there is little potential for wind-driven dust or erosion from stormwater.

View Looking East Towards the Providence River

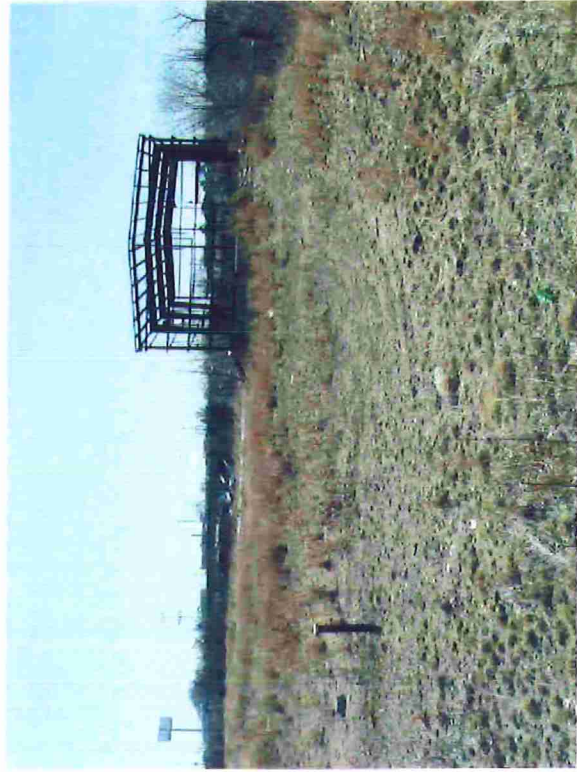
View Looking West Towards Allens Avenue
