SIR COMMENT LETTER

RE: Post Fire Site Evaluation
Rhode Island Recycled Metals, LLC
434 Allen's Avenue, Providence, R.I.
Plat 47, Lot 601
Plat 55, Lot 10

FOCUSED COMPLIANCE INSPECTION REPORT

<u>Property Owner/ Responsible Party:</u>	RI Recycled Metals	<u>Inspection Date:</u>	4/11/2024
		<u>Report Date:</u>	4/12/2024
<u>Case Number:</u>	OCI-HW-24-19	<u>Inspector(s):</u>	John Hassett, Nicole Pelletier
<u>EPA Id Number:</u>	RIR 000509497		
Begin Time:	9:55 AM	End Time:	10:40 AM

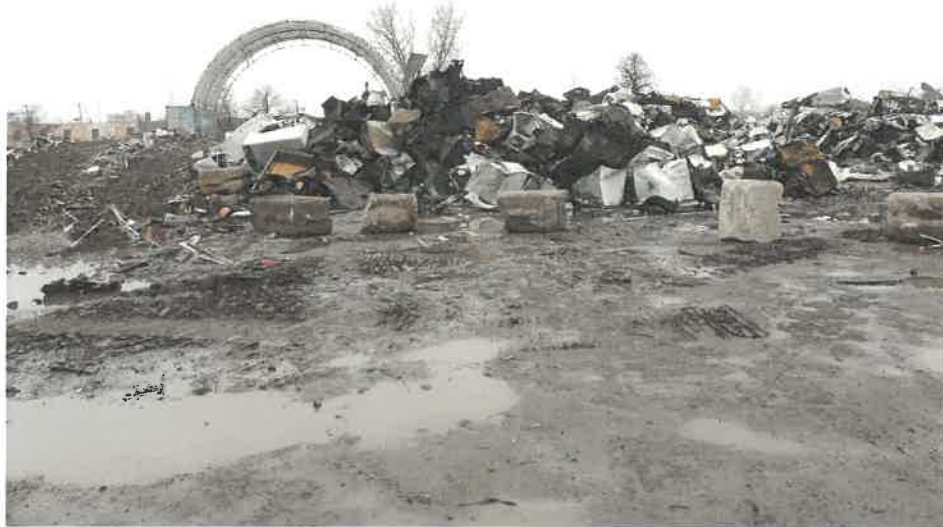
1

We then proceeded to the main yard area where the fire occurred. At this location, Mr. Hassett and I observed approximately 100 feet by 120 feet and 10 feet high scrap pile of what appeared to be burnt home appliances such as washer, dryers, refrigerators, and plastics. At the time of the inspection, there was another burnt pile approximately six (6) cubic yards in size located northeast of the main pile. Mr. Champagne stated this pile was here because they had to pick the pile apart with machines to help put out the fire. Surrounding these piles and throughout the property, I observed sporadic water ponding areas with oil sheening and several areas of oil staining on the ground surface.

Area photo of accumulated burnt materials located at the main yard area. Photo taken facing south.

After careful review of the Focused Compliance Inspection Report, the Department will require additional site soil sampling within the entire area of the fire and any areas affected by water runoff from the fire fighting. Inspectors reported observing numerous areas where visible oil and oil staining was present. Please submit a detailed soil sampling plan for these areas detailing the sampling locations and sample collection depths. Combustion/burning is a common source for polycyclic aromatic hydrocarbons (PAHs) and, as such, all soil samples shall be analyzed at a laboratory for PAHs via EPA Method 8270. In addition, it is the Department's understanding the

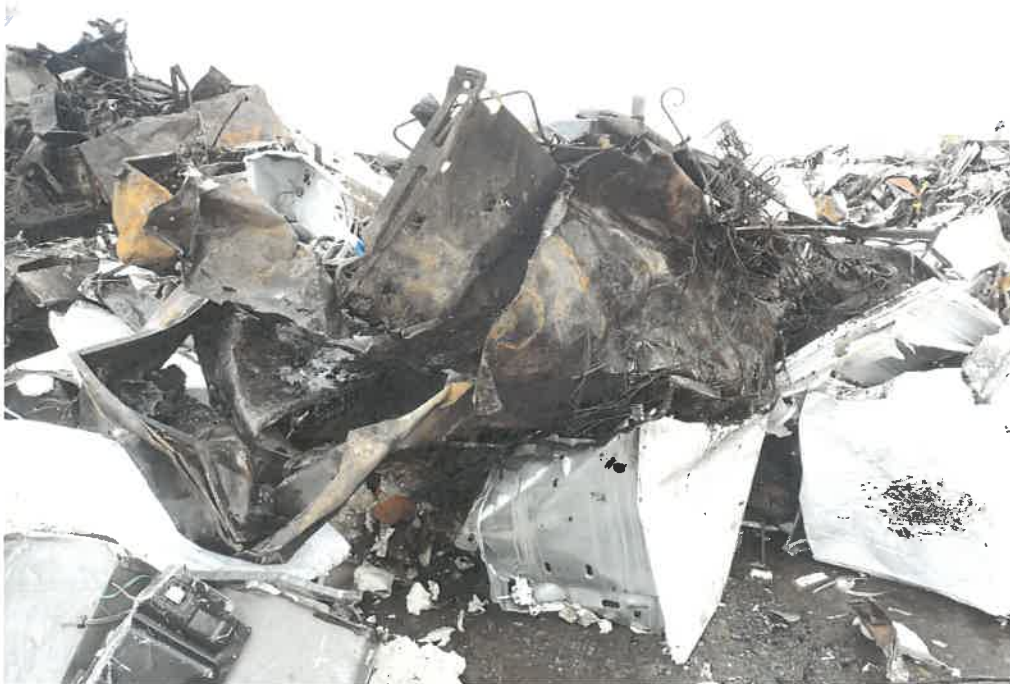
2

Close up photo of the burnt material depicted in photo number one.

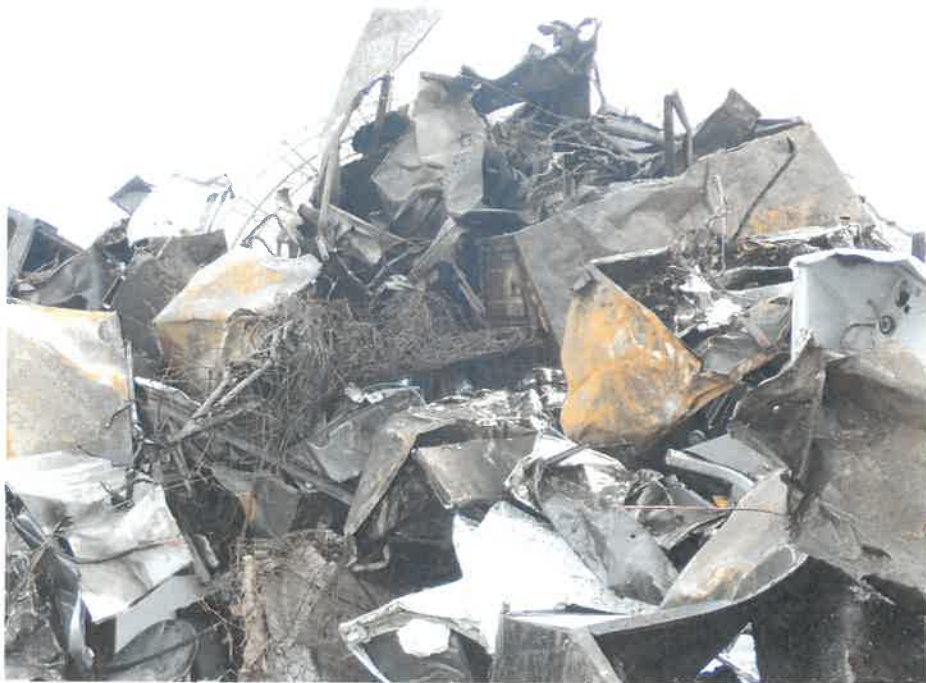
3

Close up photo of burnt materials located at the main yard area.

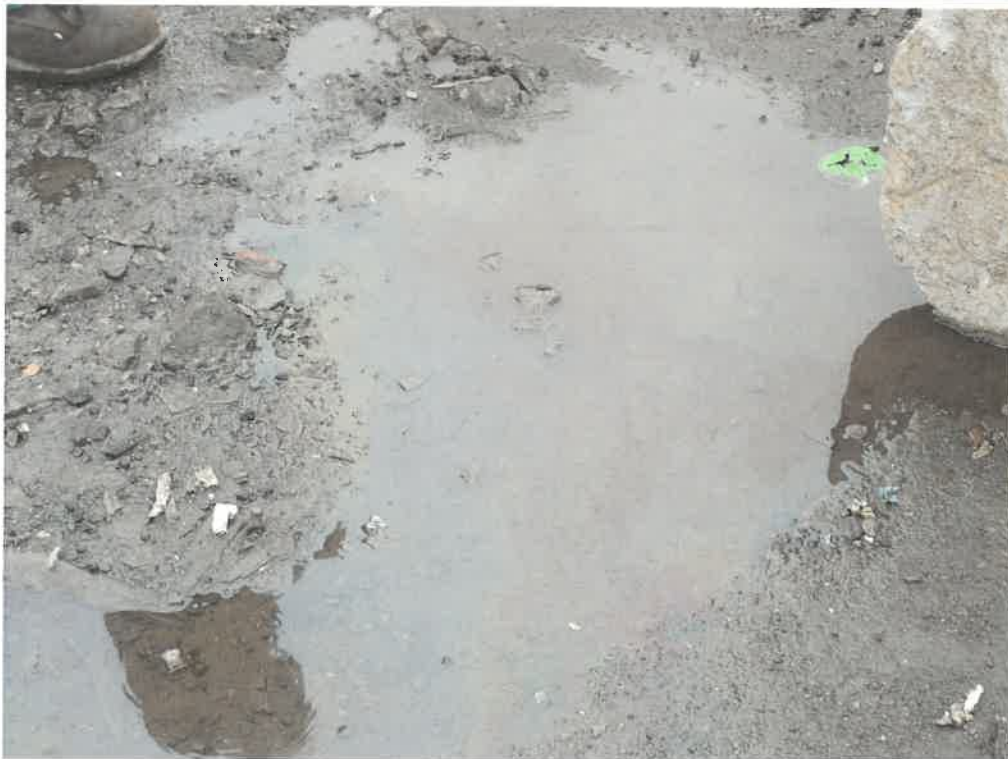
4

Area photo of oil-sheening in a ponding area at the main yard area.

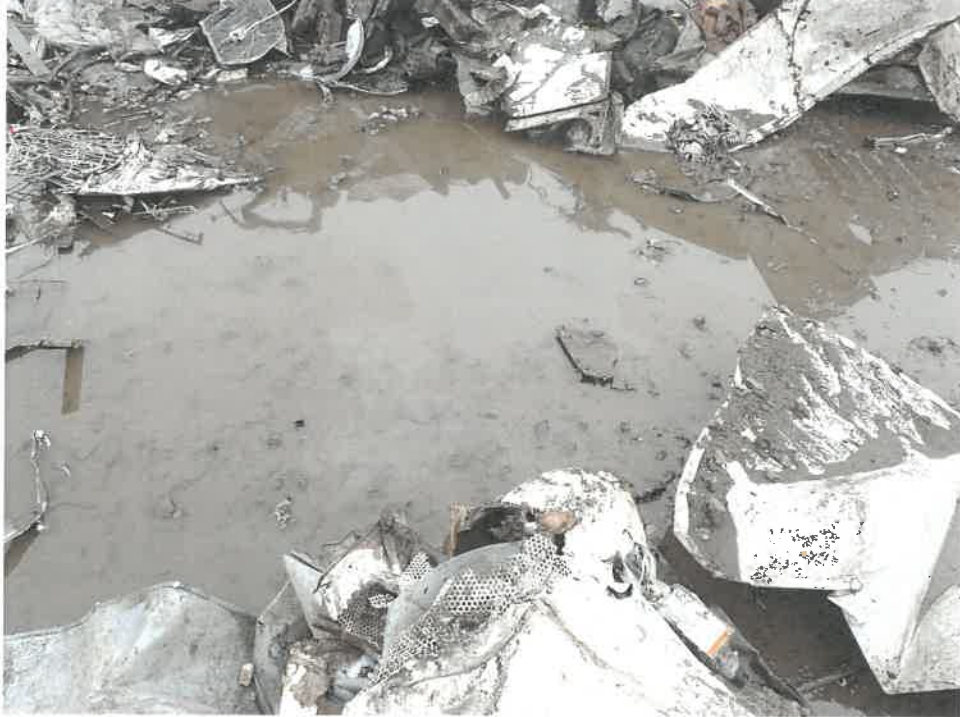
5

Area photo of oil-sheening in a ponding area at the main yard area.

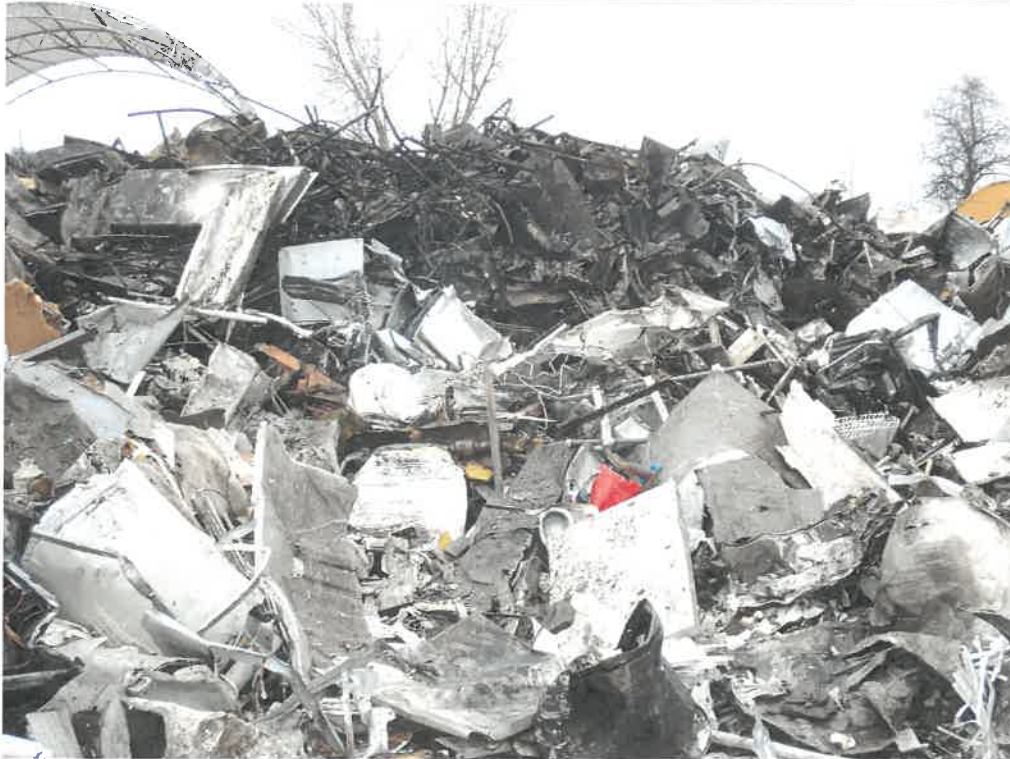
6

Area photo of burnt materials located at the main yard area. Burnt materials mostly consisted of metal and plastic materials.

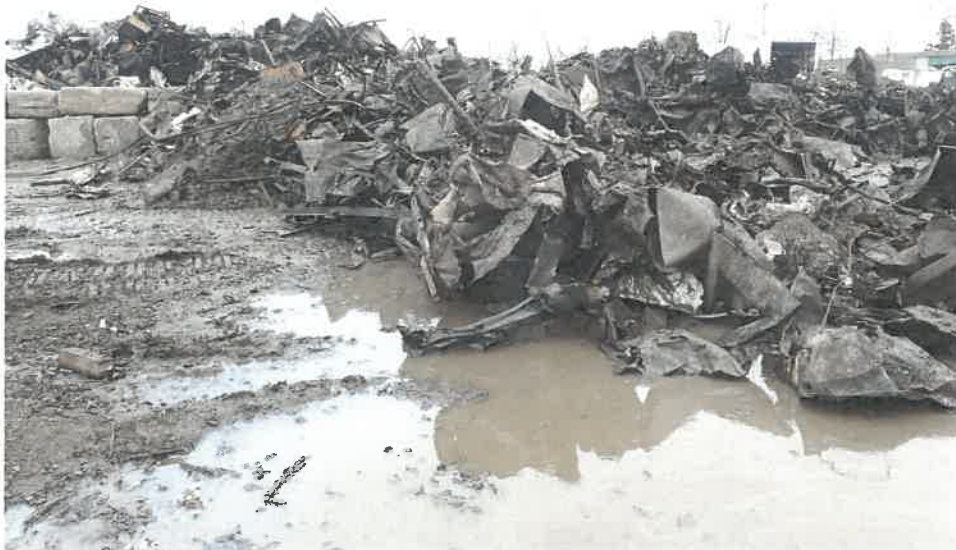
7

Area photo of burnt materials located at the main yard area.

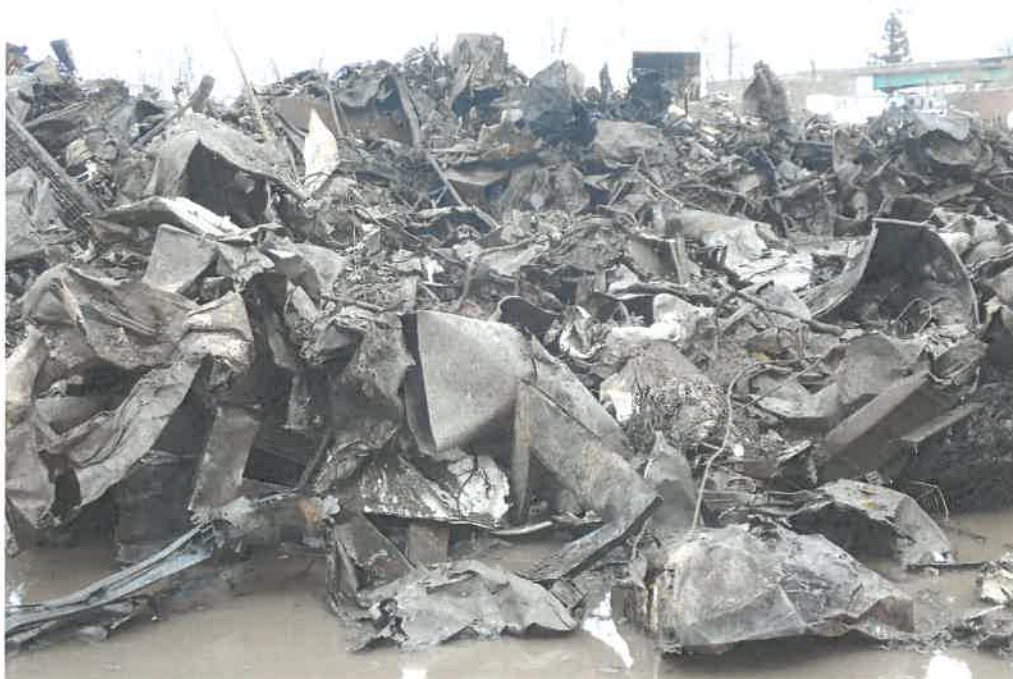
8

Area photo of burnt materials located at the main yard area.

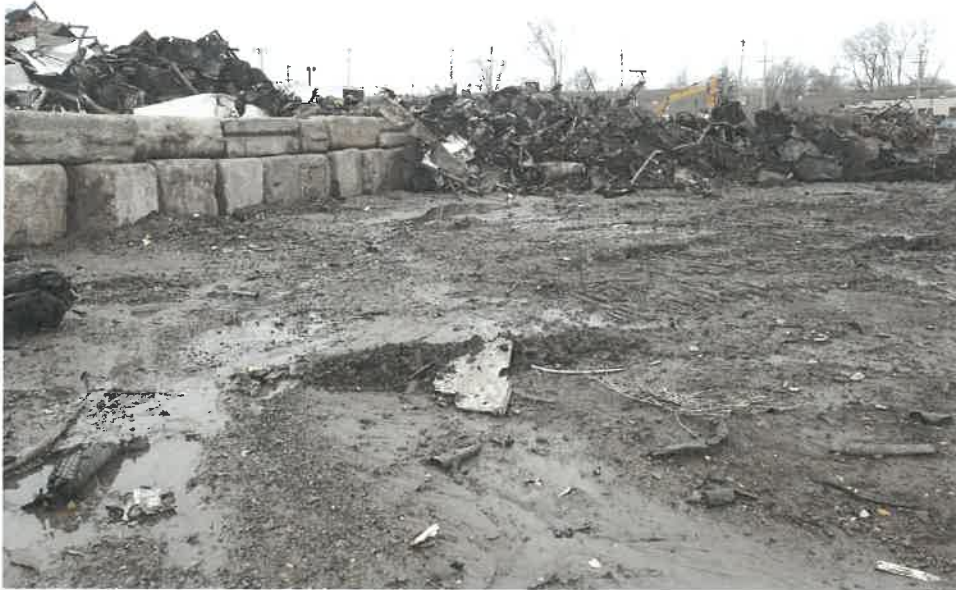
9

We then walked east towards the Providence River and observed two (2) runoff streams originating from the burnt piles flowing across the property, underneath pollution control - straw waddle lining the edge of the land, and then into the water. At the time of the inspection, the runoff did not have oil or an oil sheen. In the Providence River, where the water run off was occurring, I observed a surface water area approximately 15 feet by 30 feet with debris in the form of foam and wood chips floating. Additionally, in this location I observed that there was a hard boom installed to prevent contaminates to enter the Providence River. At the time of the inspection, I observed no oil sheening entering the Providence River.

Area photo of accumulated surface water migrating from accumulated burnt materials to the Providence River.

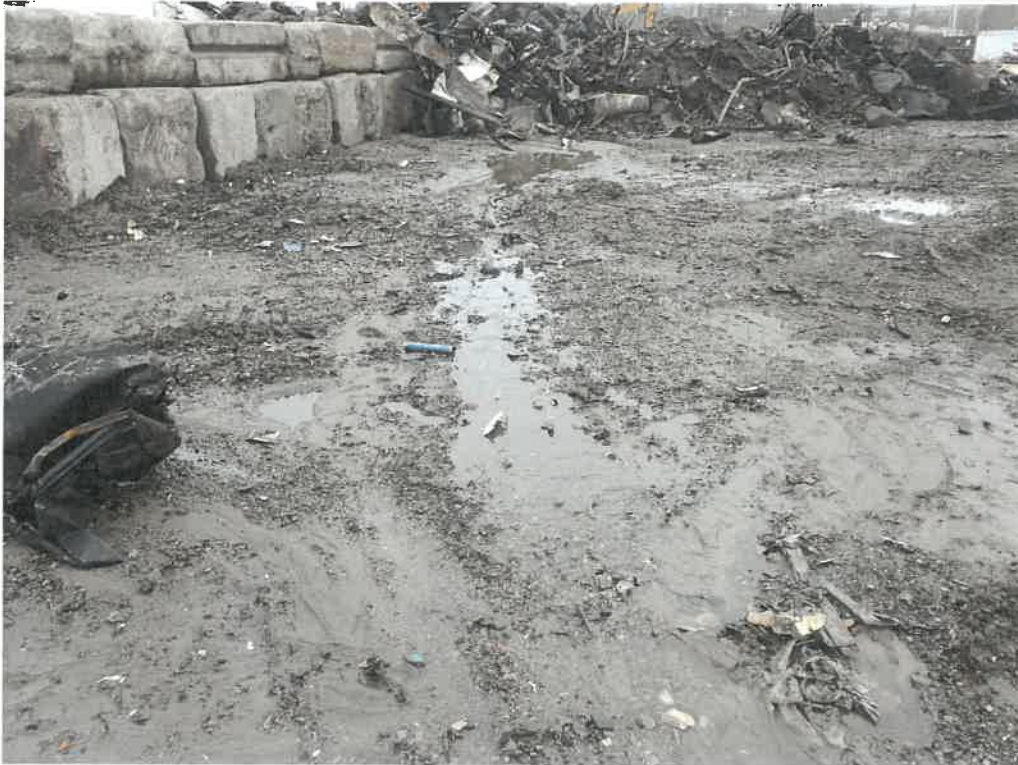
10

Close up photo of the migrating surface water depicted in photo number 9.

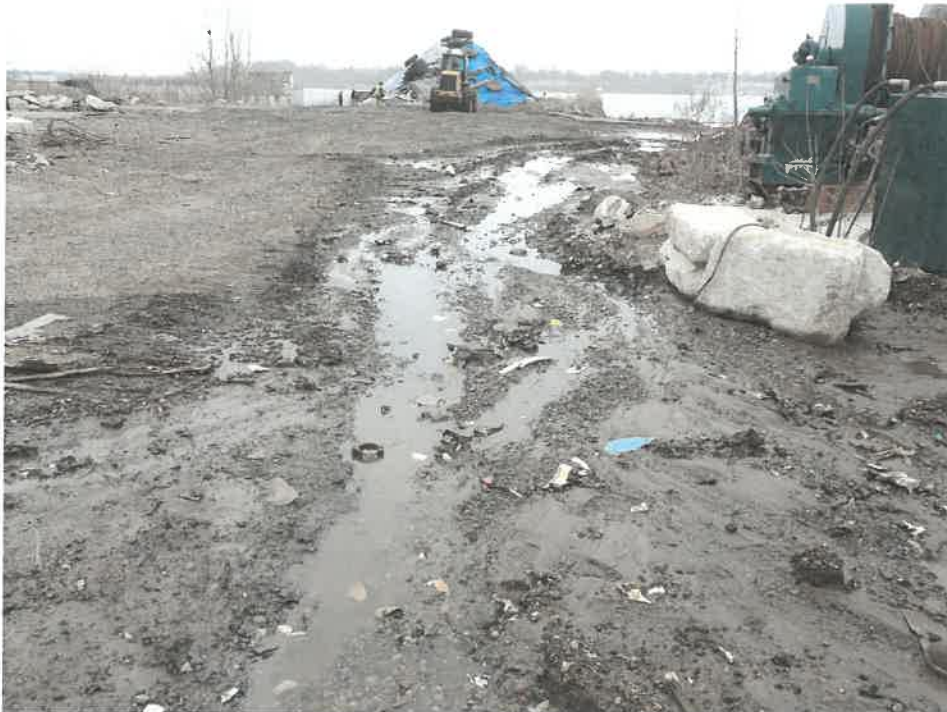
11

Area photo of surface water originated from the burnt pile of materials migrating to the Providence River.

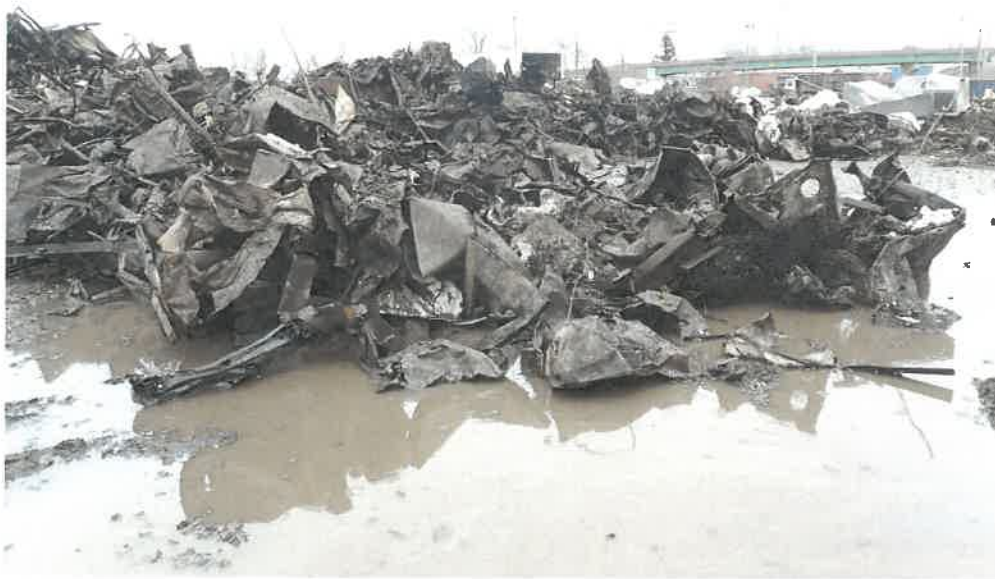
12

Area photo of accumulated surface water and burnt materials located at the main yard area.

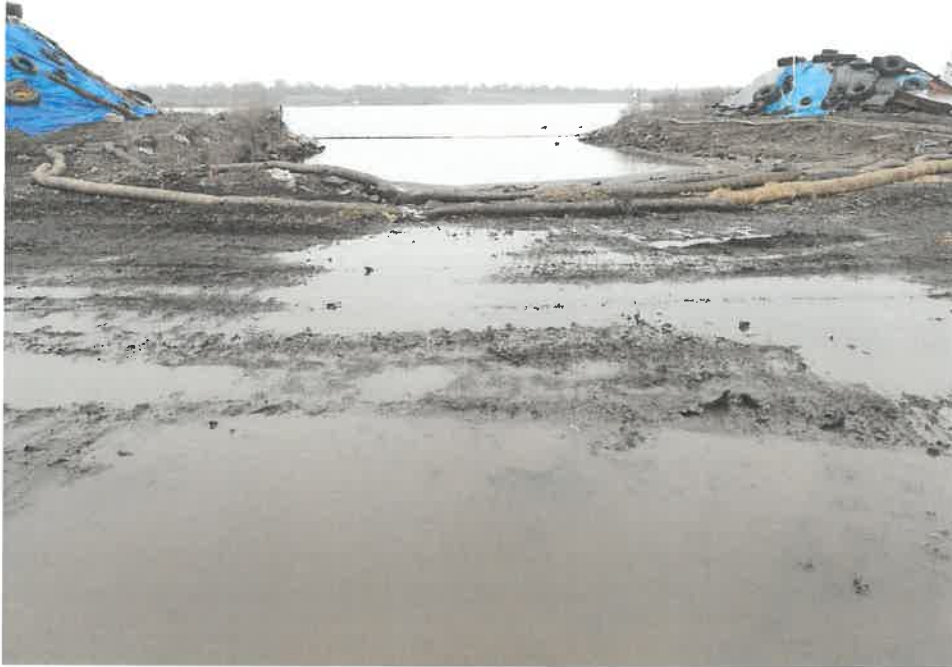
13

Close up photo of accumulated surface water migrating to the Providence River.

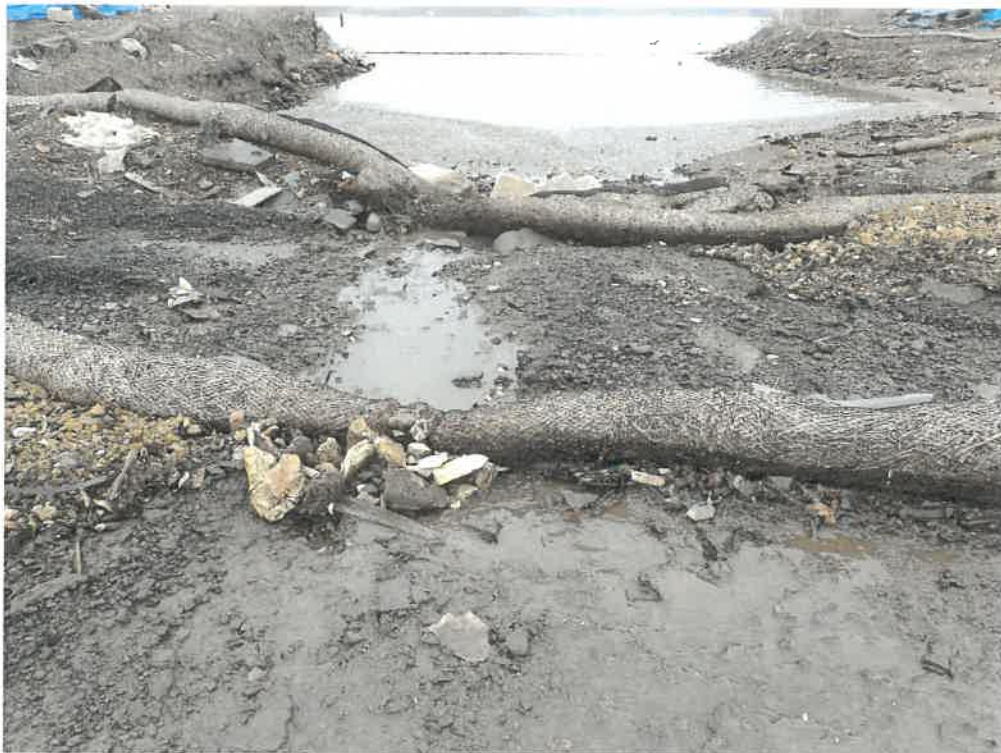
14

Close up photo of accumulated surface water migrating to the Providence River.

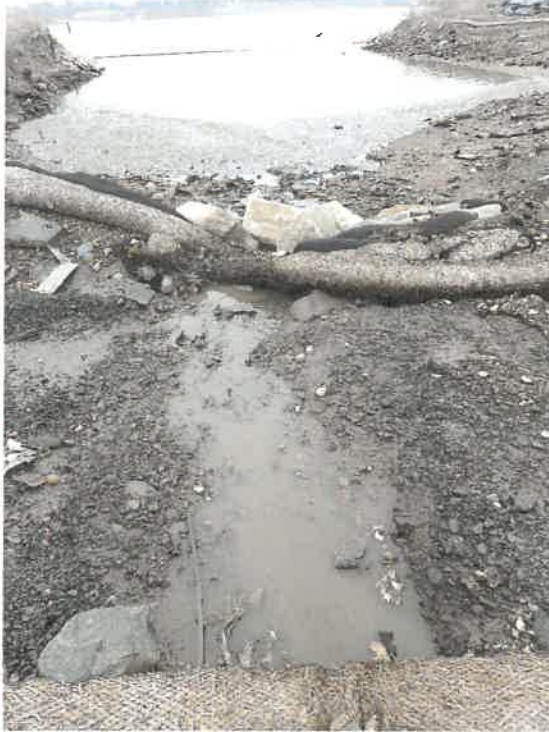
15

Close up photo of accumulated surface water from the main yard area that's migrating to the Providence River.

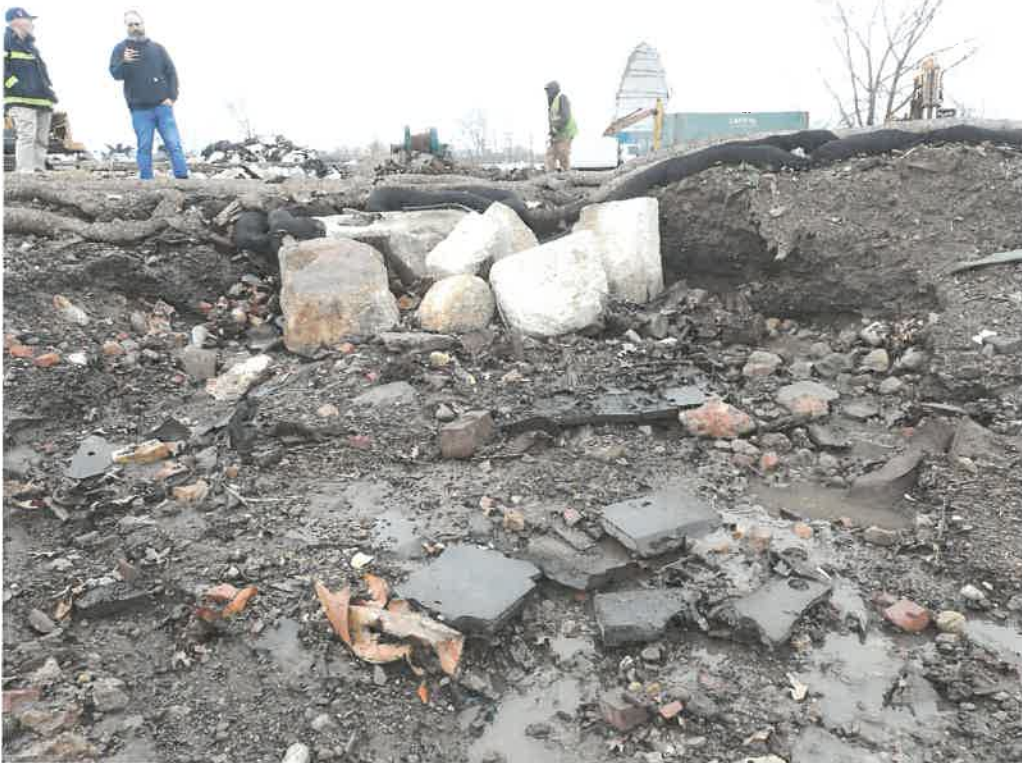
16

Close up photo of accumulated surface water migrating to the Providence River.

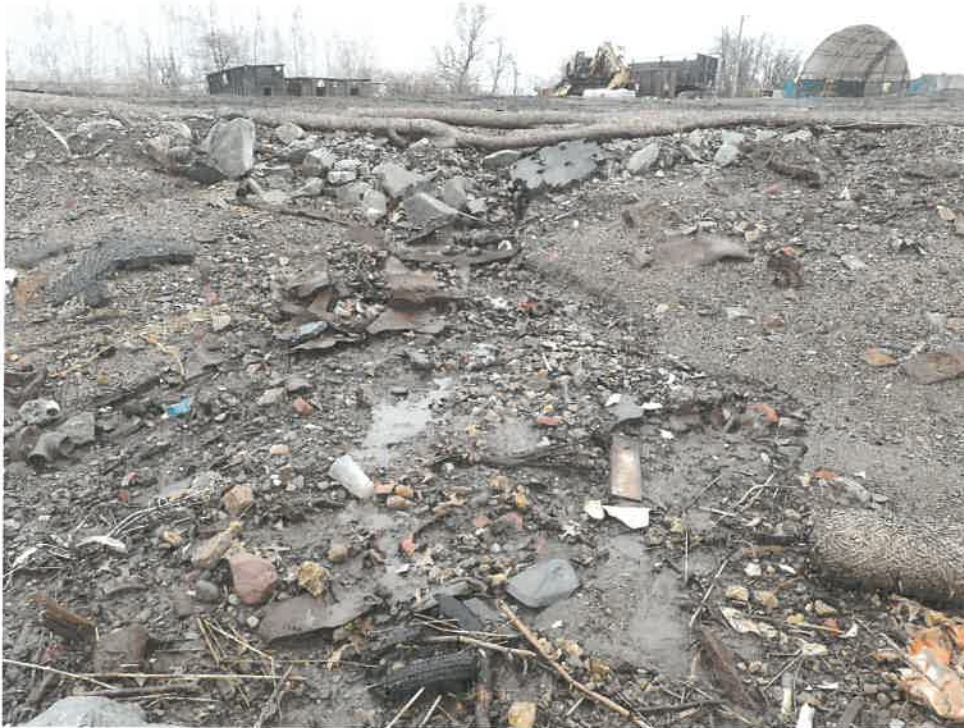
17

Area photo of a second location where accumulated surface water is migrating to the Providence River.

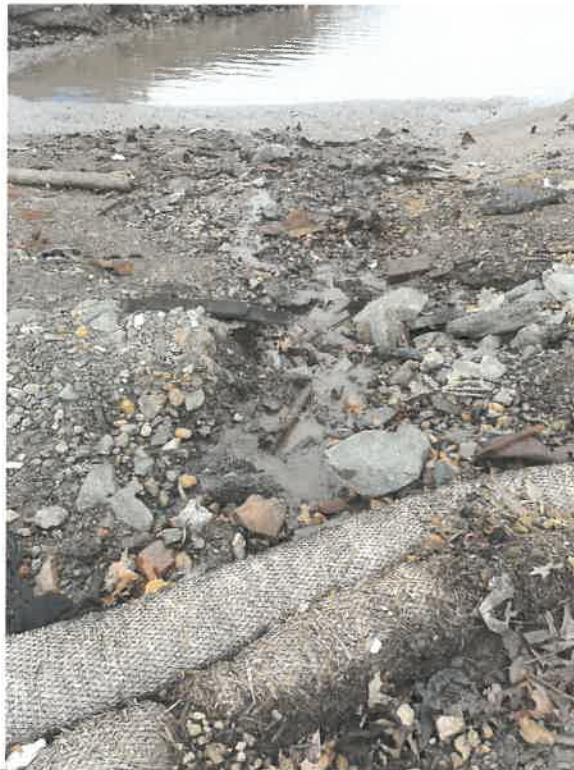
18

Close up photo of accumulated surface water from the main yard area migrating to the Providence River that's also depicted in photo number 17.

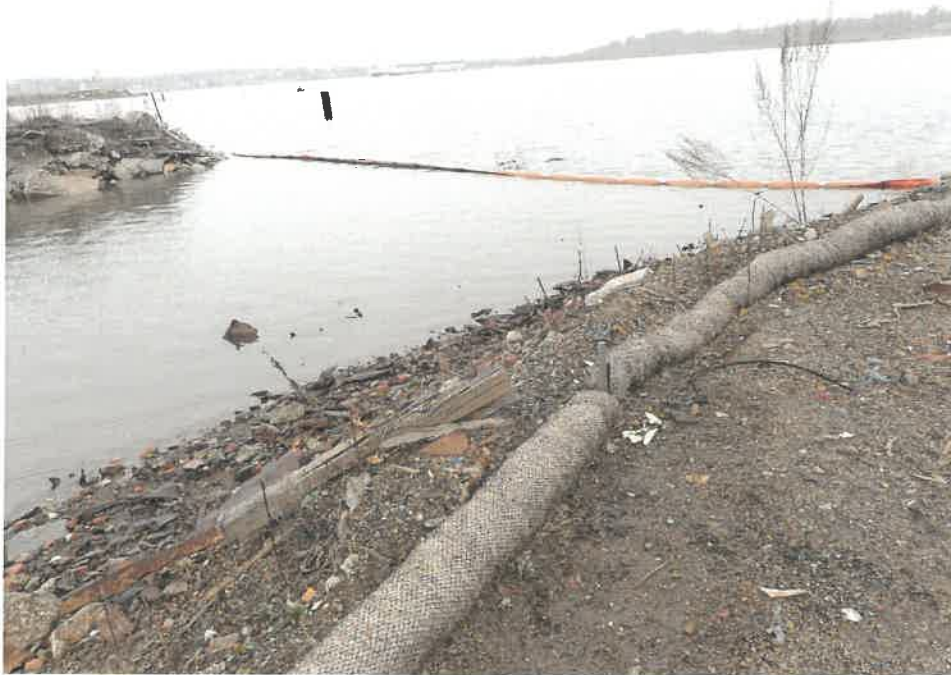
19

Area photo of a boomed area to the Providence River at the R.I. Metals Recycling facility. No oil sheening observed at this location.

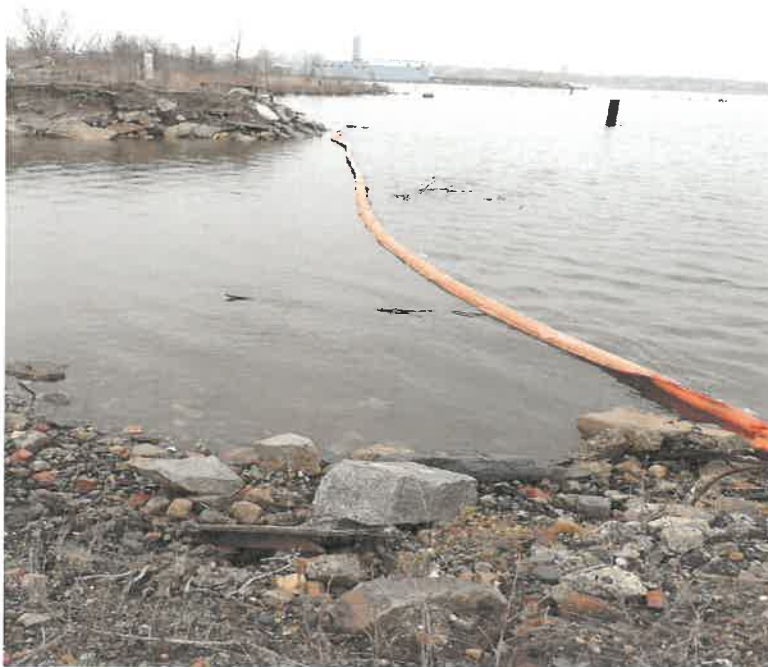
20

Second area photo of a boomed area at the R.I. Metals Recycling facility. Same boom depicted in photo number 19.

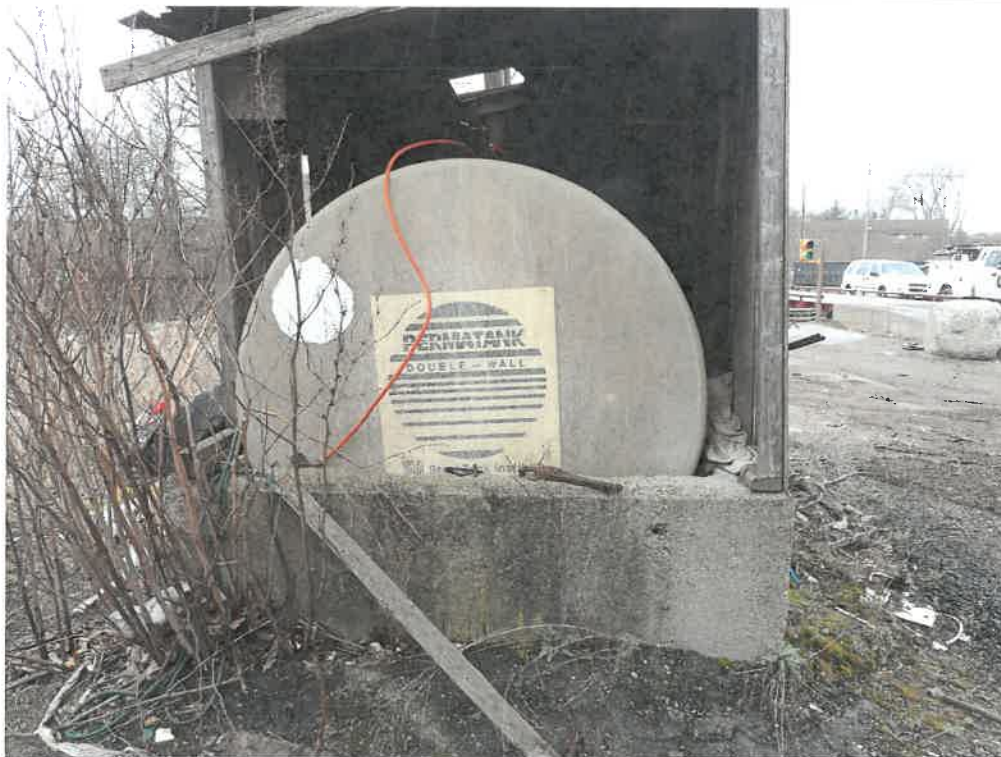
22

Area photo of an approximate 1000-gallon above ground storage tank (AST) that is no longer in use per facility personnel. Any contents in the AST could not be visually confirmed.
