# RI Department of Environmental Management Environmental Land Usage Restriction (ELUR) Annual Compliance Evaluation Form (Please

Site N	fame: Gorham – P	arcel A	Property Owner: Providence Redevelopment Agency		
RIDEM File No.: Case No. 97-030			Owner Mailing Address:		
RIDEM Project Manager: Joe Martella			444 Westminster Street, Providence, RI 02903		
	Recording Date		Inspection Date: December 10, 2019		
	~	mber: (401) 680-8418	E-Mail: cdupre@providenceri.com		
of any	y active remedia		appropriate for use on sites that require the use SDS, ongoing air or groundwater monitoring, tranted by the Department.

1. Site	e Description				
a.	Site Address:	77 Reservoir Ave			
		Providence, RI 02907			
b.	Plat: <u>51</u>	Lot(s): <u>326</u>			
		No describe the portion of the	e property subject to the ELUR:

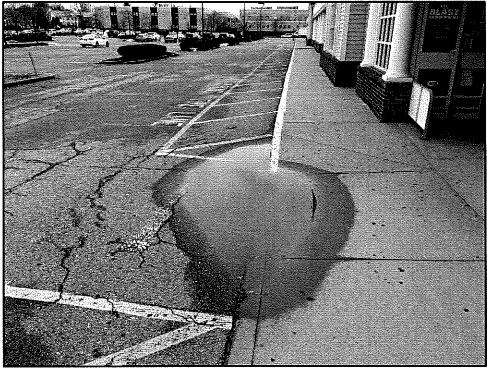
2.	Please provide a description of the area(s) of concern:  Substantial areas of asphalt cracking. Some areas appear to have been filled previously, but repairs needed throughout. Areas of ponding observed, one being substantial, implicating surface runoff may be slowly infiltrating into cap and ontaminated soils.  Could water infiltrate through these areas into underlying contaminated soils?  X Yes No N/A; Infiltration Not Restricted  When will the area(s) of concern be repaired? TBD

Photo 2: Puddling (see Photo Location Figure)

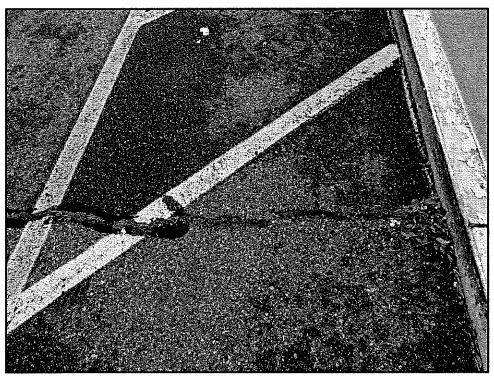
Photo 3: Example of cracking and previous fill efforts (see Photo Location Figure)

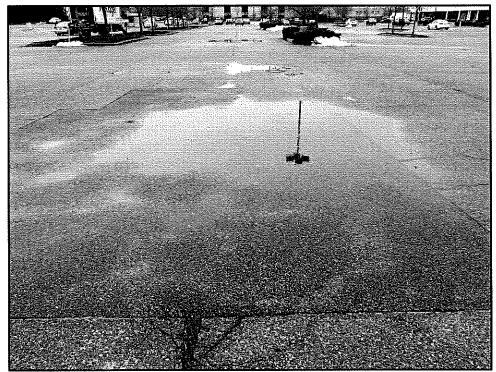
Photo 14: Puddling (see Photo Location Figure)

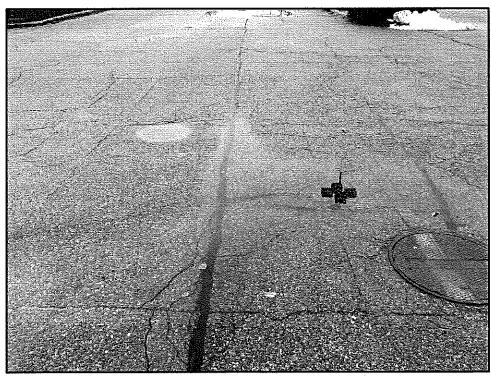
Photo 15: Puddling (see Photo Location Figure)

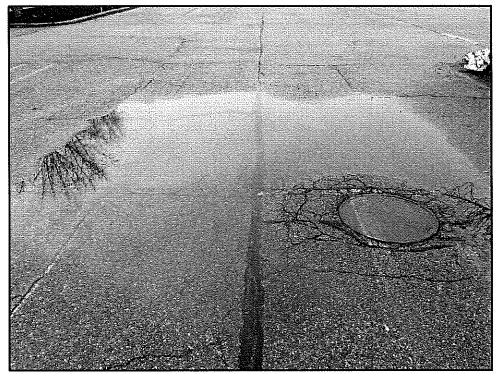
Photo 16: Puddling (see Photo Location Figure)

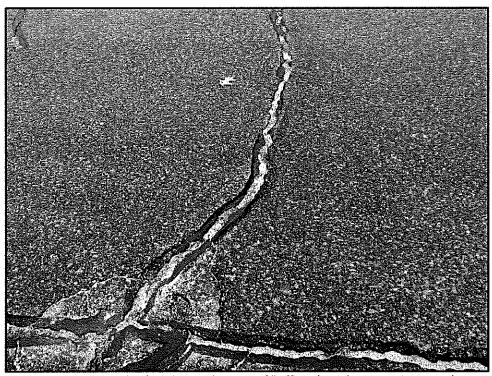
Photo 18: Example of cracking and previous fill efforts (see Photo Location Figure)

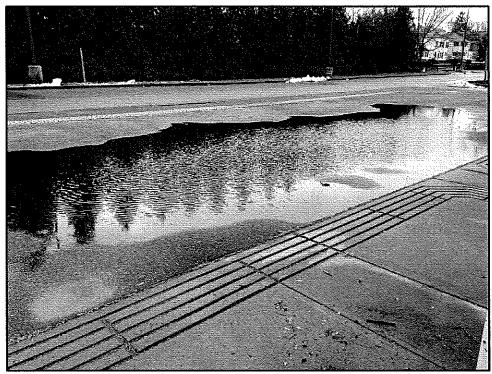
Photo 24: Puddling (see Photo Location Figure)

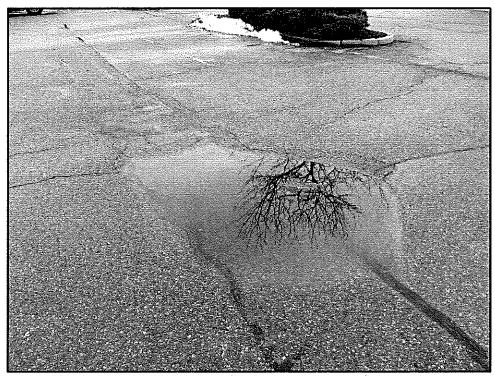
Photo 26: Puddling (see Photo Location Figure)

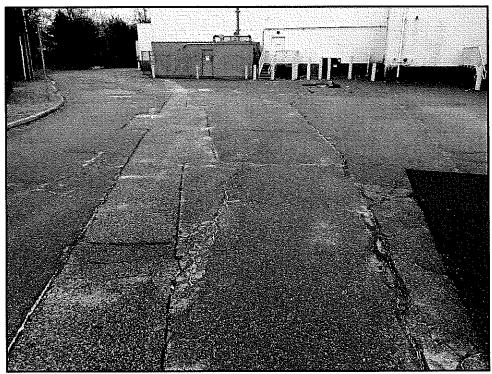
Photo 30: Pavement cracking (see Photo Location Figure)

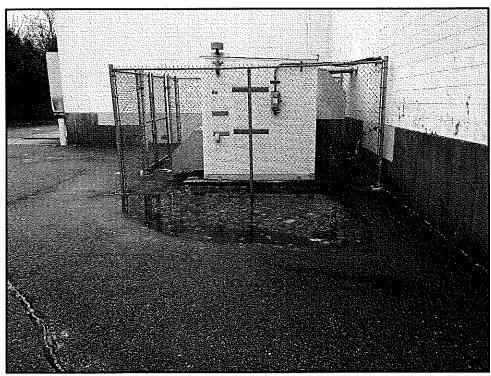
Photo 31: Puddling (see Photo Location Figure)

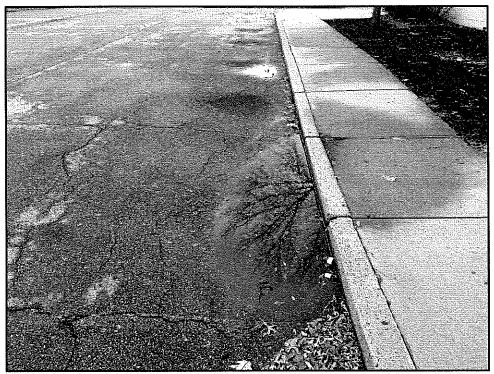
Photo 36: Puddling (see Photo Location Figure)
