GZA GeoEnvironmental, Inc.

Re: Short-Term Response Action Summary Report
Former Tidewater Facility
Pawtucket, Rhode Island
RIDEM Case No. 95-022

FORMER TIDEWATER FACILITY

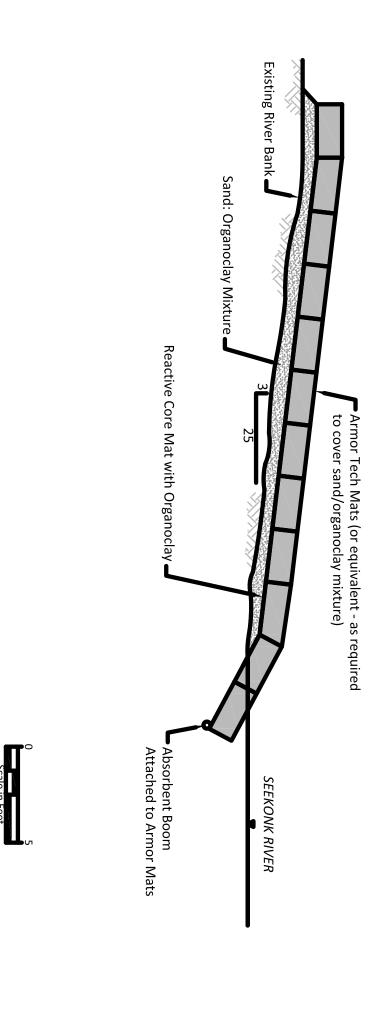
# TIDEWATER TYPICAL CAP CROSS-SECTION

The temporary cap was installed in the area of the sheen and extends from the top of the bank to the river, to the elevation on the bank where the waterline contacts the bank near the time of low tide. The cap is approximately 50 feet long (measured parallel to the shoreline) and extends from

the top of the riverbank bank slope to approximately 1 foot below the water surface at low tide. As such, the total width of the cap varies from approximately 10 to 25 feet based on field conditions. A typical cap cross section is provided as Figure 3.

The temporary cap was installed between December 15 and 17, 2009, and was completed in general accordance with the December 4, 2009 STRAP. In summary, the temporary cap consists of the following, from top layer to bottom layer:

- An armor layer constructed from 8-foot by 8-foot armor mats, to retain underlying cap materials in place. Under the submerged edge of the armor layer, a sorbent boom was attached with a cable to the toe of the mattresses installed closest to the water and oriented parallel to the shoreline. The armor layer was secured to the top of the bank as required to prevent sliding of the armor mats on the bank. A minor deviation occurred at the northern water-side corner of the slope. Due to the presence of several large stones that were unable to be removed from the toe of the slope with the on-site equipment, the RCM and armor mattresses were unable to reach to design elevation near the low tide water line. The two affected RCM and armor mattress units were placed as far down the slope as possible, hard up against the stones, as seen Photograph 10. An additional deviation from the STRAP involved substituting an alternative approach for anchoring of the armor mats at the top of the bank. Rather than anchored at the top of the bank using bin blocks, armor mats were anchored by extending the mats over the top of the bank. Extending the mats provides a combination of additional mass and surface area/friction that resists potential sliding of the cap and therefore substitutes for the bin blocks. These deviations from the design proposed in the STRAP are not expected to affect the cap performance.

- Under the armor layer, reactive core mats (RCM), constructed from two geotextile layers enclosing an approximately ½-inch thick layer of organoclay to provide capacity to absorb the sheen before it forms on sediment or surface water.

- Under the RCM a thin layer of sand (approximately 12 inches thick) was placed to form a smooth surface for the RCM to be placed upon. Bulk organoclay was mixed with the sand in the vicinity of the sheen outbreak to provide additional capacity to absorb sheen materials.

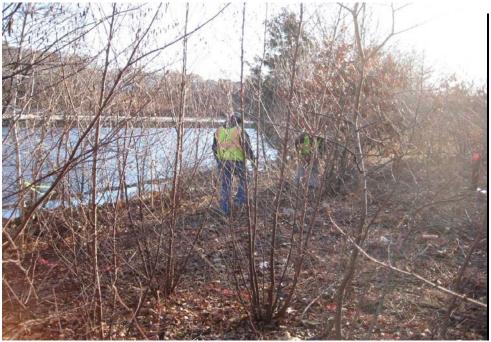
Photo No. 1 - Upland portion of worksite prior to clearing

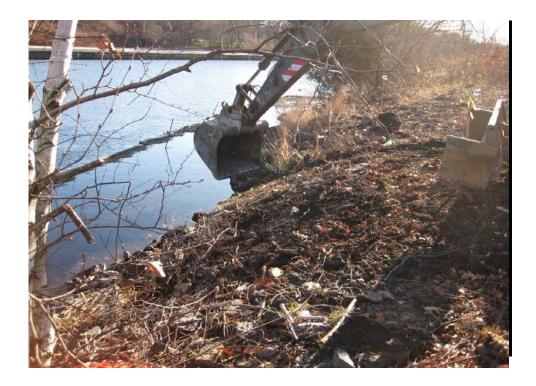
Photo No. 2 - Clearing and grading the riverbank

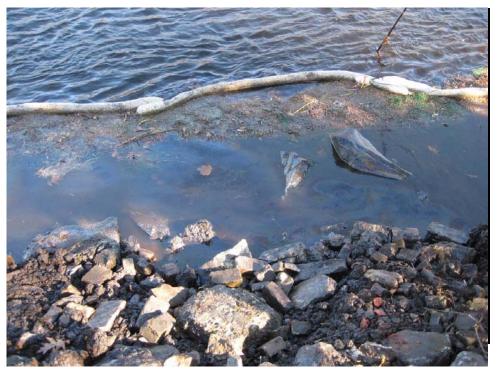
Minor sheens were observed on the water at the bottom of the bank during cap construction, as indicated in attached photographs. The sheens were observed within the boom system that had been installed at the site. The boom system remained in place during construction, and sheens were not observed to migrate beyond the boom.

Photo No. 3 - Sheen emanating from voids following rock removal

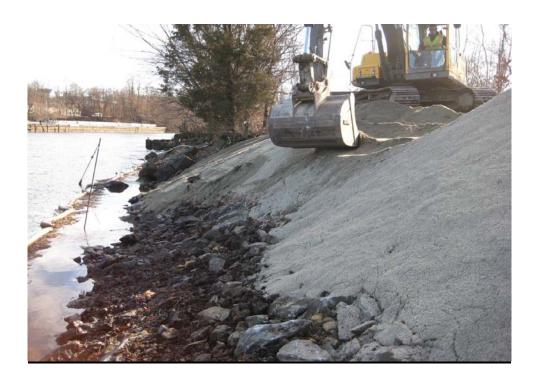
Photo No. 4 - Spreading of sand along riverbank

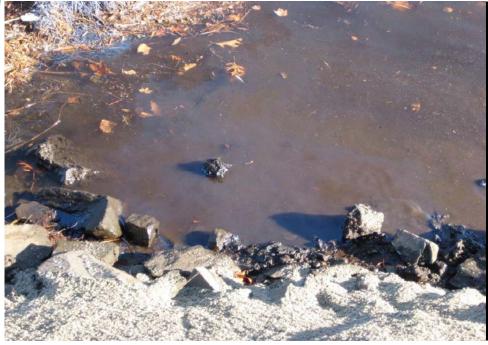
Photo No. 5 - Sheen emanating from toe of slope during bank work

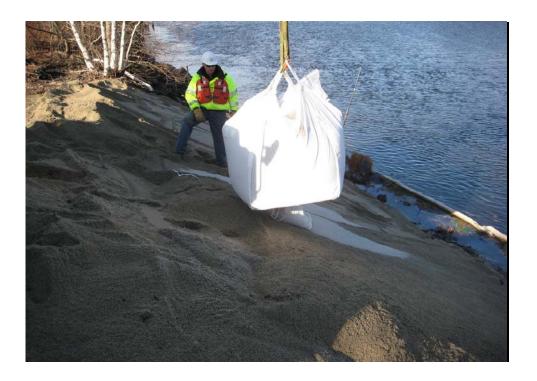
Photo No. 6 - Application of bulk organoclay to sand surface

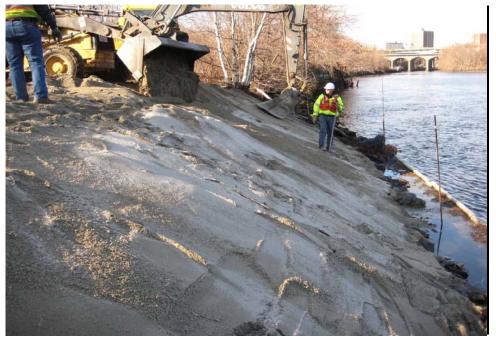
Photo No. 7 - Riverbank prior to RCM placement

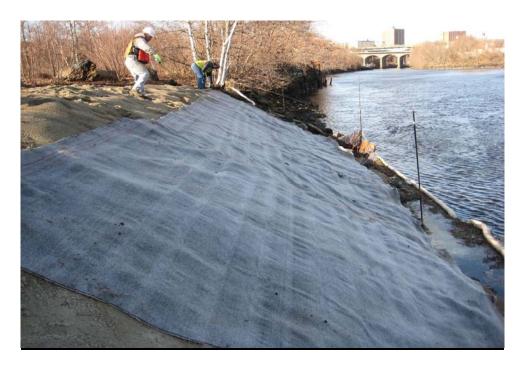
Photo No. 8 - Placement of RCM

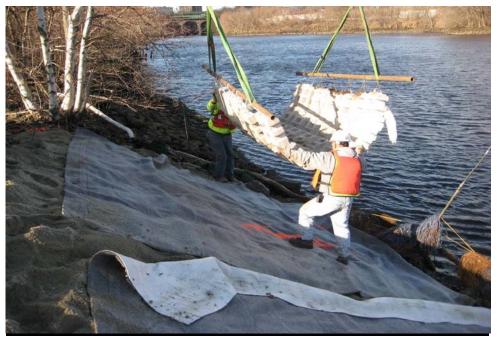
Photo No. 9 - Placement of armor mattress

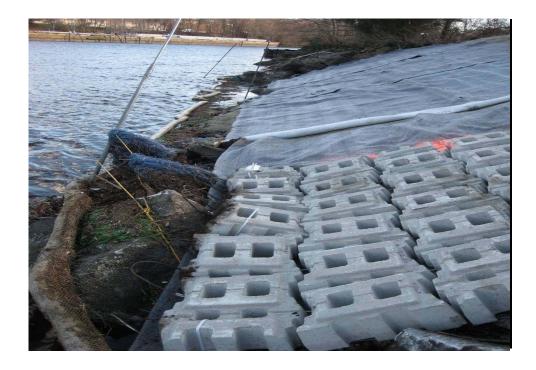
Photo No. 10 - RCM and armor mattress at northern corner showing minor design deviation where armor mattress could not be installed to low water line due to presence of obstructions, including boulders

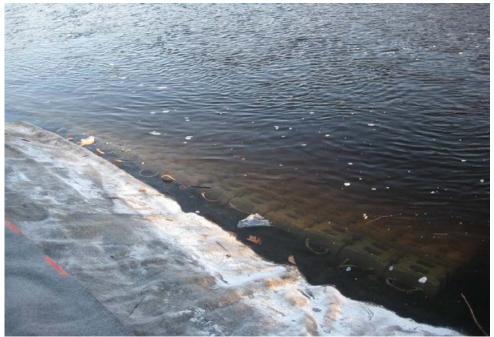
Photo No. 11 - Armor mattresses submerged at high tide the morning of December 17, 2009

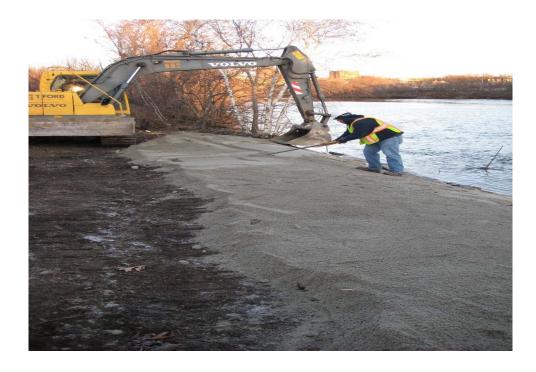
Photo No. 12 - Sand spreading to the top of the bank

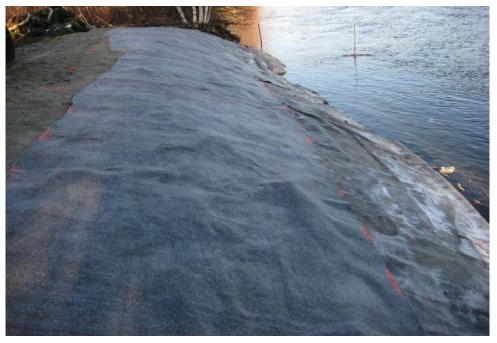
Photo No. 13 - Final RCM coverage

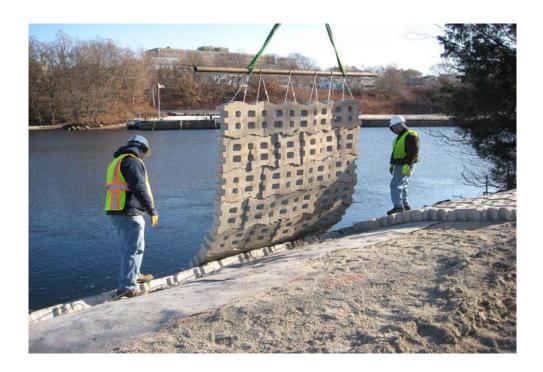
Photo No. 14 - Placement of final two rows of armor mattresses

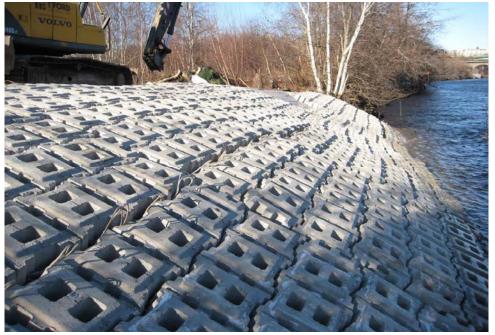
Photo No. 15- Completed temporary cap, looking north

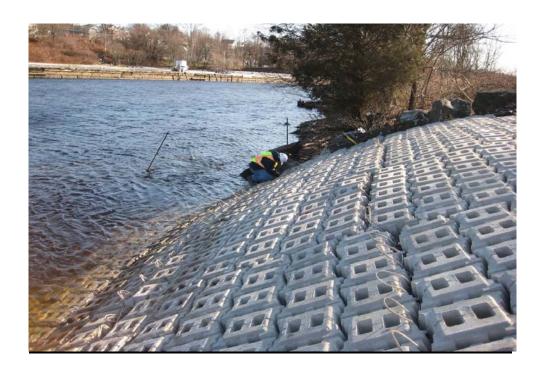
Photo No. 16 - Completed temporary cap, looking south

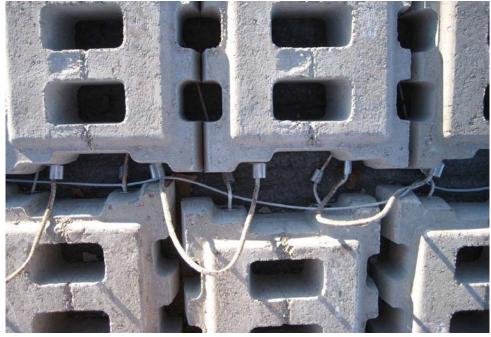
Photo No. 17- Cabling of armor mattress rows

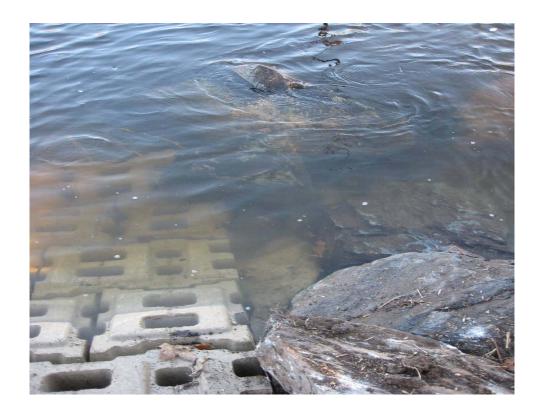
Photo No. 18 - Rocks covering exposure of RCM in southeast corner of temporary cap

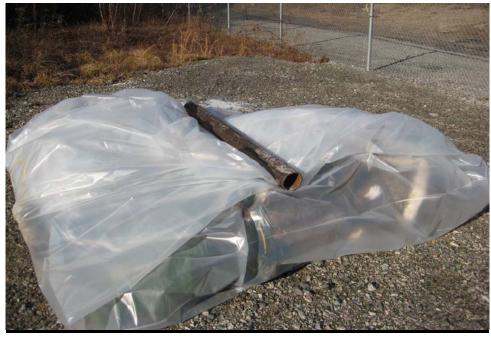
Photo No. 19- Project waste bundled in poly-sheeting, stored upland
