**008**  
**HARRISVILLE POND**

## HARRISVILLE POND DAM, BURRILLVILLE (008)

### 1.00 SUMMARY OF SITE AND POTENTIAL DOWNSTREAM IMPACT AREA

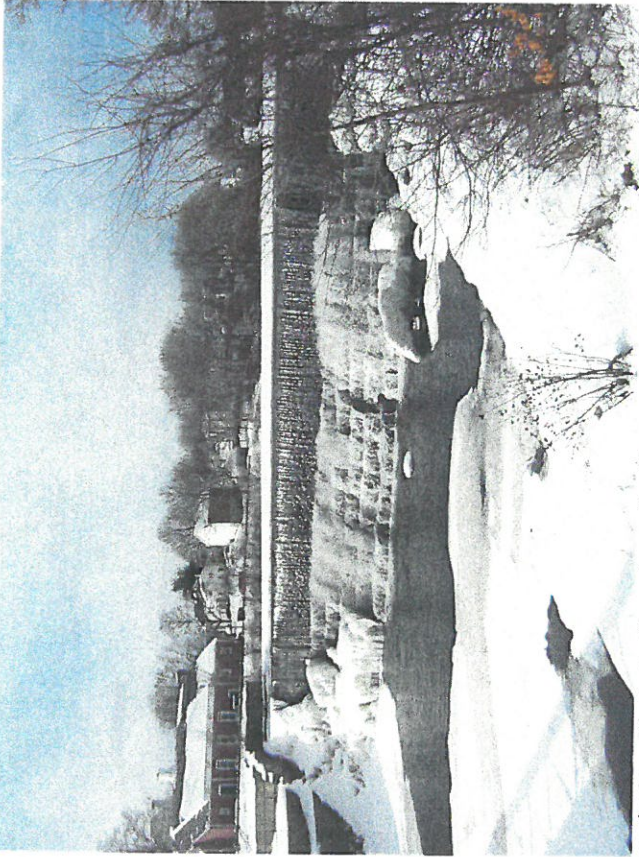
**Description:** Photo 1. Overview of spillway.

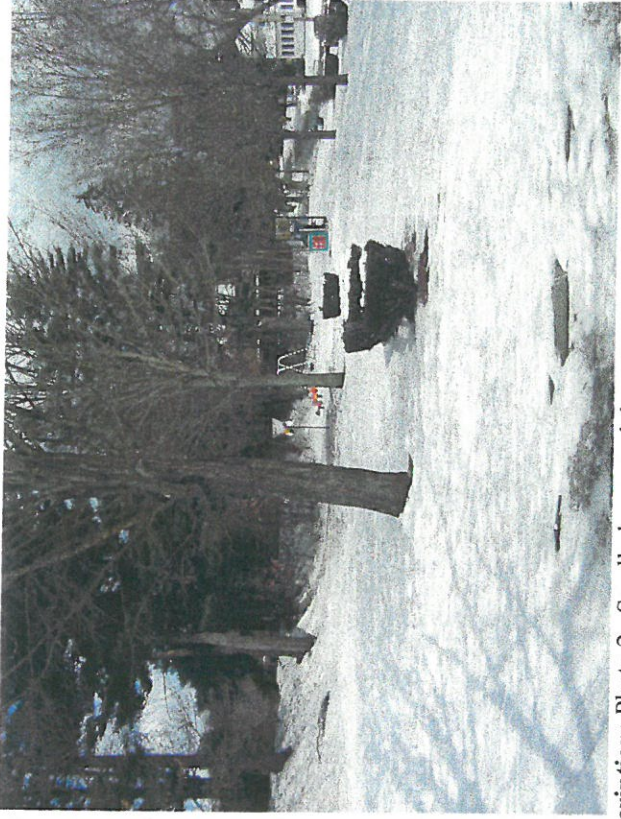
There is a playground and park immediately downstream of the left portion of the dam embankment. Additionally, there are residential structures along Steere Street, which runs parallel to the downstream toe of the embankment.

**Description:** Photo 2. Small playground downstream of left dam embankment.

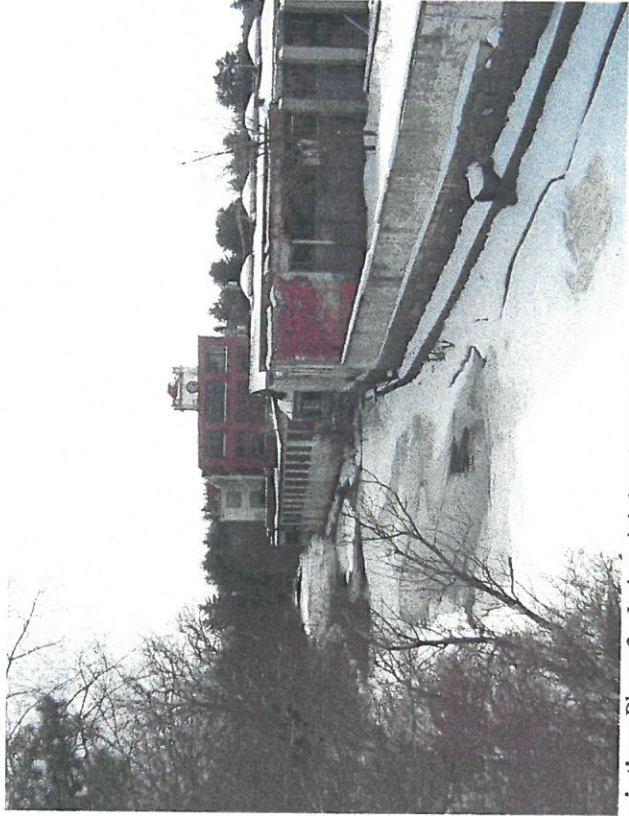
The right bank of the Clear River downstream of East Avenue is home to a large, unoccupied industrial complex. The industrial complex is partially protected by flood walls, estimated to be at least 15 ft high. However, the downstream portions of the complex immediately abuts the river.

**Description:** Photo 3. Industrial development (unoccupied as of GZA's visit on 1/29/2004) along the right river bank.

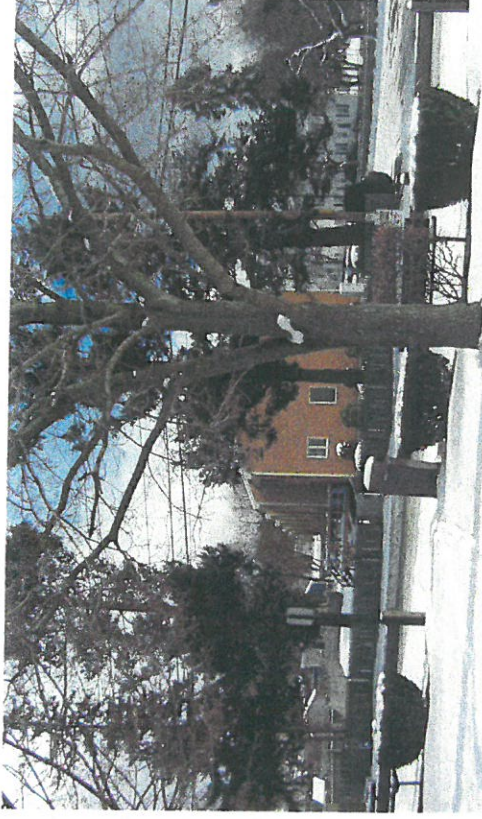
**Description:** Photo 4. Residential development downstream of the left dam embankment.

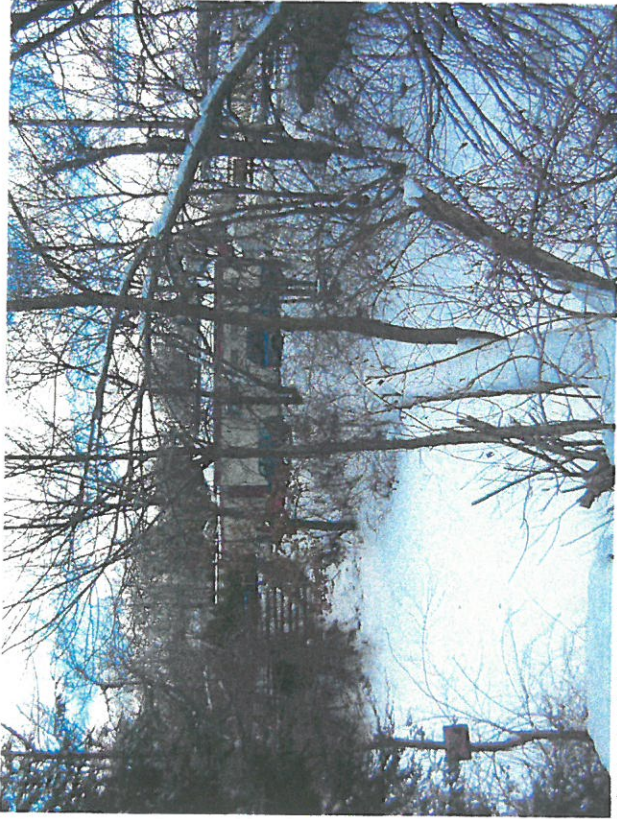
**Description:** Photo 5. Commercial / industrial structure on the left bank of the river about 2 miles downstream.

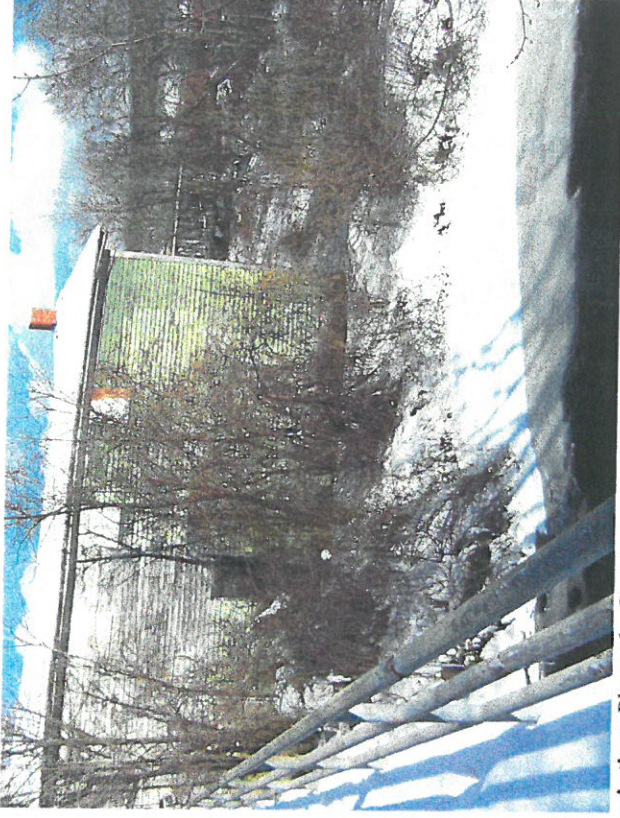
Commercial and residential structures were observed near the Clear River in the Oakland section of the Town of Burrillville near Route 102 and Victory Highway. These structures (some appeared to be unoccupied) were estimated to range from 8 to 15 ft above the river.

**Description:** Photo 6. Commercial / Industrial structure along the left riverbank near Victory Highway.

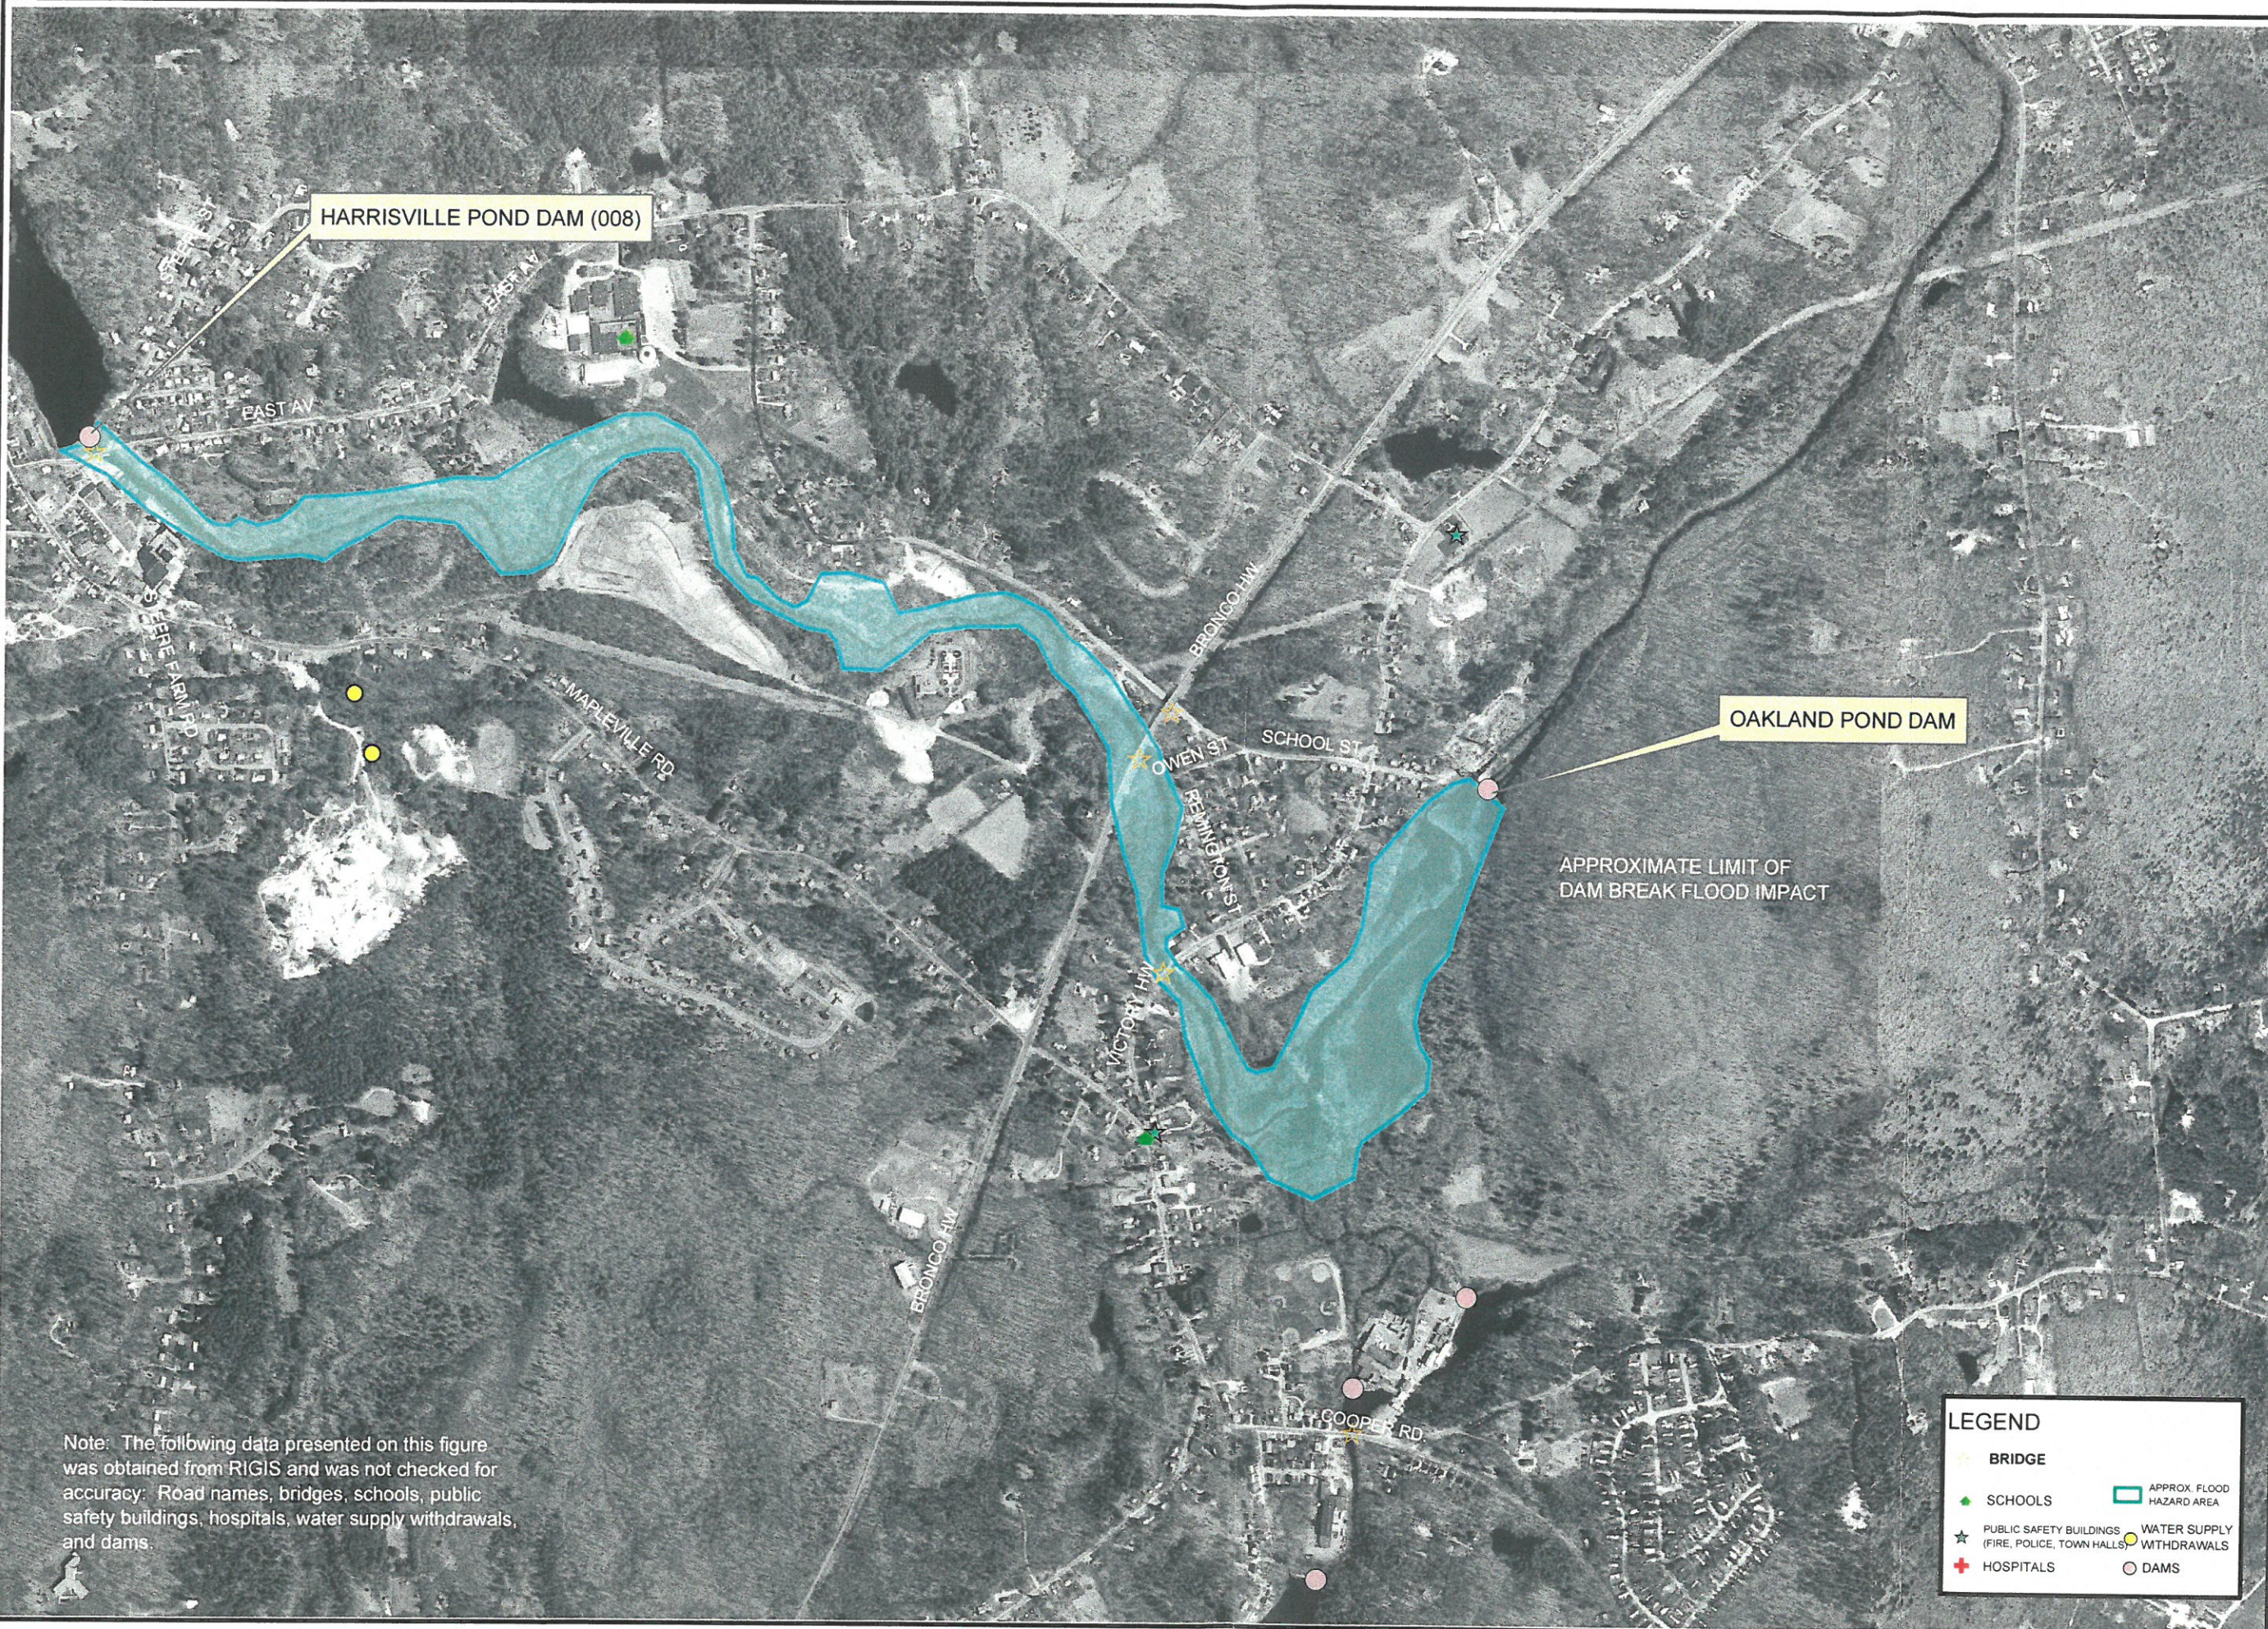
**FIGURE 2**

Several riverine cross sections, developed by GZA from USGS 7.5 minute quadrangle maps, were input into the SMPDBK model to preliminarily estimate approximate peak water surface elevations. The results of the analysis are provided as the approximate inundation area depicted in **Figure 2**.

Results of the analysis indicate a peak flood depth at the immediate toe of the dam of about 9 feet. As the flood wave progresses downstream, it is expected to attenuate. Thus, peak flood flows 1.7 miles downstream of the dam are predicted to decrease to about 2,500 cfs. The extent of flooding due to the hypothetical dam break is likely to include portions of the unoccupied industrial complex downstream of the dam. Shallow flooding of commercial and residential structures may also occur in the vicinity of the Oakland section of town, near Route 102 and Victory Highway. Note that if the dam were to fail at its embankment section, shallow overland flow would likely occur at the playground and Steere Street as the flood wave works its way back to the river channel. Such a failure would likely result in some flooding of the residential structure opposite the dam and playground on Steere Street.

GZA recommends that Harrisville Pond Dam be classified as *Significant Hazard* based on the aforementioned analyses, site / downstream valley reconnaissance, site-specific GIS

mapping and other existing data, and professional judgment. A potential dam failure of Harrisville Pond Dam would likely result in no probable loss of human life, but cause widespread, major economic losses, including some scour damage to East Avenue (Route 107) bridge, and flooding of the unoccupied mill buildings abutting the river downstream of the spillway. Commercial and residential buildings at Steere Street, Route 102 (Bronco Highway), and Victory Highway are also susceptible to shallow flooding as a result of the hypothetical dam failure. Note that if the unoccupied industrial complex downstream of East Avenue (Route 107) is renovated and/or becomes occupied, a *High Hazard* classification is recommended.
