**021**  
**CHERRY VALLEY POND DAM**

## CHERRY VALLEY POND DAM, GLOCESTER (021)

Cherry Valley Pond Dam (Figure 1) has been classified by DEM as having a **Significant Hazard** potential. The following report summarizes GZA’s evaluation of the dam’s potential impact area due to failure of the dam.

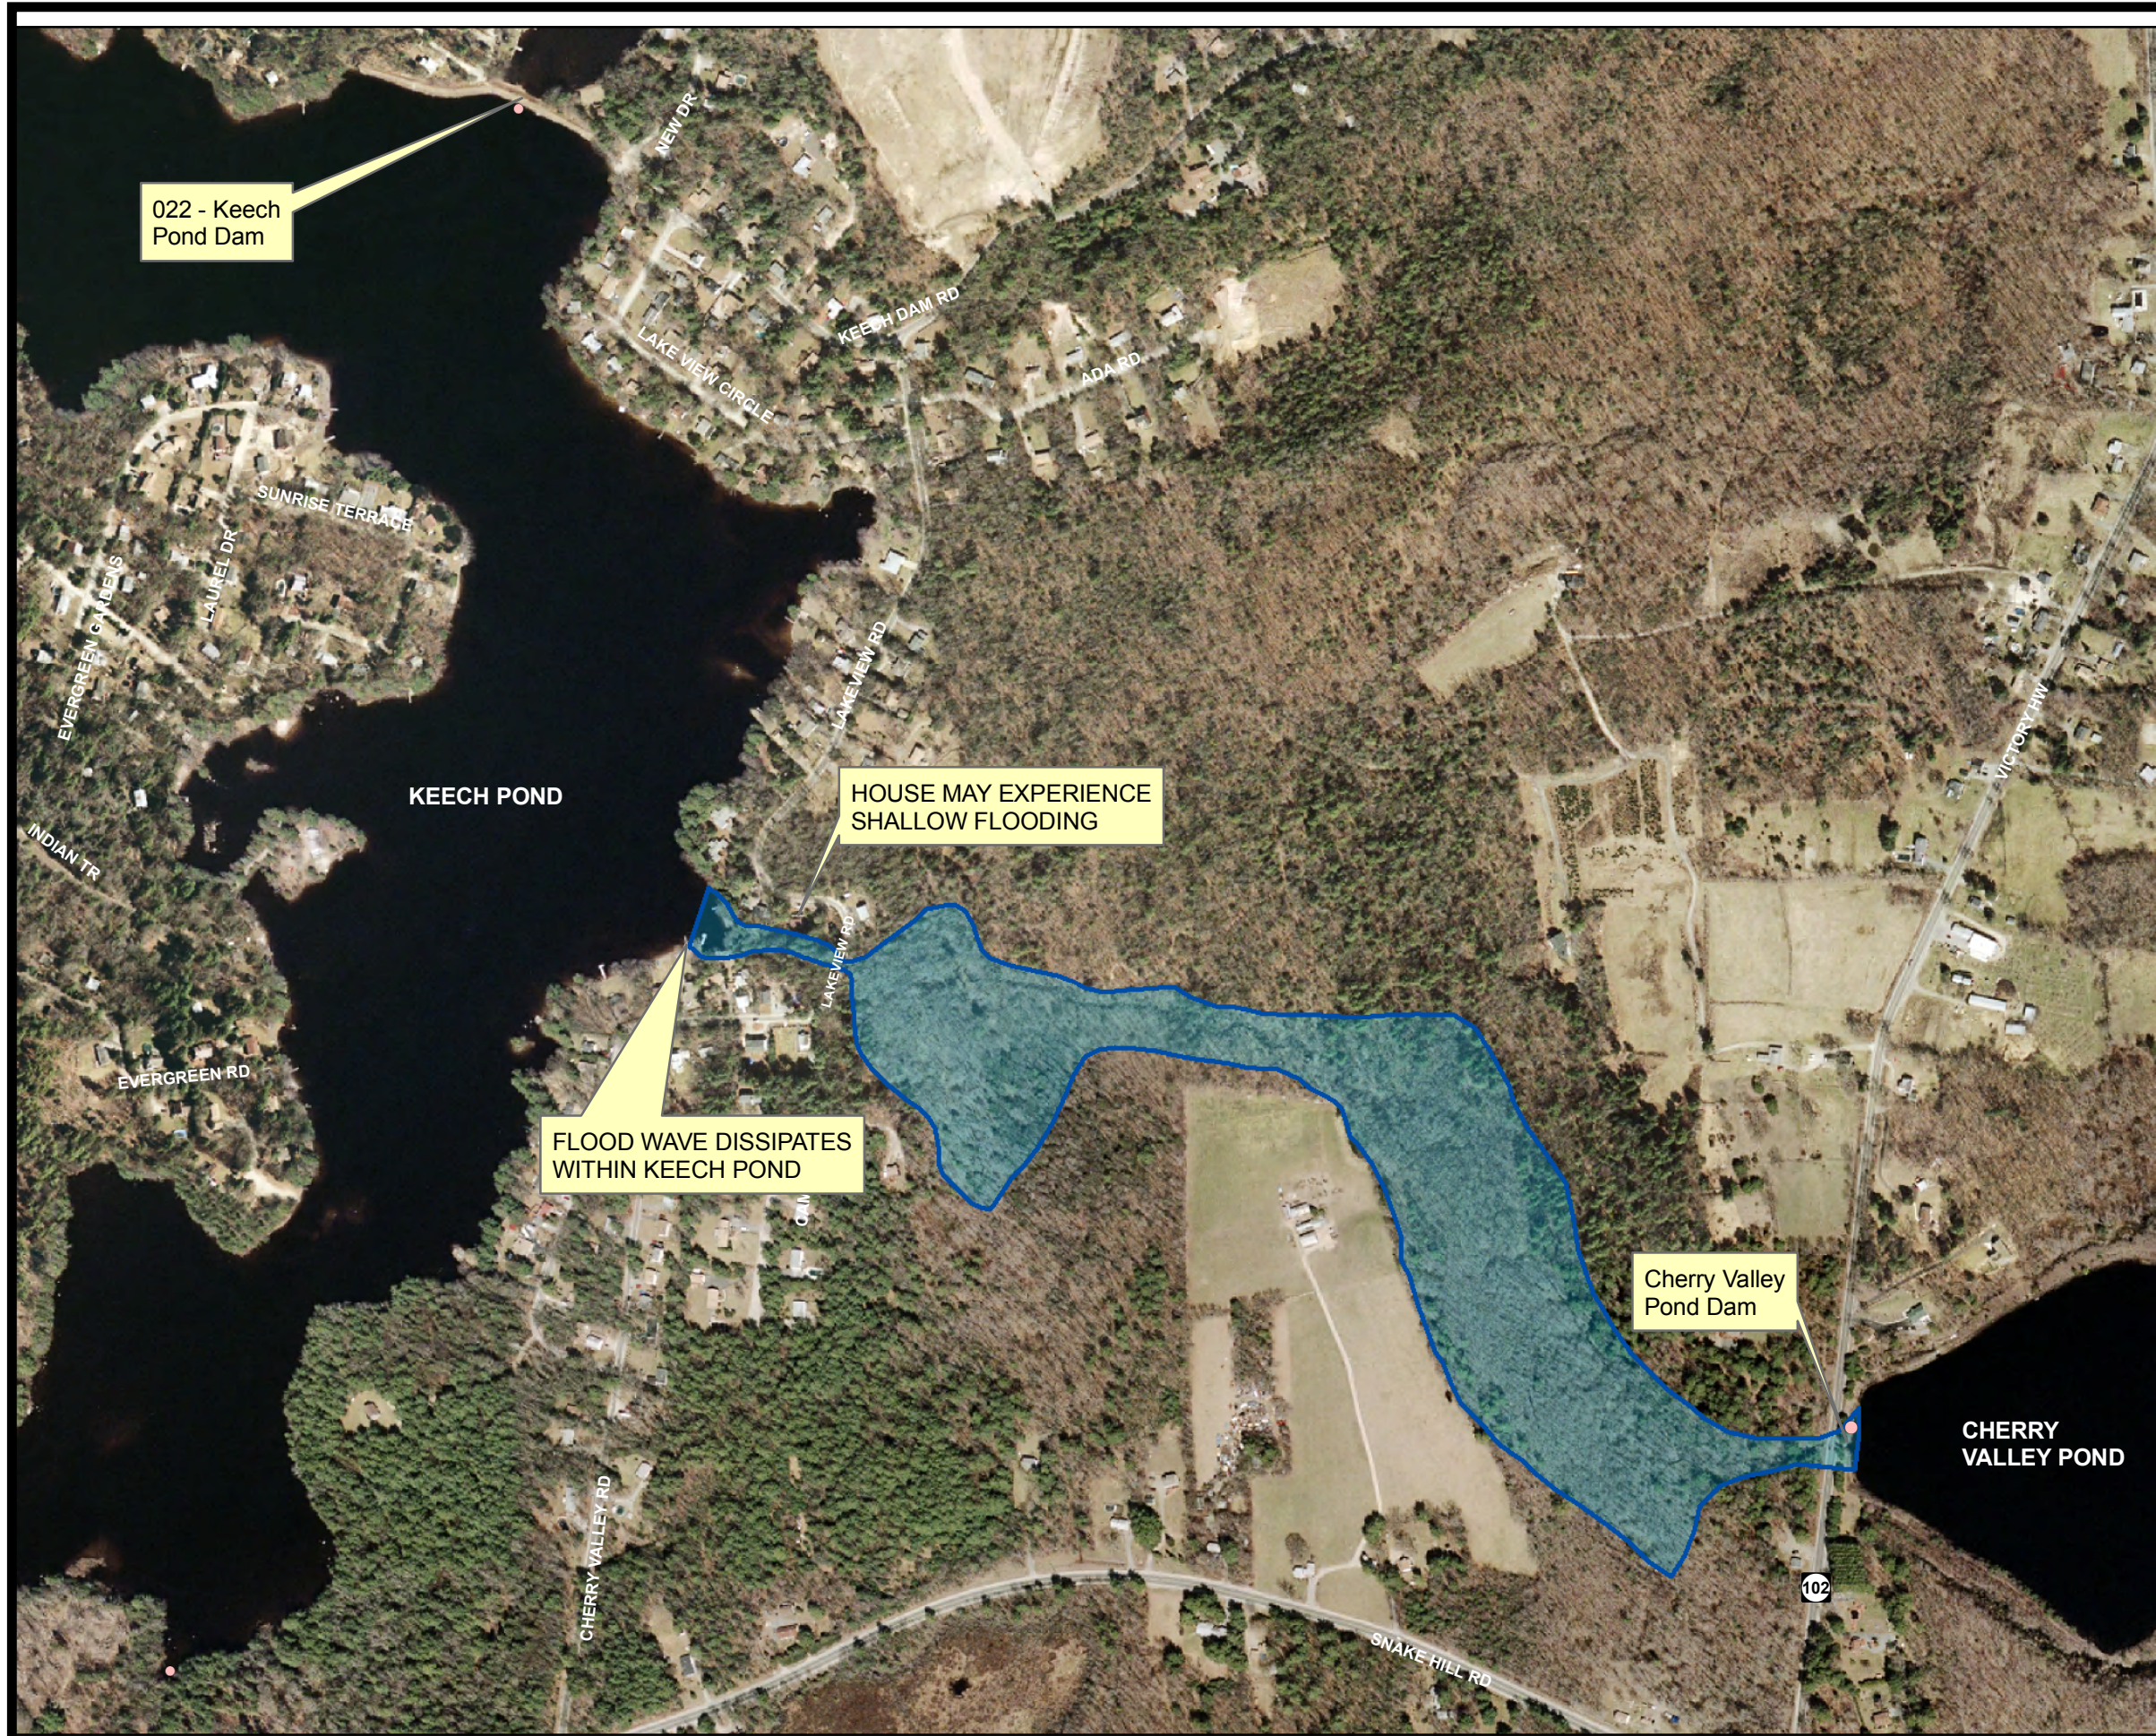
Proj. Mgr.: DML	Dwg. Date: 11-02-07	Figure No.:
Designed By: BBF	Job No.: 17085.30	<b>2</b>
Reviewed By: PHB		
Operator: BBF

Several riverine cross sections, developed by GZA from USGS 7.5 minute quadrangle maps, were input into the SMPDBK model to preliminarily estimate approximate peak water surface elevations. The results of the analysis are provided as the approximate inundation area depicted in **Figure 2**.

A potential dam failure of Cherry Valley Pond Dam would, by default, result in the destruction of Victory Highway (State Route 102) at top of the dam. Also, the Lakeview Road crossing is expected to be washed away due to its limited culvert discharge capacity. In addition, a house located near the confluence of the Chepachet River with Keech Pond may experience some shallow flooding. Loss of life is not expected due to the hypothetical dam failure of Cherry Valley Pond Dam, in GZA's opinion. Results of the analysis indicate a peak flood depth of about 6 feet about 0.5 miles downstream of Cherry Valley Pond Dam. Then the flood wave attenuates to less than 1 foot at Keech Pond approximately  $\frac{3}{4}$  miles downstream of Cherry Valley Pond.

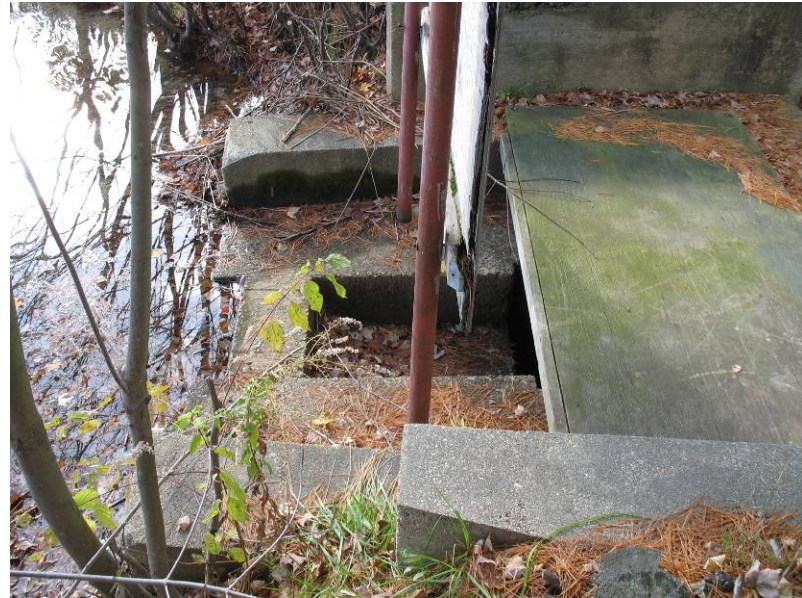
Photo 2: View of spillway from top of dam.

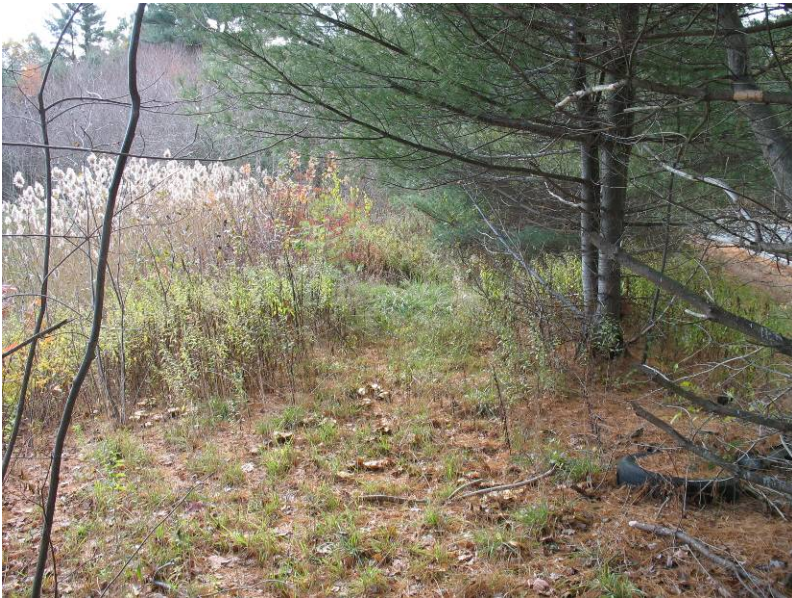
Photo 3: View of crest looking toward the left abutment.

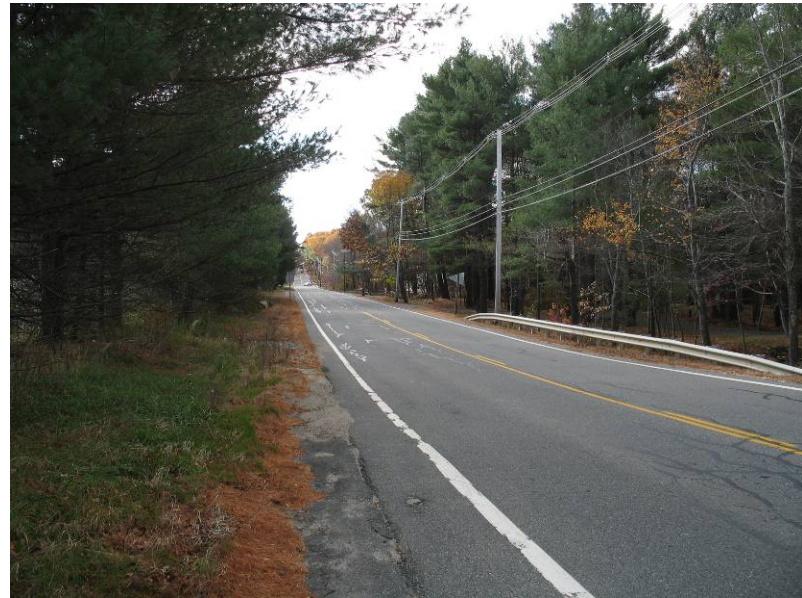
Photo 4: Victory Highway (Route 102) on top of dam.

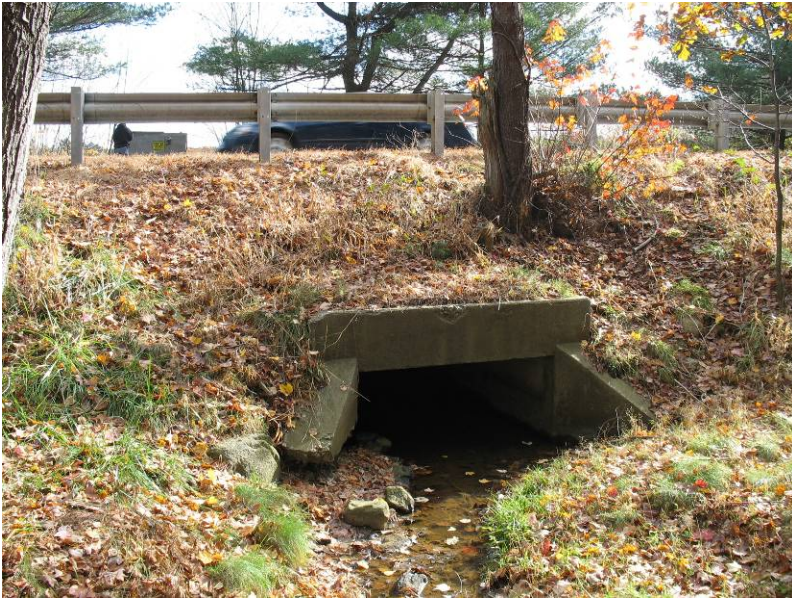
Photo 5: View of dams' outlet looking upstream.

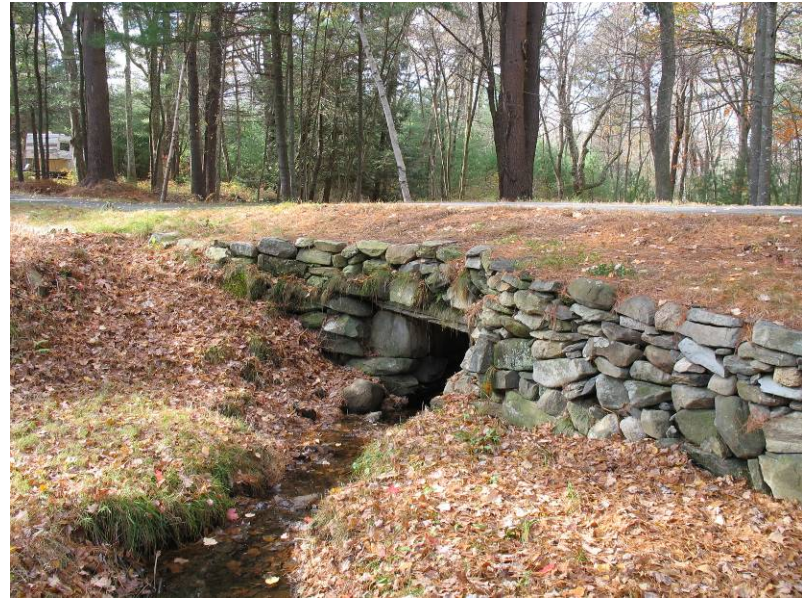
Photo 6: View of private driveway with culvert about 50 ft downstream of the dams' outlet.

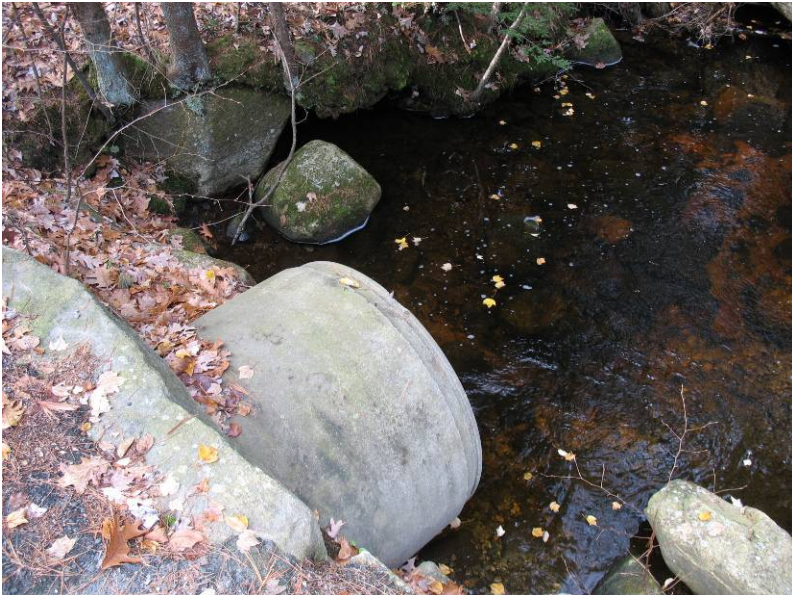
Photo 7: 4-foot diameter pipe under Lakeview Road.

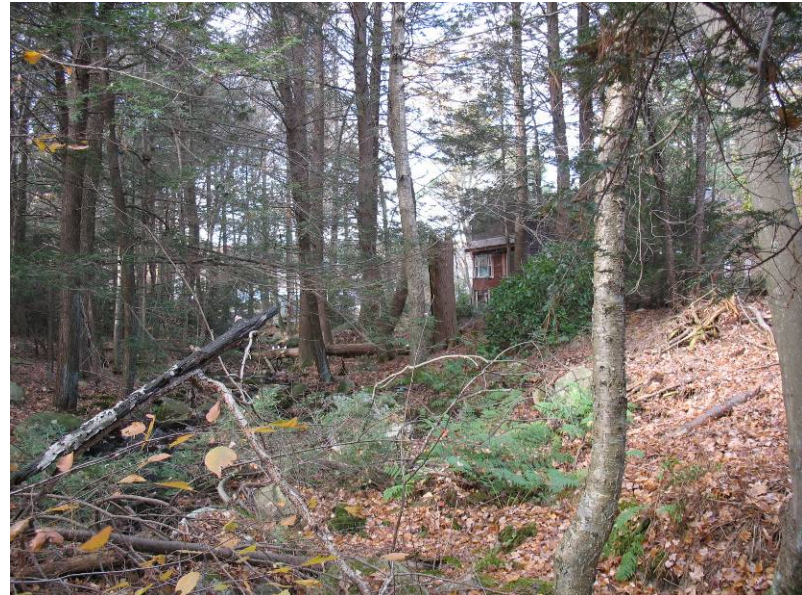
Photo 8: Note house near the stream, about  $\frac{3}{4}$  miles downstream of dam in a relatively low elevation.
