Barden Reservoir Dam

VISUAL INSPECTION / EVALUATION REPORT

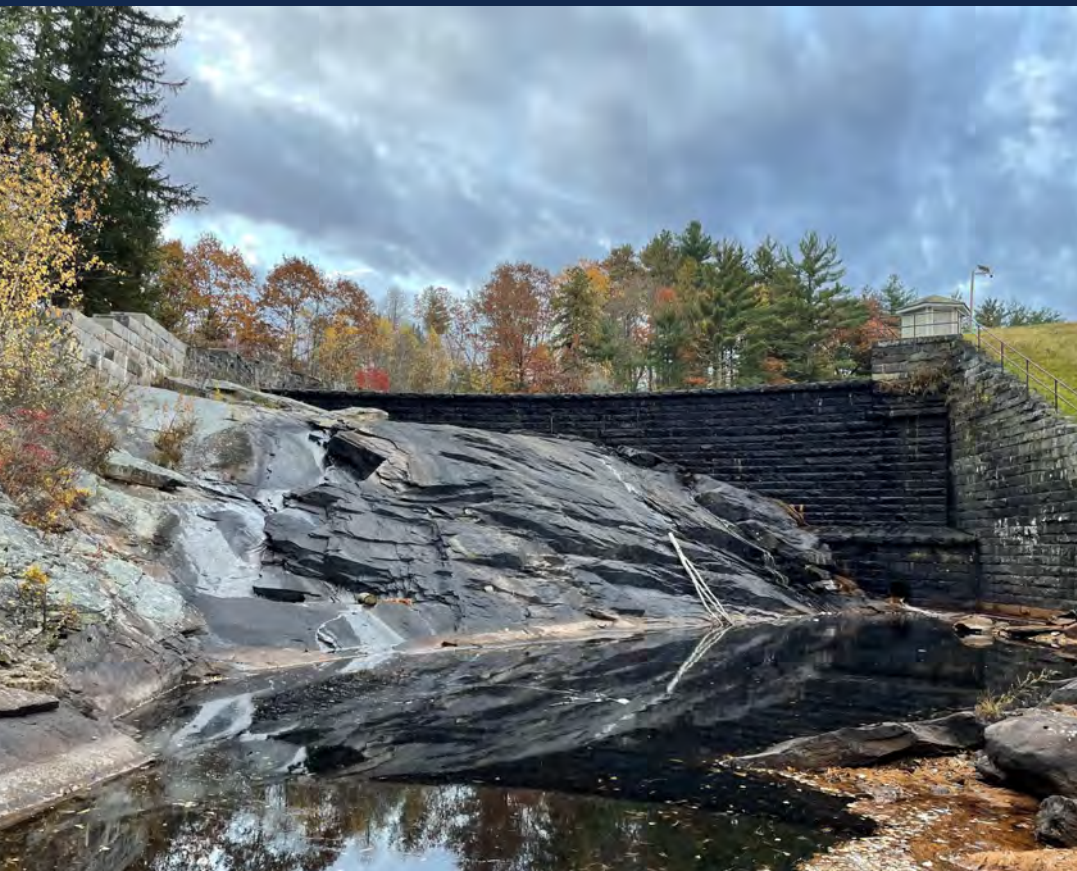
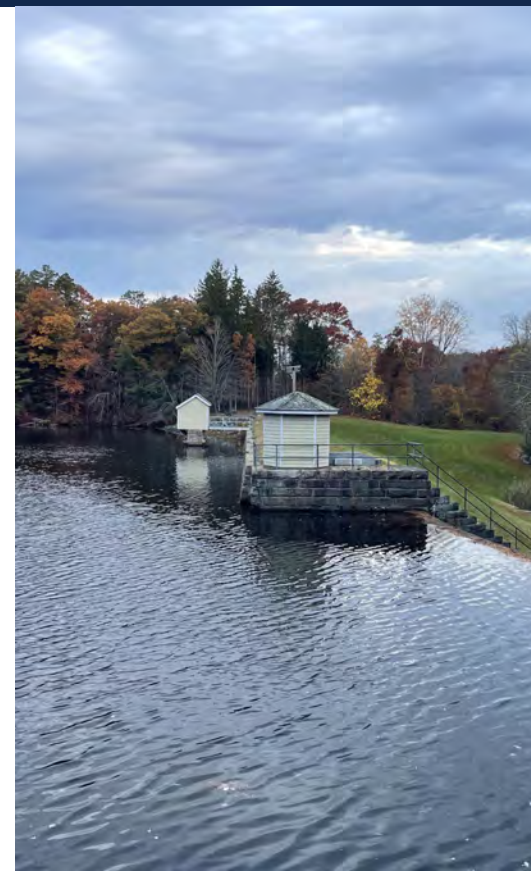
**PARE**
CORPORATION
10 Lincoln Road, Suite 210
Foxboro, MA 02035

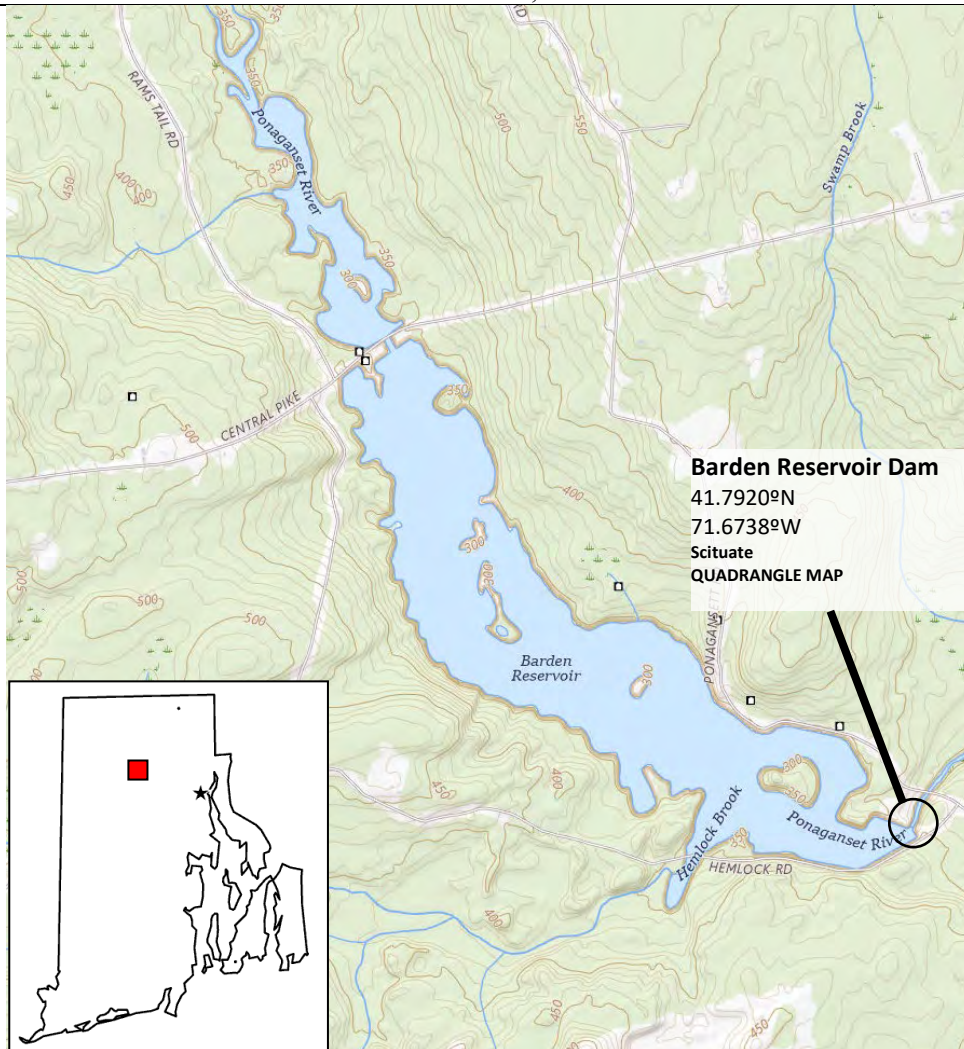
When describing the dam, “left” and “right” refer to the respective sides of the dam as viewed when facing downstream (with normal flow of water).

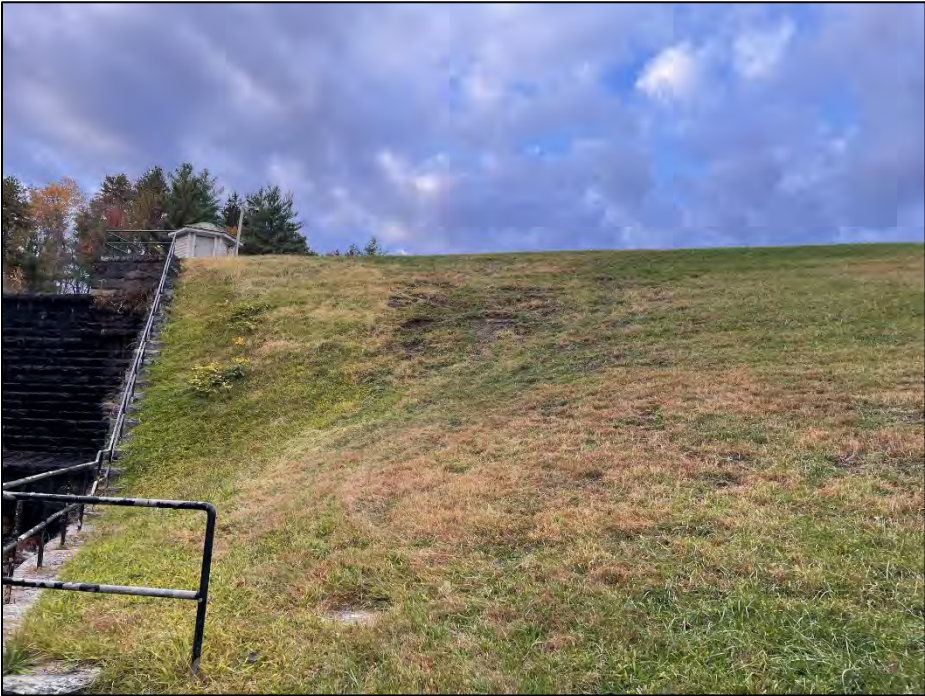
Photo No. 8.: Downstream slope from left of spillway channel looking upstream Note isolated areas of turf damage.

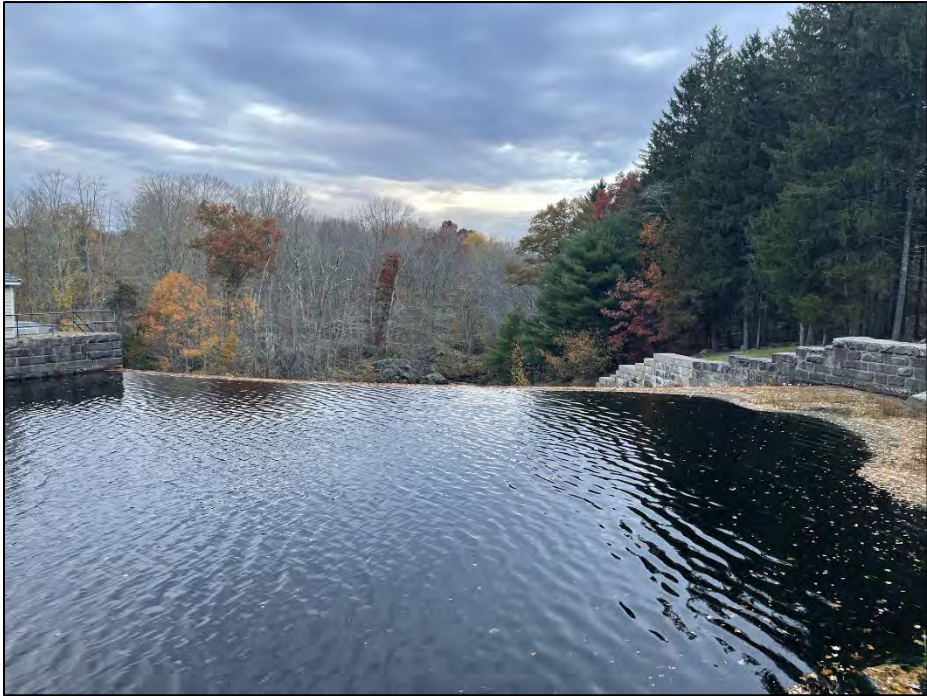
Photo No. 9.: Approach to the spillway looking downstream.

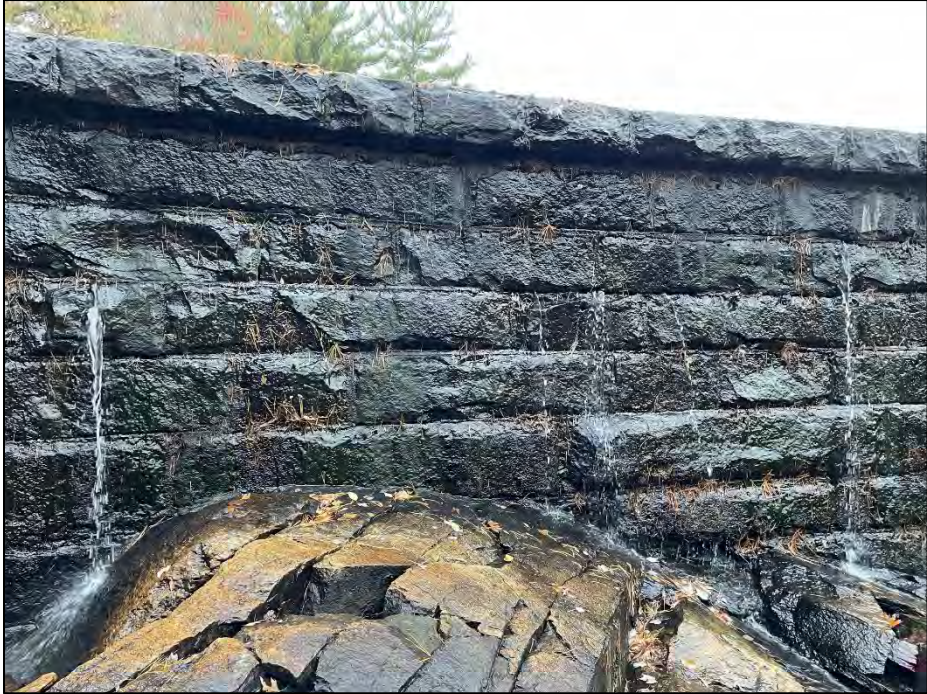
Photo No. 11.: Minor leakage through stone masonry blocks of the spillway.

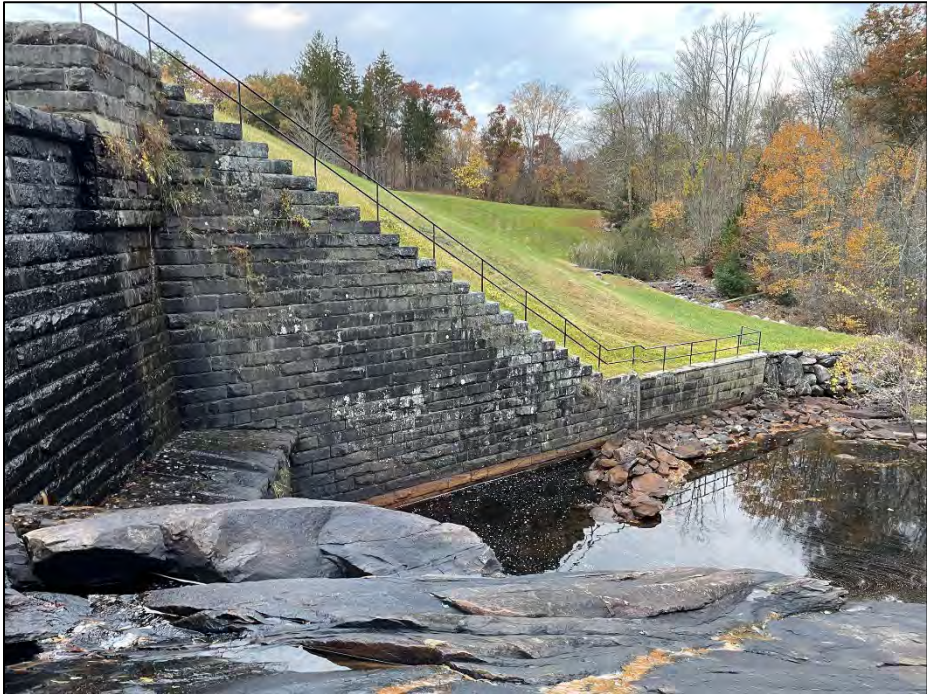
Photo No. 12.: Overview of left downstream training wall of the spillway.

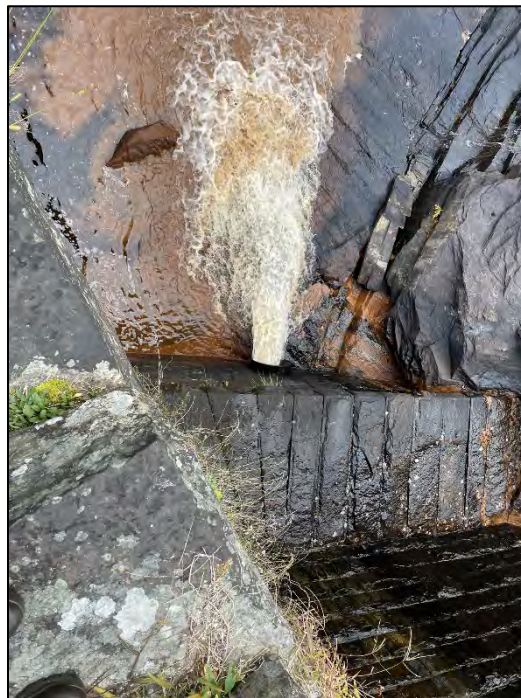
Photo No. 18.: Discharges through the outlet conduit following operations of the gate valve within the gatehouse; note that the iron oxide staining within conduit was flushed out after approximately 15 seconds of flowing.

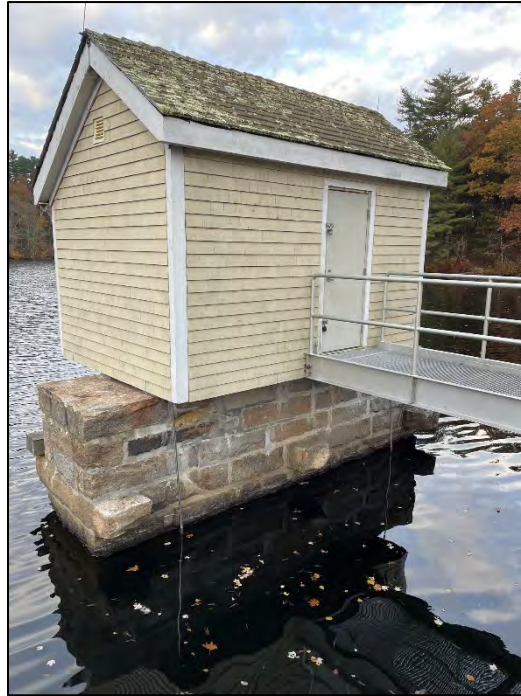
Photo No. 19.: Overview of the exterior of the gatehouse of the "Mill Supply" outlet system.

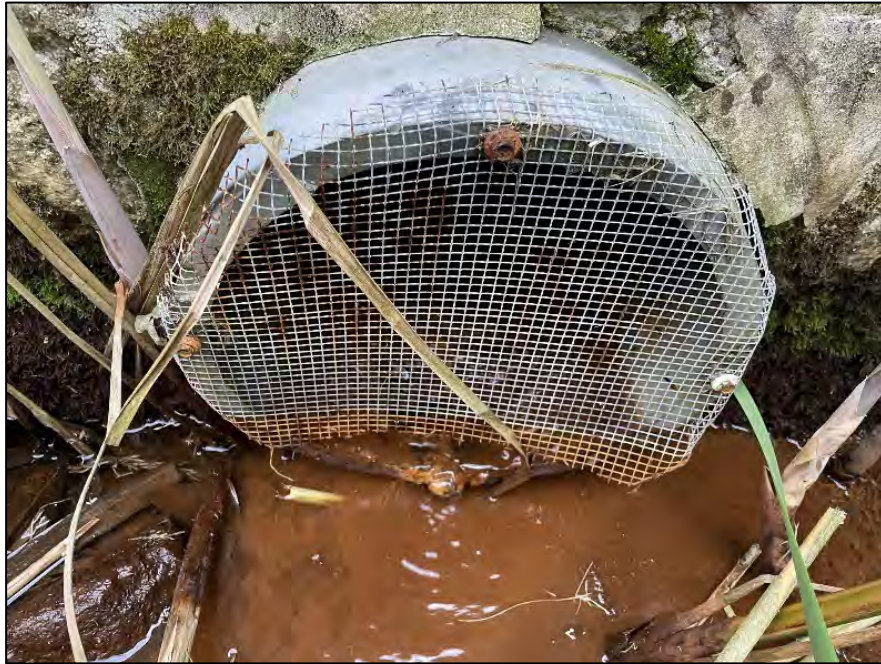
Photo No. 25.: Toe drain outfall at the "Mill Supply" low level outlet headwall. Note the iron oxide staining and the chewed-out bottom of the rodent screen.

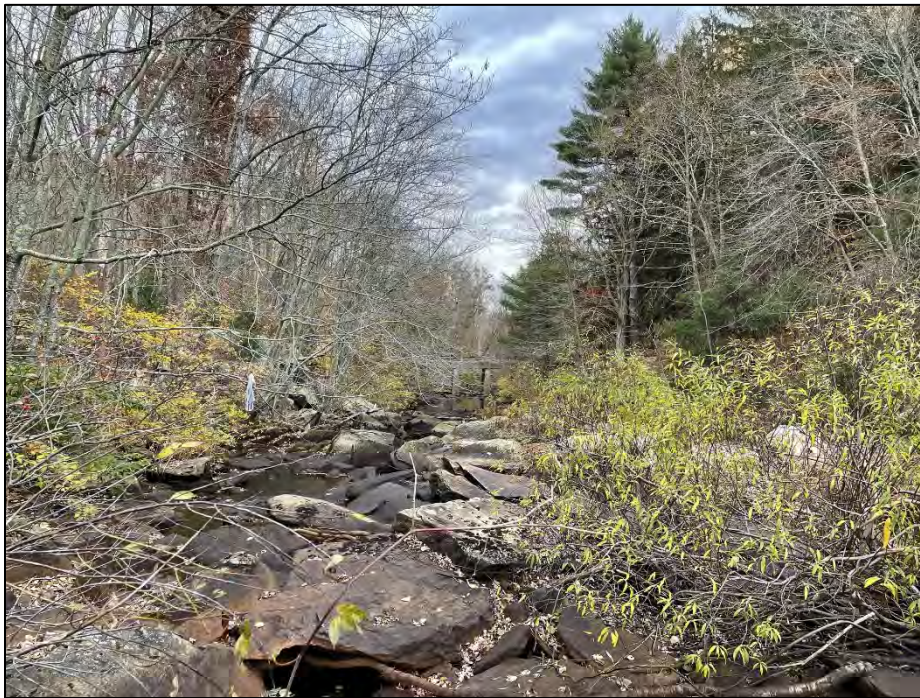
Photo No. 26.: Downstream channel of the spillway from where the "Old Mill Channel" diversion channel converges with the downstream channel of the spillway looking downstream.
