-- WYOMING UPPER DAM --
VISUAL INSPECTION / EVALUATION REPORT

Dam Name: Wyoming Upper Dam

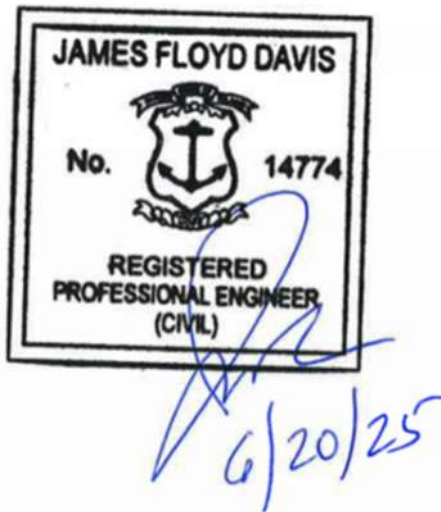
JAMES F. DAVIS, P.E.

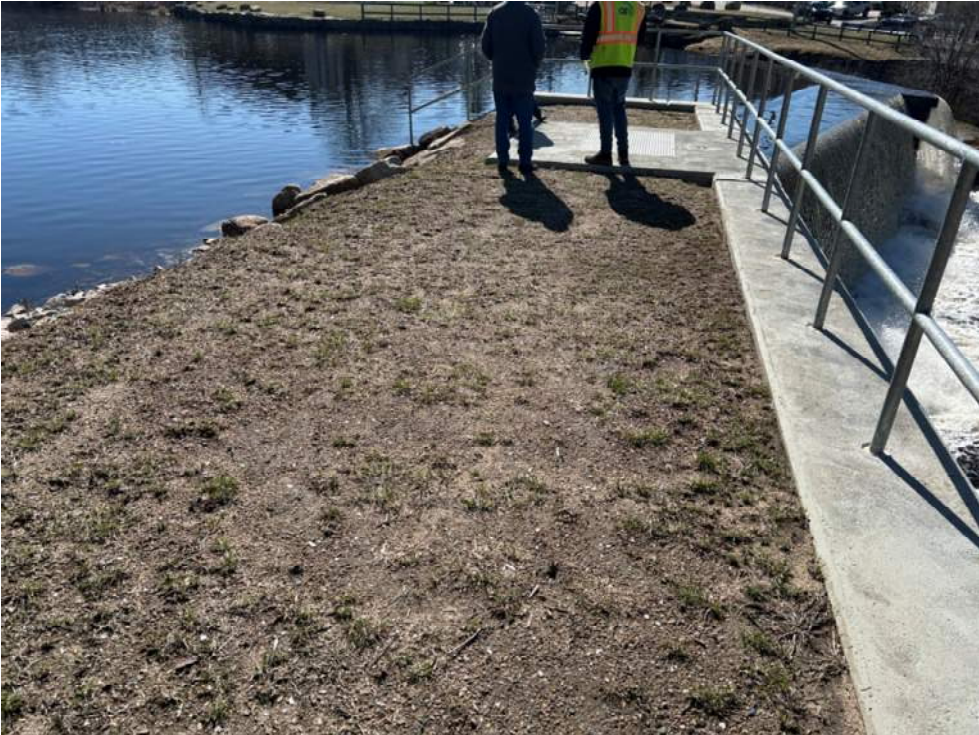
Direction Photo Taken: East			
Description: Overview of right embankment. Sparse grass cover observed and large areas of exposed soil.

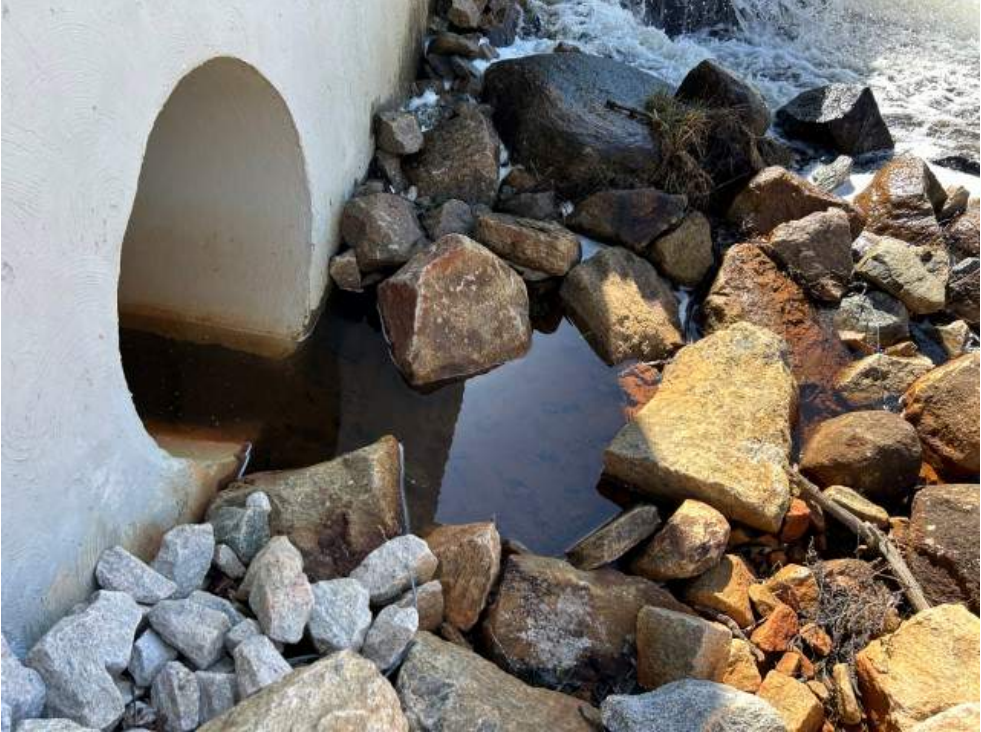
Direction Photo Taken: Down			
Description: Iron flocculent, limited leakage (estimated less than 1 gallon per minute) and pooling of water at the toe of the low-level outlet.

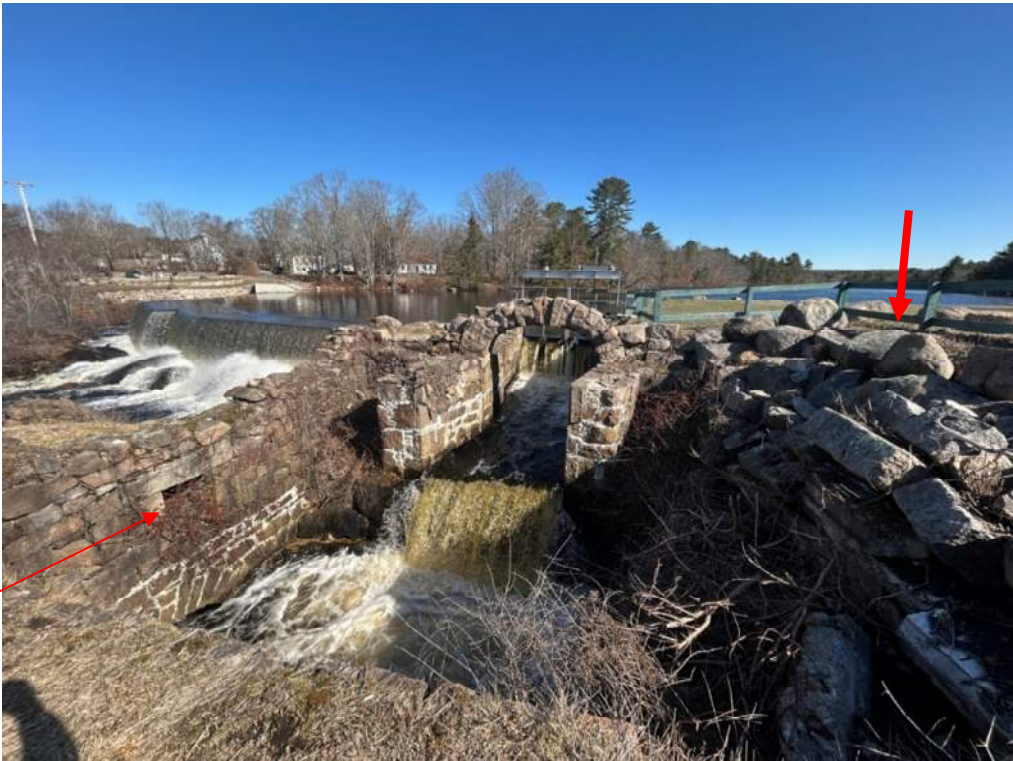
Direction Photo Taken: North			
Description: Overview of downstream sluiceway channel. Note the displaced stone masonry along the left side of the downstream channel. Refer to photo 16. Possible opening that soil is migrating through (see Photos 17 and 18)

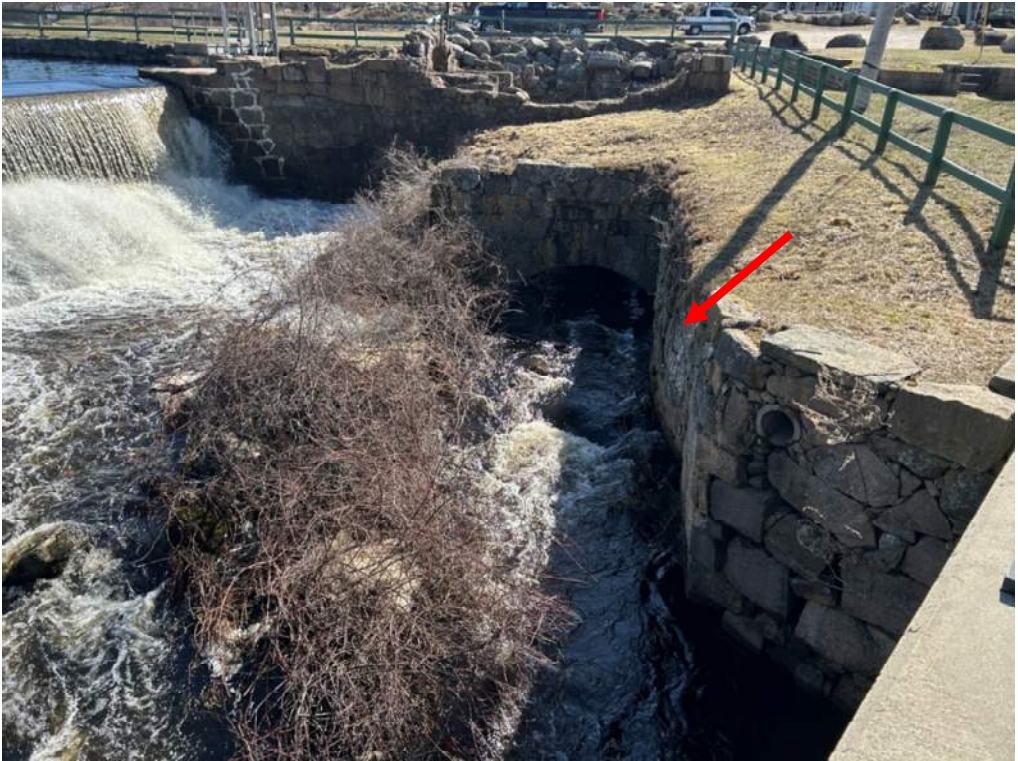
Direction Photo Taken: East			
Description: Overview of sluiceway downstream channel and culvert. Bulge along the downstream wall as noted in Photo 20.
