FINAL SITE CHARACTERIZATION AND SELF-IMPLEMENTING CLEANUP PLAN PAWTUCKET 1 No. 107 SUBSTATION - CONTROL HOUSE 6 THORNTON STREET PAWTUCKET, RHODE ISLAND

March 30, 2023 Coneco Project No. 5675.F.101

RE: **Final Site Characterization and Self-Implementing Cleanup Plan** Pawtucket 1 No. 107 Substation - Control House 6 Thornton Street Pawtucket, Rhode Island

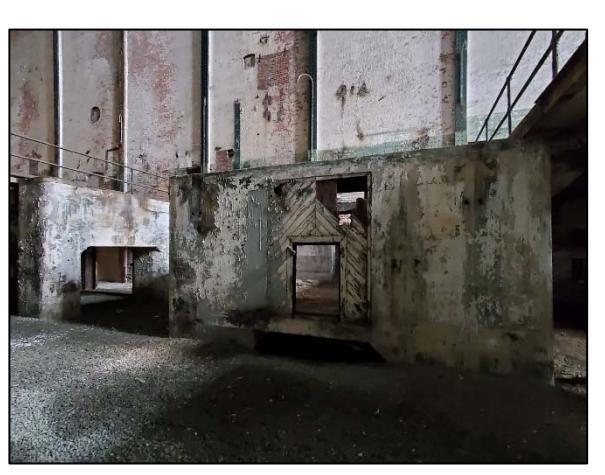
#### Photo 6

Concrete foundations associated with former turbines on September 2, 2021, as viewed from the southwest.

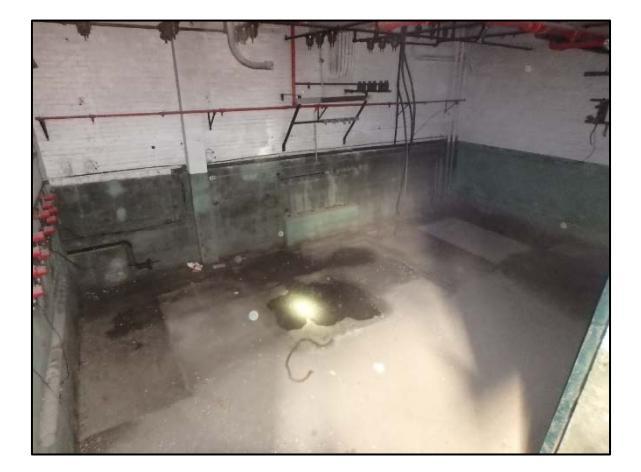
### Photo 7

Overview of Room No. 2, located adjacent to the Turbine Room on September 9, 2018, as viewed from the east.

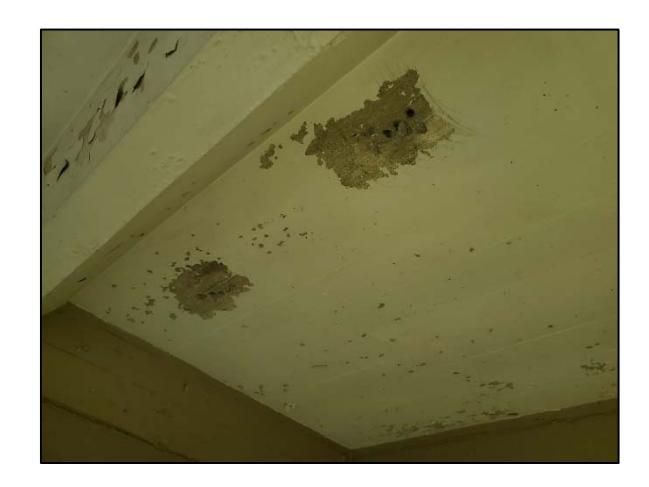
#### Photo 9

A view of paint and concrete ceiling samples collected from the second floor Office 1 on September 2, 2021.
