WATER QUALITY - BLACKSTONE RIVER

Final Report 2: Field Investigations

***Rhode Island
Department of
Environmental Management***

The Louis Berger Group, Inc.

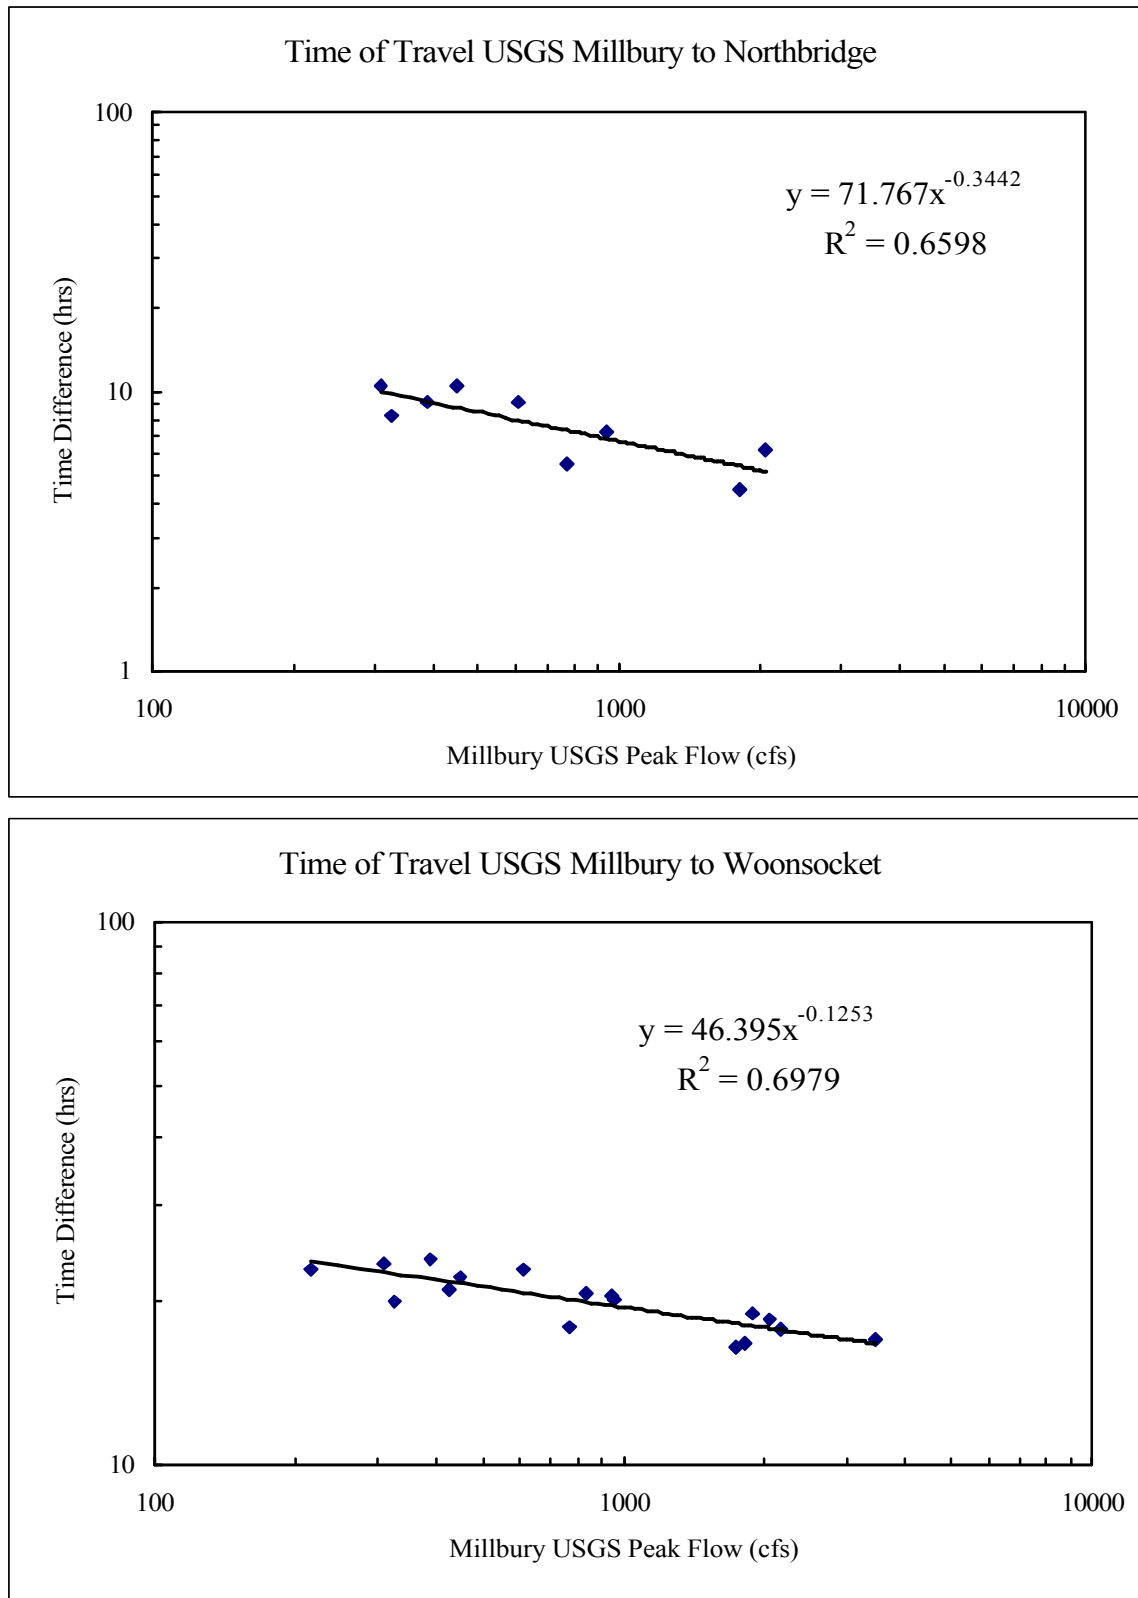
Figure 2-6: Time of Travel Relationships using Millbury USGS Peak Flow

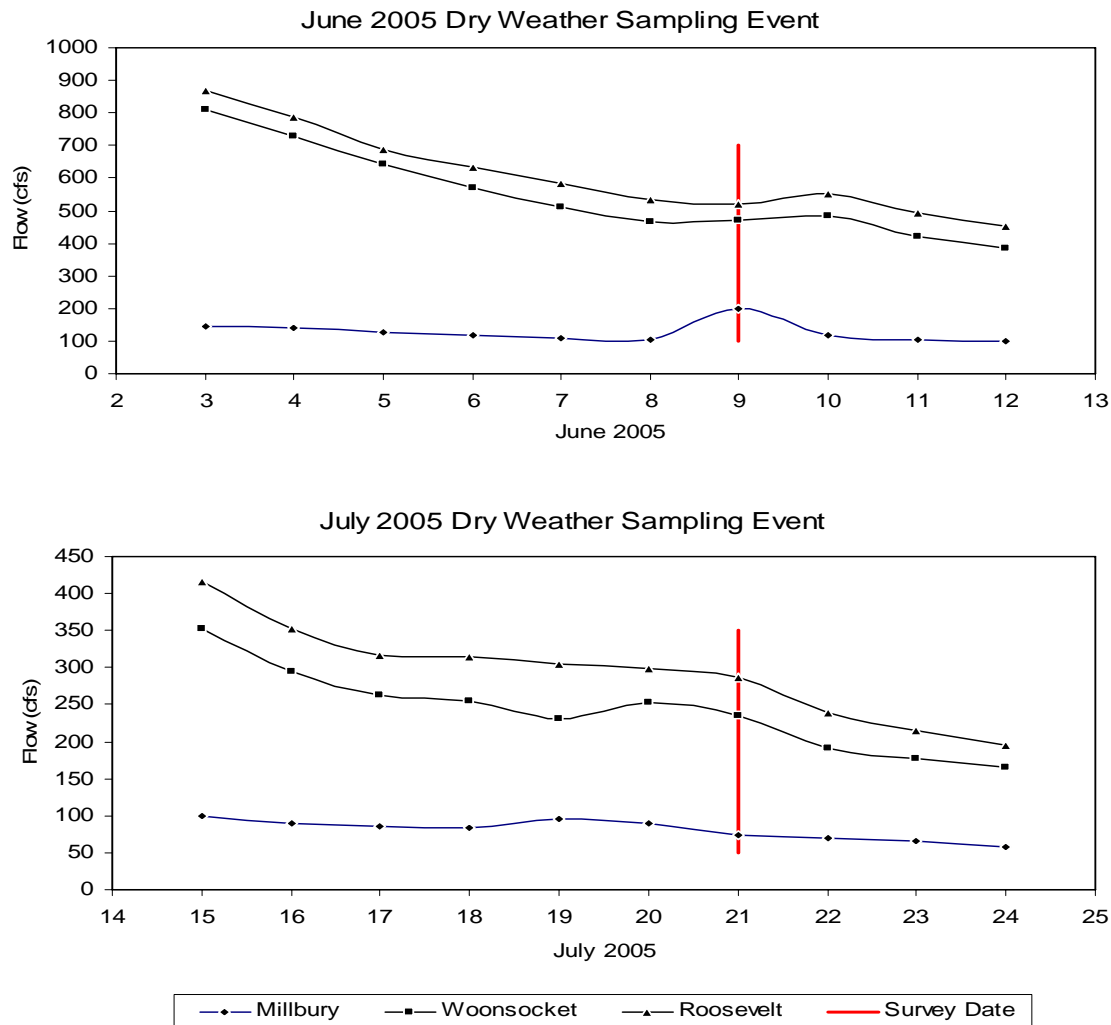
Figure 3-6: River Flows prior to June and July Dry Weather Sampling Events

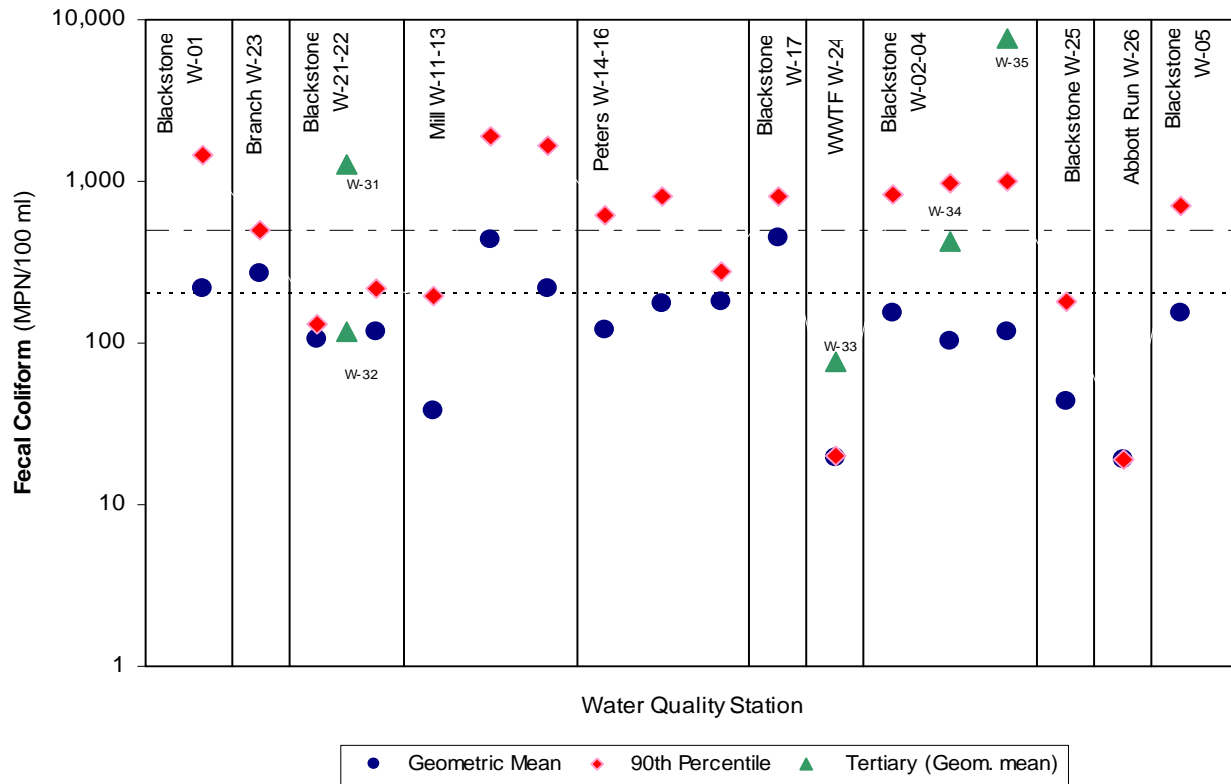
Figure 3-13: Dry Weather - Mean Fecal Coliform Concentrations (upstream to downstream)

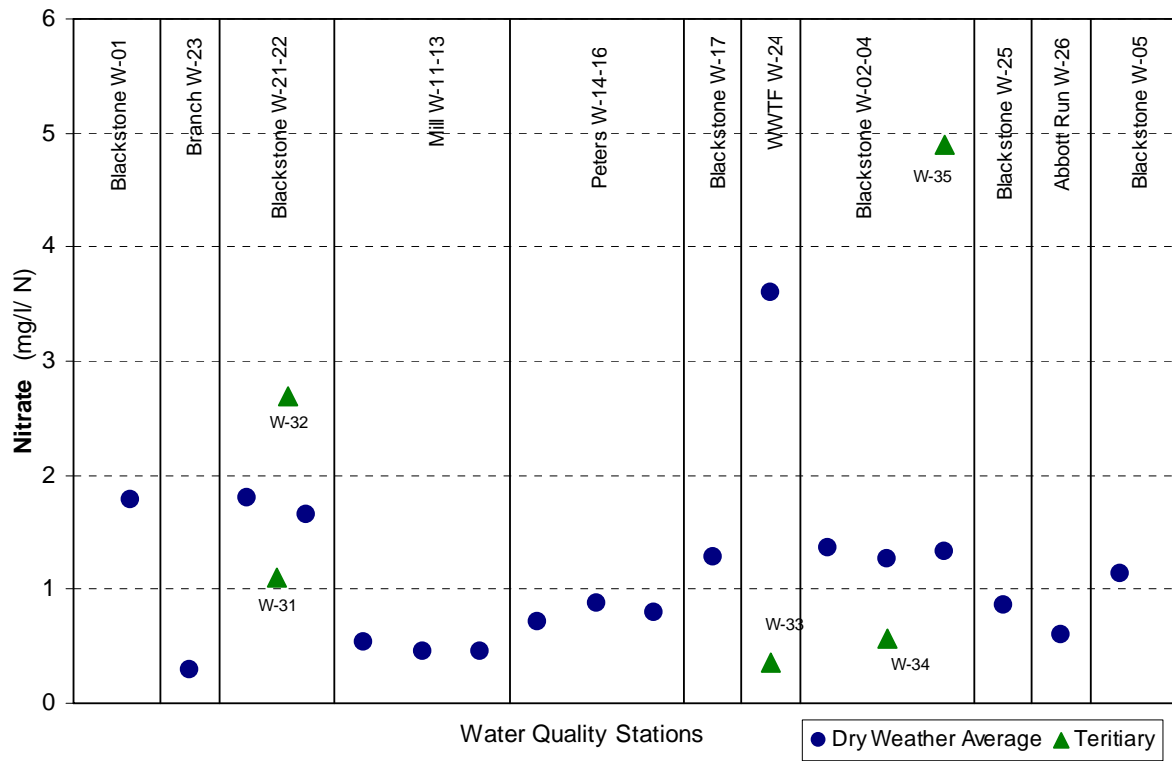
Figure 3-28: Dry Weather - Mean Nitrate Concentrations (upstream to downstream)

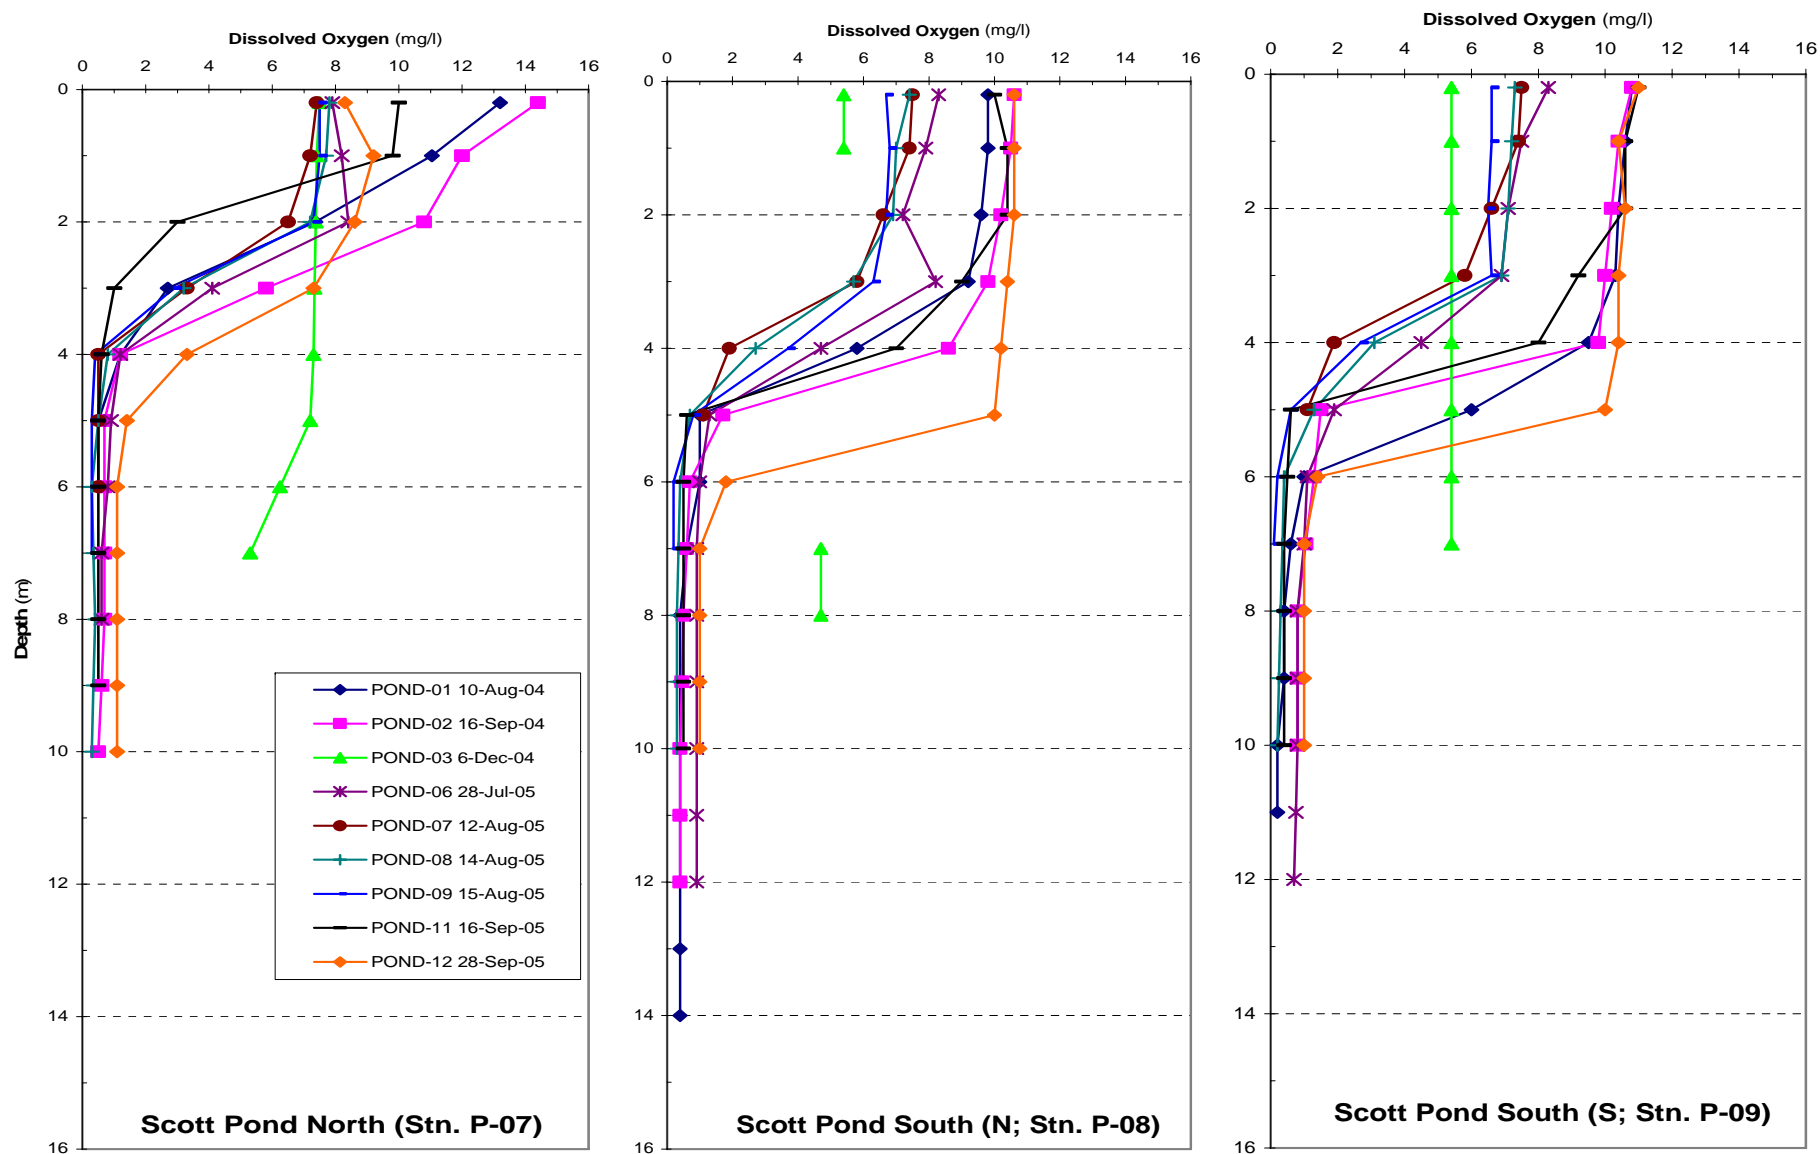
Figure 8-24: Dissolved oxygen with depth in Scott Pond North and South.

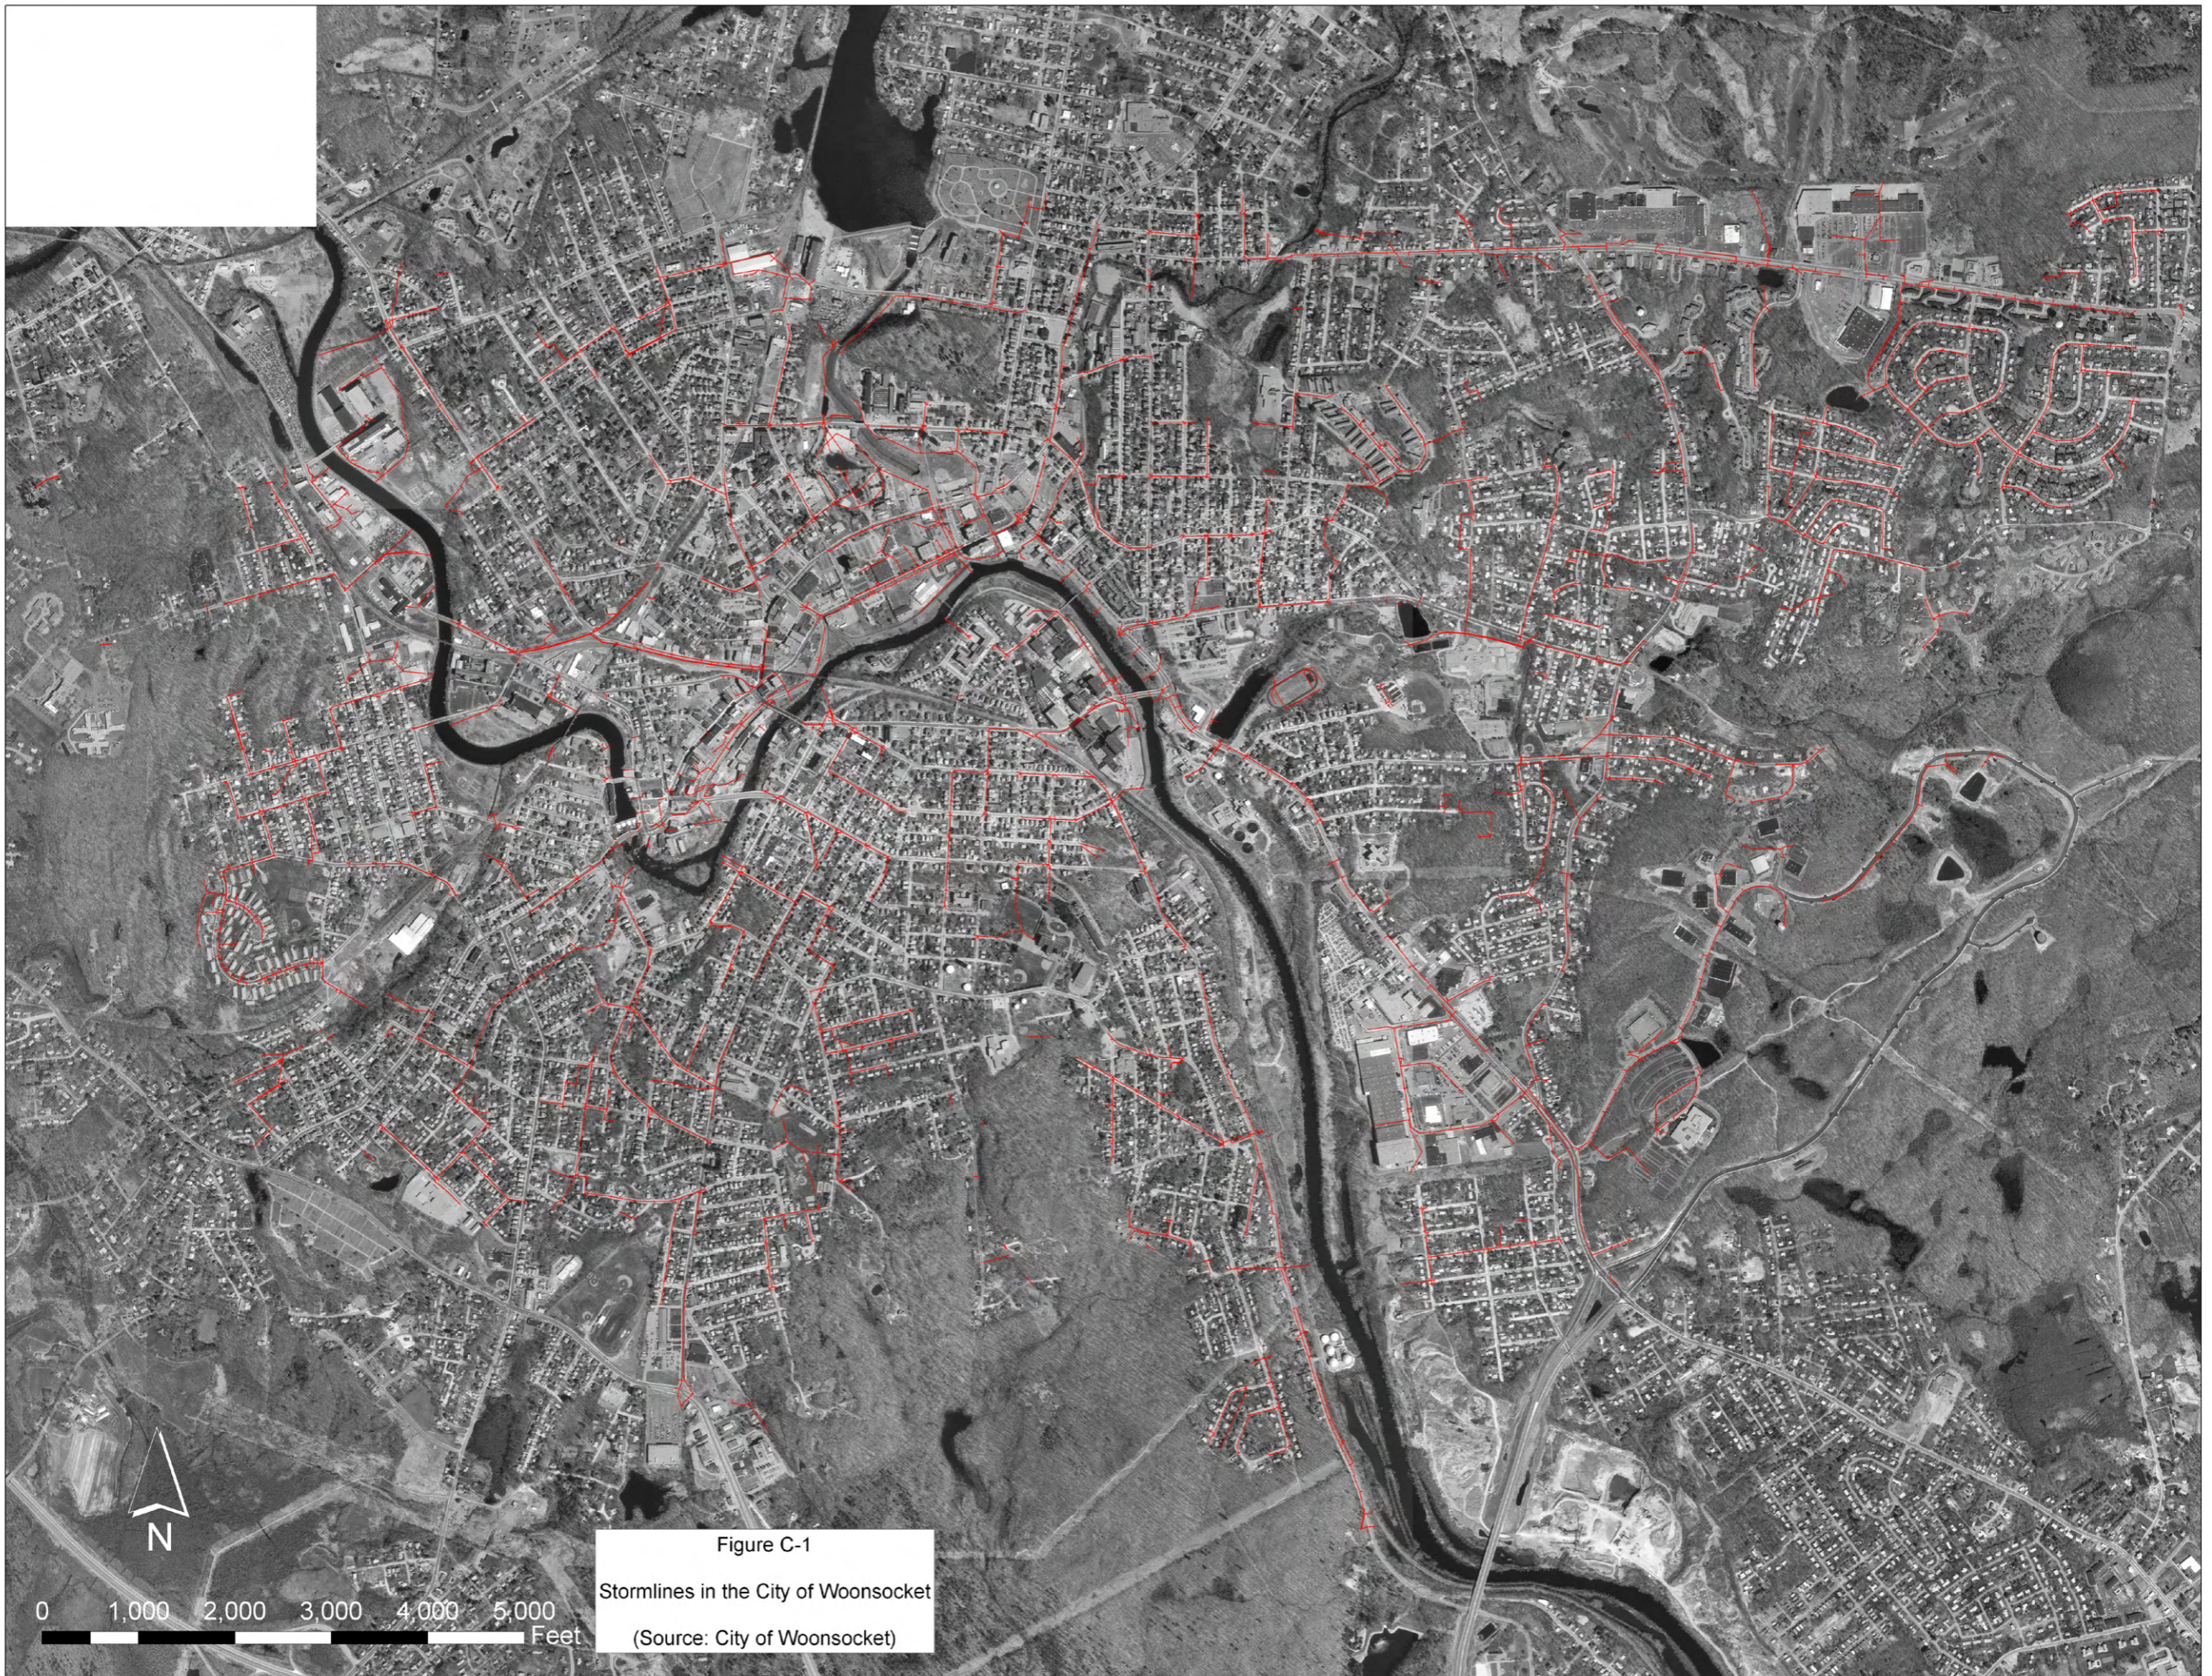
Stormlines in the City of Woonsocket

- Figure C-1 Aerial photograph with storm drains mapped by the City of Woonsocket (*enclosed in pocket in the back of the report*).
- Figure C-2 Map of very rough watershed boundaries for larger point sources in the Town of Cumberland. These boundaries are meant to be used for meant ONLY as a guide for more detailed watershed assessments as needed. See Figures 5-6 to 5-11 for corresponding outfall ID numbers.
- Figure C-3 Map with location of NBC CSO entering Valley Falls Pond in the City of Central Falls (numbered in this study as Outfall OF-501 [NBC CSO#007]).
- Figure C-4 Map with locations of other NBC CSOs entering the Blackstone River within the City of Central Falls. These outfalls were not studied.
- Figure C-5 Map with locations of other NBC CSOs entering the Blackstone River within the City of Pawtucket. These outfalls were not studied.
