**Department of Environmental Management  
Office of Waste Management**

**FIELD INVESTIGATION REPORT**

**Facility Name:** Portsmouth Town Dump  
**Date of Investigation:** September 29, 2014  
**Facility Address:** East Main Road, Portsmouth

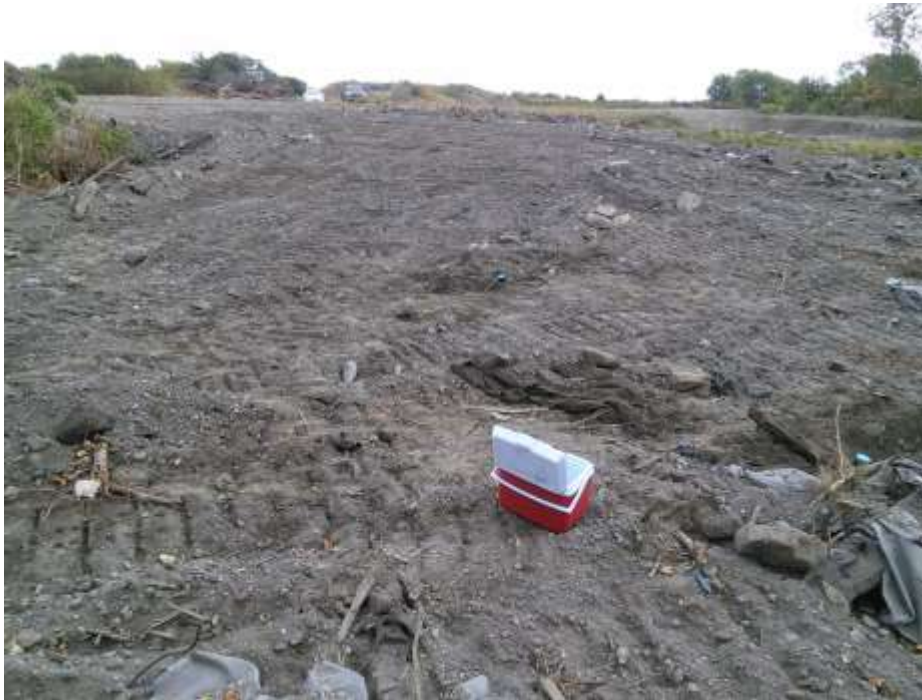
Photo 1:  
Sampling area looking south. East Providence material is in the foreground. Material from Newport is the terraced area in background on right.

I laid out a sampling grid at approximately 10 foot intervals. From each location I dug 3 shallow (<1 foot) holes and composited the soils from these 3 holes into 1 sample. I took 9 such samples I labeled SS-3 through SS-11. As my sampling was specific for arsenic I did not refrigerate the samples.

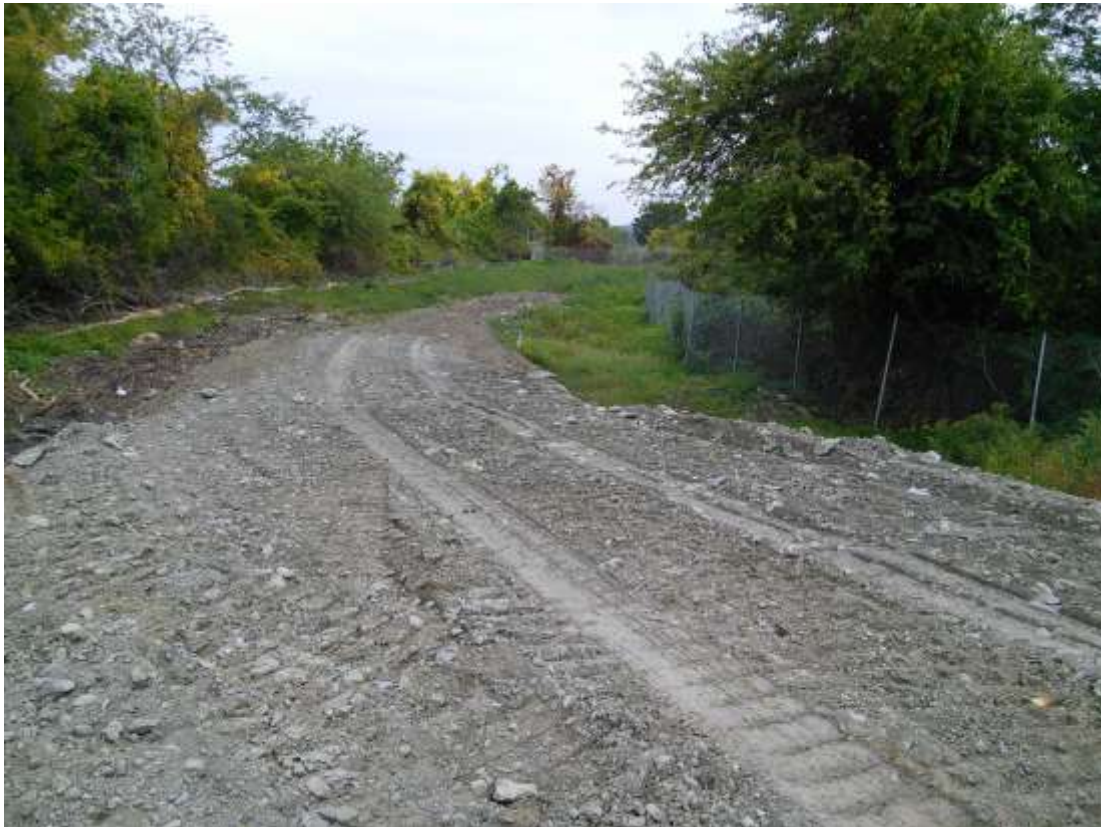
Photo 2: Newly spread out material on boundary of residential property in northeast corner of property.

We also walked the area adjacent to the residences in the northeast corner of the property where some clean material had been spread out as cover. I asked about the timing of covering the rest. Mr. Almeida said they would start spreading more of the stockpiled clean soils on the west boundary of the site on Wednesday.

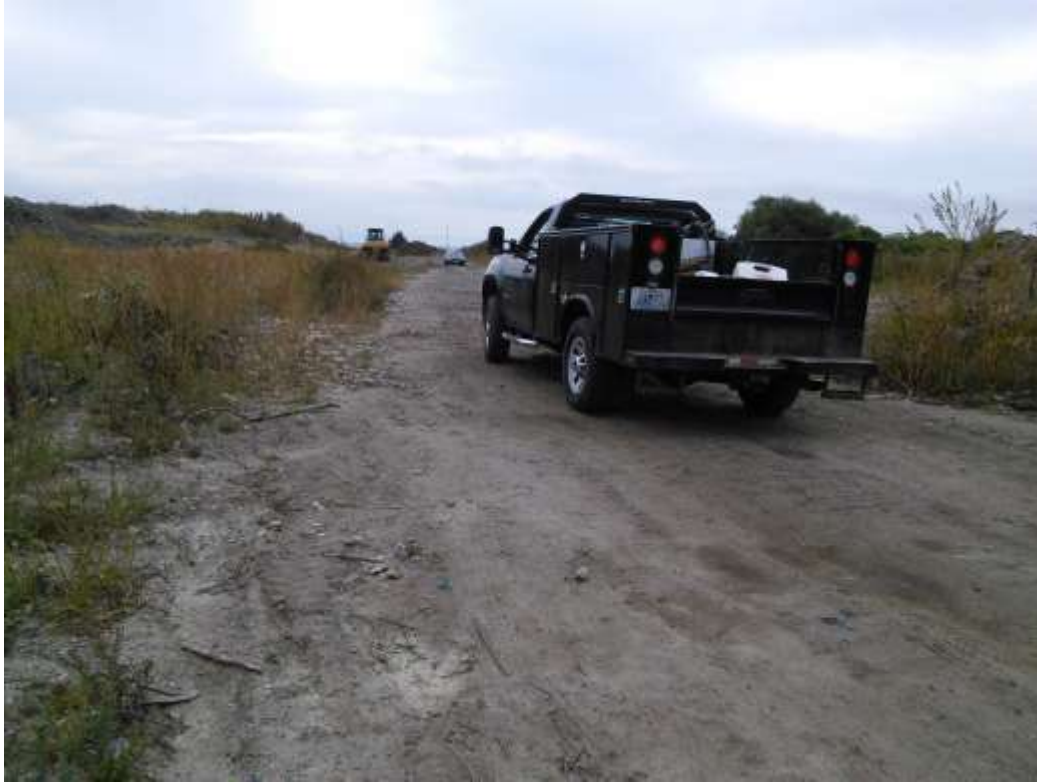
Photo 3: Pickup truck driving on dirt road showing reasonably good dust control

As shown in photo 2, dust on the dirt road on the site is well under control. I also I inspected the area where I noticed a dust issue on 9/12/2014 and found there was not a problem. Mr. Almeida said he had buried the dusty material that had created the issue and had also spread calcium chloride over the ground.
