Re: *Short-Term Response Action Plan*
Former Tidewater Facility
Pawtucket, Rhode Island
RIDEM Case No. 95-022

FORMER TIDEWATER MANUFACTURED GAS PLANT PAWTUCKET, RHODE ISLAND

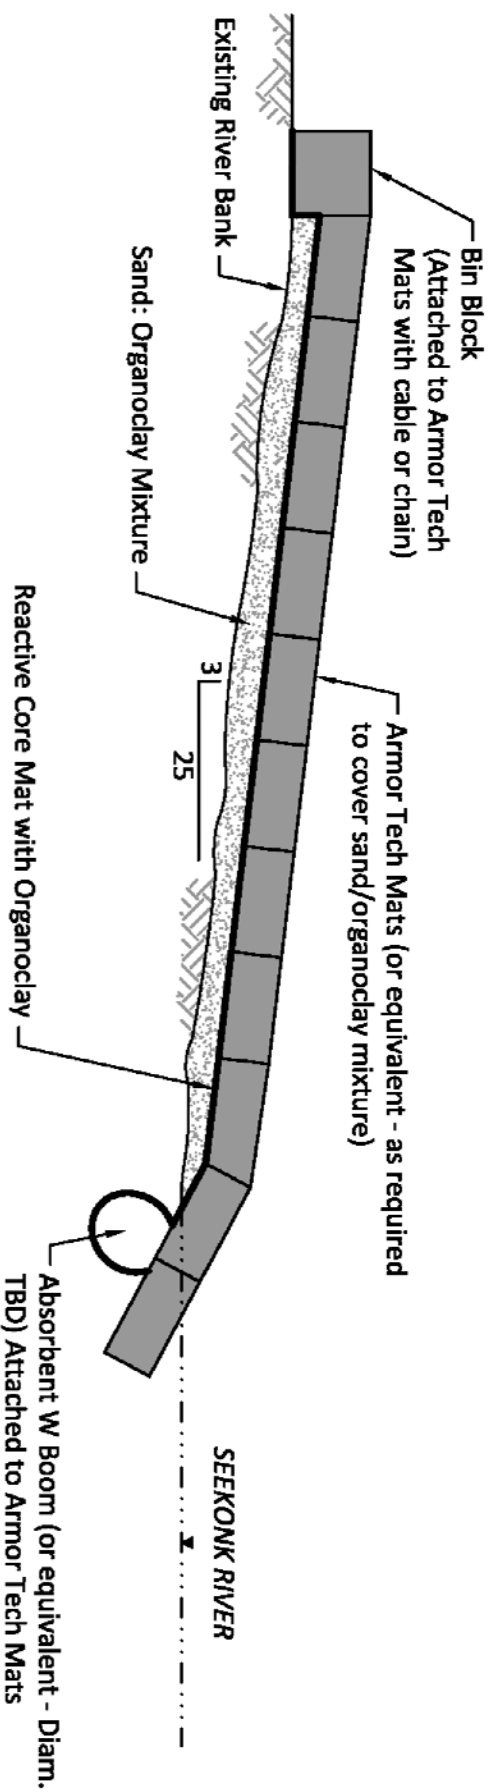
TIDEWATER CONCEPTUAL CAP CROSS-SECTION

The temporary cap will consist of the following, from top layer to bottom layer:

- An armor layer, constructed from armor mats or equivalent materials, to retain underlying cap materials in place. The armor layer will be stabilized as described below.

- Under the armor layer, reactive core mats (RCM), constructed from two geotextile layers enclosing an approximately ½-inch thick layer of organoclay to provide capacity to absorb the sheen before it forms on sediment or surface water.

- Under the RCM a thin layer of sand (approximately 12 inches thick) will be placed to form a smooth surface for the RCM to be placed upon. The bank is rocky and has an irregular surface. Without the sand layer, voids would likely remain under the RCM that may act as migration pathways for sheen materials. The expectation is that sand will fill the irregular surface and can be graded to provide a smooth surface for RCM placement. Bulk organoclay will be mixed with the sand, particularly in the sheen area immediate vicinity, to provide additional capacity to absorb sheen materials.

- GENERAL CONSTRUCTION NOTES:**
1. Cap to be installed in area of shoreline shown on Figure 1.
 2. Surface of shoreline area to be capped shall be graded prior to cap installation. Rocks greater than or equal to 6-inch diameter shall be removed before installation.

A cross-section schematic for the temporary cap is attached as Figure 3.

- A sand layer will be placed over the bank (from waterline landward to top of bank) to a maximum thickness of approximately 12 inches. In the area of the seep, mix organoclay in the sand, to a 1:1 (by volume) ratio. The resultant sand and sand/organoclay mixture forms a surface that will accommodate placing RCM with armor mats over it and also provides sorbtive capacity for seeping material.

- A RCM layer will be placed over the sand and organoclay layer. The RCM will be cut in the field with a heavy-duty utility knife and placed to overlap a minimum of 1 foot with adjoining RCM sections. The RCM will extend a minimum of 12 inches beyond the sand and organoclay layer.

- The armor layer will be placed over the RCM. The layer will extend a minimum of 12 inches beyond the edge of the RCM in all directions. At the waterline, the armor layer will extend into the water up to 24 inches. Under the submerged edge of the armor layer, a sorbent boom will be attached with cable. The sorbent boom adds another line of defense against seeping materials should the petroleum materials migrate through the sand and organoclay layer and under the RCM to the waterline.

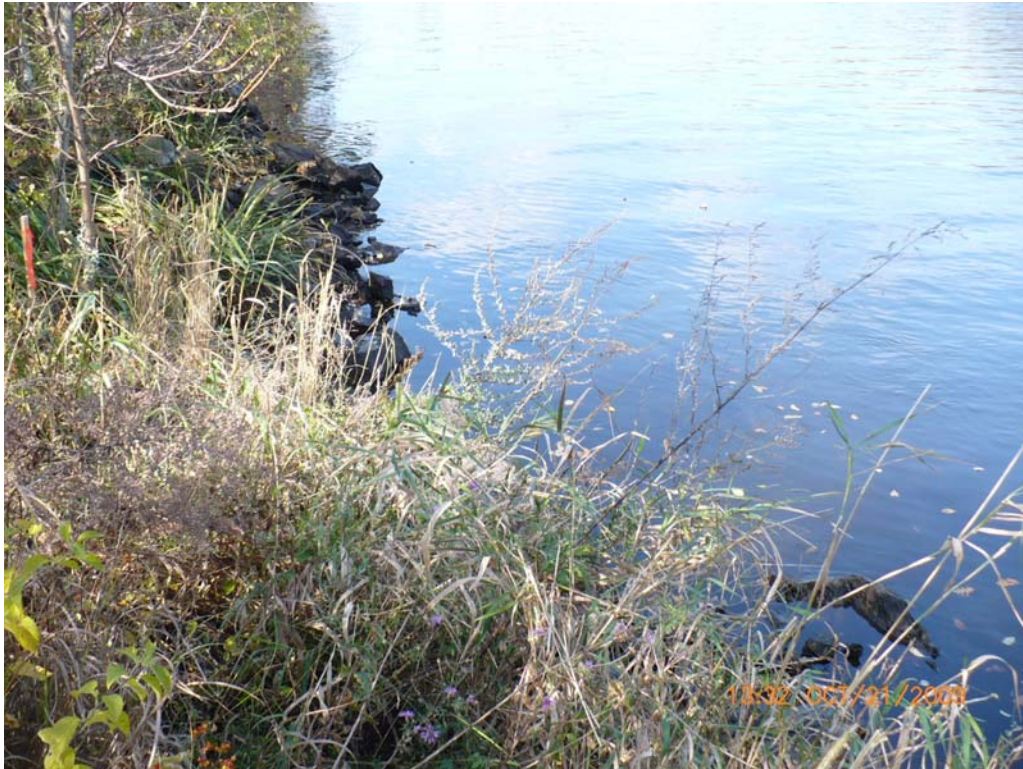
Photo 1: Area of River Bank Where Sheen Appears

A multi-colored sheen has been periodically observed since it was first observed in late October 2009 on the water surface of the Seekonk River adjacent to the Former Gas Plant Area, apparently emanating from an approximate 30-ft length of river bank, as shown on Figure 2. This sheen appears prior to low tide and dissipates after low tide and likely originates from existing on-Site manufactured gas plant residuals. The presence of the sheen constitutes a release as defined per Section 3.54 of RIDEM's Remediation Regulations.

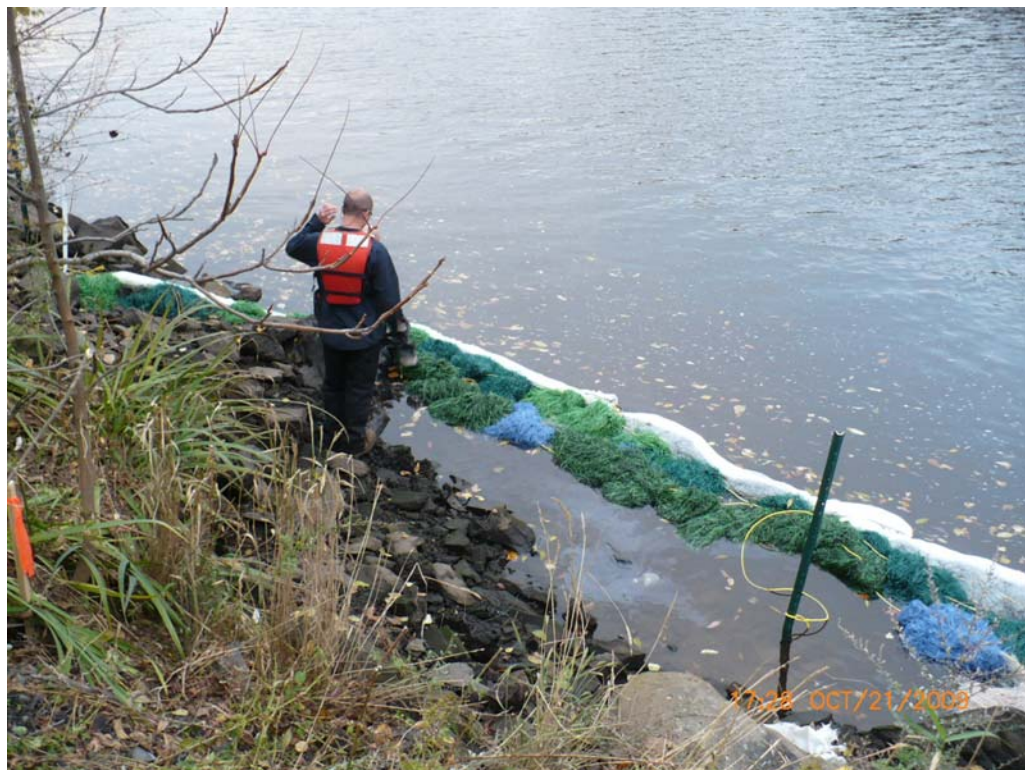
Photo 2: Containment Boom and Oil Snares Installed at Sheen Area

Upon discovery of the sheen, National Grid provided verbal and written notification to RIDEM. In addition, National Grid provided verbal notification to the National Response Center, Local Emergency Response Commission/Pawtucket Fire Department and State Emergency Response Commission. The United States Coast Guard was notified by the National Response Center, who in turn contacted National Grid. Oil containment booms were installed in the Seekonk River, along the shoreline where the sheen was observed approximately 50-feet north of the sheen area to approximately 50-feet south of the sheen area during the week of October 18, 2009. In addition to the oil containment booms, oil snares were placed on the inside of the booms to absorb additional sheens that may not be collected by the booms.
