Maidford River (Segment 2A)

Watershed Description

Assessment Unit Facts (RI0007035R-02A)

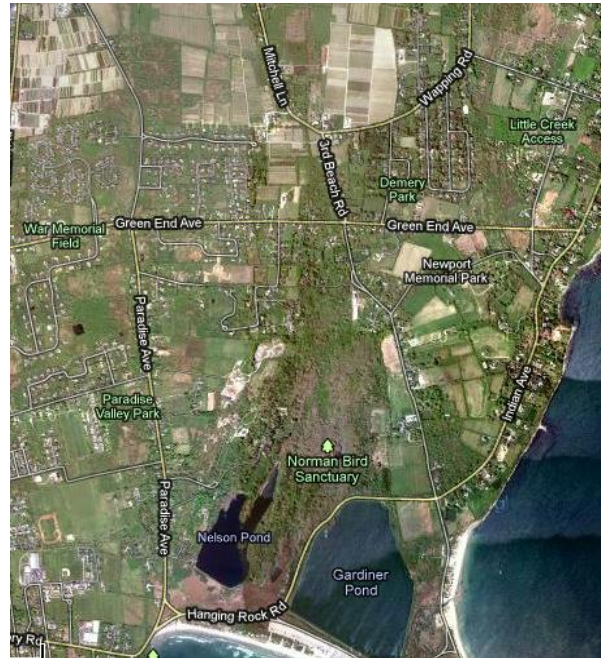
Figure 3: Partial aerial view of the Maidford River watershed (Source: Google Maps)

This portion of the Maidford River watershed covers 2.3 square miles. As shown in the aerial image of Figure 3, agricultural uses occupy approximately half (48%) of the Maidford River watershed. Developed uses (including residential and commercial uses) occupy approximately 36% of the land area. Impervious surfaces cover a total of 11.5% of the watershed. Non-developed areas, such as forests, occupy 13%, wetland and surface waters occupy 2%.

As indicated in Figures 2 and 3, the Maidford River watershed is highly agricultural (48%), particularly in the northern and central portions of the watershed. Agricultural operations are an important economic activity and landscape feature in many areas of the state. There are approximately 14 farms in the Town of Middletown, and multiple cattle farms are located within the watershed itself (Berger, 2006a). Agricultural practices such as allowing livestock to graze near streams, crossing livestock through waterbodies, and spreading manure as fertilizer may contribute to bacterial contamination. A 2003 Department of Health ribotyping study and a 2005 DNA-analysis in the Maidford River identified cattle and other farm animals as a major source of bacteria to the northern portion of the river (Berger, 2006a).
