#### **INLET SUMMARY SHEET**

**INLET:** Greene Point (#20)

## 20 - GREENE POINT

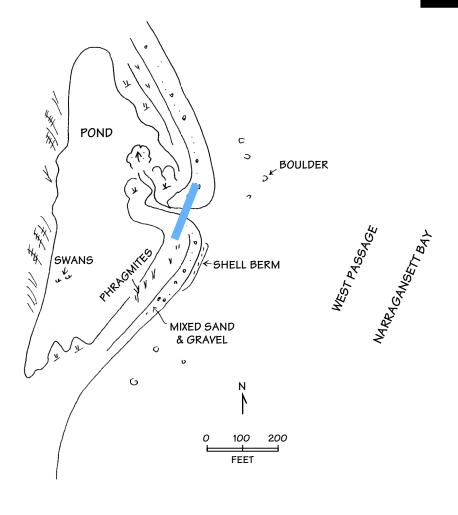
# POTENTIAL PROTECTION STRATEGY (FLOOD TIDE)

<u>PRELIMINARY PROTECTION STRATEGY</u>: The objective is to prevent oil from entering the pond by constructing a sediment dike (approximately 150 ft. long) across the small channel that connects the pond with the ocean, using sediment from the intertidal zone. Care should be taken not to disturb any birds that may be nesting on the beach, or any harbor seals that may be present. Do not take sediment from vegetated areas.

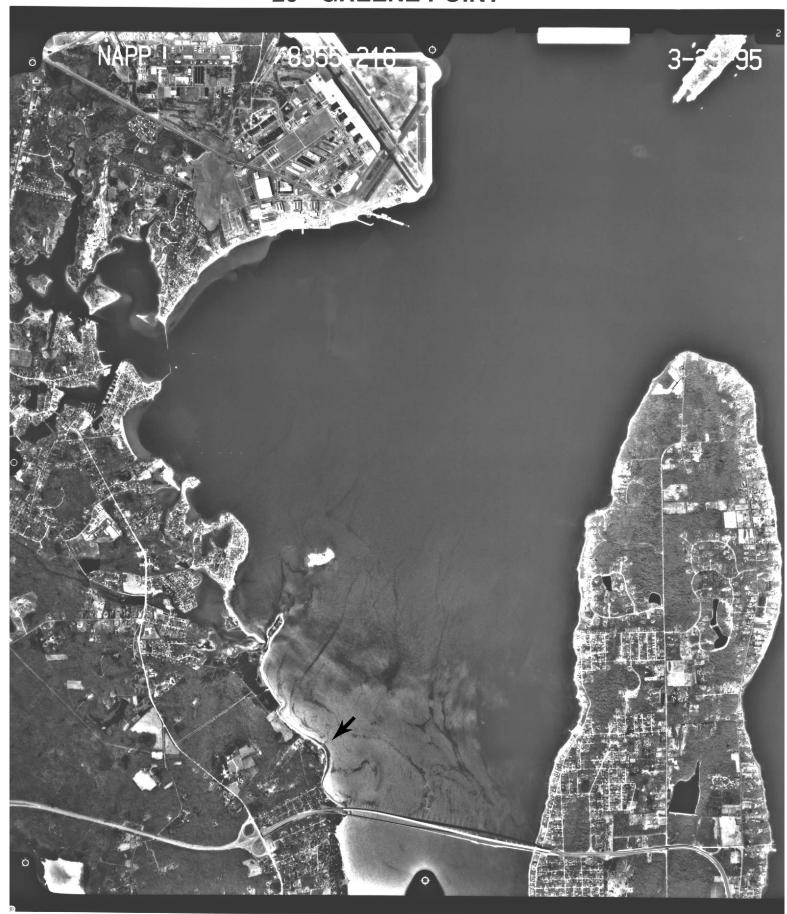
#### **INLET SKETCH MAP**

<u>GEOMORPHOLOGY</u>: A minor headland composed of two depositional spit/bar complexes that enclose a small pond. Outlet channel is at crest of headland. Well-developed flood-tidal delta with marsh cover. Sand, gravel, and shell beaches.

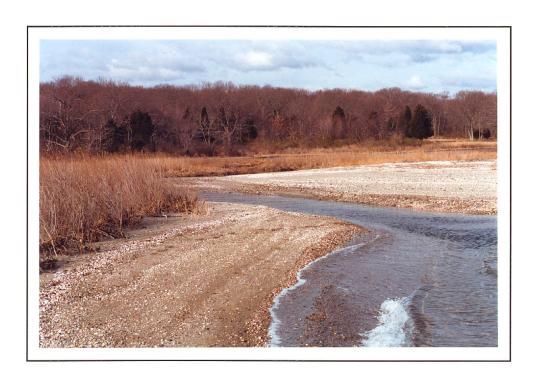
Looking NNE at channel at proposed sediment dike location at near high tide on 19 March 1999, Greene Point (#20).

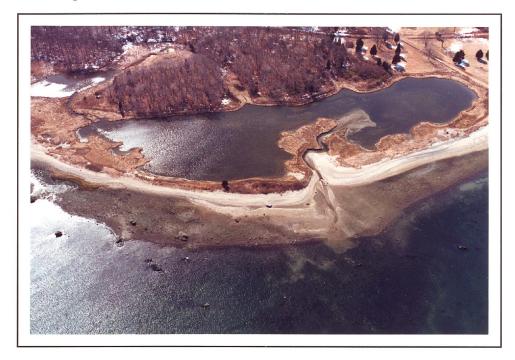
Looking west at low tide on 17 March 1999, Greene Point (#20).
