INLET SUMMARY SHEET

INLET: Bissel Cove; Annaquatucket River (#21)

21 - BISSEL COVE; ANAQUATUCKET RIVER

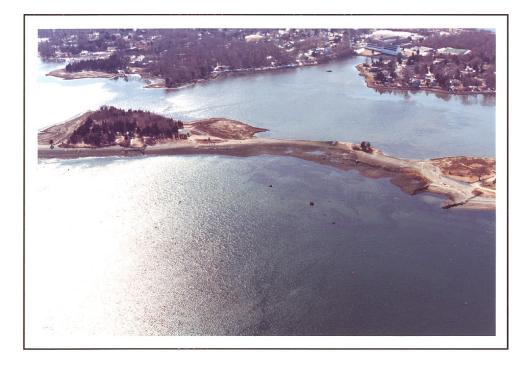
Looking NWW at low tide on 17 March 1999, Bissel Cove; Annaquatucket River (#21). Inlet throat in foreground.

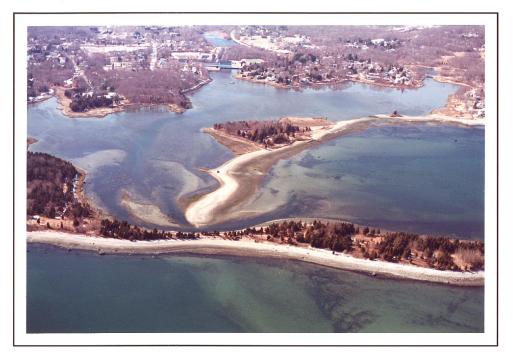
Looking SSW at low tide on 17 March 1999, Bissel Cove; Annaquatucket River (#21). This part of the spit (neck) is under water at high spring tide.

<u>GEOMORPHOLOGY</u>: A long spit has built down the shore from the northwest, forcing the river mouth to the southeast and creating a "half inlet" configuration. The neck (northwest end) of the spit is under water at high spring tide.
