### **INLET SUMMARY SHEET**

**INLET:** Mussachuck Creek (#35)

## 35 - MUSSACHUCK CREEK

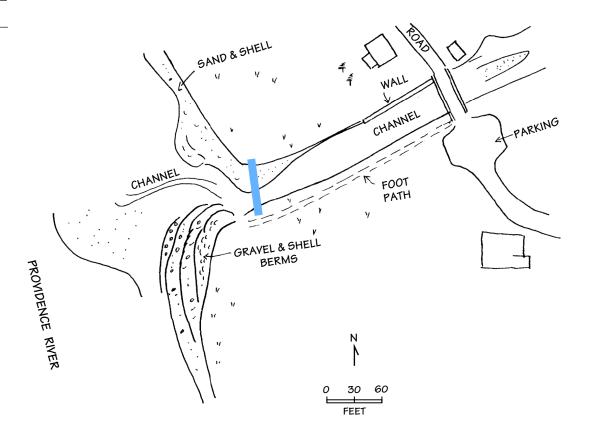
### **INLET SKETCH MAP**

POTENTIAL PROTECTION STRATEGY (FLOOD TIDE)

**Sediment Dike**

<u>PRELIMINARY PROTECTION STRATEGY</u>: The objective is to prevent oil from entering the pond by constructing a sediment dike (approximately 60 ft. long) across the small channel that connects the creek with the ocean. Use sediment from the intertidal zone, the ebb-tidal delta, and the high gravel/shell berms to construct the dike. The dike will be oriented in a north-south direction. Care should be taken not to disturb any birds that may be nesting on the beach. Sediment from vegetated areas should not be used in constructing the dike.

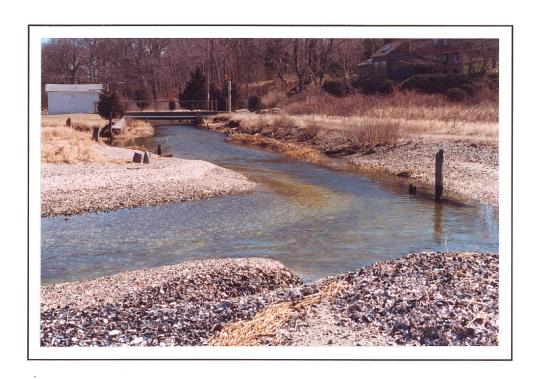
Looking NEE up channel from beach at near high tide on 20 March 1999, Mussachuck Creek (#35).

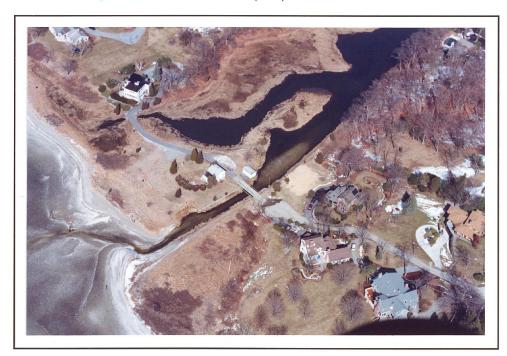
Looking NE at low tide on 17 March 1999, Mussachuck Creek (#35).
