# REMEDIAL ACTION CLOSURE REPORT

## PARCEL C-1 PHASE I CAP FORMER GORHAM MANUFACTURING FACILITY 333 ADELAIDE AVENUE PROVIDENCE, RHODE ISLAND

AMEC Environment & Infrastructure, Inc.  
2 Robbins Road  
Westford, Massachusetts 01886

April 2013

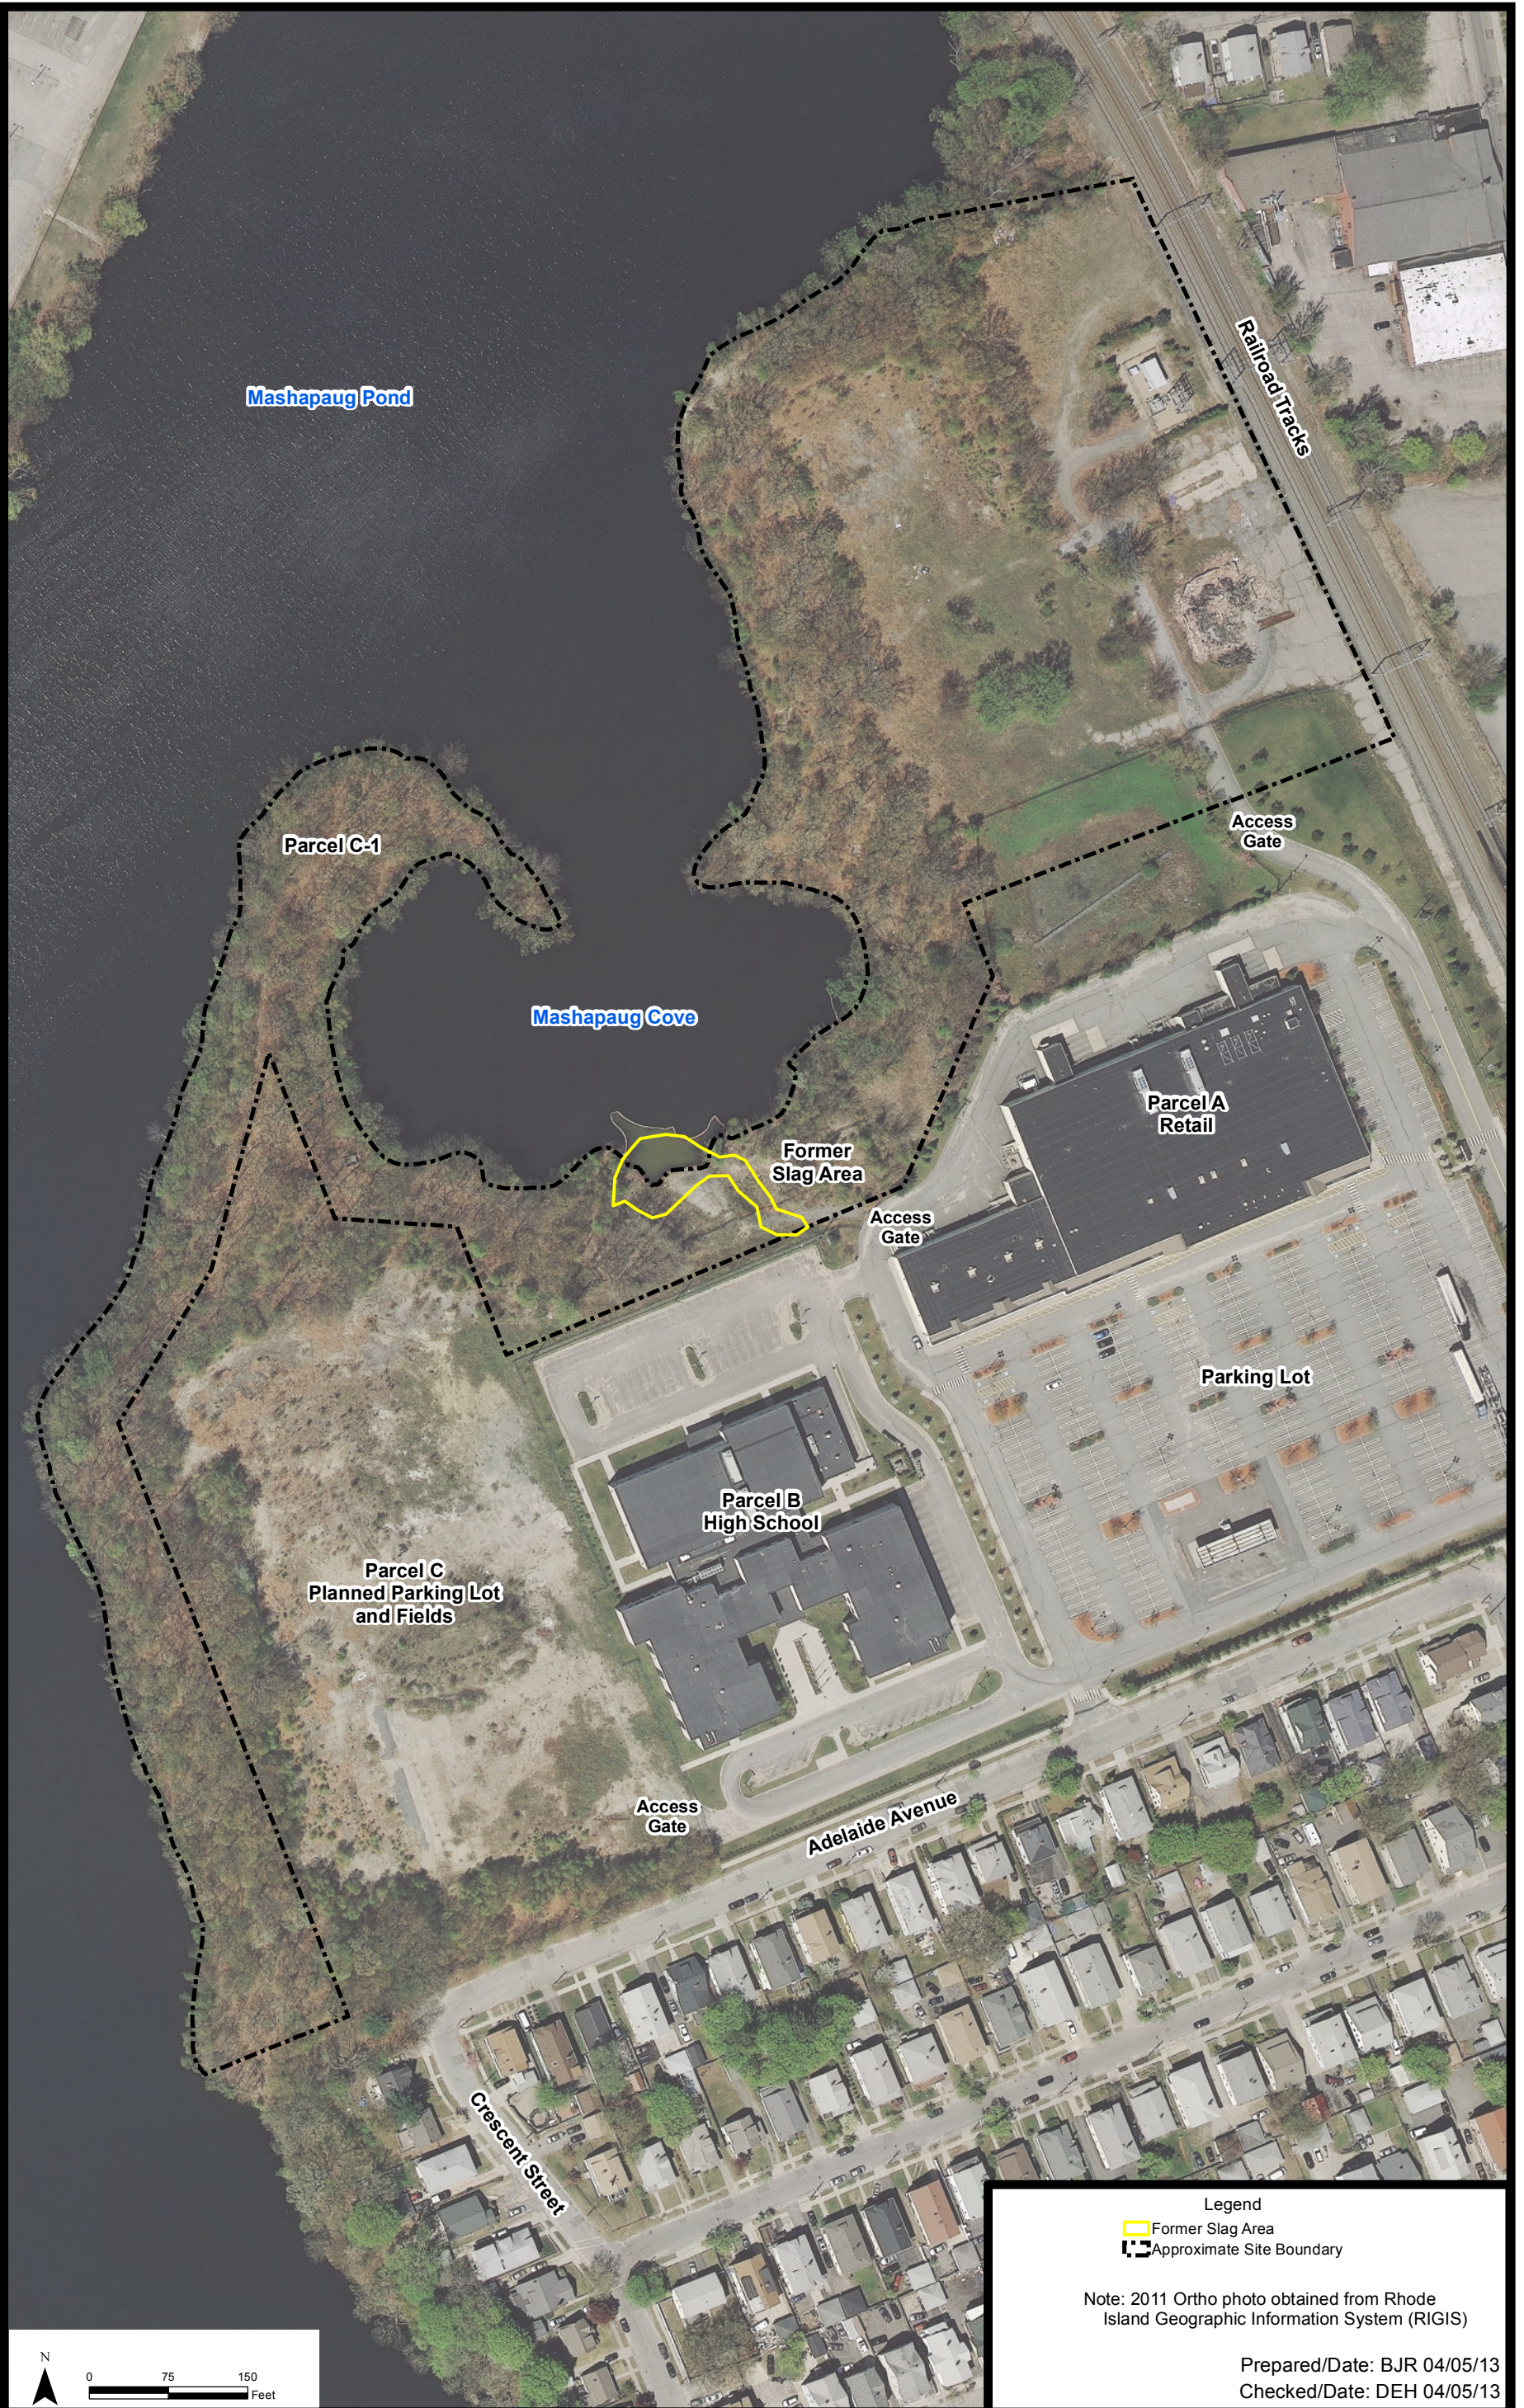
Figure 2

More recent Site conditions are shown in the aerial photograph in Figure 2. In this figure, the Site is located immediately north of Adelaide Avenue and west of the Amtrak railroad tracks. The former manufacturing facility has been razed. A retail development has been completed on the southeastern portion (Parcel A). A public high school (Alvarez High School) has been constructed on a second parcel (Parcel B). A grassed lawn area/open space and parking lot is

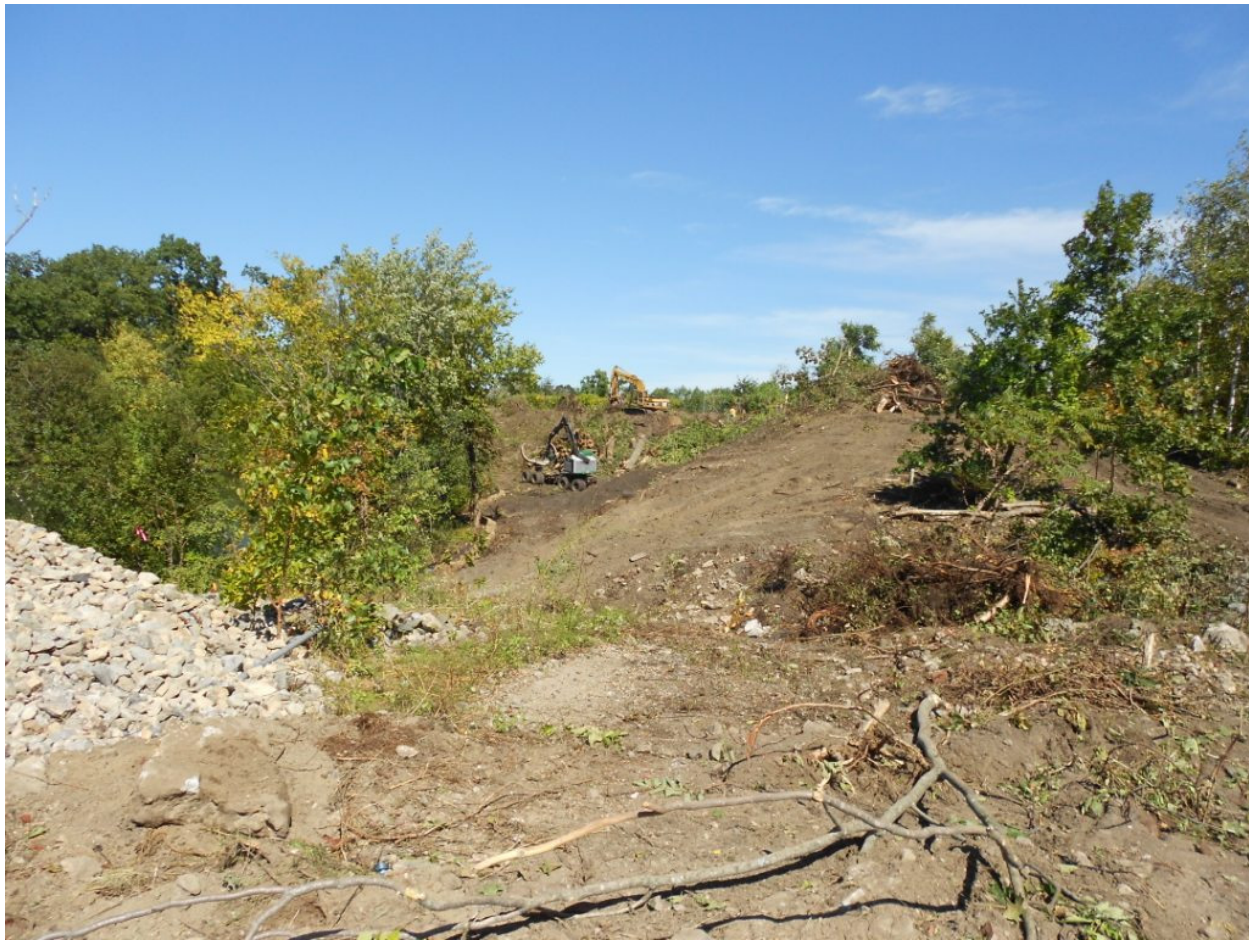
<b>Date</b>	<b>Photo ID</b>	<b>Description</b>
09/19/12	0885	Clearing on the eastern side of the site, looking northeast from the former slag area

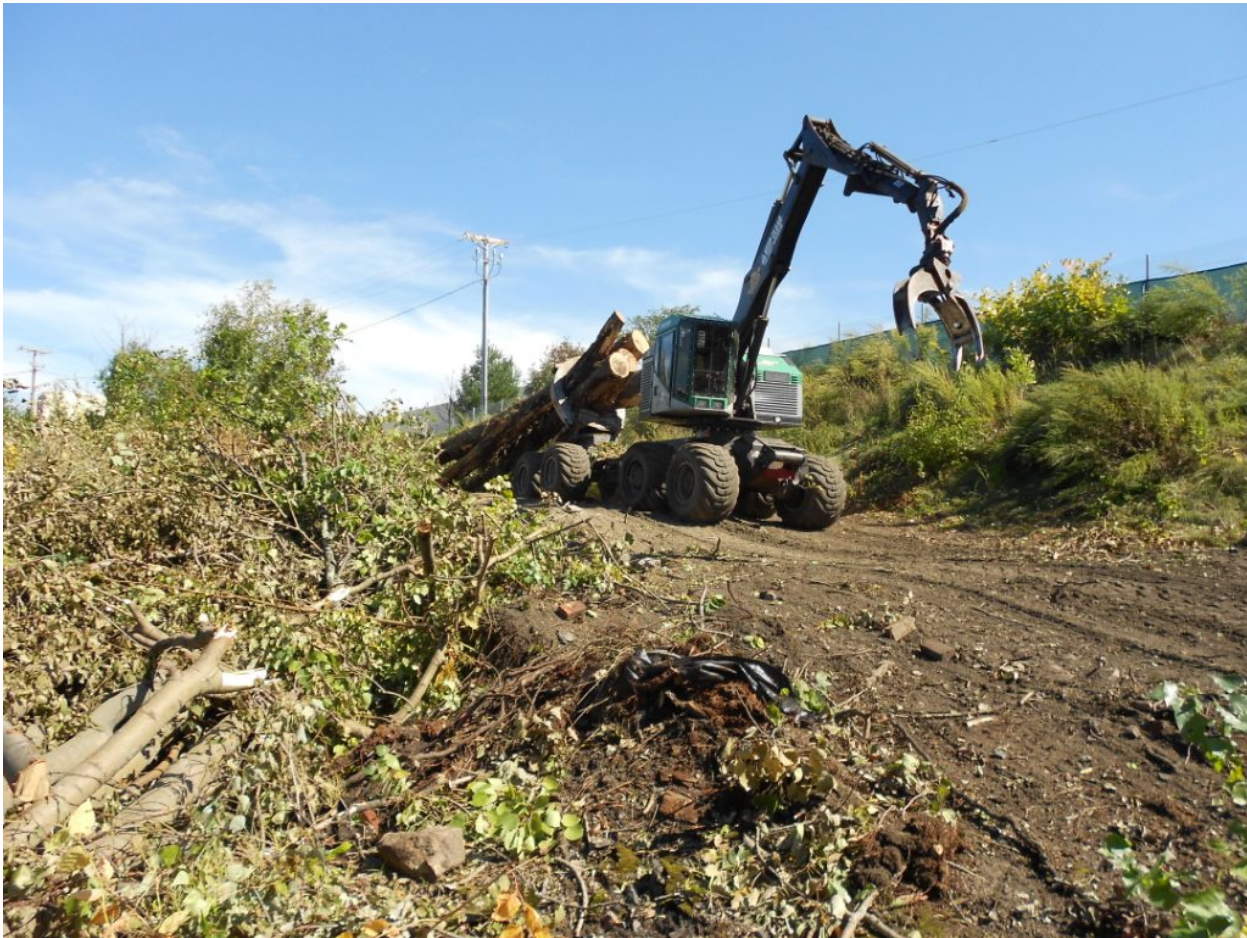
<b>Date</b>	<b>Photo ID</b>	<b>Description</b>
09/19/12	0886	Skidding trees (by Wagner Wood) from the area to be capped

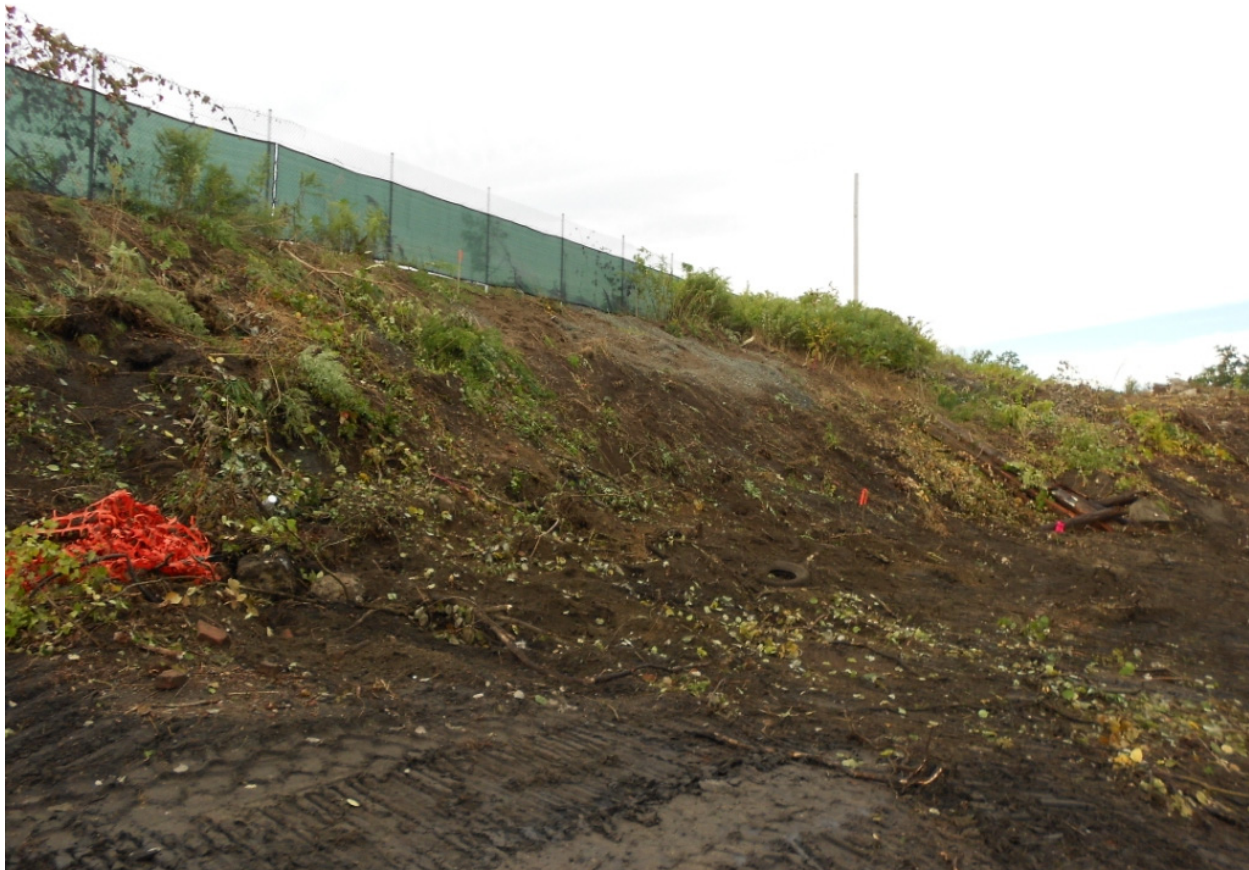
<b>Date</b>	<b>Photo ID</b>	<b>Description</b>
09/21/12	0895	Looking southwest at the cleared slopes north of the HS

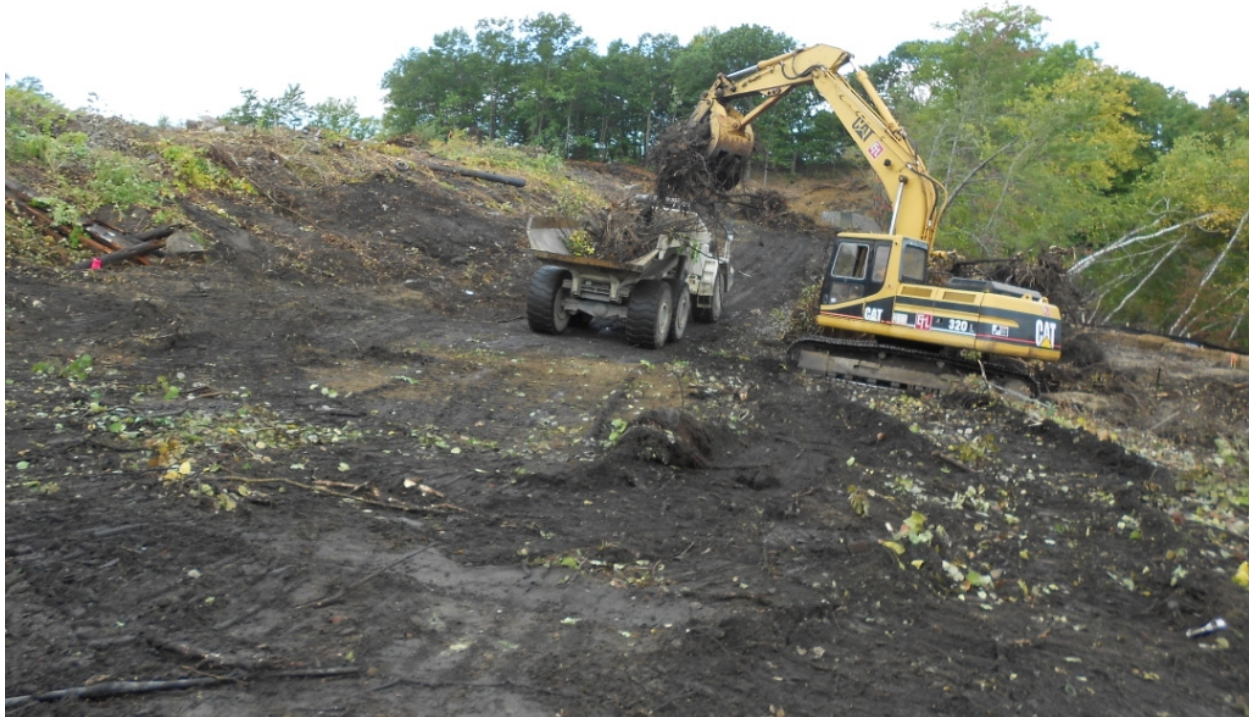
<b>Date</b>	<b>Photo ID</b>	<b>Description</b>
09/21/12	0896	Loading out cleared material from the area to be capped, looking southwest

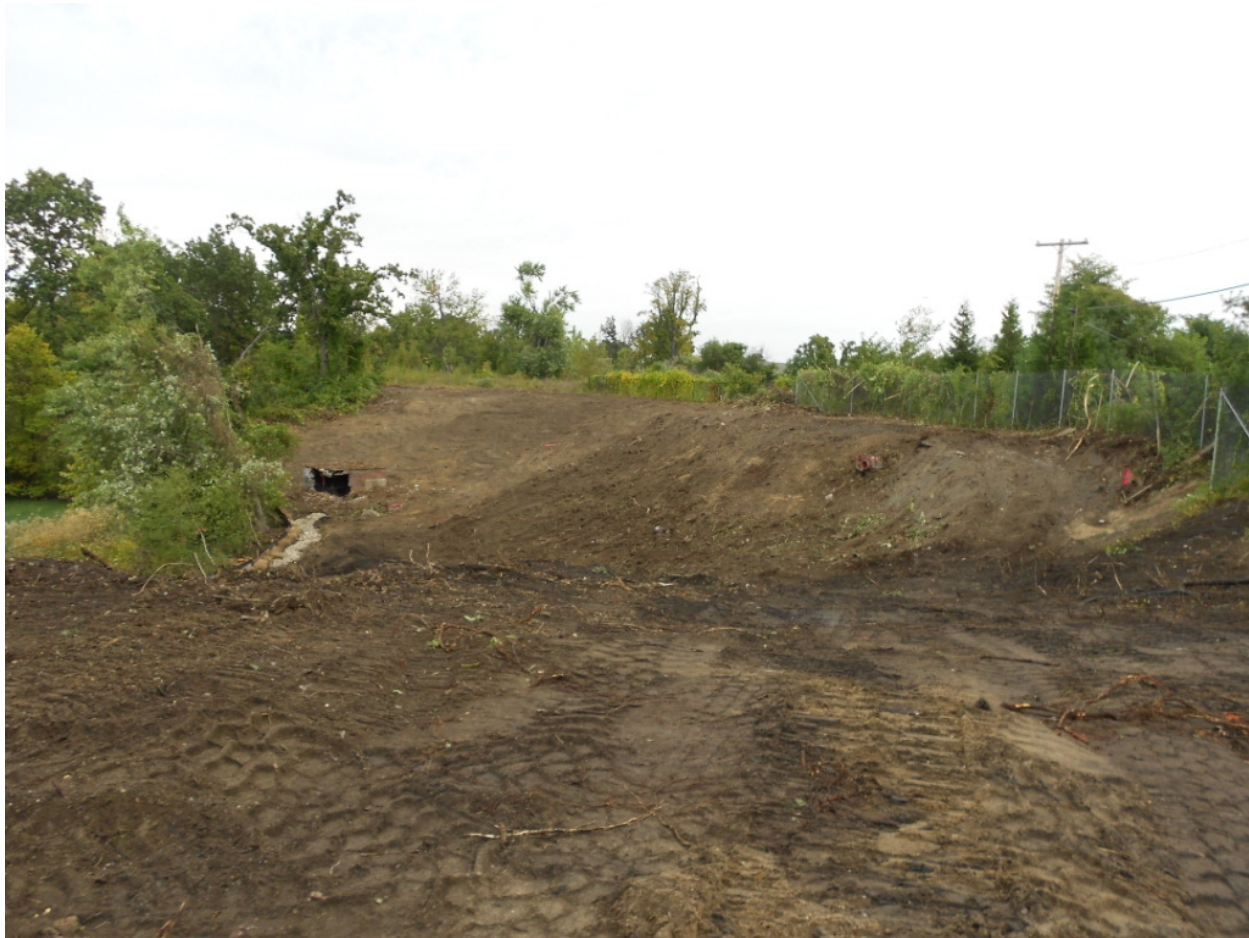
<b>Date</b>	<b>Photo ID</b>	<b>Description</b>
09/21/12	0898	Looking east at the cleared area to be capped. Two culvert (storm drain) outlets are visible. One is at the right center of the photo and one is at the right side of the photo. Both are marked with fluorescent paint. These are not shown on the plans, but they will be plugged and abandoned in place

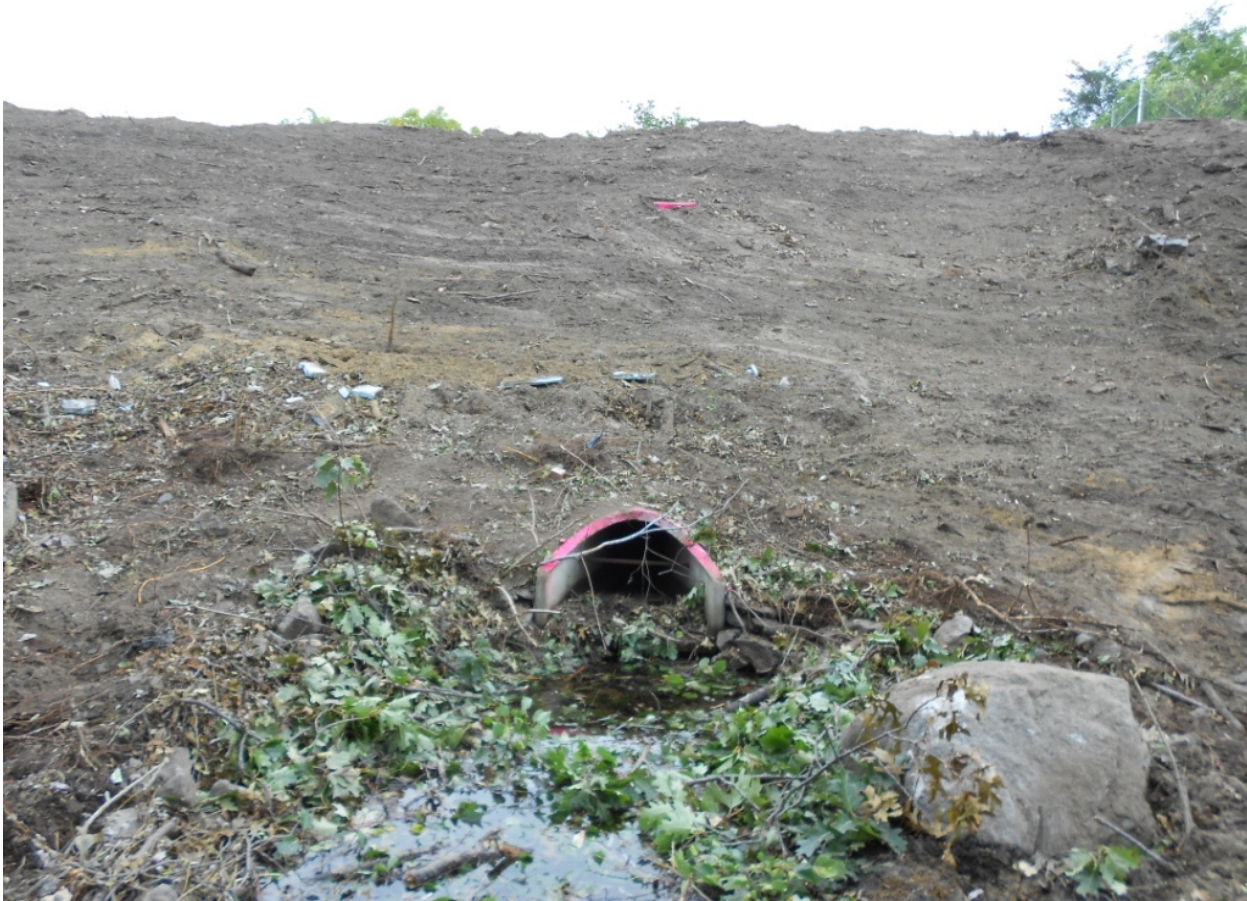
<b>Date</b>	<b>Photo ID</b>	<b>Description</b>
09/21/12	0900	Looking east at the detention basin outlet. Also, there is a manhole that appears to be in line with the culvert from the detention basin. The manhole will need to be raised to accommodate the cap.

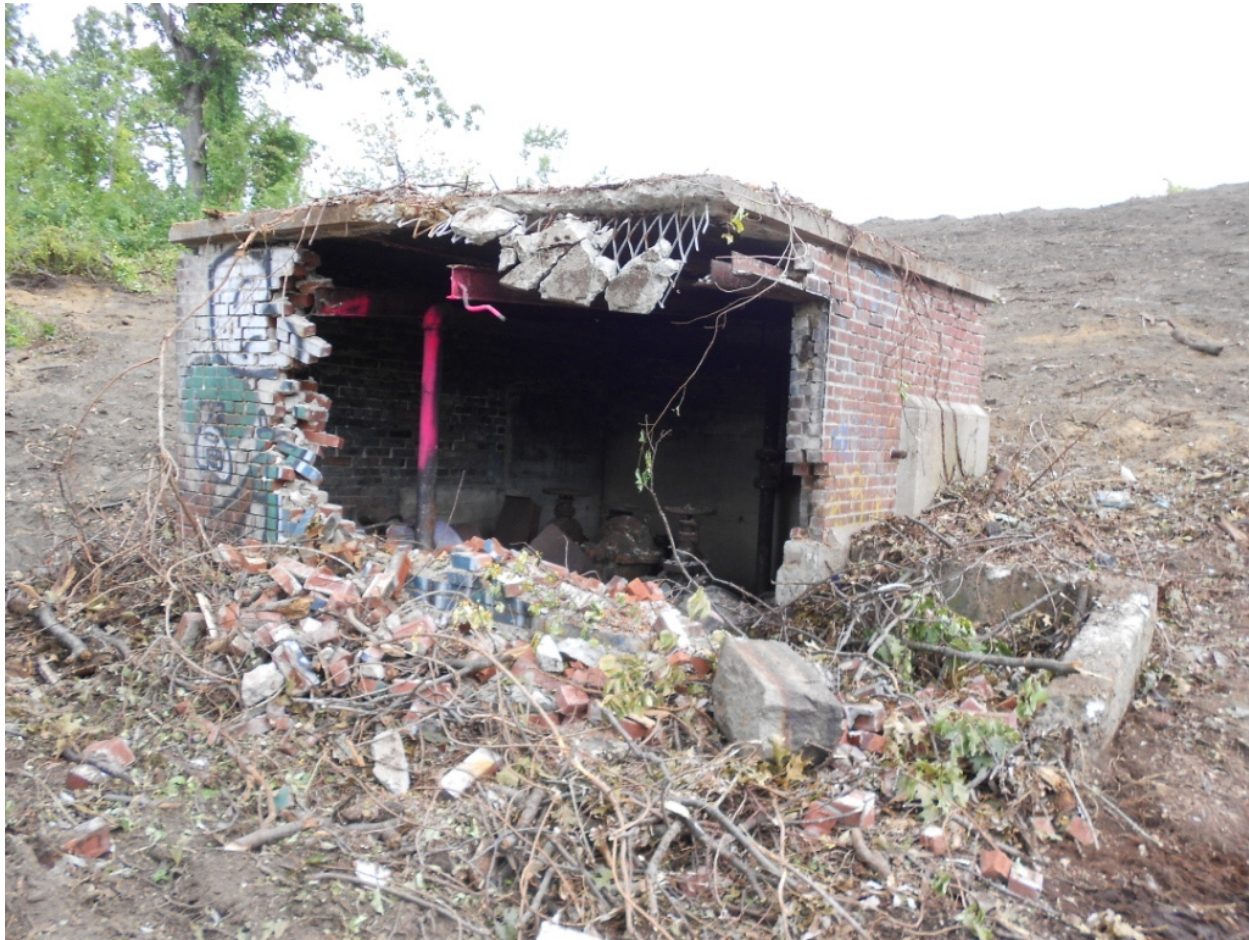
<b>Date</b>	<b>Photo ID</b>	<b>Description</b>
09/21/12	0901	Concrete and brick structure to be removed at the northeast of the site

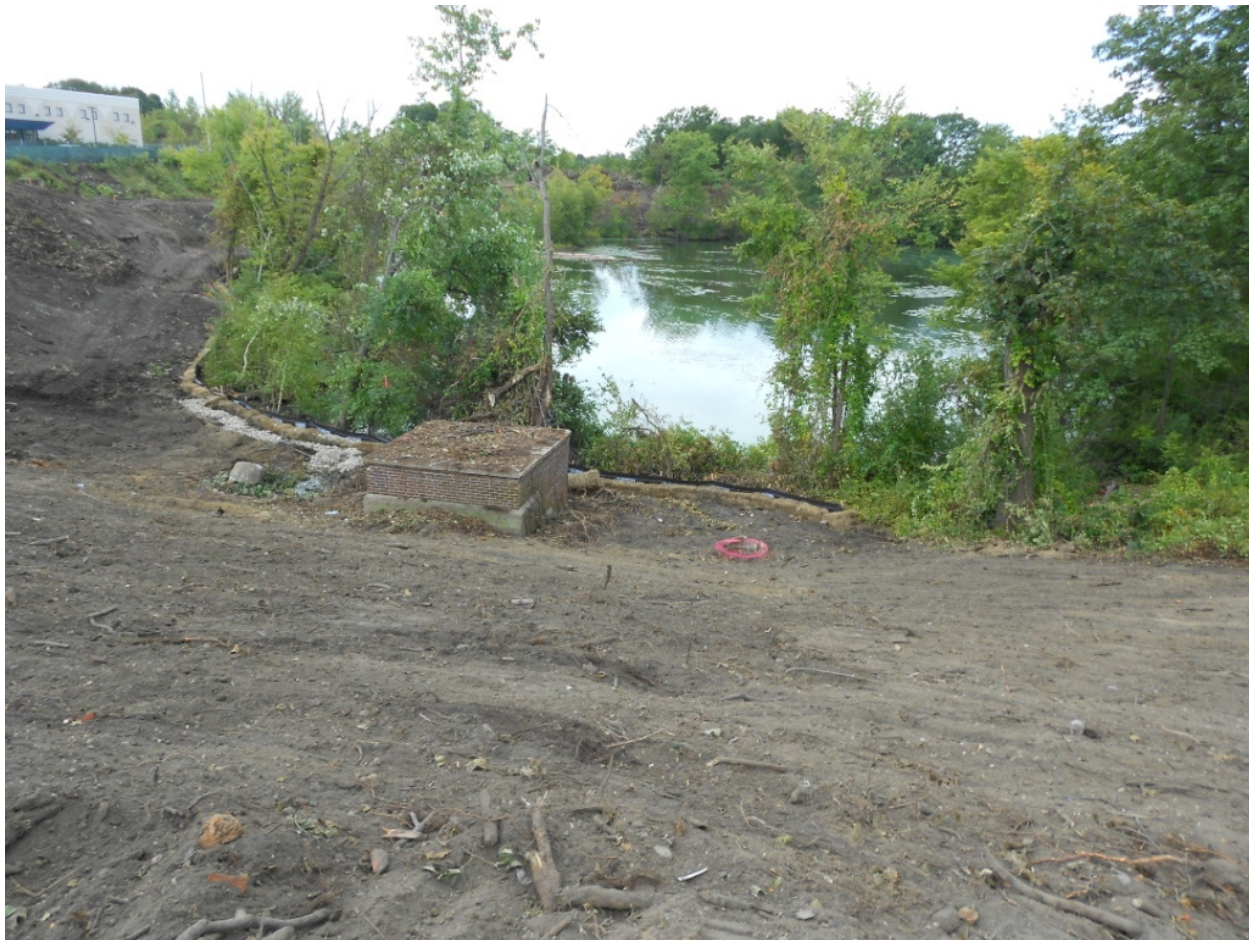
<b>Date</b>	<b>Photo ID</b>	<b>Description</b>
09/21/12	0904	Looking west at the concrete and brick structure to be removed. The well to be abandoned may be located to the right of the structure.

Only one well was abandoned - a former process water supply well that was most likely associated with the fire suppression system at the former manufacturing facility. The well was located in a concrete structure (foundation for a well housing) on the western shoreline of the Inner Cove and within the wetland cap area (Sheet C-103, Appendix G). It was abandoned by Geosearch on October 5, 2012, in accordance with Specification 02526 (AMEC, 2012), by tremie grouting. The bottom of the well was approximately 102 ft bgs. The concrete debris from the well housing was broken up to six-inch minus pieces and placed under the former slag area cap. The well abandonment report is included in Appendix M.

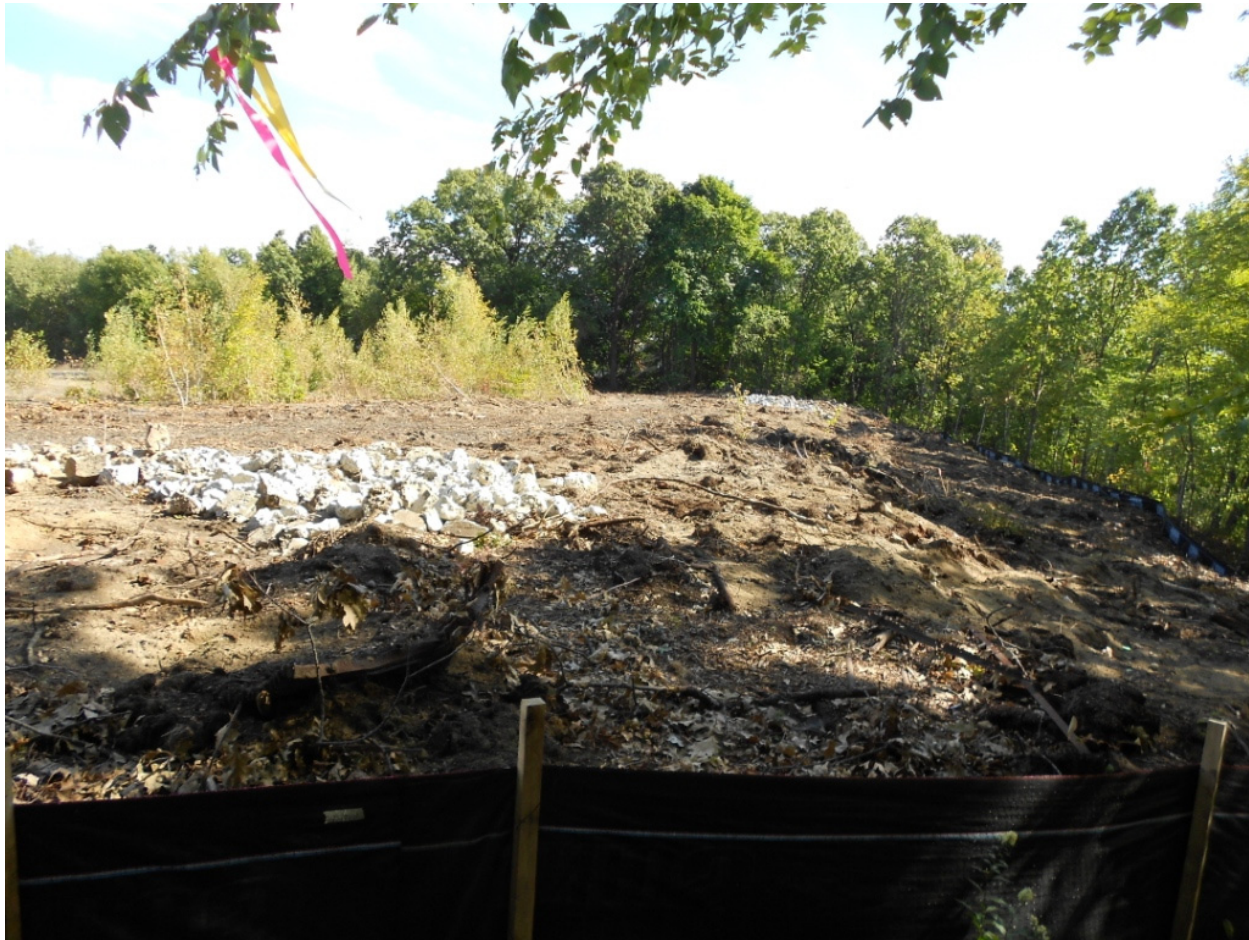
<b>Date</b>	<b>Photo ID</b>	<b>Description</b>
09/21/12	0910	Western shoreline area to be graded and capped

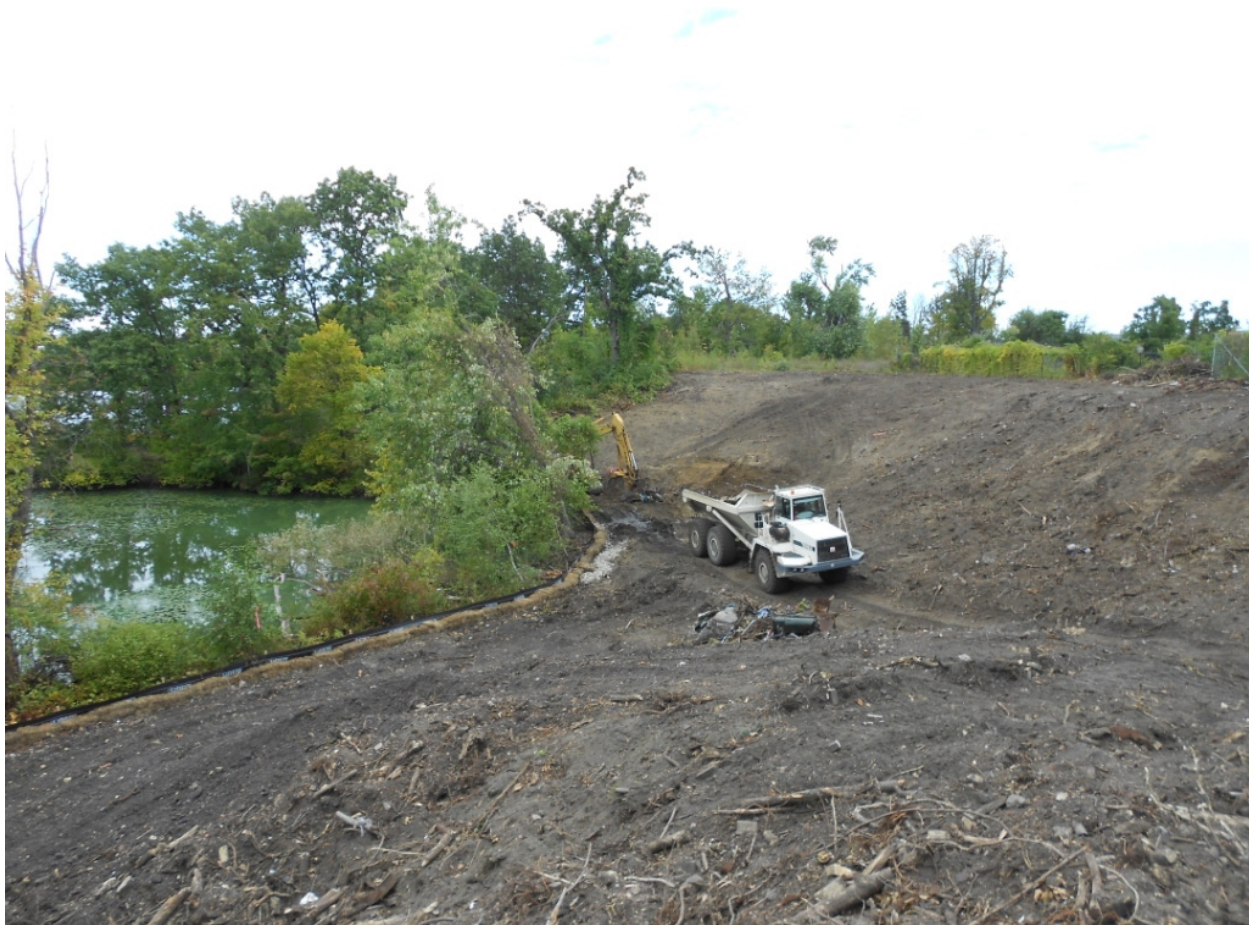
<b>Date</b>	<b>Photo ID</b>	<b>Description</b>
09/24/12	0916	Excavator loading out brick and concrete from the pump house (to be broken up and placed under the cap), looking northeast

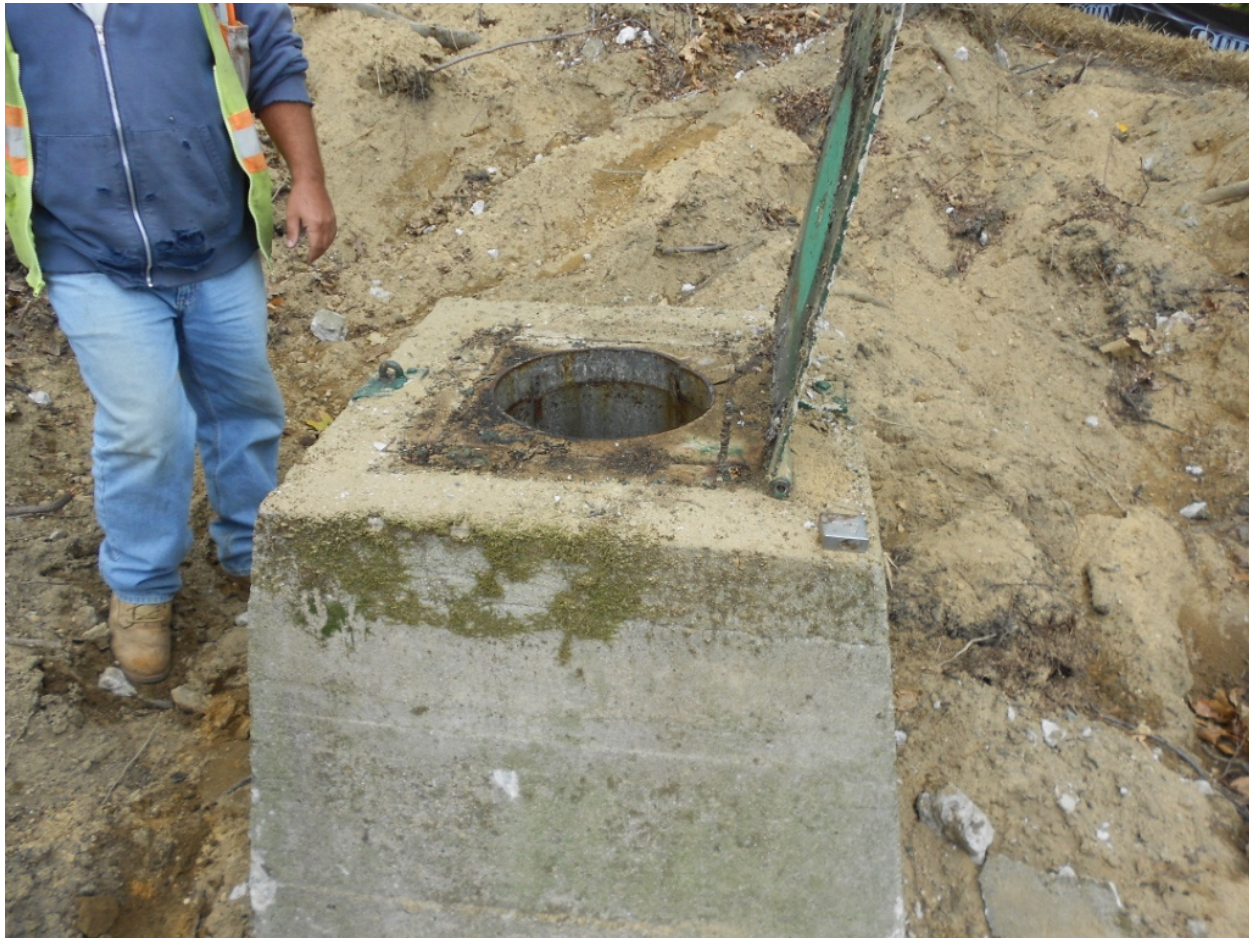
Date	Photo ID	Description
09/24/12	0918	Concrete vault containing well at the beginning of the peninsula

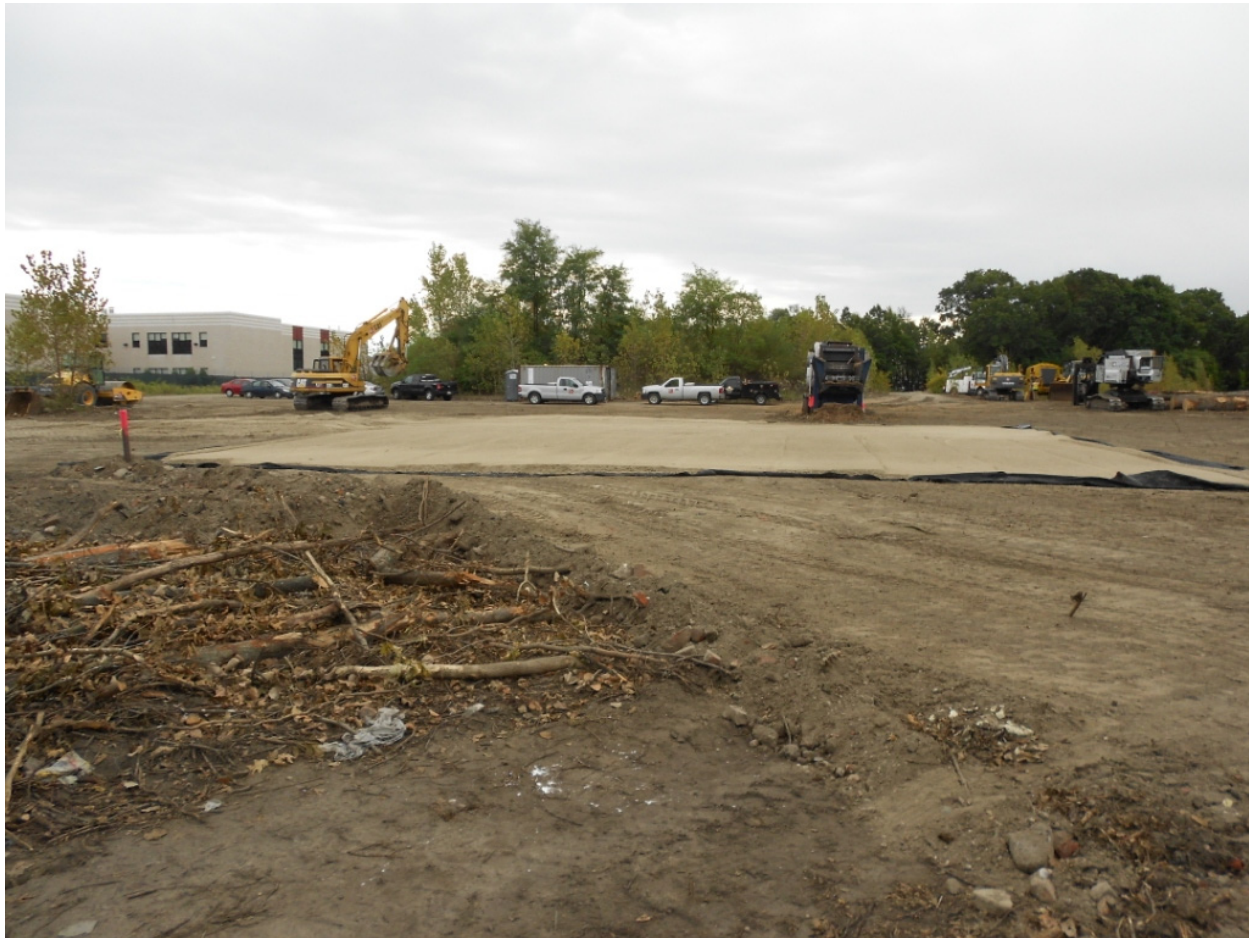
<b>Date</b>	<b>Photo ID</b>	<b>Description</b>
09/24/12	0921	Looking southeast at the lay down area

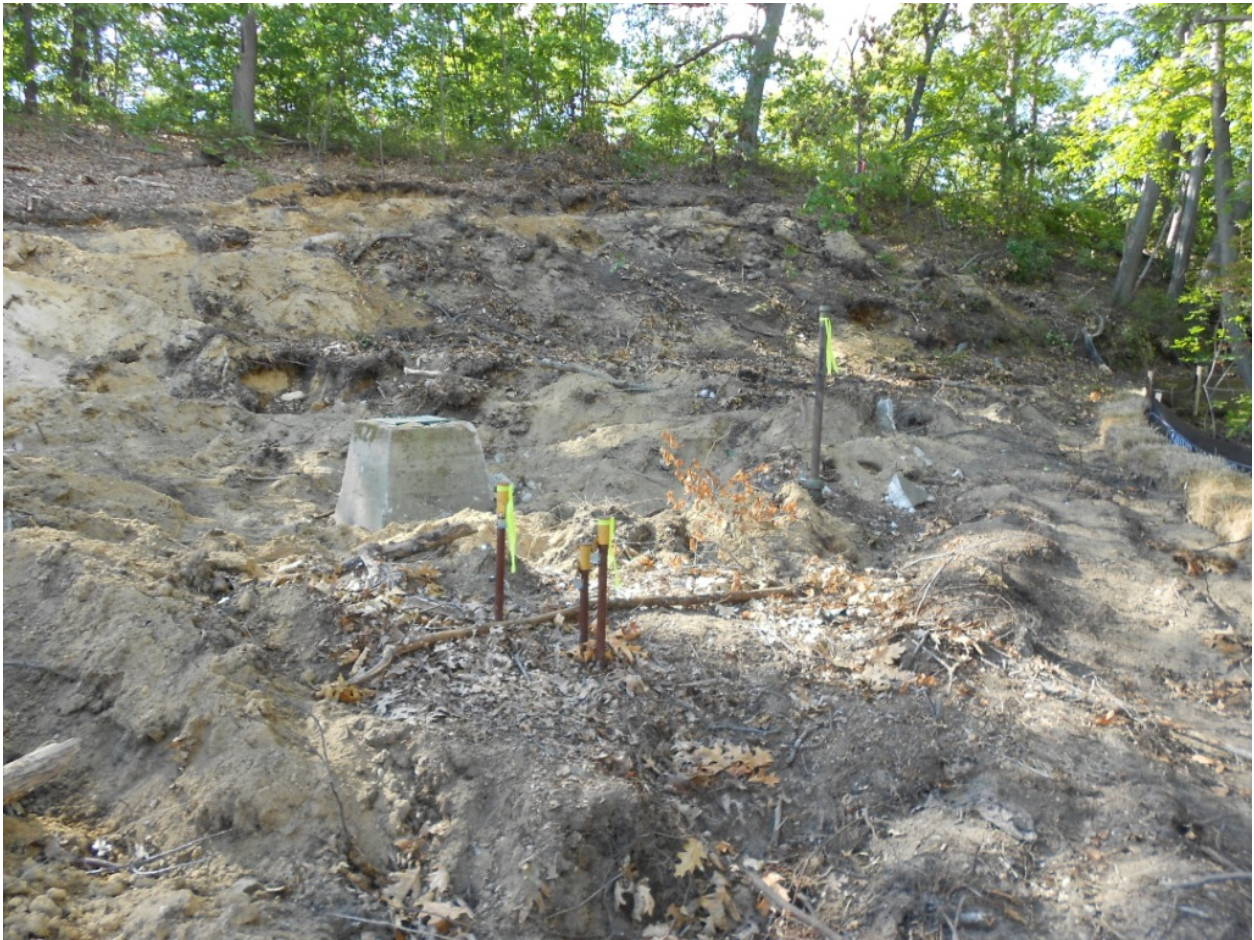
<b>Date</b>	<b>Photo ID</b>	<b>Description</b>
09/24/12	0931	Concrete vault containing well at the beginning of the peninsula, looking southwest. MW-235S and MW-235D located in front of the vault. Feature to the right of the concrete vault was not identified.

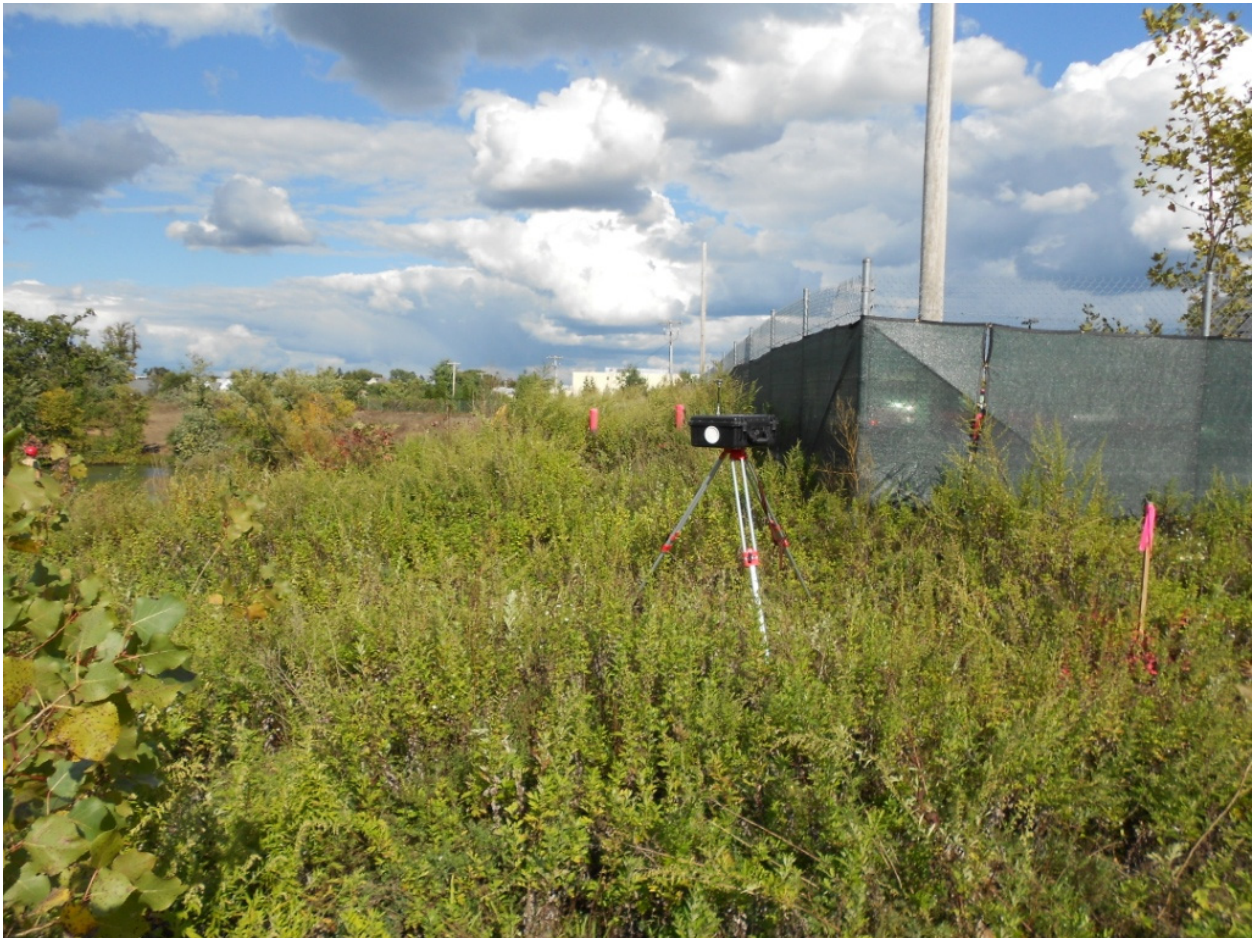
<b>Date</b>	<b>Photo ID</b>	<b>Description</b>
09/24/12	0932	Air monitoring station no. 2 set-up outside the northwest corner of the high school fence, looking east. MW-238S and MW-238D in the background

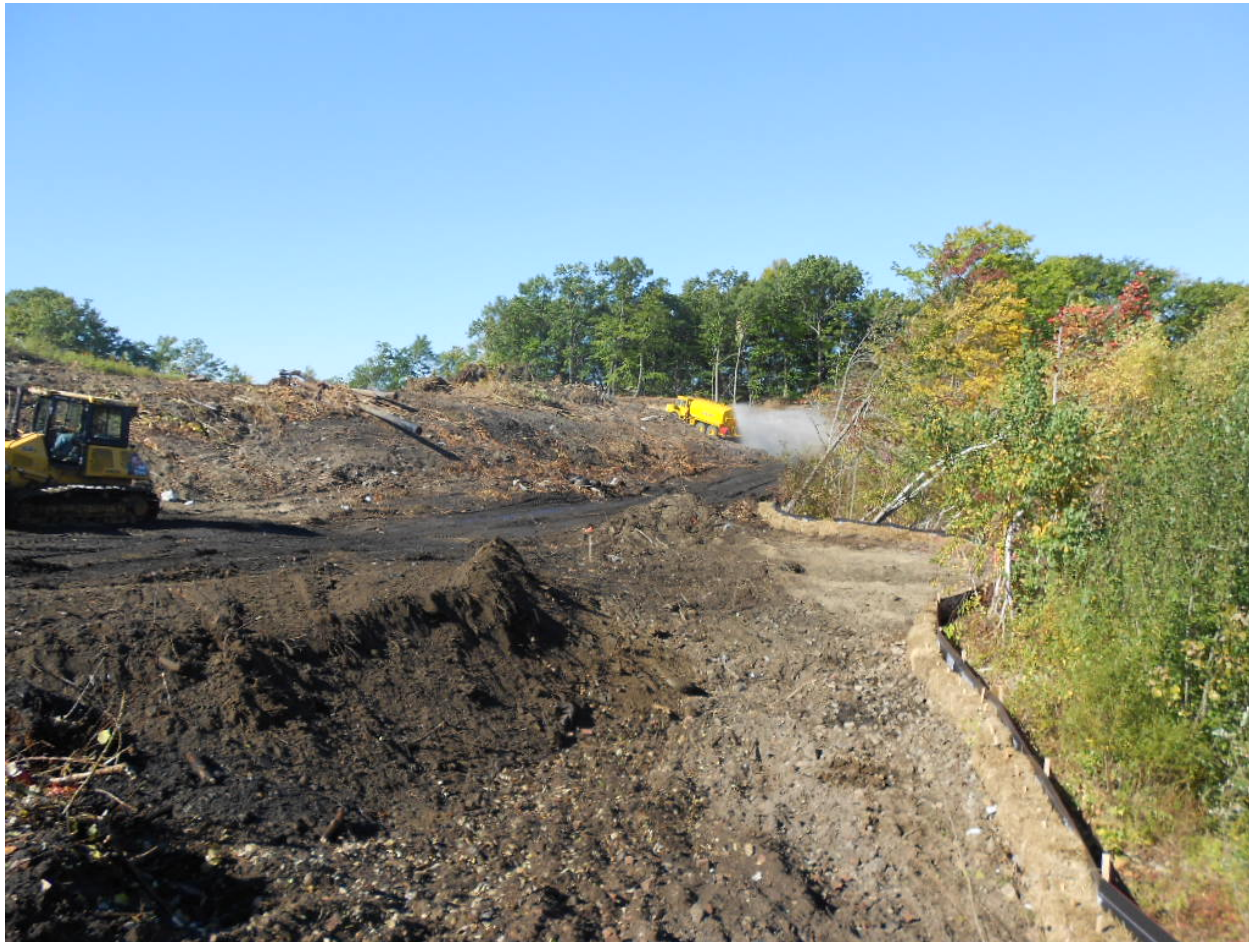
<b>Date</b>	<b>Photo ID</b>	<b>Description</b>
09/25/12	0940	Water truck applying dust control at Areas 3 and 4, looking south

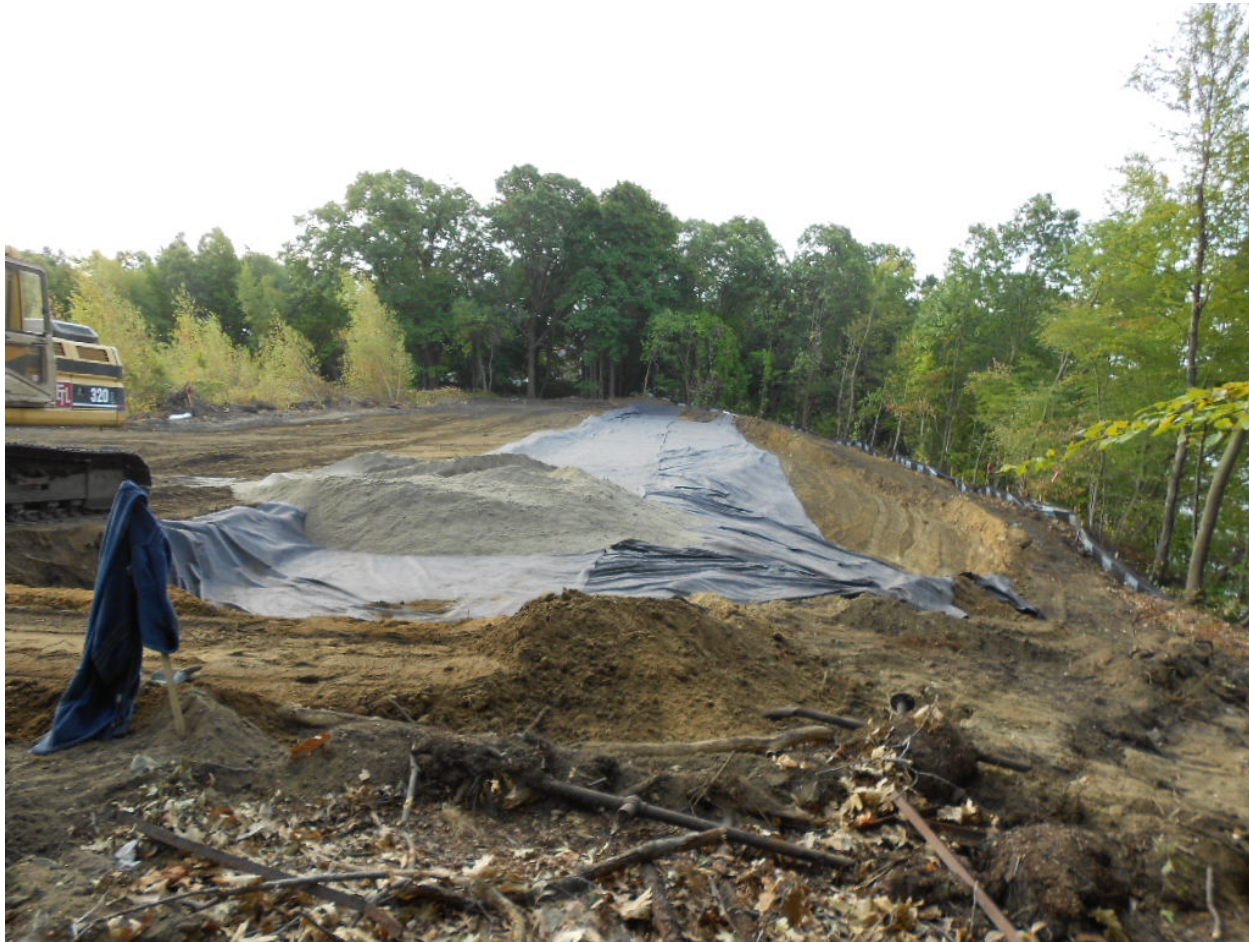
<b>Date</b>	<b>Photo ID</b>	<b>Description</b>
09/26/12	0947	Cover soil and geotextile installed at Area 1, looking south
