# REMEDIAL ACTION CLOSURE REPORT

## PARCEL C-1 PHASE I CAP FORMER GORHAM MANUFACTURING FACILITY 333 ADELAIDE AVENUE PROVIDENCE, RHODE ISLAND

AMEC Environment & Infrastructure, Inc.  
2 Robbins Road  
Westford, Massachusetts 01886

April 2013

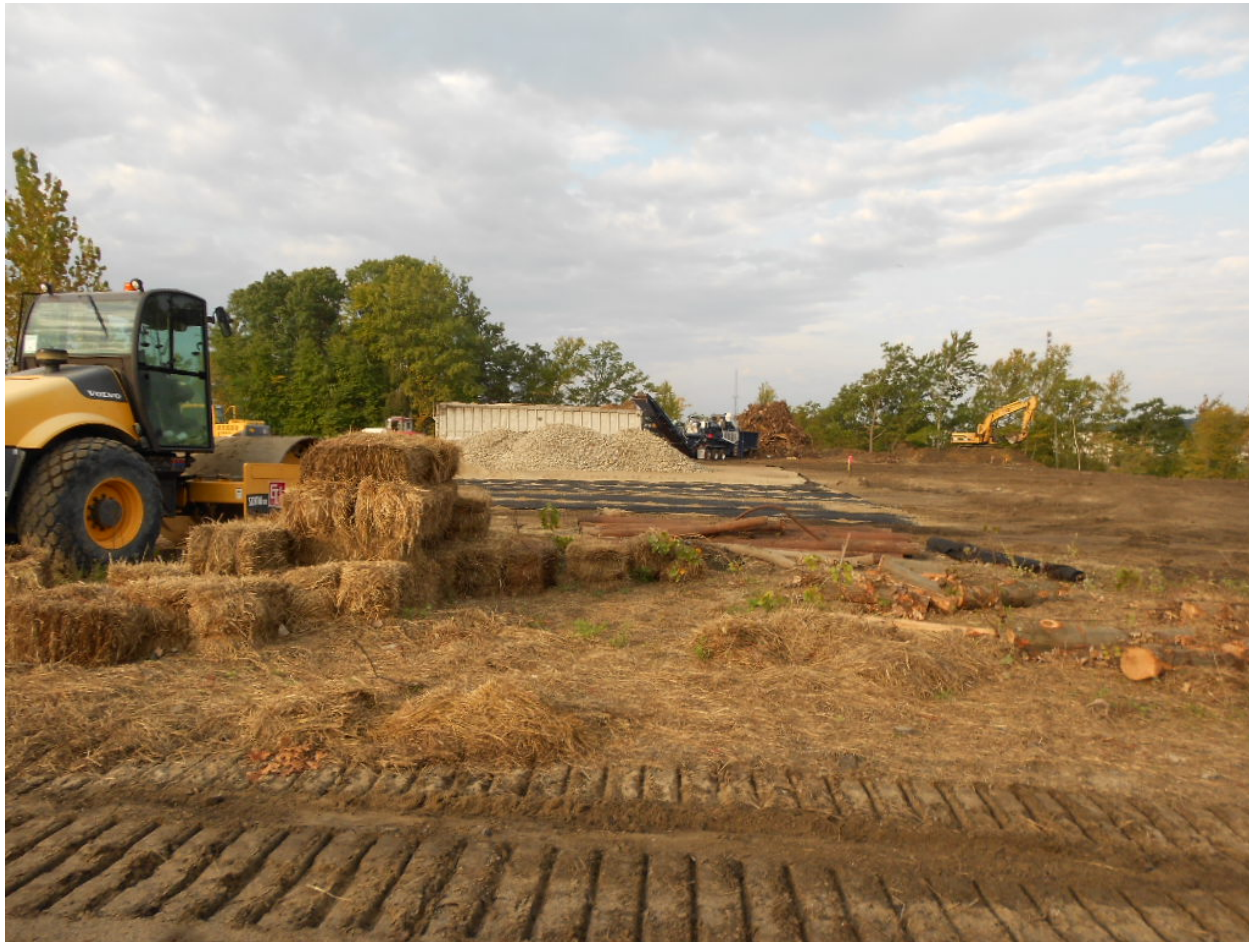
<b>Date</b>	<b>Photo ID</b>	<b>Description</b>
09/27/12	0957	Wagner Wood chipper set up to dispose chipped stumps into Clean Harbors-provided trailer truck, looking southwest

ET&L excavated the larger stumps remaining from clearing activities and stockpiled them inside proposed capping limits. Wagner Wood sheared the stumps to separate visibly clean woody material from stump material impacted by soil. The visibly clean woody stump material was chipped and disposed off-site by Clean Harbors Environmental Services (Clean Harbors) as non-hazardous material. The soil-impacted stump material was broken down into small pieces by on-site heavy equipment and consolidated on-site within the proposed cap limits.

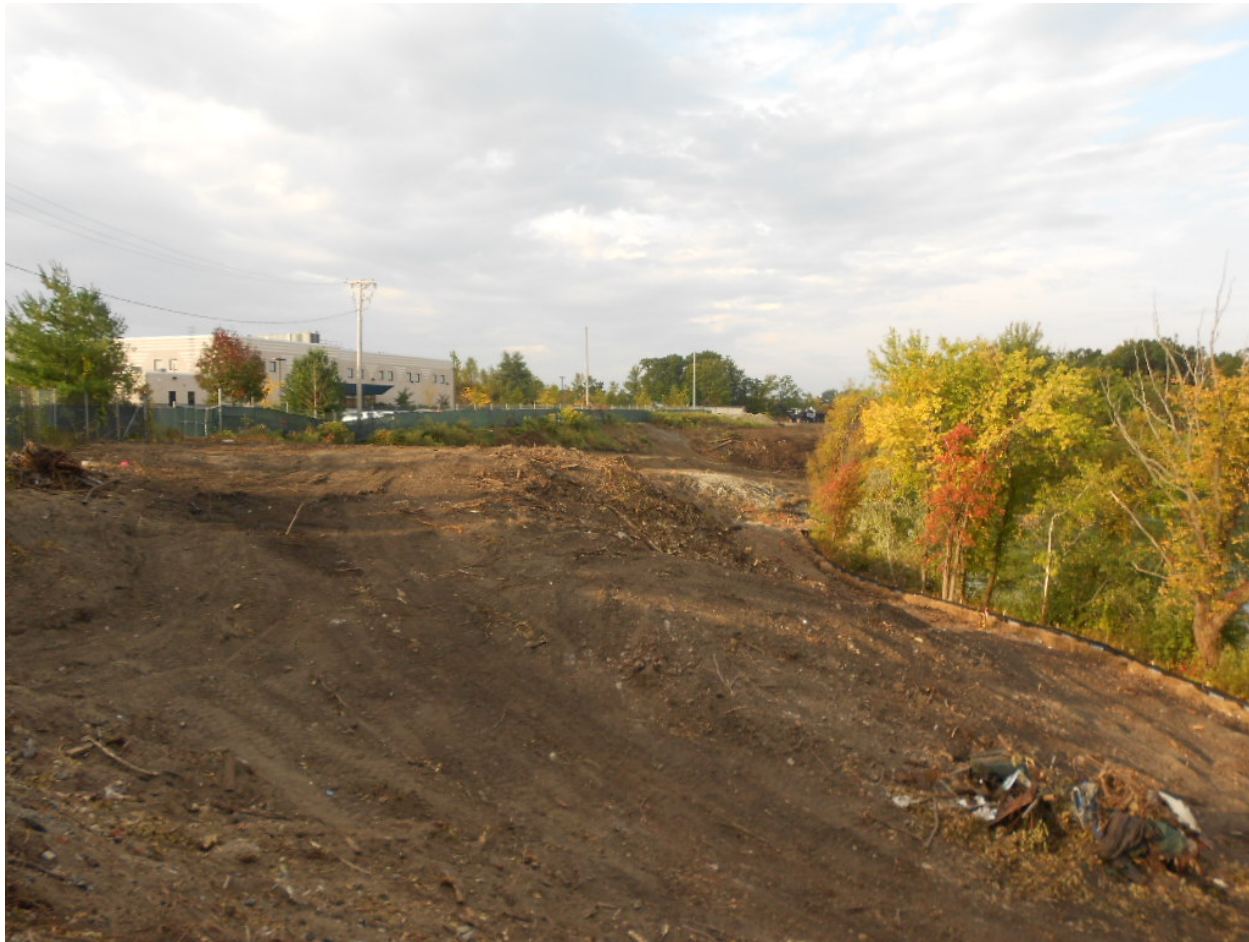
<b>Date</b>	<b>Photo ID</b>	<b>Description</b>
09/27/12	0958	Looking southwest from Area 5 at the cleared slopes on-site

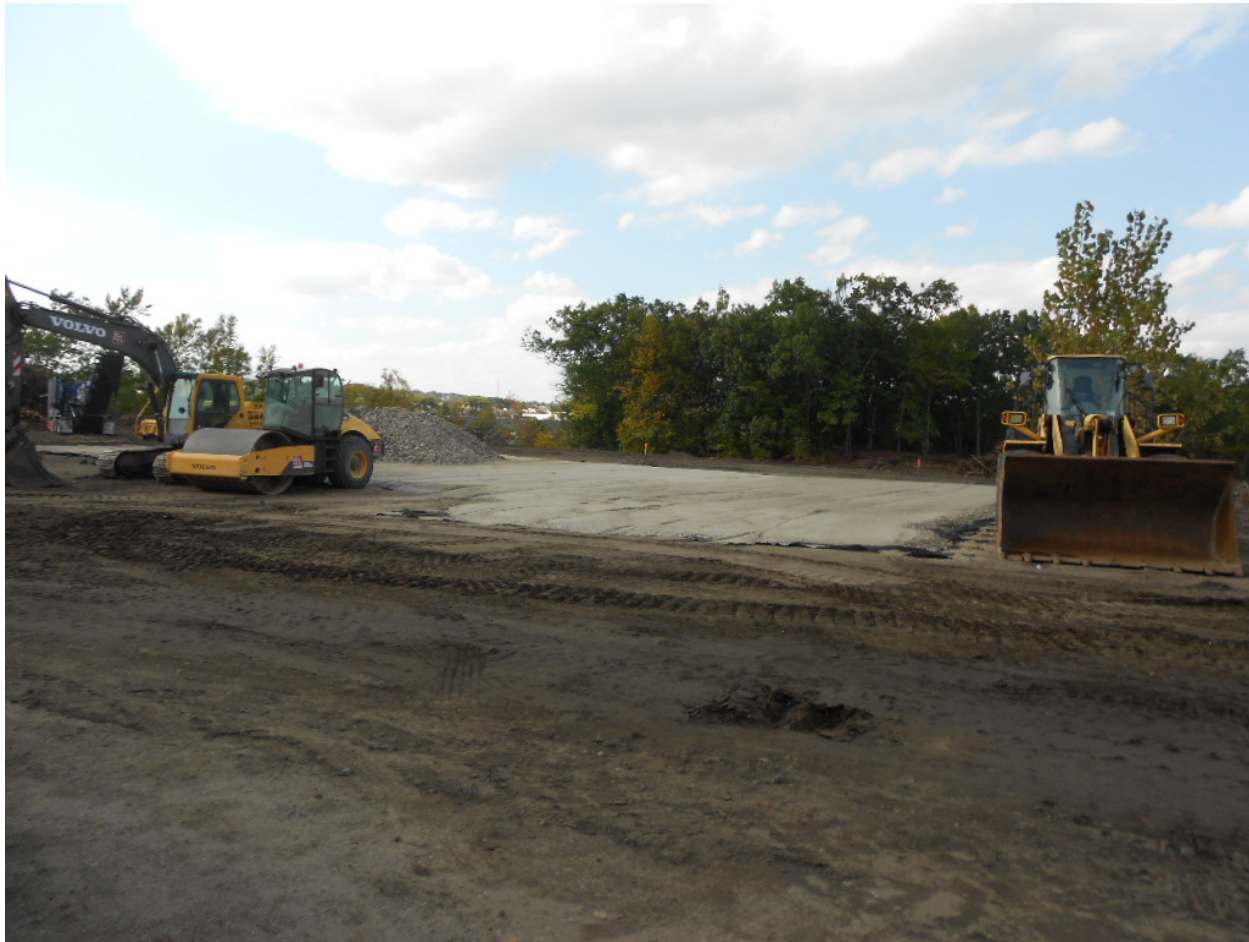
<b>Date</b>	<b>Photo ID</b>	<b>Description</b>
09/27/12	0962	Lay down area extended, looking south

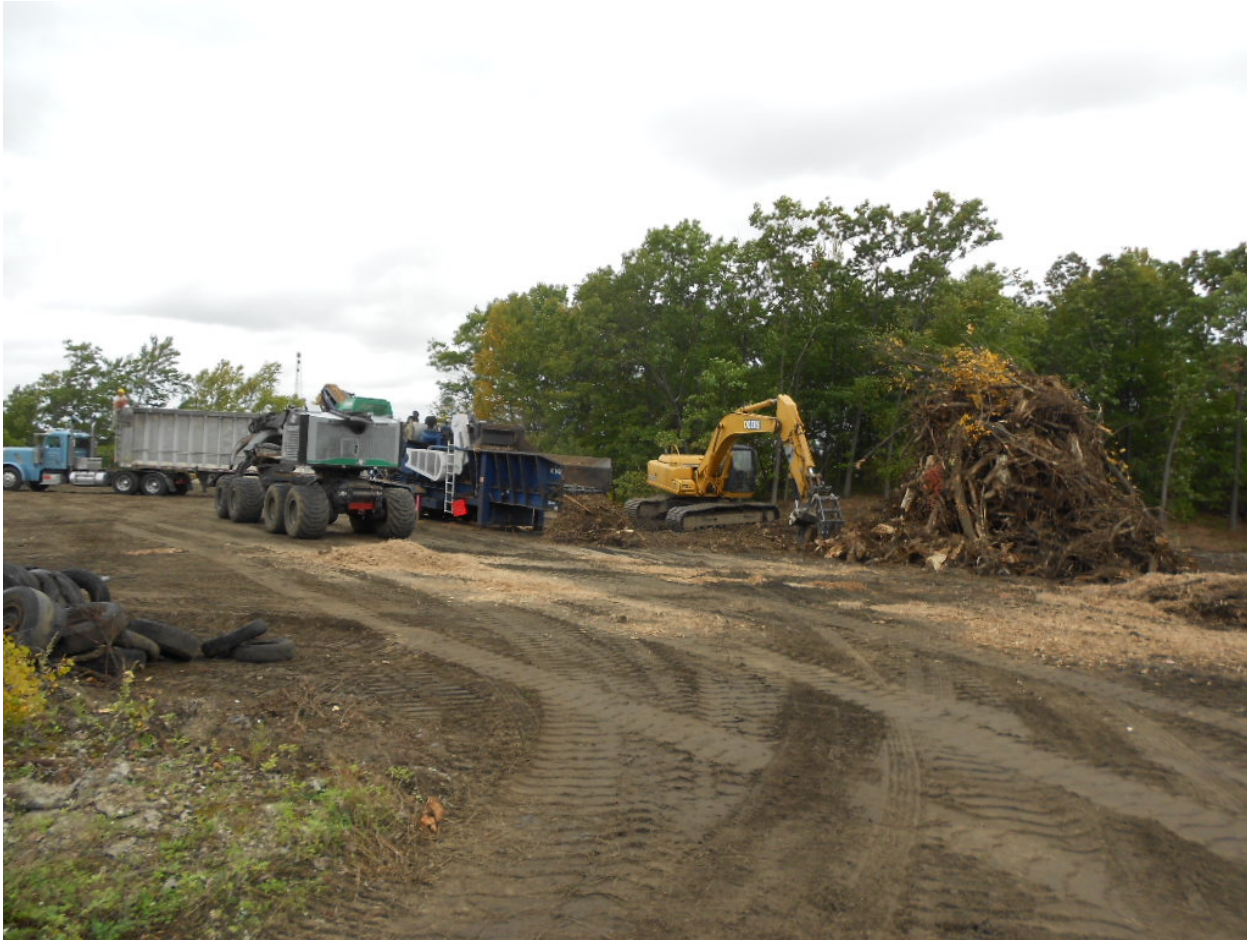
<b>Date</b>	<b>Photo ID</b>	<b>Description</b>
09/28/12	0963	Wagner Wood shearing stumps for chipping, looking west

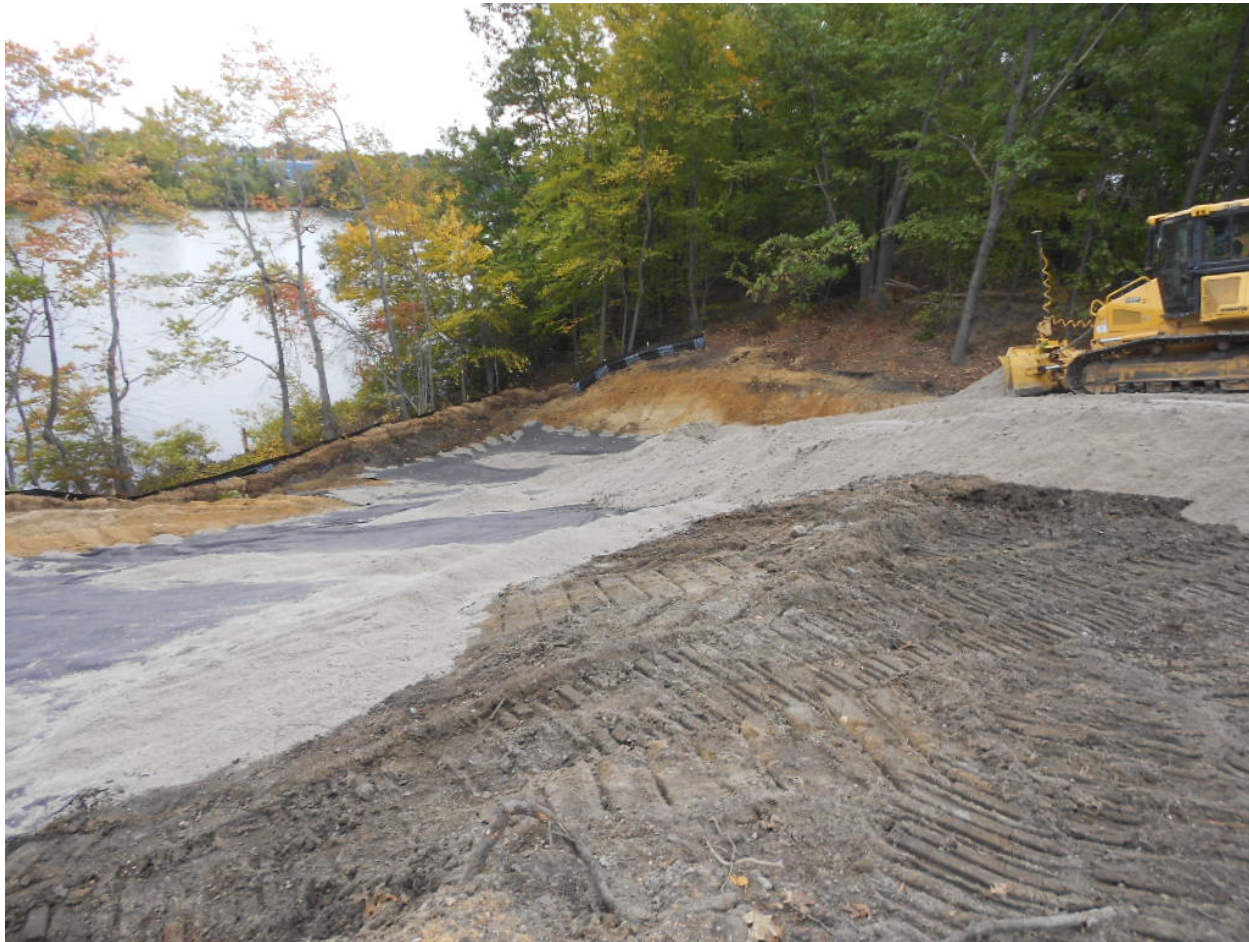
<b>Date</b>	<b>Photo ID</b>	<b>Description</b>
09/28/12	0965	Placing cover soil at Area 2, looking west

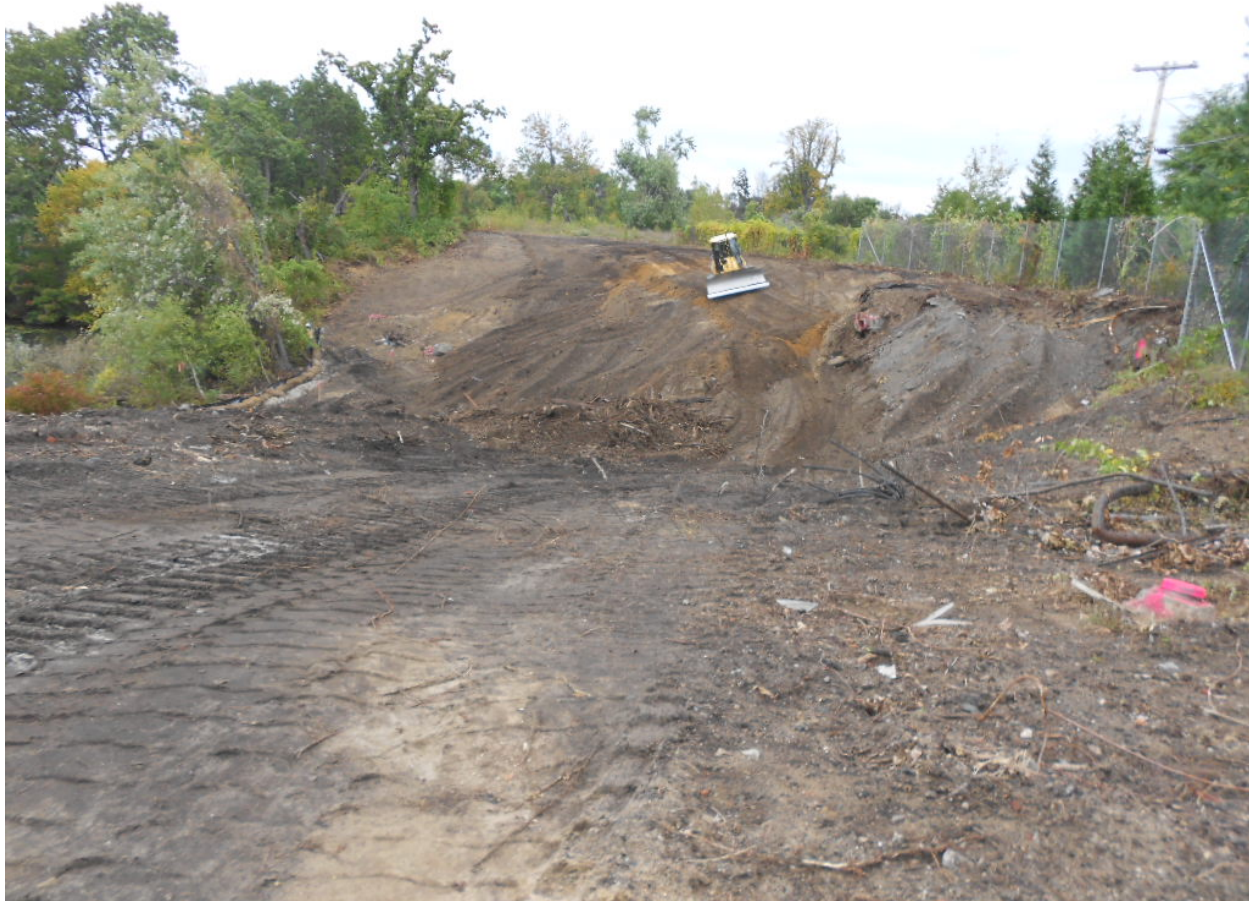
<b>Date</b>	<b>Photo ID</b>	<b>Description</b>
09/28/12	0966	Dozer grading sub-grade at Area 5, looking northeast

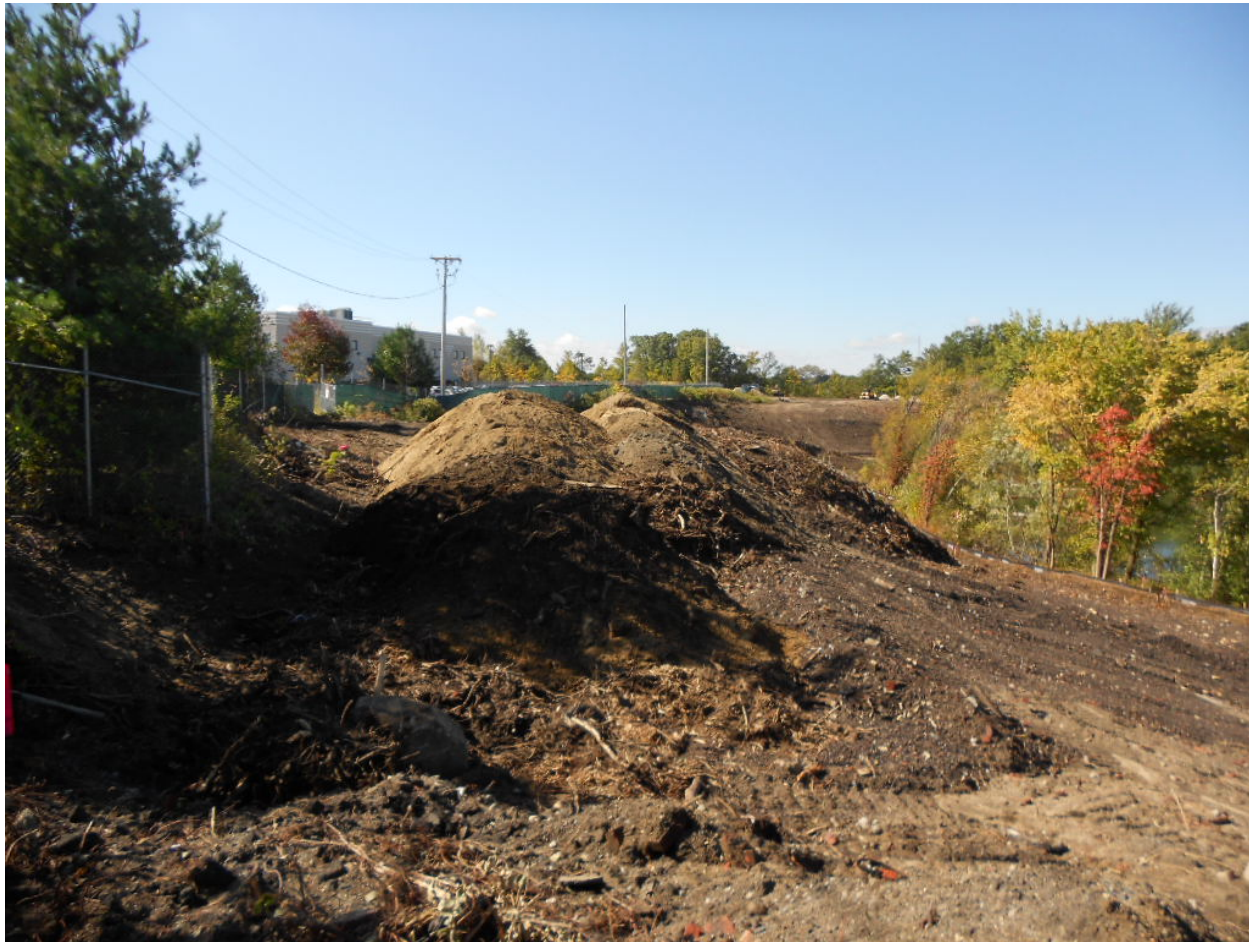
<b>Date</b>	<b>Photo ID</b>	<b>Description</b>
10/01/12	0970	Excavated soil from Area 2 stockpiled at Area 5, looking southwest

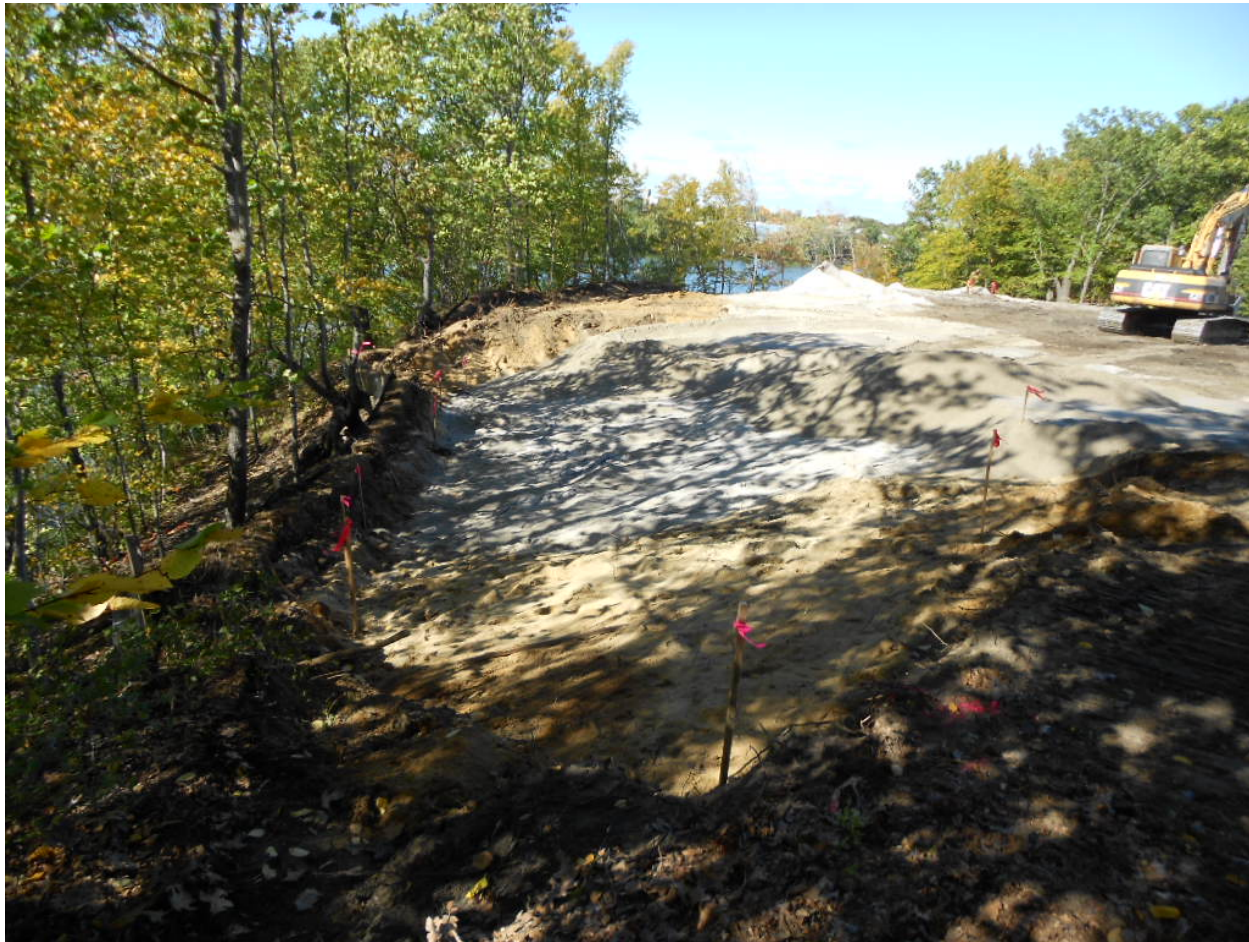
<b>Date</b>	<b>Photo ID</b>	<b>Description</b>
10/01/12	0976	Backfilling Area 2 with cover soil, looking northwest

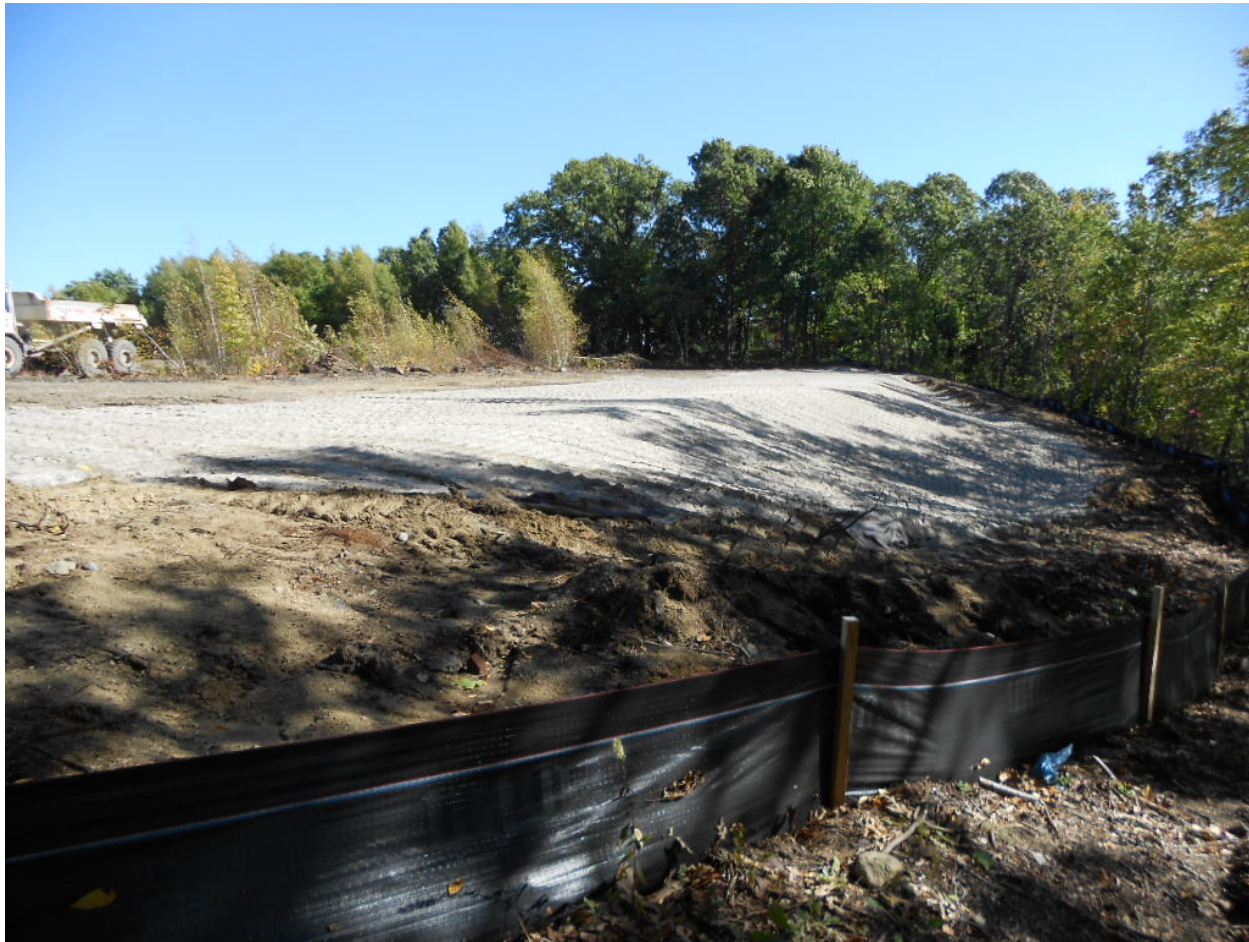
<b>Date</b>	<b>Photo ID</b>	<b>Description</b>
10/01/12	0977	Area 1 backfilled with cover soil, looking southeast

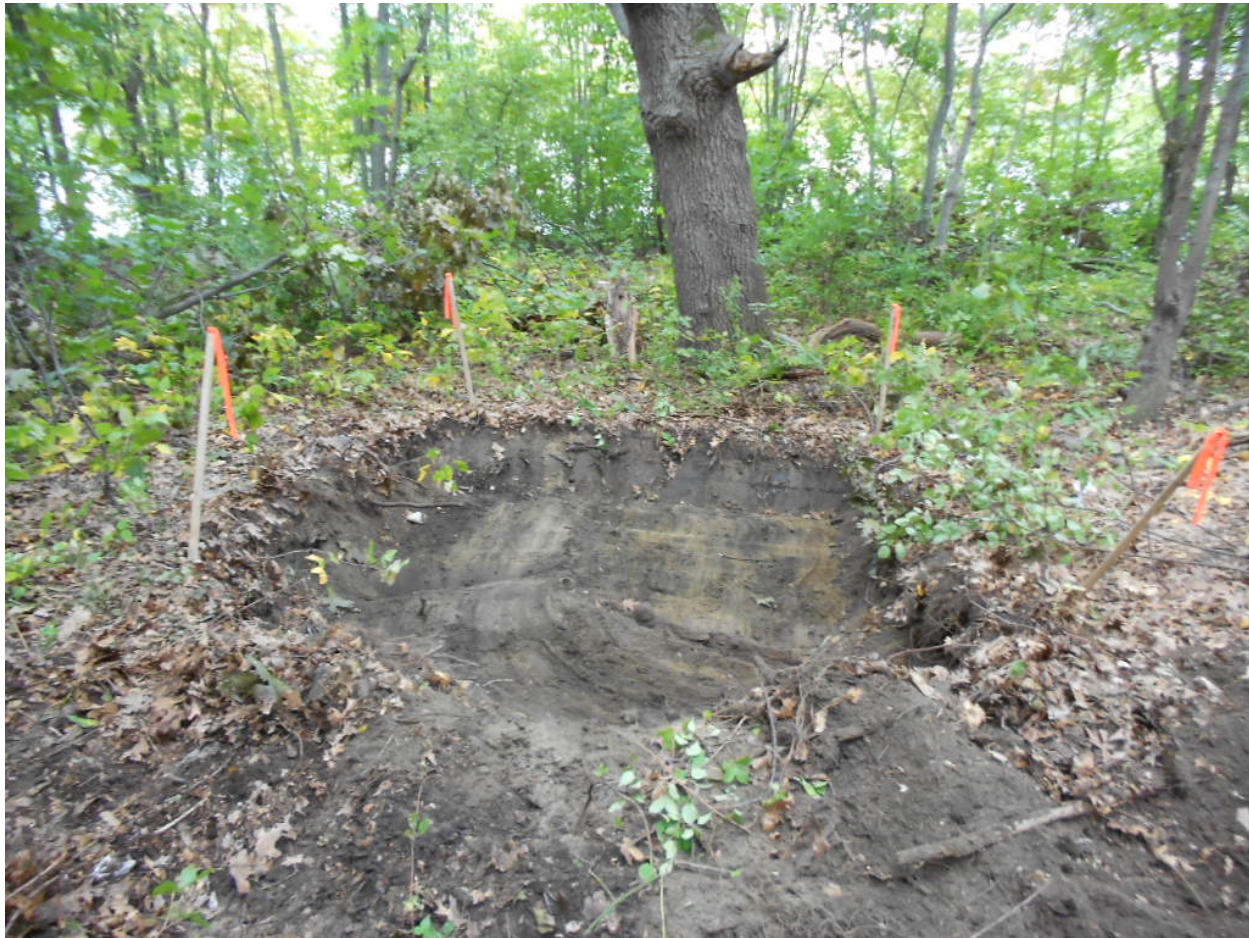
<b>Date</b>	<b>Photo ID</b>	<b>Description</b>
10/02/12	0978	Hotspot excavation at the southwest of the site in the drainage channel

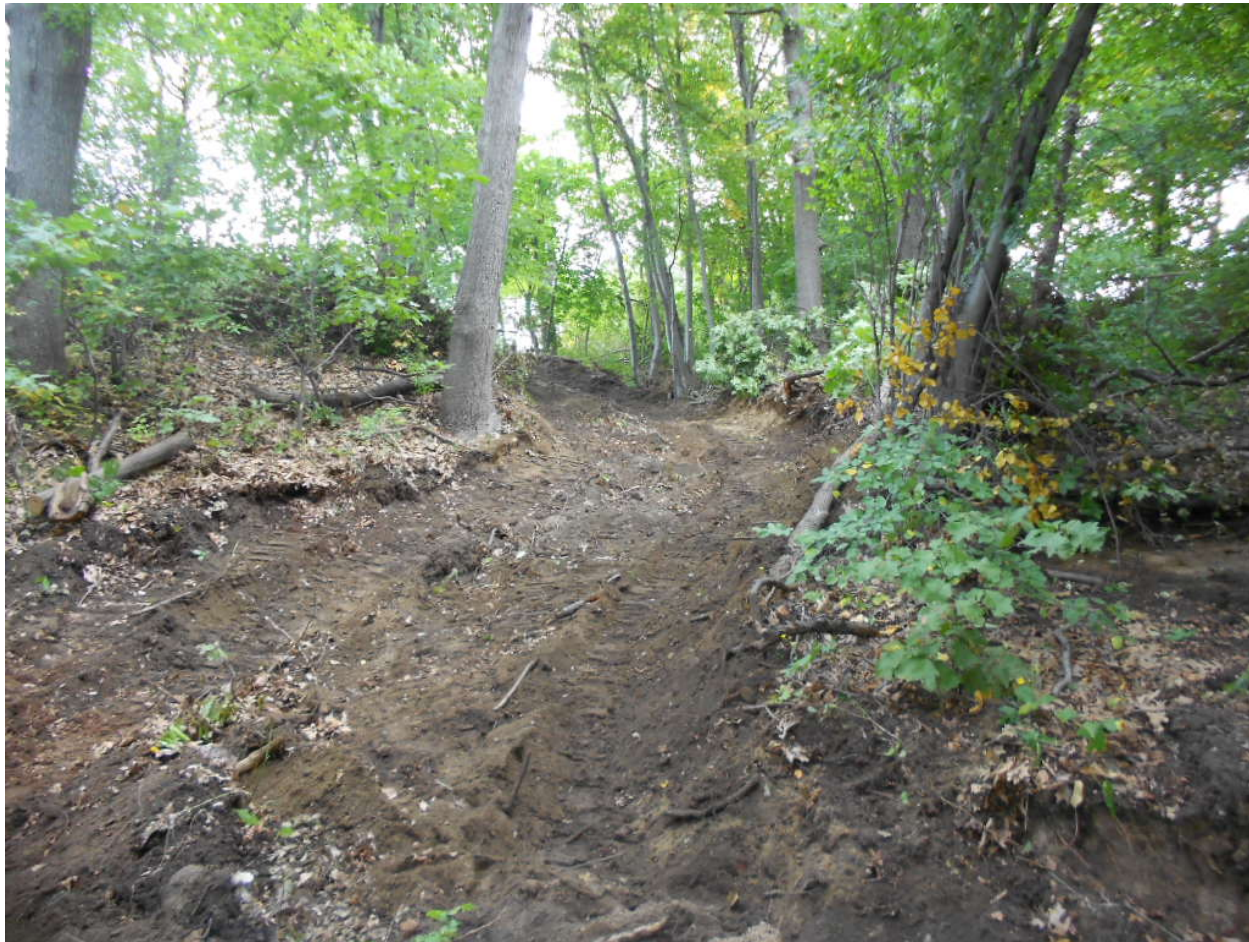
<b>Date</b>	<b>Photo ID</b>	<b>Description</b>
10/02/12	0979	Looking at the drainage channel from the hot spot excavation. Note: the drainage channel was widened slightly for access.

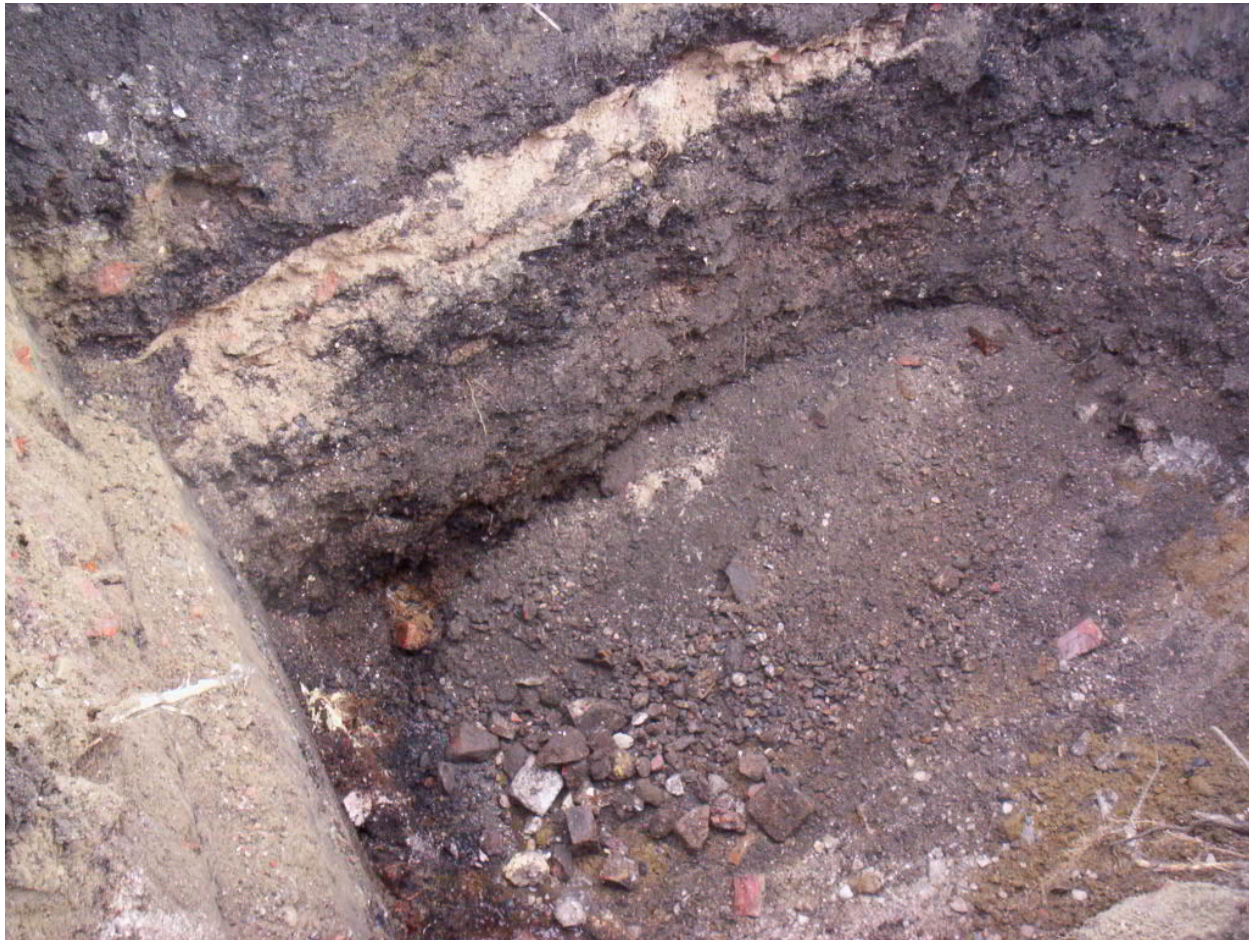
<b>Date</b>	<b>Photo ID</b>	<b>Description</b>
10/02/12	1509	TP 11, excavated 8 ft bgs

During test pitting, there were no large pockets or veins of additional slag uncovered. Only a few small pieces of slag were observed. Confirmatory grab soil samples were conducted at each test pit for total lead (by USEPA Method 6010) and Synthetic Precipitation Leaching Procedure (SPLP) lead (by USEPA Method 1312). The sample depths were chosen based on the most likely location in the test pit to contain lead. These were typically within layers of industrial fill. Table 3 includes a summary of the analytical data for test pit samples. The analytical results of the test pit samples (Appendix E) indicated that total lead frequently exceeded the RDEC in the samples of industrial fill; however the highest result of SPLP lead was 0.358 mg/L. Thus, the leaching potential of the industrial fill within the test pits was limited. Even though the leaching potential of the industrial fill within the former slag area was confirmed to be limited, the area was capped as proposed with an impermeable liner, as described in subsection 3.5.1, further reducing the potential for leaching.

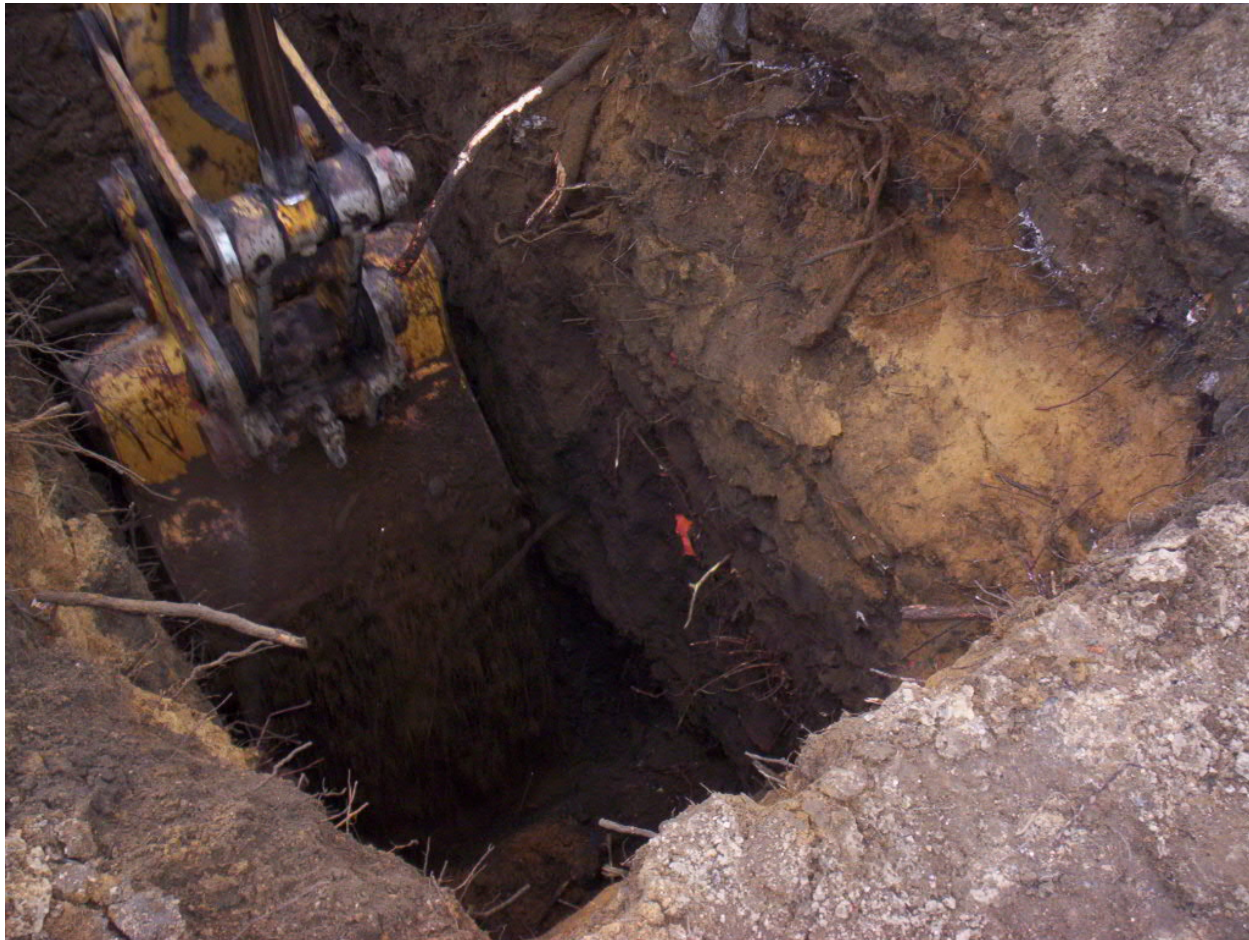
<b>Date</b>	<b>Photo ID</b>	<b>Description</b>
10/02/12	1526	TP 5, excavated 5 ft bgs

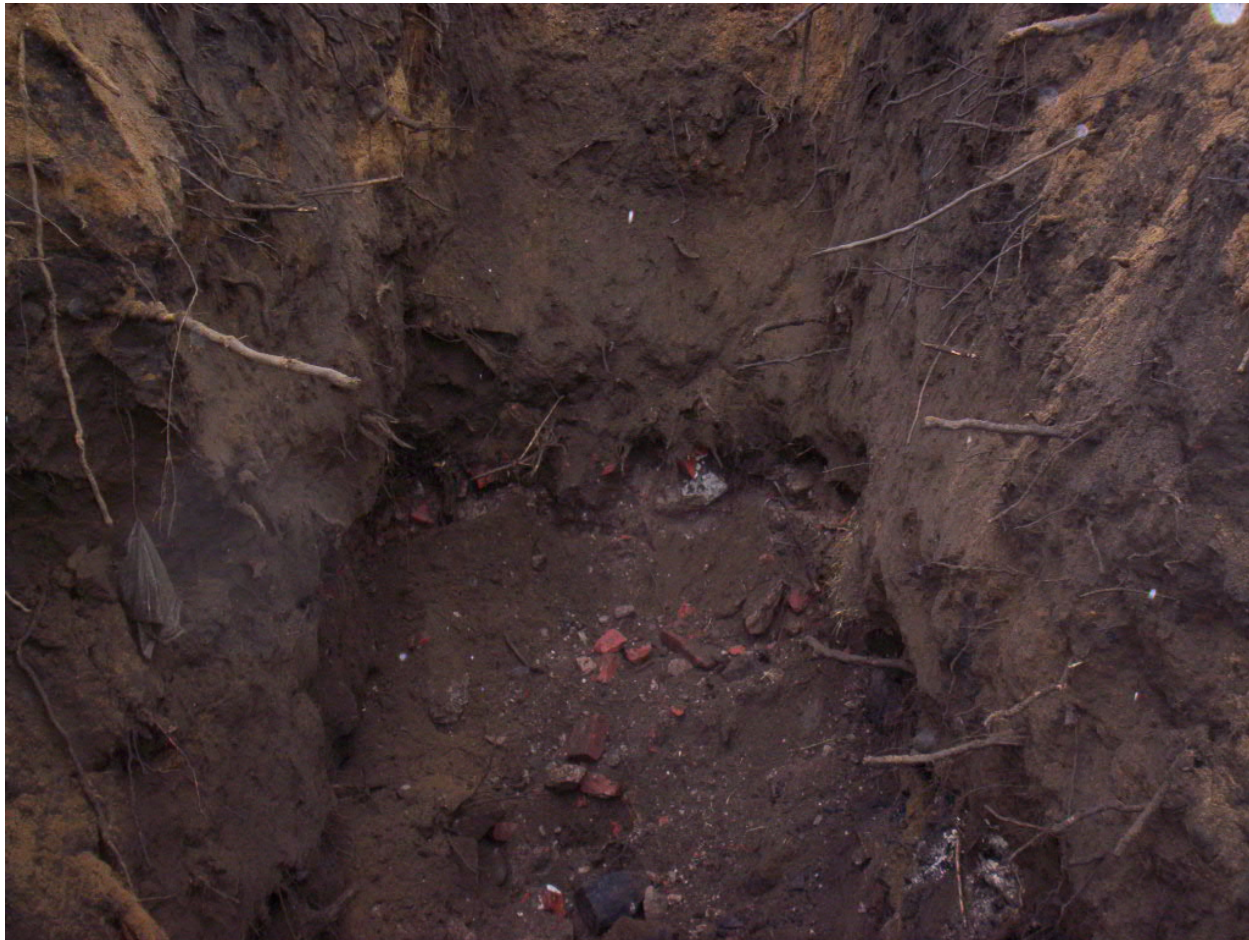
<b>Date</b>	<b>Photo ID</b>	<b>Description</b>
10/02/12	1529	TP 8, excavated 10 ft bgs

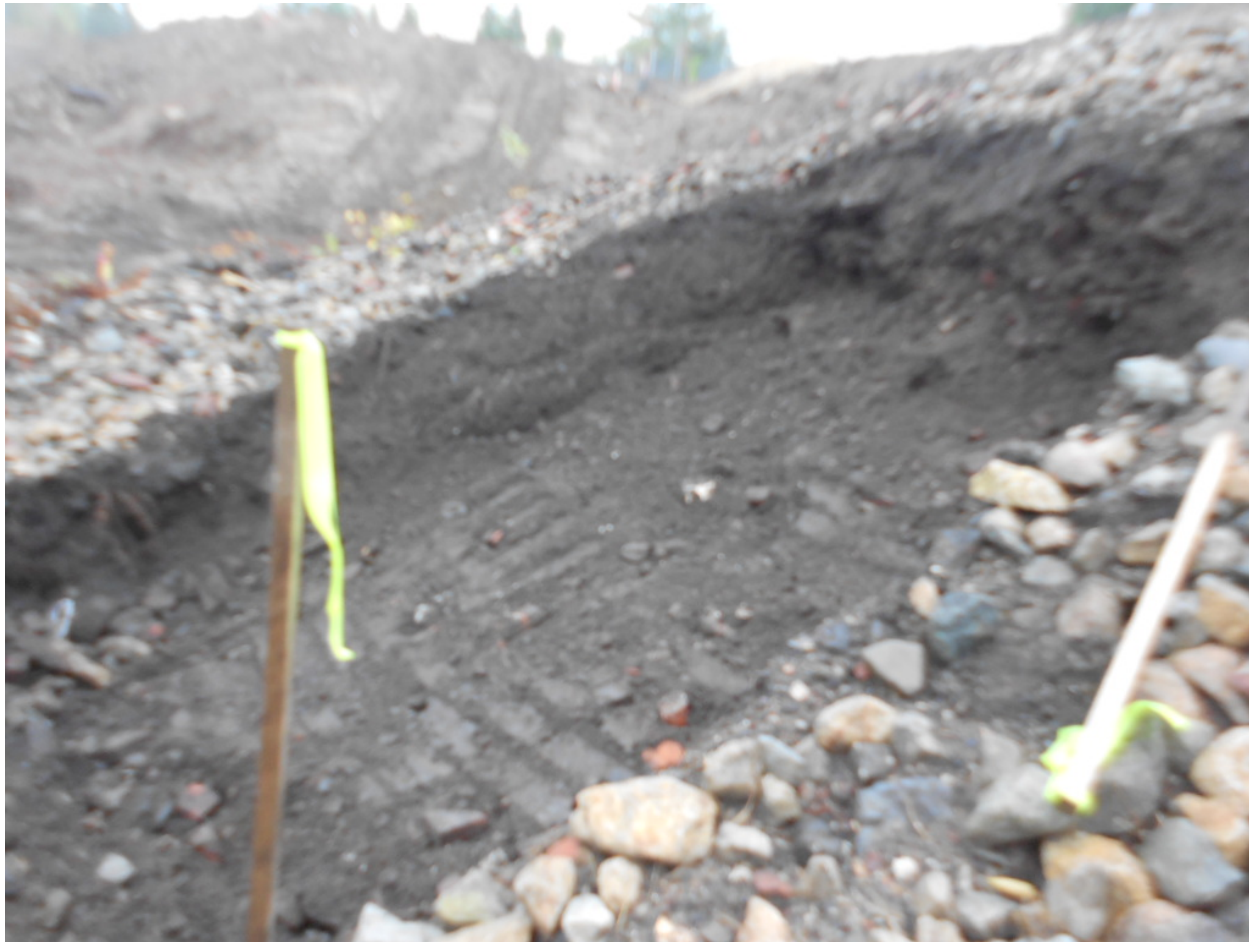
<b>Date</b>	<b>Photo ID</b>	<b>Description</b>
10/03/12	0991	Hot spot excavation at former slag area

Soil was excavated at one location in the former slag pile area (10 feet x 10 feet x 2 feet deep, Figure 5 and Sheet C-104) by ET&L and loaded into a roll-off container in accordance with the approved RAWP. This soil was transported by Clean Harbors as hazardous waste and disposed at Clean Harbors' Corunna, Ontario Canada facility on March 11, 2013 (Appendix O). In addition, eleven test pits (TP01 – TP11) were conducted at the perimeter of the former slag pile removal area and at locations within the former slag pile to determine if additional slag material was present. A representative of RIDEM was on site during the test pit operations. Test pits were excavated to native soil or groundwater (3 -10 ft bgs). The test pit locations are shown on Figure 5 and were coordinated in the field with RIDEM.

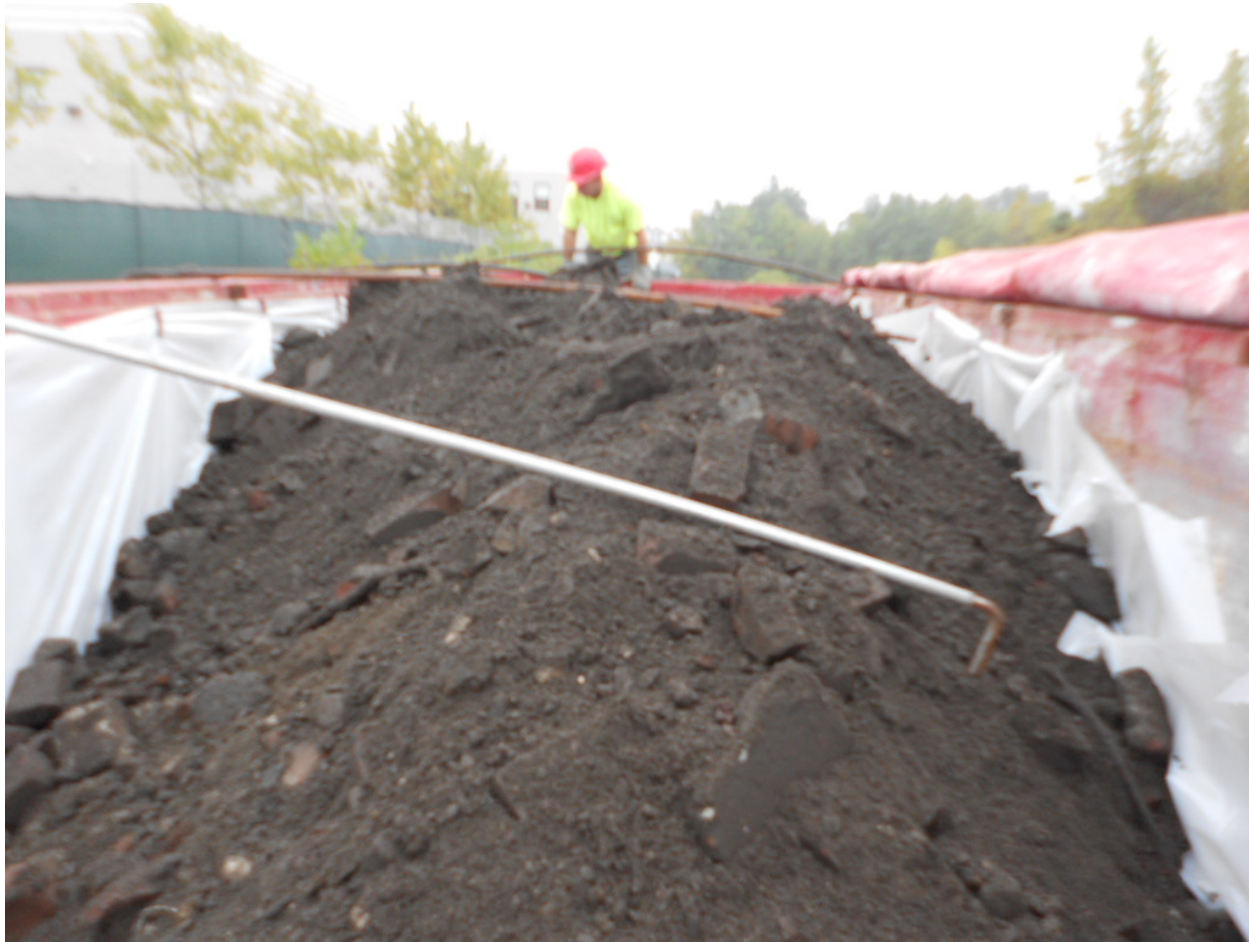
<b>Date</b>	<b>Photo ID</b>	<b>Description</b>
10/03/12	0993	Excavated material from the former slag area placed inside roll-off for T&D

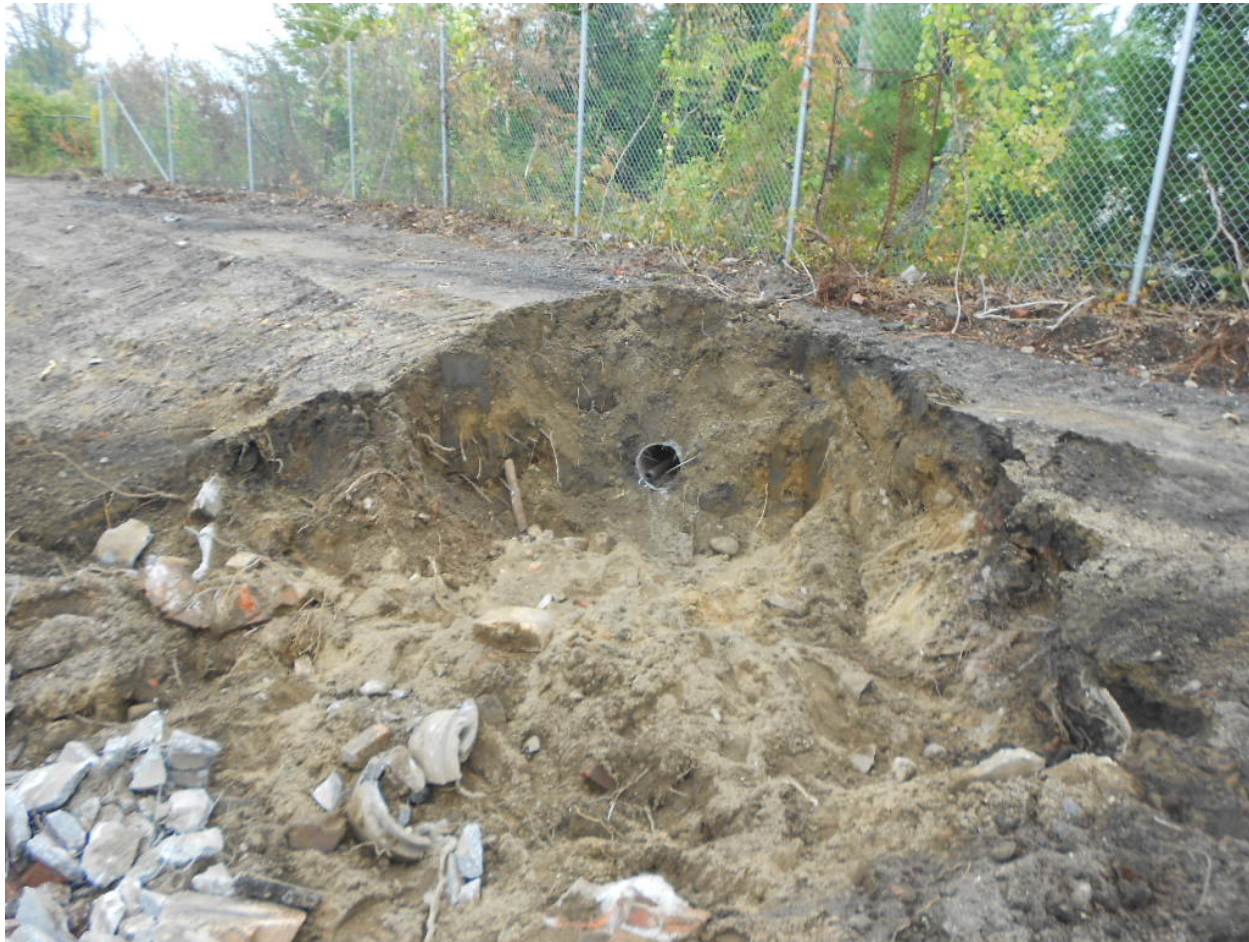
<b>Date</b>	<b>Photo ID</b>	<b>Description</b>
10/03/12	1001	Storm drain to be plugged at the top of the bank in Area 5, looking east

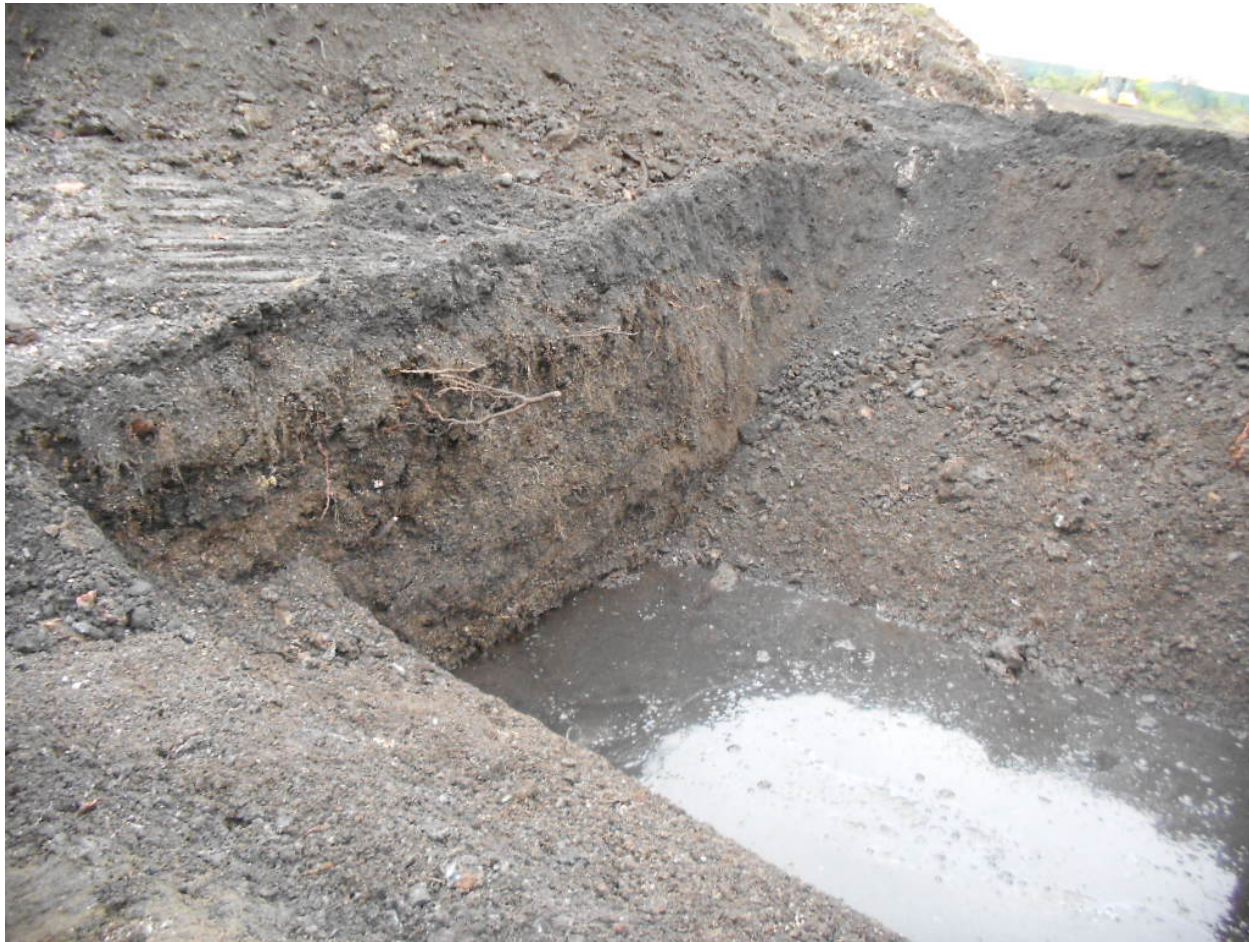
<b>Date</b>	<b>Photo ID</b>	<b>Description</b>
10/04/12	1007	Test pits in industrial fill area with volcanic rock looking material
