# REMEDIAL ACTION CLOSURE REPORT

## PARCEL C-1 PHASE I CAP FORMER GORHAM MANUFACTURING FACILITY 333 ADELAIDE AVENUE PROVIDENCE, RHODE ISLAND

AMEC Environment & Infrastructure, Inc.  
2 Robbins Road  
Westford, Massachusetts 01886

April 2013

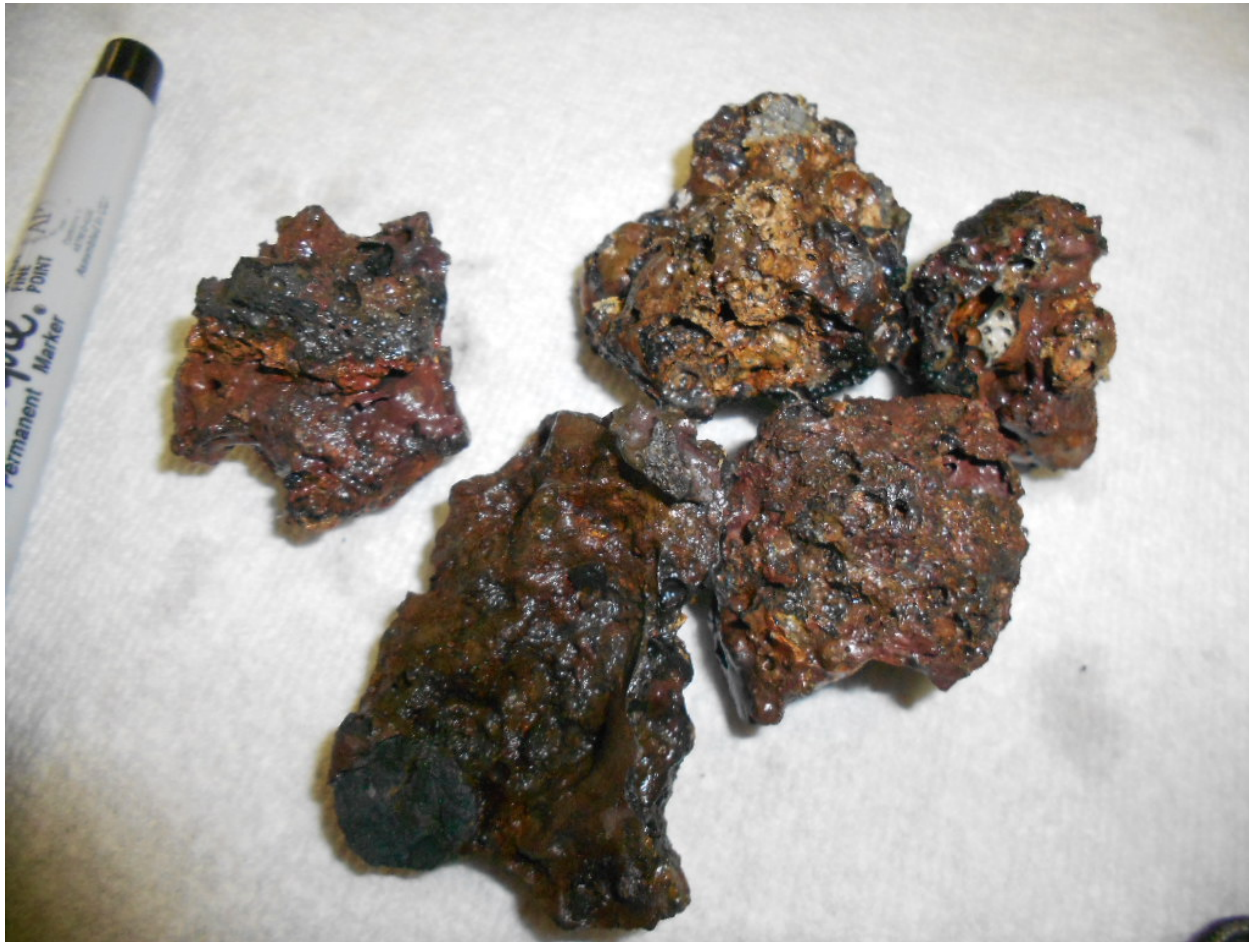
<b>Date</b>	<b>Photo ID</b>	<b>Description</b>
10/04/12	1009	Close-up of volcanic rock looking material in the industrial fill area (Area 5), sent for analysis (RCRA 8 metals)

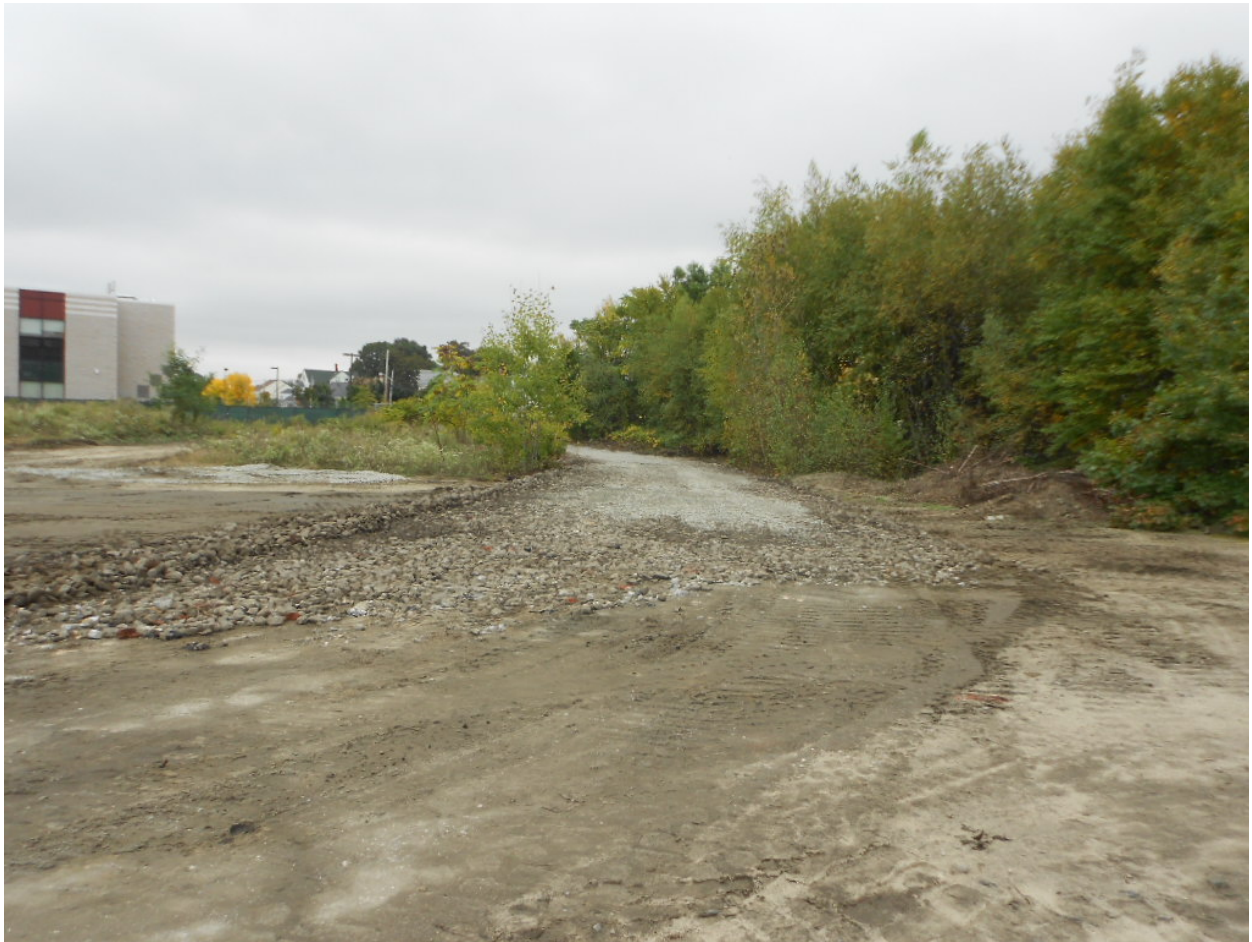
<b>Date</b>	<b>Photo ID</b>	<b>Description</b>
10/04/12	1010	Construction entrance extended with rip rap material from former slag area, looking east

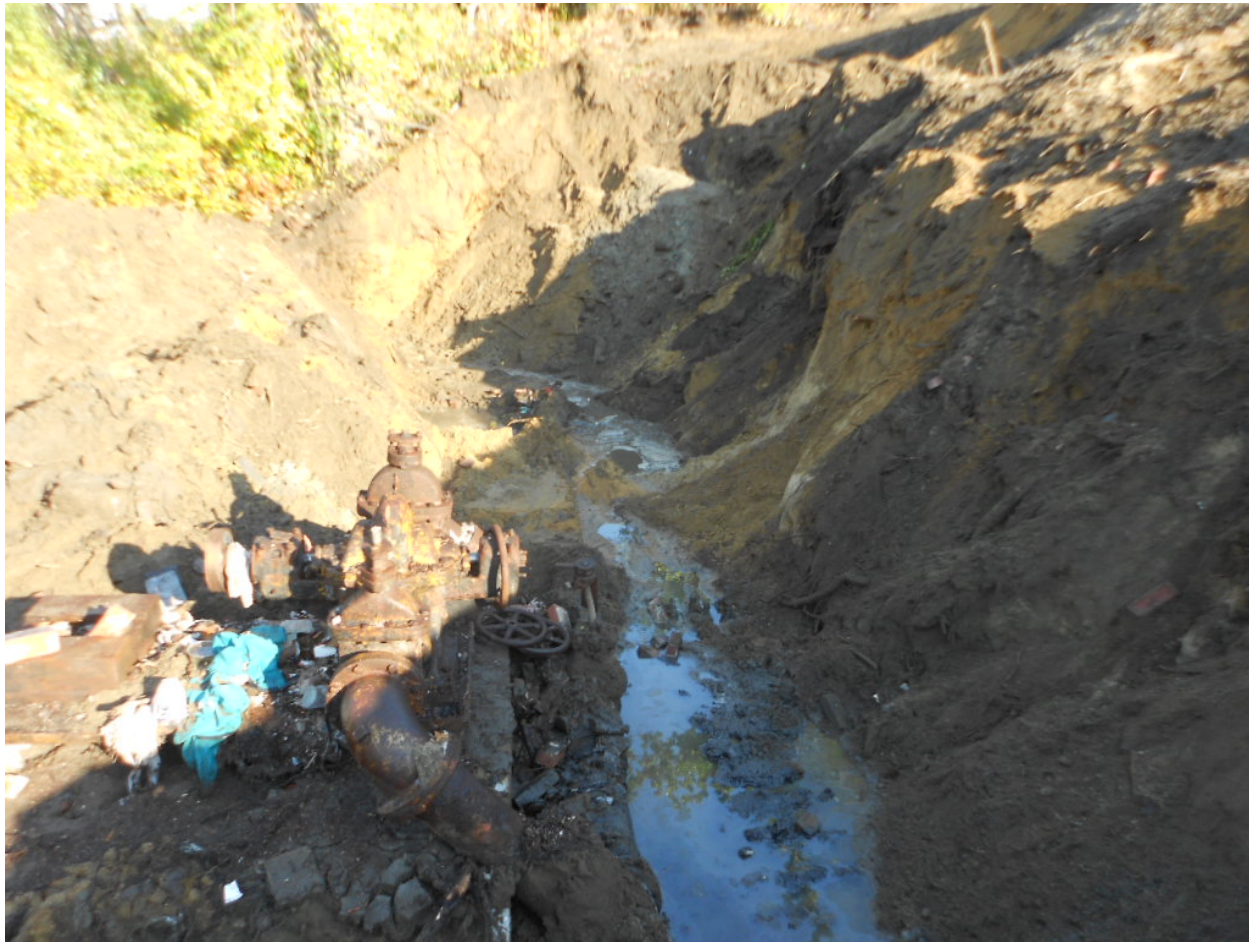
<b>Date</b>	<b>Photo ID</b>	<b>Description</b>
10/05/12	1011	Pump exposed at the former pump house, looking northwest. Supply pipe is from the cove.

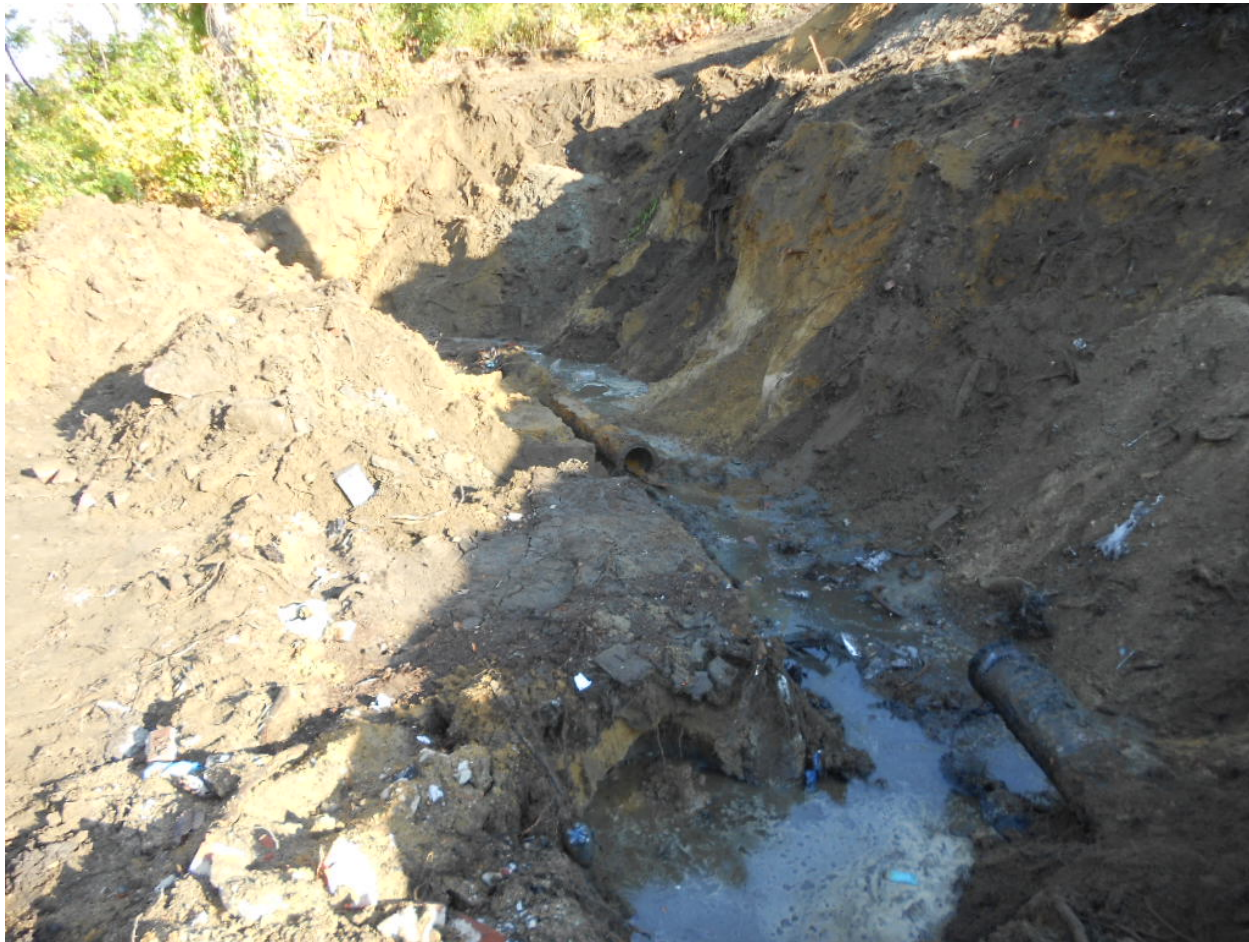
<b>Date</b>	<b>Photo ID</b>	<b>Description</b>
10/05/12	1013	Pump removed at the former pump house, looking northwest. Supply pipe is from the cove. Discharge pipe presumed to go to buried tanks.

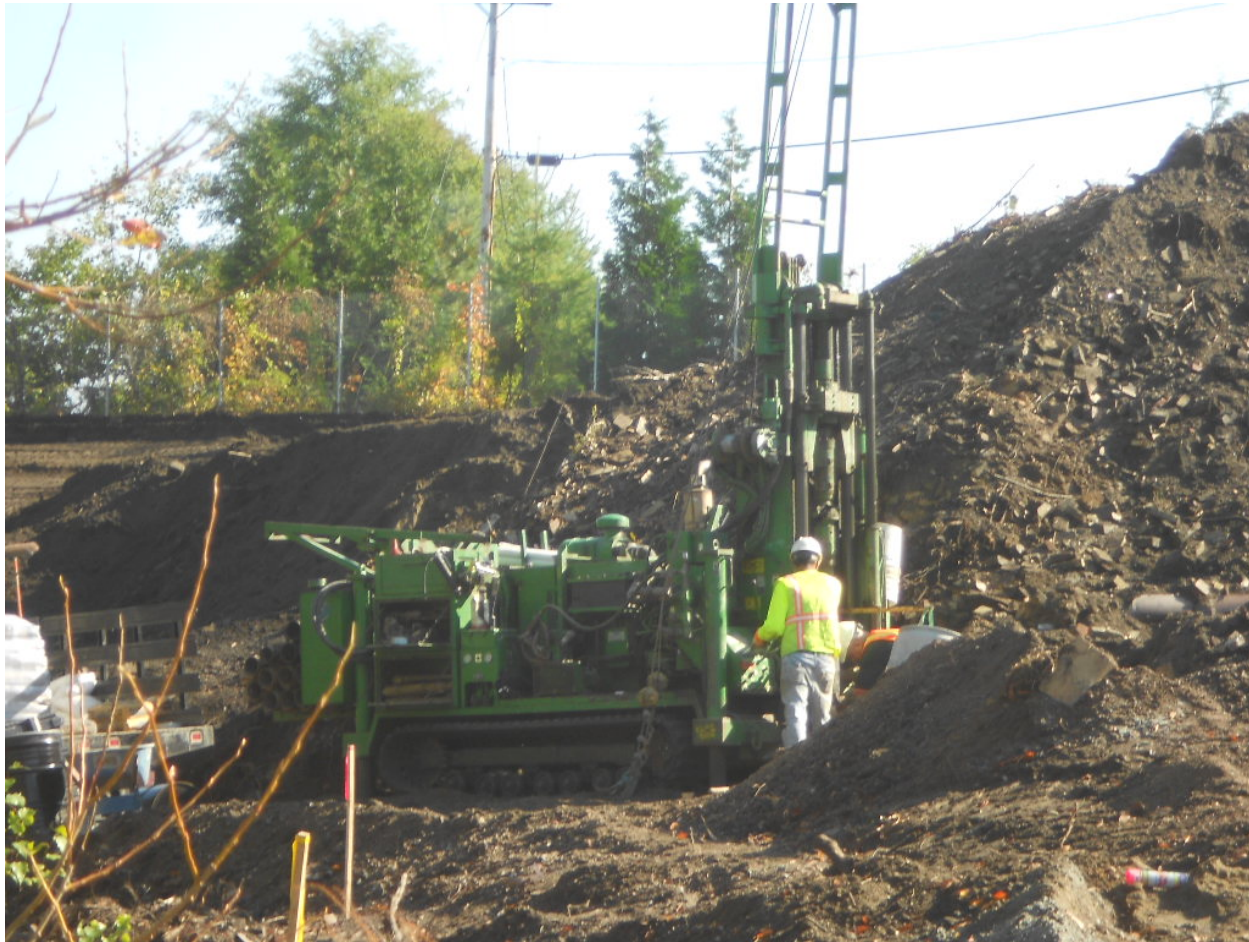
<b>Date</b>	<b>Photo ID</b>	<b>Description</b>
10/05/12	1018	Subcontractor Geosearch set-up to install new well MW-243S, looking east

On October 5, 2012, ET&L subcontractor Geosearch, Inc. (Geosearch) Fitchburg, MA, installed the new monitoring well (MW-234S) on the east side of the former slag area cap. The bottom of the well was installed at 17 ft bgs, and it was screened from 7 ft bgs to 17 ft bgs. The well is 2" PVC with a steel protective casing. The well completion report is included in Appendix M. The new well has not been developed. The GZA-5 replacement well will be installed as part of the Phase II remedial action. The location of MW-234S is shown on the as-built drawing (Appendix G) for the completed remediation.

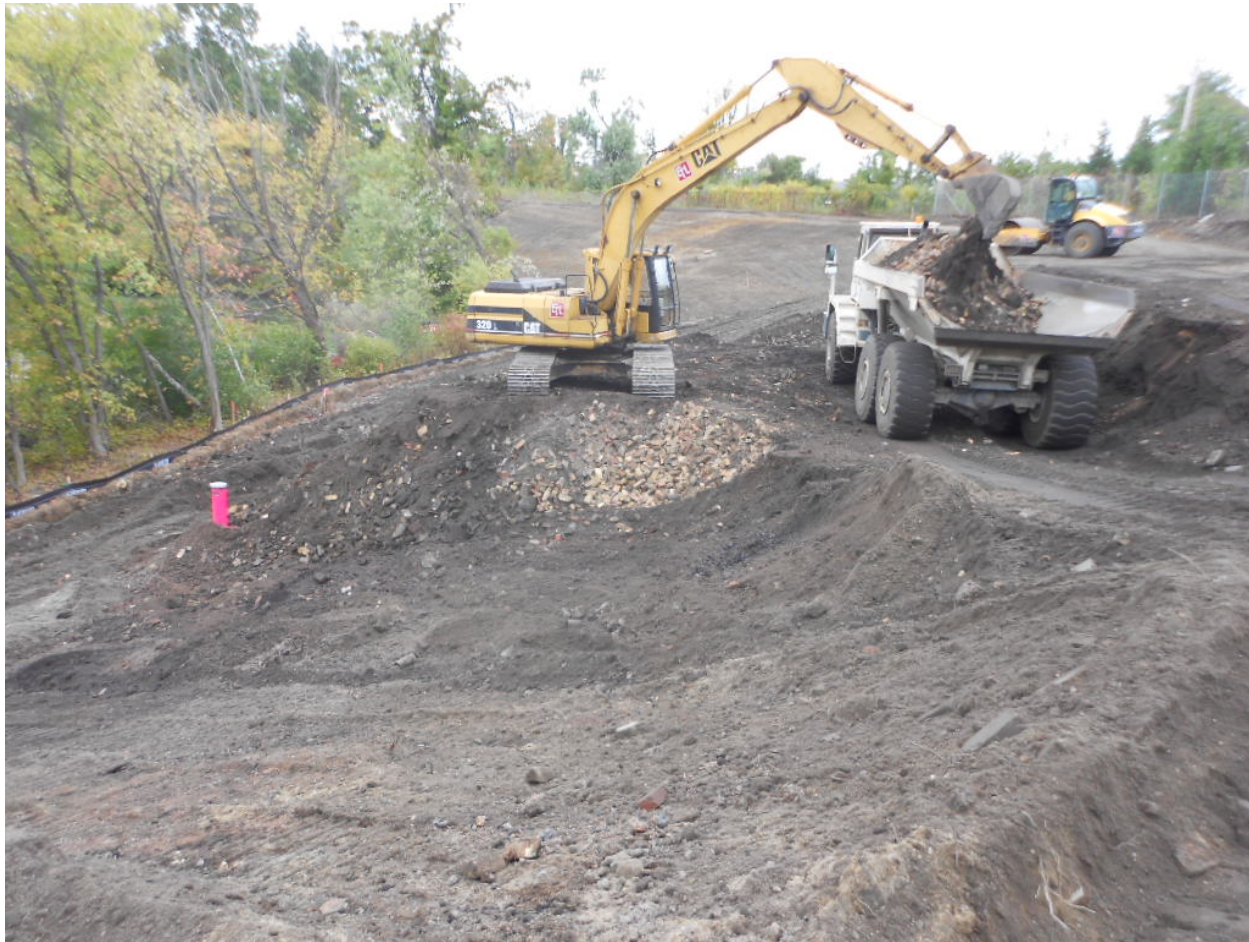
<b>Date</b>	<b>Photo ID</b>	<b>Description</b>
10/09/12	1024	Re-grading industrial fill at Area 5 with excavator and off-road dump and compacting Area 5 sub-grade with roller, looking northeast

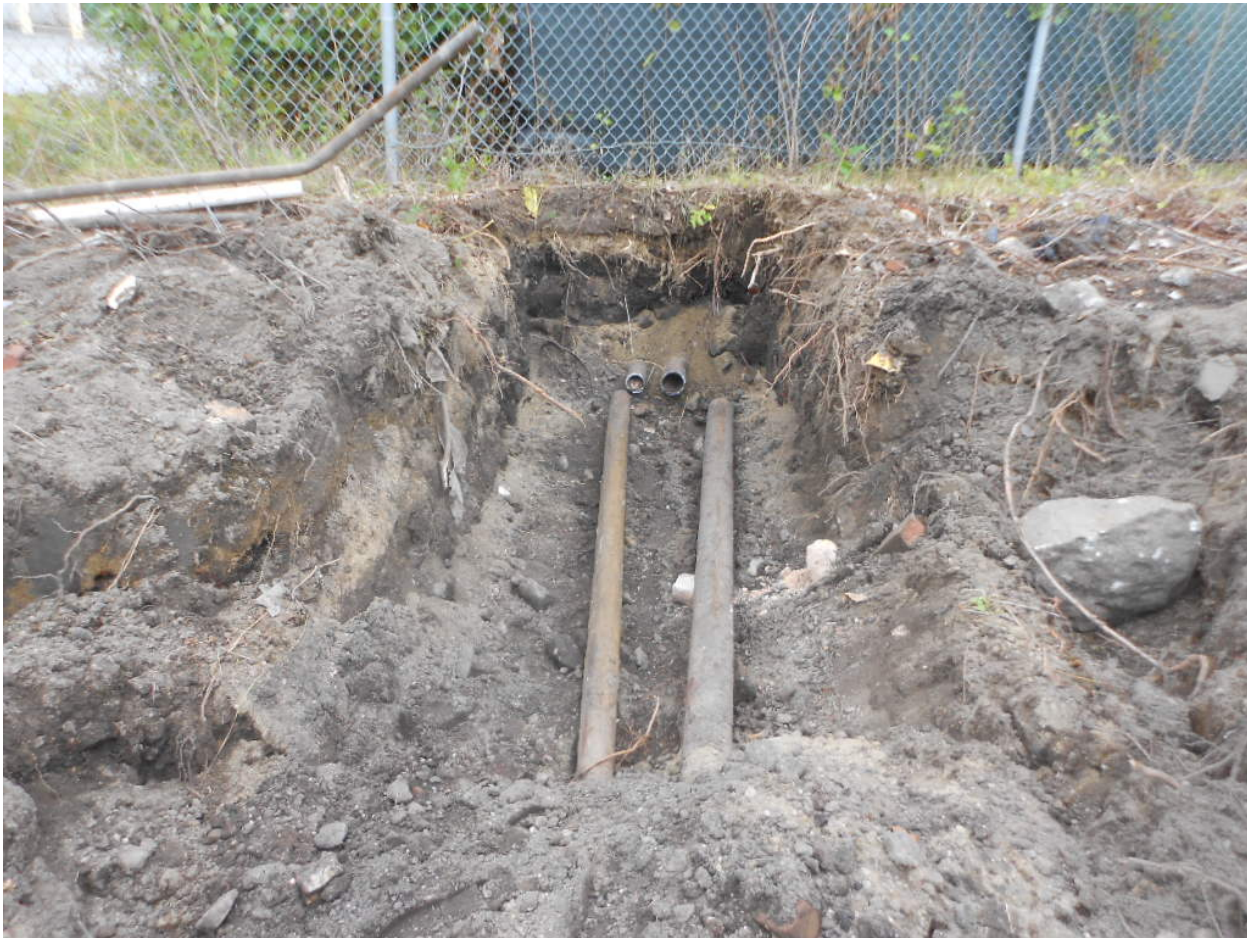
<b>Date</b>	<b>Photo ID</b>	<b>Description</b>
10/09/12	1027	Presumed water lines from the abandoned water tanks at the top of slope at Area 5, looking east. Water lines were plugged and abandoned in place.

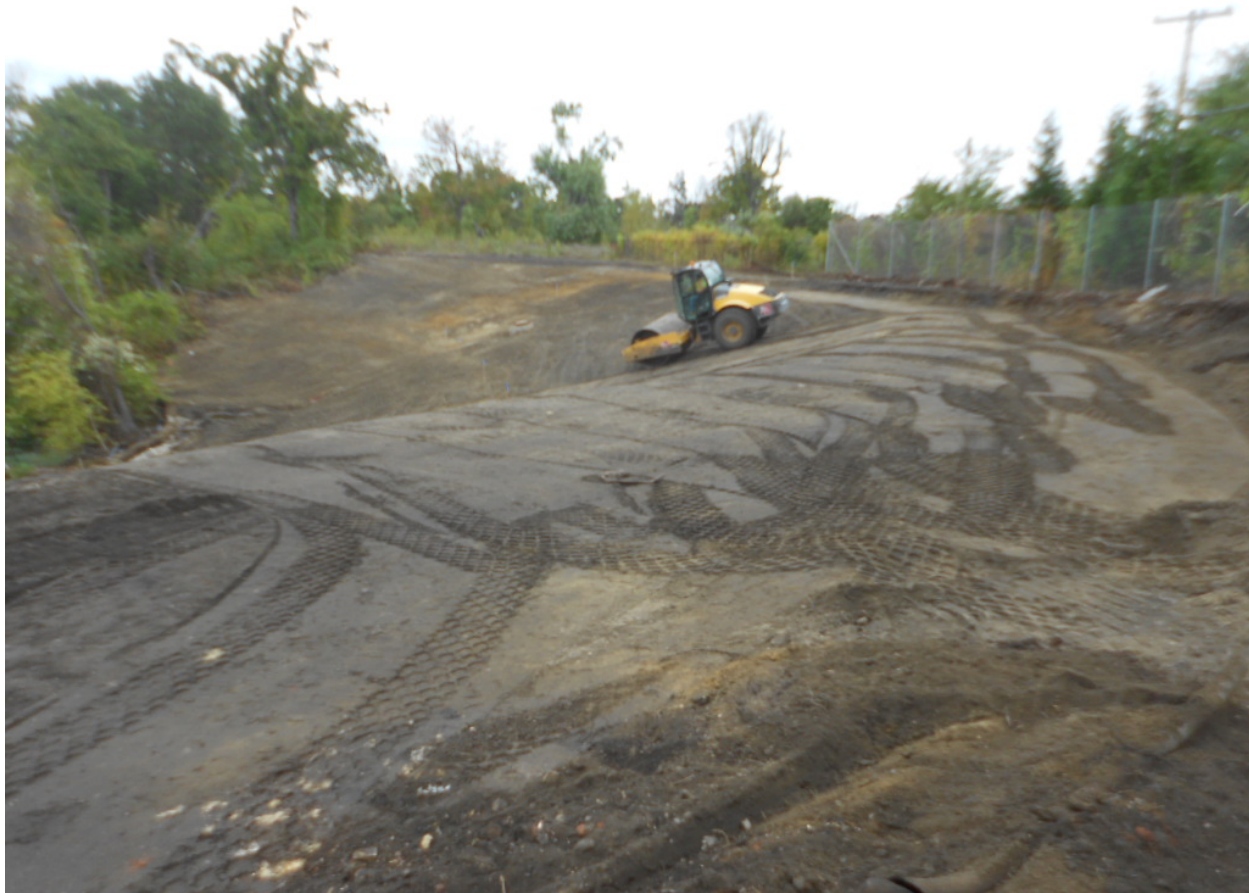
<b>Date</b>	<b>Photo ID</b>	<b>Description</b>
10/09/12	1029	Roller compacting sub-grade at Area 5, looking northeast

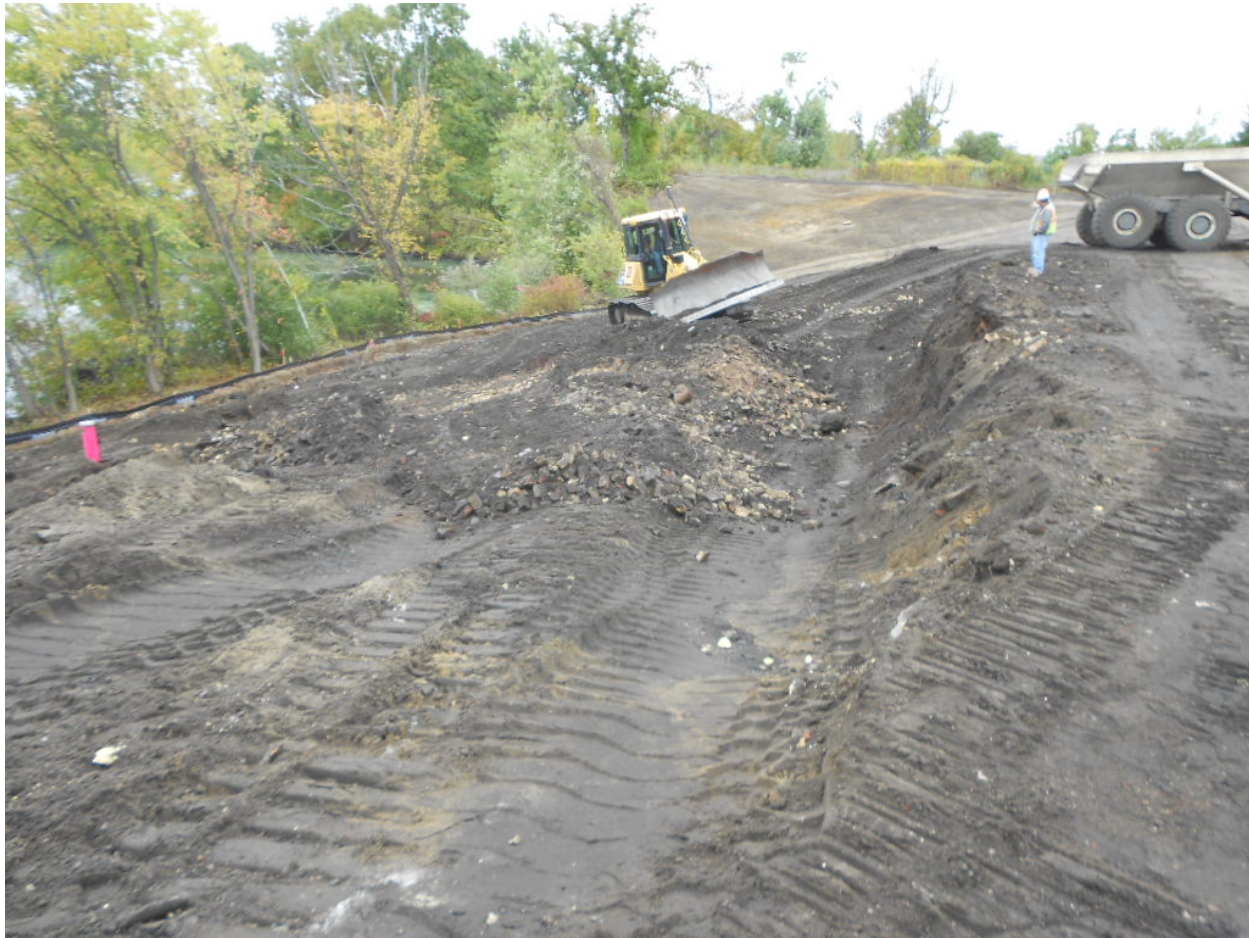
<b>Date</b>	<b>Photo ID</b>	<b>Description</b>
10/09/12	1031	Re-grading industrial fill at Area 5 with dozer, looking northeast

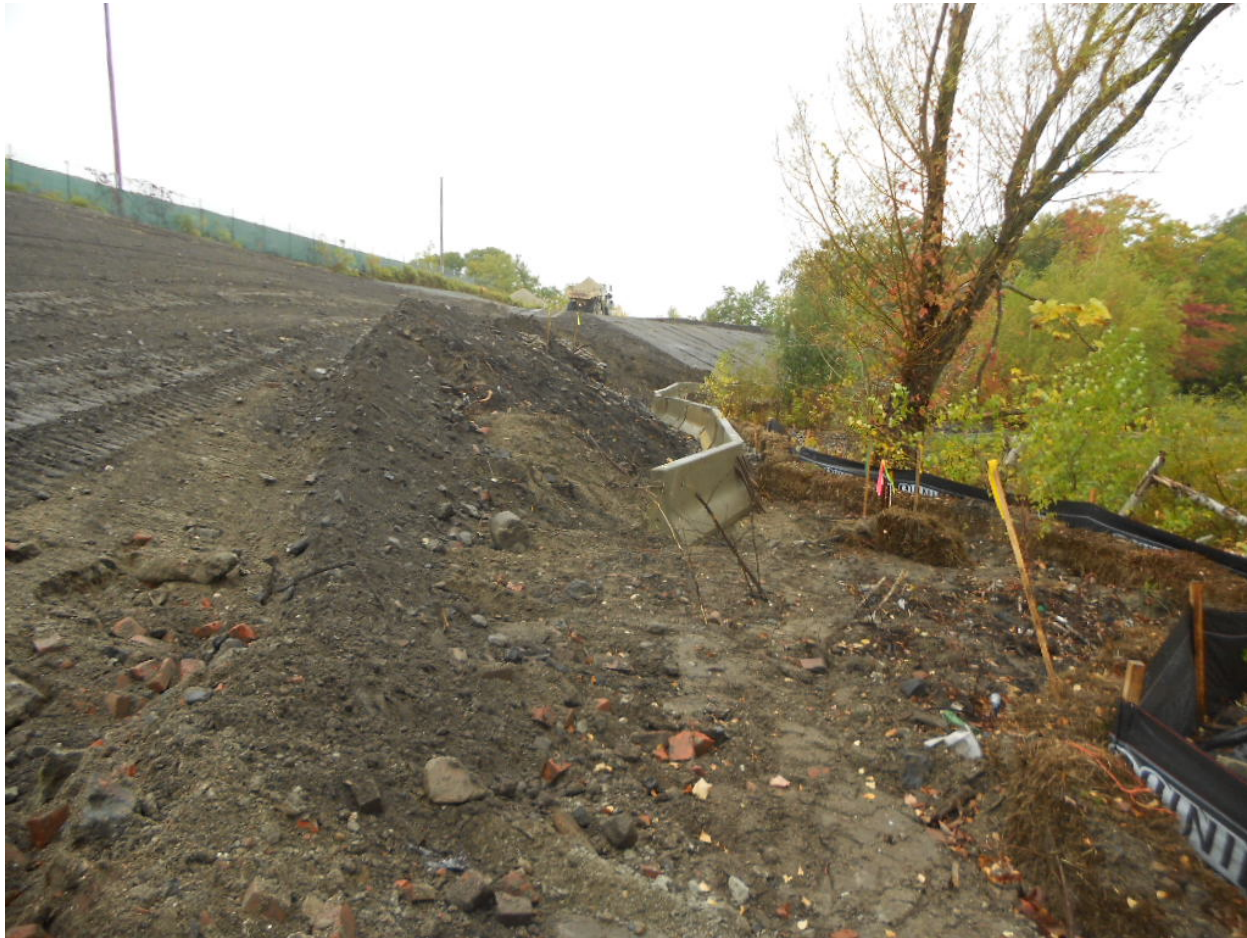
<b>Date</b>	<b>Photo ID</b>	<b>Description</b>
10/10/12	1033	Jersey Barrier retaining wall installed at the toe of slope at Area 4, looking southwest

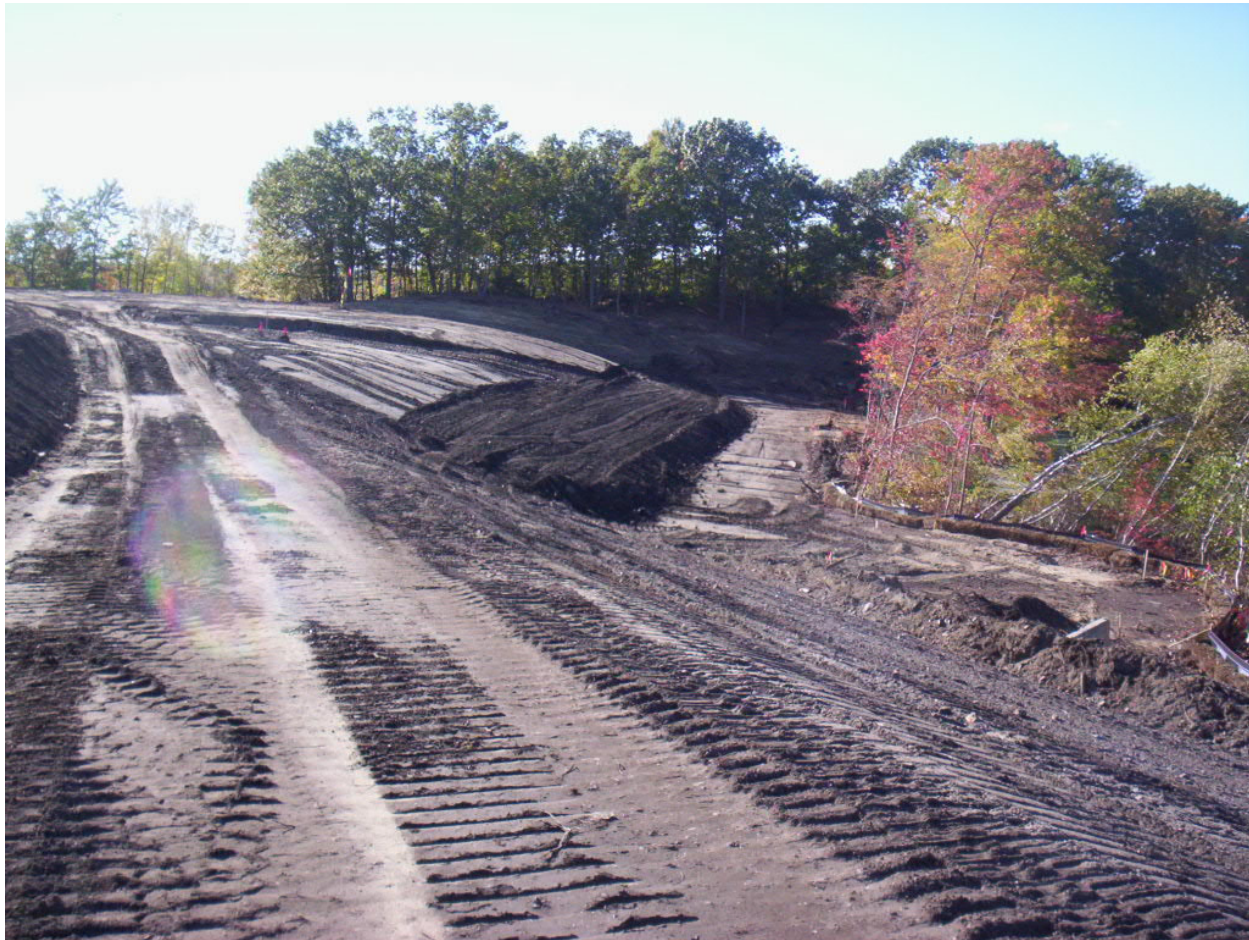
<b>Date</b>	<b>Photo ID</b>	<b>Description</b>
10/11/12	1040	Looking southwest at sub-grading at Areas 3 and 4

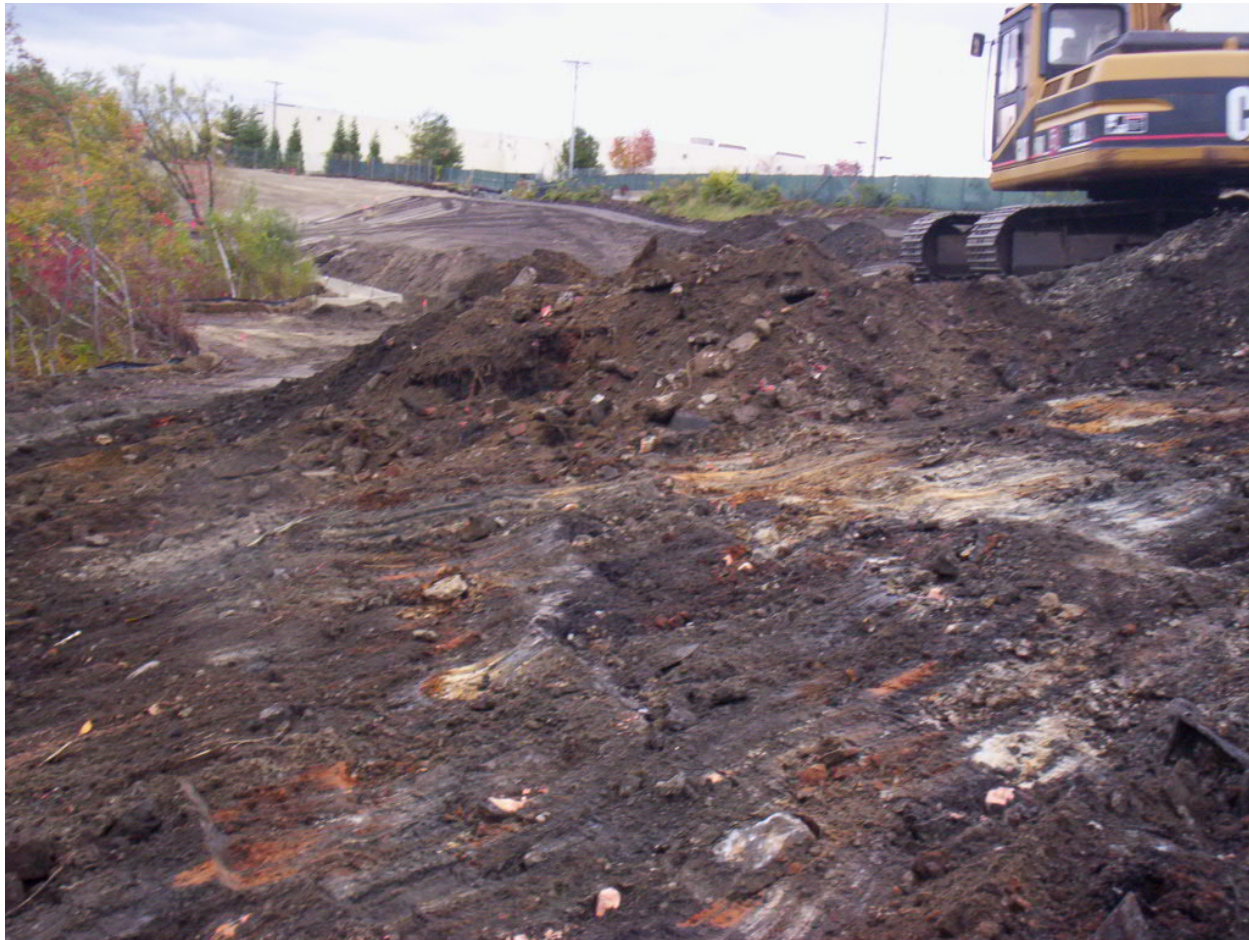
<b>Date</b>	<b>Photo ID</b>	<b>Description</b>
10/12/12	1044	Grading industrial debris with the excavator at Area 3, looking east

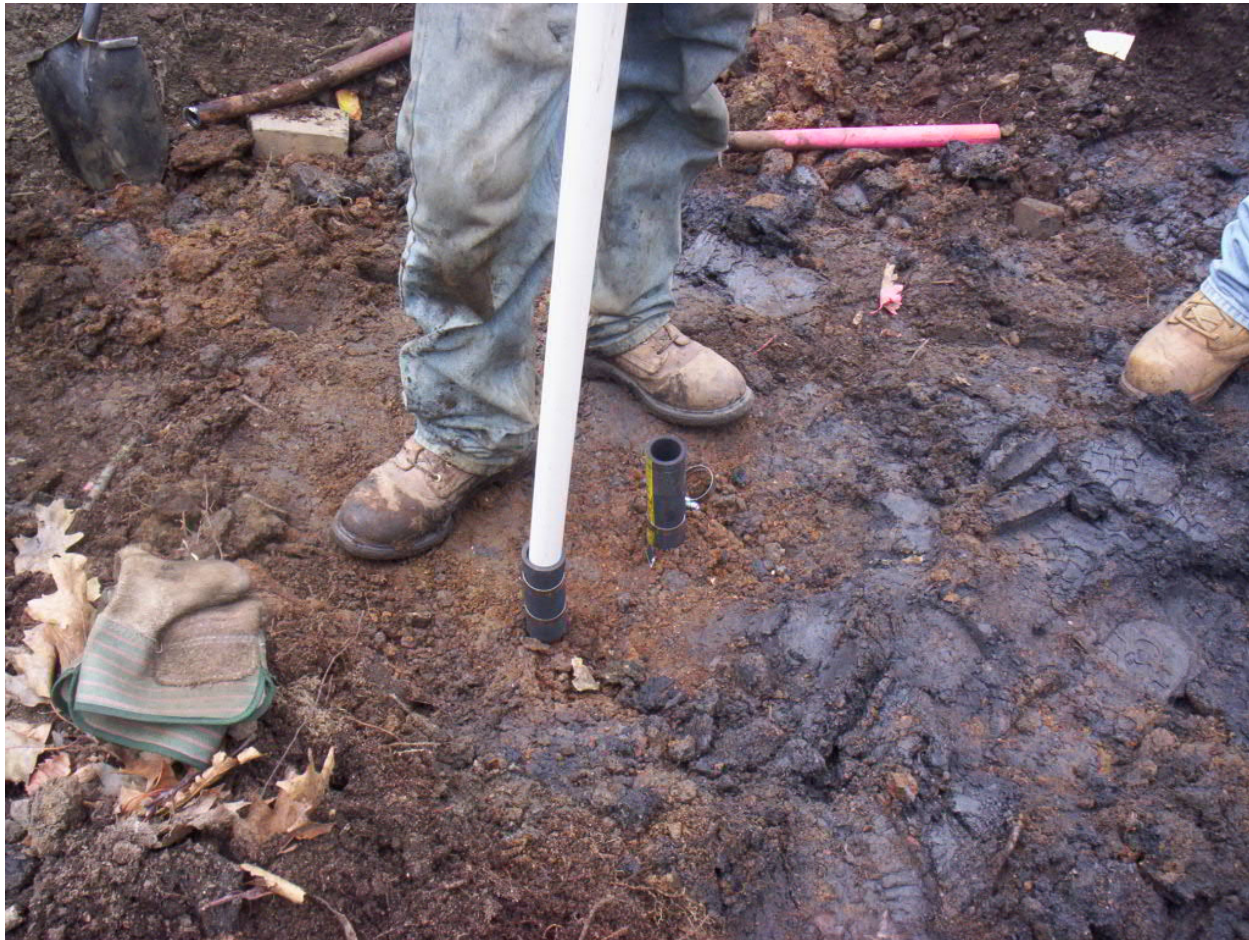
<b>Date</b>	<b>Photo ID</b>	<b>Description</b>
10/15/12	1052	MW-233 and adjacent probe raised (using hose and hose clamps) to accommodate cap

ET&L attempted to maintain all existing monitoring wells within the Phase I Cap during construction; however, some wells were damaged by heavy equipment and subsequently fixed to support groundwater monitoring efforts, as necessary. Other wells required elevation modification due to the proposed landfill grades. The following paragraphs summarize activities at the existing monitoring wells on-site:

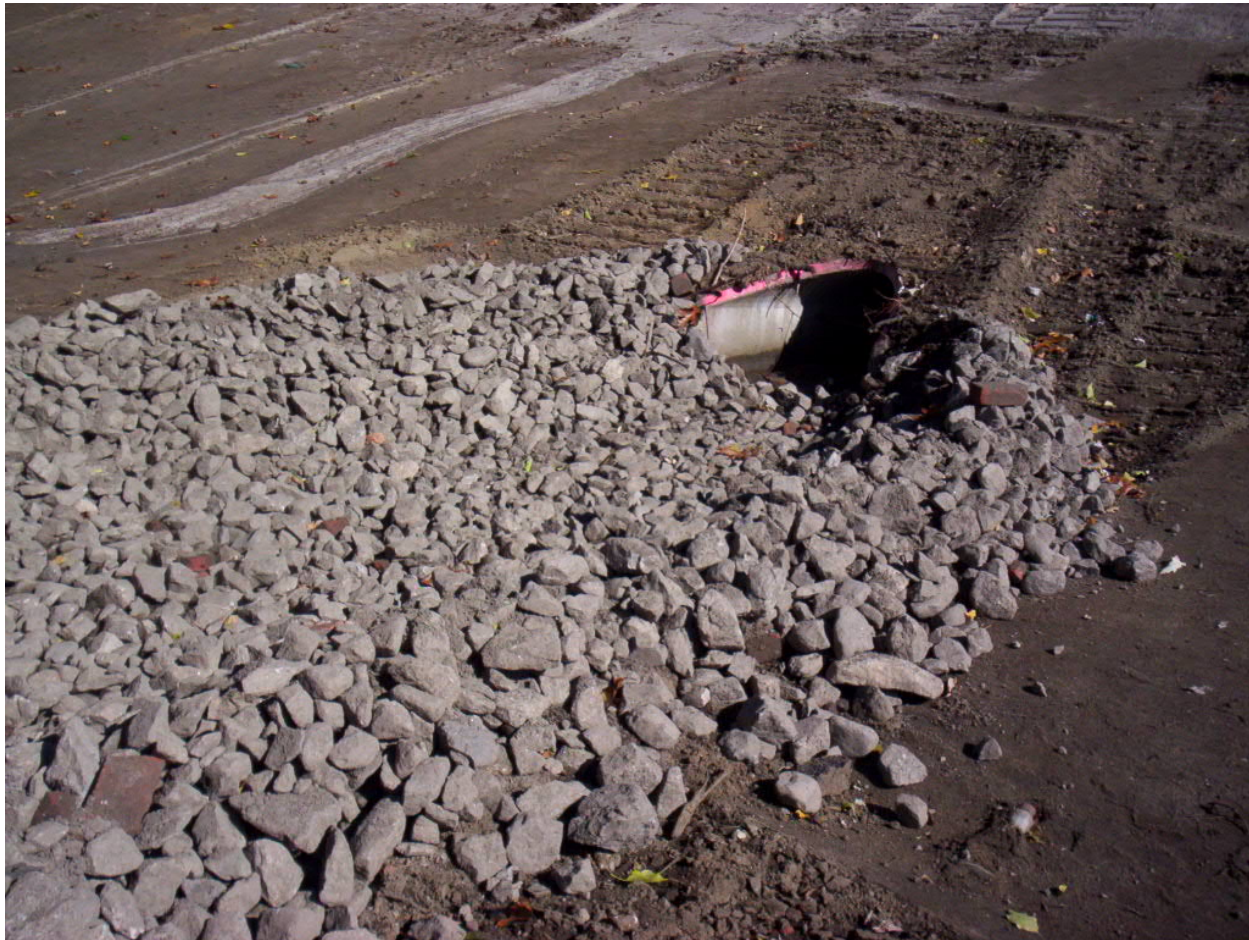
<b>Date</b>	<b>Photo ID</b>	<b>Description</b>
10/16/12	1555	Rip rap placed at the storm drain (from the detention basin) outlet

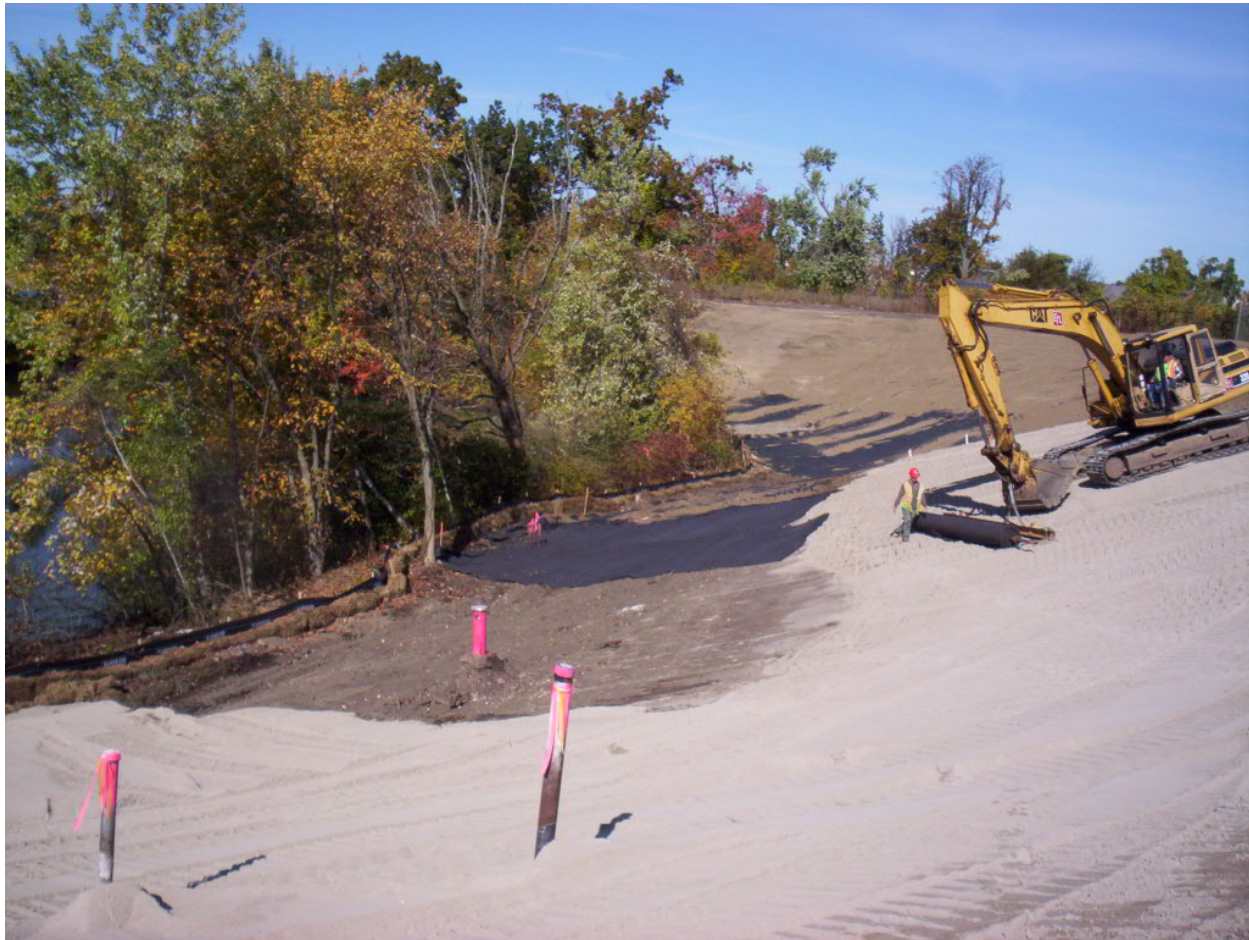
<b>Date</b>	<b>Photo ID</b>	<b>Description</b>
10/17/12	1562	Installing geotextile at the wetland buffer cap at Area 5, looking northeast

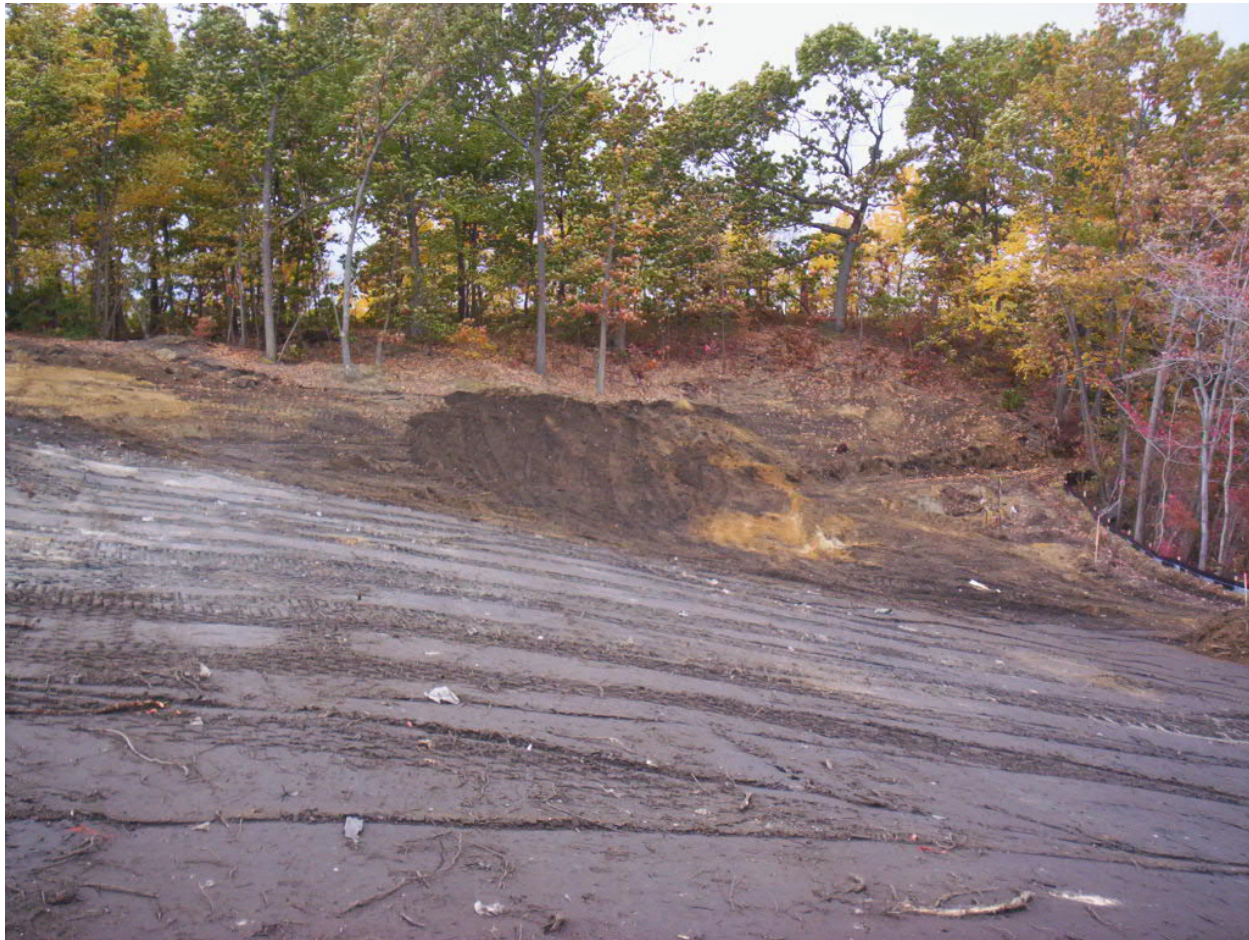
<b>Date</b>	<b>Photo ID</b>	<b>Description</b>
10/19/12	1566	Sub-grading at Area 3, looking west

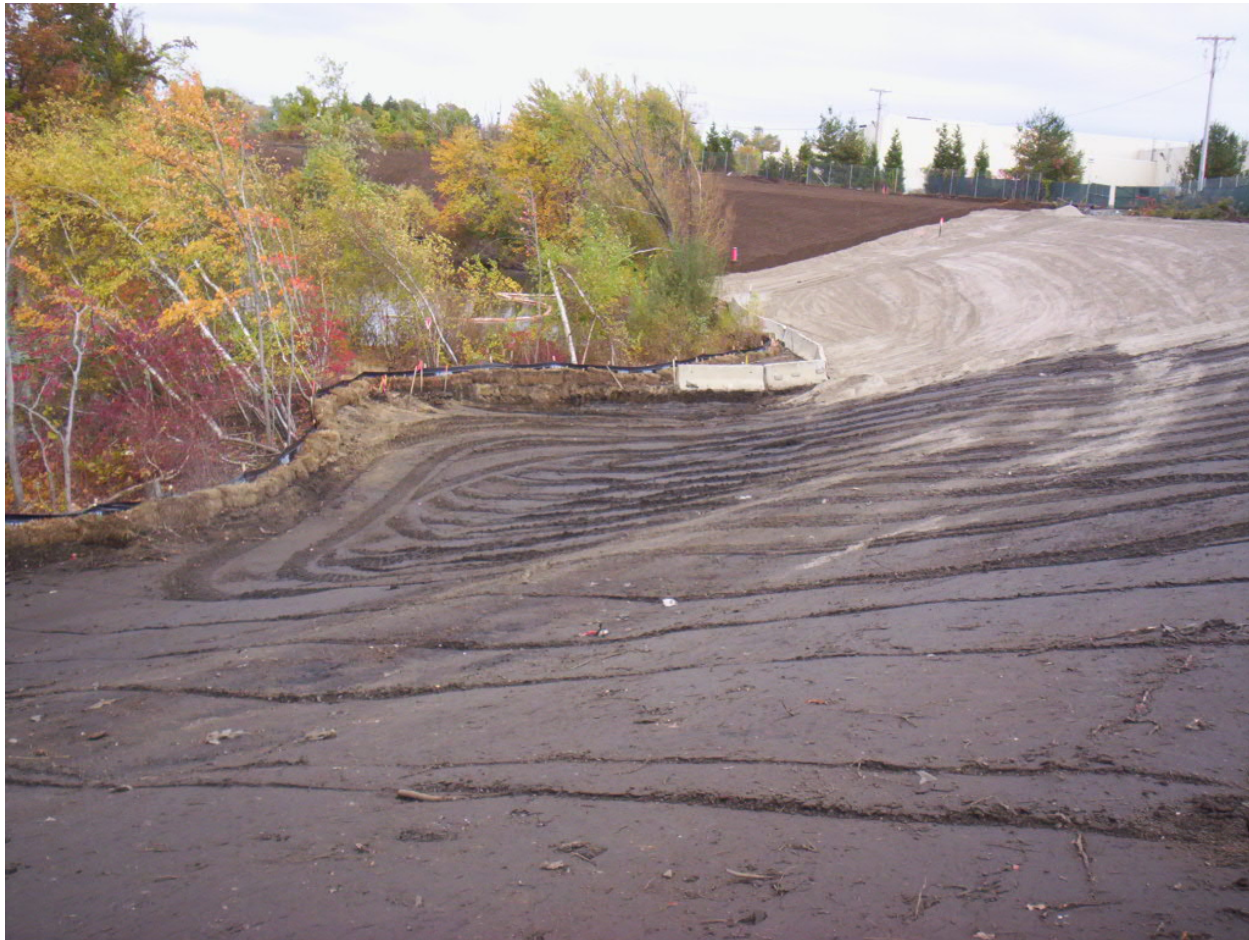
<b>Date</b>	<b>Photo ID</b>	<b>Description</b>
10/19/12	1567	Looking east from Area 3 at the finished grade at Area 5 and buffer sand at Area 4

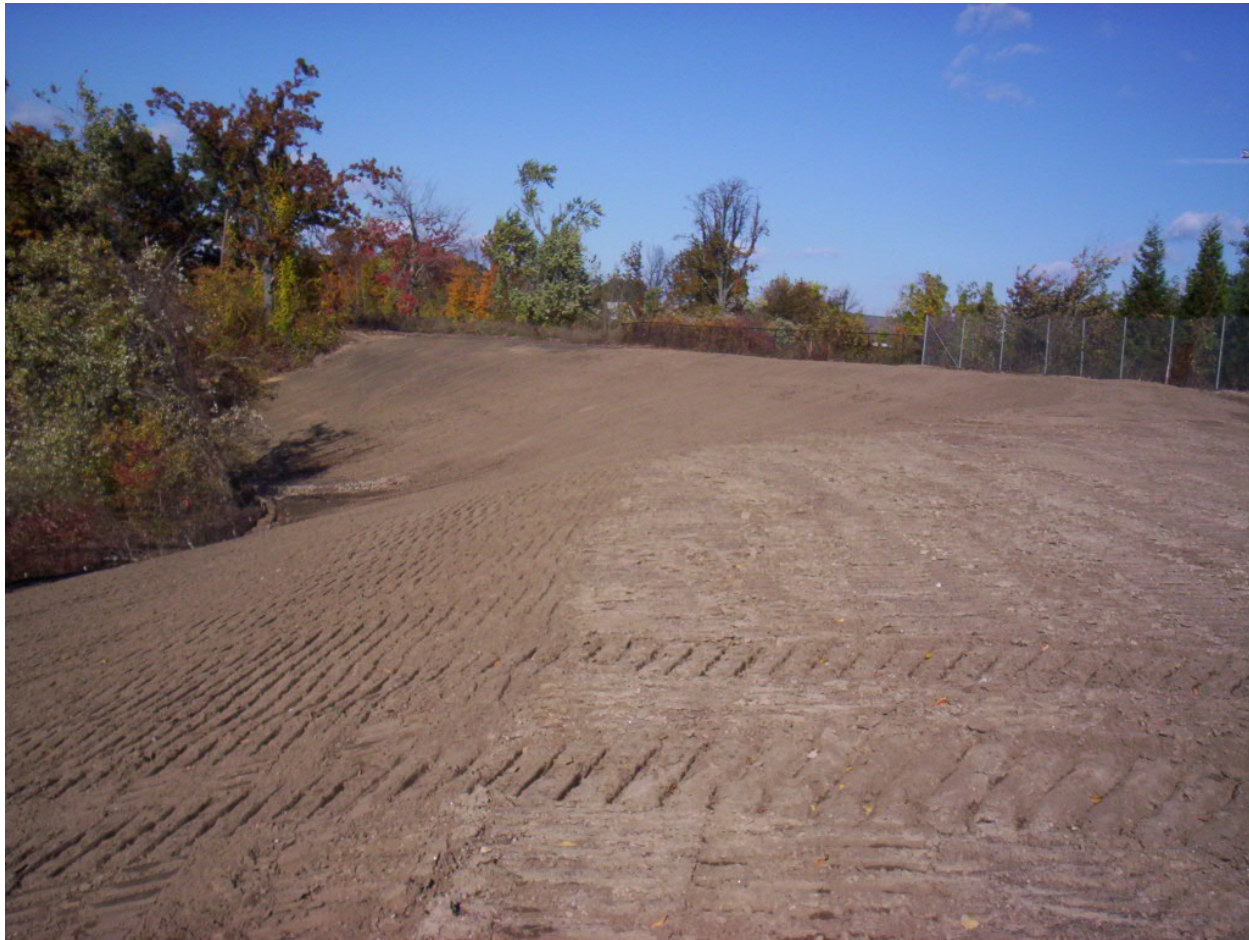
<b>Date</b>	<b>Photo ID</b>	<b>Description</b>
10/22/12	1574	Looking north at repaired topsoil on Area 5
