# REMEDIAL ACTION CLOSURE REPORT

## PARCEL C-1 PHASE I CAP FORMER GORHAM MANUFACTURING FACILITY 333 ADELAIDE AVENUE PROVIDENCE, RHODE ISLAND

AMEC Environment & Infrastructure, Inc.  
2 Robbins Road  
Westford, Massachusetts 01886

April 2013

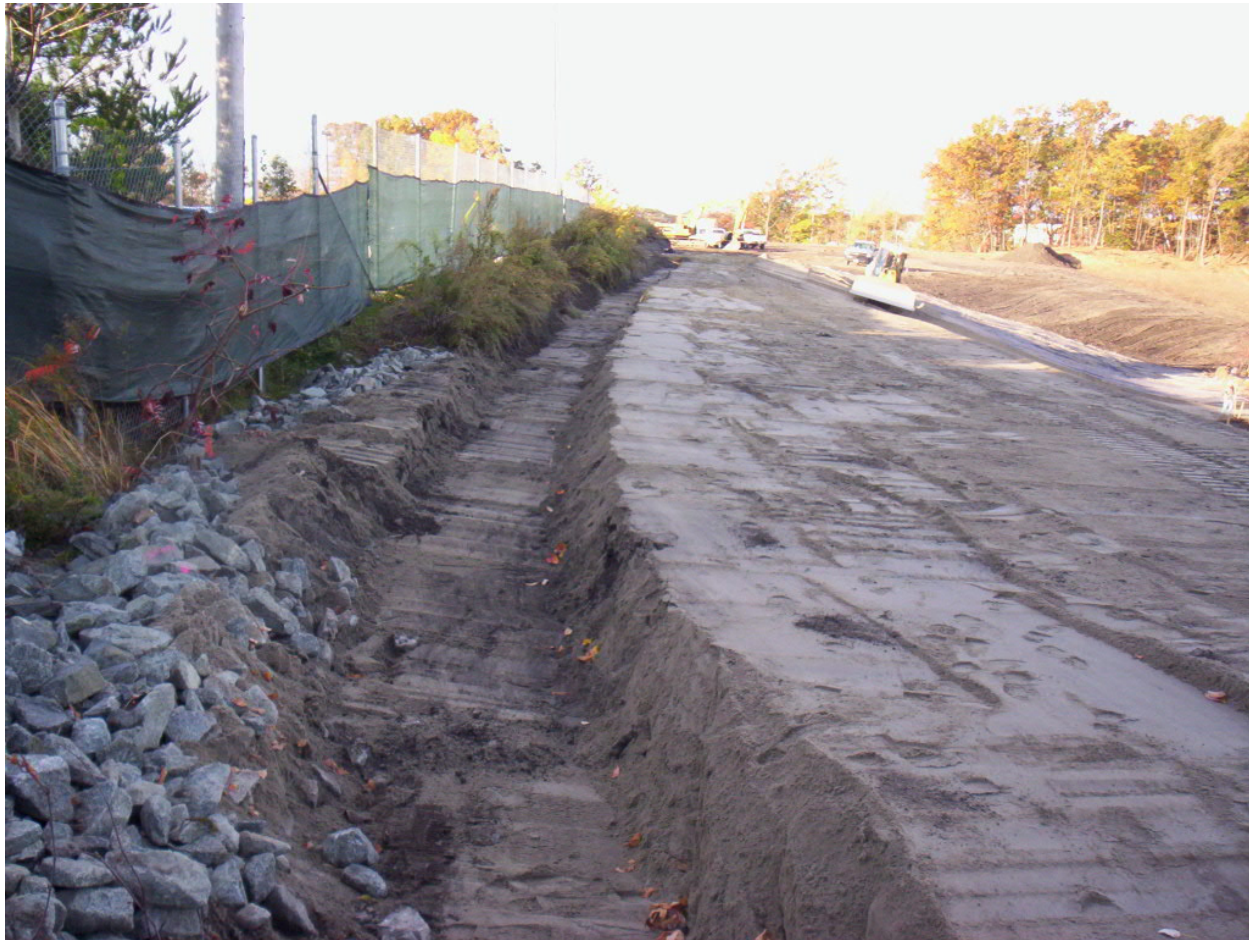
<b>Date</b>	<b>Photo ID</b>	<b>Description</b>
10/23/12	1577	Looking southwest at installed anchor trench at the top of slope at Area 4. Dozer is fine grading buffer sand.

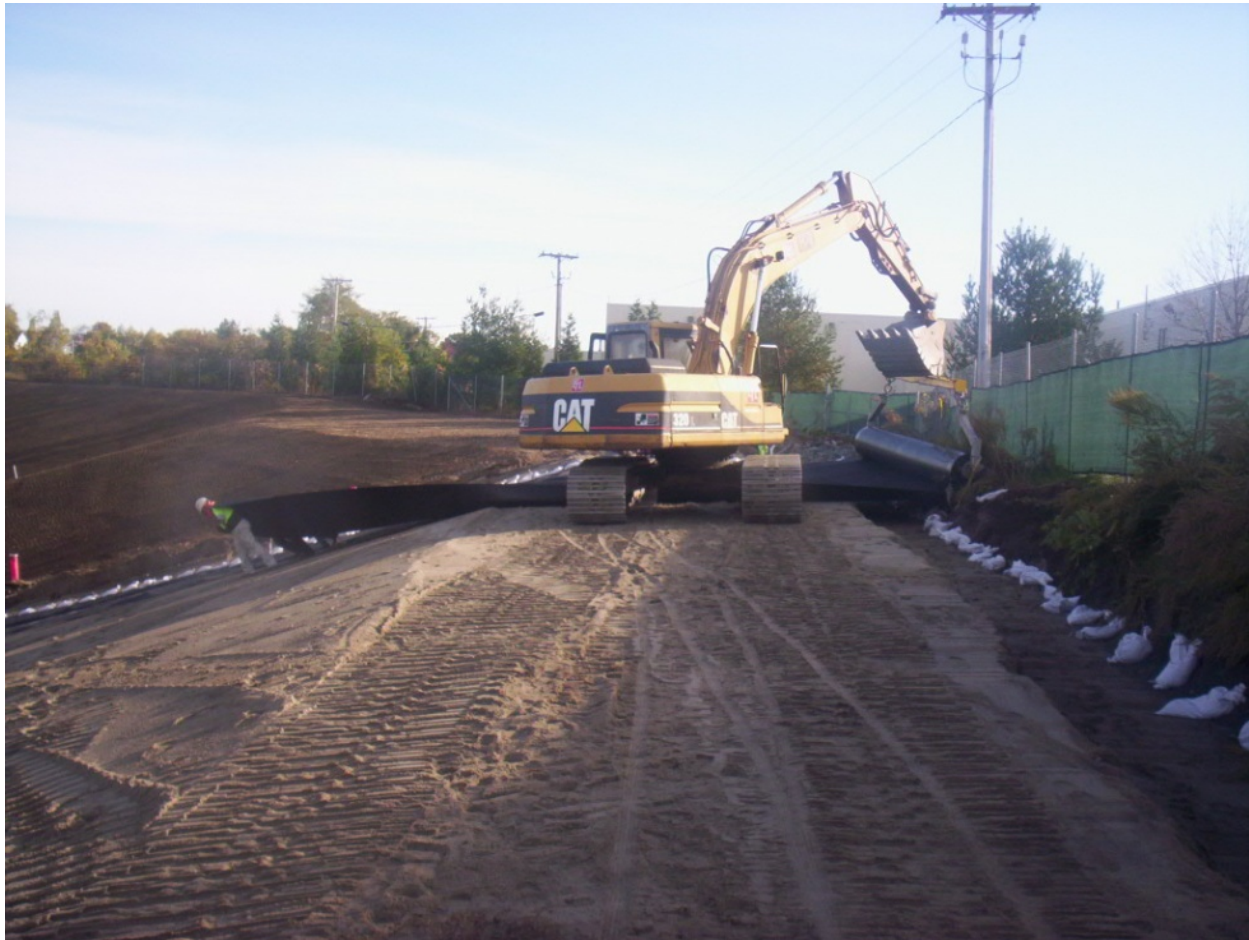
<b>Date</b>	<b>Photo ID</b>	<b>Description</b>
10/23/12	1578	Begin installing geomembrane at Area 4, looking east

In response to RIDEM questions regarding the potential leaching from the soil in contact with the former slag pile, the former slag area cap contains a drainage geocomposite layer over a 40-mil LLDPE geomembrane to limit infiltration and restrict contact with the underlying soils. The geomembrane was installed on October 23, 2012, by ET&L subcontractor, New England Liner Systems, Inc. (NE Liner Systems) Plantsville, CT. The geomembrane cover was composed of 10 panels. Double track hot fusion wedge welding was used for welding straight long seams of adjacent panels and one end seam, and extrusion welding was used for welding boots for monitoring wells and repairs. Rigorous quality control testing, including destructive and non-destructive testing, was performed by NE Liner Systems and observed by AMEC. Quality control data is included in Appendix I. The geomembrane was installed over 6-inches of imported buffer sand. The installed geomembrane specifications, from the manufacturer, interface friction testing and warranty are included in Appendix J.

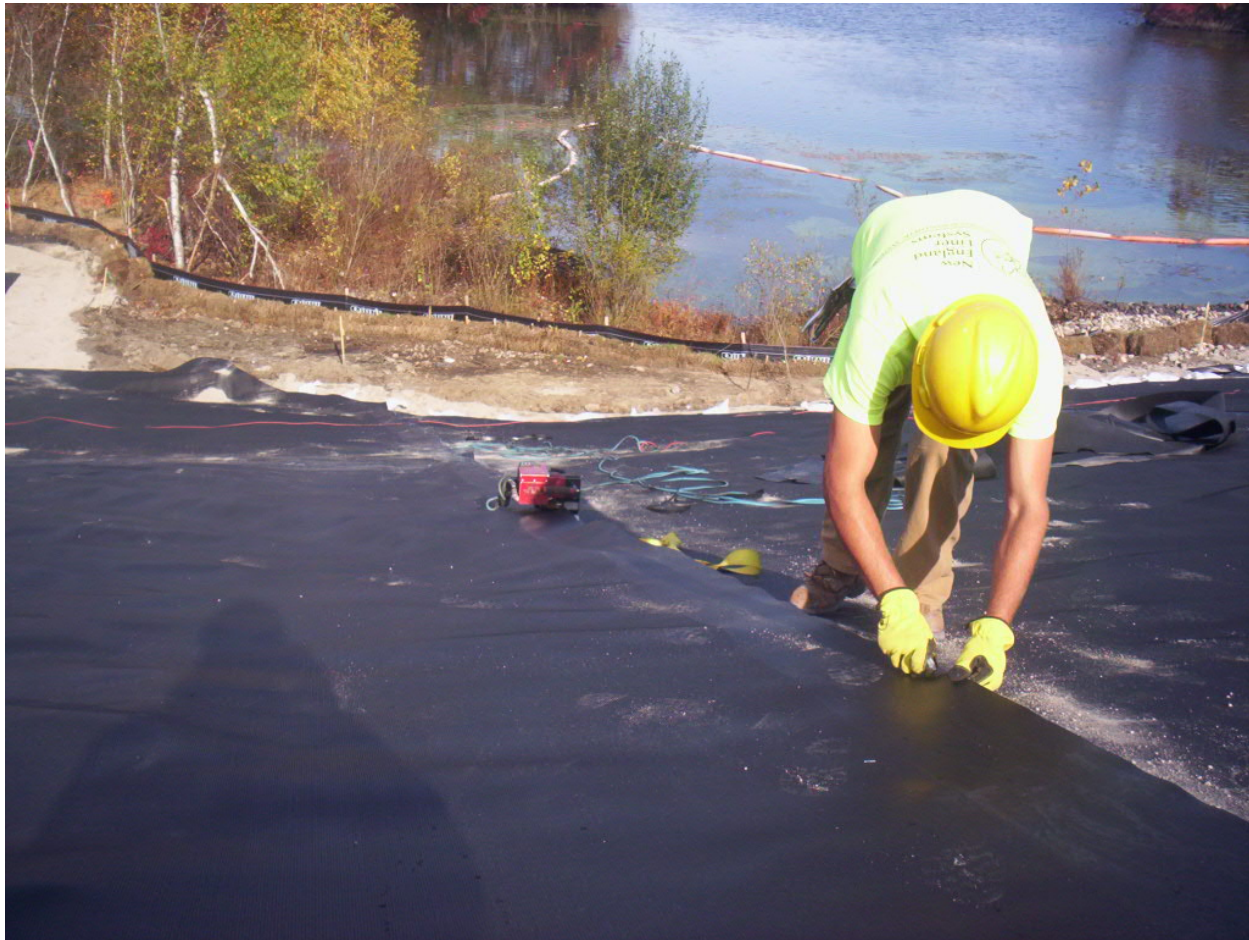
<b>Date</b>	<b>Photo ID</b>	<b>Description</b>
10/23/12	1583	Fusion welding end seams during geomembrane installation at Area 4, looking north

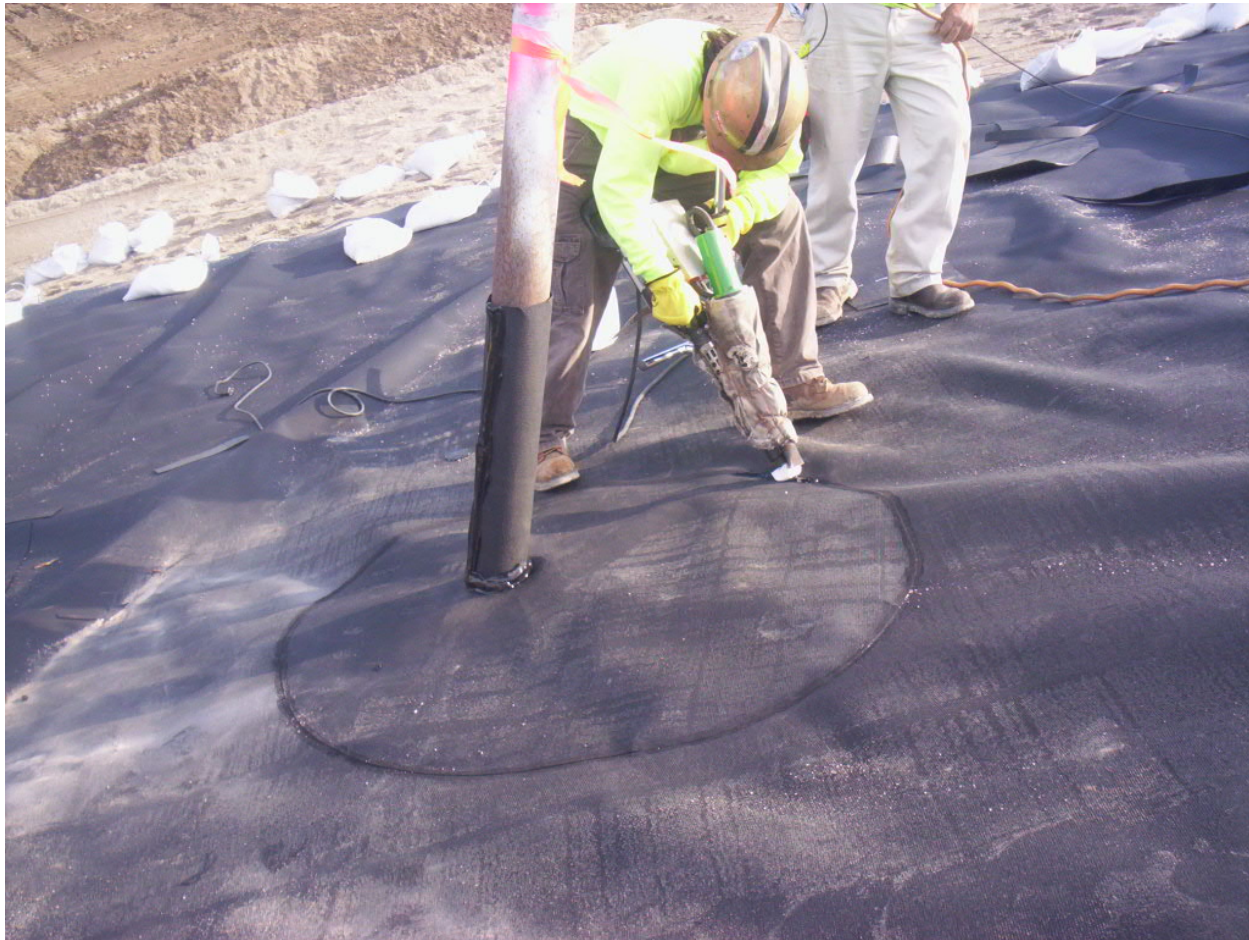
<b>Date</b>	<b>Photo ID</b>	<b>Description</b>
10/23/12	1586	Extrusion welding boot for monitoring well

- MW-GZA3 was accidentally hit during construction and the PVC riser broke. The well was repaired with a piece of rigid hose, with hose clamps, connecting the intact PVC riser and a new PVC riser (1 ½"). MW-GZA3 and MW-109D were fitted with boots, and the geomembrane was installed with penetrations and boots for these two wells (Detail 14, Sheet C-503, Appendix G).

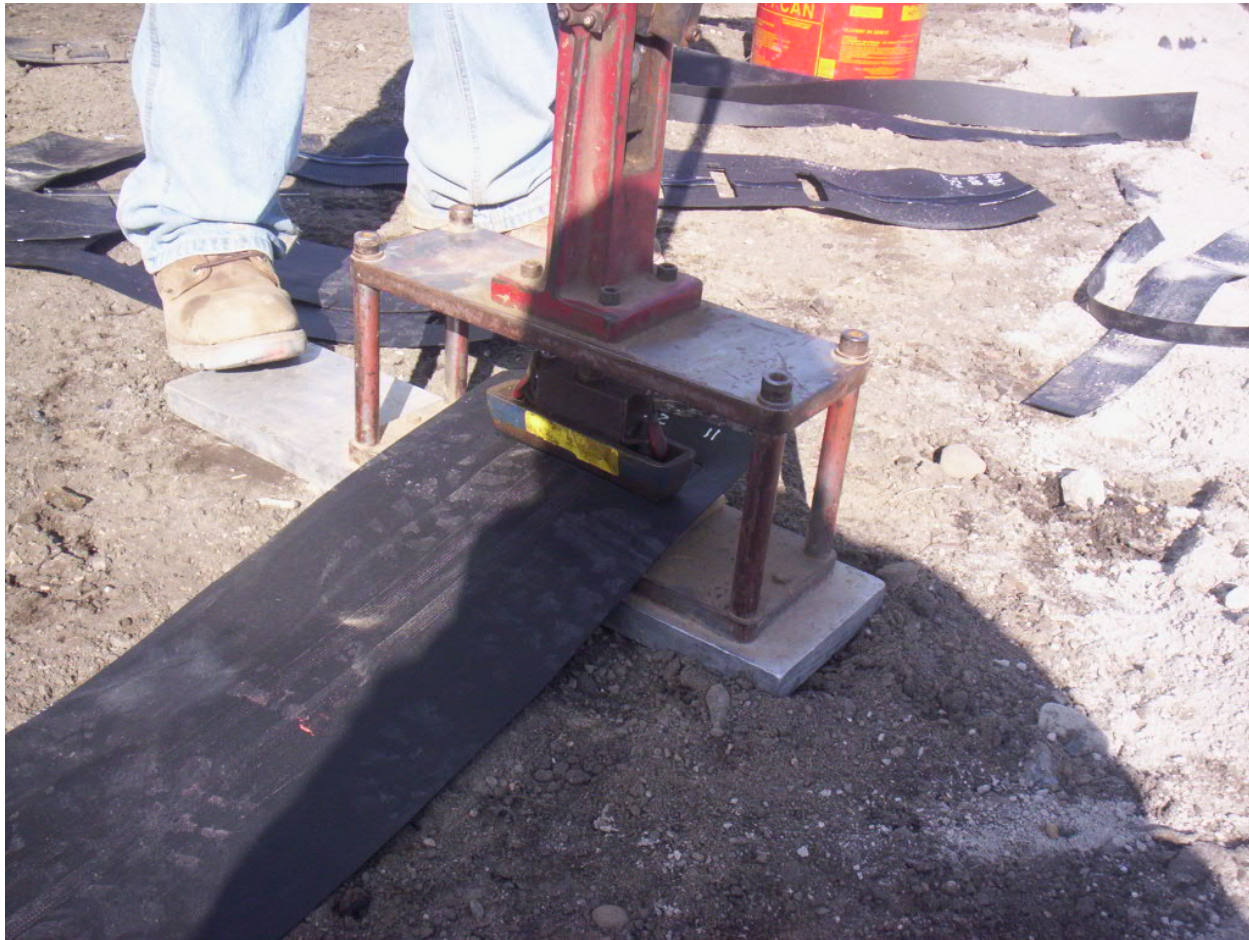
<b>Date</b>	<b>Photo ID</b>	<b>Description</b>
10/23/12	1589	Cutting pieces from geomembrane seams removed for destructive testing

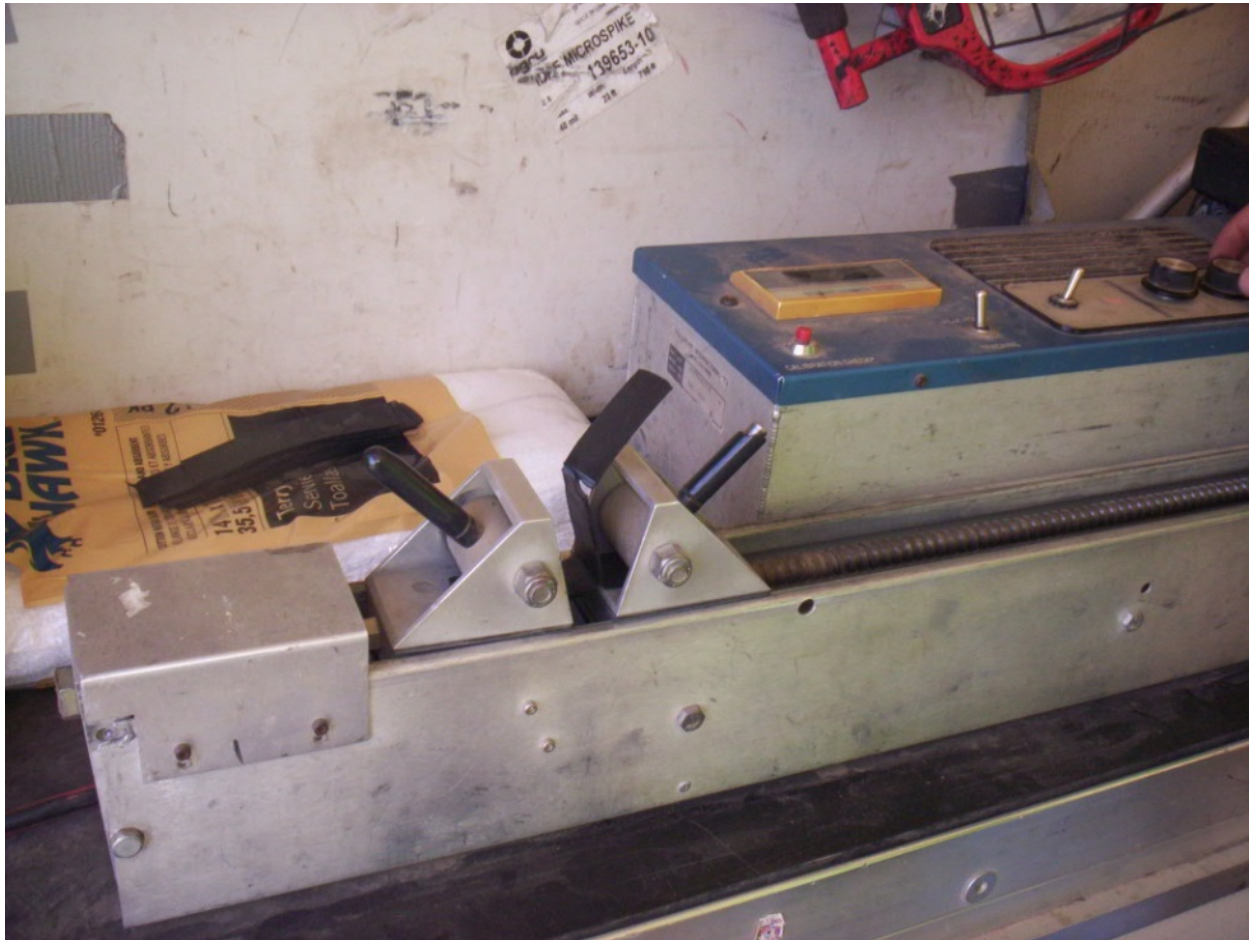
<b>Date</b>	<b>Photo ID</b>	<b>Description</b>
10/23/12	1590	On-site testing equipment for peel and shear tests

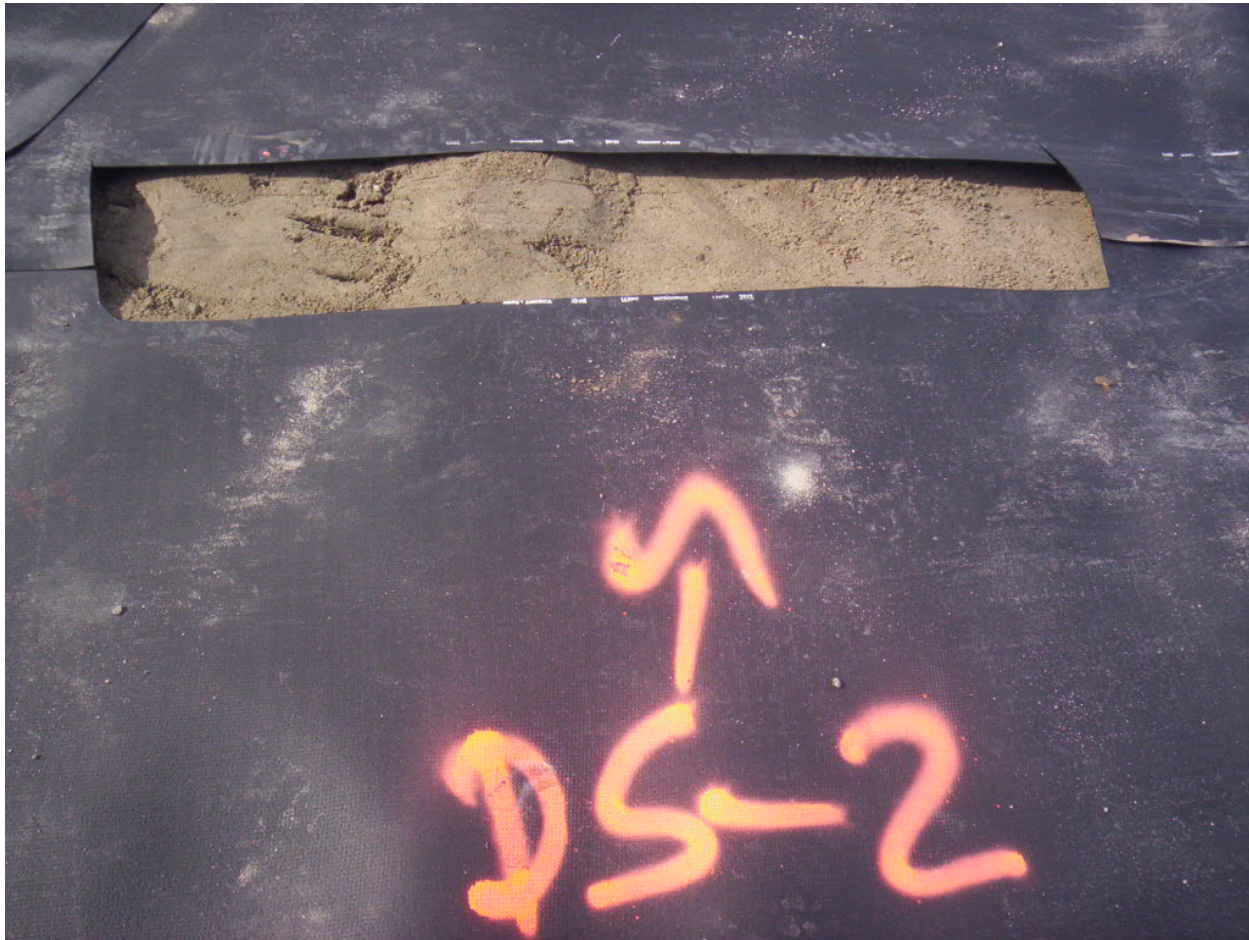
<b>Date</b>	<b>Photo ID</b>	<b>Description</b>
10/23/12	1591	Location of destructive test (DS-2)

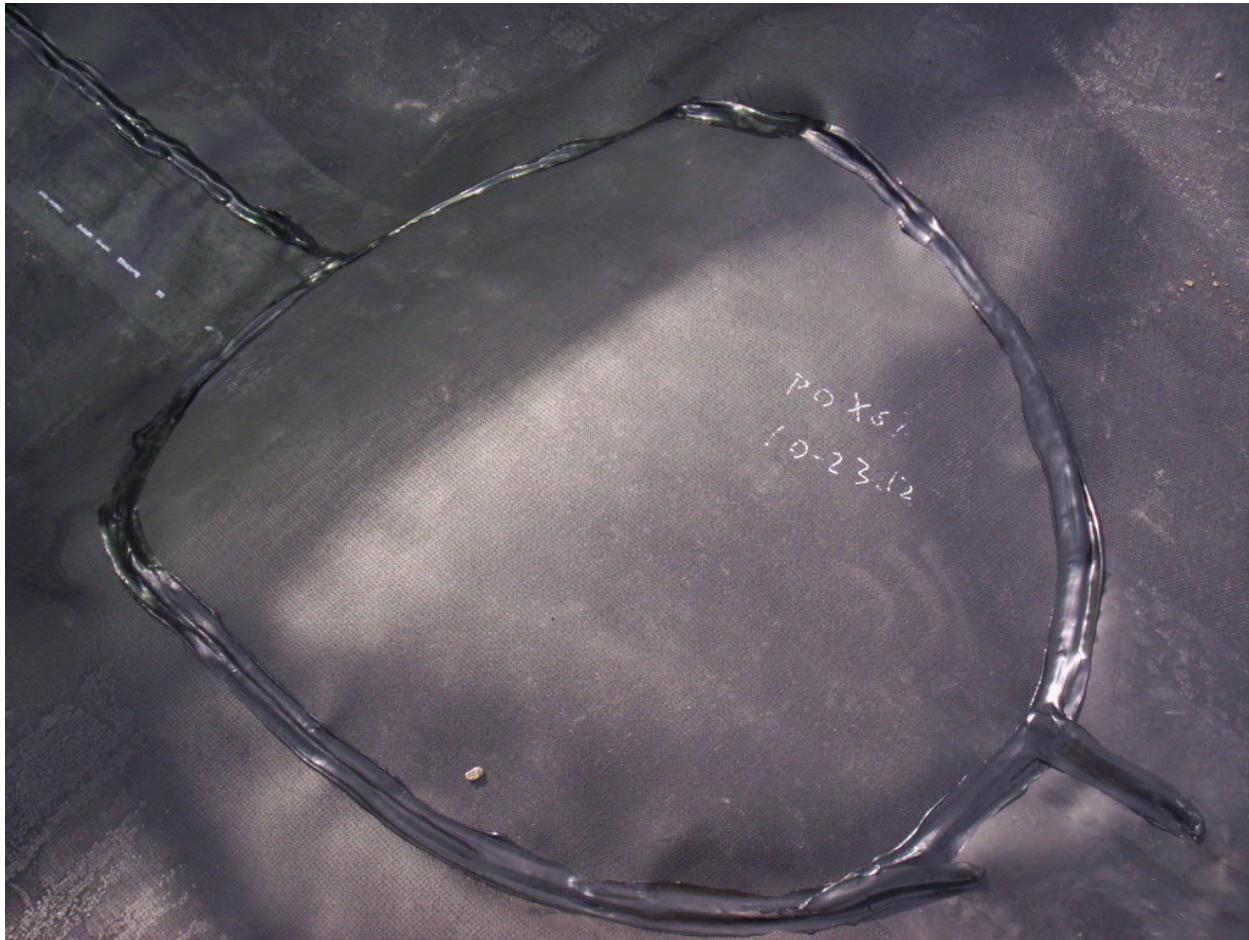
<b>Date</b>	<b>Photo ID</b>	<b>Description</b>
10/23/12	1592	Extrusion weld repair at DS-2

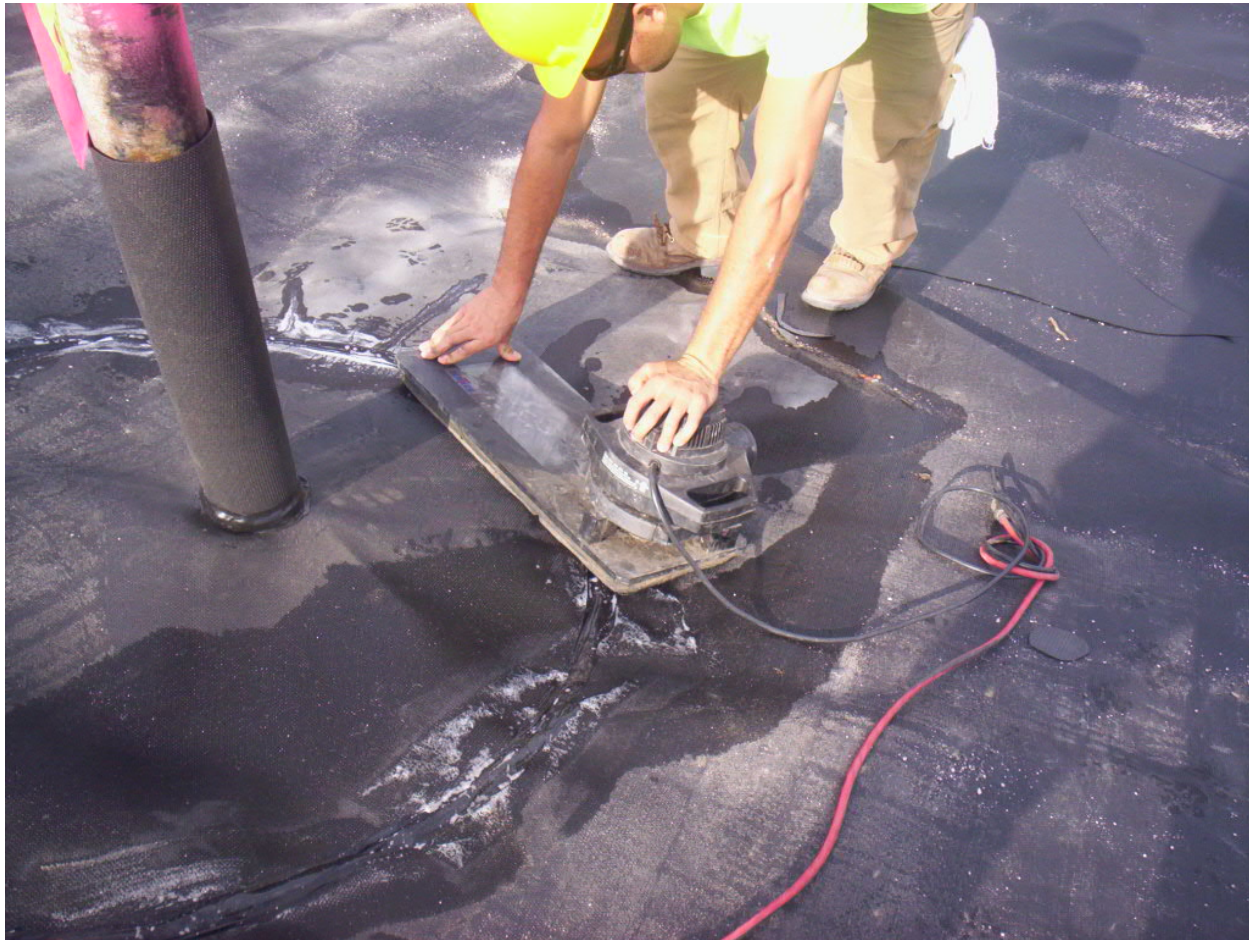
<b>Date</b>	<b>Photo ID</b>	<b>Description</b>
10/23/12	1593	Vacuum test for extrusion weld for boot at monitoring well

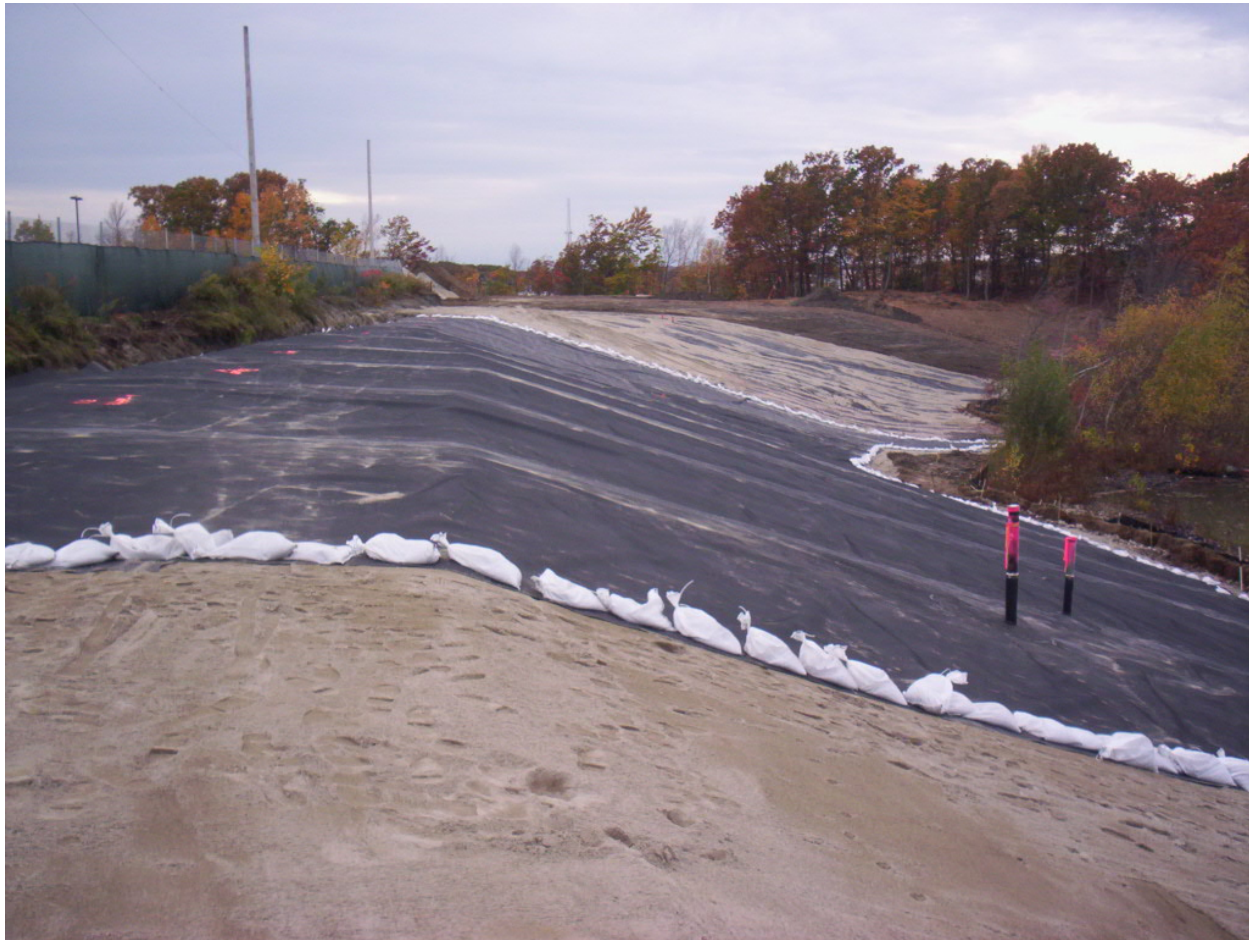
<b>Date</b>	<b>Photo ID</b>	<b>Description</b>
10/23/12	1596	Additional excavation at the southwest drainage swale at the sidewalls (north and south) and bottom

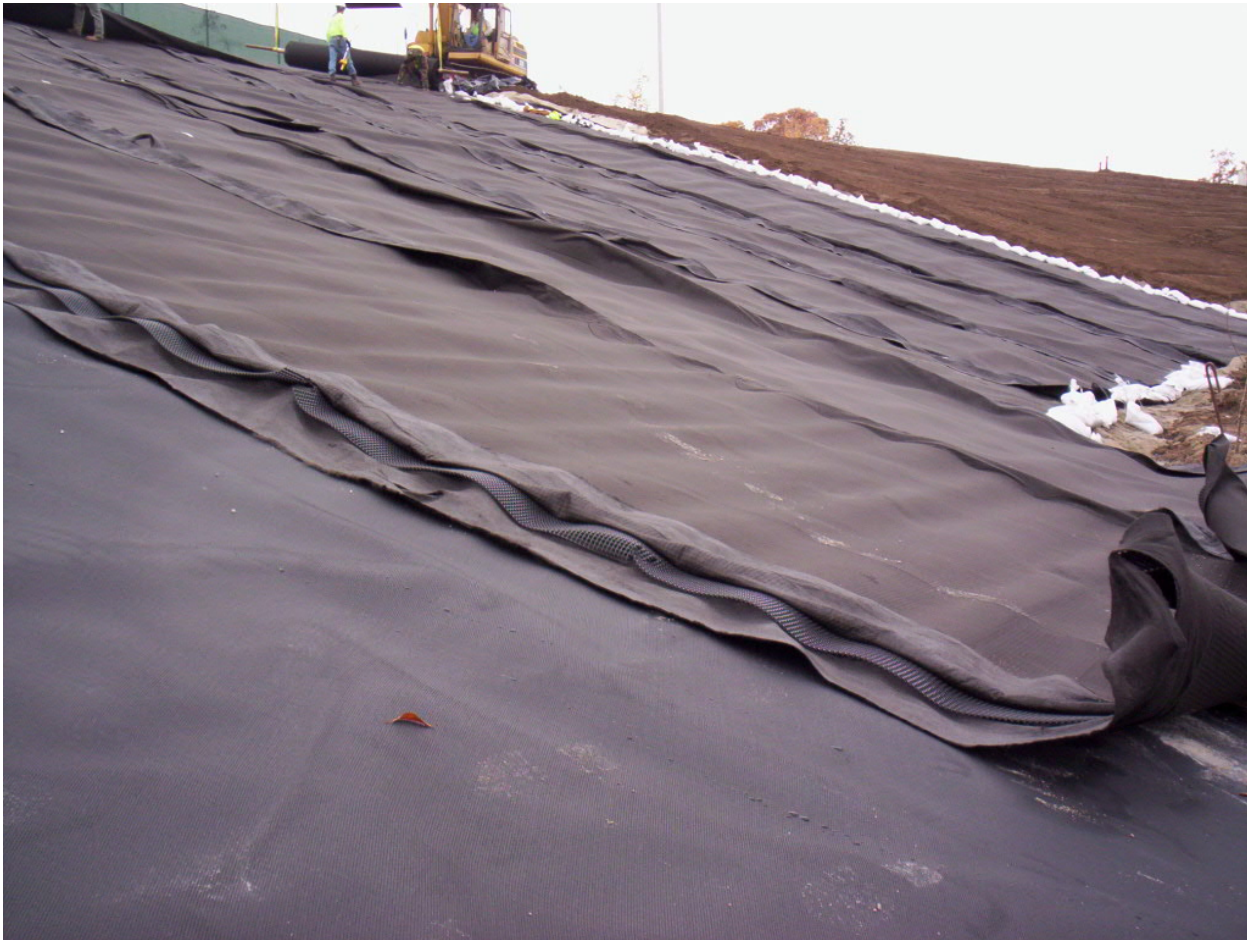
<b>Date</b>	<b>Photo ID</b>	<b>Description</b>
10/23/12	1597	Looking southwest at the installed geomembrane at Area 4

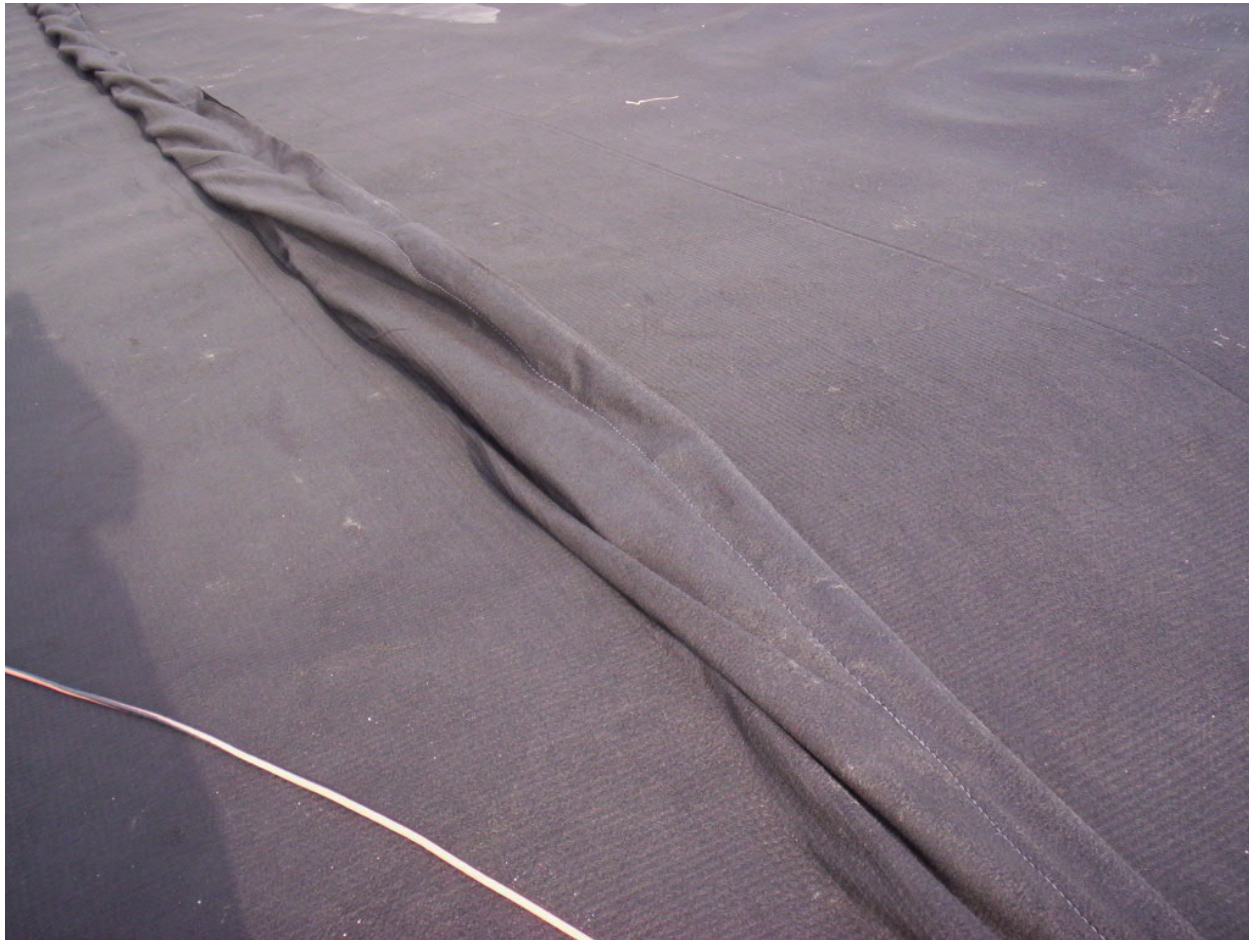
<b>Date</b>	<b>Photo ID</b>	<b>Description</b>
10/26/12	1610	Geotextile fabric sewn at the seams of the drainage geocomposite

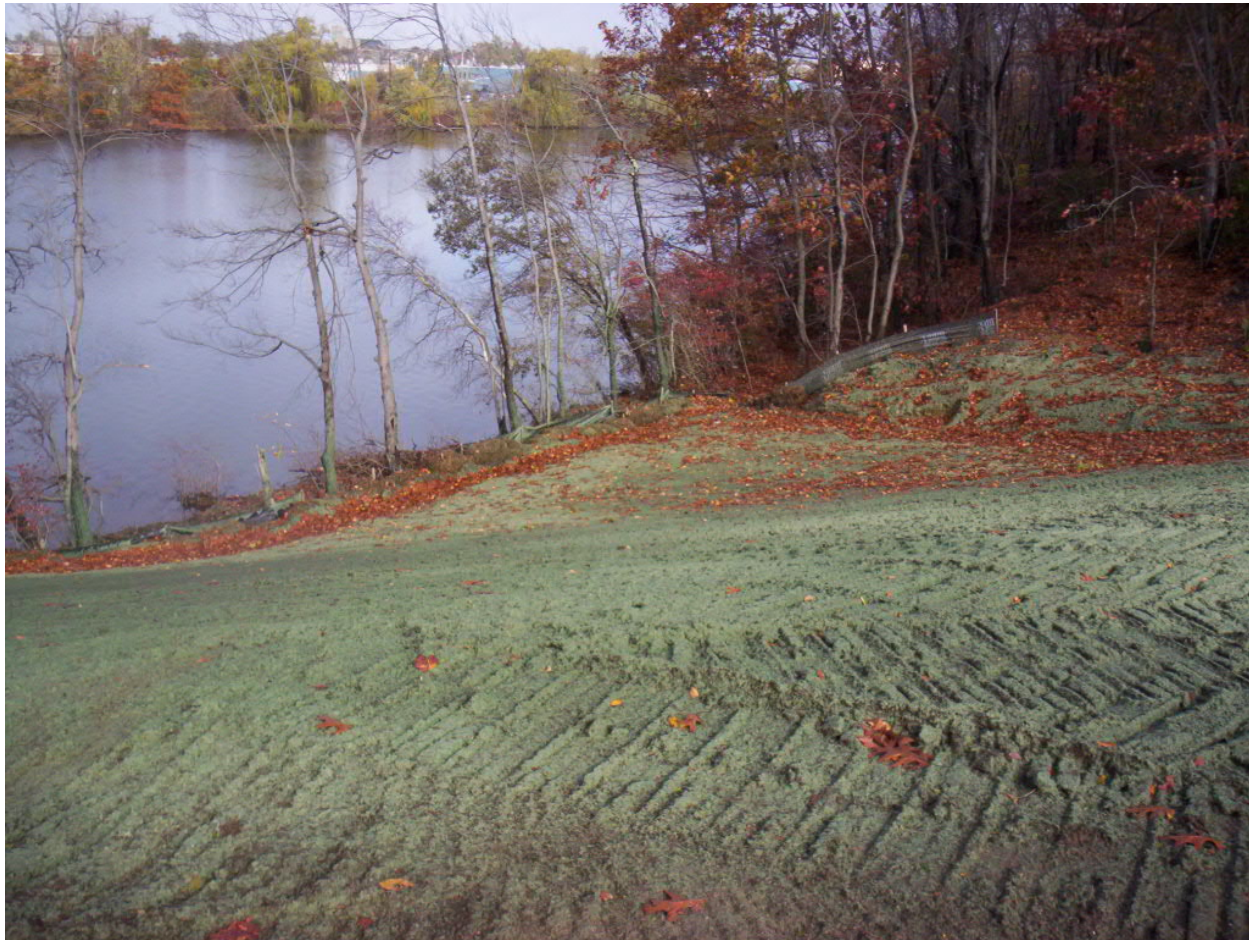
<b>Date</b>	<b>Photo ID</b>	<b>Description</b>
10/30/12	1622	Topsoil and hydroseeding remained in good condition after the hurricane at Area 2, looking west

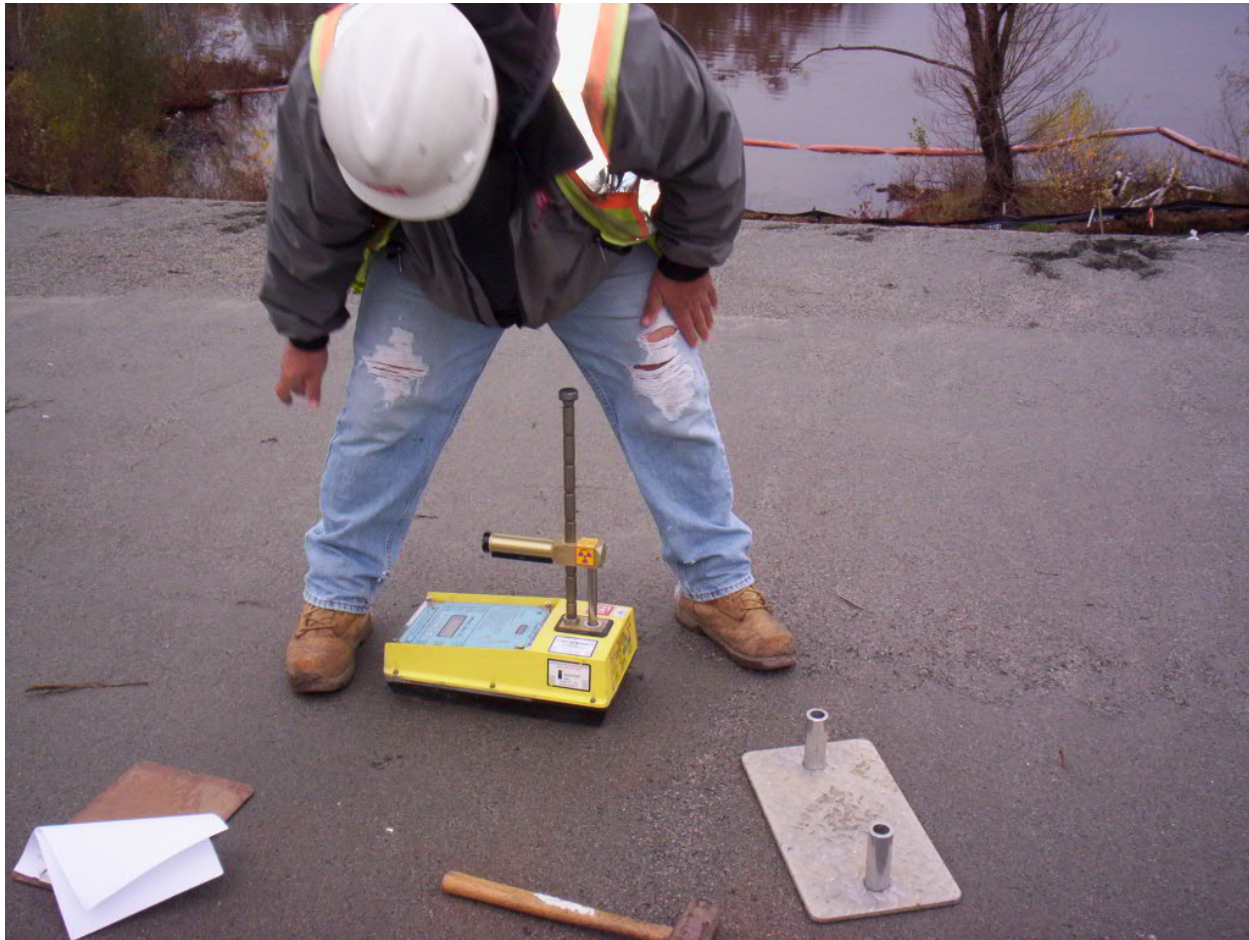
<b>Date</b>	<b>Photo ID</b>	<b>Description</b>
10/31/12	1630	Compaction testing on the protective soil at the top of the slope at Area 4

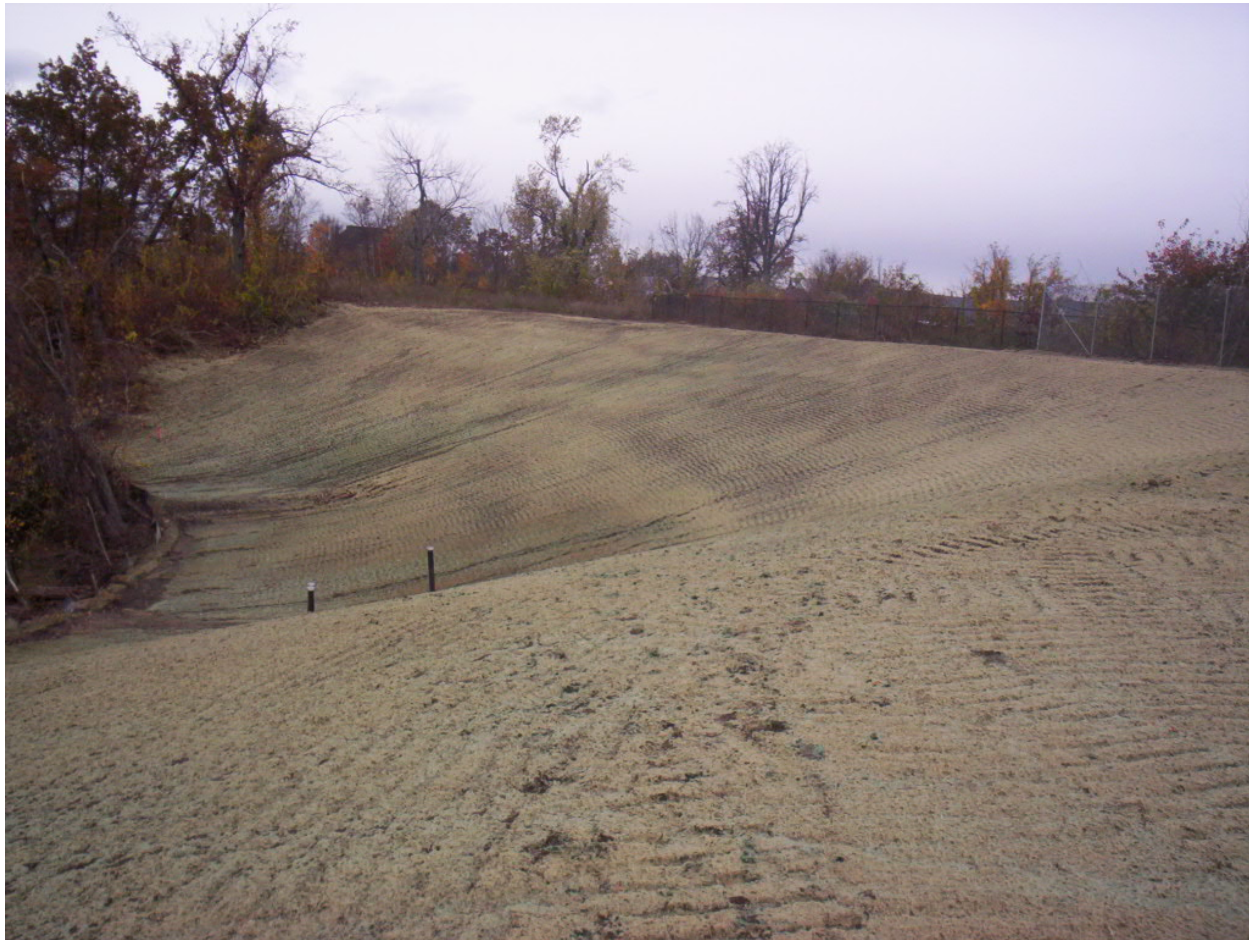
<b>Date</b>	<b>Photo ID</b>	<b>Description</b>
11/02/12	1649	Looking north at Area 5. Protective steel casings installed at MW-233 and adjacent probe and GZA-6.

- MW-GZA6 was also accidentally hit during construction and the protective steel casing, PVC riser, and the top of the screen were damaged. ET&L repaired the well with a piece of rigid hose, with hose clamps, connecting the top of the PVC screen to a new PVC riser (1 ½"). Then, a second PVC riser (2") was connected to the 1 ½" riser and extended to the surface. A new protective steel casing was installed.

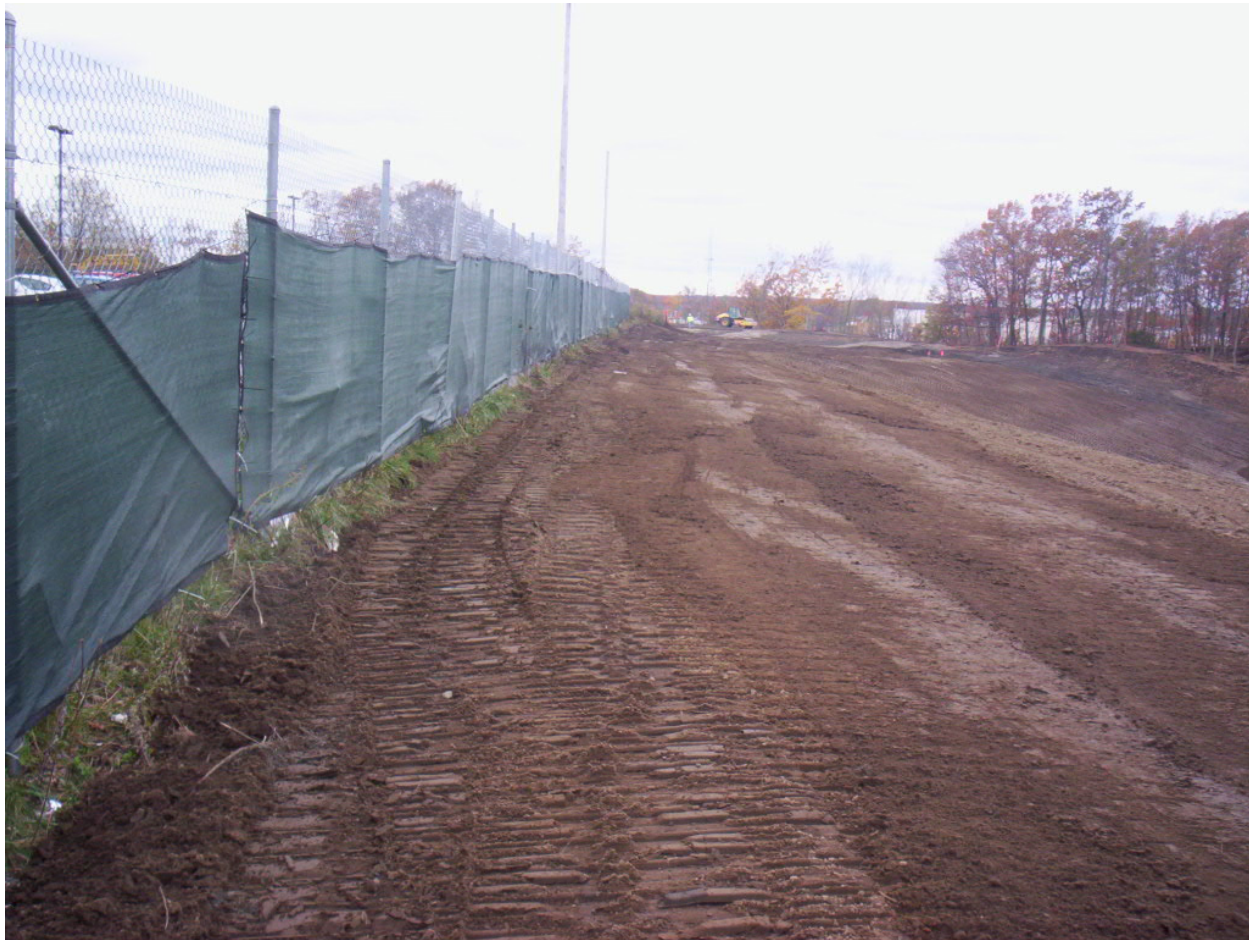
<b>Date</b>	<b>Photo ID</b>	<b>Description</b>
11/02/12	1653	Area between the gate and Area 5 upland soil cap graded, looking southeast

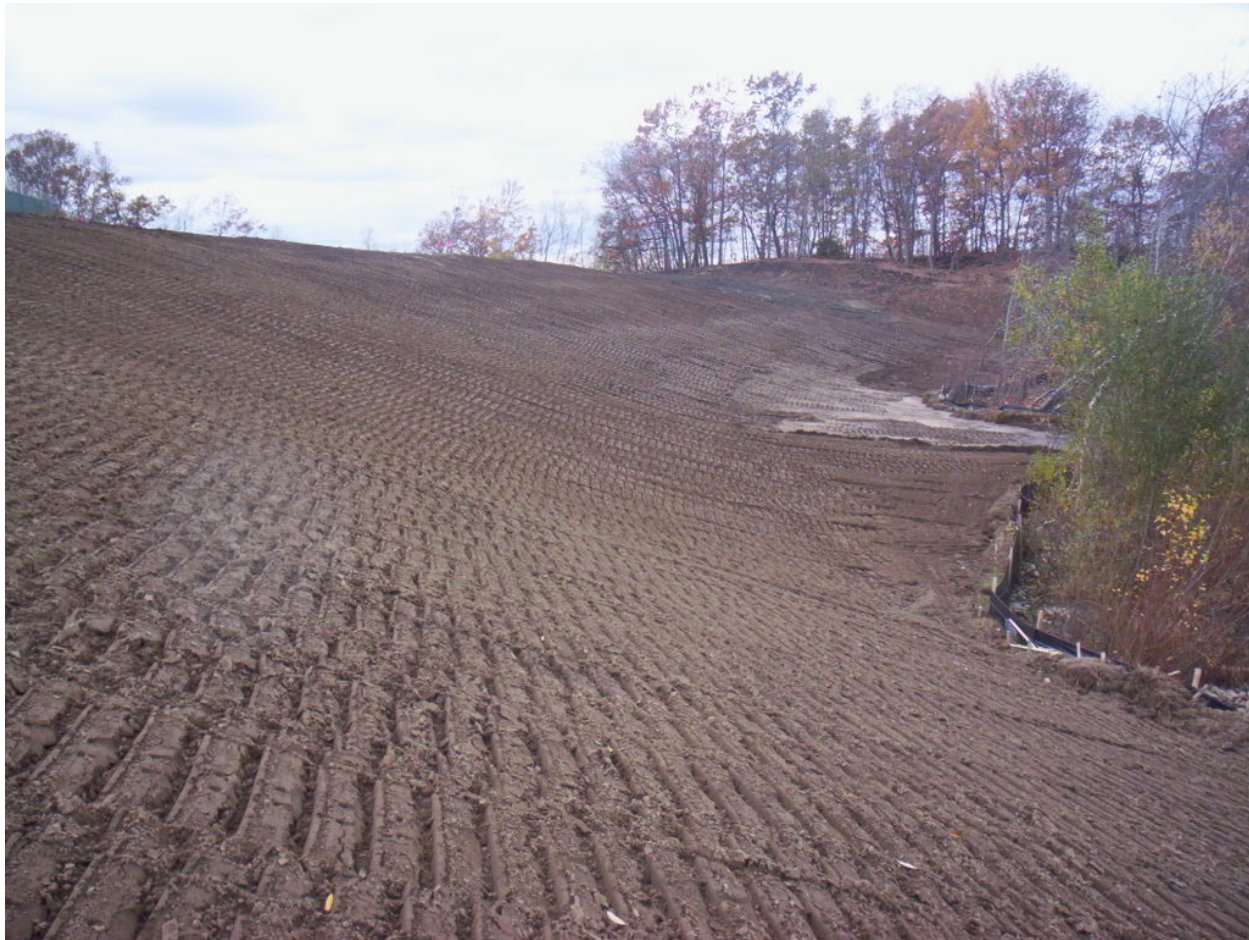
<b>Date</b>	<b>Photo ID</b>	<b>Description</b>
11/02/12	1654	Looking west along the outside of the High School fence at the grading between Area 4 and the fence

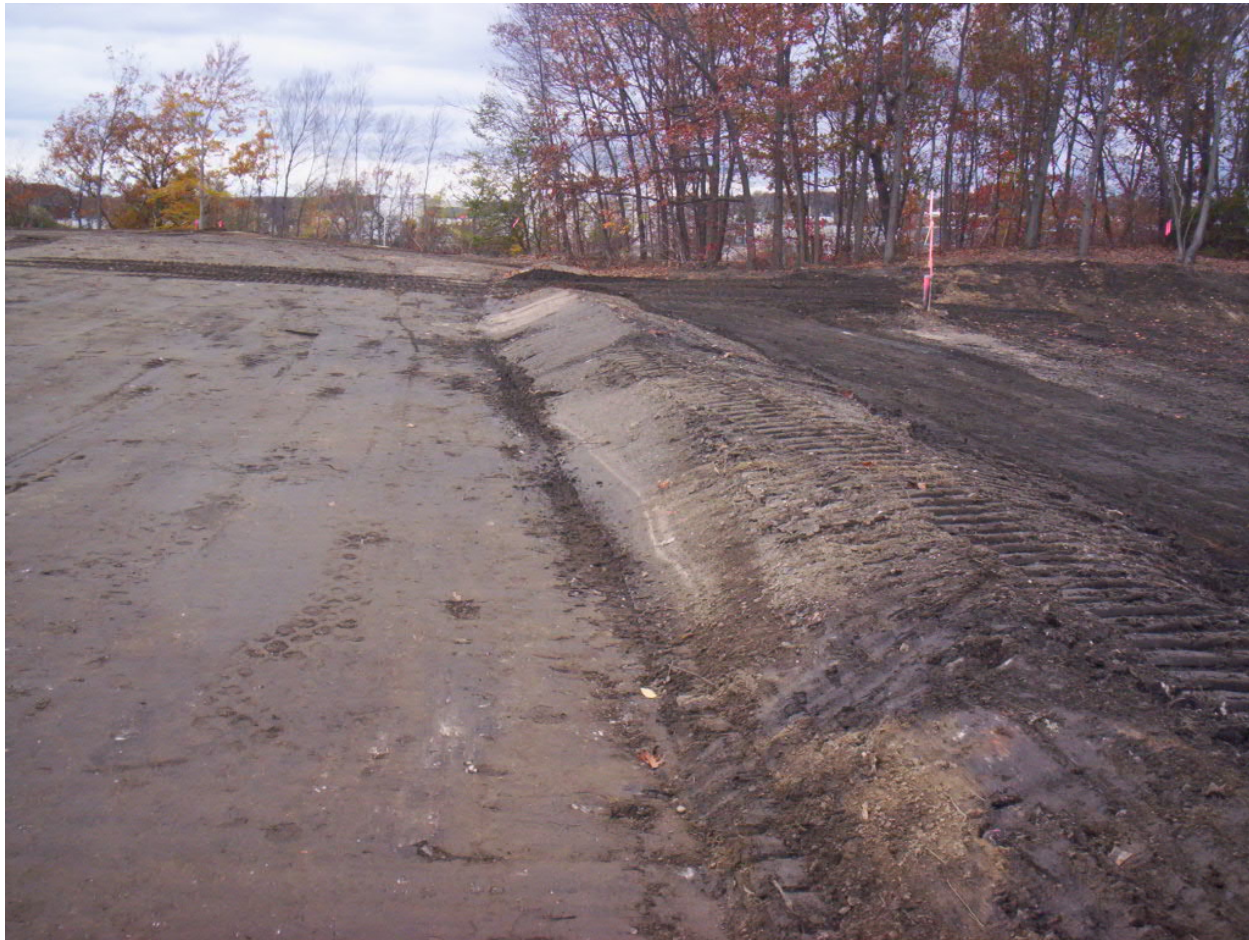
<b>Date</b>	<b>Photo ID</b>	<b>Description</b>
11/02/12	1656	Looking southwest at Areas 3 and 4. Final grading achieved.
