# REMEDIAL ACTION CLOSURE REPORT

## PARCEL C-1 PHASE I CAP FORMER GORHAM MANUFACTURING FACILITY 333 ADELAIDE AVENUE PROVIDENCE, RHODE ISLAND

AMEC Environment & Infrastructure, Inc.  
2 Robbins Road  
Westford, Massachusetts 01886

April 2013

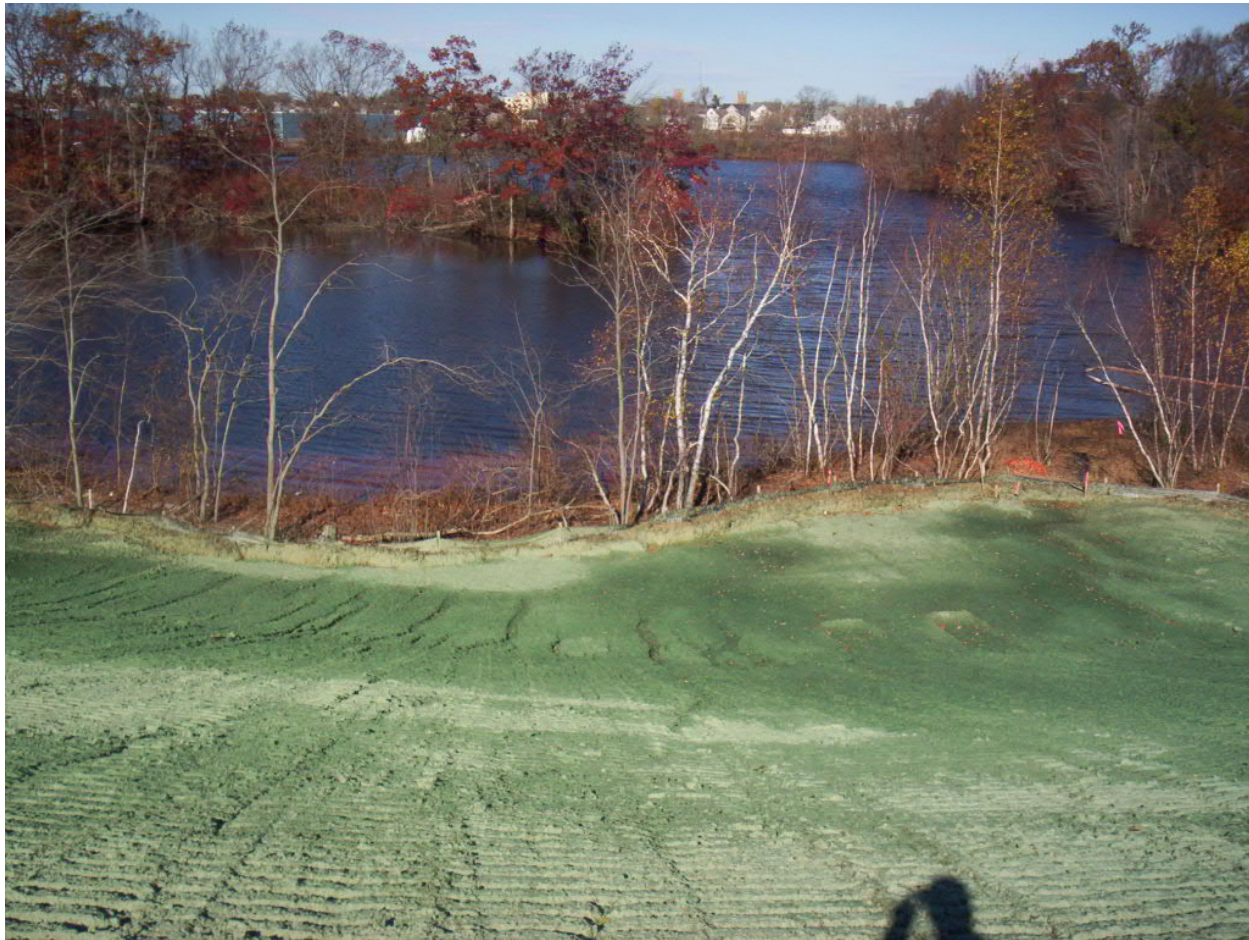
<b>Date</b>	<b>Photo ID</b>	<b>Description</b>
11/06/12	1662	Hydrograss hydroseeding Area 4, looking northeast

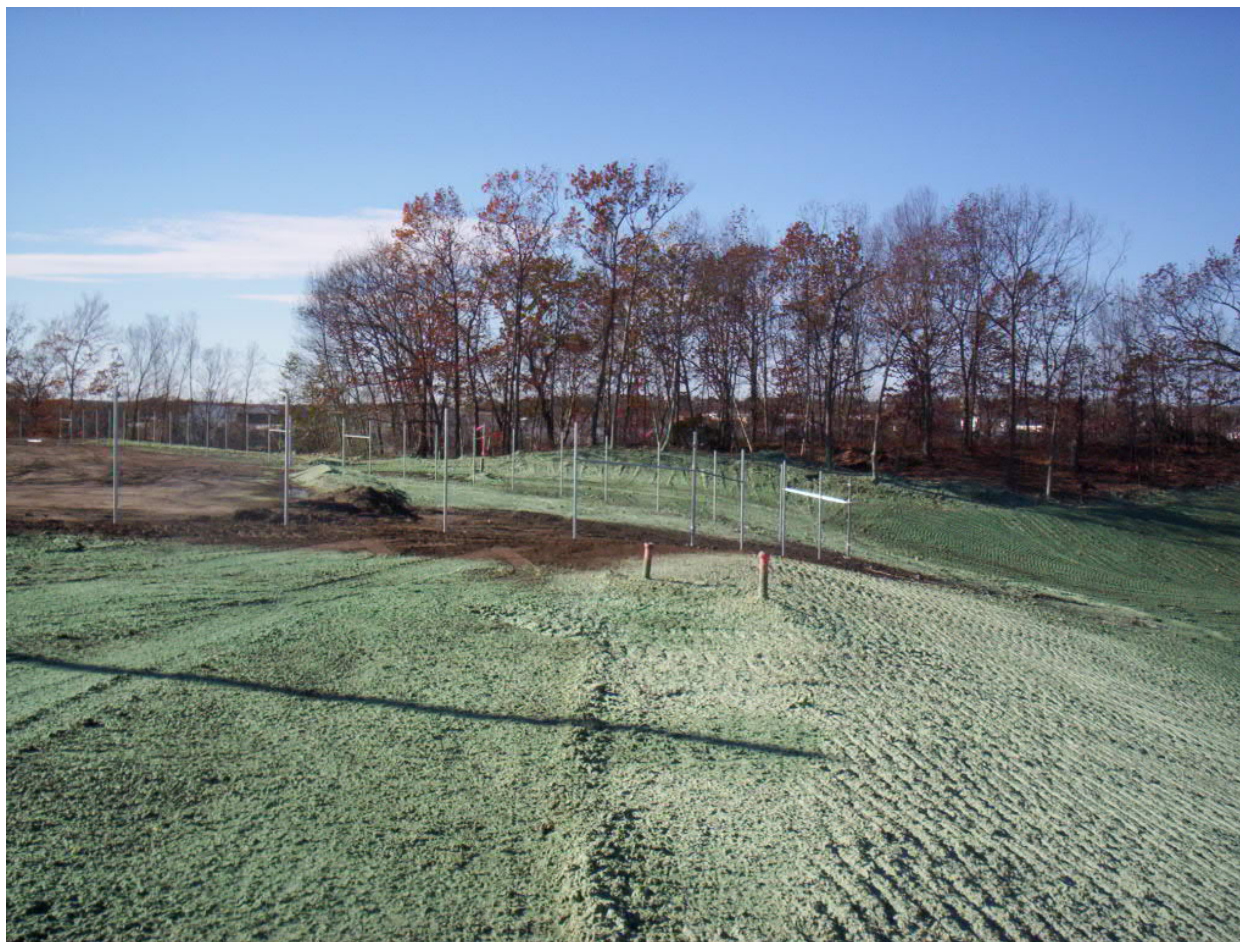
<b>Date</b>	<b>Photo ID</b>	<b>Description</b>
11/09/12	1671	Looking north at slope of Area 3 after Nor'easter

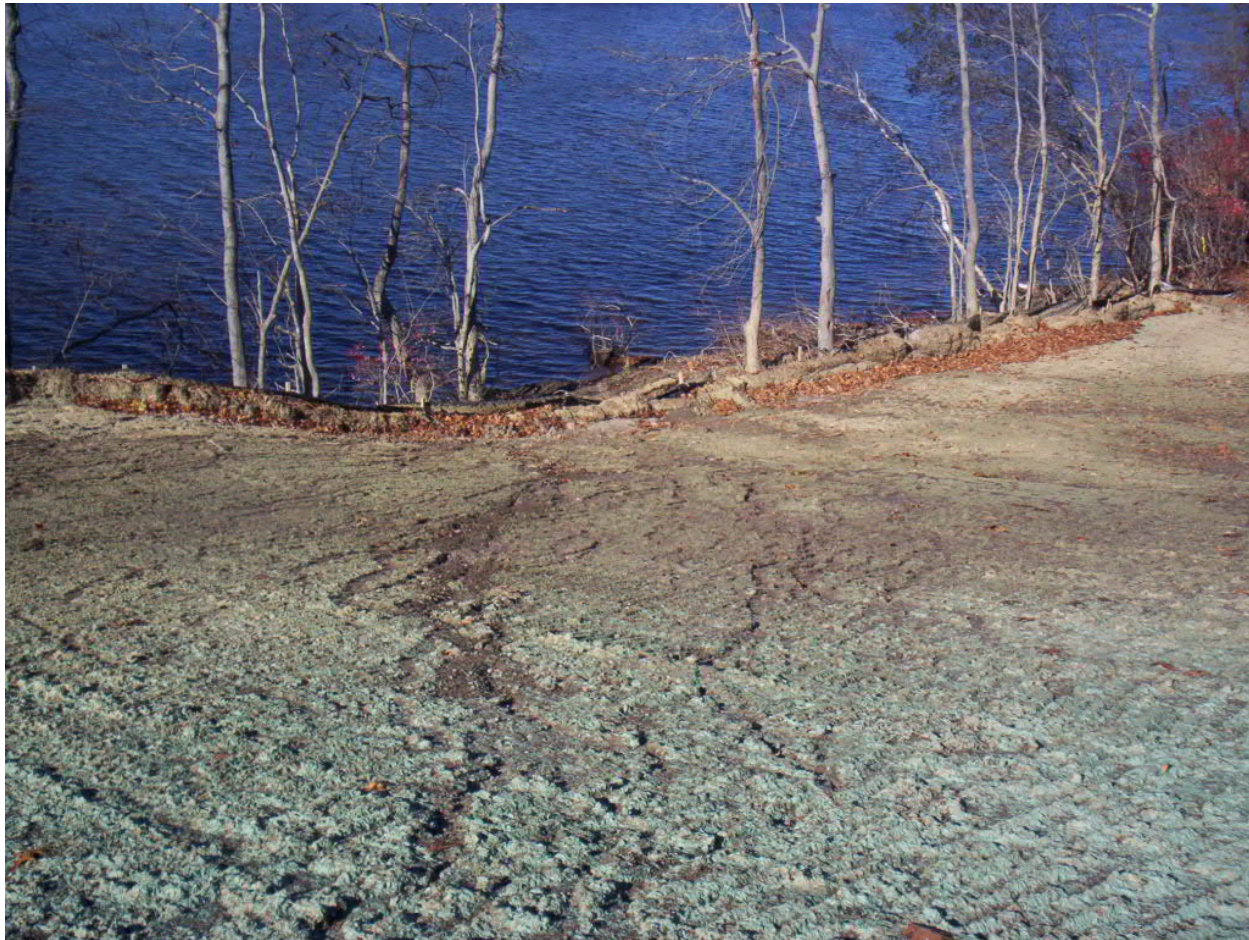
<b>Date</b>	<b>Photo ID</b>	<b>Description</b>
11/09/12	1674	Looking southwest at slope of Area 3 after Nor'easter. Also, some areas outside the cap were hydroseeded. Fence posts installed upgradient of Area 3.

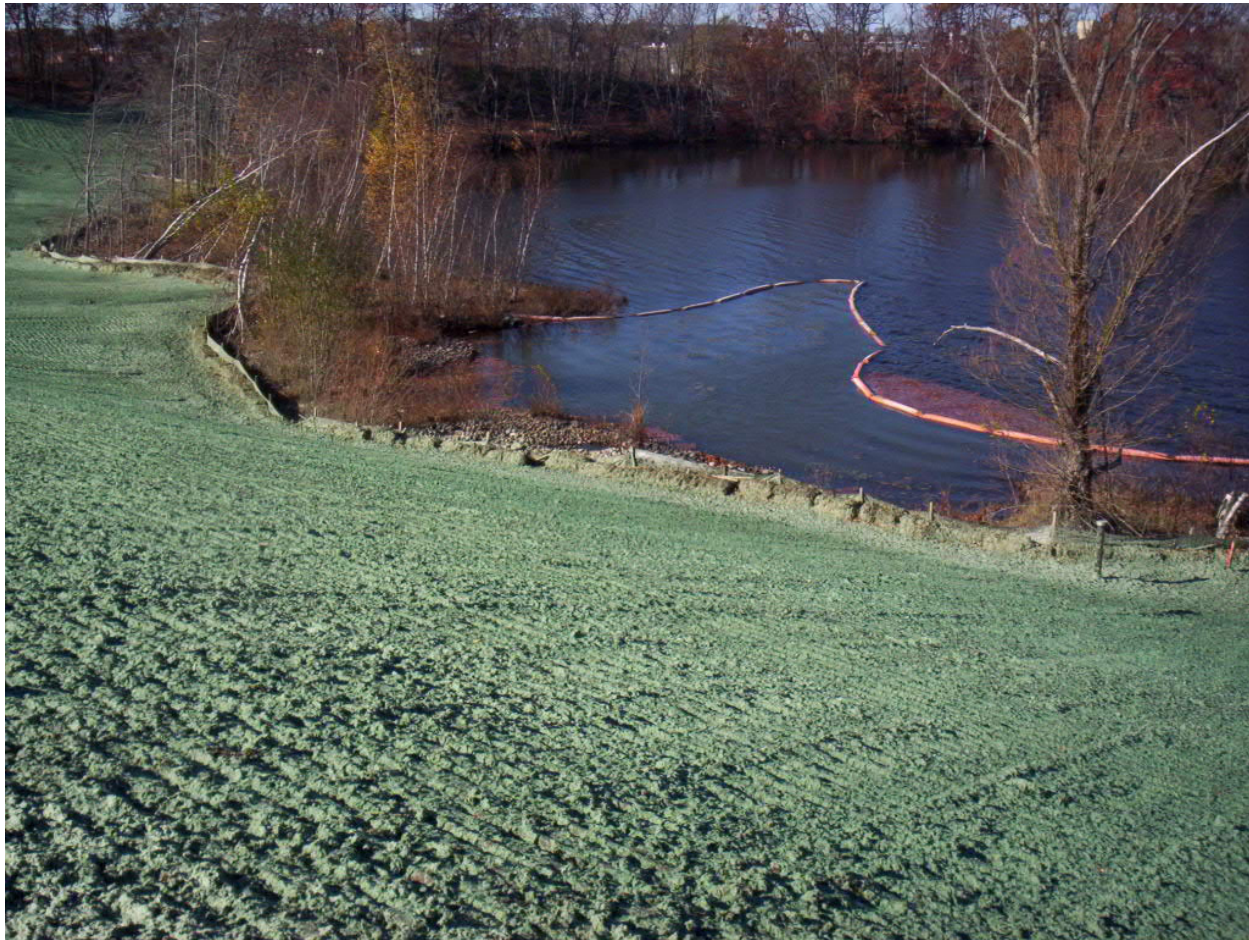
<b>Date</b>	<b>Photo ID</b>	<b>Description</b>
11/09/12	1677	Looking west at slope of Area 2 after Nor'easter

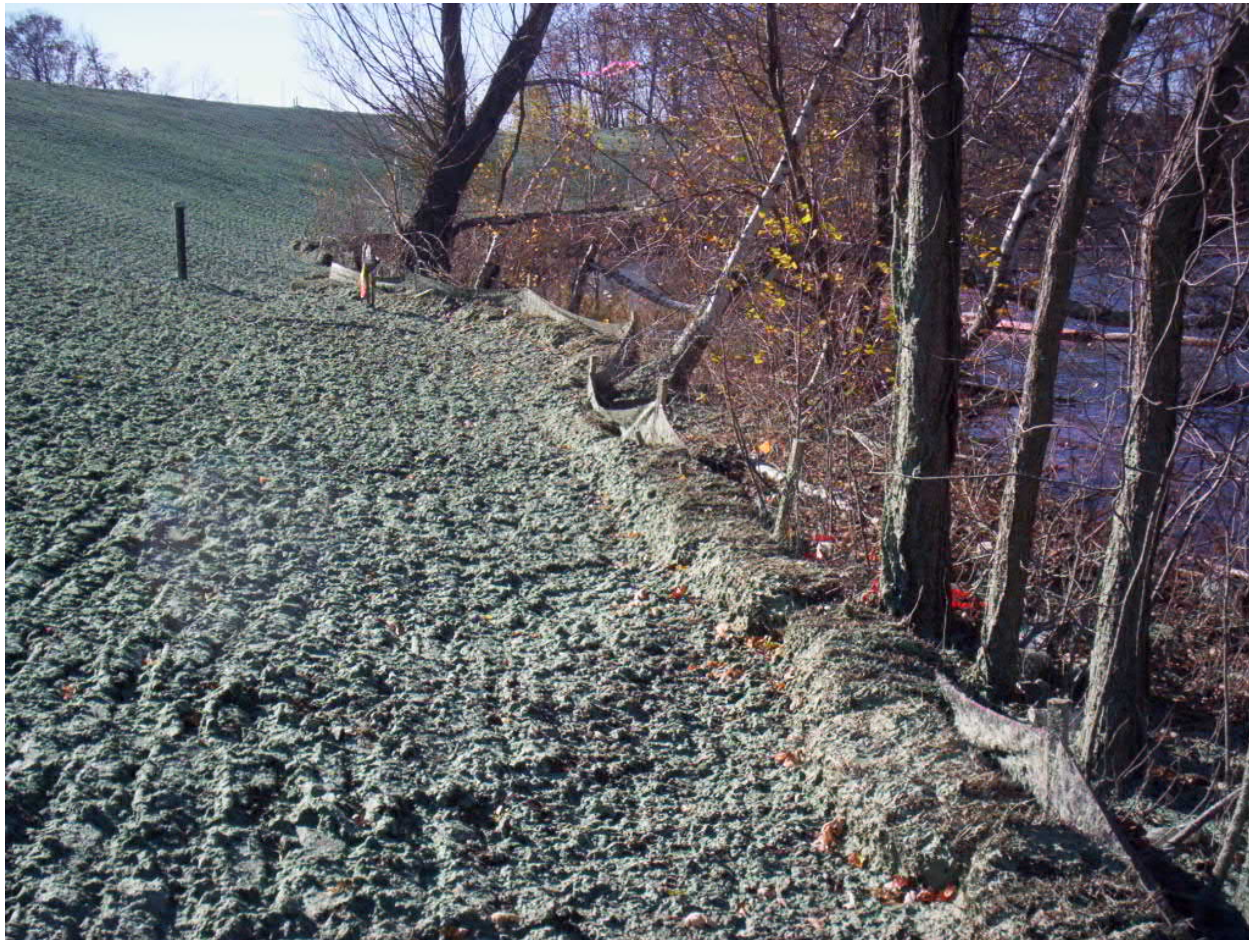
<b>Date</b>	<b>Photo ID</b>	<b>Description</b>
11/09/12	1678	Looking west at slope of Area 4 after Nor'easter

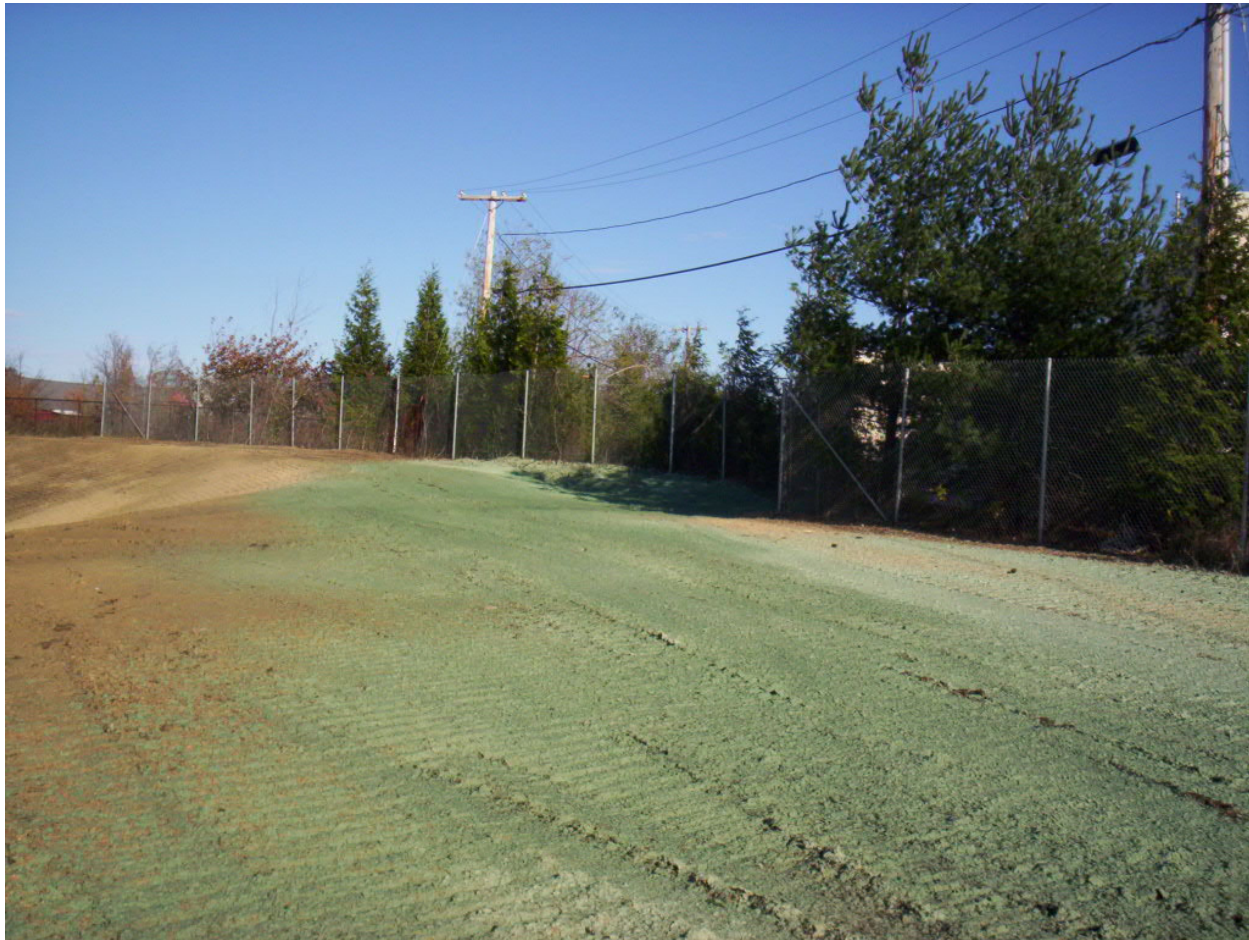
<b>Date</b>	<b>Photo ID</b>	<b>Description</b>
11/09/12	1682	Toe of slope at Area 5 after Nor'easter, looking southwest
