Re: Status Report: August 2015 Remedial Action Work Plan (RAWP) Activities

Former Gorham Manufacturing Facility
333 Adelaide Avenue, Providence, RI
File No.: SR-28-0549D

Wildlife Management Plan Implementation – August 2015

Port-A-Dam - Vandalism Incident

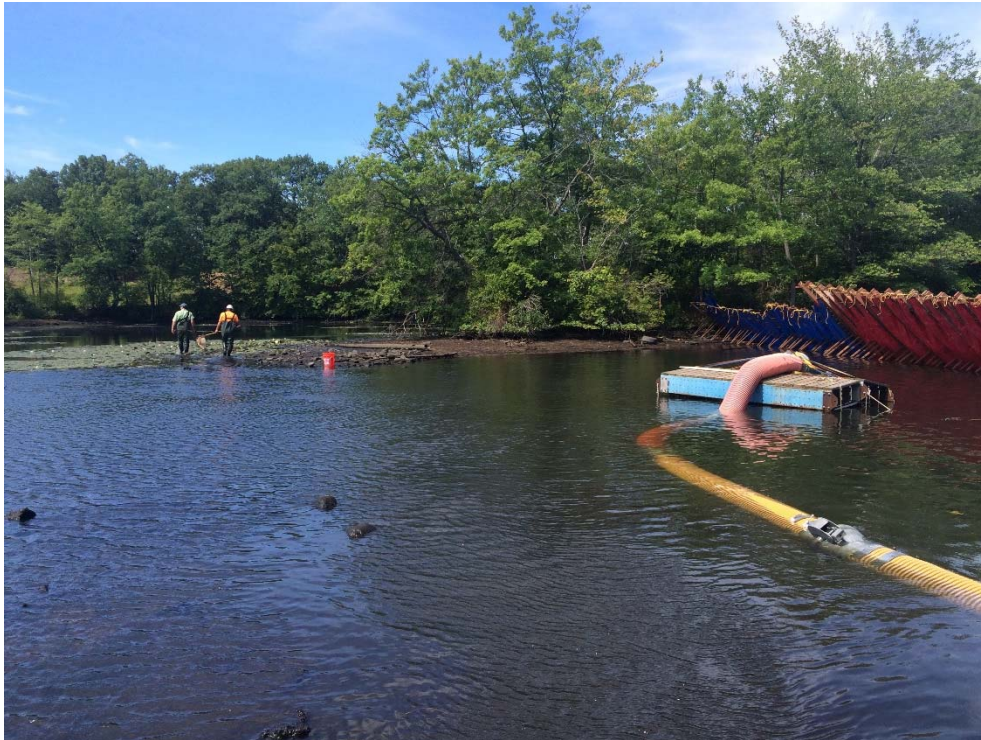
Photo 1

Facing west, View of Mashapaug Inner Cove and Port-A-dam after approximately 3 hours of pumping; Charter/ESS catching and relocating aquatic wildlife to Outer Cove.

During the dewatering of the Inner Cove Charter and ESS collected the aquatic wildlife from the Inner Cove using hand nets. The wildlife was then transported in 5-gallon buckets to the waters on the opposite side of the Port-A-Dam. This continued until all of the water was removed from the Inner Cove except for 1 foot of water immediately near the base of the Port-A-dam. Selected photographs of the process are included in Attachment B.

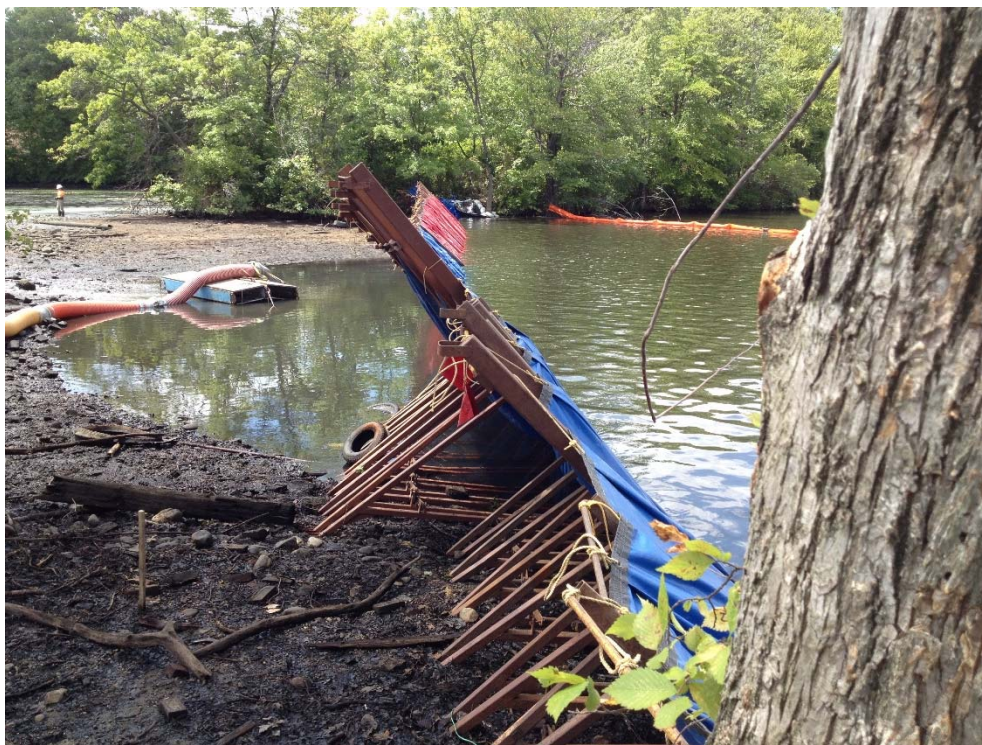
Photo 2

Facing west, View of Inner Cove, Port-A-dam and turbidity curtain after pumping was complete.

Following the removal of the aquatic wildlife from the Inner Cove, the remaining surface water and construction dewatering water was discharged to the infiltration gallery located at the northern end of the Phase III Area where any residual sediment settles within the temporary structure and the water infiltrates into the groundwater table and discharges into the Mashapaug Pond.

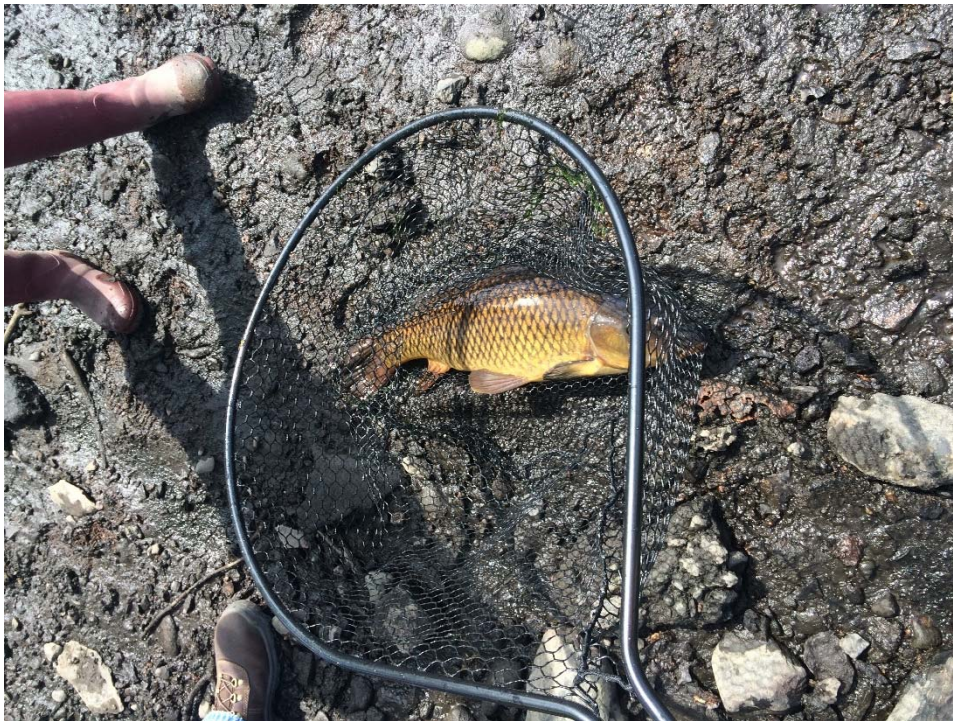
Photo 3

View of Carp prior to transporting to the Outer Cove.

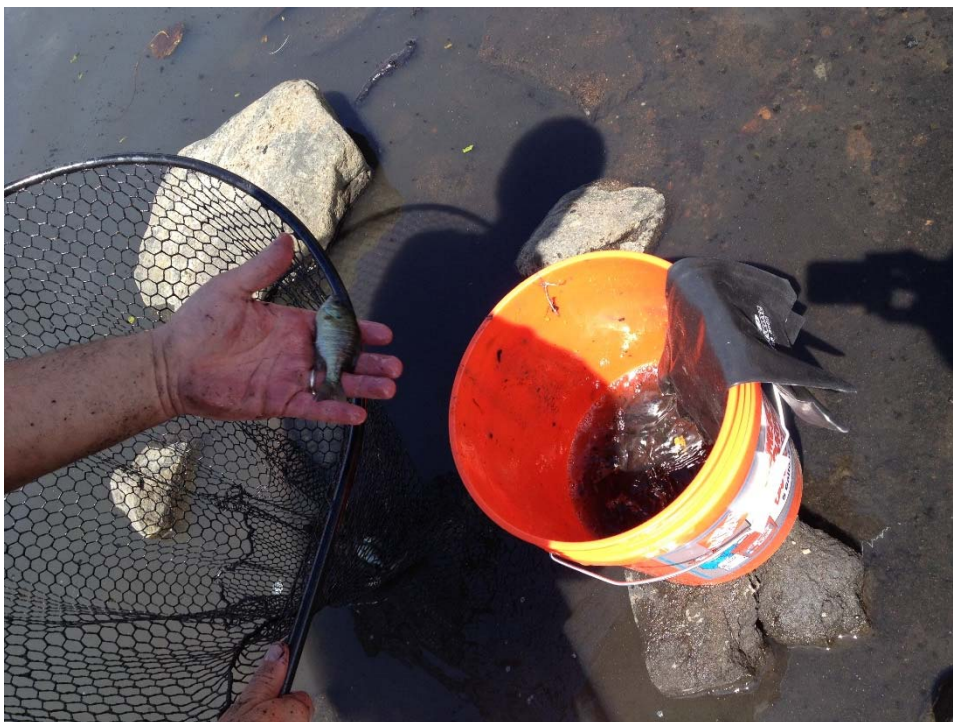
Photo 4

View of several small fish prior to transporting to the Outer Cove.

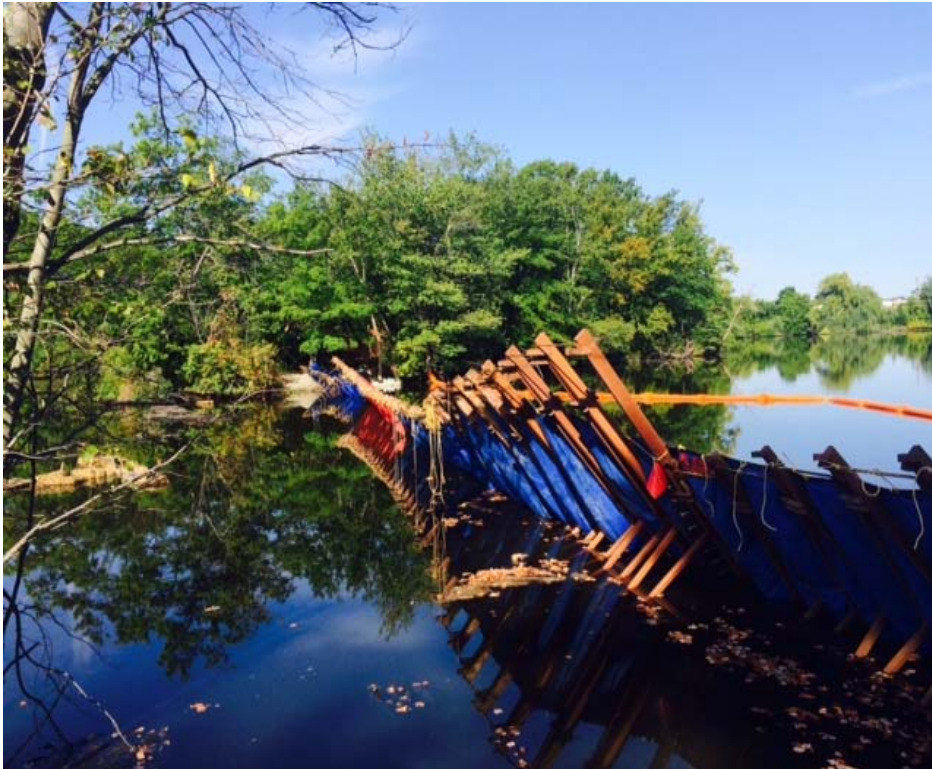
Photo 1

On morning of August 28, 2015, the Port-A-Dam was damaged as described below. The damage caused a failure of the western end of the Port-A-Dam and the Inner Cove to refill with water. Amec Foster Wheeler notified Joe Martella and Neal Personeaus, RIDEM, of the damage between August 30th and 31st. Amec confirmed that Charter would follow the previously approved dewatering plan to restore the Inner Cove for sediment removal. Any wildlife found within the Inner Cove would be relocated by hand net as much as possible. Between August 29 and September 9, 2015 Charter repaired the Port-A-dam and pumped the water back out of the Inner Cove following the approved Dewatering Plan. Some wildlife were found in the Inner Cove and were later transported outside the Port-A-Dam. Due to the soft sediment material present in the middle of the cove, this area was inaccessible and Charter was not able to relocate all aquatic life.

Inner Cove and Mashapaug Pond are in elevation in equilibrium.

On Monday August 31, 2015, Charter began repairing the Port-A-Dam. Plywood was placed to stop the leaks, and two 6-inch pumps were fitted to pump the water from the Inner Cove to the Outer Cove between the turbidity curtain and the Port-A-Dam. Wildlife was removed from the Inner Cove as described above.

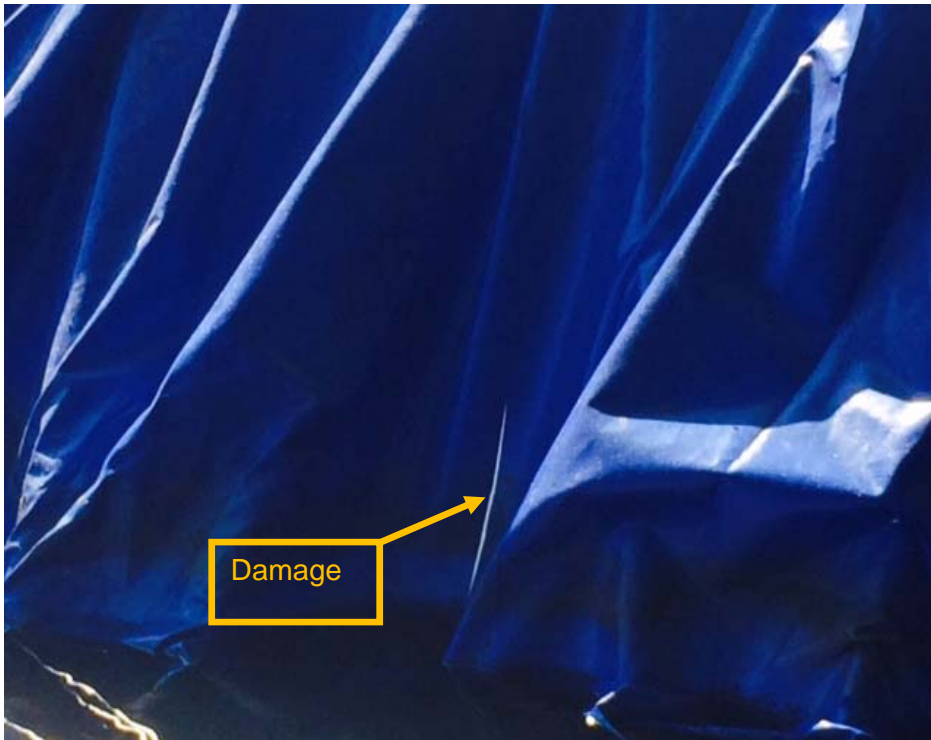
Photo 2

On Friday August 28, 2015 around 2:00 PM during a delivery of fuel for the onsite generator, the Charter fuel truck driver observed that the water elevation within the cove appeared higher than normal. The driver notified a Charter foreman Eric Mendonca who arrived at the site at approximately 6:30 PM. Eric confirmed that the cove water elevation had risen substantially, and noticed 4 locations near the peninsula on the western side of the cove where water was entering the cove from the pond through the Port-A-Dam. The water elevation within the cove was approximately 14-inches lower than the pond elevation. Eric notified the Charter Project Manager (Paul Leofonti) and turned off the pumps. It was noted that Charter was not working on Friday August 28, 2015 due to the annual company outing, therefore no personnel were onsite until the fuel delivery at approximately 2:00 PM. Upon arrival to the site on Saturday morning August 29, 2015, Eric (Charter) informed Danielle Ahern (Amec Foster Wheeler) about the Port-A-Dam damage. At this time the cove water elevation was in equilibrium (Attachment C, Photo 1) with the pond water elevation. Amec Foster Wheeler (Danielle) and Dean (Charter) investigated the damage. No evidence of trespassing (homeless camps, alcohol, camp fires, vandalism, etc.) was present; however, two slashes in the Port-A-Dam material were observed (Attachment C, Photos 2, 3 and 4). The two breaks were located at the pond elevation staining, were approximately 12-inches long (did not continue to the bottom of the pond), and both were clean slashes (indicating vandalism vs. defective material breaks). The breaks were also located at the more shallow water elevation (near shore) indicating it was not a material defect since the pressure on the material would be greatest at the deeper portions of the dam. The other two breaks (Eric observed four locations where water was entering the cove on Friday August 28, 2015) could not be seen from the water's edge due to the wrinkled nature of the material.

Observed damage to Port-A-Dam material. Notice water staining and location and length of slash.

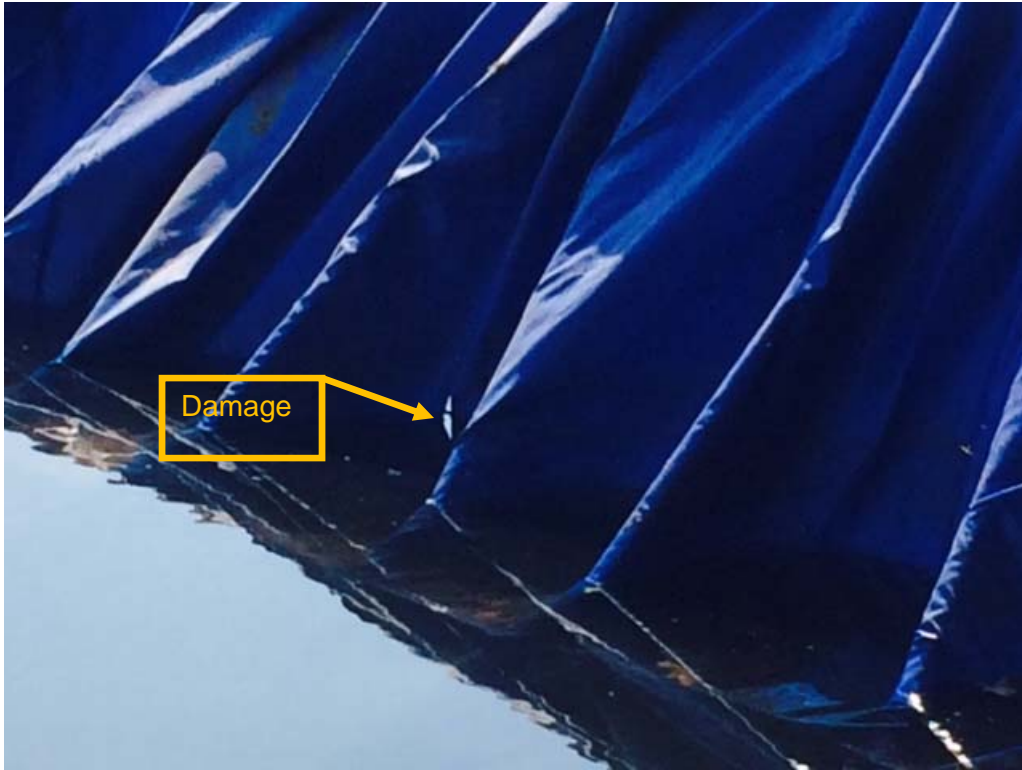
Photo 3

Observed damage to Port-A-Dam material.

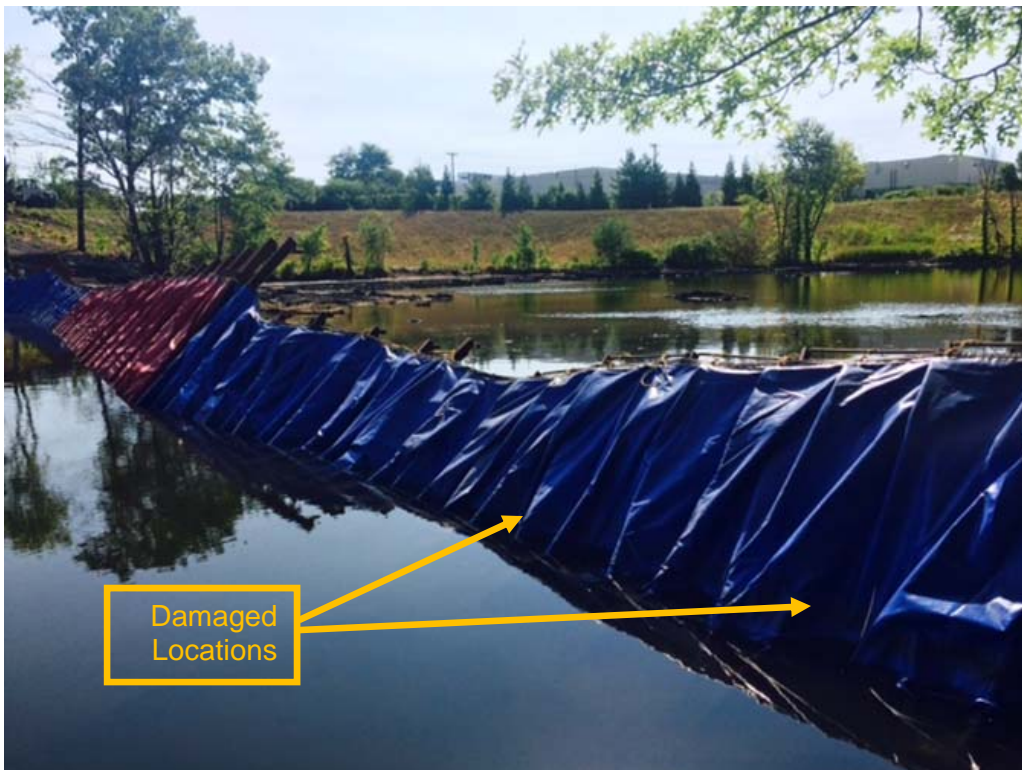
Photo 4

Observed damage to Port-A-Dam material.
