Textron, Inc.
Former Gorham Manufacturing Facility, Providence, RI
Remedial Action Completion Report: Phase II Area – Mashapaug Inner Cove,
Phase III Area – Northeast Upland And Parcel C
Project No.: 3652160001
February 12, 2016

APPENDIX J
WILDLIFE MANAGEMENT SUMMARY PLAN

**Implementation of the Wildlife Management Plan
 Former Gorham Manufacturing Site
 333 Adelaide Ave.
 Providence, RI**

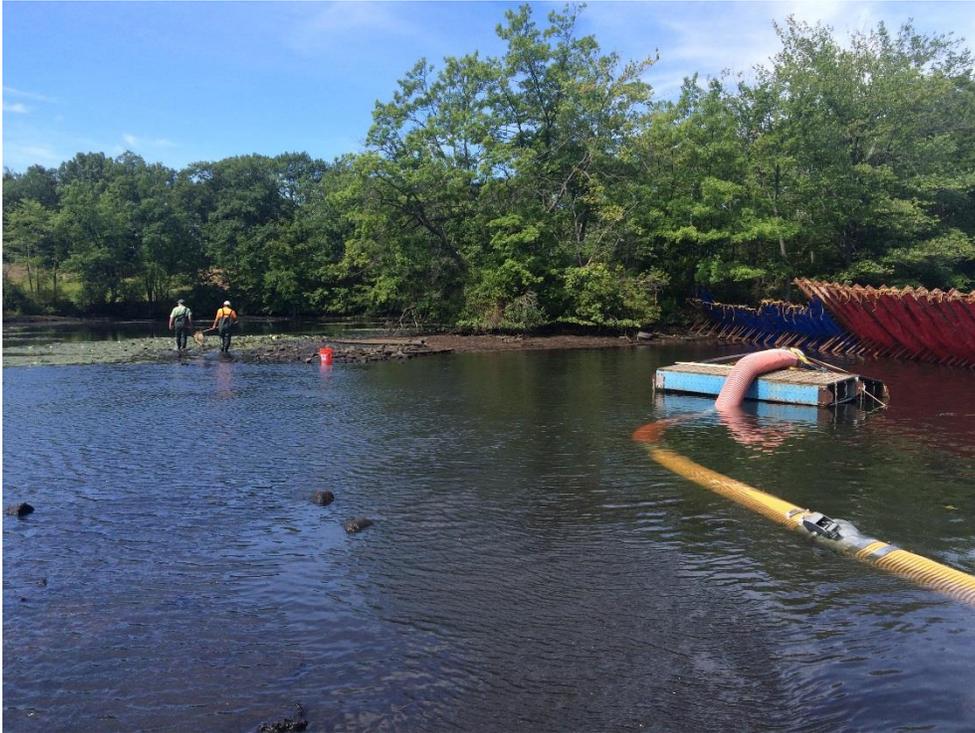
Photo 1

Facing west, View of Mashapaug Inner Cove and Port-A-dam after approximately 3 hours of pumping; Charter/ESS catching and relocating aquatic wildlife to Outer Cove.

On August 6, 2015, Amec Foster Wheeler oversaw the implementation of the Mashapaug Inner Cove Dewatering Plan and Wildlife Management Plan, approved under the July 9, 2015 Order of Approval. Noise makers were employed along the southern shore line of the Inner Cove on August 3, 2015 by Charter Contracting Company, LLC (Charter). This was done to encourage the movement of the aquatic wildlife out of the Inner Cove prior to the installation of the turbidity curtain and Port-A-Dam. ESS Group, Inc. (ESS), a subcontractor to Charter, determined that using a seine net to herd aquatic wildlife out of the Inner Cove, as discussed in the Wildlife Management Plan dated March 12, 2015, would not be feasible due to abundant debris present on the cove's bottom. Charter installed the turbidity curtain on August 4, 2015 and completed the construction of the Port-A-Dam on August 5, 2015. They began the dewatering of the Mashapaug Inner Cove that afternoon. The water level within the Inner Cove was dropped to approximately one foot of water using one (1) 12-inch pump with a pumping velocity of approximately 120 gallons per minute. The surface water was discharged between the Port-A-dam and the turbidity curtain.

During the dewatering of the Inner Cove Charter and ESS collected the aquatic wildlife from the Inner Cove using hand nets. The wildlife was then transported in 5 gallon buckets to the waters on the opposite side of the Port-A-dam. This continued until all of the water was removed from the Inner Cove except for 1 foot of water immediately near the base of the Port-A-dam.

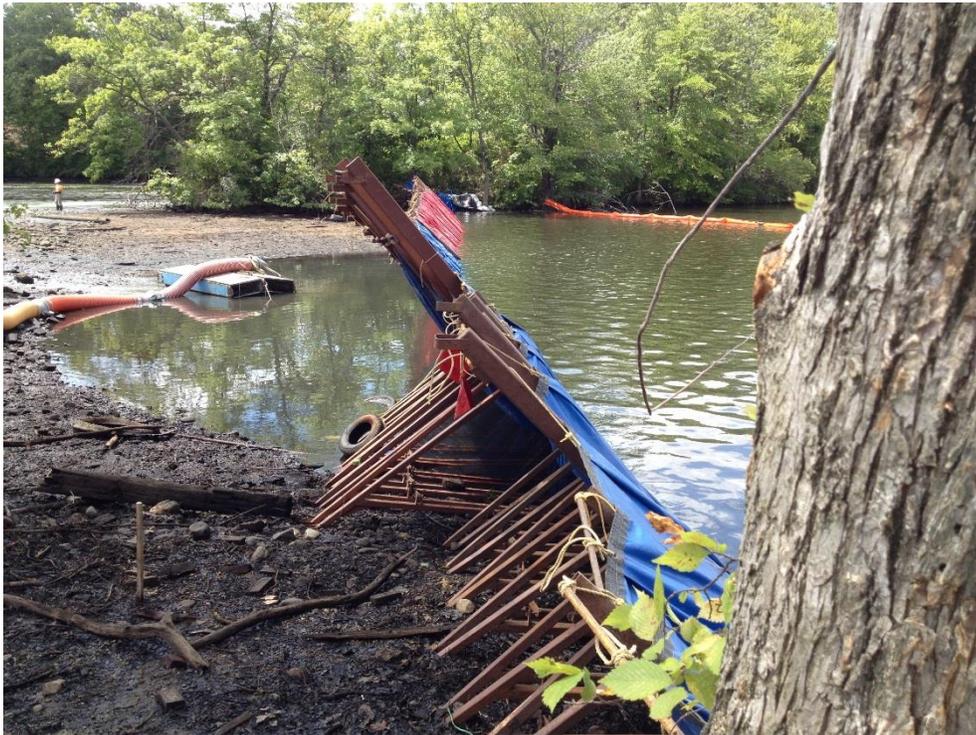
Photo 2

Facing west, View of Inner Cove, Port-A-dam and turbidity curtain after pumping was complete.

Following the removal of the aquatic wildlife from the Inner Cove the remaining surface water and construction dewatering water was discharged to the infiltration gallery located at the northern end of the Phase III Area where any residual sediment settles within the temporary structure and the water infiltrates into the groundwater table and discharges into the Mashapaug Pond.

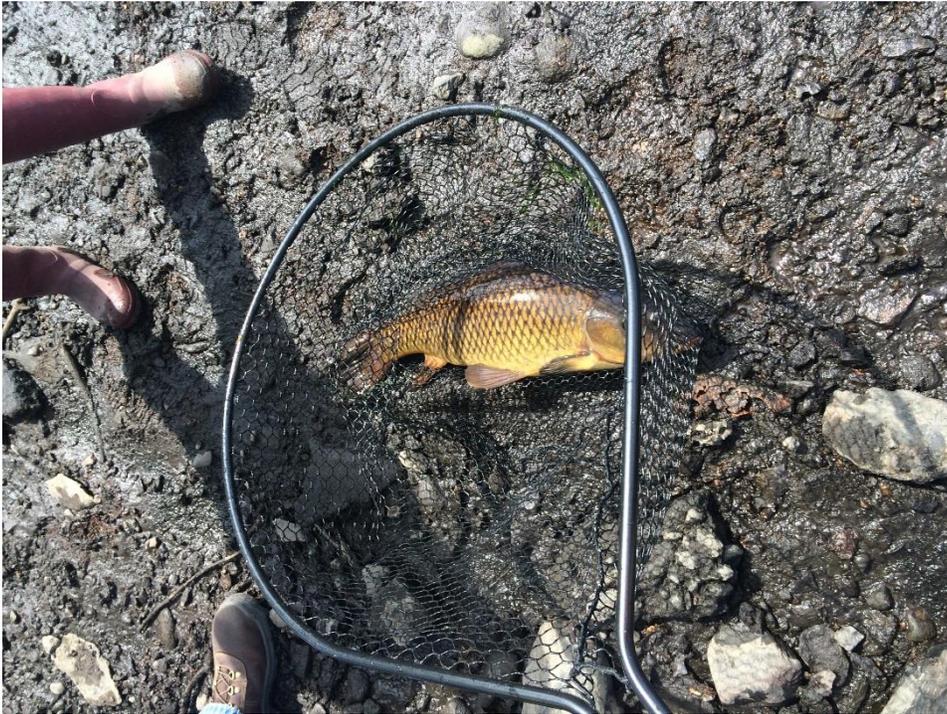
Photo 3

View of Carp prior to transporting to the Outer Cove.

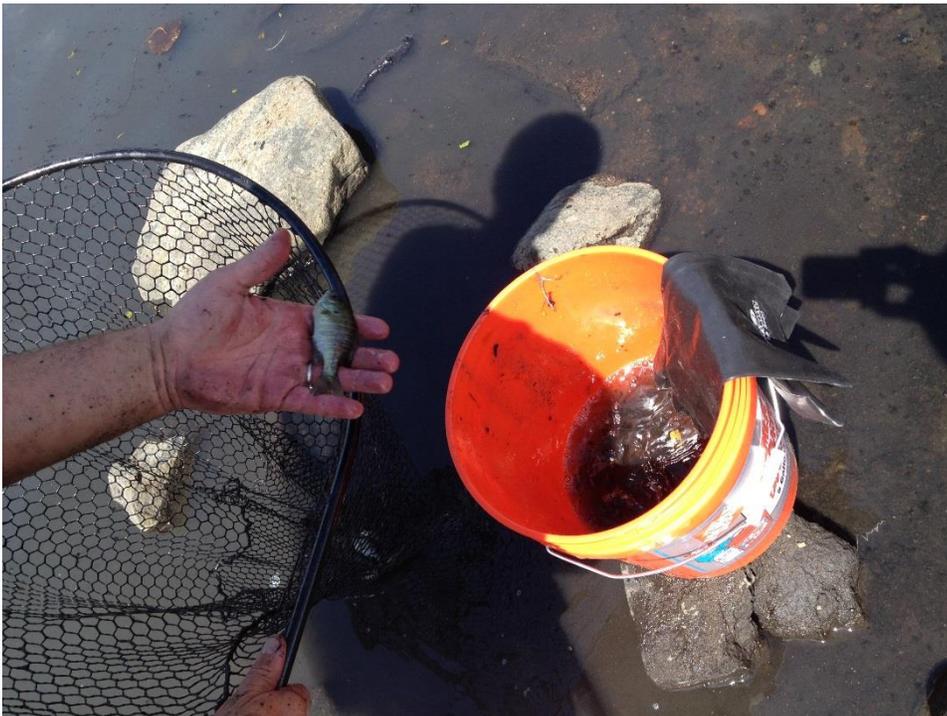
Photo 4

View of several small fish prior to transporting to the Outer Cove.
