Memo

To:	Joe Martella, RIDEM
From:	David Heislein, Amec Foster Wheeler
cc:	Greg Simpson, Textron Melinda Ferullo, Amec Foster Wheeler
Date:	June 15, 2016
Re.	Parcel C-1 Restored Wetlands Assessment Monitoring Report #1, Mashapaug Inner Cove and Mashapaug Pond Former Gorham Manufacturing Site, Providence, Rhode Island

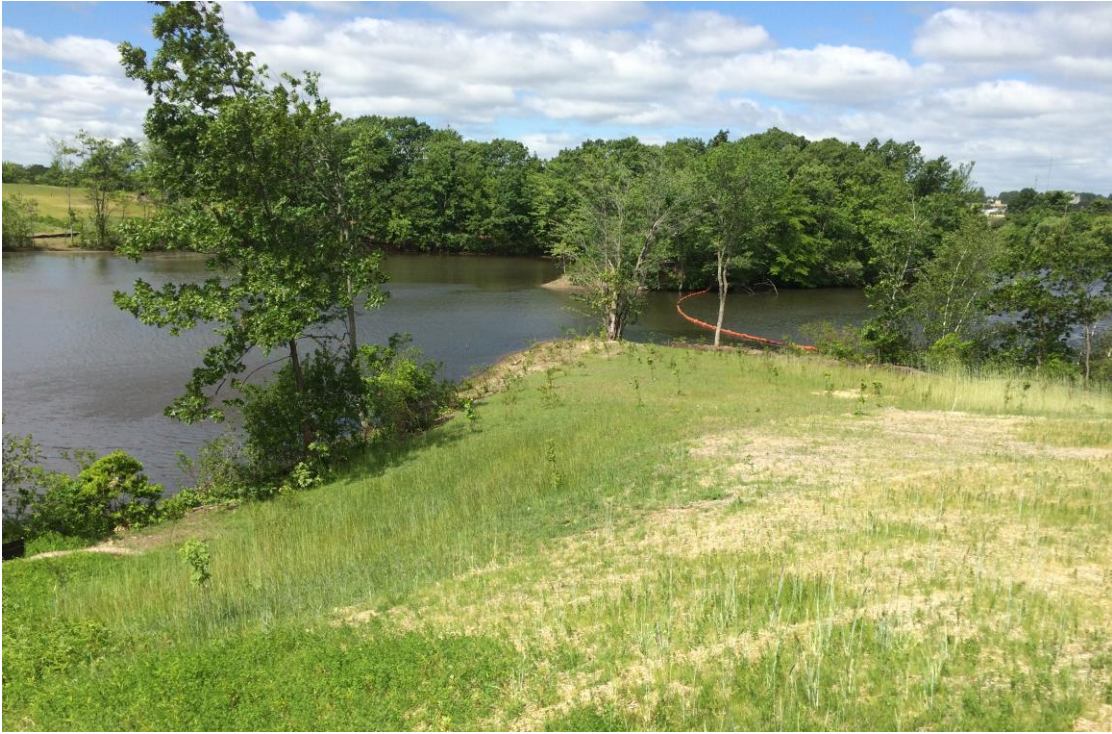
Photo #1: Perimeter and Fringe Wetlands Phase III Area Western Slope facing West

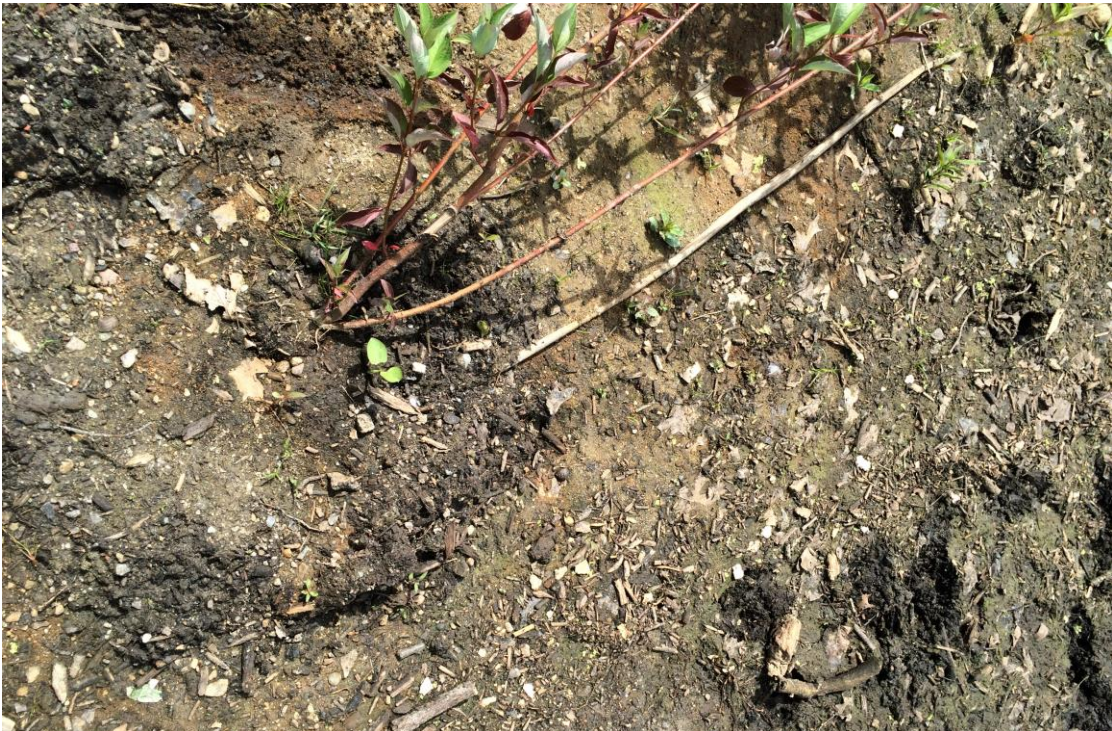
Many plants were observed with exposed roots likely attributable to the settling of the soil along the Inner Cove edge. Many of the plants with partially exposed roots were alive and growing well (Photo #2). These can be replanted and were not included in the dead/missing count. Possible other factors that contributed to the observed mortality might be related to the dry weather conditions immediately following planting in November and the elevated water surface during the winter and early growing season. Amec Foster Wheeler personnel righted or re-dug several of the plants that were exposed, but alive. Charter will replant the remaining plants, as necessary. We observed little herbaceous growth in the fringe wetland. Wetland seed that was

Photo #2: Phase I Area Fringe Wetland Plant exposed roots, to be replanted

We requested that Charter work with their subcontractor under the plant warranty to replace the dead plants in the fringe wetland. Many of these plants were Swamp Rose or Virginia Rose variety. We suggest replanting the 164 plants with a mix of these two roses, plus Speckled Alder if available. This species was not included in the original mix due to the limited availability at the time of ordering the plants, but was observed on site and would likely perform well in the site conditions. The fringe wetlands will also be over seeded with the New England Wetland Plants "Wetmix".

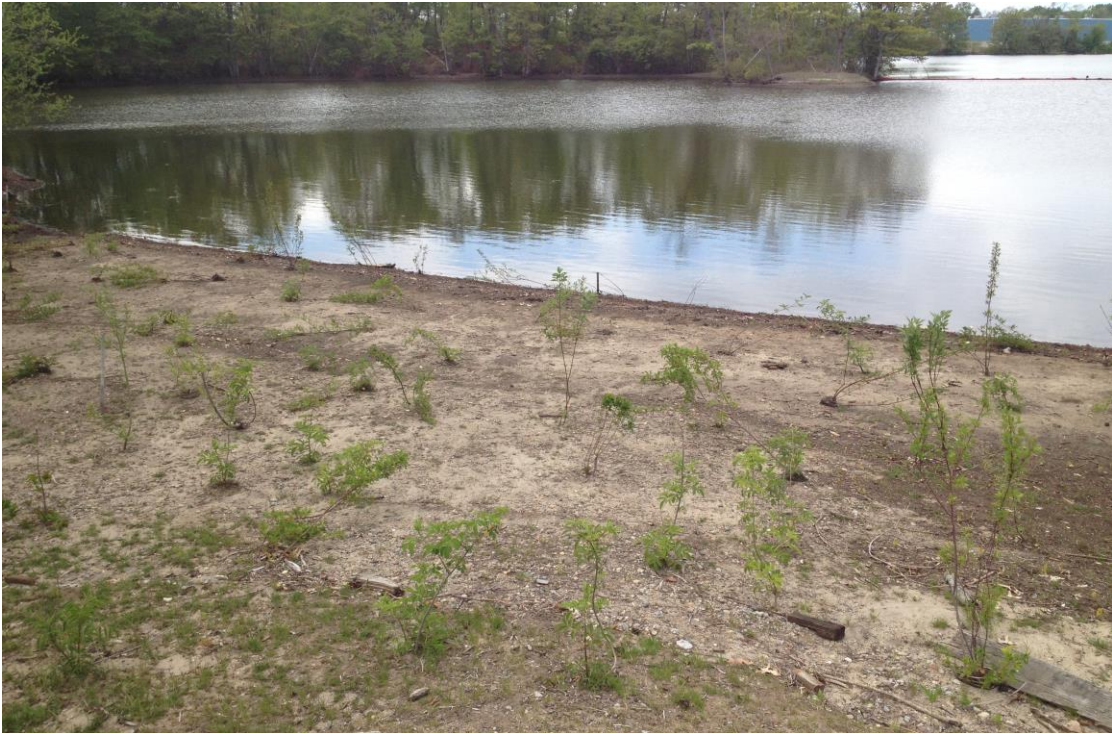
broadcast there has shown minimal germination (Photo #3). Seed growth is expected to continue through spring/summer months.

Photo #3: Phase I Area Fringe Wetland requires reseeding with Wetland Mix, facing Northeast

- New England Wetland Plants "Wetmix" 1 lb per 2500 sf; (for 11,000 sf fringe wetland = 4.5 lbs)
- Straw mulch spread by hand

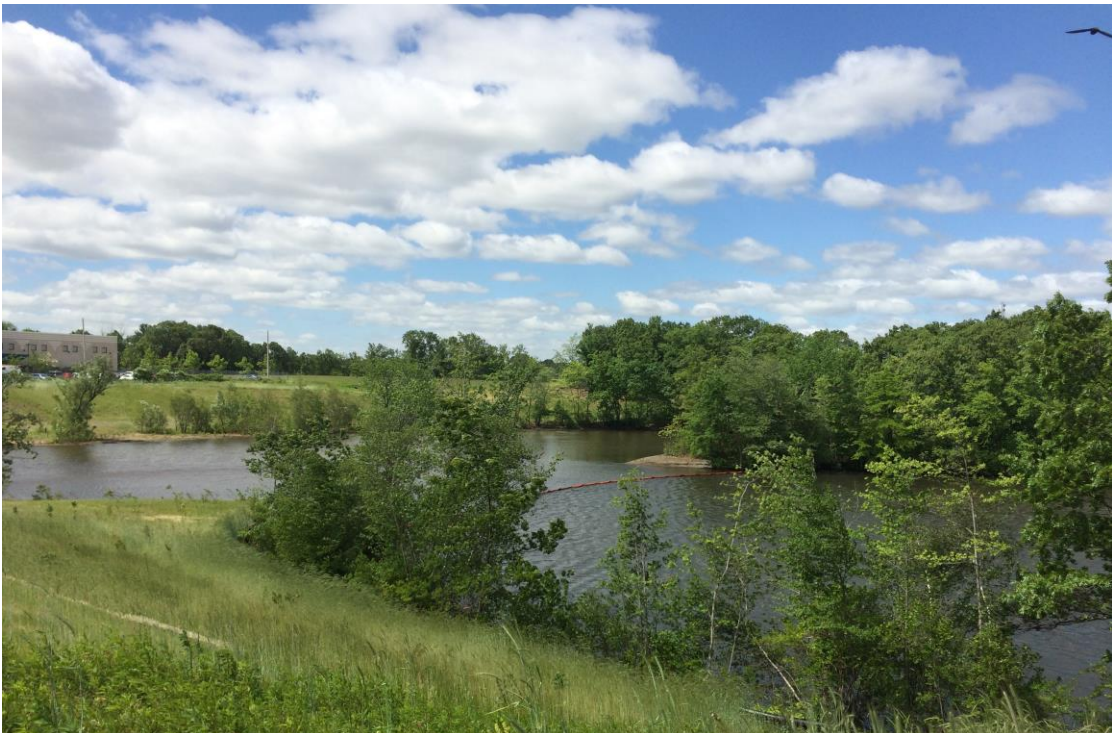
Almost all of the plants observed in the perimeter wetland were healthy at the time of inspection. The few not-as-healthy plants were blueberry and sweet pepperbush that experienced dieback of the woody tops, but had healthy sprouts and leaves near ground level. The grass mix growing in the perimeter wetland was generally healthy (Photo #s 4 and 5). Some plants may have been missed during counting because of the dense grass growth; therefore the number of live plants is likely higher than counted. We recommend leaving the perimeter area in its current state with no replanting.

Photo #4: Phase III Area Perimeter Wetland growth, facing Southeast

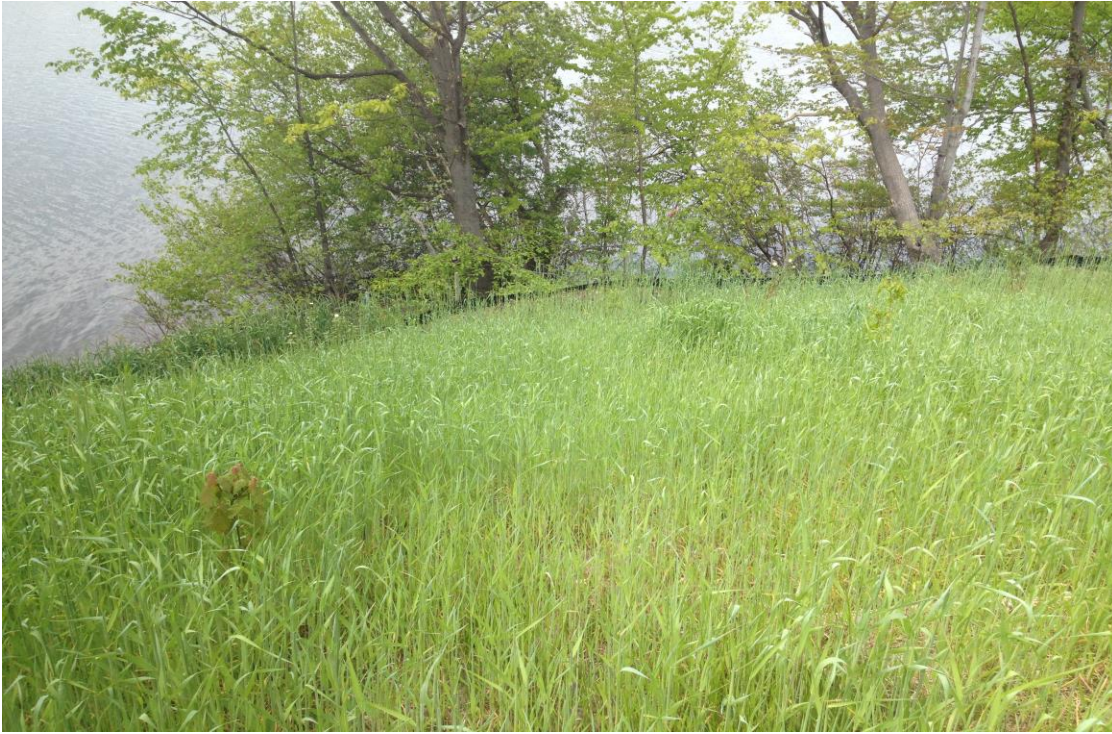
Photo #5: Phase III Area Western Slope Perimeter Wetlands facing Northwest
