Supplemental SI
 Former Gorham Manufacturing Site
 Providence, Rhode Island

Figure 3.6. Collection of Sediment Cores at Mashapaug Cove Using Vibracorer™ Technology
Supplemental Site Investigation Report
Former Gorham Manufacturing Facility
Providence, Rhode Island

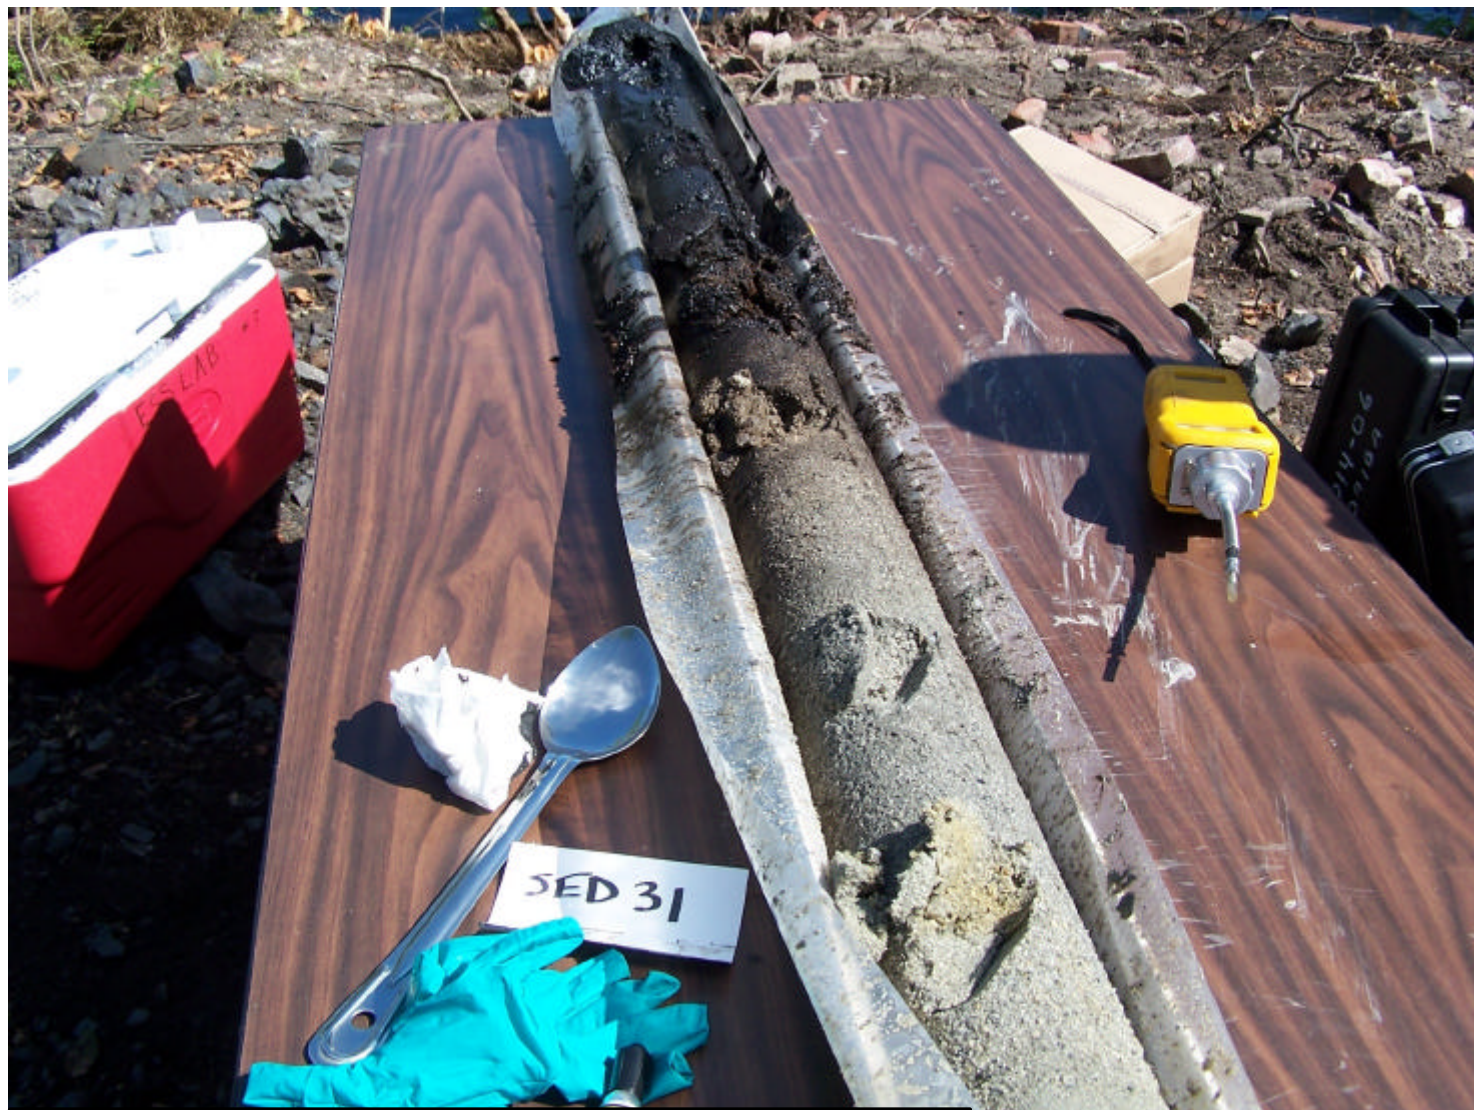
Figure 4.14. Sediment Core Typical of Mashapaug Cove
Supplemental Site Investigation Report
Former Gorham Manufacturing Facility
Providence, Rhode Island

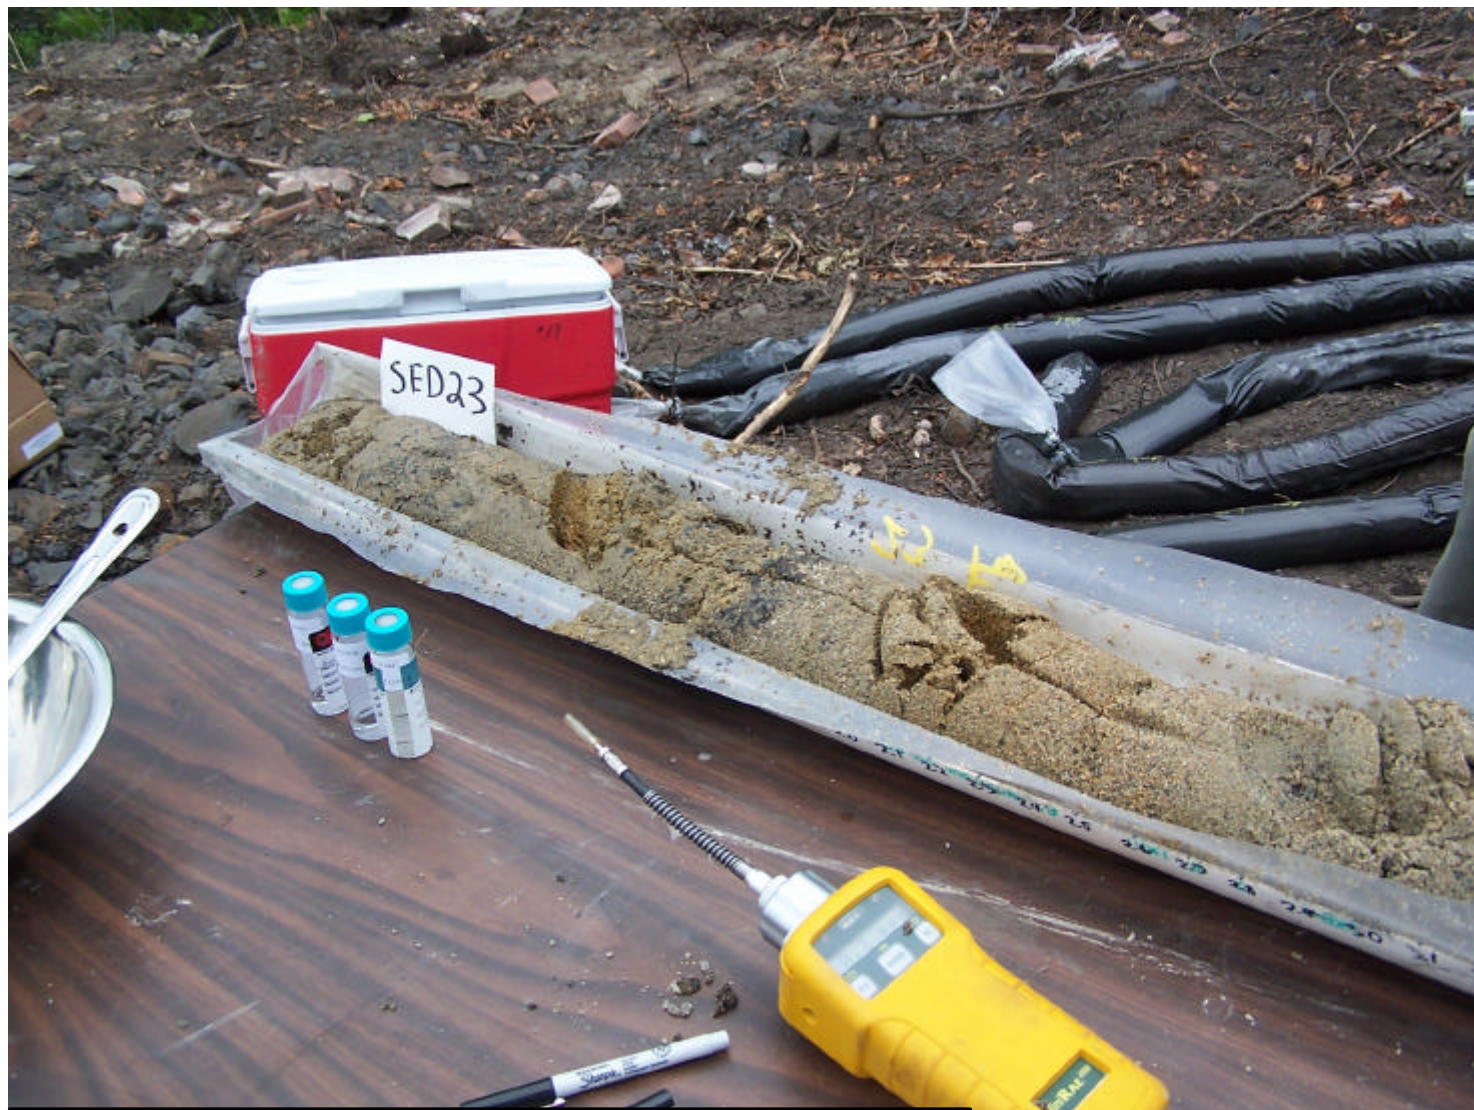
Figure 4.15. Sediment Core Outwash Area of Mashapaug Cove
Supplemental Site Investigation Report
Former Gorham Manufacturing Facility
Providence, Rhode Island

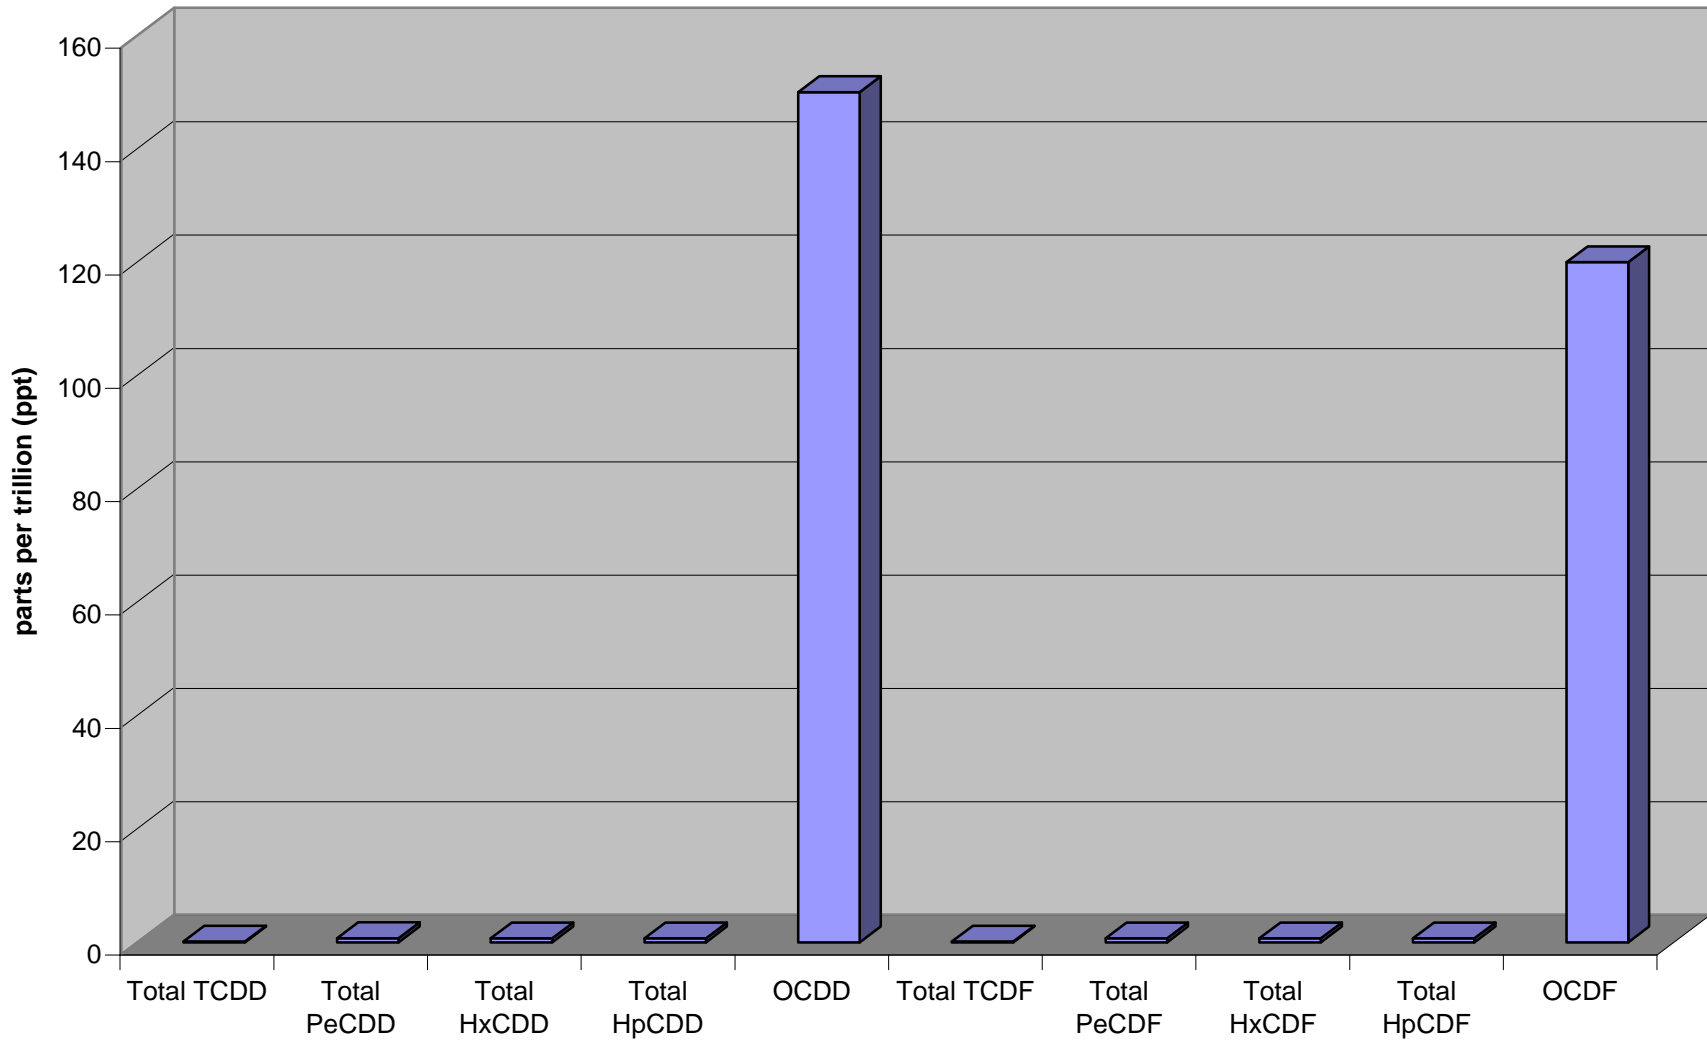
Figure 4.34
Distribution of Dioxins and Furans in Unimpacted Sediment Sampl SED1201
Supplemental Site Investigation Report
333 Adelaide Avenue
Providence, RI

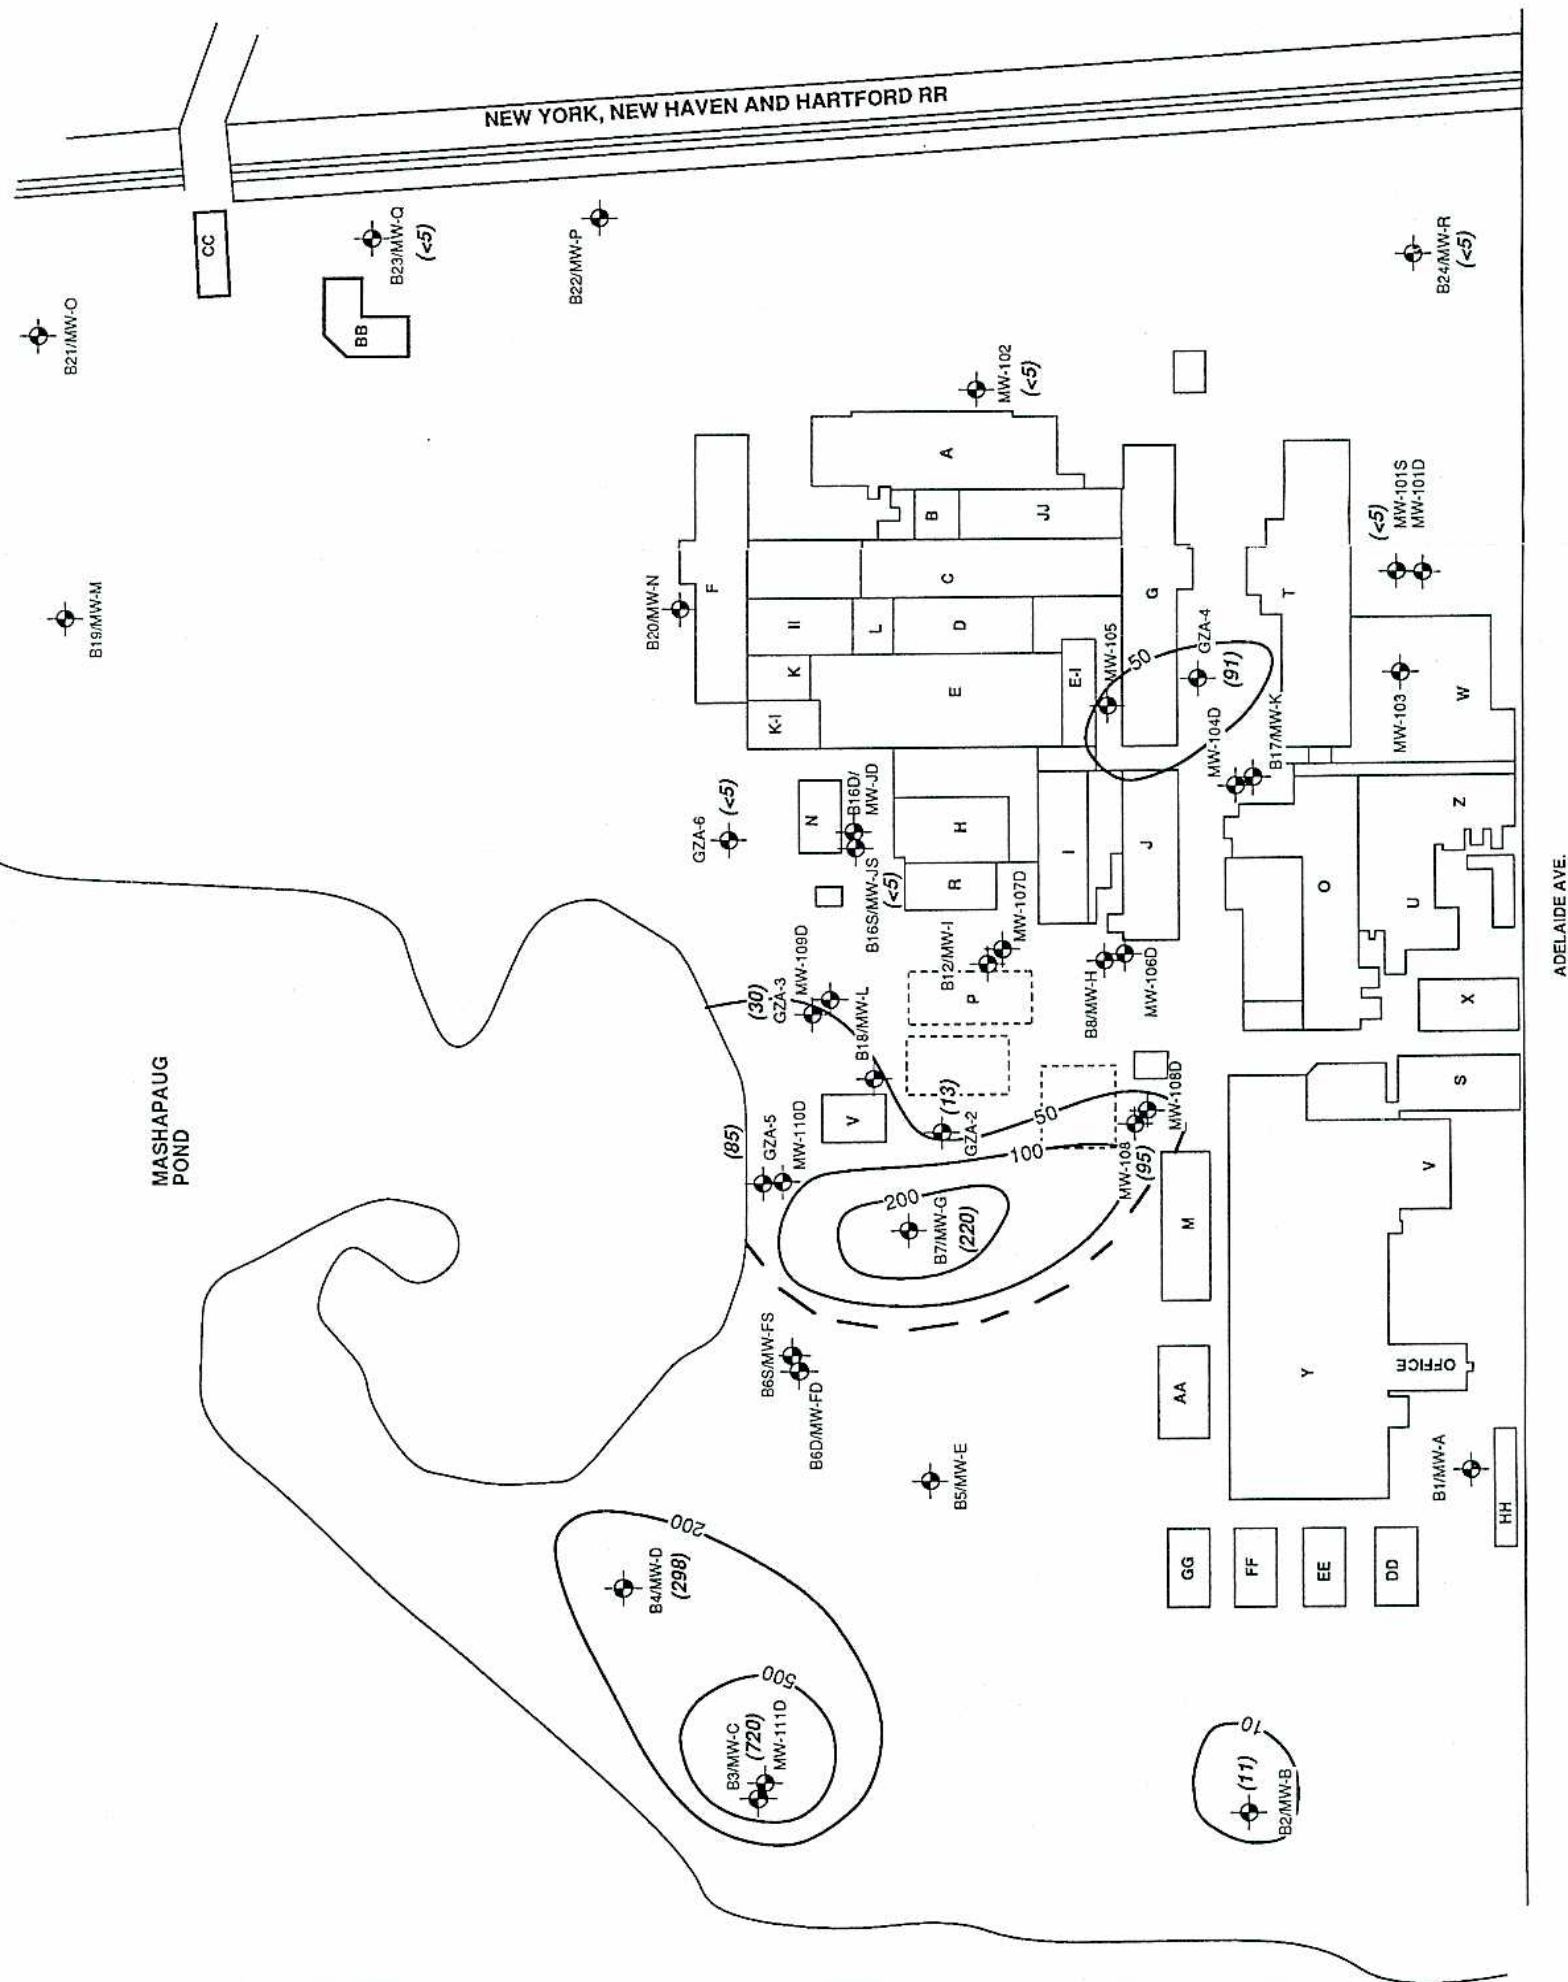
Figure 4.38
TCE Concentrations in Shallow Aquifer
(from 1995 RI Report)
