## Appendix C

As-built Drawings Parcels C and C-1 Response Actions

**FIGURE 1**  
**PARCEL C**  
**AS-BUILT PLAN**  
 TEXTRON FORMER GORHAM SITE  
 PROVIDENCE, RHODE ISLAND  
 FEBRUARY 1, 2016

**Draft**  
**Parcel C Annual Cap Inspection**  
**333 Adelaide Avenue**  
**Providence, RI**  
**RIDEM Case No. 97-030**

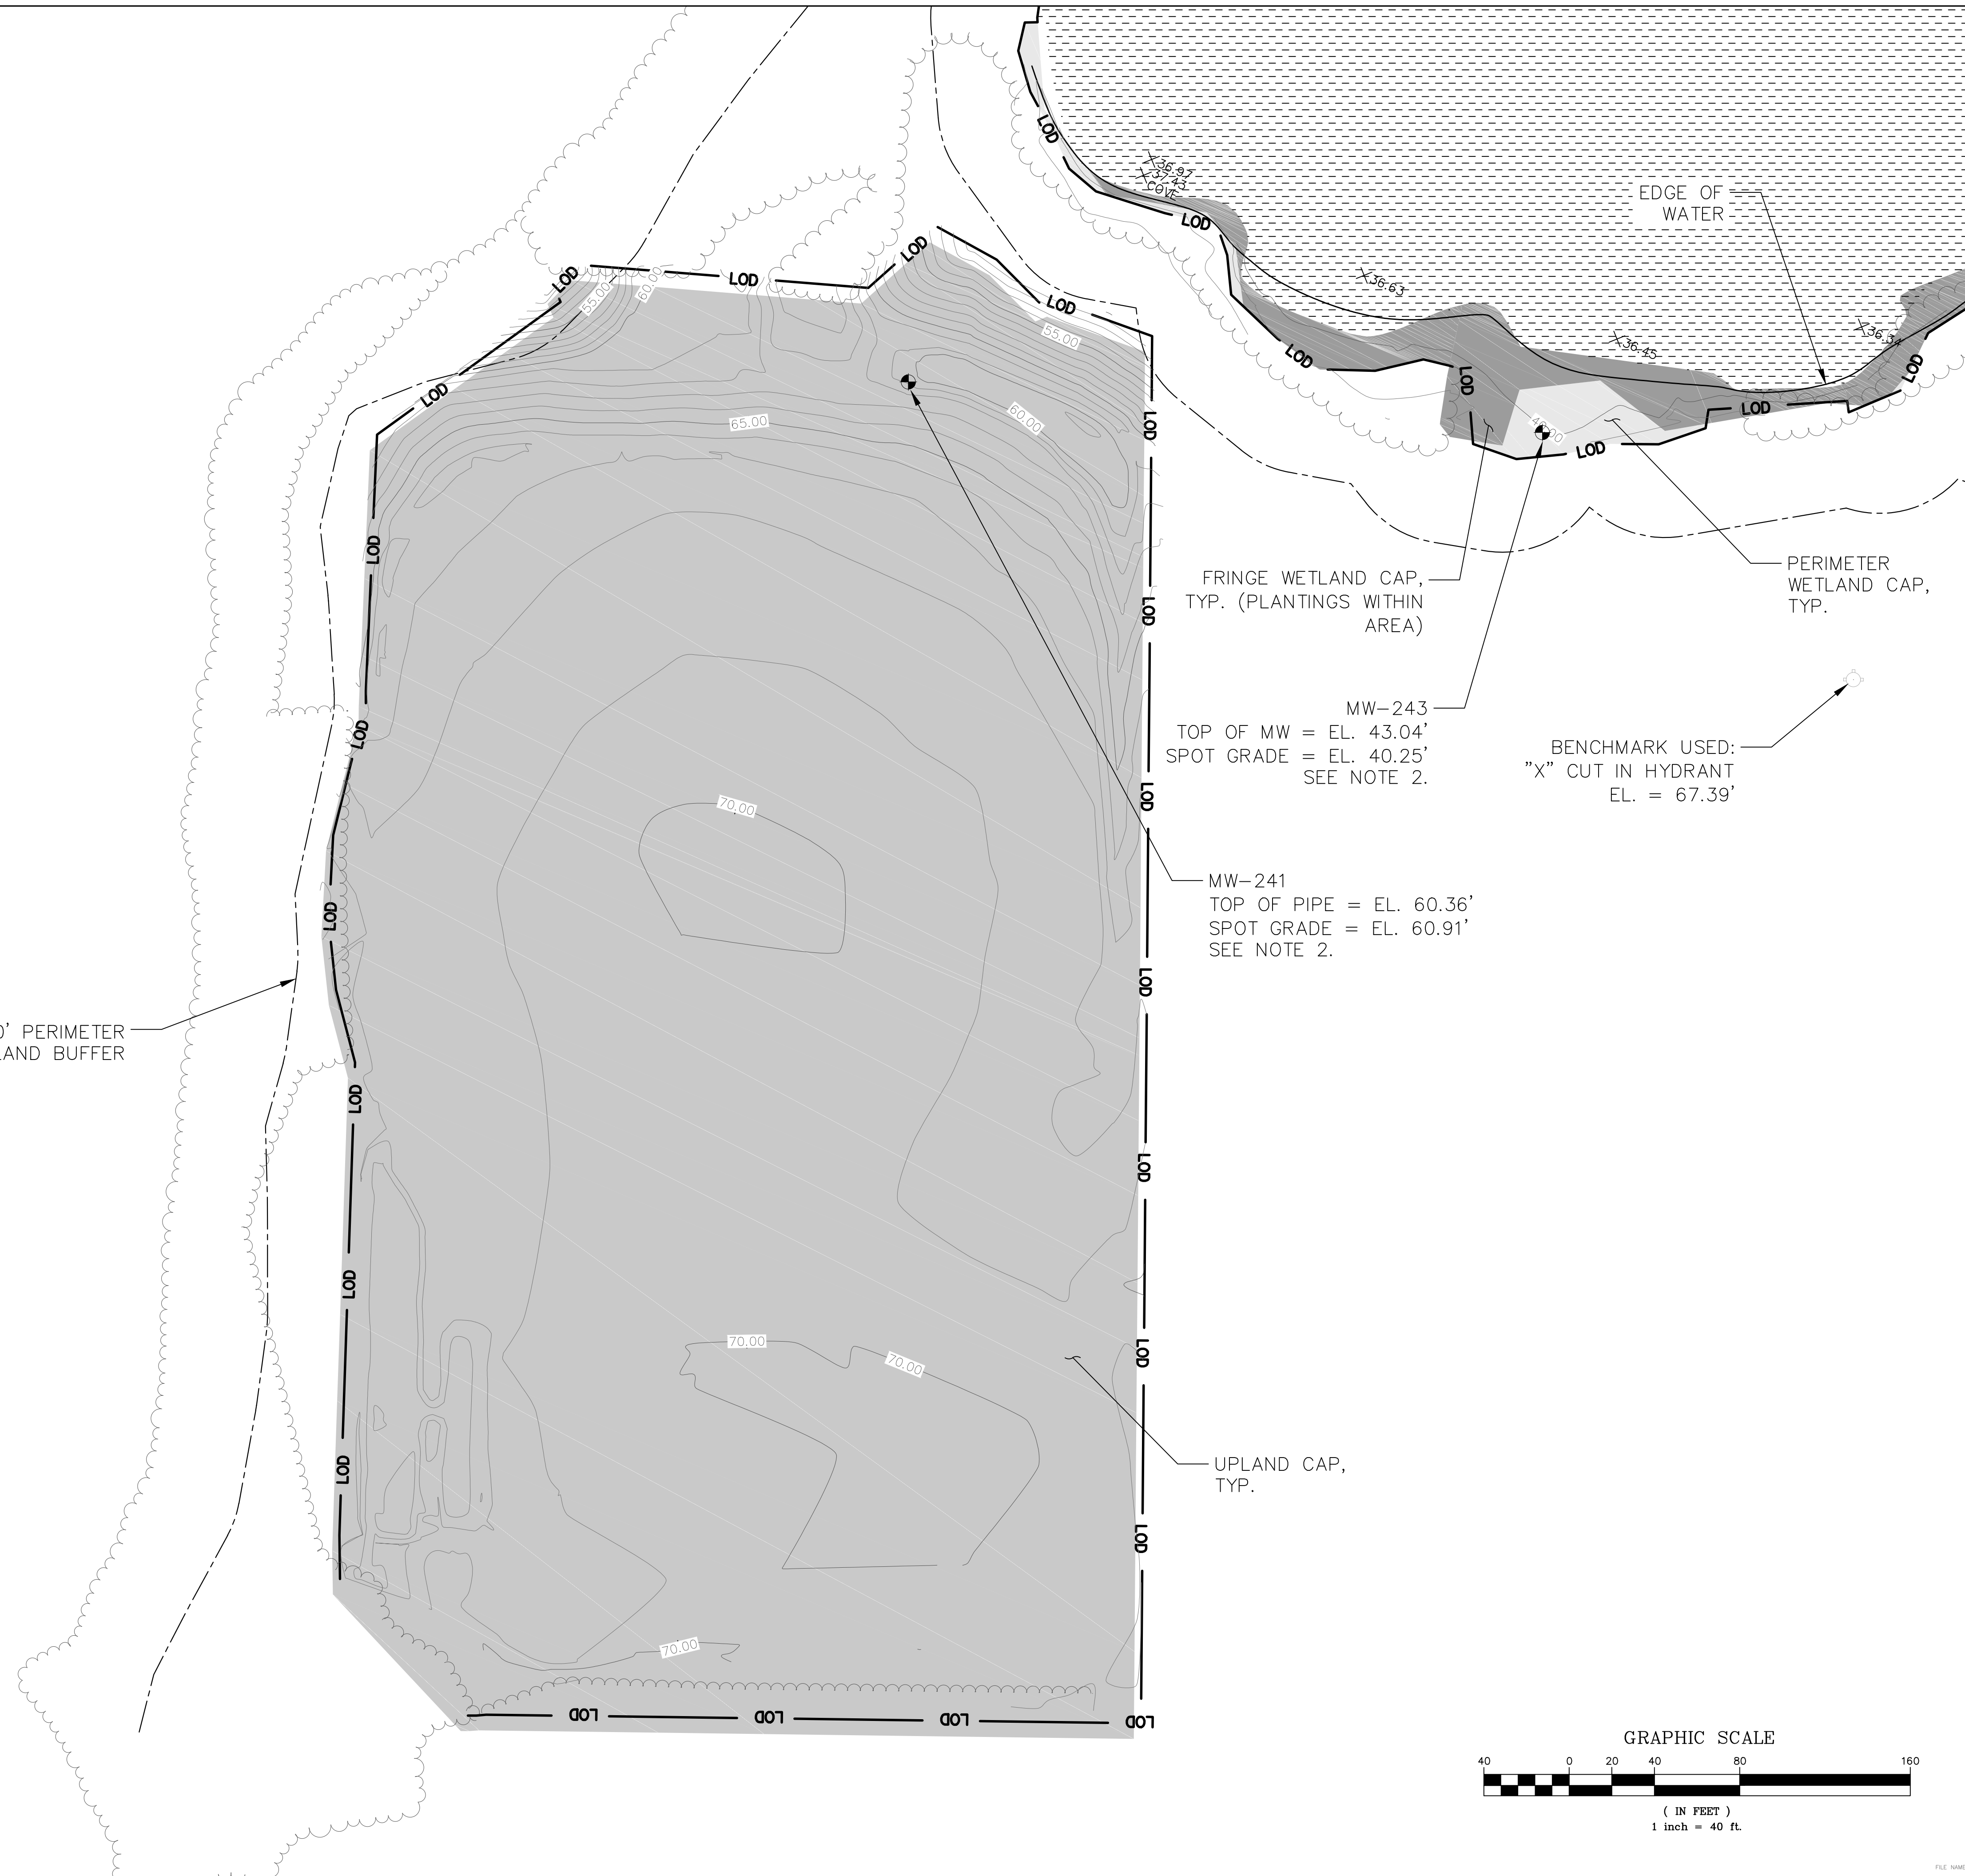
MW-243  
TOP OF MW = EL. 43.04'  
SPOT GRADE = EL. 40.25'  
SEE NOTE 2.

MW-241  
TOP OF PIPE = EL. 60.36'  
SPOT GRADE = EL. 60.91'  
SEE NOTE 2.

UPLAND CAP,  
TYP.
