Subject: **Underground Storage Tank Closure Report**
Gould Island – Fire Station (FUDS No. D01RI033800; NED Site No. 12)
Narragansett Bay, Jamestown, Rhode Island, 02835

Underground Storage Tank Closure Report

**Gould Island – Fire Station (FUDS No. D01RI033800; NED Site No. 12)
Narragansett Bay
Jamestown, Rhode Island**

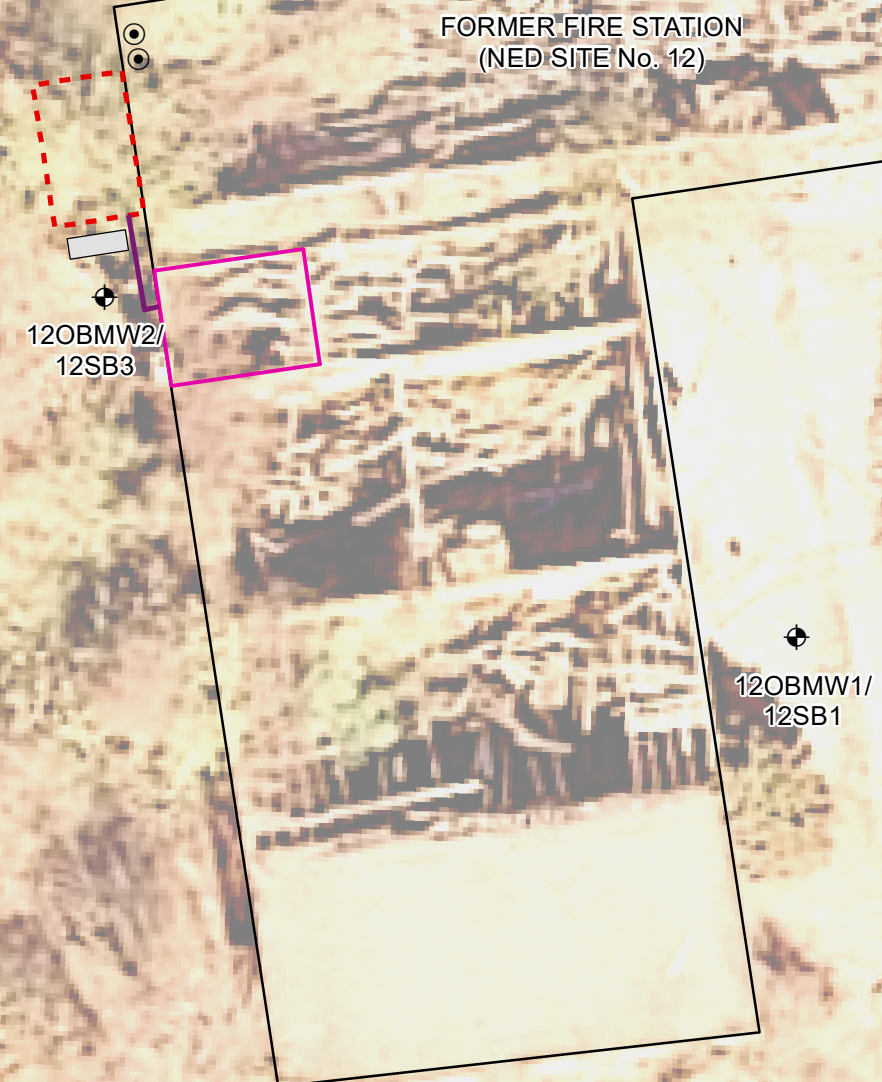
FIGURE 2
UST CLOSURE ASSESSMENT PLAN

Figure 1 shows the location of the Site in Jamestown, Rhode Island. **Figure 2** is a detailed Site map depicting the location of the UST, piping, and other pertinent features of the Site, as well as soil sampling locations in the excavation area.

Crede collected seven soil screening samples on February 21, 2019 from the preliminary tank excavation at piping joints/elbows and the stockpiled soil. Crede conducted an additional 11 soil screening samples from the tank grave on March 13, 2019. At each screening point, soil was screened for total volatile organic compounds (VOCs) with a PID. PID field screening results were no higher than 0.322 ppm_v, which is below the GA/GAA groundwater threshold of 20 ppm outlined in the RIDEM UST Guidelines for release reporting and to separate contaminated soil for offsite disposal from soil that may be reused onsite as tank grave backfill. Soil screening locations and results from March 13, 2019, are depicted on **Figure 2**.

FIELD SCREENING RESULTS		
LOCATION	SOIL SAMPLE ID	PID FIELD SCREENING RESULT (PPMv)
BASE	1	0.205
	2	0.192
	3	0.064
WEST SIDEWALL	4	0.246
SOUTH SIDEWALL	5	0.322
	6	0.165
EAST SIDEWALL	7	0.170
	8	0.032
NORTH SIDEWALL	9	0.116
	10	0.128
	11	0.288

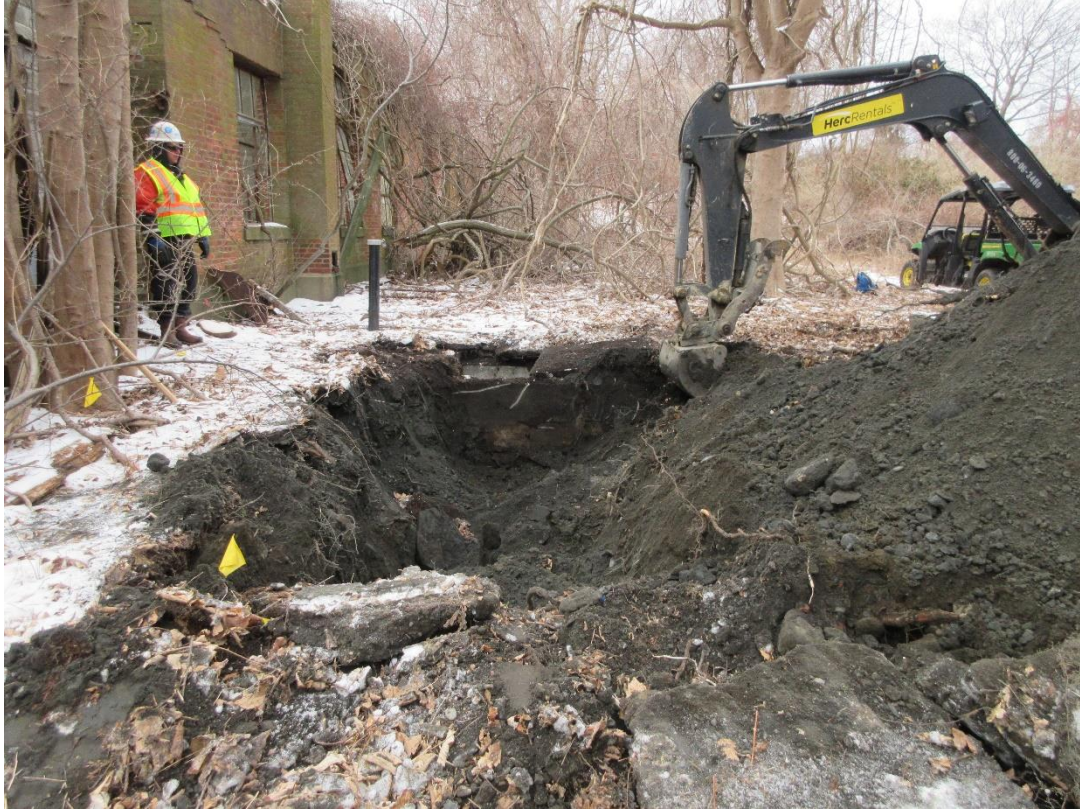
One 1,500-gallon UST was uncovered, but not removed, on February 20, 2019 (**Photographs 1 and 2**). The following day, NRC gauged the tank and observed the product contained within the tank. To access the tank product, the single pipe extending from the top of the tank was broken off. Interior conditions of the tank were monitored using a multi-gas detector and conditions were determined to be non-explosive. The product was observed to be mostly water (90%) mixed with minimal residual petroleum product (10%). In addition, Credere screened the accessible north sidewall of the excavation, the soil located adjacent to the piping on the top of the tank, and the stockpiled soil removed from above the tank. The soil was screened using a Rae Systems ppbRAE 3000 photoionization detector (PID) calibrated to a 10 part per million by volume (ppm_v) isobutylene standard and an instrument response factor of 1.0. Screening detections ranged from 0.201 ppm_v to 0.315 ppm_v. No evidence of contamination was observed (i.e., visual staining, olfactory indications, elevated PID detections) in the stockpiled soil or the open excavation; therefore, no cover was placed on the stockpiled soil or excavation during the interim prior to tank removal and subsequent backfill.

1. View of UST being uncovered by NRC on February 20, 2019.

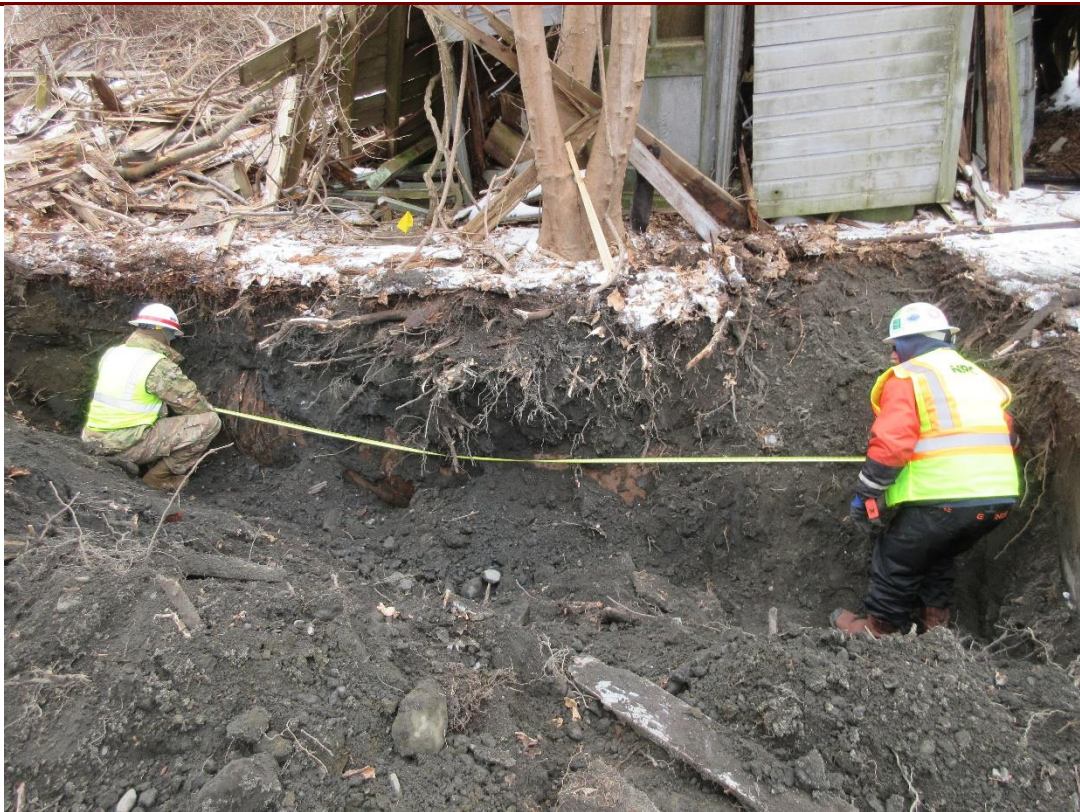
2. View of uncovered north side of the UST on February 20, 2019.

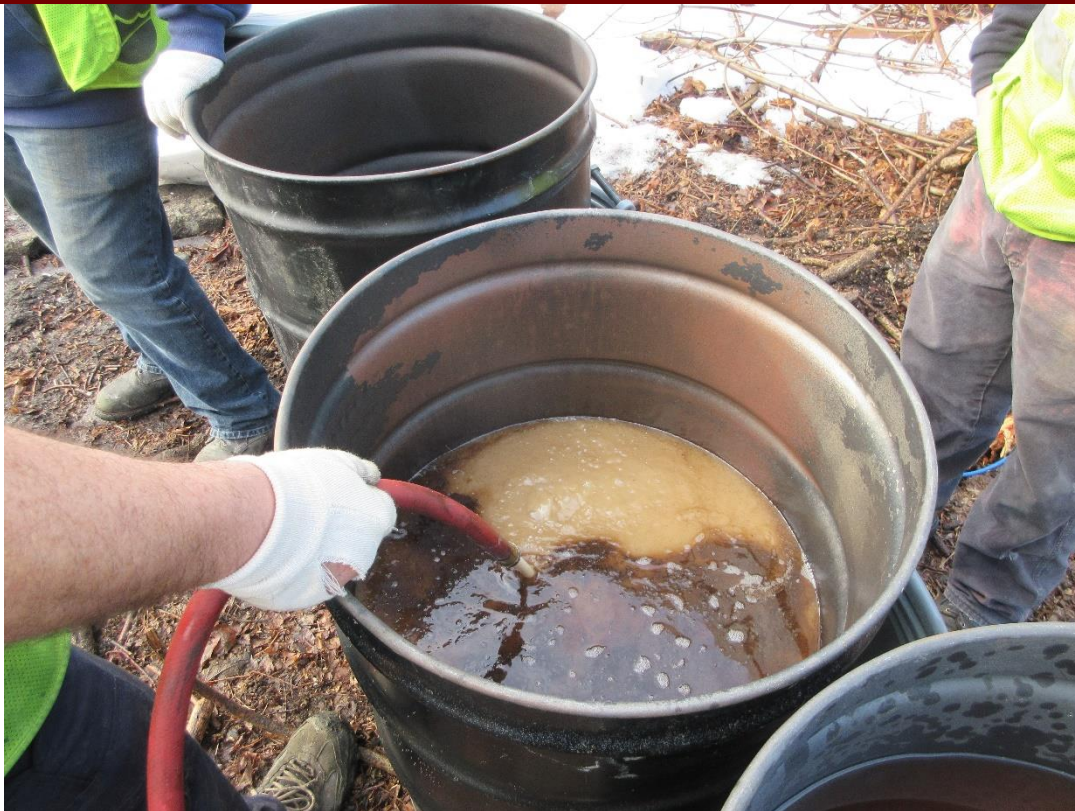
On March 11, 2019, a total of approximately 250 gallons of product was removed from the tank (**Photograph 3**) to DOT-approved steel drums. The product was confirmed to be mostly water mixed with residual petroleum product. Once the tank interior conditions were monitored using a multi-gas detector and confirmed to be non-explosive, the tank was cut and interior conditions were again confirmed to remain non-explosive prior to further cleaning the same day using a pressure washer (**Photograph 4**). Waste from the tank was disposed of at ENPRO of Maine in South Portland, Maine. A copy of the manifest is included as **Appendix C**.

3. View of tank contents being pumped from the tank on March 11, 2019.

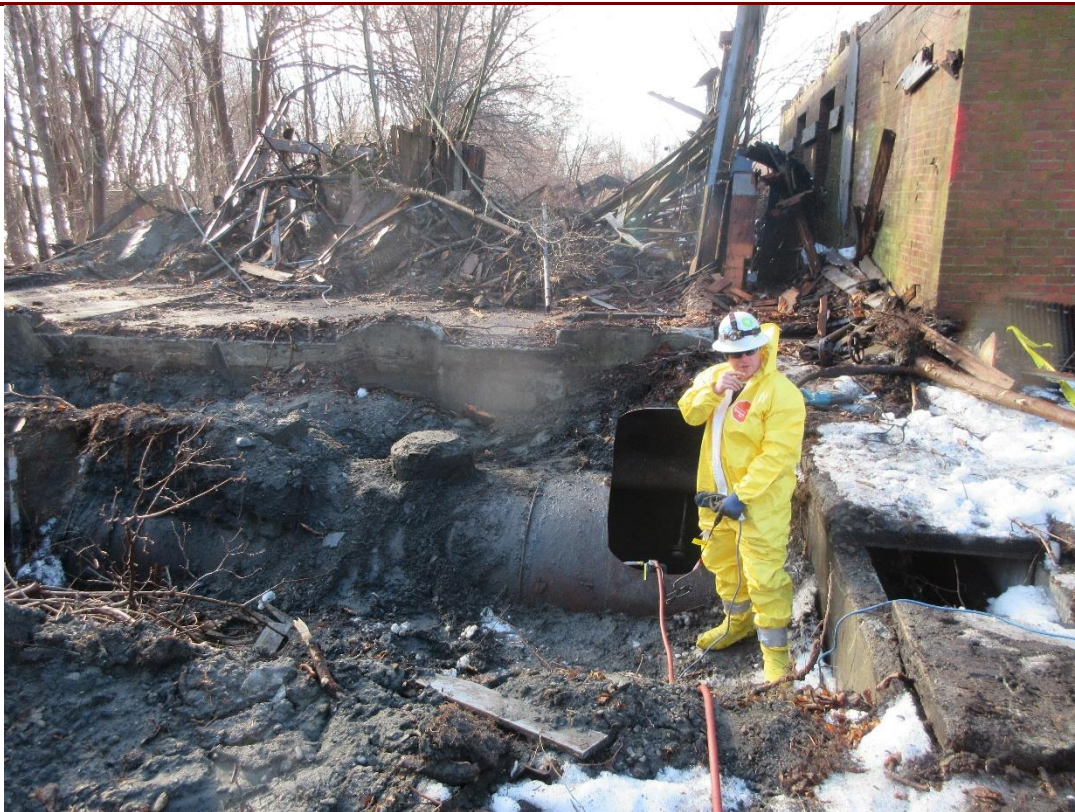
4. View of NRC personnel prepping to clean the tank on March 11, 2019.

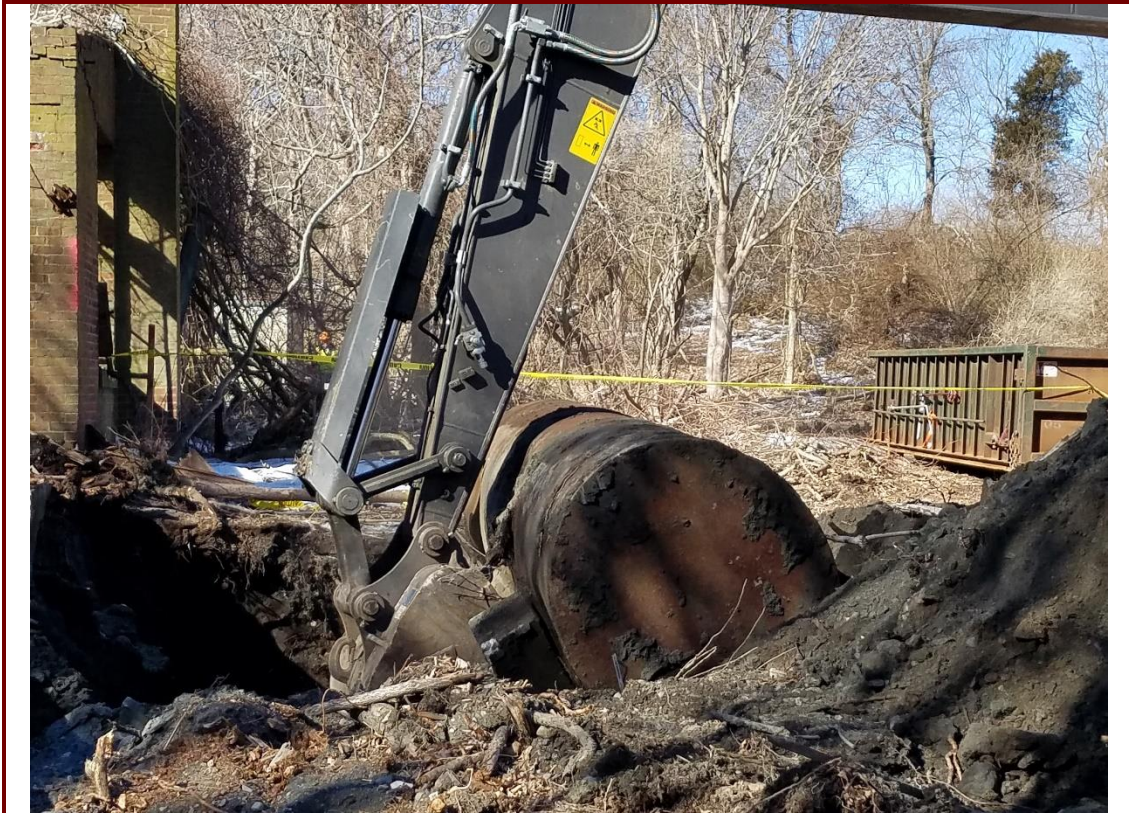
On March 13, 2019, the tank was unearthed and removed from the excavation by EV (**Photograph 5**). No petroleum saturated soil or evidence of a petroleum release from the tank was observed in the excavation (**Photograph 6**). Upon removal, the tank was determined to be a single-walled steel tank, and no evidence of holes or pitting was observed (**Photograph 7**). The

5. View of EnviroVantage unearthing tank on March 13, 2019.

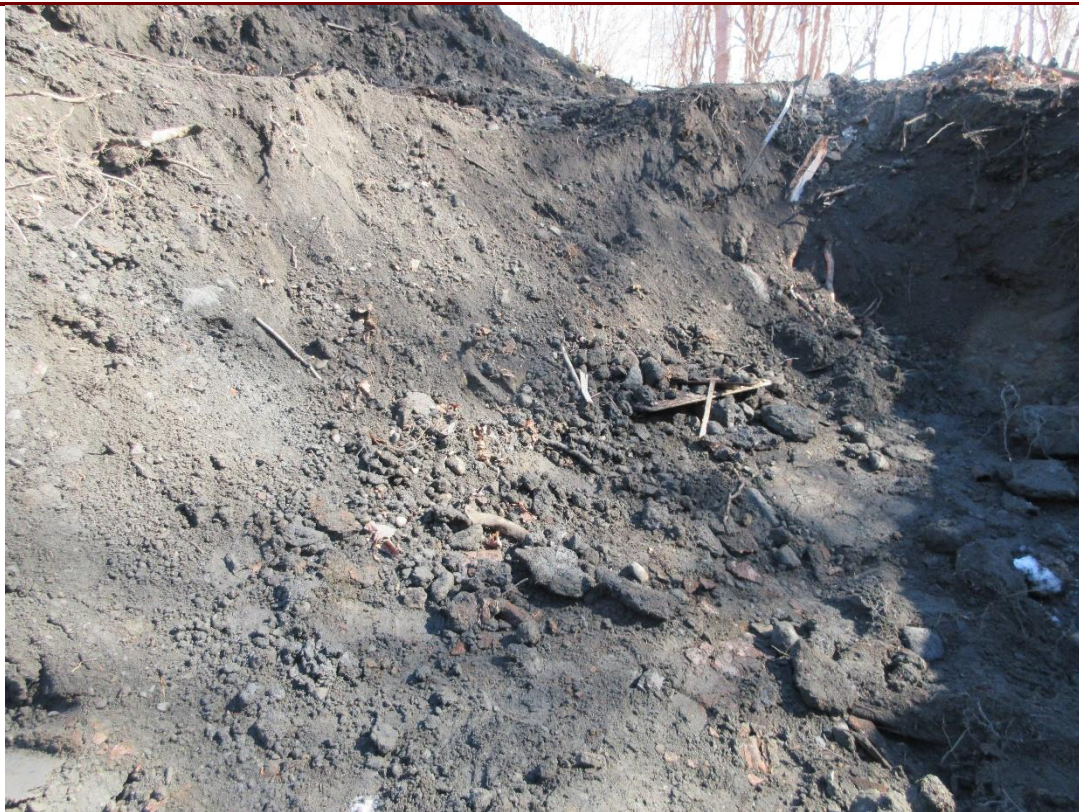
6. View of tank grave with no evidence of a petroleum release on March 13, 2019.

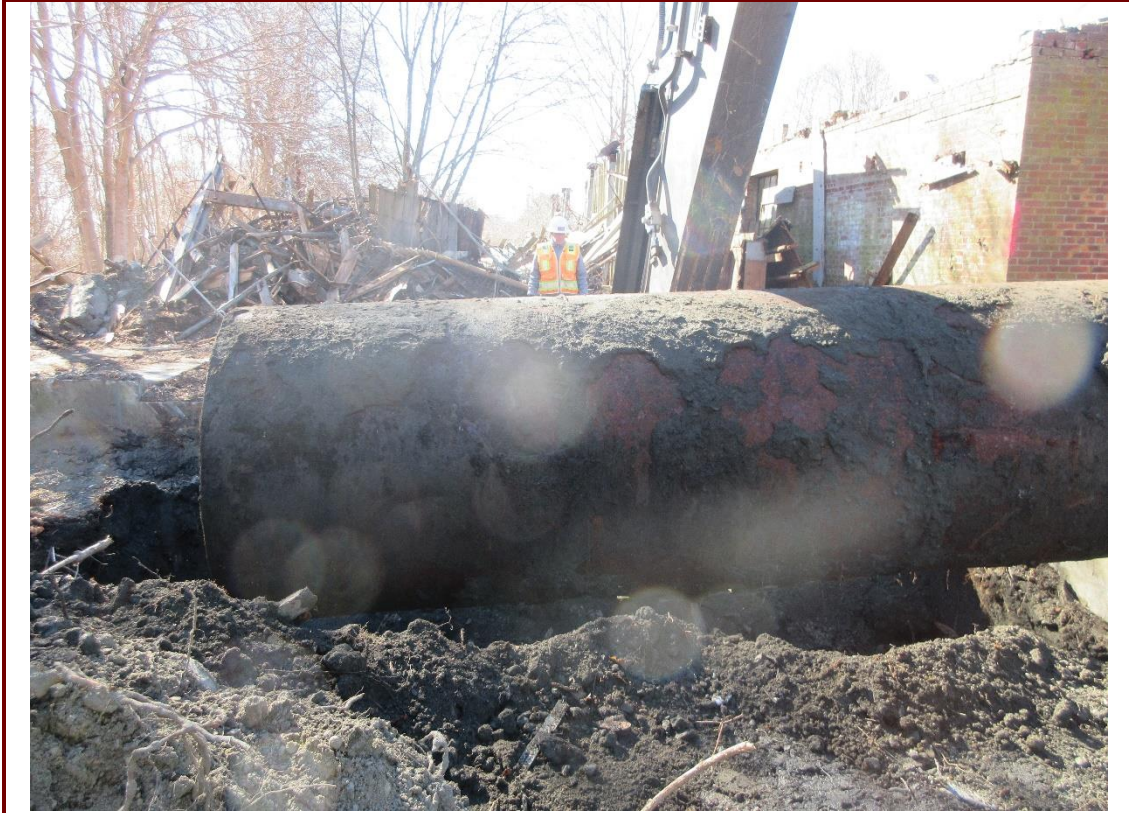
- The 1,500-gallon UST was in good condition upon removal with no holes or other damage observed. No evidence of a release of petroleum to the environment was observed from the UST or associated piping.

7. View of bottom of tank with no evidence of corrosion or holes.

Based on the observed conditions and sample results and need for further investigation in the vicinity, it is Credere's opinion that no further action is warranted with regard to the UST removed from the Site. Credere has no recommendations for additional assessment or cleanup specific to this UST at this time.
