# Memo

**RE:** Gas Holder Demolition – Ruptured Vactor Hose  
Former Gas Holder Dismantling  
Former Tidewater Facility  
Pawtucket, Rhode Island  
RIDEM Case No. 95-022

**FORMER GAS HOLDER DISMANTLING**  
Former Tidewater Facility, Pawtucket, Rhode Island

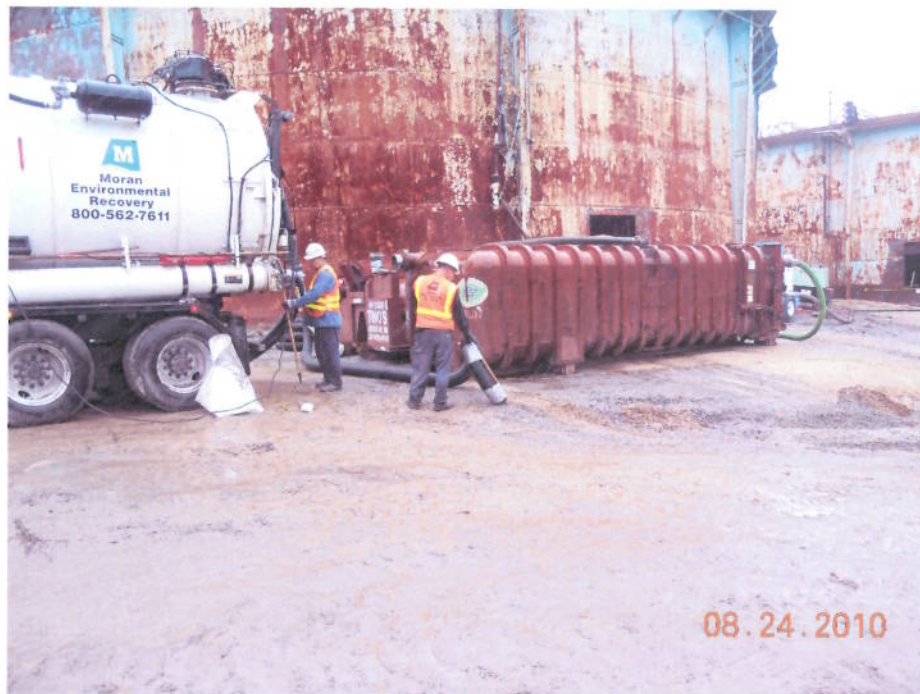
PHOTOGRAPH NO. 1 - Removal of visually impacted processed gravel with vector truck.

- Sludge and visually impacted materials (processed gravel work platform and access road) were immediately removed by TFord with a backhoe and by Moran with a vactor truck and containerized in a lined roll-off container (approx. 2 to 3 cubic yards). The lateral extent of visually impacted materials is shown on the attached Figure 1. The depth of visually impacted materials was limited to approximately 2- inches (i.e, to a depth above the geotextile layer).
