# Canonchet Brook

## Watershed Description

## Assessment Unit Facts *(RI0008040R-04B)*

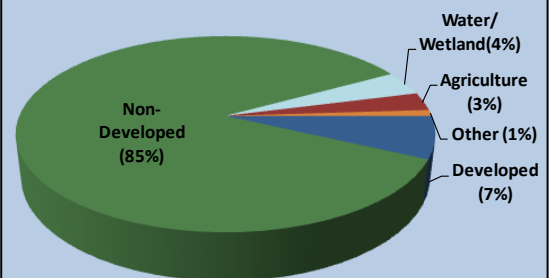
**Watershed Land Uses**

The Canonchet Brook watershed covers 7.7 square miles. Non-developed areas, including the Black Farm Wildlife Management Area, occupy a large portion (85%) of the watershed. Developed uses (including residential and commercial uses) cover approximately 7%. Wetland and other surface waters occupy 4% and agricultural land uses occupy 3% of the watershed. Other land uses combine to cover the remaining 1%.

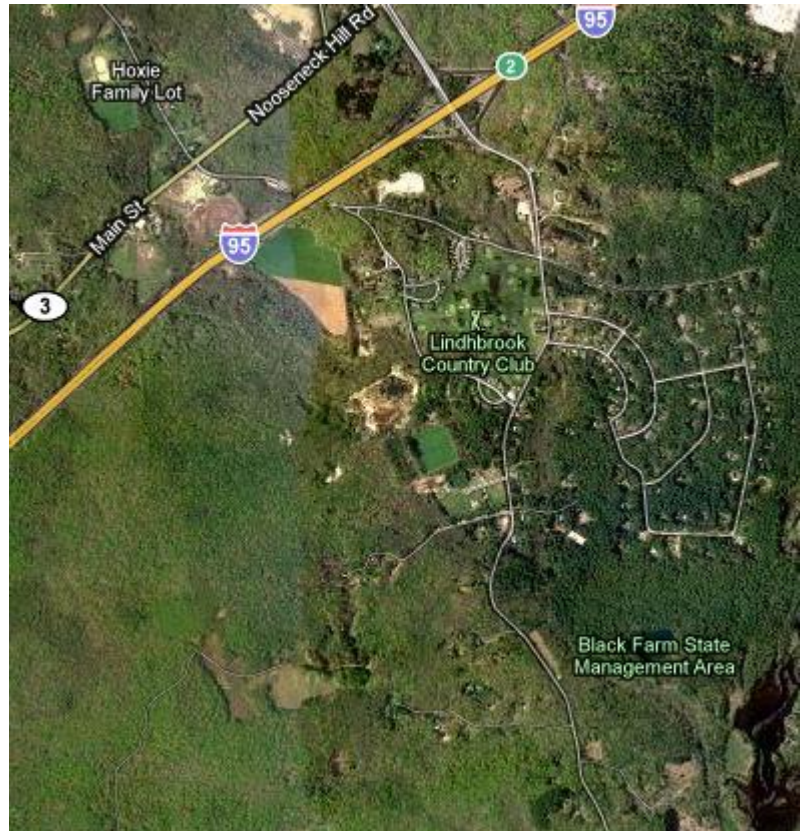
**Figure 3: Partial aerial view of the Canonchet Brook watershed. (Source: Google Maps)**
