Rhode Island Department of Environmental Management

Office of Water Resources – Shellfish Program

2017 Shellfish Program Classification Report

Upper Narragansett Bay 2017 Annual Update

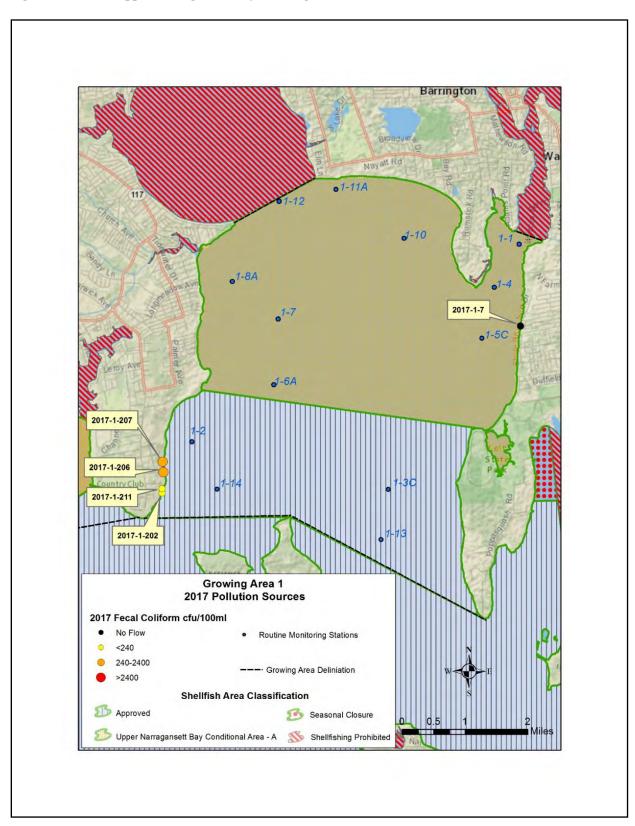
Figure 1-1 2017 Upper Narragansett Bay Growing Area 1 Pollution Sources

The 2017 annual shoreline survey occurred on 8/31/2017 with four (4) sources (1-7, 1-202, 1-206, and 1-207) revisited and sampled (if there was flow present) that had previously elevated bacteria levels. One (1) (2017-1-007) of the four (4) sources did not have flow. Three (3) of the original four (4) sources had flow and were sampled at the time of the survey. In addition, one (1) new source 1-211, was actively flowing and sampled at the time of the shoreline survey. The four sources that were sampled had bacteria counts below 2,400 cfu/100ml, which does not warrant follow-up sampling.

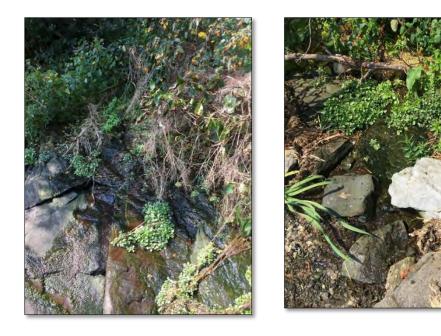
Figure 1-3 Source 2017-1-207

Source ID	Date Visited	Description	Act/Pot Dir/Ind		2009 Results MPN FC/100ml	2017 Results mTEC cfu/100ml	2017 Volumetric Flow (cfs)	
1-207	8/31/2017	GW STREAM	А	D	4300	450	trickle

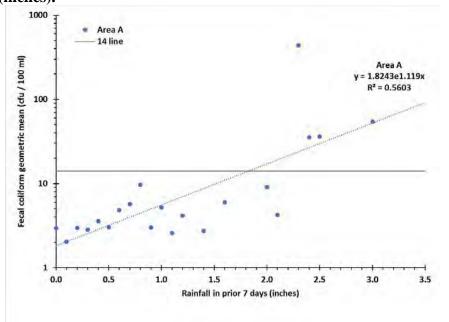
A regression analysis was completed to quantify fecal coliform concentration response to rainfall in Area A. Rainfall within the 7 days prior to sample collection was grouped into 0.1" bins and the geometric mean fecal coliform response was calculated from all samples in that bin (Figure 1-11). Data are from January 2010 (Phase 1 start) through December 2017. On average, Area A is predicted to cross the 14 cfu/100 ml fecal coliform threshold at a rainfall of ~1.8". The mean rain-fecal response curve (Figure, below) indicate that the current 'Conditionally Approved' classification of Area A with a rainfall closure of 1.2" is protective of public health.

Fecal coliform in Upper Narragansett Bay "Area A" in relation to rain fall amounts (inches).

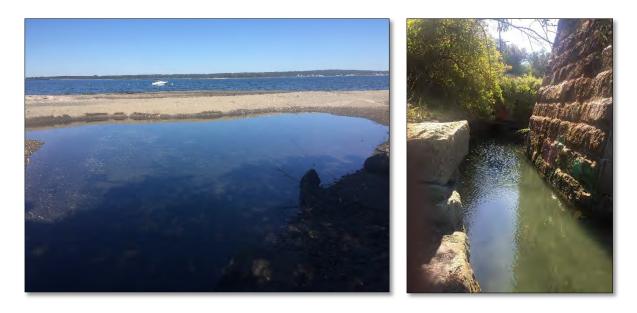
Figure 1-4 Source 2017-3-201

Source 3-201 is a stream that drains from the Lawton Valley Reservoir into Prohibited shellfishing waters. However, during the 2017 sampling the stream flowed into a pond on the beach approximately 50 feet from the shoreline. The source is not discharging into the receiving waters; thus, it is not directly impacting the shellfish growing area.

Source ID	Date visited	Description	Act/Pot	Dir/Ind	2010 Results MPN FC/100ml	2016 Results mTEC cfu/100ml	2017 Results mTEC cfu/100ml	2017 Volumetric Flow (cfs)
2017- 3-201	10/2/2017	Stream at R/R trestle Burma (Defense Drive) Road. In 2017, stream was not flowing into receiving waters. Ended ~50' from shore in a "pond" on beach. Possibly seeping underneath sand.	A	D	4600	0	1000	0

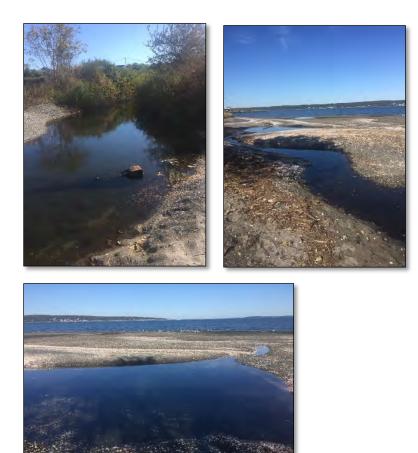
Figure 1-5 Source 2017-3-209

Source 3-209 is a stream that drains the upland Melville Pond next to the New England Boat Works in Portsmouth. During the 2017 survey the stream ended approximately 50 feet from the shoreline in a basin on the beach. The source is not discharging into the receiving waters; thus, it is not directly impacting the growing area.

Source ID	Date visited	Description	Act/Pot	Dir/Ind	2010 Results MPN FC/100ml	2016 Results mTEC cfu/100ml	2017 Results mTEC cfu/100ml	2017 Volumetric Flow (cfs)
2017- 3-209	10/2/2017	Stream at R/R trestle Burma (Defense Drive) Road. In 2017, stream was not flowing into receiving waters. Ended ~50' from shore in a "pond" on beach. Possibly seeping underneath sand.	A	D		0	800	1.214

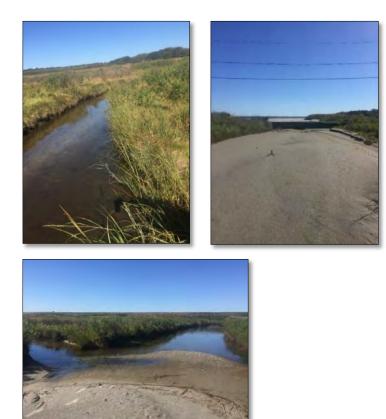
Figure 1-2 Source 2017-4-540

flow rate of 8.5 cfs and a FC of 91 cfu/100ml. Instream samples were collected 50 feet north and south of the outlet with FC of 2 cfu/100ml and 24 cfu/100ml respectively. During an additional follow-up in 2018 the source was not reaching the receiving waters or high tide line, thus this source is intermittent and not impacting the growing area.

Source ID	Date Visited	Description	2013 Results mTEC cfu/100ml	2017 Results mTEC cfu/100ml	2017 Volumetric Flow (cfs)
2017-4- 540	10/2/2017 1 st Follow-up: 11/2/2017 2 nd Follow-up: 5/8/2018	Stream from uplands wetland. Not flowing through culvert. Culvert filled with sand. Stream diverges away through bird sanctuary and empties into wetland/pond near 3rd Beach boat ramp.	0	10/12/17 – 5500 11/2/17 – 1090 5/8/2018 – 91 (IS-S = 24, IS-N = 2)	2.55 1 st Follow-up: 15.69 2 nd Follow- up: 8.5

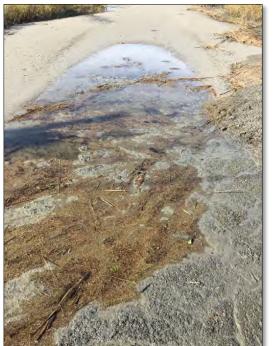
Figure 1-3 Source 2017-4-540E

Source 4-540E is located on the east side of source 4-540. During the 2017 survey the water was stagnant within the culvert with a slight cloudiness. This source is pooling onto the beach and not draining into the Sakonnet River, thus it is not impacting the growing area. A follow-up should be performed during the 2018 annual shoreline survey.

Source ID	Date Visited	Description		2017 Results mTEC cfu/100ml	2017 Volumetric Flow (cfs)
2017-4- 540E	11/2/2017	Stagnant water in culvert after rainfall. East side of culvert. Water cloudy.	NA	1640	Stagnant

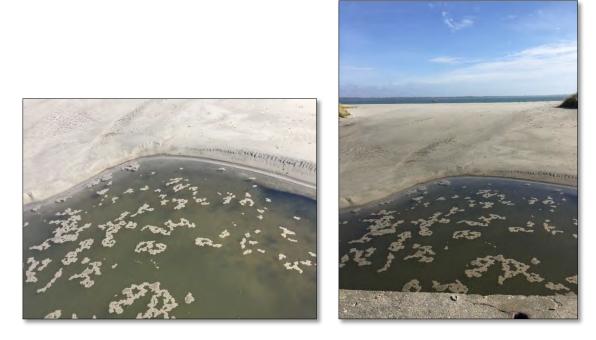
Figure 1-4 Source 2017-4-540W

Source 4-540W is located on the west side of source 4-540W. During the 2017 survey the water was stagnant within the culvert with debris and floating grey sediment. The bacteria count was elevated at 3300 cfu/100ml, which requires a follow-up during the 2018 annual shoreline survey. Because the water is not discharging into the Sakonnet River but rather pooling on the beach it is not impacting the growing area.

Source ID	Date Visited	Description	2013 Results mTEC cfu/100ml	2017 Results mTEC cfu/100ml	2017 Volumetric Flow (cfs)
2017-4- 540W	11/2/2017	Stagnant water in culvert after rainfall. West side of culvert. Full of debris and floating grey sediment.		3300	Stagnant

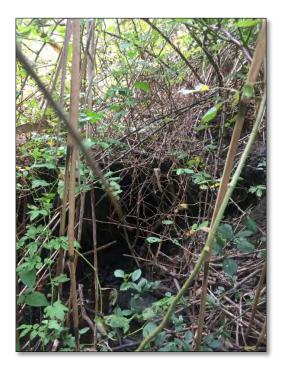
Figure 1-5 Source 2017-4-710

Source 4-710 is White Wine Brook, which drains through a 24-inch CMP into Nanaquaket Pond in Tiverton. The source had an elevated bacteria count at 1100 cfu/100ml but the volumetric flow was a trickle at the CMP, which is located within a dense phragmites stand and must travel over 100 feet before reaching the receiving waters. A follow-up sampling was conducted on 5/8/2018 with a result of 100 cfu/100ml and an instream of 31 cfu/100ml. This source should be followed-up during the 2018 annual review, however, the instream results indicate that the travel distance from the CMP to the receiving waters is sufficient to filter and dilute bacteria levels before reaching open shellfishing waters.

Source ID	Date Visited	Description	2013 Results mTEC cfu/100ml	2014 Results mTEC cfu/100ml	2015 Results mTEC cfu/100ml	2016 Results mTEC cfu/100ml	2017 Results mTEC cfu/100ml	2017 Volume tric Flow (cfs)
2017-4- 710	9/5/2017	White Wine Brook at road crossing 24" diameter	1500	6600	NF	320	9/5/17 -1100 5/8/18 – 100 (IS = 31)	trickle

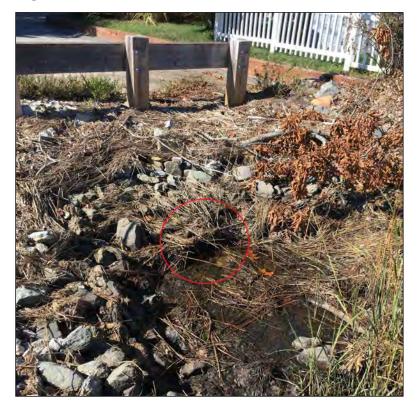
Figure 3-2 Source 2017-5-030

Of the seven sources surveyed, three had no flow at the time of sampling. Four of the sources sampled had low FC results of less than 100 CFU/100ml. The remaining source, 5-030, was initially sampled on 10/17/2017 and had a high FC result of 2900 CFU/100ml, although the flow was only a slight trickle and the area the pipe discharges to was filled with debris. Because of the high bacteriological results, it was resampled on 11/2/2017 and an in-stream sample was taken just downstream of where the source discharges into the receiving waters. The results of the source were <100 and again the source was barely flowing and still surrounded with debris. Despite this, the in-stream sample was higher at 546 CFU/100ml. However, this source is only ~500 feet from routine monitoring station 5/4, which is in compliance (Table 6-1). In addition, the sampling conducted on 11/2/2017 was in wet weather, 3 days after a 2.63" rain event (Tables 3-2 and 3-3). This may explain why the in-stream sample was high, it should be noted however that the entire growing area was closed at the time of sampling due to its conditional classification. Therefore, no reclassification of the growing area is recommended at this time, but this source and the in-stream sample will be resurveyed as part of the 2018 Annual Review and evaluated during dry weather open conditions.

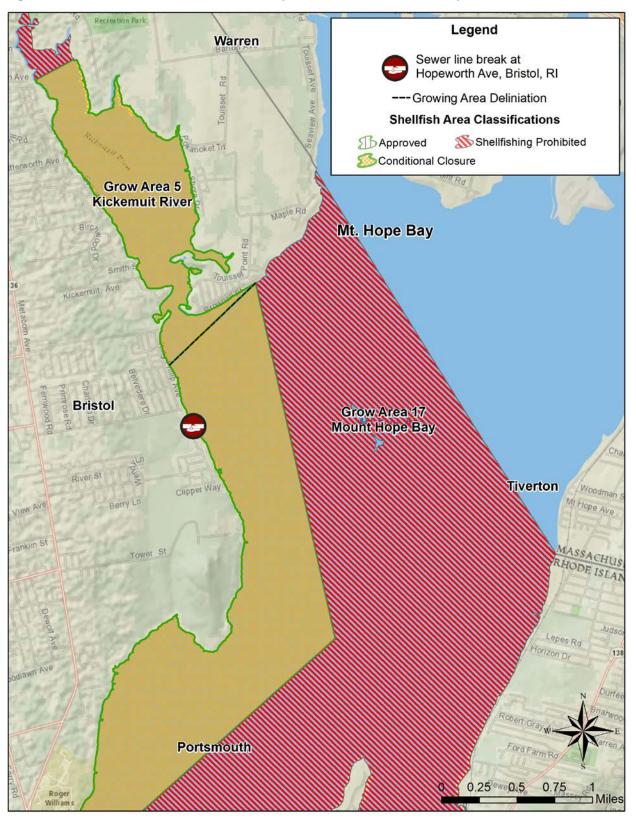
Figure 6-1 Location of Bristol Sanitary Sewer Overflow January 2018

In January 2018, a break in a sewer line caused by work on a water main in the same vicinity resulted in 265,000 gallons of untreated sewage to enter a stream and discharge into the conditionally approved Mt. Hope Bay (GA17) receiving waters just south of the Kickemuit River growing area (Figure 6-1). The discharge occurred from January 5 until January 24 when town officials were made aware of the issue. DEM was notified immediately and the necessary repairs to the sewer line were made on January 25. The Kickemuit River growing area was closed throughout the overflow event due to its seasonal January closure. An extension to the closure was made until February 15 (resulting in a full 21-day closure from the end of the SSO event on January 24). The RI Department of Health verified that no shellfish product from these waters entered the market

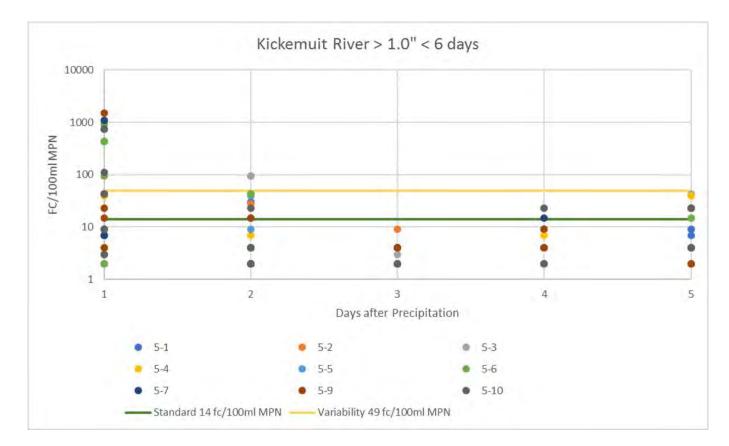
Figure 7-1 Historic Analysis (1985 – 1995)

RIDEM shellfish program began a wet weather sampling strategy for investigating the recovery time for precipitation events greater than 1.0" to ascertain the ability to amend the CAMP closure criteria and eliminate the closed till further notice stipulation for these higher volume precipitation events. In addition to this historic analysis more recent results indicate that the current seven-day closure (3-4 days for recovery and 2 days for cleansing) is still valid. The following graphs represent this analysis.

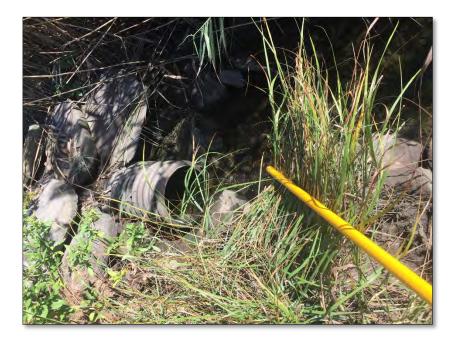
Source ID	Date Visited	Description	Act/Pot	Dir/Ind	2016 Results mTEC cfu/100ml	2017 Results mTEC cfu/100ml	2017 Volumetric Flow (cfs)
-	2017-7-803	10/3/2017	10" CPP from upland wetland	А	D	280	1000	0.0118

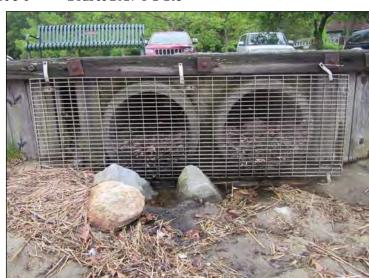
Figure 3-5 Source 2017-8-1-103

The first source, 2017-8-1-103, had FC results at 1040 CFU/100ml, well above the 240 CFU/100ml trigger level. This source is stormwater drainage from the Goddard Park beach parking lot. Upstream inputs to the stormwater come from the parking lot where runoff collects and various wildlife and seagull activity contribute to fecal inputs. It is discharging into conditionally approved waters, however it had an extremely low volumetric flow rate of 0.0000075 ft³/s (just a slow drip at the time of the survey), which amounts to only 0.65 ft³/day. Thus, no reclassification is recommended at this time based on this source, however, it should be resurveyed during the 2020 Triennial evaluation.

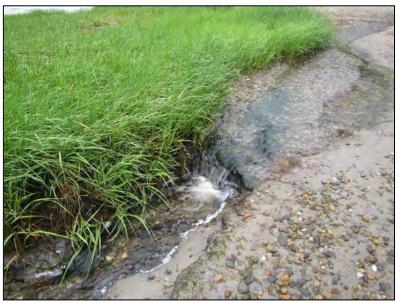
Figure 3-6 Source 2017-8-1-109

The second source, 2017-8-1-109, is a stream that drains an upland marshy area into the receiving waters of Greenwich Bay. It had a relatively high flow rate of 1.25 ft³/s or 108,000 ft³/day, resulting in a FC load of $9.16E^9$ FC/day. However, two in-stream samples were taken just East and West of the outlet of the stream, and both had low FC results (2 and 24 CFU/100ml respectively). Thus, it does not seem that this stream significantly impacts the receiving waters. This source will also be resurveyed in 2020.

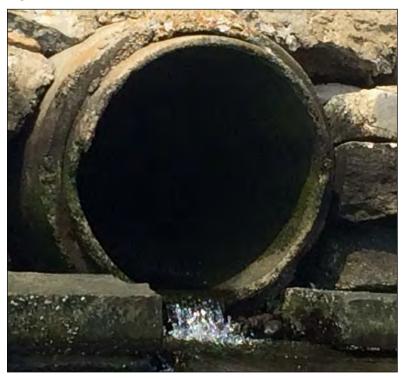
Figure 3-9 Source 2017-8-2-205

There were four samples within Greenwich Cove with FC levels above 240 CFU/100ml, however all had very low flow rates at the time of sampling. Source 2017-8-2-213 was originally surveyed on 7/19/2017 and had a result of >1600 CFU/100ml. It was resampled on 12/12/2017 and had a lower result of 1200 CFU/100ml and was still only flowing at a trickle. One source (2017-8-2-208) was tested for Male-Specific Bacteriophage with a result of 1200 PFU/100ml, suggesting anthropogenic sources of bacteria being discharged from this pipe. RIPDES staff have been made aware of this source and will notify East Greenwich town officials for follow-up to ensure compliance with their MS4 Municipal Stormwater permit. Because this area is already classified as Prohibited to shellfishing due to the high volume of marinas and mooring fields as well as the closed safety zone for the East Greenwich WWTF, no reclassification is recommended based on the shoreline pollution sources analyzed during this survey. Follow-up sampling will be completed during the 2020 Triennial Evaluation. Photos of these sources are provided on the following page.

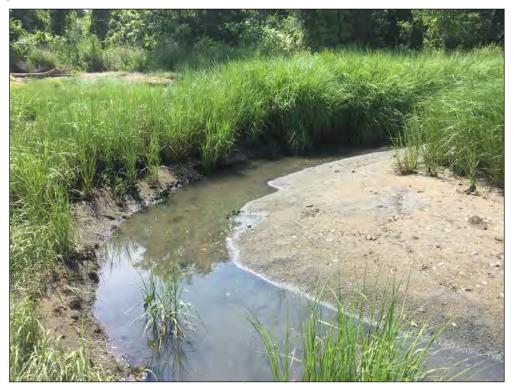
Figure 3-14 Source 2017-8-3-305

There were two sources in the Chepiwanoxet survey area in which bacteriological results exceeded 240 CFU/100ml (Figures 3-14 and 3-15). 2017-8-3-305 is a stream from a marshy area and had FC results of 340 CFU/100ml with a volumetric flow rate of 1.2 ft³/s. However, two instream samples were taken just East and West of the end of the stream and both results were fairly low (25 and 22 CFU/100ml respectively). Thus, it does not appear that this stream is impacting the bacteriological levels of the receiving waters. Source 2017-8-3-311 had FC results of 400 CFU/100ml, also above the 240 CFU/100ml threshold. However, the pipe had lots of sediment in it and the flow was so slight that it was not able to be measured. Therefore, it does not seem that this source would be a significant contributor to bacterial pollution to Greenwich Bay. However, both sources should be resurveyed during the 2020 Triennial Evaluation.

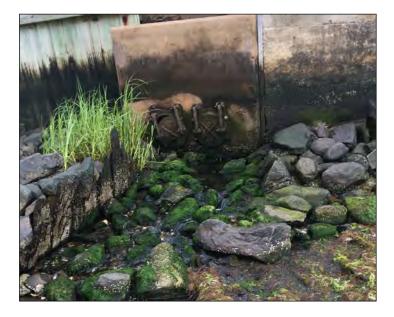
Figure 3-17 Source 8-5-504

There were five sources in the Buttonwoods area that exceeded the 240CFU/100ml criteria (Figure 3-17, Table 3-7). The first is a concrete canal draining a wetland area, source 2017-8-5-504. With a flow rate of 0.094 ft3/s and a FC level of 1120 CFU/100ml, a dilution volume of 6.53E5 ft3 or a radius of 455 feet from shore is required to provide proper dilution, which is more than adequately provided by the current prohibited area surrounding the source.

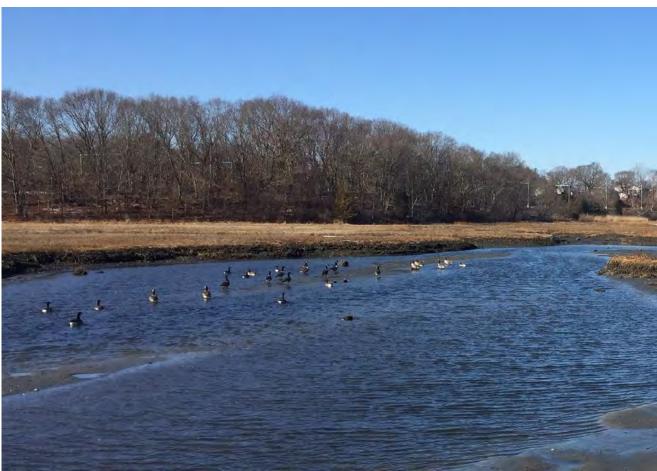
Figure 3-22 Water Fowl in Mary's Creek in January 2018

Wildlife inputs of bacteria may be a significant source within the Greenwich Bay area. It is common knowledge that numerous waterfowl use the bay as a resting area, especially during the winter months. This was noted on several occasions during the shoreline survey and routine monitoring runs. Figure 3-28 is an example of winter ducks and geese in Mary's Creek, which discharges to Apponaug Cove.

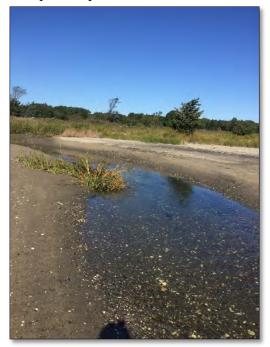
Figure 1-2 Source 2017-9-011

Source 9-011 is a Tibbets Creek, which runs through the Quidnessett Country Club before discharging into West Middle Bay in North Kingstown. Fecal coliform was slightly elevated at this source at 909 cfu/100ml and a flow of 17.44 cfs. However, the sources in-stream results were much lower (9-011N = 300 cfu/100ml and 9-011S < 100 cfu/100ml) due to the travel time across a sandy beach where the water percolates through the sand before reaching the bay. Thus, this source is determined to not be causing adverse impacts to the surrounding shellfishing waters. It will be re-sampled as part of the 2018 annual review.

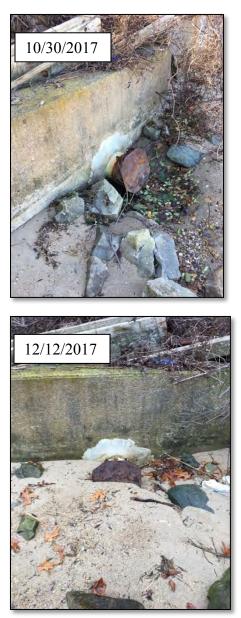
Figure 3-2 Source # 2017-10-018 (and 018 IS)

Source 2017-10-018 is a storm drain outfall on Great Island and was first visited on 10/30/2017 and found to have a slow trickle with a small pool of water below the pipe. There was evidence of previous water draining across the beach into Point Judith Pond. The sample results were 300 CFU/100ml requiring a follow-up sampling because it is located within approved waters. The second visit occurred on 12/12/2017 and the drain pipe was covered with sand and there was no flow. It appeared to have had a small water flow coming from the pipe and across the sand possibly from high tide water receding. A sample was taken from the shoreline in front of the pipe to determine if there was any seepage occurring. The results came back at <100 CFU/100ml. After both visits during dry weather it is most likely that the little water dripping from the pipe during the first visit is a result of flooding during high tide thus not causing water quality issues in the adjacent receiving waters.

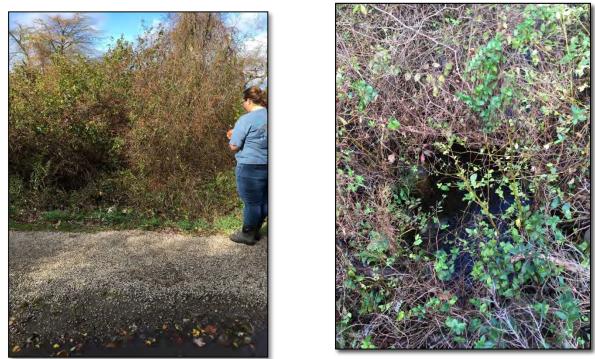
Figure 3-3 Source # 2017-10-023

Source 2017-10-023 is a stream running under Sunset Shore Drive and is thickly overgrown with vines. The stream drains a large upland wetland located on the East side of the road and eventually drains into Point Judith Pond. The sampling results were 4700 CFU/100ml with a flow of 0.96 cfs. A follow-up sample was taken and the results were 100 CFU/100ml. The previous sampling occurred in 2011 with a result of 1100fc/MPN. It is a remote, seasonally occupied area with few houses near the headwaters, which means that this cause of the high bacteria levels is most likely due to wildlife.

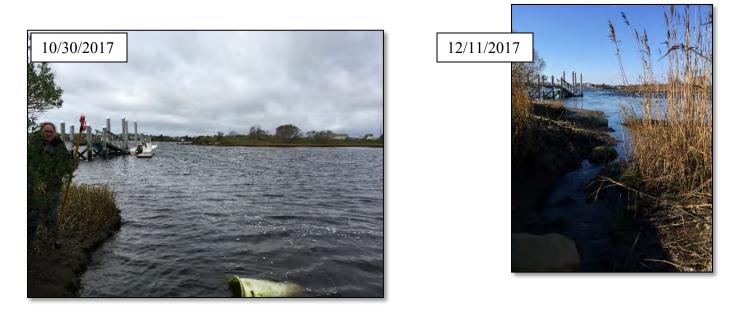
Figure 3-5 Source # 2017-10-025S

Source 10-025S is the in-stream sample in the receiving waters of the previous source (10-024) and was first sampled on 10/30/2017 during a windy wet weather day (3.44" in previous 24-hours) with an elevated bacterial level of 10,000 CFU/100ml. The follow-up sampling (12/11/2017) results were much lower (<100 CFU/100ml) along with less flow (1.94 CFS initial and 0.085 CFS follow-up). Because of the improved bacteria results upon the follow-up visit, this source does not impact the receiving waters. However, due to the initial elevated sampling results this source will be followed-up on during the 2018 annual shoreline survey.

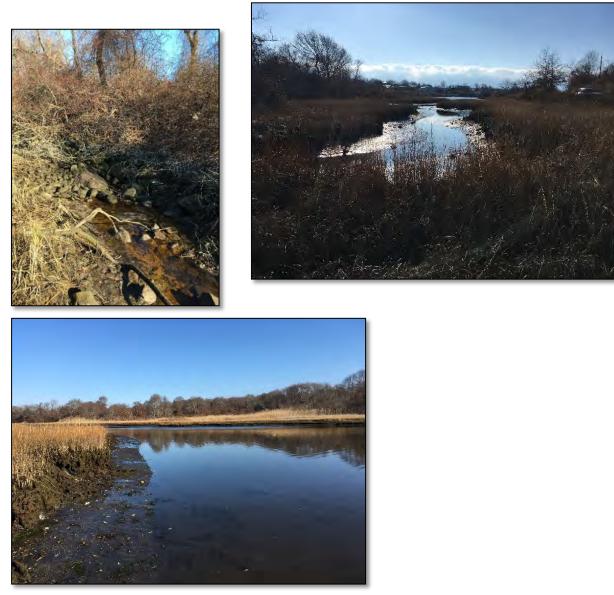
Figure 3-6 Source # 2017-10-26A

Source 10-26A is a stream that drains into Rye Cove. It was first sampled on 10/30/2017 during wet weather conditions (3.44" in the previous 24-hours) with elevated bacterial levels of 7000 CFU/100ml upstream before the stream enters the marsh and 1,124 feet from the in-stream results near the mouth of the stream at <100 CFU/100ml. Follow-up sampling results on 12/11/17 were lower at 100 CFU/100ml and in-stream results remained <100 CFU/100ml. Bacterial counts were much lower during the follow-up sampling. The distance traveled from the stream source drastically diluted bacterial levels in both in-stream samples near the receiving waters confirming that this source is not of concern to the nearby shellfishing waters.

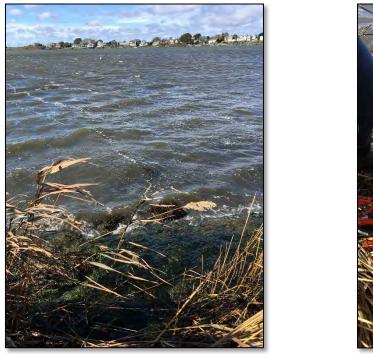
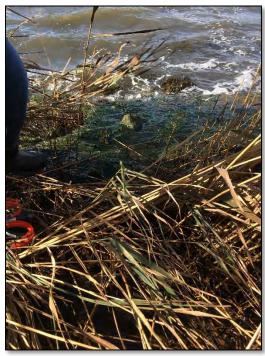
Figure 3-7 Source # 2017-10-61

Source 10-61 is a stormwater outfall at the end of Sunset Blvd., which is located within waters open to shellfish harvesting. The source is so densely overgrown with Phragmites that is was not possible to sample directly at the outfall and thus was sampled near the receiving waters. The first sampling on 10/30/2017 had elevated bacteria levels at 1,000 CFU/100ml. A follow-up sampling was conducted on 12/1/2017 and the outfall was accessible and sampled along with an in-stream sample near the receiving waters and both results were <100 CFU/100ml.

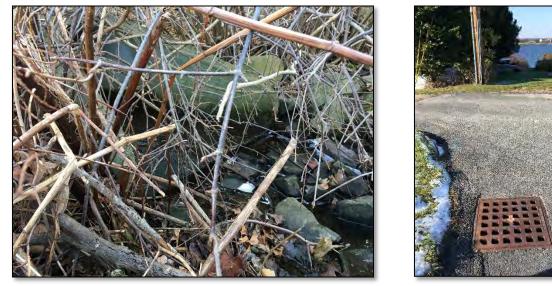
Source 10-62 is a storm drain outfall at the end of Pond View Avenue, which is located within waters open to shellfish harvesting. Initial sampling of source 10-62 occurred on 10/30/2017, which was a rainy day with rainfall amounts in nearby Kingston at the NOAA weather station measuring 3.44" of rain. The resulting bacteria level was 2,900 CFU/100ml with a flow rate of 0.2125 cfs. The follow-up sampling occurred on 12/11/2017, which was a clear and dry day with recent snow precipitation within the previous 48 hours totaling 2.3" from the NOAA weather station in Kingston. There was some snow melt (approximately 2" of snow, which would be around 0.2" melt water) that occurred on the day of the second sampling (12/11/2017) due to temperatures reaching above freezing (43° F). The bacteria level was much higher at 41,000 CFU/100ml but with slightly less flow (0.106 cfs). The initial sampling event occurred during wet weather conditions, which could be one reason for the higher bacteria levels measured. The second sampling event occurred during a recent snowfall followed by snow melt event, which would contribute to additional runoff at the outfall and also lead to higher bacteria levels. Rainfall of > 0.50" and snow melt events > 0.2" are a somewhat common occurrence within the area, thus this source may be contributing excess bacteria into Bluff Hill Cove during any rainfall or snow melt event.

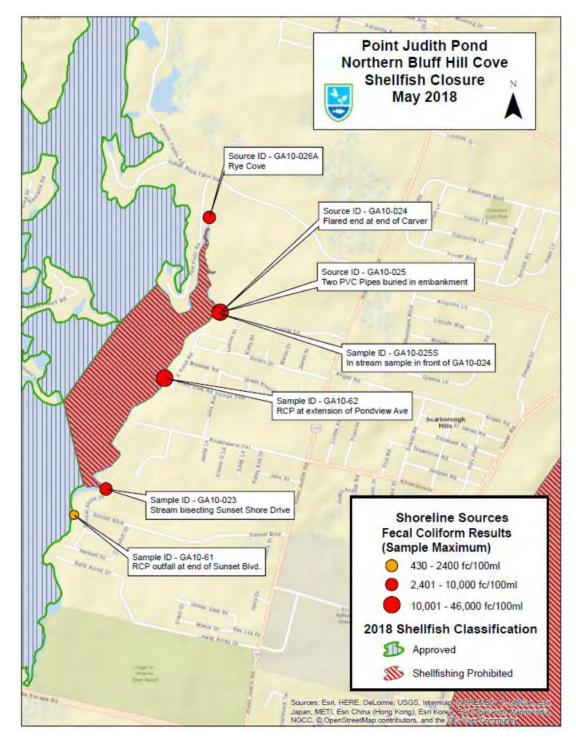
Figure 3-9 Proposed 2018 closure Bluff Hill Cove

As a result, the following re-classification of waters within the Bluff Hill Cove area is recommended to be implemented with the issuance of the 2018-2019 annual notice of polluted shellfishing grounds. Notice has also been made to the town as part of their requirements to meet the EPA mandated MS4 Stormwater Management Program that they conduct investigative study of the sources that may be contributing to these elevated bacteria results within their storm drain systems. The area will remain closed to shellfishing until the bacteria sources have been identified and addressed and follow up sampling indicates they are no longer impacting the growing area. Additional back up discussion and analysis of closure and subsequent correspondence to town officials is contained in the programs growing area file.

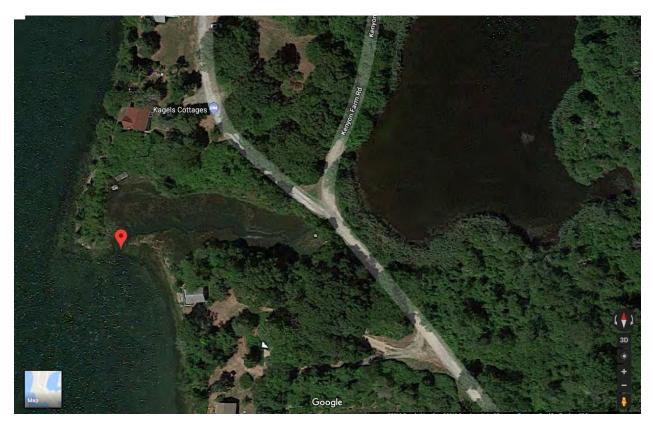
Figure 3-10 Source # 2017-10-200

Source 2017-10-200 is a culvert draining a pond at Kenyon Farm. The initial sampling occurred on 10/30/2017 during wet weather conditions and bacteria results were elevated at 2400 cfu/100ml. Upon follow-up sampling on 11/15/2017, during dry weather conditions, both the culvert outfall and instream results were <100 cfu/100ml.

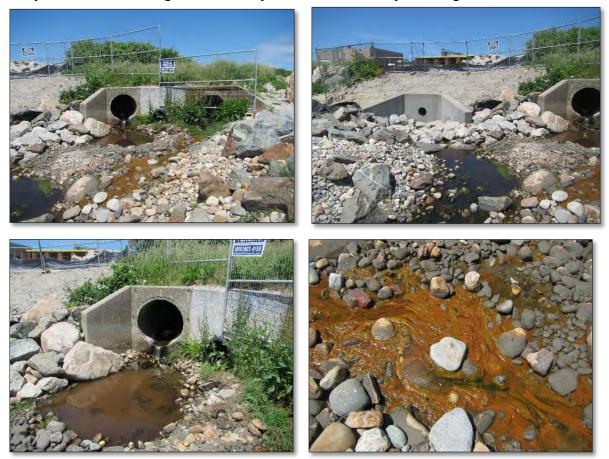
Figure 1-3 Source 2017-14E-007

Source 14E-007 is a 36-inch diameter concrete pipe and one 18-inch diameter plastic pipe located at the Scarborough WWTF. During the 2017 sampling the outflow had orange algae or bacteria with a strong odor. The source flows across a rocky upper beach, which transitions into sand before discharging into the ocean. The bacteria count was elevated at 1,600 cfu/100ml and a flow of 0.258 cfs. These pipes discharge into waters encompassed by the closed safety zone related to the outfall from the WWTF therefore no shellfishing is allowed in proximity to this discharge. The volume of flow from these pipes is not causing any impacts beyond the closed safety zone due to the large volume of open ocean waters they discharge to.

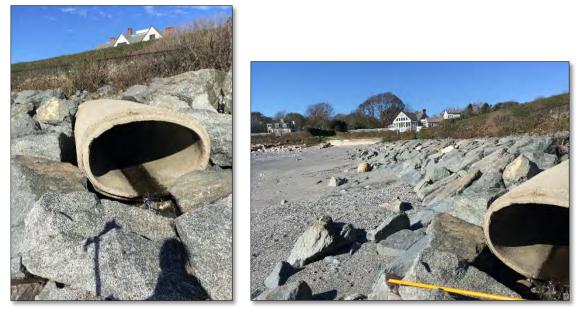
Figure 1-5 Source 2017-14E-717

Source 14E-717 is a 5' wide by 3' tall oval concrete pipe. The source had an elevated bacteria count at 1,500 cfu/100 ml but had a low flow rate of 0.004 cfs. The source is located along the Newport Cliff walk and discharges onto a rocky beach where it dissipates into the beach before reaching the receiving waters of the open ocean.

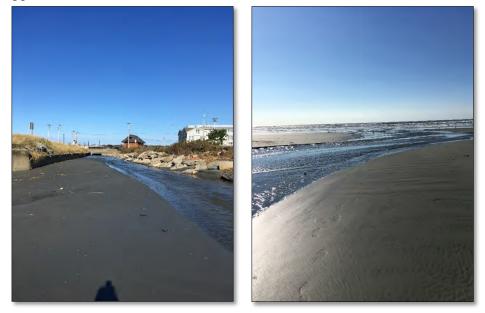
Source 14E-800 is a stream from an upland marsh, which flows across First Beach before reaching the receiving waters. The bacteria count was elevated at 15,000 cfu/100ml and a steady flow rate at 1.214 cfs. This source is in prohibited waters and thus not causing any impact to approved shellfish waters.

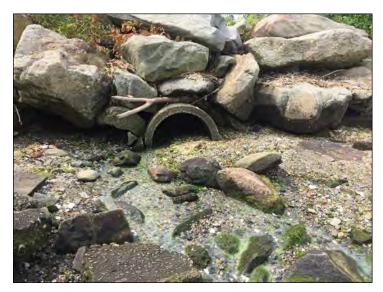
Figure 3-2 Source 2017-16-001

Source 2017-16-001 is a 24-inch diameter Reinforced Concrete Pipe draining onto a cobble beach located on the western shoreline of the Providence River. The pipe is filled halfway with sand and cobble, and green algae is growing on the rocks within the discharge water. Sampling results, as shown in the table below, were slightly elevated but had a very low flow rate. Due to the low flow and the relatively low bacteria concentration of this source it does not appear to be impacting the shellfish growing area.

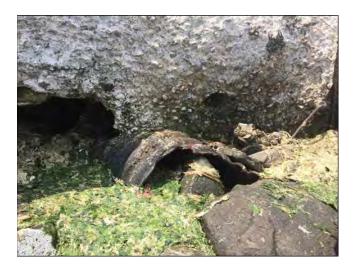
Source 2017-16-011 is a 24-inch diameter Reinforced Concrete Pipe (RCP) storm drain located on the western shoreline of the river and discharges onto a pile of large rocks and flows across a sandy beach at low tide. Adjacent to the RCP is a broken Corrugated Metal Pipe that is mostly filled with sand and debris. The source was initially sampled 8/2/2017 during dry weather and had elevated Fecal coliform results with a low volumetric flow (See table below). A follow-up sampling occurred on 10/19/2017 (5 days since 0.17 inches of rainfall) with decreased bacteria count from 8/2/2017 but remaining elevated. Volumetric flow had also decreased compared to prior sampling. Triennial survey results from 2009 show elevated Fecal coliform levels, which indicate that this source may be impacting the growing area. The source will be re-visited during the 2020 triennial shoreline survey. Due to the elevated bacteria counts consideration of dilution requirements will need to be account for while considering re-classification of these waters from Prohibited to any upgraded classification.

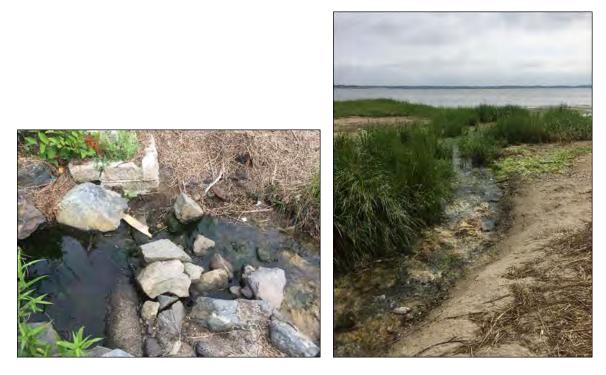
Source 2017-16-044 is a stream that drains onto a marshy beach. The source was sampled during dry weather on 8/3/2017 with a volumetric flow of 0.00047 cfs and a bacteria count of 160 CFU/100ml. The drainage basin of the stream was littered with the green algae Ulva, which was mostly decayed. This source has a very low flow rate and is draining into currently prohibited growing waters, thus the source has enough dilution area before reaching approved growing waters. The potential re-classification area of the lower Providence River would encompass this source, which would require further follow-up on the potential impacts of this stream to the growing area during the 2018 annual review.

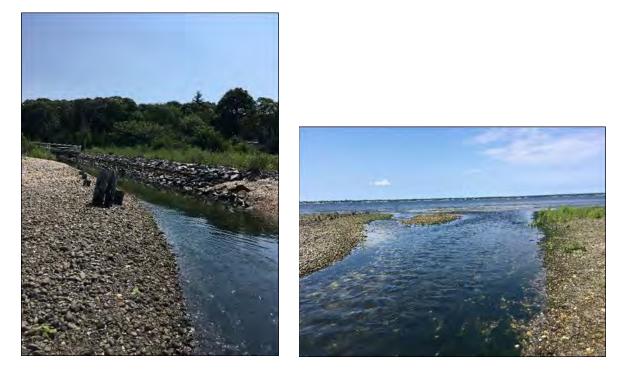
Figure 3-5 Source 2017-16-084

Source 2017-16-084 is Mussachuck Creek (10 feet wide by 1 foot deep) located in Barrington at the end of Nayatt road, which drains Echo Lake and Brickyard Pond and flows through the Rhode Island Country Club golf course and across a gravely beach before draining into the Providence River. The source was sampled during dry weather on 8/4/2017 with a flow of 5.1 cfs and bacteria count of 134 CFU/100ml. In-stream samples were taken with bacteria count of 120 CFU/100ml on the North side and <2 CFU/100ml on the south side of the stream. The receiving waters for this source are currently classified as prohibited, thus this source currently has enough dilution area before it reaches approved waters, but additional dilution calculations need to be performed in order to determine the boundary between this prohibited area and the potential conditionally approved area.

Source	Date of		Actual/	Direct/	Volume	CFU/100ml	
ID	Sampling	Source Description	Potential	Indirect	(cfs)	2009 Results	2017 Results
2017-16- 084IS	8/4/2017	IN STREAM (10' wide x 1' deep)-flows under bridge and road from residential area	А	D	5.1	15	134
2017-16- 084N	8/4/2017	Downstream on North side	А	D	Not Measured	NA	120
2017-16- 084S	8/4/2017	Downstream on South side	А	D	Not Measured	NA	<2

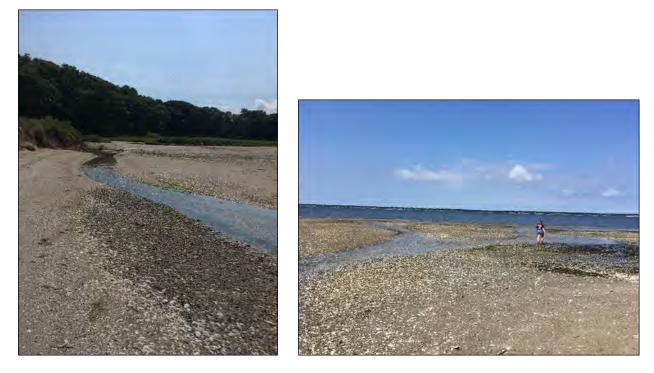
Figure 3-6 Source 2017-16-085

Source 2017-16-085 is a stream located in Barrington south of Annawamscutt, which drains from an upland wetland. The stream flows through a sandy dune before reaching a gravely beach where it discharges into the Providence River. The source was sampled on 8/4/2017 with bacteria count of 60 CFU/100ml and a flow rate of 1.275 cfs. Because of the low bacteria count during the 2017 survey and historically low bacterial results from this source it does not appear to impact the Providence River growing area.

Source	Date of	Source	Actual/	Direct/ Indirect	Volume	CFU/100ml	
ID	Sampling	Description	Potential		(cfs)	2009 Results	2017 Results
2017-16- 085IS	8/4/2017	Marsh In- stream of outlet that flows over gravely beach	А	D	1.275	39	60
2017-16- 085N	8/4/2017	In Stream on North side	А	D	Not Measured	NA	60
2017-16- 085S	8/4/2017	In Stream on South side	А	D	Not Measured	NA	54

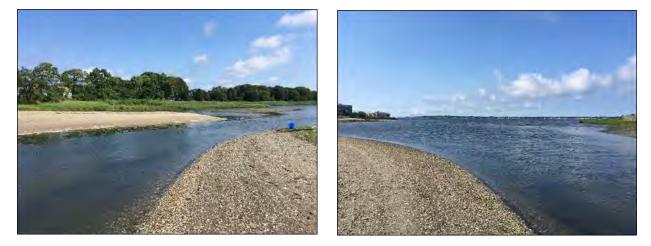
Source 2017-16-087A is the outlet of Allin's Cove (Drown Cove) in Barrington. Allin's Cove is a 10 acre cove located at the mouth of Annawamscutt Creek and is bordered by a small buffering salt marsh. The cove is both tidally impacted and has a freshwater stream input from the northeast, which is fed from an upland wetlands complex north of Bay Spring Avenue. The cove was dredged in 2005 for a salt marsh restoration project (Save the Bay and RI CRMC), which included widening the channel draining into the Providence River (see section 4-5 for more details). The results from sampling the outlet of the cove are listed in the table below. Results from the 2017 sampling were elevated compared to 2009 indicating that the source has the potential to impact the growing area because of the high flow rate and bacteria level measured during dry weather. This source is currently discharging to the prohibited Providence River growing area.

Source ID	Description	Sample date	Previous results 2009 survey MPN/100ml	Volume of source	2017 Survey Results CFU/100ml	Volume of source
2017-16- 087A	Outlet of Allins Cove	8/4/2017	21	Ebb tide	140	155.833 cfs
2017-16- 087IS2	Outlet of Allins Cove downstream	8/4/2017	NS		20	Not measured

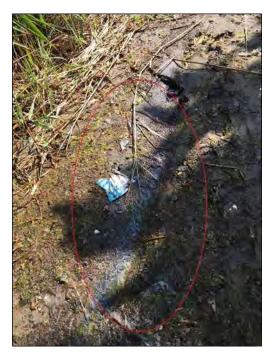
Figure 3-9 Source 2017-16-001

Source 2017-16-101 is a groundwater seep running down a sandy boat launch next to a Phragmites stand located in Bullocks Cove. The source had a small and steady trickle during the time of sampling (8/16/2017) with elevated bacteria count at 4,000 CFU/100ml. However, this source is draining into prohibited receiving waters, which will not be reclassified due to the high volume of marinas, thus this source is not likely impacting waters beyond the current prohibited area.

Source	Date of	Source	Actual/	Direct/	Volume	CFU/100ml	
ID	Sampling	Description	Potential	Indirect	(cfs)	2009 Results	2017 Results
2017-16- 101	8/16/2017	Groundwater seep running down sandy boat launch next to Phragmites stand	А	D	Trickle	NA	4000

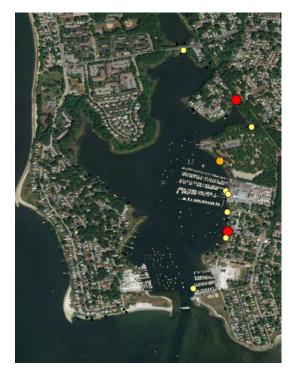
Figure 3-12 Aerial view Bullock Cove

Bulluck Cove's outlet is more represented by routine monitoring station GA16-4 which is located in the channel that has been dredged to allow boat traffic to enter and exit this heavily used mooring and marina area. As evidenced in the annul statistical analysis this station also appears to be impacted during wet weather. For an approved classification the most recent thirty (30) sample results indicate the station is out of compliance for the 90th percentile (90.2 CFU/100ml) and the geo-mean is approaching non-compliance at 13.1 CFU/100ml. During dry weather the most recent fifteen (15) taken during dry weather indicate the station is in compliance with zero of the samples greater than 31 CFU/100ml and the geo-mean is at 2.4 CFU/100ml. A marina closure due to the large number of vessels, and moorings within this protective cove would need to remain in place and has been calculated using our best professional judgment on the number of slips, occupancy and discharge rates to be an area of approximately nineteen (19) acres. Further details on this calculation can be obtained from the shellfish program document entitled "Evaluation of Waters Adjacent to Marinas, Marina Dilution Analysis Background, June 2017". The area of Bullocks Cove is approximately one hundred and twenty-nine (129 acres) which is ample dilution volume in the event there is a sanitary discharge from the vessels currently utilizing these harbor waters. In addition to the numerous vessels and the necessary marina closure there are several freshwater sources and stormwater outfalls that contribute bacteria loads to this cove. The following graphic illustrates the locations of those sources and the magnitude of the bacteria counts along with the general occupation of the area both in the water and the adjacent land occupation which is a heavily developed residential area with limited access to municipal sewers which are primarily located on the western banks of the cove (2004 RI DEMGIS).

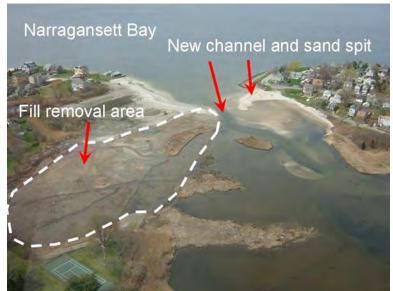
Figure 4-5 Allin's Cove Dredging Project

Allin's Cove located South of Bullocks Cove, underwent a major salt marsh restoration project beginning in 2005, which involved dredging 7,000 cubic feet of fill from three and a half acres located within the channel and marsh (as shown in the image below). In 1959 the Army Corp of Engineers filled in a section of the salt marsh with dredged material from the Providence River Bullock Cove project. This marsh filling lead to changes in the salt marsh native vegetation and increased erosion. The restoration project regraded the marsh elevation so as to reestablish native high and low marsh plant communities and to reduce the robustness of the invasive Phragmites australis. They moved the outflowing channel and created a sand bar to protect the salt marsh and upland on the northern side of the cove. In addition, they hoped to minimize the mosquito population within the cove by remaking historic ditches within the marsh to increase drainage from areas of standing water.

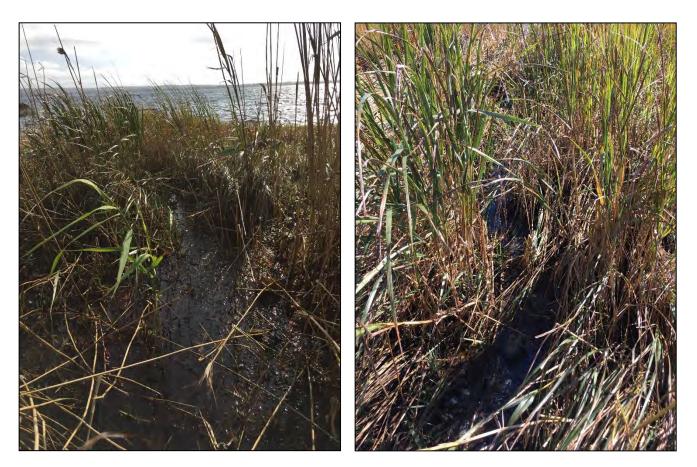
Figure 3-2 Source 17-2

Of the four sources revisited for this triennial survey, three exhibited no flows at the time of sampling. Two of these were either completely dry or no longer exist (sources 17-411 and 17-101, both drainage swales). The remaining source, 17-2, is a stream that runs from a detention basin through an apartment complex on the Roger Williams University campus. It was initially sampled on 10/17/2017 with FC results of 700 CFU/100ml and flowing at only a trickle. Because of the elevated bacteriological results, it was resampled on 11/2/2017. It again showed high bacteria levels, with a result of 818 CFU/100ml and a slightly higher flow of 0.085 ft³/s. A sample was also taken just beyond the end of the stream, with results of 200 CFU/100ml. The initial sample was taken during dry weather, however the follow-up sample on 11/2/2017 was taken during wet weather when the conditionally classified receiving waters were closed (3 days after a 2.63" rain event) (Table 3-3). This would likely have been the reason for the slightly higher flow and bacteria levels. Despite this, the in-stream sample was not incredibly elevated (below the 240 CFU/100ml criteria for triennial resampling) and so dilution is occurring. In addition, the closest routine monitoring station (station 17-13, Figure 3-1) is in compliance for conditionally approved areas, despite being located in prohibited waters (Table 6-1). Because of these considerations, it does not seem that this source is adversely impacting the receiving waters of the growing area. No reclassification is recommended. The source will be resurveyed in dry weather open conditions as part of the 2020 Triennial Evaluation.
