Rhode Island Department of Environmental Management

Office of Water Resources – Shellfish Program

2018 Shellfish Program Classification Report

GA 1 Triennial Review: Upper Narragansett Bay

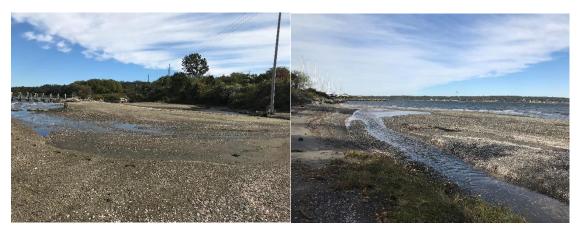
During the 2018 shoreline survey two (2) sources which had bacteria levels above 240 cfu/100 ml in the 2017 survey were re-sampled. Source 3-201, a 2' by 3" deep stream flowing under a railroad trestle bridge) was sampled on 10/15/2018. On that date, source 3-201 had a fecal coliform reading of 440 cfu/100 ml and the stream was flowing at approximately 1 cubic foot per second. However, the stream flow was dissipating into a sandy beach before reaching the receiving waters of Growing Area 3. Source 3-209, a 3' wide by 1' deep stream that drains uplands in the Melville Pond area was also sampled on 10/15/2018. When sampled, the stream was flowing at approximately 3 cubic feet per second and fecal coliform was found to be 76 cfu/100 ml. Source 3-209 also dissipated into the sand/gravel beach above the high tide line before reaching the receiving waters of Growing Area 3 also not impacting GA3 waters..

Figure 2: Sources 3-201 (left) and source 3-209 (right) on 10/16/2019.

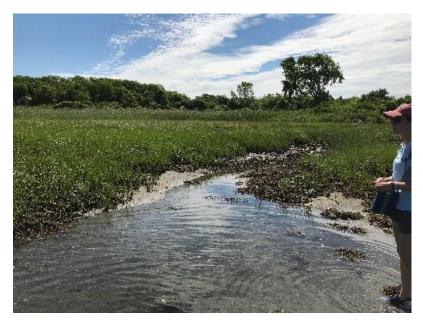
A comprehensive shoreline survey of Hog Island was also completed during 2018 (survey dates were 6/21/2018 and 8/1/2018). Hog Island is a small island (190 acres) located near the mouth of Bristol Harbor. Hog Island has no year-round residents and has no distributed electrical power system. Hog Island has approximately 50 small residences that are occupied primarily in the summer months. Seven (7) sources were identified in the shoreline survey of Hog Island. Of these, one (1) source, 2018-3-303, had a fecal coliform value of greater than 240 cfu/100 ml. Source 2018-3-303 is a small tidal creek (1' wide by 1/2 inch deep stream with a flow of approximately 0.01 cfs on 6/21/2018) that drains a saltmarsh and enters a shallow (3-5' depth) cove in Growing Area 3. On 6/21/18, fecal coliform in this small stream were observed at 1,600 cfu/100 ml and instream sampling at the shoreline of the shallow cove revealed an instream fecal coliform result of 100 cfu/100 ml. An oyster aquaculture lease (lease # 2016-06-047) is located in the shallow cove on the western side of Hog Island, approximately 500 feet from source 2018-3-303. Follow-up sampling of source 2018-3-303 on $\frac{8}{1}$ showed that fecal coliform at the stream mouth had declined to <2 cfu/100 ml and two (2) samples collected by boat at the nearby aquaculture lease were also <2 cfu/100 ml. Although fecal coliform results were slightly elevated, in stream results indicated that this source is not impacting the waters of GA3.

Figure 3: Source 3-303 on Hog Island (6/21/2018)

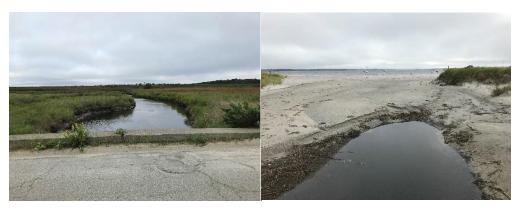
Figure 4: Source 4-540 view looking inland from culvert (left photo) and view looking seaward towards GA4 (right photo). Photos taken 9/19/2018.

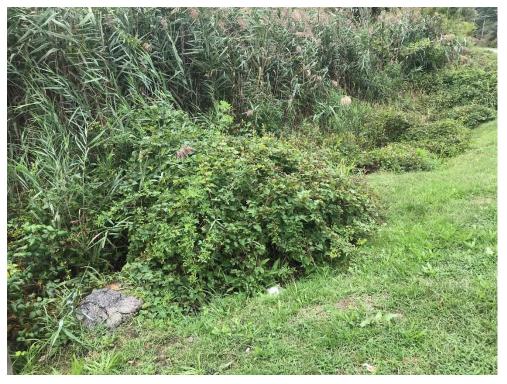
Source 4-710 is White Wine Brook, which drains through a 24-inch CMP into Nanaquaket Pond in Tiverton. The source had an elevated bacteria count of 1600 cfu/100ml in 2018 but the volumetric flow was a trickle at the CMP, which is located within a dense *Phragmites* stand and must travel over 100 feet before reaching the receiving waters. A follow-up sample was taken on 5/8/2018 with a result of 100 cfu/100ml and an instream of 31 cfu/100ml. These instream results indicate that the travel distance from the CMP to the receiving waters is sufficient to filter and dilute bacteria levels before reaching open shellfishing waters.

Figure 5: Source 4-710 White Wine Brook. The Brook was a trickle running through the dense Phragmites stand (photo on 9/19/2018).

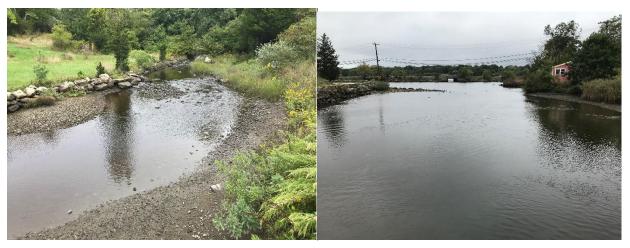
Road. The gut is a tidal basin of approximately three (3) acres area adjacent to Nanaquaket Pond. Tidal flow from the Gut (prohibited waters) discharges through a culvert to the approved waters of GA4 at the northeastern side of Nanaquaket Pond. Recent sampling has indicated elevated fecal coliform bacteria in Sin and Flesh Brook where it enters Mill Gut, especially during wet weather, with observations of 91 cfu/100 ml (2017) and 1,600 cfu/100 ml in 2018. In addition, a collaborative effort by URI Watershed Watch and the Tiverton Harbor Commission has monitored fecal coliform 5-6 times per year at a location near where Sin and Flesh Brook enters the Gut (site URI WW258) for the past several years. Analyses of the URI Watershed Watch fecal coliform data showed that readings during 2014 to 2018 had a range of 2 to 717 mpn/100 ml with a geometric mean of 111 mpn/100 ml. Sin and Flesh Brook is on the State of Rhode Islands impaired waters list (303d list) for bacterial (Enterococcus) contamination with a TMDL plan scheduled for 2030. DEM Shellfish staff have talked with the Tiverton Harbor Commission and the Harbor Commission is aware of the elevated fecal coliform in Sin and Flesh Brook and is beginning to develop best management practices to prevent fecal coliform contamination in the watershed. DEM Shellfish Program station 4-4 is located approximately 500 feet southwest of the culvert that is continuous with the prohibited waters of 'the Gut'. Station 4-4 is currently in compliance but the elevated fecal coliform in nearby Sin and Flesh Brook is a concern and this station will have to be monitored closely for continued compliance with NSSP standards for approved waters.

Figure 6: Source 4-711 Sin and Flesh Brook. Upstream view (towards freshwater, left photo) and downstream view looking towards prohibited waters of 'the Gut'' (right photo). Photos taken 9/19/2018.

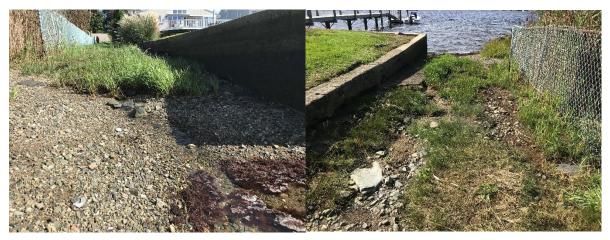
Three (3) potential sources were examined as part of the 2018 annual update. Source 5-013 is a broken PVC pipe within the extension of the ROW of Chace Lane in Touisset. Originally identified as a groundwater seep, erosion has exposed this as an actual broken pipe since first discovered. Original sample results in 2015 had results of 8,000 cfu/100ml with a trickle flow, re-sampling had results greatly reduced at 80 cfu/100ml with a corresponding instream sample of <3 cfu/100ml. Sampling source 5-013 on 10/16/2018 revealed a fecal coliform concentration of 720 cfu/100 ml. As observed in the past, the flow was only a trickle and nearby instream waters, which were closed at the time of sampling, demonstrated a rapid dilution. This intermittently elevated source should be monitored in future surveys.

Figure 1: Source 5-013, a seep at the end of a right-of-way at extension of Chace Avenue. Left photo is looking inland, right photo is view towards Kickemuit River. Source was a trickle on day photos taken (10/16/2018).

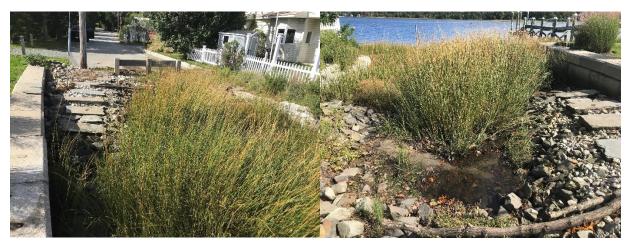
The final source examined during the 2018 annual update was source 5-030 which is an 18" corrugated metal pipe at the end of Smith Street in Warren, RI. This source was initially sampled on 10/17/2017 and had a high FC result of 2,900 CFU/100ml. The flow was only a slight trickle and the area the pipe discharges to was filled with debris. Because of the high bacteriological results, this source was resampled on 11/2/2017 with a result of <100 cfu/100 ml. 2018 follow-up sampling at source 5-030 on 10/16/2018 showed a fecal coliform level of > 1,600 cfu.100 ml. However, despite wet weather during October 2018 (GA5 shoreline source sampling was completed on 10/16/2018 while the conditionally approved GA5 was in the closed status. Sampling was done four days after 1.66" rain at the Taunton rain gauge. Source 5-030 was only a trickle and the source source 5-030 on the receiving waters of the Kickemuit River (GA5). The limited impact of source 5-030 on the receiving waters of GA5 is evidenced by the fact that nearby GA5 shellfish monitoring station 5-4 which is ~500 feet east of source 5-030 was in compliance during 2018 with a geometric mean fecal coliform of 3.3 cfu/100 ml with 0% of samples exceeding 31 cfu/100 ml when the area was open to shellfish harvest.

Figure 2: Source 5-030, an 18" corrugated metal pipe at the end of Smith Street, Warren, RI. View inland (left photo) and view toward the Kickemuit River (right photo). No detectable flow was present when examined on 10/16/2018.

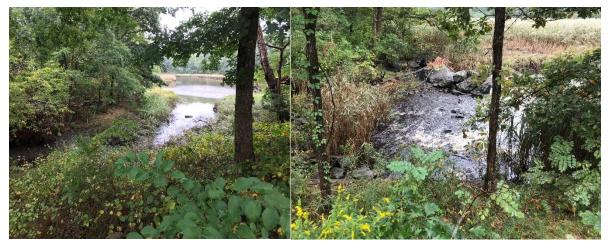
Figure 2: Sources 7-6 (left) and 7-7 (right); both small streams enter prohibited waters of Mill Cove, inner Wickford Harbor. Photos taken 10/3/2018.

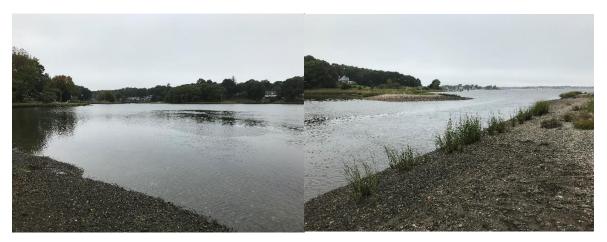
Source 7-14B is the channel draining the prohibited waters of Duck Cove. Duck Cove has been prohibited to shellfish harvest for years because of elevated and variable fecal coliform concentration. The 2018 follow-up had a fecal coliform observation of 760 cfu/100 ml on 10/3/2018 which was 1 day after 1.46" rain and 9 days after 3.75" rain at TF Green Airport. Past observations indicate that Duck Cove fecal coliform levels are variable, with no clear pattern in regard to wet versus dry weather. Given this variability, Duck Cove is properly classified as prohibited to the harvest of shellfish.

Figure 3: Source 7-14B, Prohibited waters of Duck Cove, North Kingstown views looking inland (left photo) and looking seaward towards GA7 (right photo).

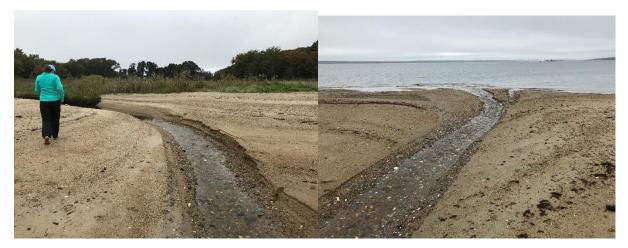
Source 7-023 is a small stream that flows from an upland marsh across a beach in the Shore Acres area of North Kingstown. This source had a fecal coliform result of >1,600 cfu/100 ml and a flow rate of 0.83 cfs on 10/3/2018. The small stream enters a prohibited safety zone around Quonset Point which provides a sufficient dilution buffer between the source and the approved waters of GA7.

Figure 4: Source 7-023 a small stream flowing from an upland marsh (left photo) and across a beach in the Shore Acres section of North Kingstown into GA7 (right photo). Photo taken 10/3/2018.

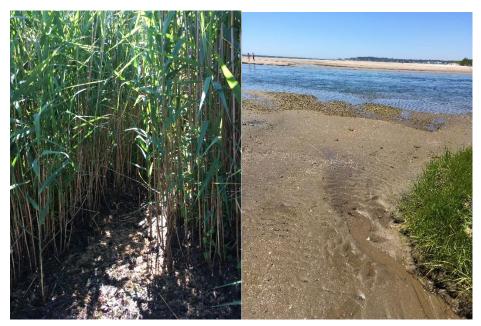
A single source (7-2-028) was found to have fecal coliform exceeding 240 cfu/100 ml. Source 7-2-028 is a small seep (approximately 1 foot wide by 0.25" deep) flowing from an upland *Phragmites* spp. stand and across a small beach. The seep dissipates into the sand at low tide but would enter the receiving waters of GA7-2 at high tide. On 7/10/2018, this seep had a trickle of flow and a fecal coliform concentration of 1,600 cfu/100 ml was observed at the location where the seep exits the *Phragmites* stand. A companion sample (7-2-28A) collected from this source on the narrow beach near the low tide line had a fecal coliform concentration of 280 cfu/100 ml. Because of the low flow, source 7-2-028 presents little potential for negatively impacting the bacteriological quality of Growing Area 7-2 or adjacent Growing Area 14. Source 7-2-028 will be monitored with follow-up sampling.

Figure 2: Source 7-2-028 a small seep flowing out of uplands, through a Phragmites stand (left photo) and across a small beach (right photo) before dissipating into the sand. Photo taken 7/10/2018.

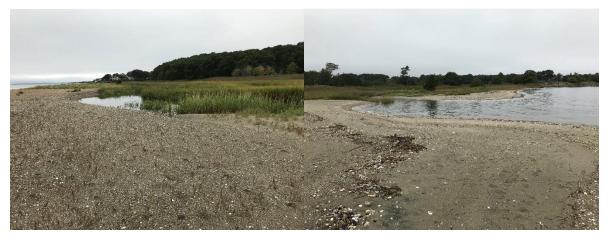
A follow-up of source 9-011 (Tibbet's Creek flowing into GA9 near Quidnesset Country Club) was completed on 10/3/2018 (Figure 3). The autumn of 2018 was exceptionally wet (24.4" of rain compared to a long-term average of 12.4" during September 1 to November 30, 2018) and the sample at Tibbett's Creek was collected 1 day after 1.16" of rain had fallen at TF Green Airport. Despite the wet weather, a result of < 2 cfu/100 ml was obtained at source 9-011 during the 2018 follow-up.

Figure 3: Source 9-011 Tibbet's Creek flows through a salt marsh (left photo) and enters the waters of Growing Area 9 in the West Passage of Narragansett Bay (right photo). Photos taken 10/4/2018.

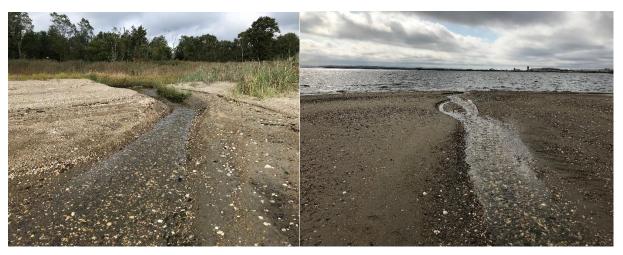
Source 9-201 is a small stream (Figure 4; approximately 2 feet wide by 3 inches deep) draining an upland marsh and entering a portion of GA9, Fry Cove, that is classified as prohibited to shellfish harvest. The fecal coliform concentration in this stream was 320 cfu/100 ml on 10/4/2018. At that time the flow rate of the stream was approximately 0.25 cfs; this was on 10/4/2018 which was one day after a substantial rainfall (1.61" of rain at nearby TF Green Airport). In stream samples taken adjacent to the source in prohibited waters indicated a reduction due to dilution in the receiving waters and nearby shellfish program monitoring station 9-4, located in approved waters, was in compliance during 2018. Follow-up sampling of source 9-201 and nearby receiving waters should be conducted during the 2019 triennial update of the West Middle Bay.

Figure 4: Source 9-201, a small stream draining an upland marsh (left photo) and flowing across a sandy beach (right photo) to the receiving waters of Fry Cove in the West Passage of Narragansett Bay.

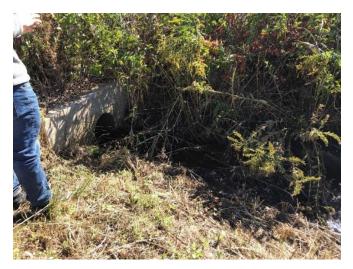
Figure 3: GA10, Source 10-11

Source 2012-10-011 is an RCP outfall located on Harbor Island adjacent to the Harbor Island Assoc. marina (Figure 3). There is 25' seasonal marina radius closure associated with these docks that is in effect from Memorial Day to Columbus Day. This source had no flow during the time of sample, however water pooled at the source was sampled with a result of 320 cfu/100ml. Given there was no actual flow this source is of limited concern. It appears that this is a wet weather source as there were no flows observed on several dry weather sampling runs. Routine monitoring station GA10-10 representing the receiving waters is located just offshore of this source. Water column samples collected at station GA10-10 indicated that the receiving waters meet NSSP criteria, but fecal coliform concentration is variable (2018 geometric mean and variability 90th percentile are 4.5 cfu/100ml and 25.7, respectively).

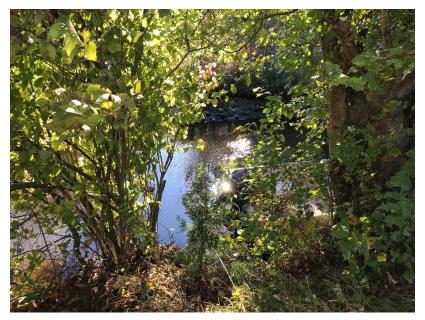
Figure 3: Source 11N-1000, a stream flowing from Cross Mills Pond to tidal Ninigret Pond.

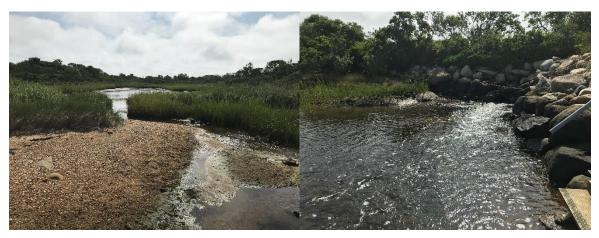
The following five sources (13-009, 13-010, 13-011, 13-012, 13-013) discharge to the outer portion of Great Salt Pond (Figure 3). Source 13-009 is a small tidal stream that drains a tidal wetland and discharges to the outer portion of Great Salt Pond (Figure 5). This source has historically had low flow (Table 1). During 2019 sampling this source had a fecal coliform result of 100 cfu/100 ml and a flow of 0.3 CFS on 8/22/2018 which was six days after 1.63 inches of rain fell at the NWS Block Island weather station.

Figure 5: Source 13-009 (left) and source 13-010 (right).

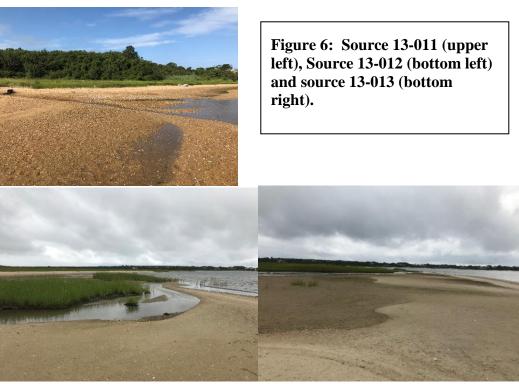
Source 13-011 is a small tidal stream draining a wetland and flowing across a sandy beach before reaching the receiving waters at low tide (Figure 6). 2018 results were 600 cfu/100 ml on 8/22/2018 (six days after 1.63 inches of rain fell at the NWS Block Island weather station). On this day, flow at the upland edge of the salt marsh tidal stream was 1 cfs. However, most of this flow dissipated into the sand before it reached the receiving waters (Figure 6) indicating this source has little direct impact on the receiving waters.

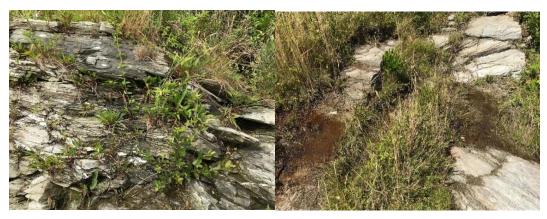
Source 2018-14E-200B is a ground water seep near Lions Head Rock located on the eastern side of Beavertail. This source is a ground water seep that spans ~ 20 ft along a rock edge next to the stairwell and flows directly into an area of GA14 that is classified as Approved. This source was sampled on one of the primary sampling days 7/24/2018 and was then followed up on 10/23/2018. The initial result was 2,800 cfu/100 ml, and the follow-up result was 40 CFU/100mL. The flow on both sample days was only a trickle as shown in the photo below. The low flow and the reduced fecal coliform concentration in the follow-up sample suggest that this source has little impact on the receiving waters of GA14. This is a source that we will continue to monitor and will sample again in the annual survey. Source 2018-14E-200R (Figure 5) is also a ground water seep located close to Lions Head rock had a result of 1,600 CFU/100mL and no previous sample has been collected from this source. This source had a trickle flow and therefore is not a concerning source. It will be followed up in the next triennial survey.

Figure 5: Source 14E-200B (left), a groundwater seep near Lion's Head Rock on the east side of Beavertail, Jamestown, RI. Source 2018-14E-200R (right) a ground water seep on the east side of Beavertail, Jamestown, RI.

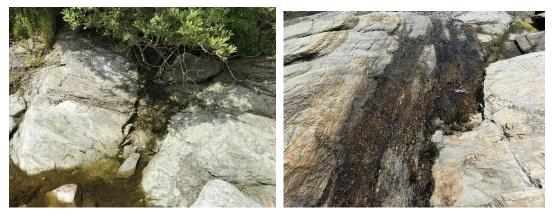
Sources 2018-14E-203F and 2018-14E-203I are both groundwater seeps on the western side of Mackerel Cove in Jamestown (Figure 6). Source 14E-203F had a fecal coliform result of 3,700 cfu/100 and a trickle flow on 7/26/2018. Follow-up sampling on 10/23/2018 had a fecal coliform result of 60 cfu/100 ml and a trickle flow. Nearby source 14E-203I had a fecal coliform result of 300 cfu/100 ml and a trickle flow on 7/26/2018. The low flow (trickle) and the moderate fecal coliform concentration of these sources suggests that they have little impact on the receiving waters of GA14.

Figure 6: Source 2018-14E-203F (left) and 2018-14E-203I (right) are both groundwater seeps that trickle over the rocks on the west side of Mackerel Cove, Jamestown, RI.

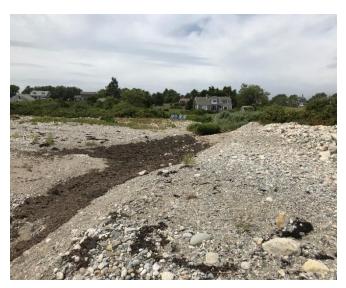
Figure 8: Source 2018-14E-1100 a small stream draining Little Pond in Little Compton, RI this source was not flowing during the 2018 survey.

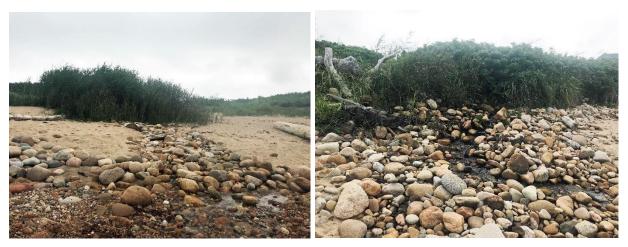
Sources 2018-14W-1306 and 2018-14W-1312 (Figure 10) are located on the west side of Block Island in the area of Cooneymus Road. Both of these sources drain small freshwater ponds and associated wetlands. The area is sparsely populated with less than 10 residences within a 1,000 foot radius of each source. Source 14W-1306 had a fecal coliform result of 300 cfu/100 ml, but this source was not flowing on the day of the survey (8/21/18). Source 14W-1312 had a fecal coliform result of 500 cfu/100 ml on 8/21/18 and had only a trickle flow. The 2006 survey of this area had a fecal result of 93 cfu/100 ml at both sources 14W-1306 and 14W-1312. The low flow of these sources and the rapid dilution experienced in the open ocean of Block Island Sound immediately adjacent to the sources suggest that these sources will have little negative impact on the bacteriological water quality of GA14.

Figure 11: Source 14W-1306 (left) and source 14W-1312 (right). Both are small streams draining wetlands and small ponds on the west side of Block Island.

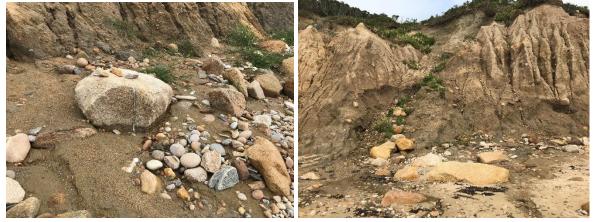
Sources 14W-1316 and 14W-1317 (Figure 12) are both ground water seeps at the base of a bluff on the southwest corner of Block Island. Both of these sources had fecal coliform results of 300 cfu/100 ml on 8/21/18. However, both of these sources had only a trickle flow and were not reaching the receiving waters during the 2018 survey. Because these sources dissipated before reaching the receiving waters, they are not impacting the water quality of GA14.

Figure 12: Sources 2018-14W-1316 (left) and 2018-14W-1317 (right) are ground water seeps at the base of cliffs on the southwest corner of Block Island.

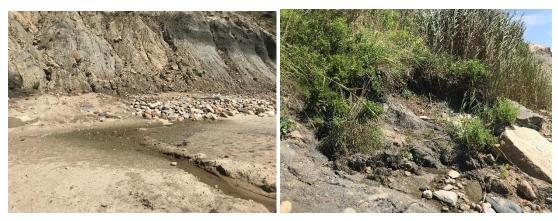
Figure 13: Sources 14W-1322 (left) and source 14W-1323 (right) are both ground water seeps at the base of cliffs on the south side of Block Island.

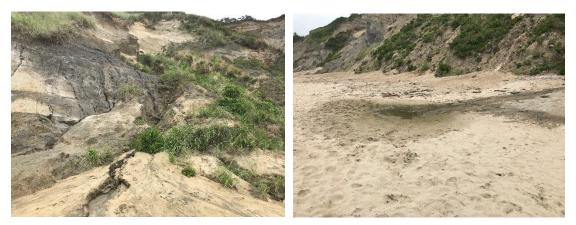
Sources 14W-1302 and 14W-1319 (Figure 15) are both groundwater seeps flowing down the bluffs to the west of the Mohegan Bluffs trail head parking area. Source 2018-14E-1302 was sampled in 2006 and had a result of 23 MPN/100mL, and in 2018 had a result of 5,000 CFU/100mL and a trickle flow. At the time of sample this trickle flow was reaching the high tide mark. Nearby source 14W1319 had a result of 300 cfu/100 ml and a trickle flow on 8/21/18. The area up the bluff from these sources is sparsely populated, with nine (9) residence within approximately 1,000 feet of the sources. Both of these sources are located on the southern end of Block Island and the area is in proximity of Mohegan Bluffs which is a popular summer day-tourist destination. As with other seeps in the area, the adjacent portion of GA14 is open ocean

Figure 15: Sources 14W-1302 (left) and 14W-1319 (right) are both groundwater seeps flowing down the bluffs to the west of the Mohegan Bluffs trail head parking area

with high surf action that is expected to rapidly dilute the sources and minimize the impact on the water quality of GA14. This source should be followed up in the next annual survey.

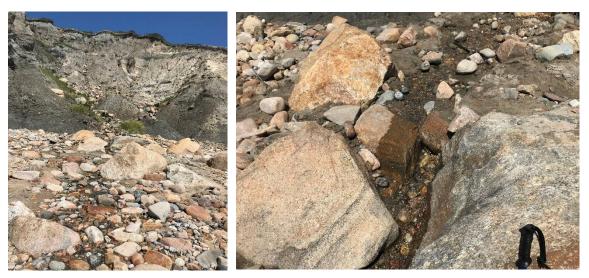
Figure 16: Sources 14W-1301 (left) and 14W-1328 (right) are groundwater seeps flowing down the bluffs to the east of the Mohegan Bluffs trail head parking area.

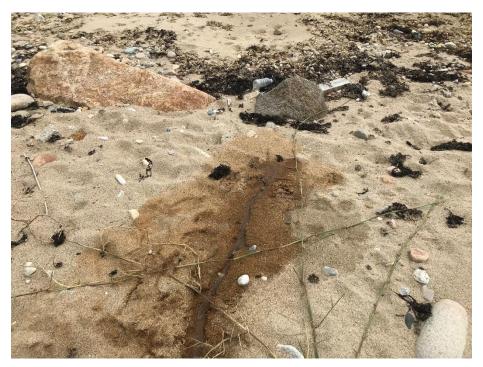
Figure 17: Source 14W-1315 a small ground water seep on the northeast shore of Block Island. This source dissipates into the sand before reaching GA14 receiving waters.

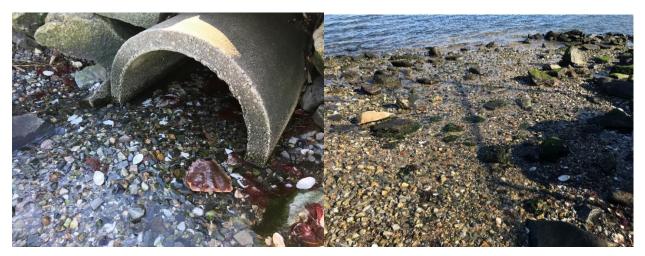
Figure 3: Source 16-001 showing discharge out of 24" RCP (left) and trickle flow across narrow beach to receiving waters (right image). Photos taken 10/22/2018.

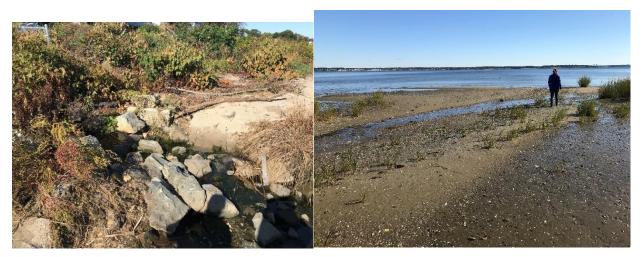
Figure 4: Source 16-022 showing point where small stream exits bank near the extension of Rock Avenue (left photo) and view of small stream as it crosses beach and flows towards GA16 (right photo). Photos taken 10/.22/2019.

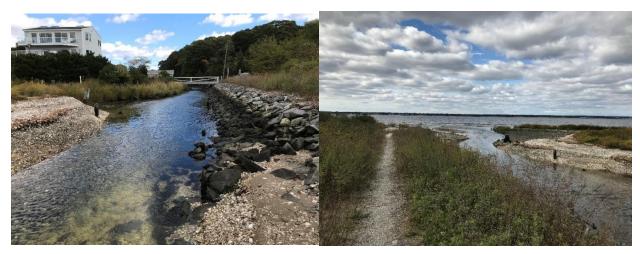
Figure 5: Source 16-084, Mussachuck Creek, Barrington, RI. View looking inland (left) and downstream towards the receiving waters of GA16 (right photo). Photos taken 10/22/2018.

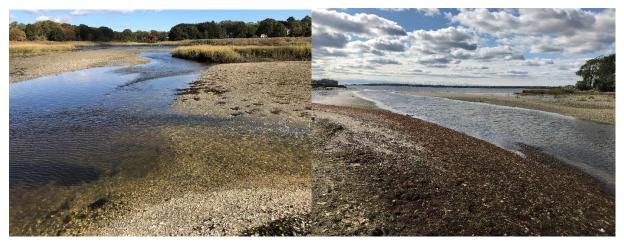
Figure 6: Source 16-087A, tidal waters of Allin's Cove. View inland (left) and seaward towards the receiving waters of GA16 (right). Photos taken 10/22/2018.
