**PHASE I & II ENVIRONMENTAL SITE
ASSESSMENT
ROBIN RUG PROPERTY
125 THAMES STREET
PROVIDENCE, RHODE ISLAND**

GZA GeoEnvironmental, Inc.
Providence, Rhode Island

July 2005
File No. 32938.01

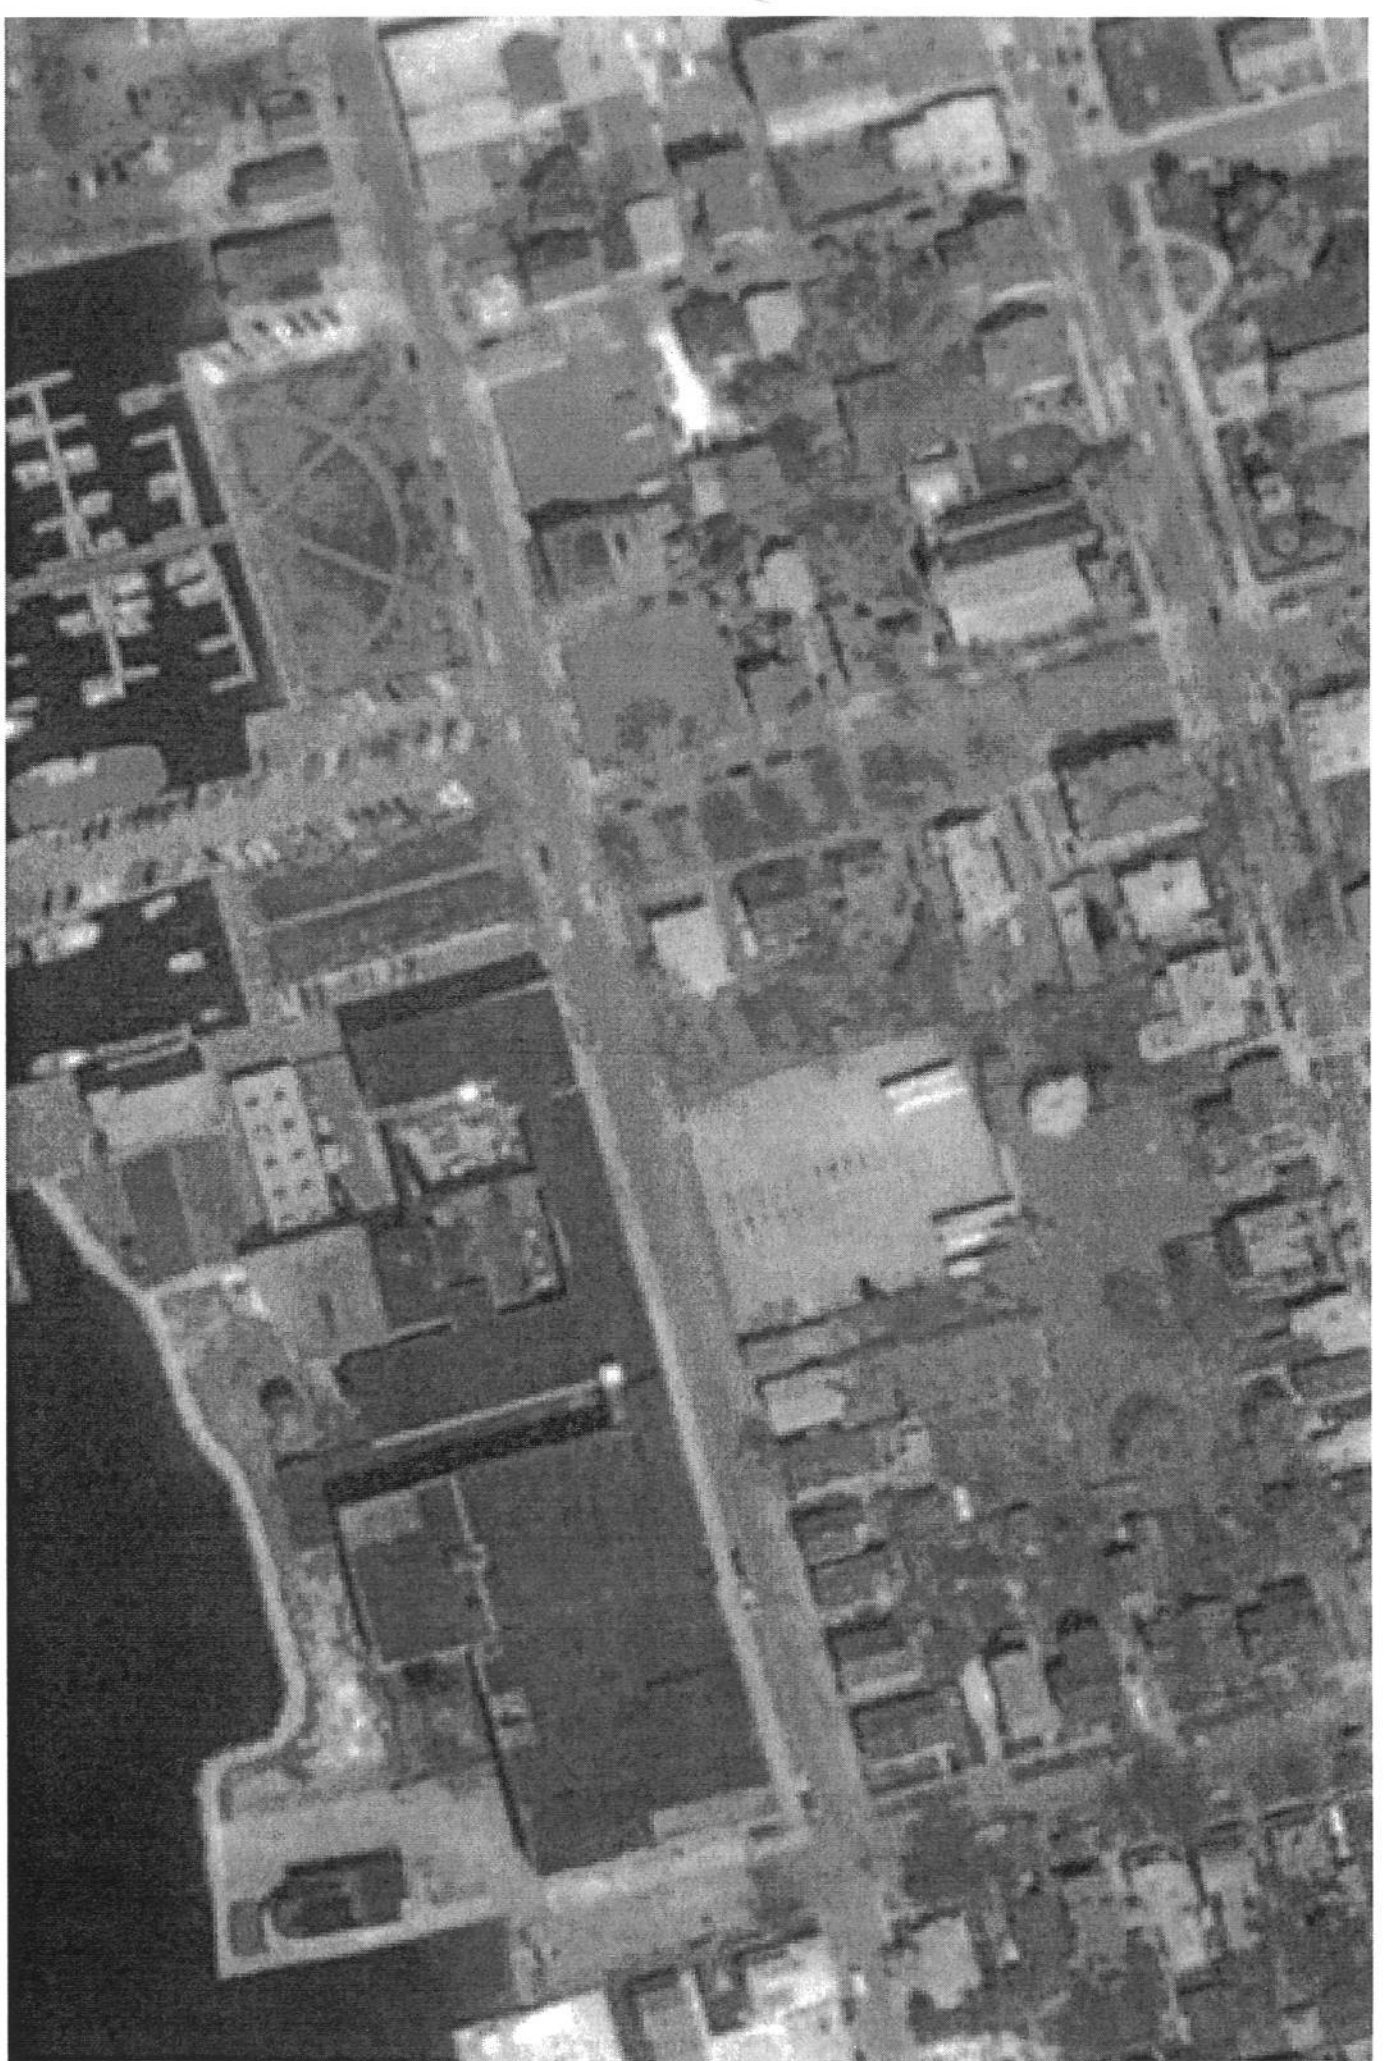
FIGURE 2
AERIAL MAP

The Site is located in the downtown/waterfront district of Bristol, Rhode Island. It is bound by Bristol Harbor to the west, John Street to the north, Hope Street to the east, and Constitution Street to the south; a locus plan is provided in the FirstSearch report, Appendix B. A copy of the *Town of Bristol Tax Assessor's Map*, attached as Figure 1, shows the approximate property boundaries. Figure 2, *Aerial View*, provides a circa 1997 aerial view of the Site and the surrounding properties.

Copies of historical fire insurance maps are attached as Figure 6 and a *1997 Aerial View* is provided as Figure 2. Table 1 (attached) provides details from the historical resources; a summary is provided below.

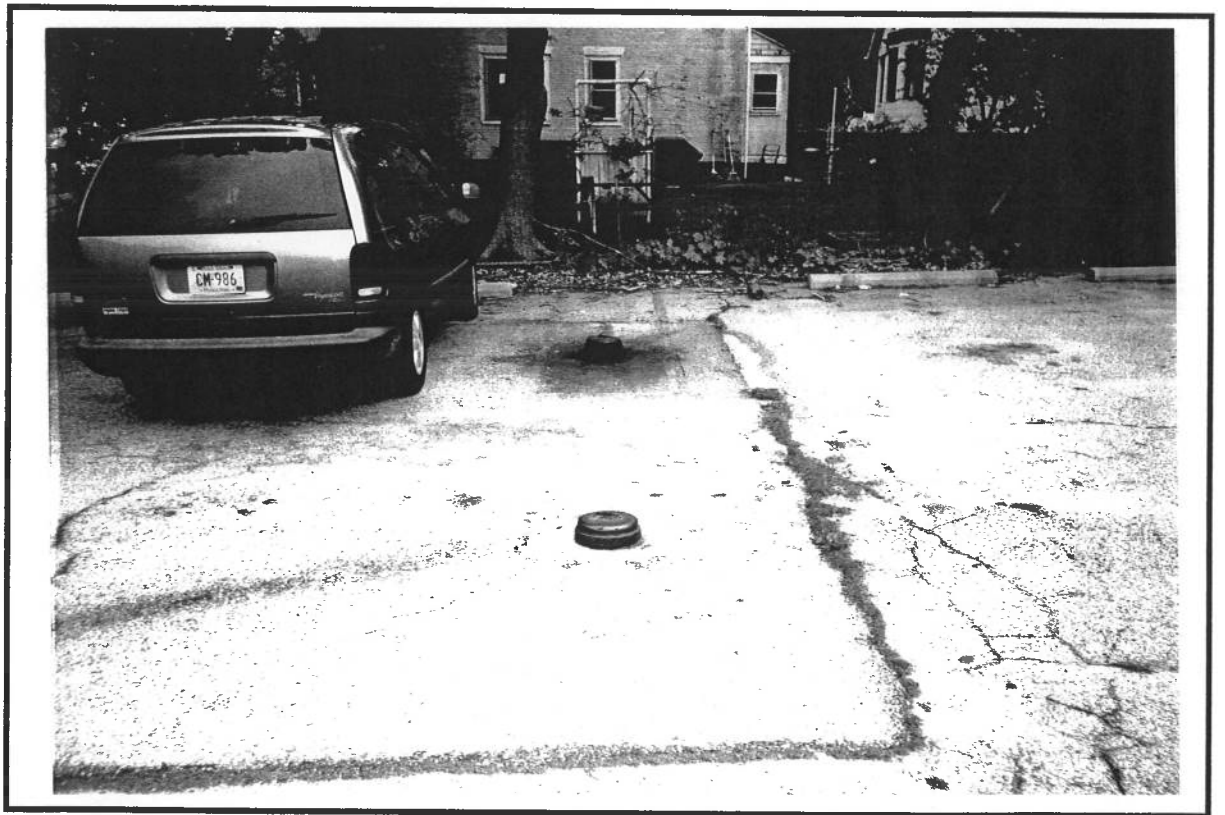
Photo No. 2: View of oil fill ports and footprint of 20,000-gallons of No 6 heating oil USTs.

The 125 Thames Street portion of the Site contains two known USTs located beneath the 106 Thames Street paved parking area (Lot 41); the oil fill ports are shown in photographs 1 and 2. According to the Site owner, the in-use USTs have a reported capacity of 20,000-gallons each of No 6 heating oil. Adjacent to the UST fill ports is a wooden cover that provides access to the transfer and steam piping. According to the Site owner, the transfer lines that extend beneath the roadway were recently replaced; refer to Section 6.20.2.

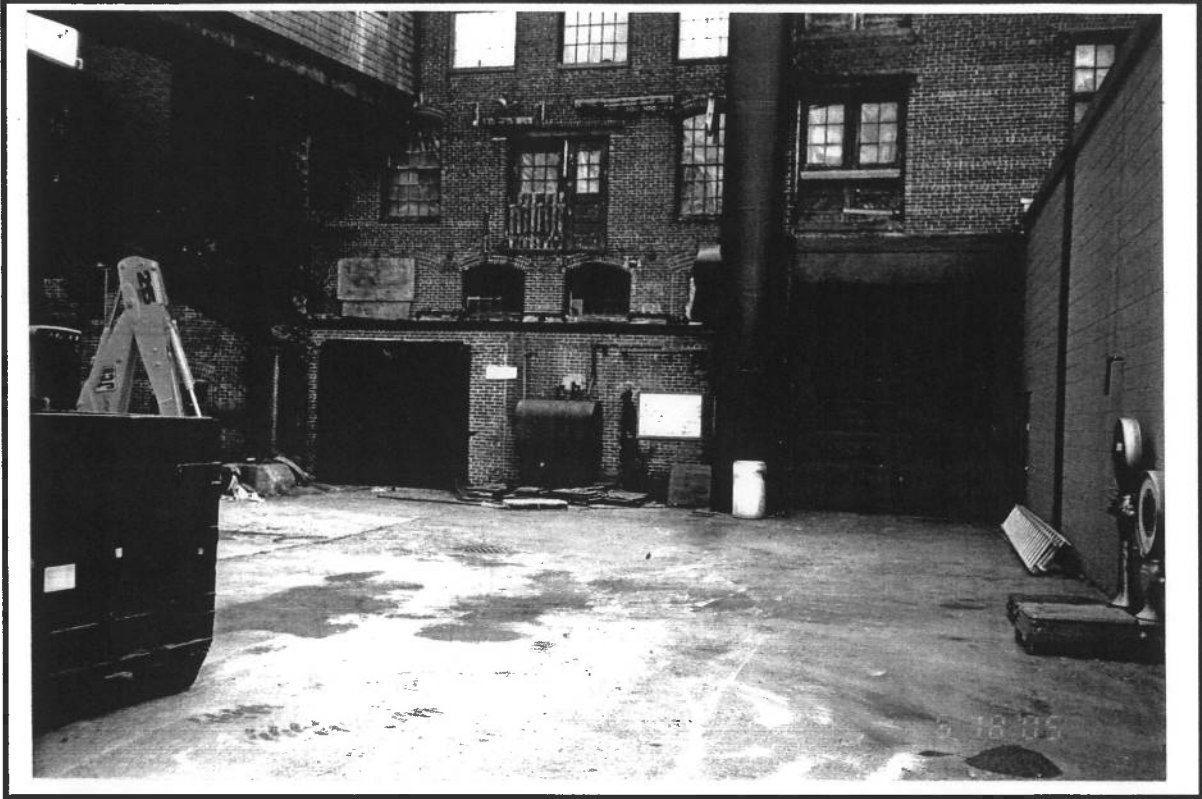
Photo No. 3: View of 275-gallon AST No. 6 overflow tank in the courtyard area to the north of Building 6.

The courtyard area to the north of Building 6 contains a 275-gallon AST No. 6 overflow tank; refer to photograph 3. No leakage was noted beneath the tank.

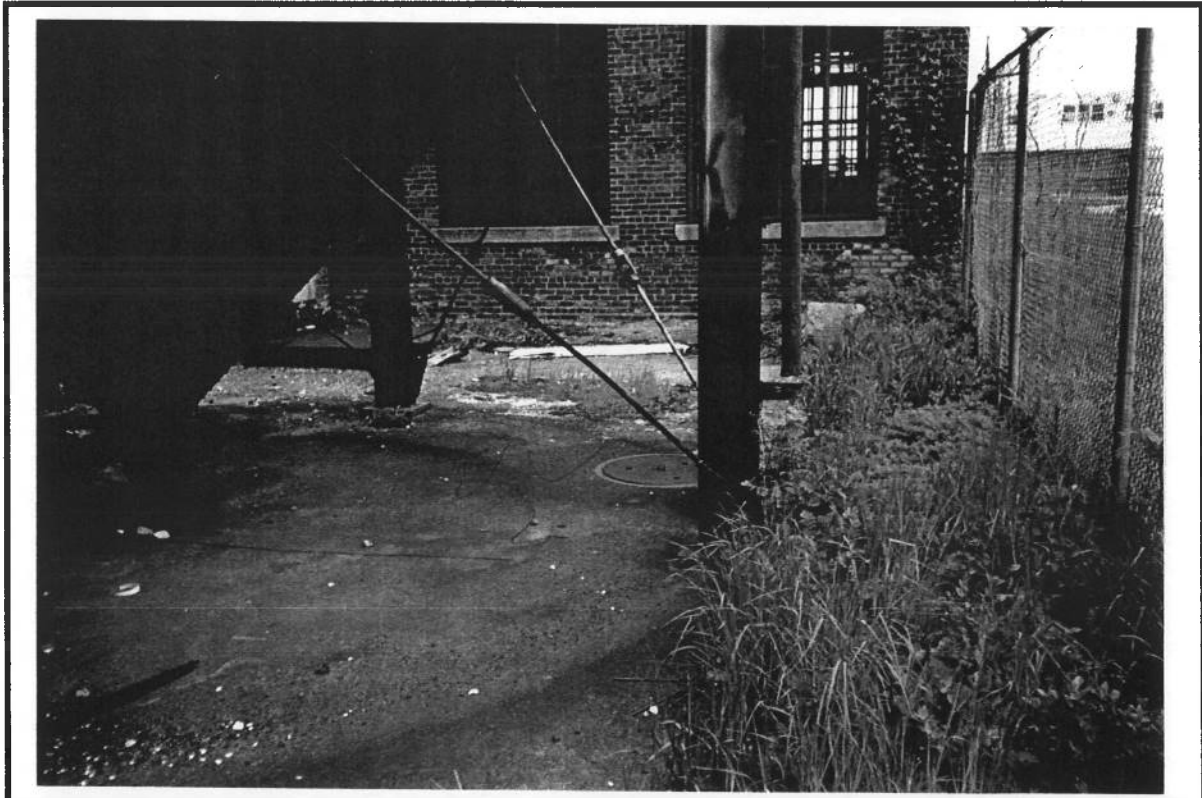
Photo No. 4: View of 60,000 gallon above ground receiving tank with a below ground concrete storage basin containing a pump and waste separator. Unpaved westerly grassed portion is beyond fence and extends to the seawall.

Area No. 15 contains a below ground water pit, i.e., concrete storage basin containing a pump and waste separator; refer to photograph 4. A sample of the suspected rainwater was obtained for visual inspection from an access cover. The water appeared clear in color; no evidence of suspended solids or an oil sheen was observed. Beyond its presence on historical maps, little is known about the actual use. It is assumed that the pit formerly functioned to remove solids from a waste stream from the dying waste process (likely before former discharge to the harbor). Refer to Section 9.8, laboratory analytical program.

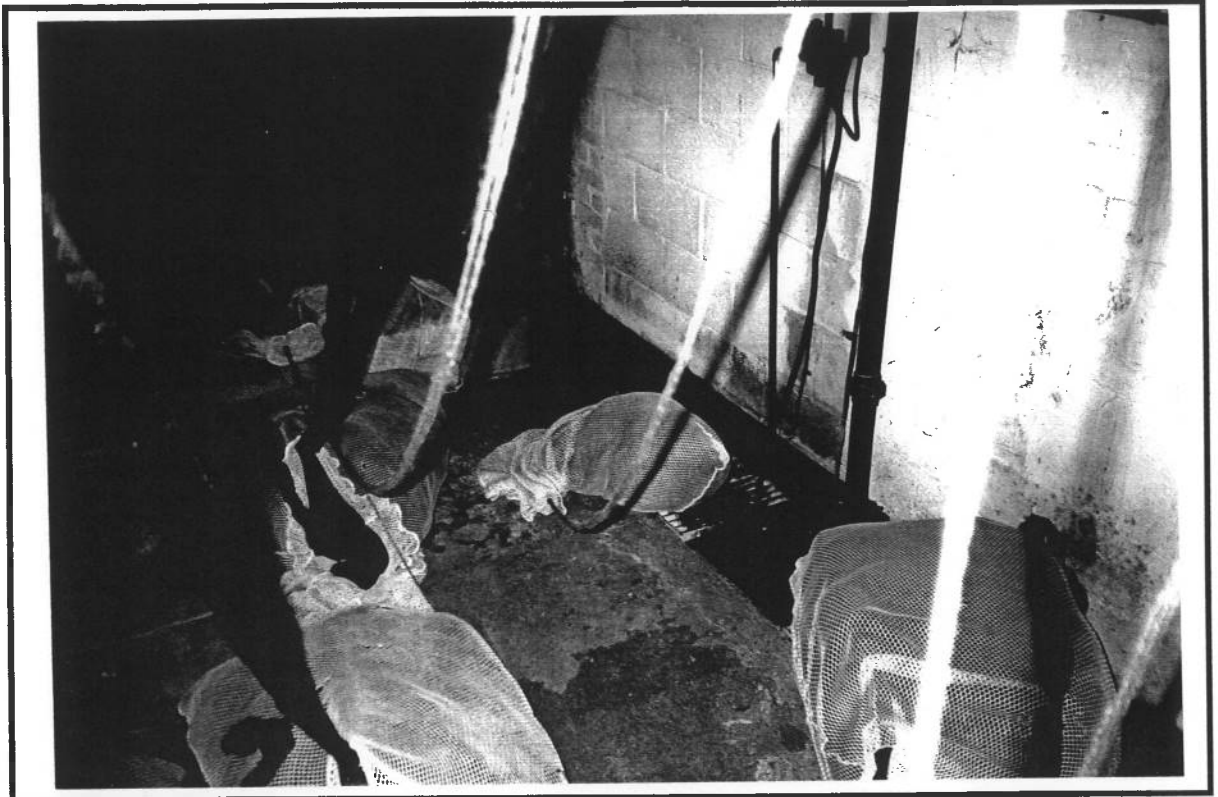
Photo No. 13: Sump pump.
