**Tim O'Connor & Company, LLC**  
environmental consultation

May 31, 2024

Re: Quarterly Report – 1st Quarter 2024  
Former Portsmouth Landfill

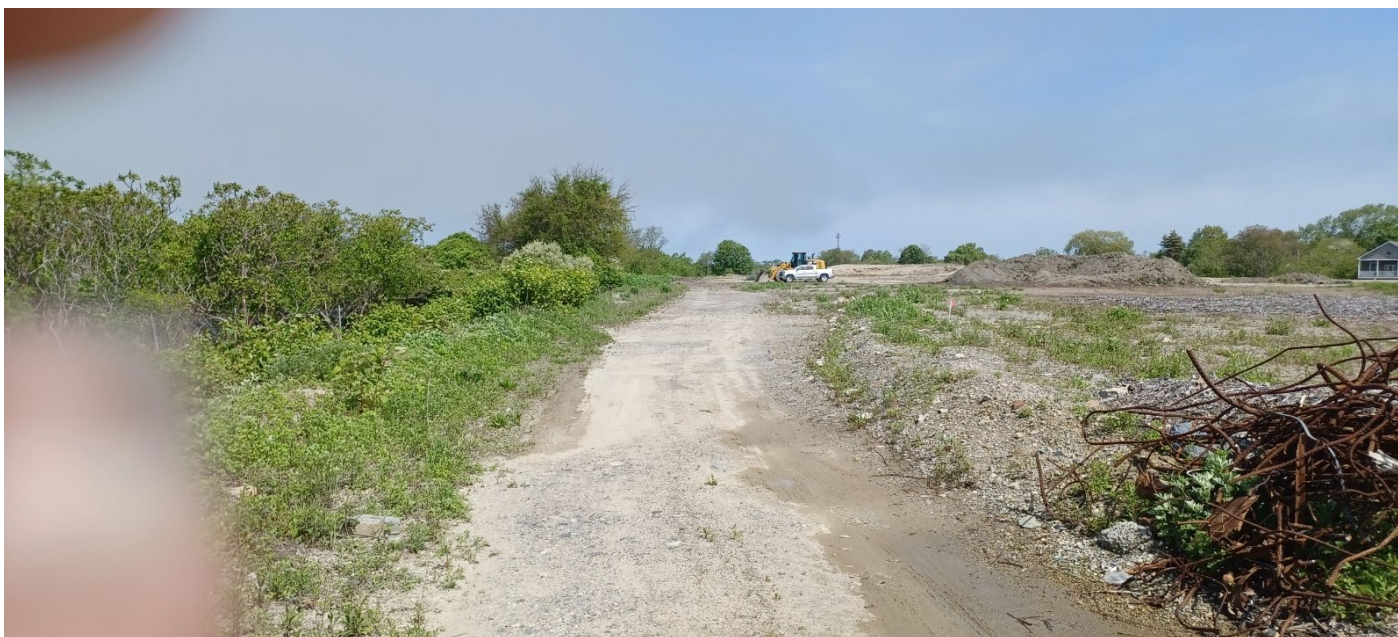
**Photo 2 – Western limit of disturbance near Park Avenue entrance**

Landscaping work was completed using hand tools to encourage vegetative growth on areas along the western and northern limits of disturbance.
